**TESTING AND EVALUATION OF THE NEW YORK  
TWO-RAIL CURBLESS AND FOUR-RAIL CURBLESS  
BRIDGE RAILING AND THE BOX-BEAM TRANSITION**

Contract No. DTFH61-98-C-00056  
Report No. 404531-F

**September 1999**

**TEXAS TRANSPORTATION INSTITUTE  
THE TEXAS A & M UNIVERSITY SYSTEM  
COLLEGE STATION, TEXAS**

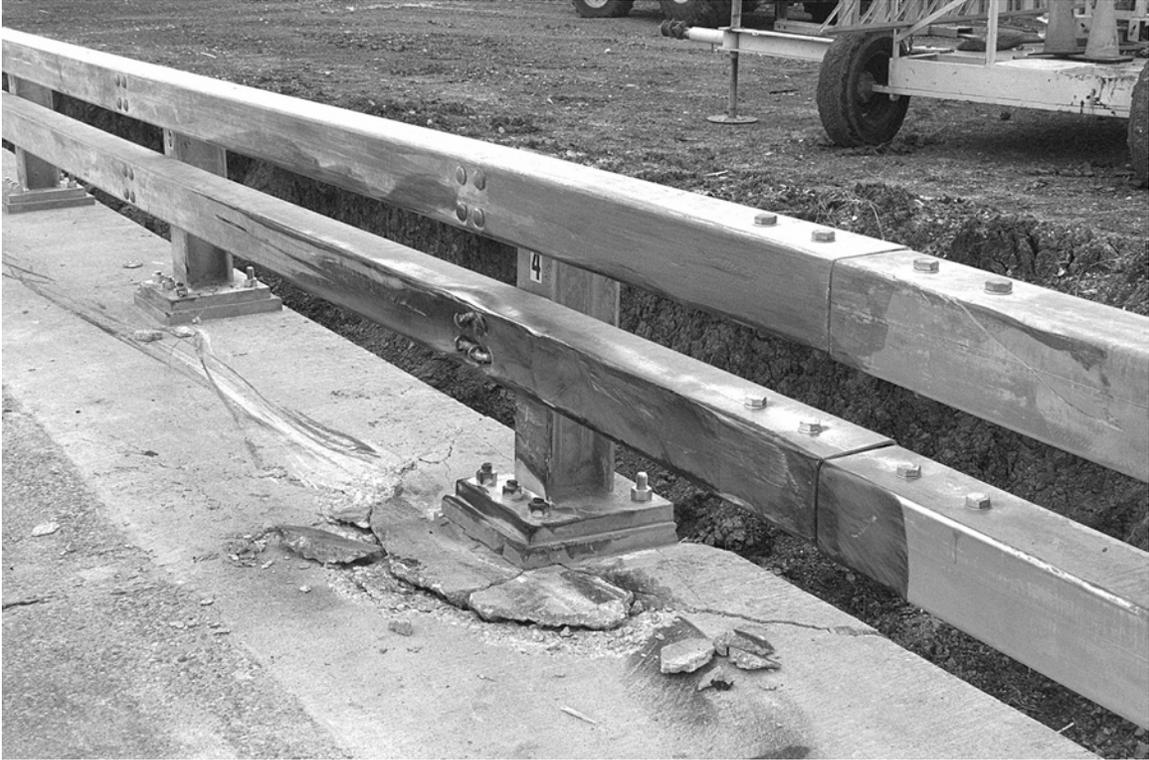
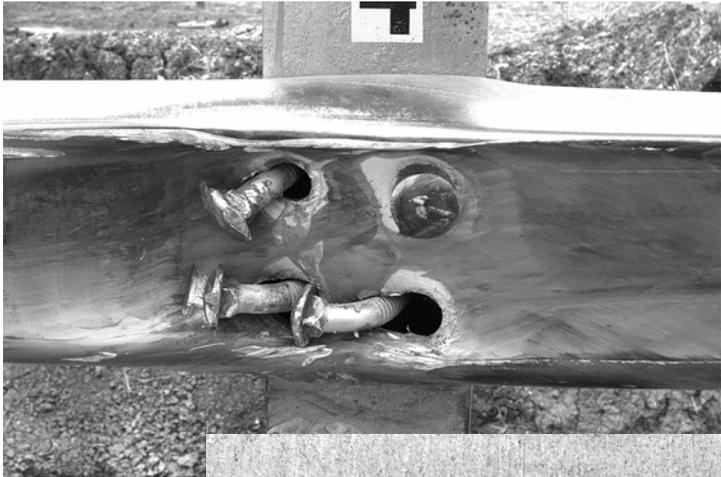
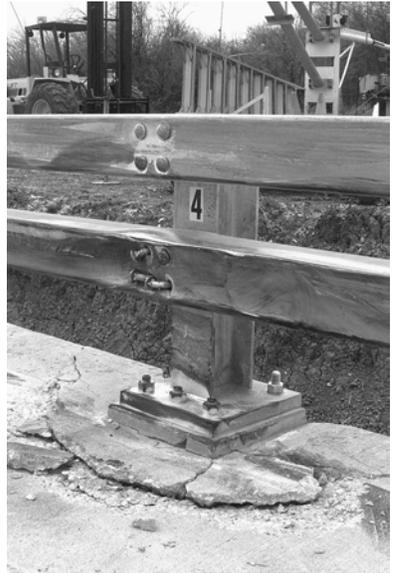
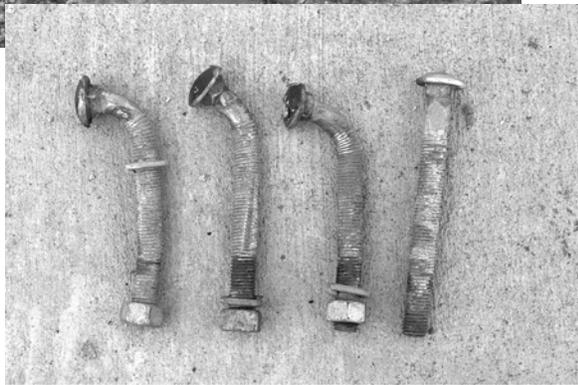
Figure 16. Damage to railing at post 4 after test 404531-2.

Damage to the New York Two-Rail Curbless Bridge Railing is shown in figures 15 through 17. Tire marks extended 225 mm behind the rail element at impact and tire marks were on the edges of the front and rear flange on the impact side of post 4, on the front face of the post and on the front anchor bolts. The tubular element in the vicinity of post 4 was partially flattened and the four bolts connecting the lower element were partially pulled out and deformed (see figure 16). Numerous cracks in the concrete deck surrounded post 4 and part of the concrete deck was broken away. After removal of the broken concrete around post 4, the exposed reinforcement did not show any signs of damage (see figure 17). At post 5, tire marks were on the front flange on the impact side of the post and extended 200 mm behind the rail element. Total length of vehicle contact with the rail elements was 3.3 m.

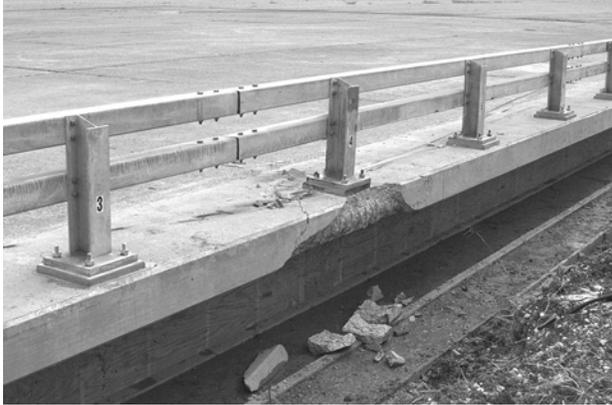
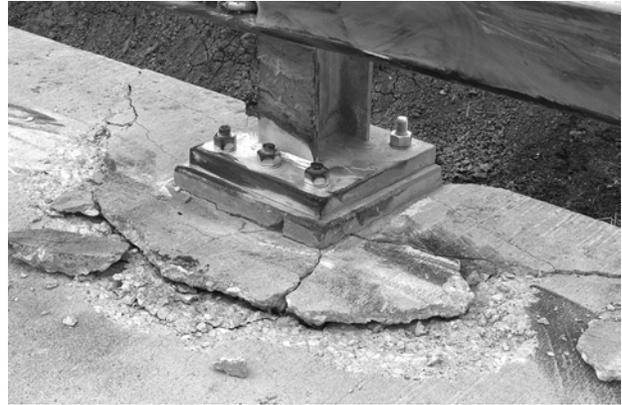
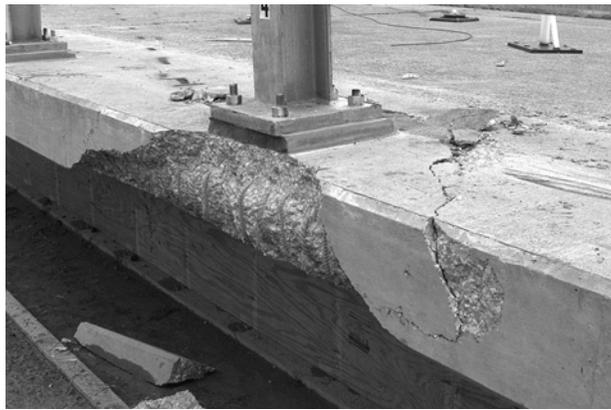
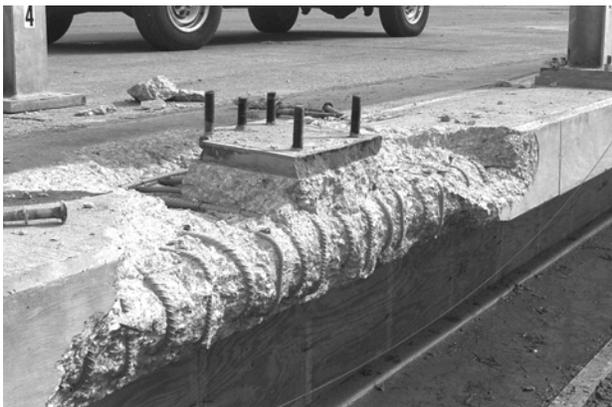
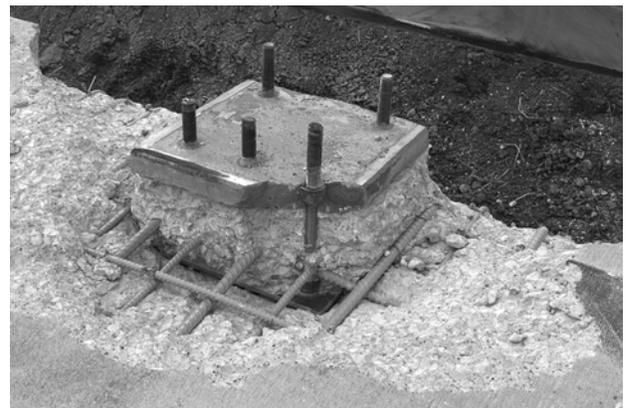
Figure 17. Damage to deck at post 4 after test 404531-2.

The concrete deck was damaged at post 4 during test 404531-2 (*NCHRP Report 350* test designation 4-11) which was performed on October 27, 1998. TTI was instructed by New York Department of Transportation personnel to remove all loose concrete from the damaged area, clean the exposed concrete surface, apply concrete bonding agent to the surface, reset the anchor plate assembly, and patch the damaged area with a comparable strength concrete patch. TTI personnel repaired the area as per these instructions on November 18, 1998. For the single-unit truck test, the impact point was moved away from this damaged area (three posts farther south) with the single-unit truck impacting the rail in the opposite direction from that of the pickup truck test. No cracking or other sign of distress was present around the repaired area before this test.

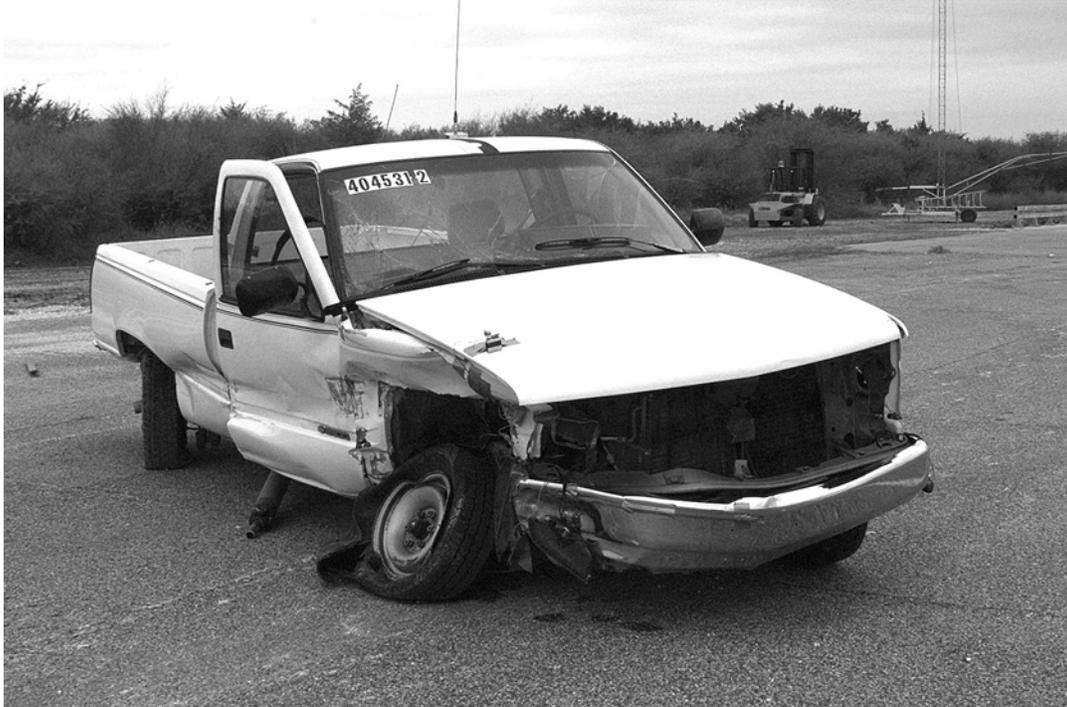
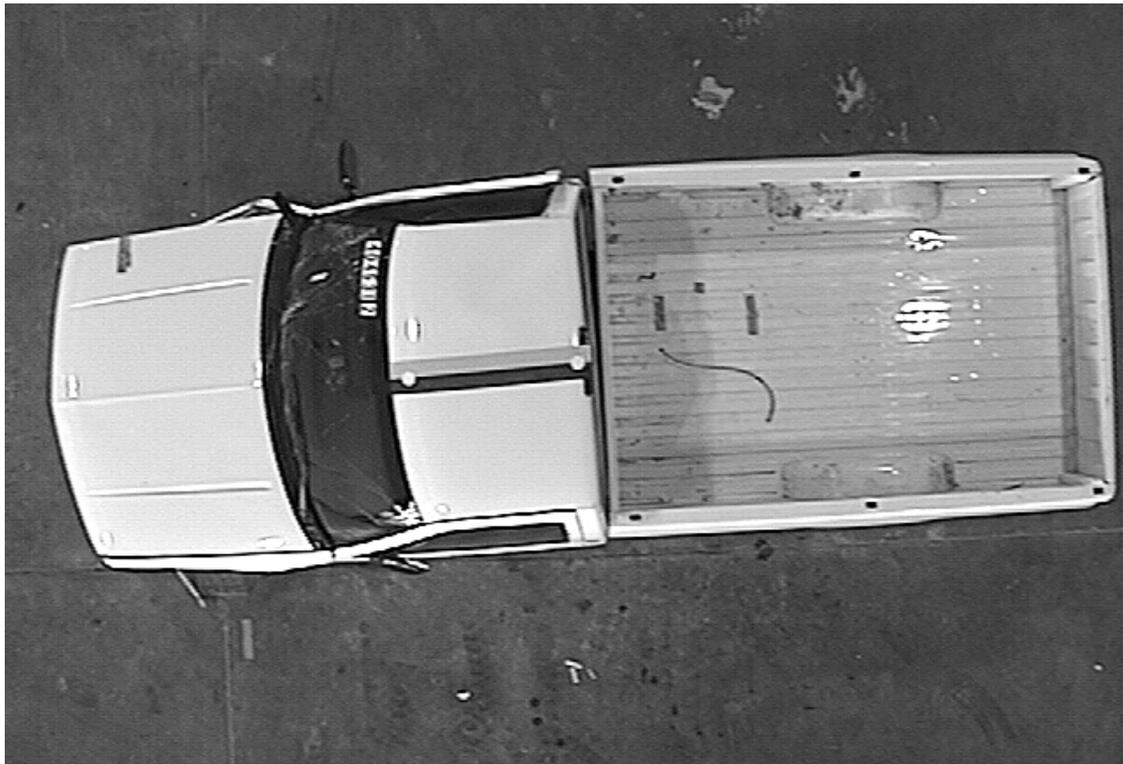
Figure 18. Vehicle after test 404531-2.

The vehicle sustained structural damage on the front right and the right side. The sway bar, tie rod, right front upper and lower A-arms, upper ball joint, right A-post, drive shaft, and transmission housing were all severely damaged. The front right portion of the bumper, hood, grill, fan, radiator, right front tire, and rim were damaged as shown in figure 18. The windshield was shattered and the right door was deformed outward 150 mm. The right front quarter panel and rear bed were dented. The front end of the vehicle shifted 150 mm to the left. At the rear of the vehicle on the right side, the rear tire and rim sustained damage, the rear axle was pushed back, and the rear U-bolts at the leaf springs were broken. The maximum exterior crush to the front bumper was 470 mm on the front and 340 mm on the right side. The floor pan was separated at the seam just above the upward curve (where the occupant's feet normally rest). The opening in the floor pan at the separation was judged to be wide enough to allow an occupant's foot to become jammed into the opening or go through (see lower photo in figure 19). This result was judged to have a potential for causing serious injury to the occupant. Maximum deformation of the occupant compartment was 199 mm (17.6-percent reduction in space) in the floor pan area and maximum reduction of space was 38.8 percent in the center floor pan to instrument panel area. The interior of the vehicle is shown in figure 19. Exterior vehicle crush and occupant compartment measurements are shown in appendix B, tables 13 and 14.

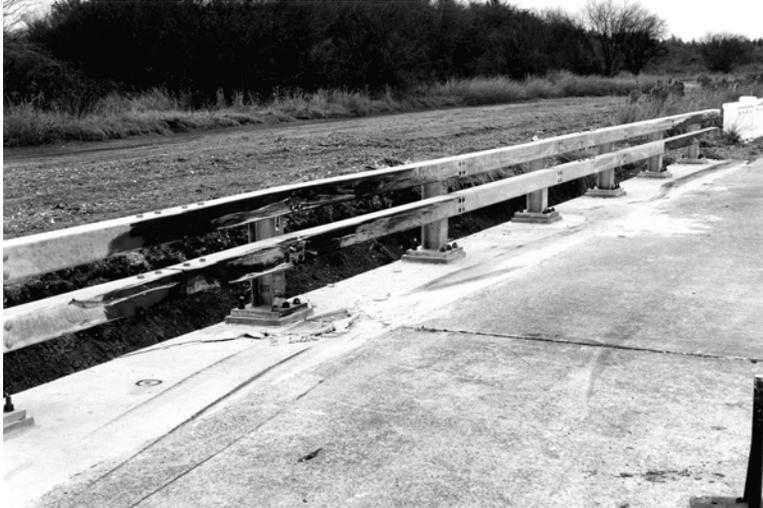
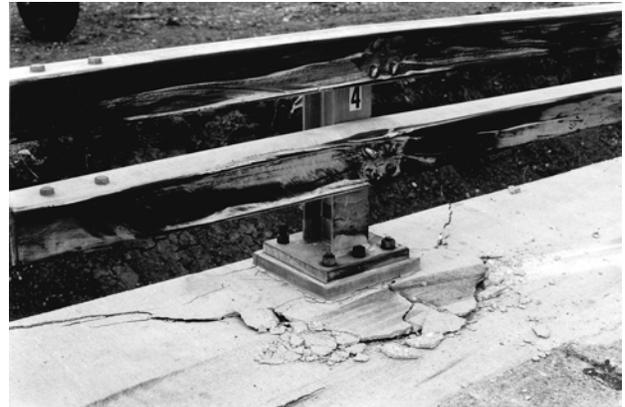
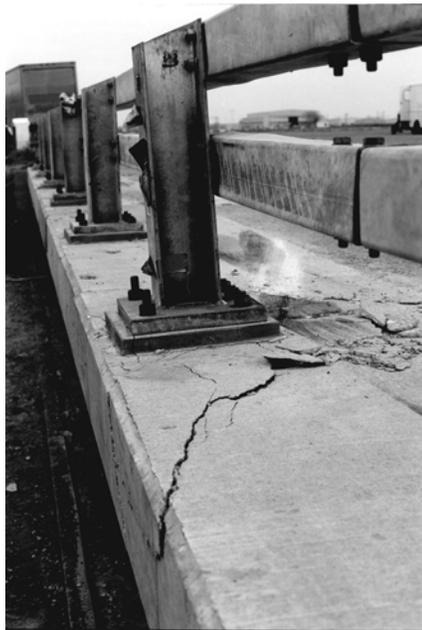
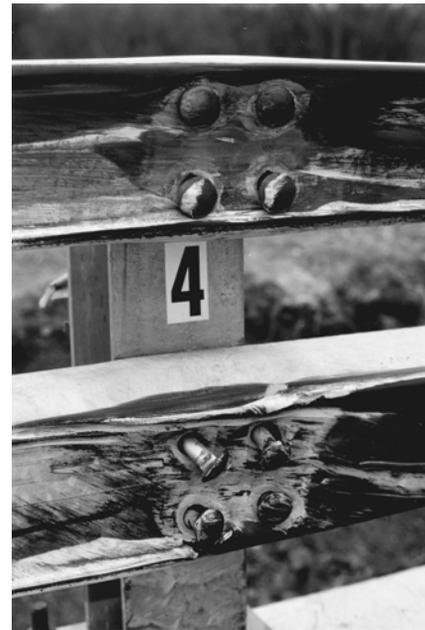
Figure 24. Damage at post 4 after test 404531-3.

Damage to the New York Two-Rail Curbless Bridge Railing is shown in figures 23 through 25. The bolts in the base of post 4 were rotated up and the rail element was partially flattened. The bolts in the lower rail element at post 4 were partially pulled out and deformed. The concrete deck around post 4 was structurally damaged. The vehicle was in contact with the bridge railing for 4.33 m. The bottom of the box-van caught the top of post 6, which rotated slightly. The vehicle lost contact, impacted the bridge railing again 400 mm downstream of post 7, and then rode along and off the end of the railing. Maximum dynamic deflection of the rail element was not attainable due to the vehicle size. Maximum permanent deformation was 30 mm.

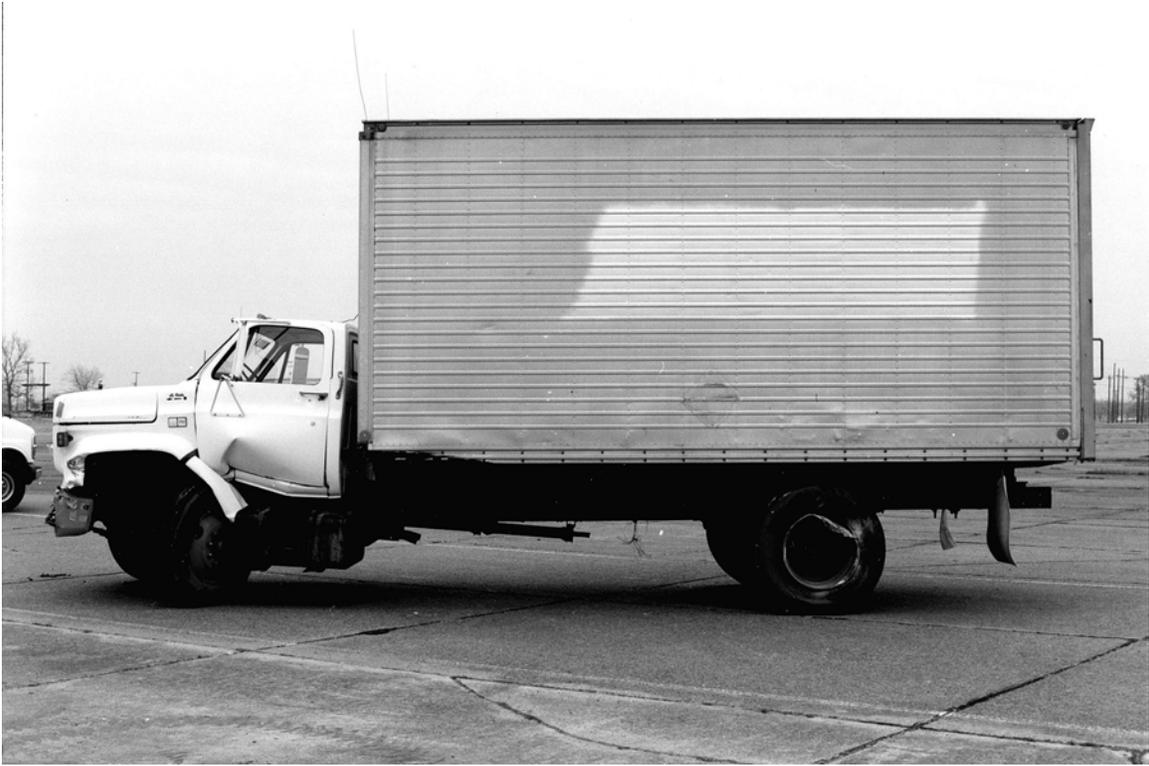
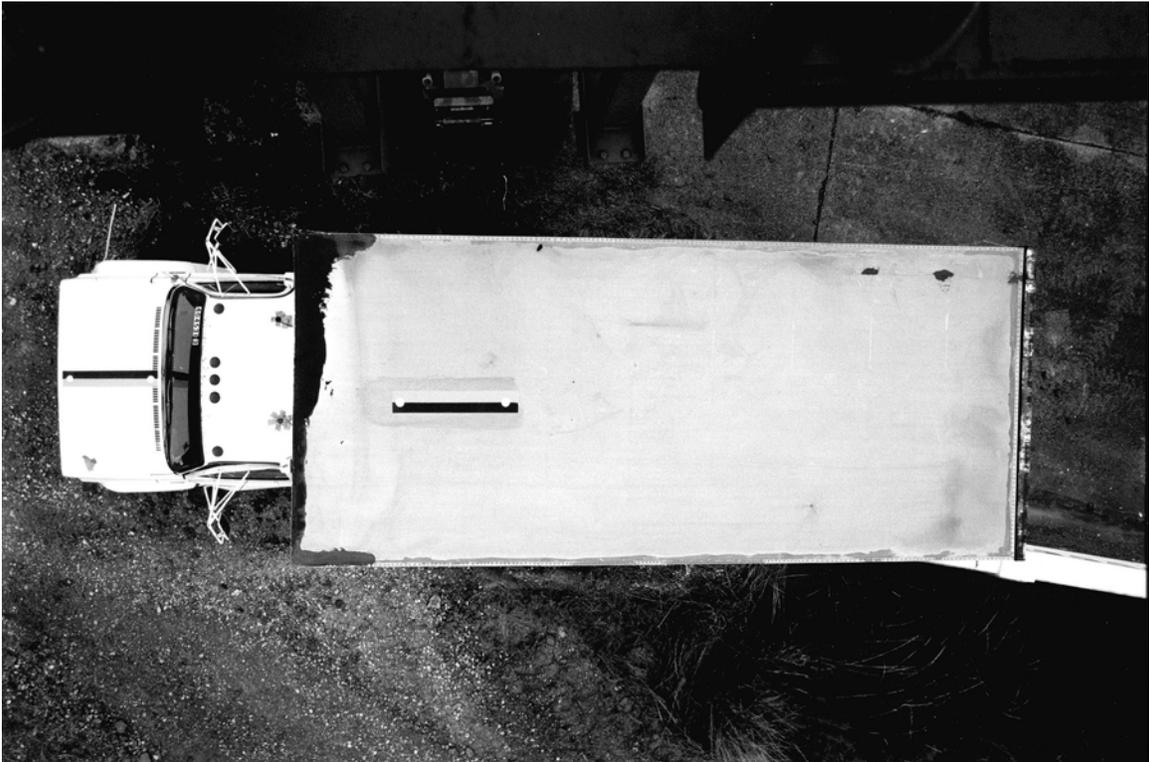
Figure 26. Vehicle after test 404531-3.

Damage to the vehicle is shown in figure 26. Structural damage included deformed left front springs, U-bolts and shock bolt. Also damaged were the front bumper, left front quarter panel, left door, left side fuel tank, left front and rear outside wheel rims, and the under side of the box-van on the left front corner. Maximum exterior crush was 230 mm to the left side at the front corner near bumper height. Maximum occupant compartment deformation was 80 mm at the side panel near the driver door. The interior of the vehicle is shown in figure 27.

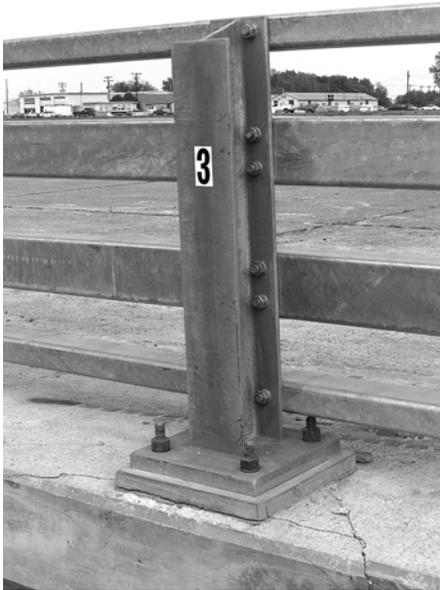
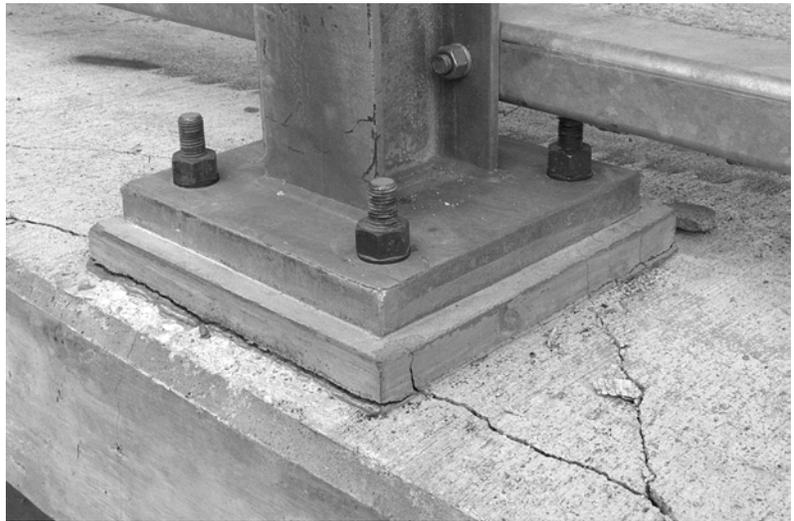
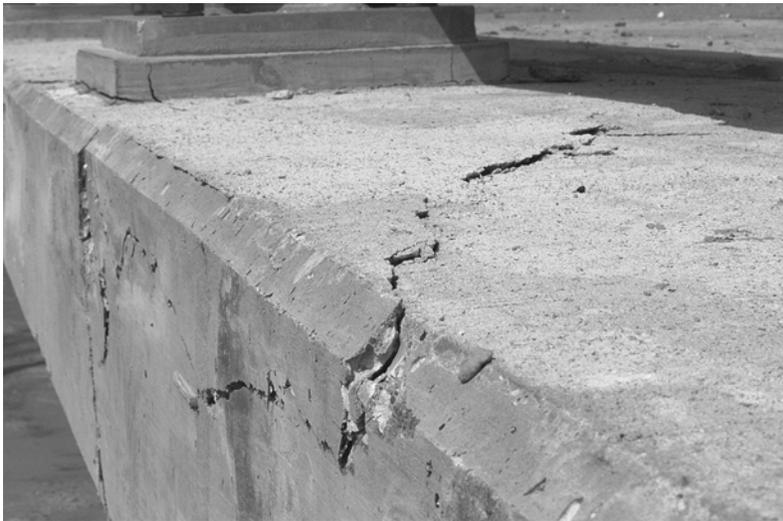
Figure 33. Damage to deck at post 3 after test 404531-4.

Damage to the New York Four-Rail Curbless Bridge Railing is shown in figures 31 through 33. The lower TS 152x152x4.8 tube was deformed inward where the vehicle made initial contact. The concrete deck around post 3 and 4 was structurally damaged. The vehicle was in contact with the railing 5.0 m and then again from post 8 to the end of the installation. Maximum dynamic deflection was not attainable due to vehicle blocking the view. Maximum permanent deformation was 10 mm.

The New York Four-Rail Curbless Bridge Railing contained and redirected the 8000S vehicle. The vehicle did not penetrate, underide, or override the installation. Minimal lateral deflection occurred; however, the bridge deck was structurally damaged around the posts on either side of impact.

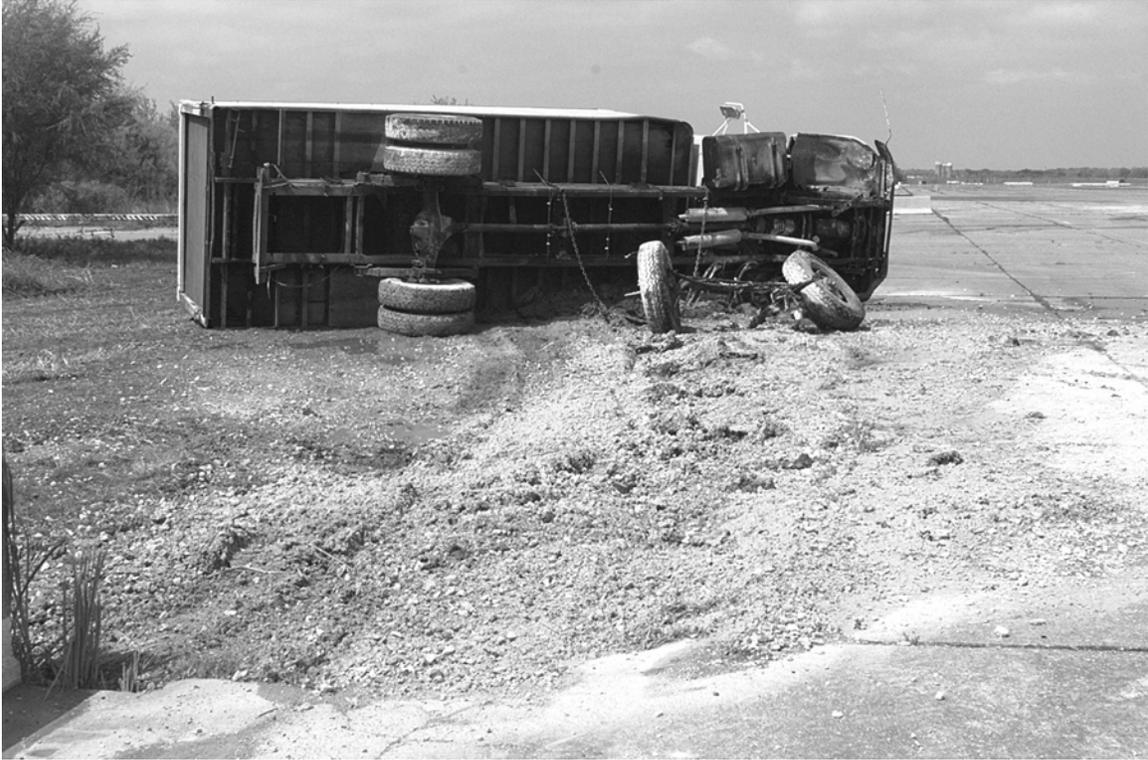
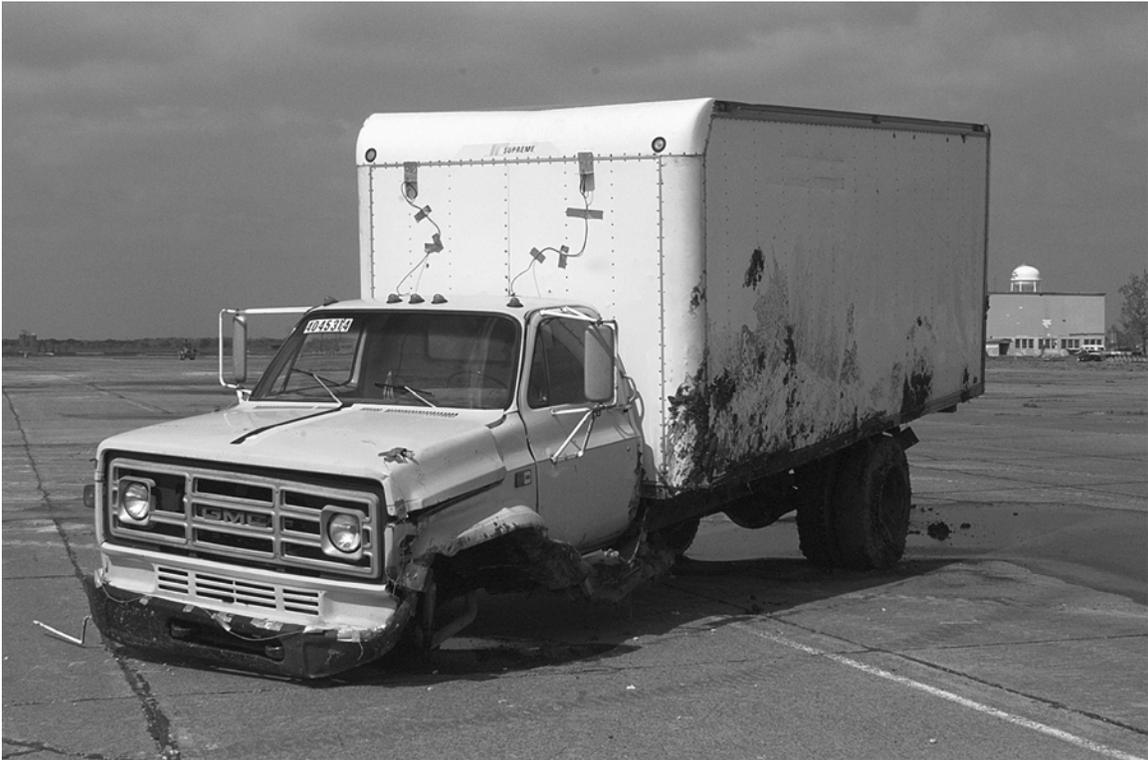
Figure 34. Vehicle after test 404531-4.

The vehicle sustained damage to the left front corner as shown in figures 34 and 35. The front axle, springs, and shocks were separated from the vehicle. The steering arm, rod ends, and left front frame were deformed. Also damaged were the front bumper, hood, grill, fan, radiator, left front quarter panel, left door and step, left front tire and rim, left side of the box, right front quarter panel, and left rear outside tire and rim. The fuel tank straps were loose and the floor pan and firewall were slightly deformed. Maximum exterior crush to the vehicle was 300 mm to the left front corner at bumper height. No measurable deformation occurred to the interior occupant compartment. The interior of the vehicle is shown in figure 36.
