# Testing of New Bridge Rail and Transition Designs

## Volume I: Technical Report

PUBLICATION NO. FHWA-RD-93-058

7. Author(s) C. Eugene Buth, T. J. Hirsch, and Wanda L. Menges		8. Performing Organization Report No. Research Foundation 7069-Vol. I	
9. Performing Organization Name and Address Texas Transportation Institute The Texas A&M University System College Station, Texas 77843-3135		10. Work Unit No. NCP No. 3A5C0042	11. Contract or Grant No. DTFH61-86-C-00071

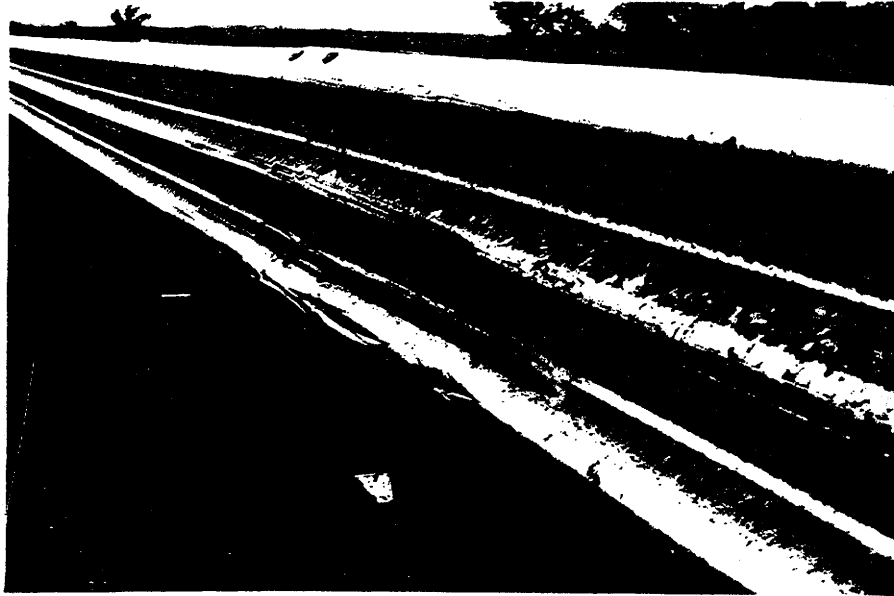
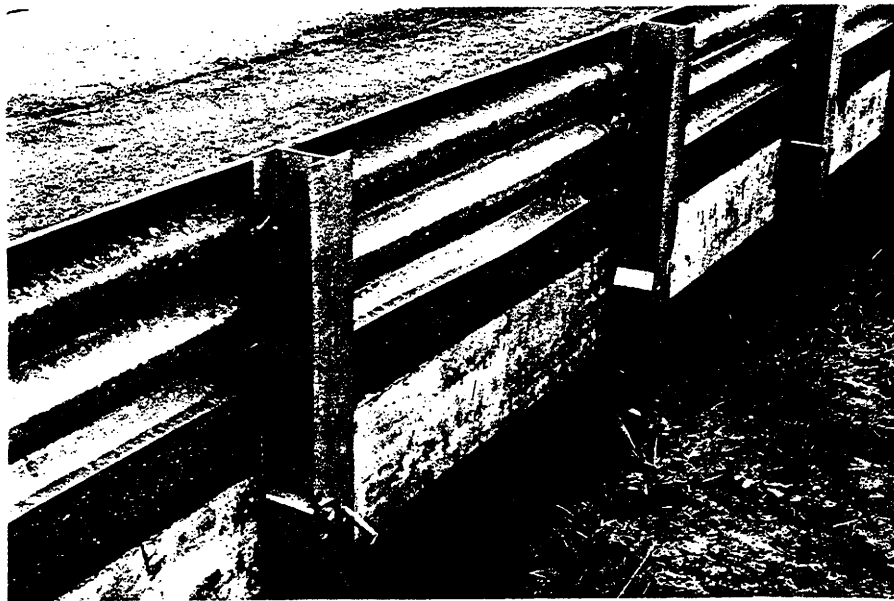
Figure 20. Damage to railing system in test 7069-17.

The railing received moderated damage (figure 20). Maximum lateral deflection was 0.5 in (13 mm) at the top of post 5. At post 4, the top anchor bolts connecting the post to the bridge deck showed structural distress. One bolt was pulled from the anchor insert in the concrete. Post 5 was bent outward about 0.5 in (13 mm) at the top and the top anchor bolts showed structural distress. One of the bolts in this post was also pulled from the anchor insert.

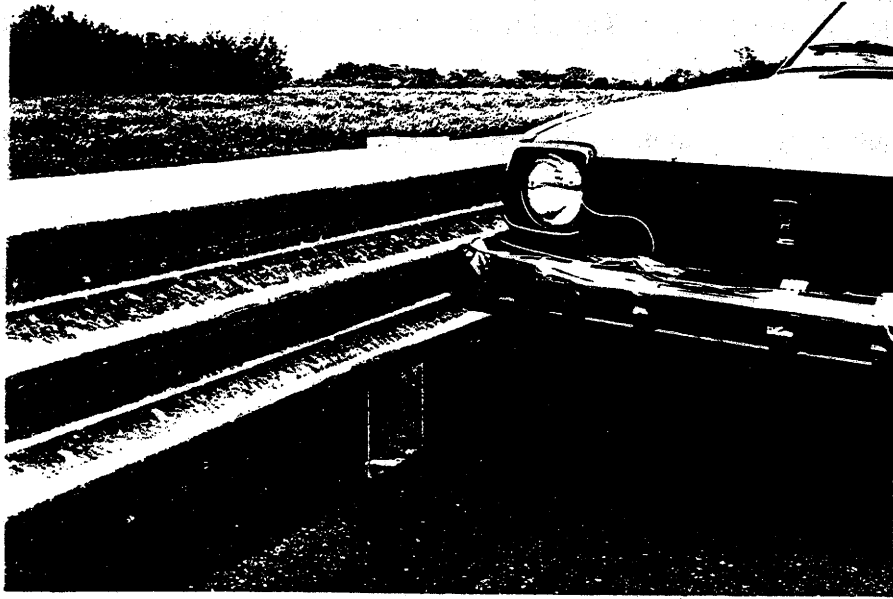
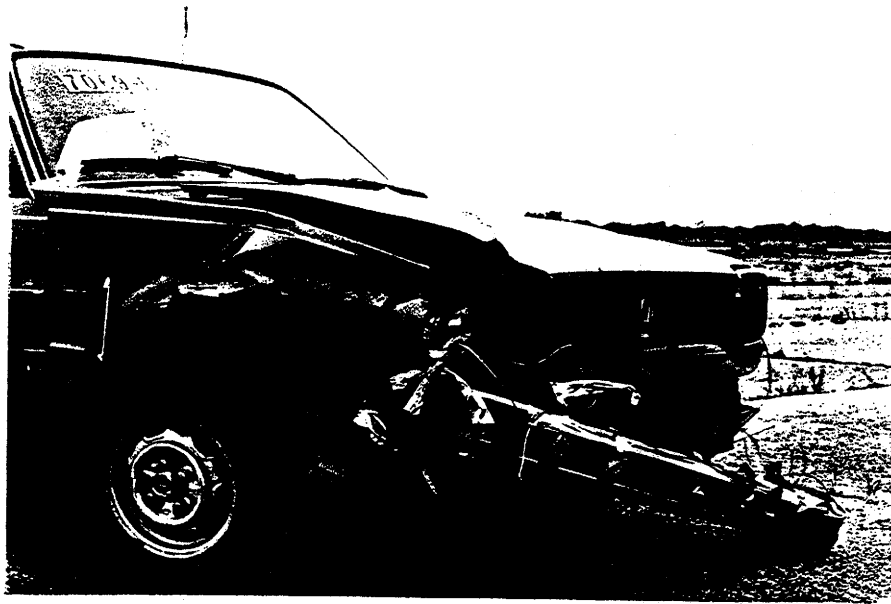
Figure 21. Vehicle and railing for test 7069-17.

The vehicle sustained damage to the right side (figure 21). Maximum crush at the right front corner at bumper height was 9.0 in (229 mm). The strut and constant velocity joint on the impact side were damaged. The right front wheel was canted inward at the bottom and pushed back into the fender well. The right side window was broken out by the dummy's head. Also, damage was done to the front bumper, hood, grill, radiator and fan, right front quarter panel, and right door.

The railing contained the vehicle with minimal lateral movement of the bridge railing. There was no intrusion into the occupant compartment and no deformation of the compartment. The vehicle remained upright and relatively stable during the collision. The bridge railing smoothly redirected the vehicle and the effective coefficient of friction was

considered fair. The occupant risk factors were within the limits recommended in the 1989 AASHTO guide specifications.<sup>(3)</sup> The vehicle trajectory at loss of contact indicates minimum intrusion into adjacent traffic lanes.

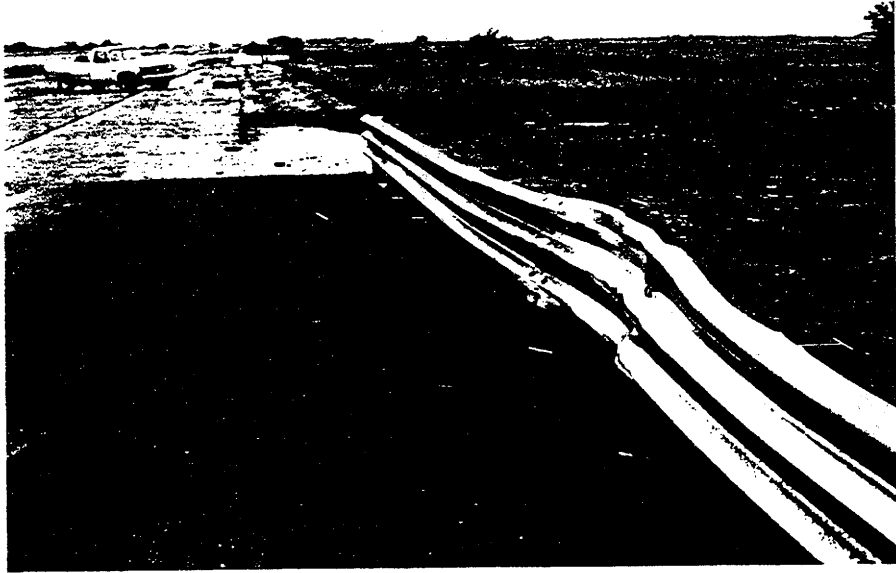
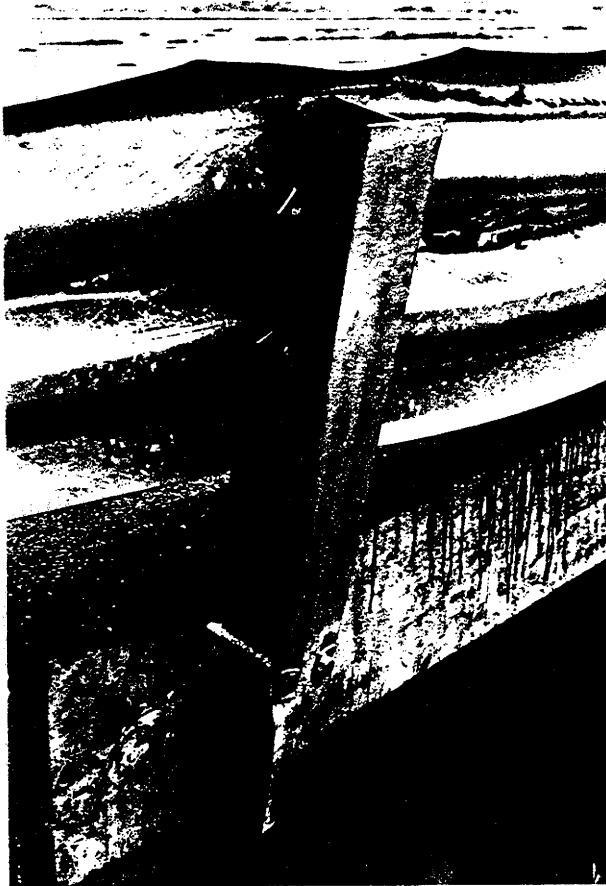
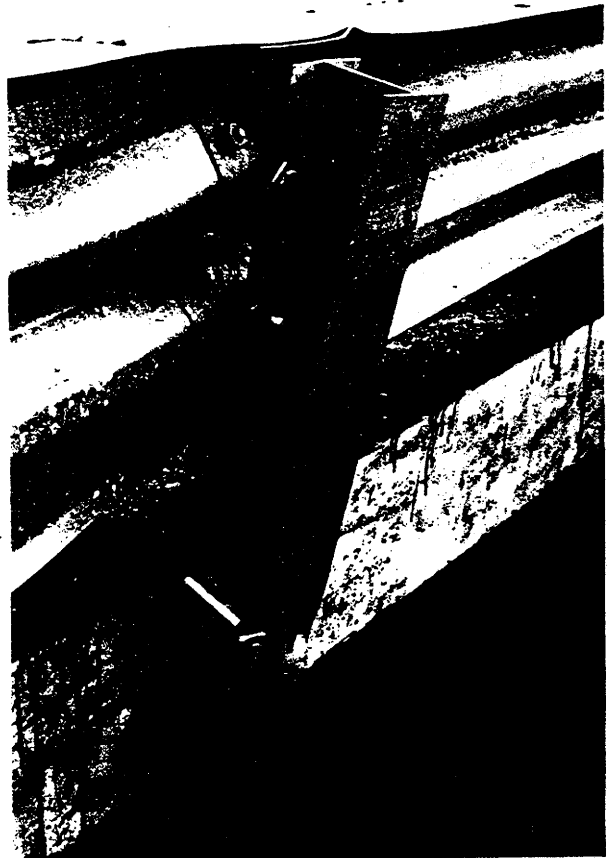
Figure 23. Damage to railing in test 7069-18.

The railing received moderate damage (figure 23). At post 8 the upper deck bolts connecting the post to the bridge deck were bent and the post was bent back 1.5 in (38 mm) at the bridge deck surface. Post 9 was bent 2.5 in (64 mm), the upper deck bolt on the right side was bent, and the upper deck bolt on the left side pulled through the outer flange. Post 10 was slightly twisted. Maximum lateral deflection was 13.0 in (330 mm) at the top of the thrie-beam between posts 8 and 9.

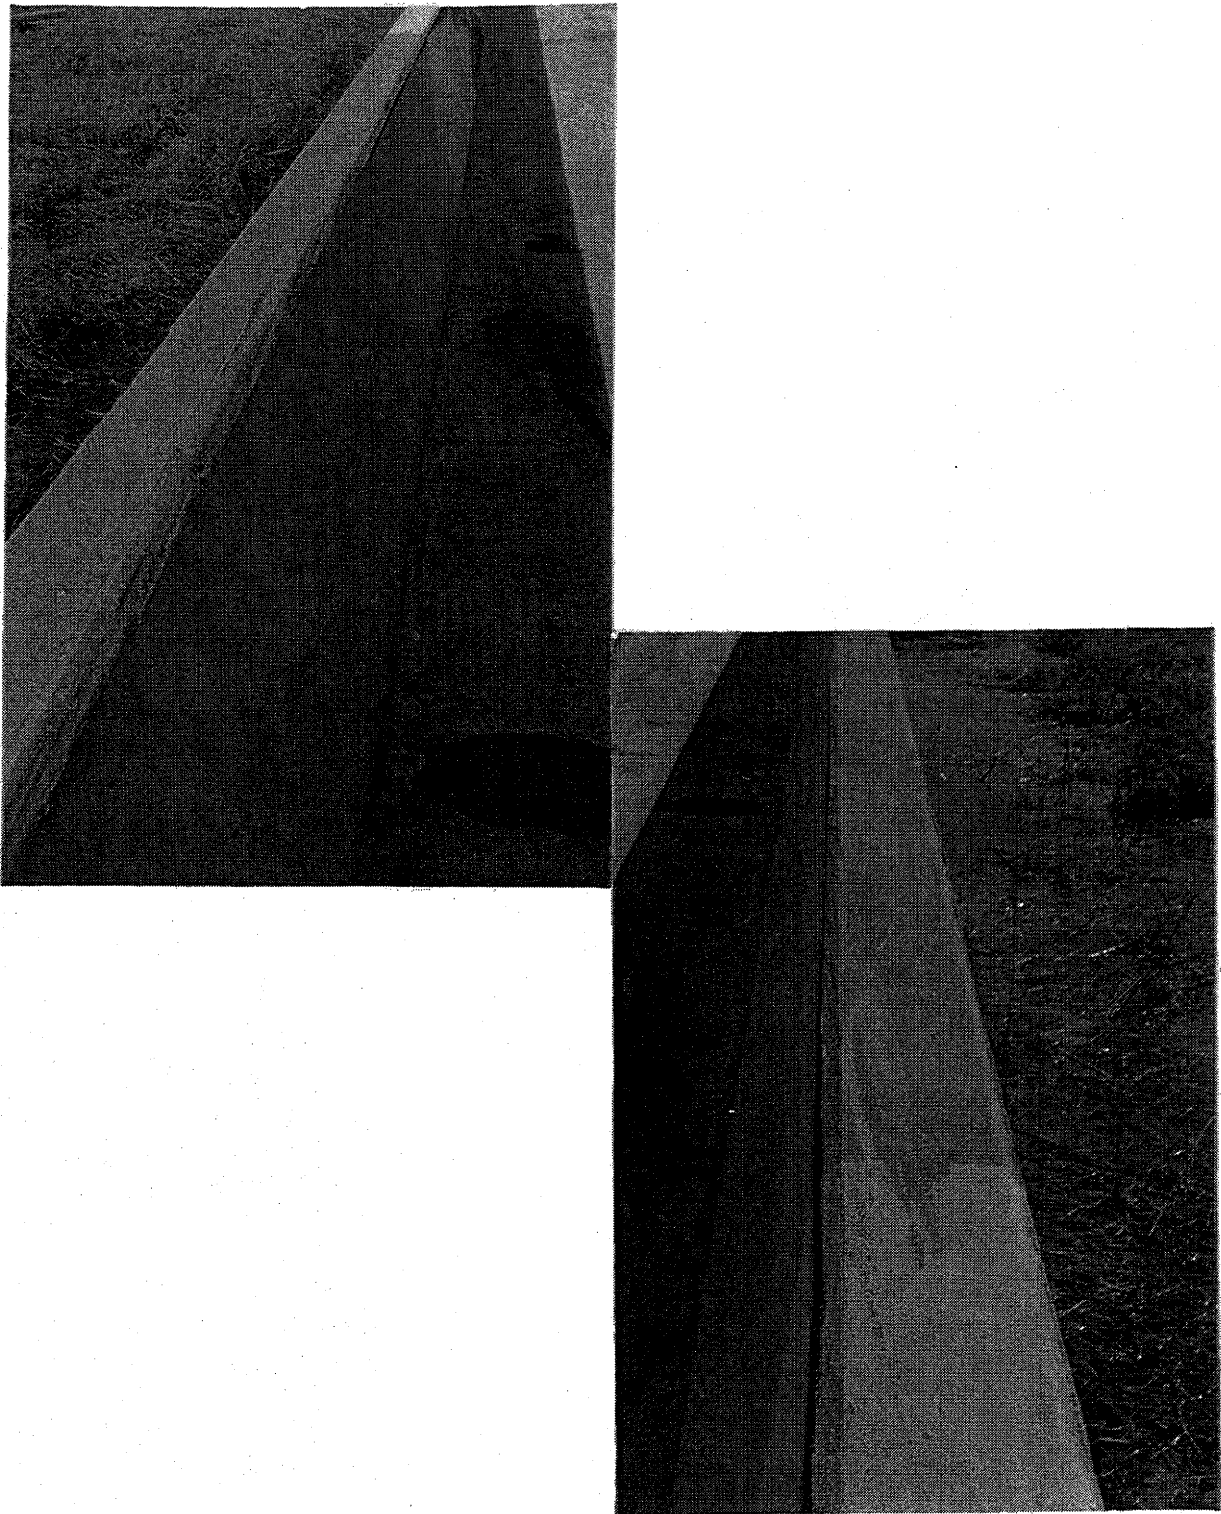
Figure 34. Damage to top of bridge railing caused by lower edge of bed of vehicle.

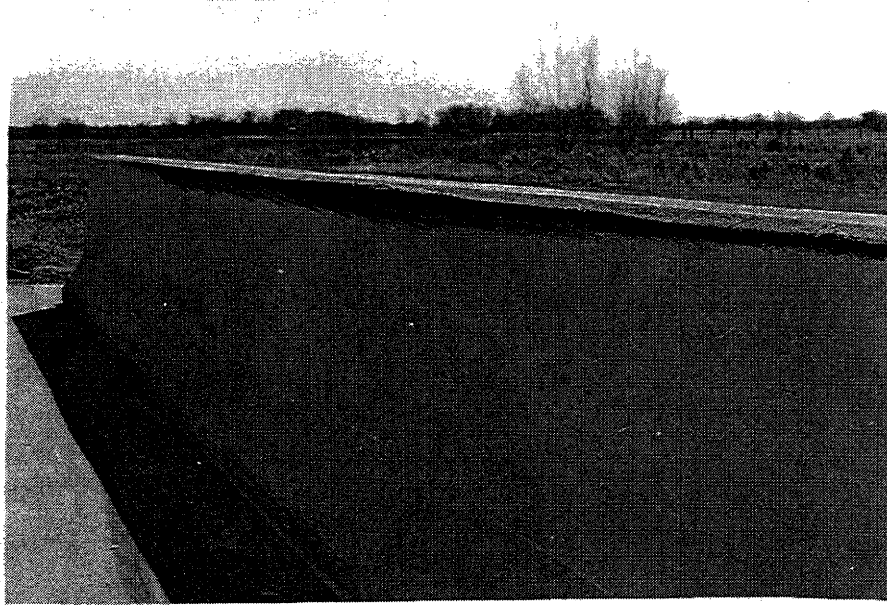
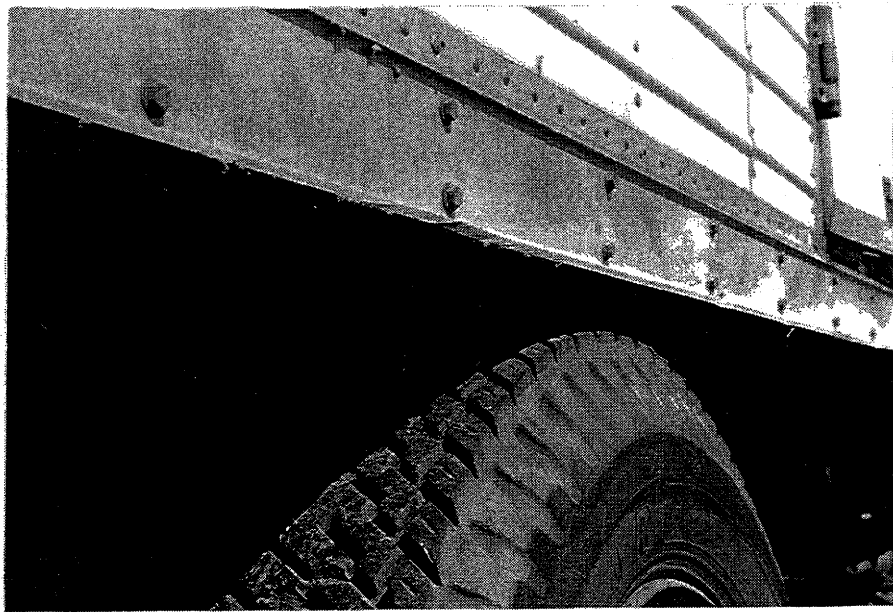
Figure 50. Damage to top of bridge railing and to lower edge truck bed.
