1. Report No. FHWA/TX-04/4852-1		2. Government Accession No.		3. Recipient's Catalog No.	
4. Title and Subtitle CRASH TESTING AND EVALUATION OF THE MODIFIED T77 BRIDGE RAIL				5. Report Date September 2003

CRASH TESTING AND EVALUATION OF THE MODIFIED T77 BRIDGE RAIL

Report 4852-1
Project Number 0-4852
Research Project Title: Development of the T77 Bridge Rail

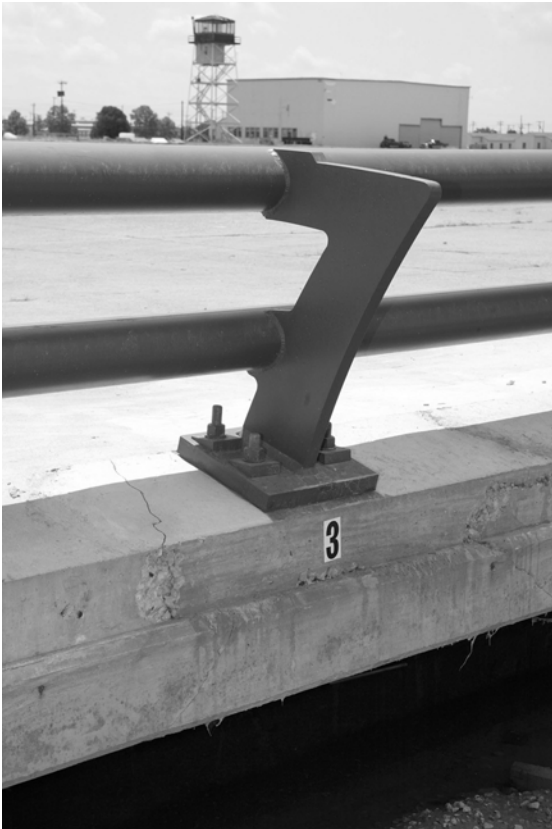
Figure 18. Installation After Test 409260-1.

Damage to the T77 bridge rail is shown in Figures 17 and 18. Cracks radiated out of the front and rear anchor bolts of post 3 and 4 and extended toward and down the rear side of the curb and into the deck. The traffic face of the curb was also fractured below the baseplate of post 4. Total length of contact of the vehicle with the bridge rail was 12.4 ft (3.8 m). Maximum dynamic deflection of the rail element was not attainable and maximum permanent deformation was 0.7 inch (18 mm).

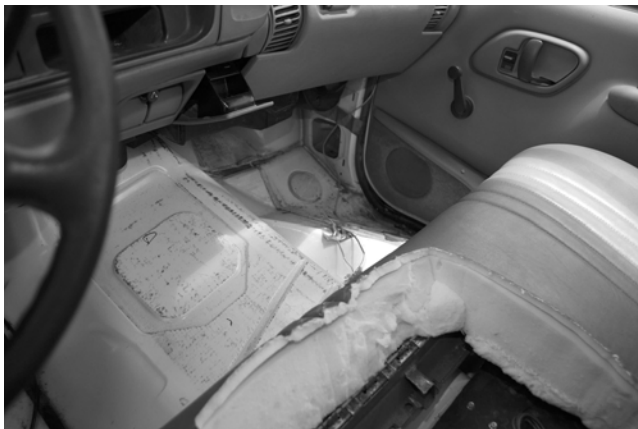
Figure 20. Interior of Vehicle for Test 409260-1.

Results: No detached elements, fragments, or other debris were present to penetrate or to show potential for penetrating the occupant compartment, or to present undue hazard to others in the area. Maximum occupant compartment deformation was 3.0 inches (76 mm) in the center front floor pan area over the transmission tunnel and in the left kick panel laterally across the cab. (PASS)
