**FULL-SCALE 18,000 LB. VEHICLE CRASH TEST  
ON THE  
IOWA RETROFIT CONCRETE  
BARRIER RAIL**

**TRANSPORTATION RESEARCH REPORT TRP-03-19-90**

January, 1990

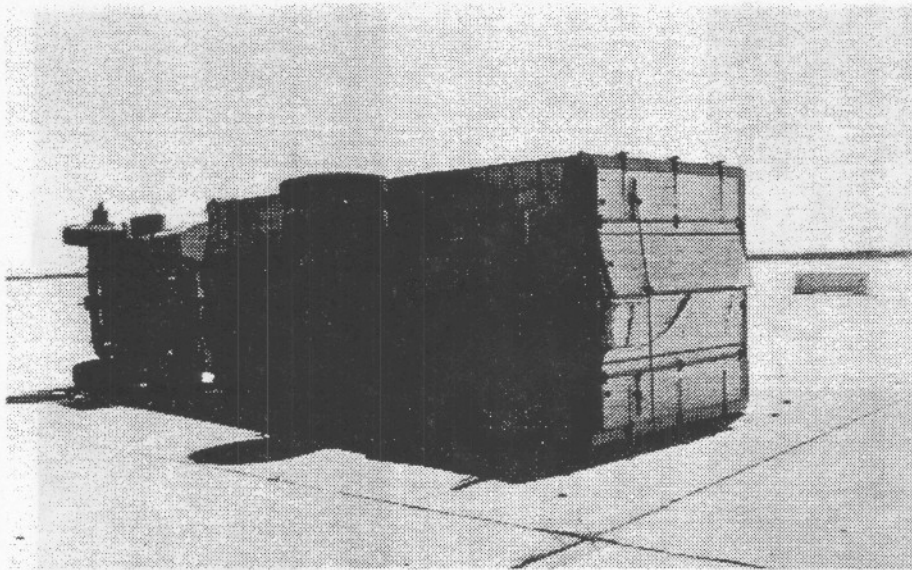
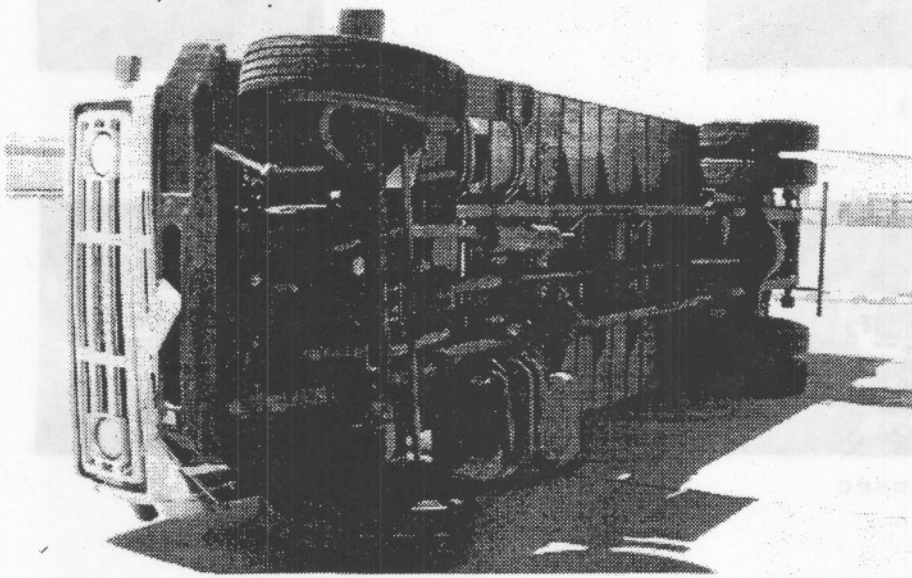
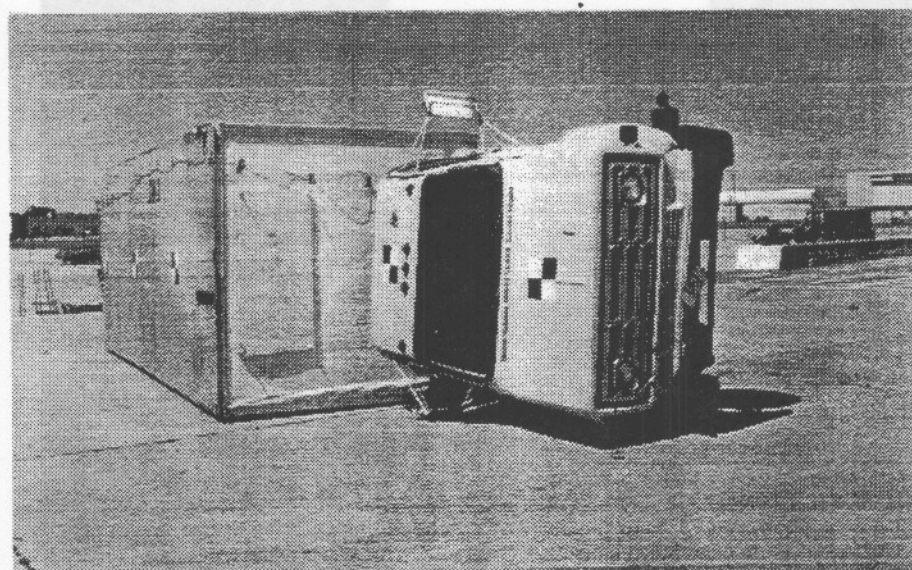
Figure 21. Photographs of vehicle damage, Test I4-1.

Upon impact with the retrofit concrete barrier rail, the right front corner of the vehicle was crushed and the wheel was bent inward. After the initial impact, the vehicle rode up on the barrier and slid along the remaining length. There was significant clockwise rolling motion as the vehicle slid along the barrier with a maximum roll angle of 31.4 degrees. After the vehicle exited from the barrier, it rolled in the counterclockwise direction for a short period of time. Hence, the momentum of the vehicle caused it to roll in the clockwise direction and tip over onto the passenger side of the vehicle. The vehicle came to rest on the passenger side of the vehicle approximately 160 ft. downstream from the point of impact.

Photographs of the vehicle damage are shown in Figure 21. The TAD (7) and VDI (8) damage classifications are shown in Figure 19. Photographs of the minimal damage to the retrofit concrete barrier rail are shown in Figure 22. Some concrete spalling occurred due to the initial impact of the vehicle.

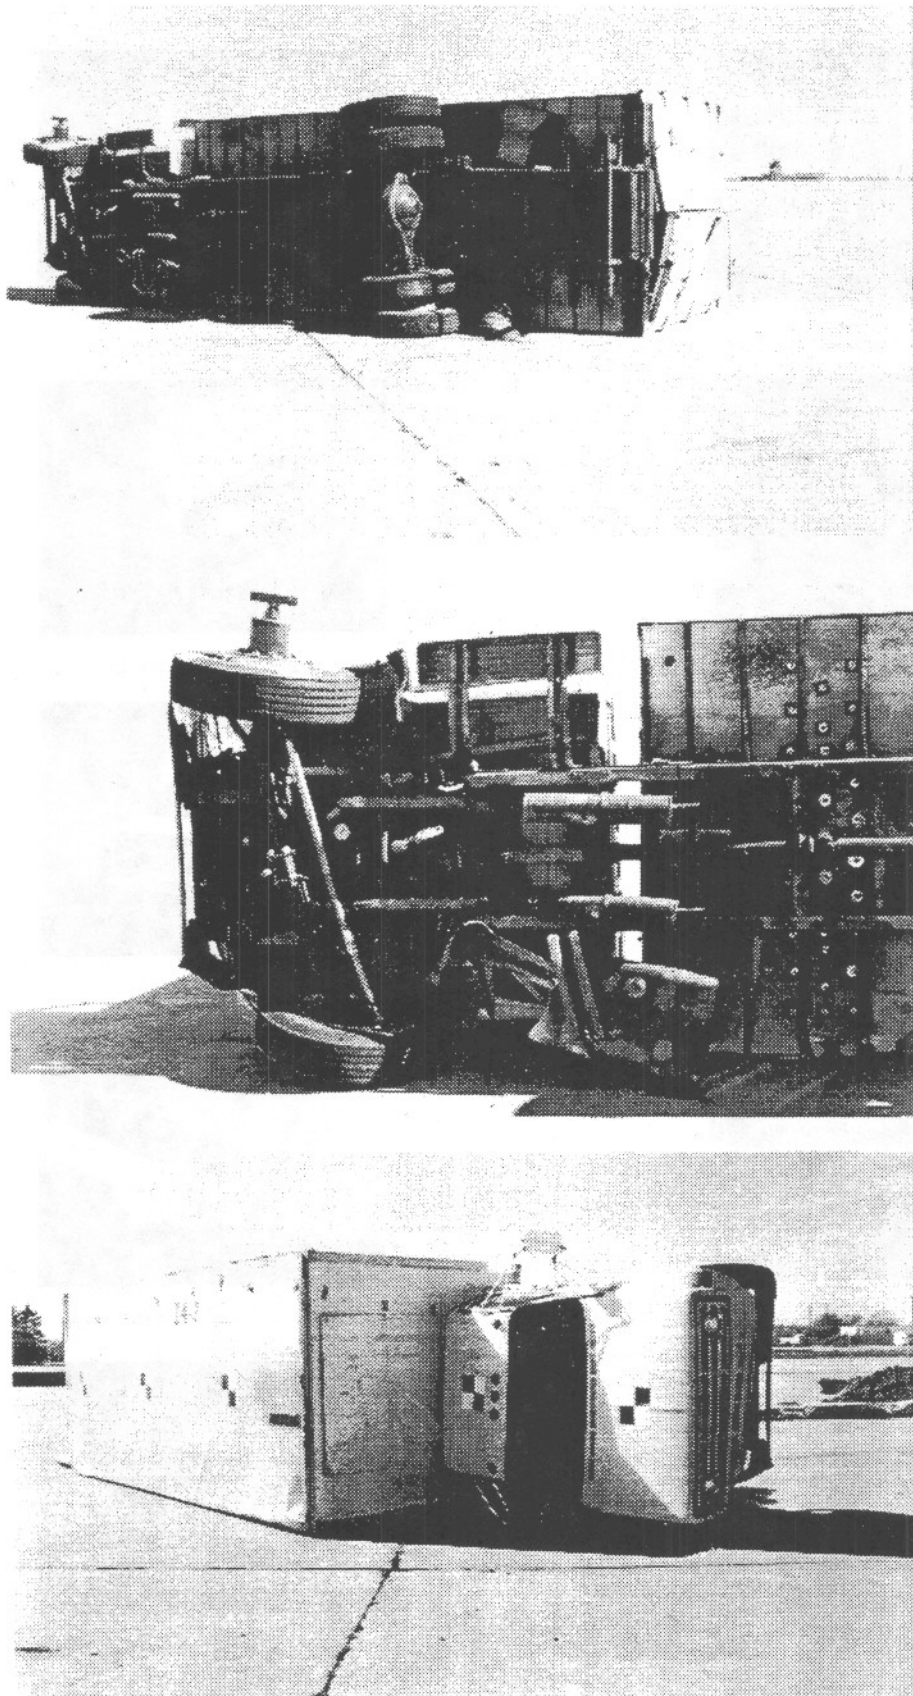
Figure 25. Photographs of vehicle damage, Test I4-2.

Upon impact with the retrofit concrete barrier rail, the right front corner of the vehicle was crushed and the wheel was bent inward. After the initial impact, the vehicle rode up on the barrier and slid along the remaining length. There was significant clockwise rolling motion as the vehicle slid along the barrier with a maximum roll angle of 28.7 degrees. After the vehicle exited from the barrier, it rolled in the counterclockwise direction for a short period of time. Hence, the momentum of the vehicle caused it to roll in the clockwise direction and tip over onto the passenger side of the vehicle. The vehicle came to rest on the passenger side of the vehicle approximately 160 ft. downstream from the point of impact.

Photographs of the vehicle damage are shown in Figure 25. The TAD (7) and VDI (8) damage classifications are shown in Figure 23. Photographs of the minimal damage to the retrofit concrete barrier rail are shown in Figure 26. Some concrete spalling occurred due to the initial impact of the vehicle.
