1. REPORT NO. FHWA/CA15-2181		2. GOVERNMENT ACCESSION NO.		3. RECIPIENT'S CATALOG NO.	
4. TITLE AND SUBTITLE COMPLIANCE CRASH TESTING OF THE TYPE 732SW BRIDGE RAIL				5. REPORT DATE April 2015/Revised May 2016/Revised September 2016

16. ABSTRACT <p>The Type 732SW bridge rail is an updated version of the Type 26 bridge rail and was tested for compliance to the Manual for Assessing Safety Hardware (MASH 09) as a part of this research project.</p> <p>The 732SW is a taller, stronger version of the Type 26 with a sidewalk. It is comprised of a sidewalk, vertical concrete wall, and steel handrail for pedestrians. The barrier tested was about 24 m (79 ft) long and was constructed at the Caltrans Dynamic Test Facility in West Sacramento, California.</p> <p>Three crash tests were conducted under MASH 09: Test 3-11 (the 2270P pickup at TL-3), Test 3-10 (the 1100C small car at TL-3), and Test 2-10 (the 1100C small car at TL-2) because Test 3-10 resulted in a ridedown acceleration that was outside of the MASH 09 limits. The results of Tests 3-11 and 2-10 were within the limits of the MASH 09 guidelines.</p> <p>The Type 732SW bridge rail is recommended for approval on California highways requi

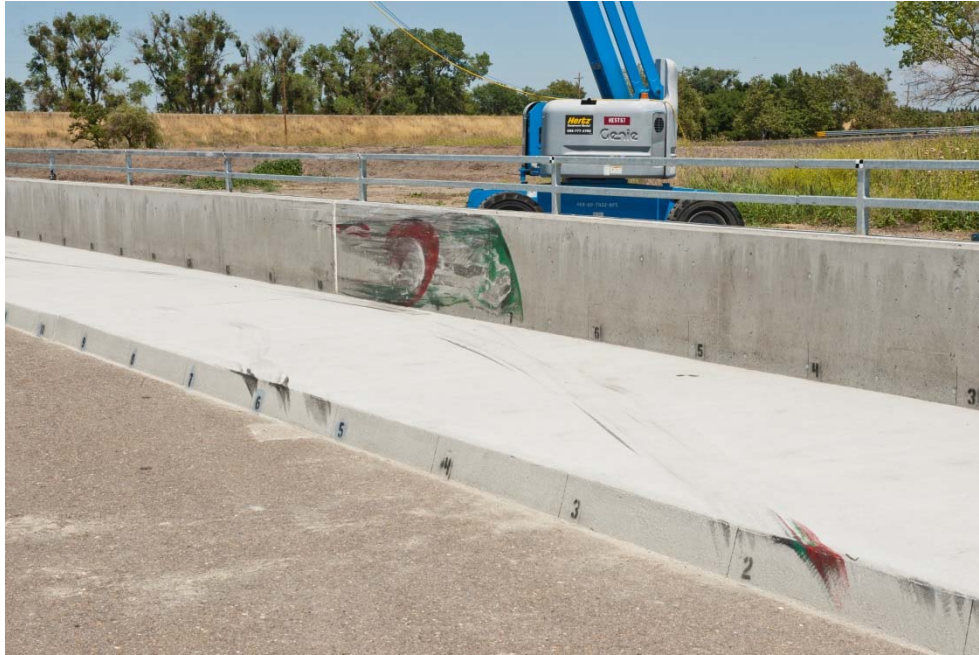
There was only minimal permanent damage to the barrier during Test 130MASH3P13-01. There was only very minor scraping of the concrete barrier face and scraping of the steel handrail. There was no structural damage to warrant immediate repair. There was no permanent deflection in the concrete curb or steel rail. As the vehicle impacted the barrier, the dynamic deflection in the steel rail was 1 inch (25 mm), as measured from the overhead camera.

Figure 3-2 – Type 732SW Barrier after Test 130MASH3P13-01

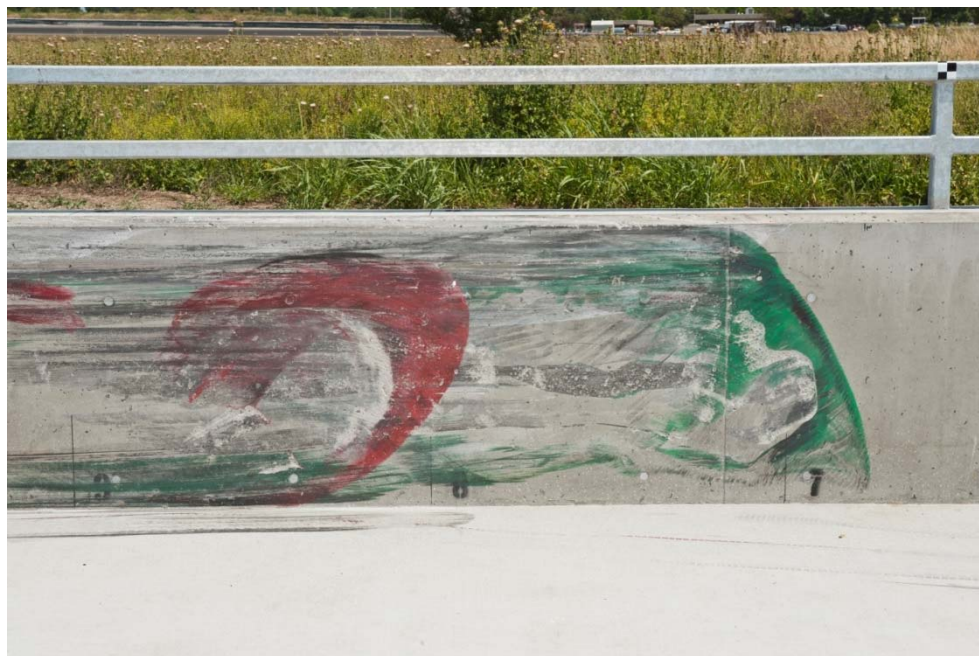
Figure 3-3 – Close-up of 732SW Barrier after Test 130MASH3P13-01

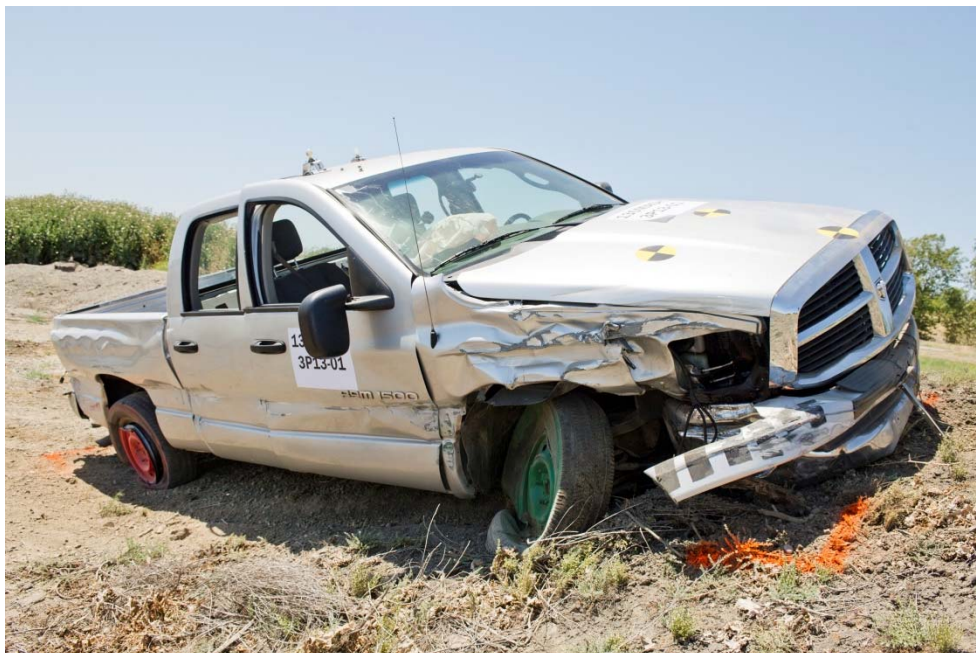
The right front tire ruptured upon impact with the sidewalk. The right front corner of the vehicle was severely damaged in the impact with the barrier face. The right front fender, hood, bumper, headlamp area, grille, and suspension components were all affected. The passenger side doorframe was deformed outward but the doors remained latched. The left front and right rear tires were also ruptured. The top of the vertical concrete wall caused denting along the entire length of the passenger side as the vehicle continued to contact the barrier after the initial impact. The right front tire was pushed rearward and slightly into the passenger side foot well area. The maximum amount of passenger compartment deformation was 54 mm (2.1 in), which occurred in the floorboard and is below maximum MASH 09 limits. All other occupant compartment deformations were below MASH 09 limits for that area of the vehicle. The passenger side of the windshield cracked but did not separate or enter the occupant compartment.

Figure 3-7 – Right front corner of test vehicle after Test 130MASH3P13-01

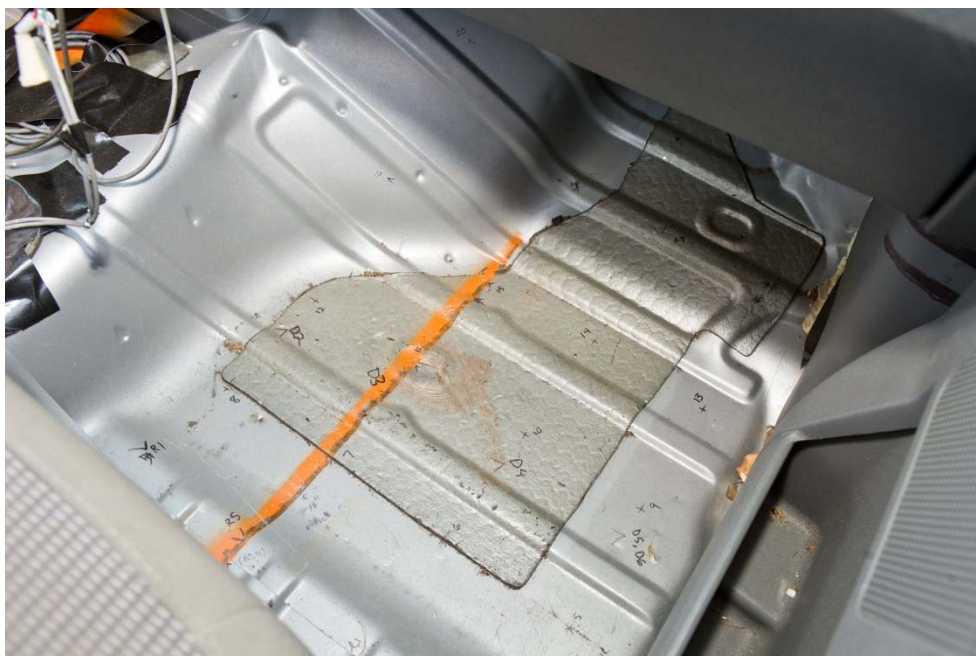
Figure 3-8 – Floorboard deformation of test vehicle after Test 130MASH3P13-01

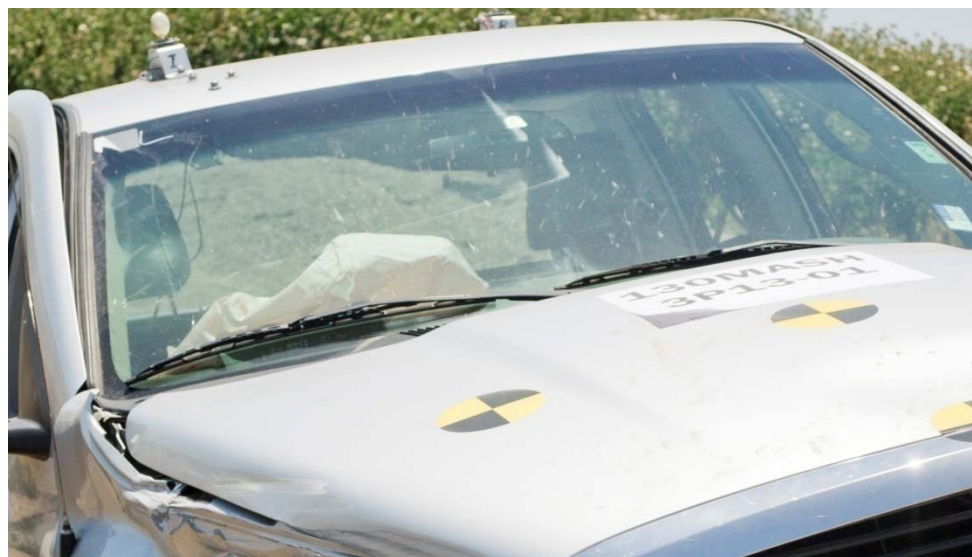
Figure 3-10 – Vehicle windshield after Test 130MASH3P13-01

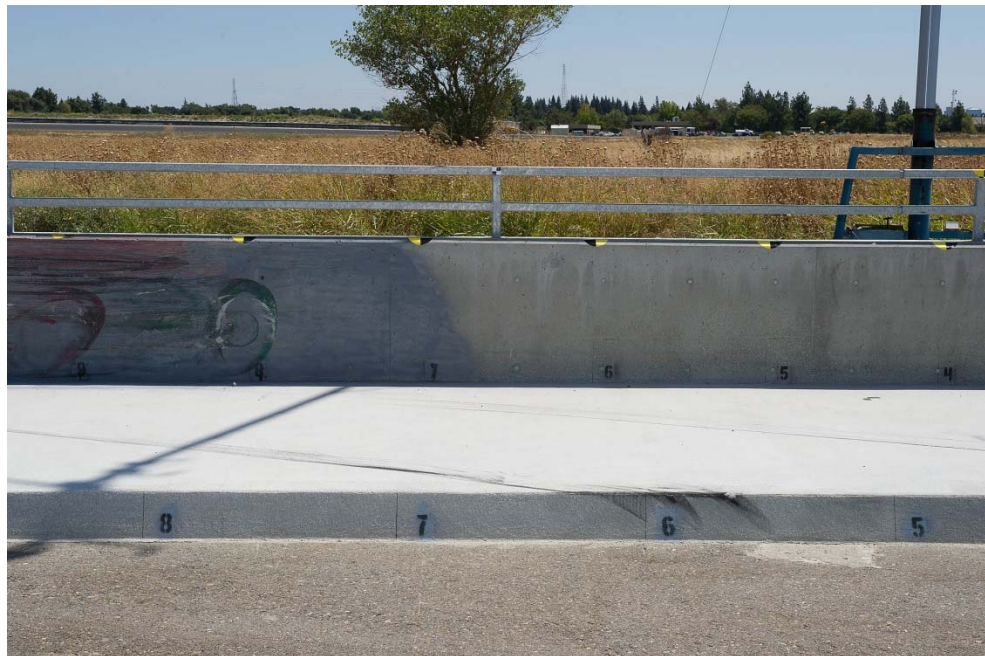
There was essentially no permanent damage to the barrier during 130MASH3C13-02. The barrier scraped paint off the vehicle along the length of contact. There was a negligible amount of scraping and gouging of the concrete face. Although the vehicle hood snagged slightly on the barrier post, there was no damage to the post. There would be no need for repair by maintenance crews.

Figure 3-13 – Type 732SW bridge rail face after 130MASH3C13-02

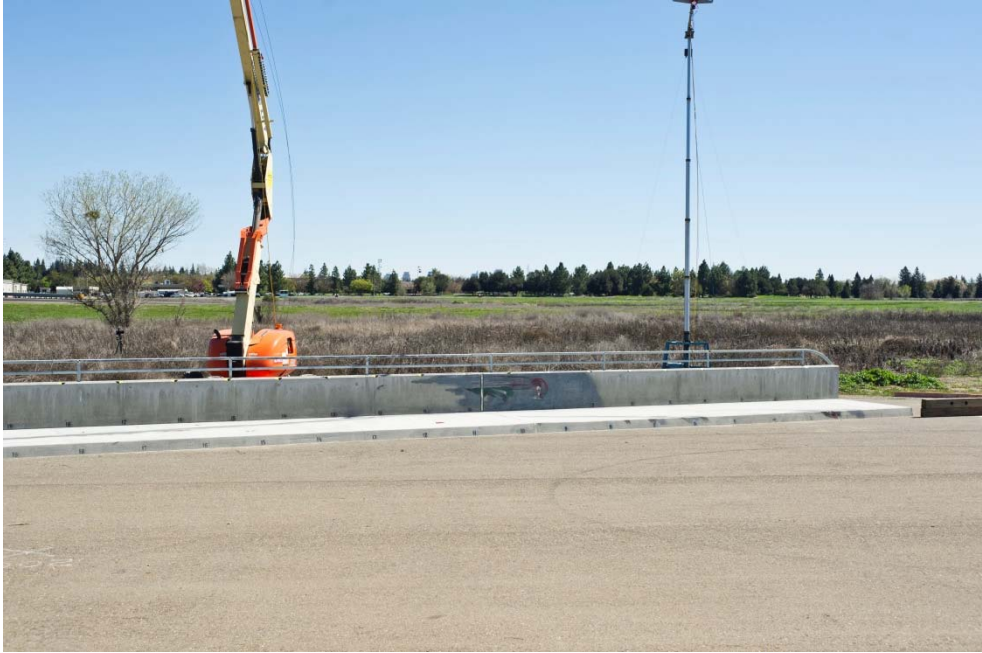
There was essentially no permanent damage to the barrier during 110MASH2C14-01. The only damage was a negligible amount of scraping and gouging of the concrete face. Damage to the barrier was considered cosmetic and would not have required field repairs.

Figure 3-24 – Type 732SW bridge rail face after Test 110MASH2C14-01

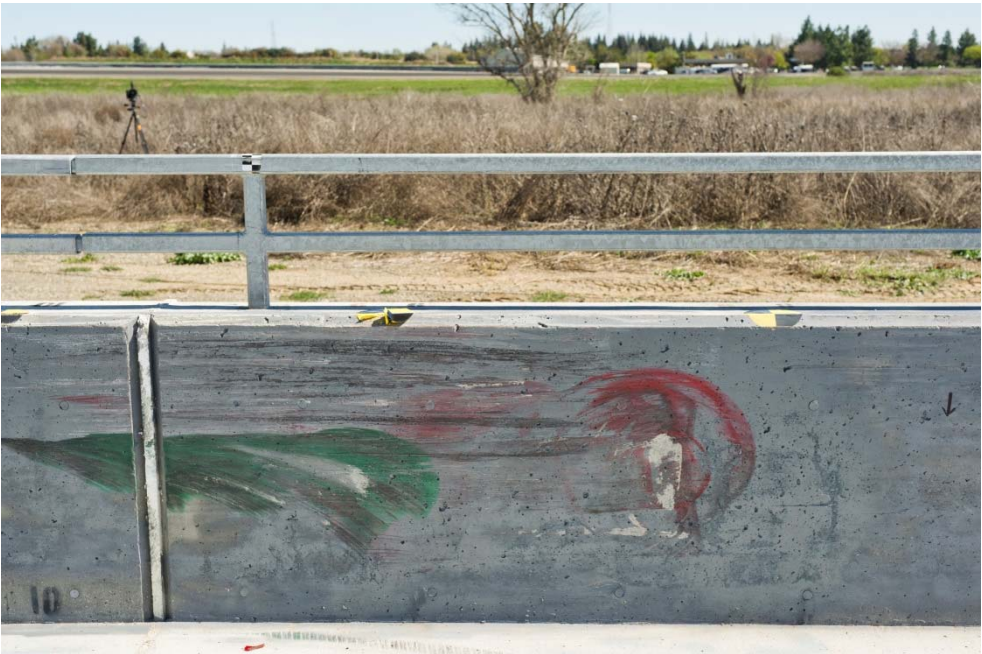
Figure 3-25 – 732SW Barrier face scraping after Test 110MASH2C14-01

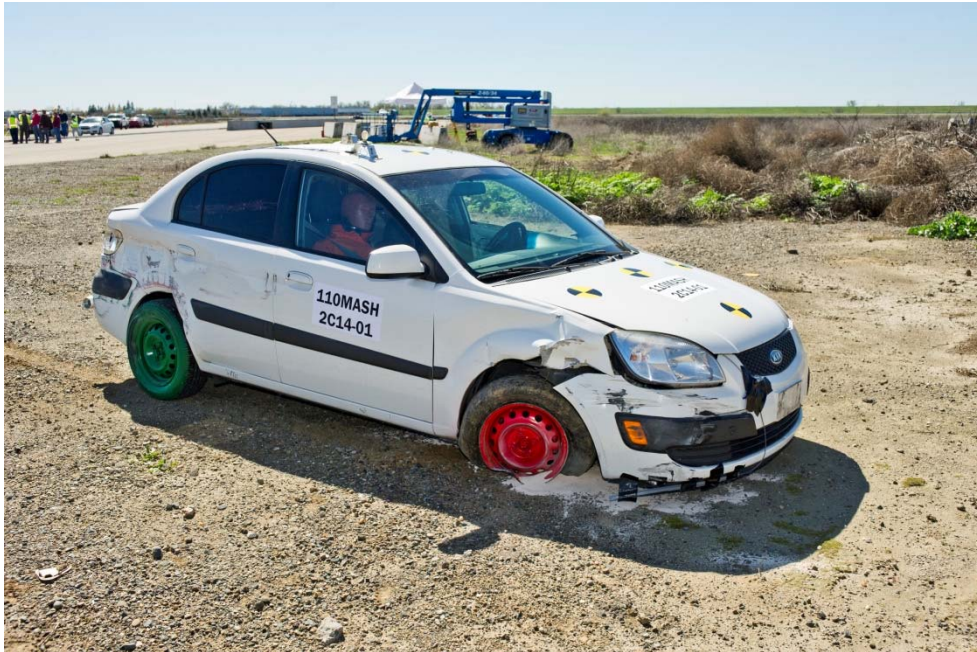
The front right wheel absorbed most of the impact. The rim was bent during impact causing the tire to deflate. The wheel well of the test vehicle sustained most of the damage. Additional damage also occurred to the side of the vehicle as it scraped the barrier when redirected. Since the front right wheel took most of the impact, there was no distinguishable damage to the floorboard (see Figure 3-31). The right front corner of the vehicle was moderately damaged. The right front bumper and right fender were pushed rearward. The right side of the vehicle at the front and rear was moderately damaged. The two front tires deflated during the impact. The maximum passenger compartment deformation was 0.6 inches at the floor pan near the passenger door.

Figure 3-29 – Front right corner of test vehicle after Test 110MASH2C14-01

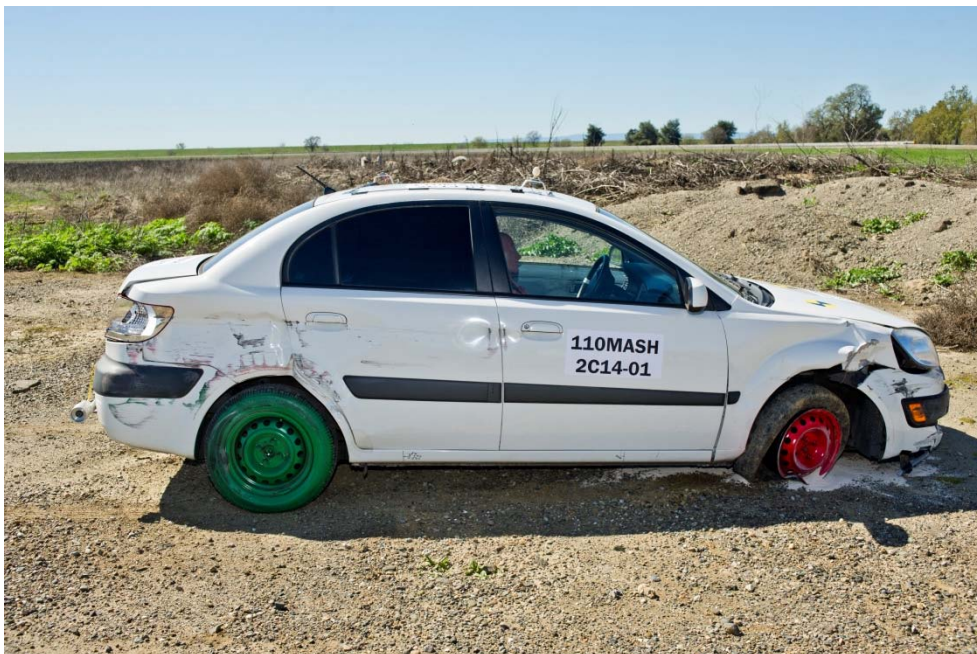
Figure 3-30 – Right side of test vehicle after Test 110MASH2C14-01
