TWO TEST LEVEL 4 BRIDGE RAILING AND TRANSITION SYSTEMS FOR TRANSVERSE GLUE-LAMINATED TIMBER DECKS

MwRSF Research Report No. TRP-03-71-01

January 30, 2002

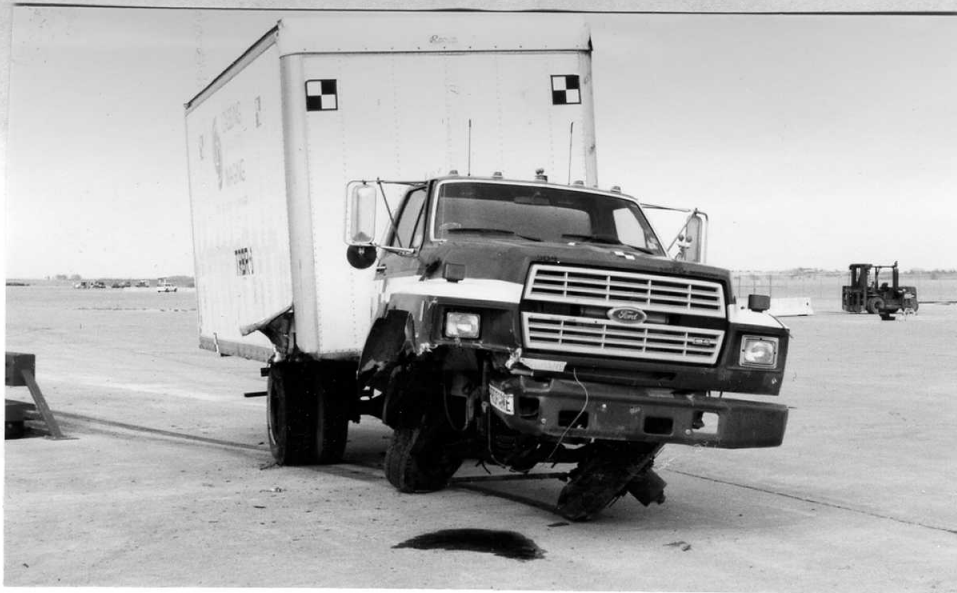
Figure 75. Typical Top of Post and Rail Damage, Test TRBR-1

The moderate bridge railing damage is shown in Figures 74 and 75. Significant gouging and scrapes occurred to the glulam rail from the midspan between post nos. 4 and 5 to post no. 6, as shown in Figure 74. Minor gouges and scrapes were found on top of the upper rail and occurred when the truck box leaned on the rail, as shown in Figures 74 and 75. The curb rail received gouges between post nos. 4 and 5, as shown in Figure 74.

Bridge post nos. 8 and 9 were damaged near the top of each post due to contact between the truck box and timber posts. Vehicle contact on post no. 8 was measured approximately 102 mm below the top of the post, and approximately 25 mm below the top of post no. 9. No visual damage was evident to the spacer blocks, scupper blocks, or shear plates. Also, no visual damage or displacement relative to the girders was evident on the deck panels. Zero displacement between the girders and deck panels was measured at all potentiometer locations.

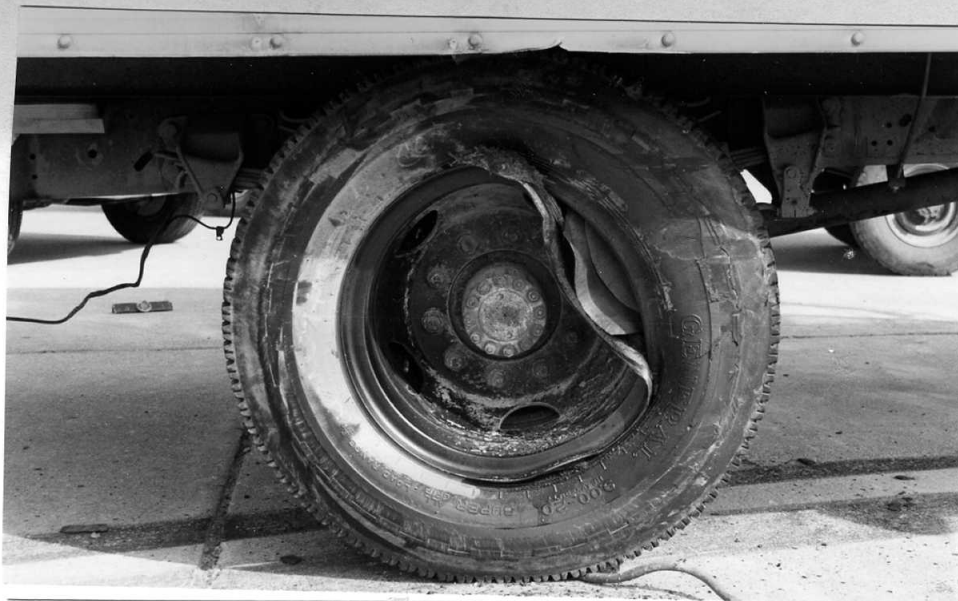
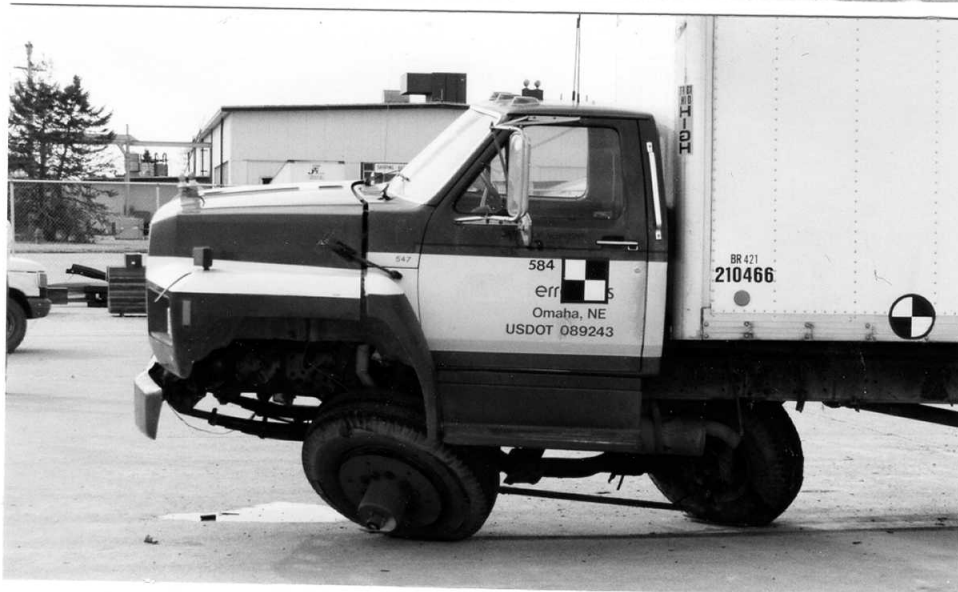
Figure 76. Vehicle Damage, Test TRBR-1

Exterior vehicle damage was moderate, as shown in Figures 76 through 78. Vehicle damage occurred to several body locations, such as right-side door and quarter panels, front bumper, right-side wheels and rims, front axle, truck box and support frame, and the side-mounted foot step. The right corner of the front bumper and the right-side door and quarter panels were crushed inward as shown in Figure 76. The lower right-front corner of the truck box was deformed inward, as shown in Figure 76. The front axle, with attached tires and steel rims, was removed from the truck and came to rest under the truck frame, as shown in Figures 76 and 77. The right-rear steel rim was also deformed, as shown in Figure 77. The truck box was shifted to the right of the longitudinal centerline of the truck cab and support frame. U-bolts, used to attach the box to the frame, were also deformed due to the box shift, as shown in Figure 78.
