GUARDRAIL TESTING – MODIFIED ECCENTRIC  
LOADER TERMINAL (MELT) AT NCHRP 350 TL-2

Prepared for  
The New England Transportation Consortium

July 2002

NETCR 35

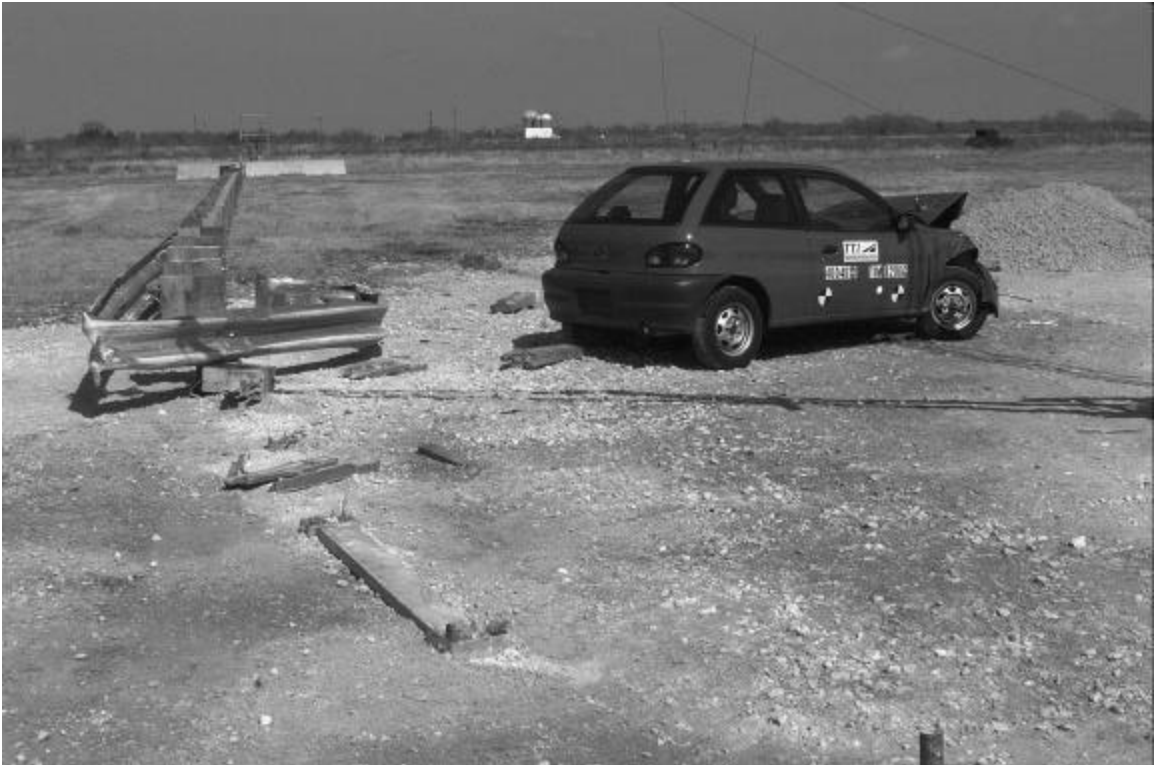
Figure 7. Vehicle trajectory after test 400401-1.

At 0.983 s, the vehicle lost contact with the rail element and was traveling at a speed of 15.5 km/h and an exit angle of 37.6 degrees clockwise to the tangent of the length of need. Brakes on the vehicle were not applied. At 2.975 s, the vehicle subsequently came to rest 4.58 m behind post 6 and 7 (7.75 m downstream of impact) and was oriented at 62.3 degrees clockwise of the tangent of the length of need. Sequential photographs of the test period are shown in appendix C, figures 21 and 22.

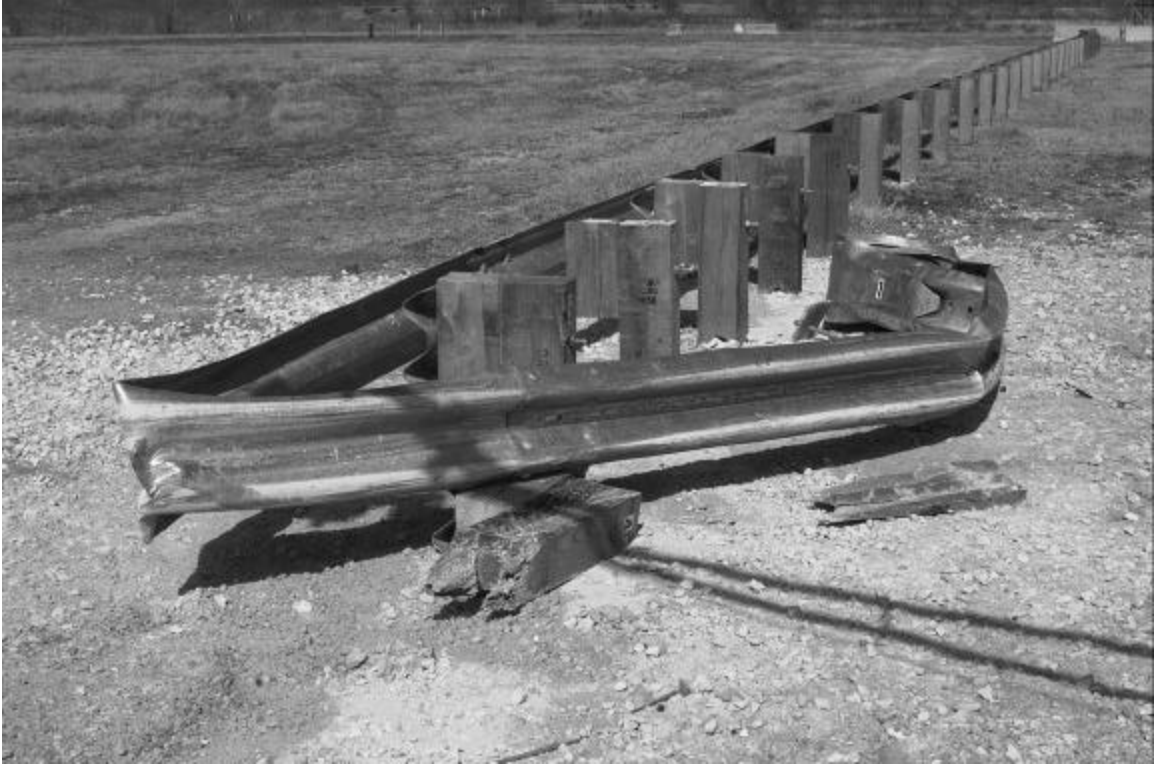
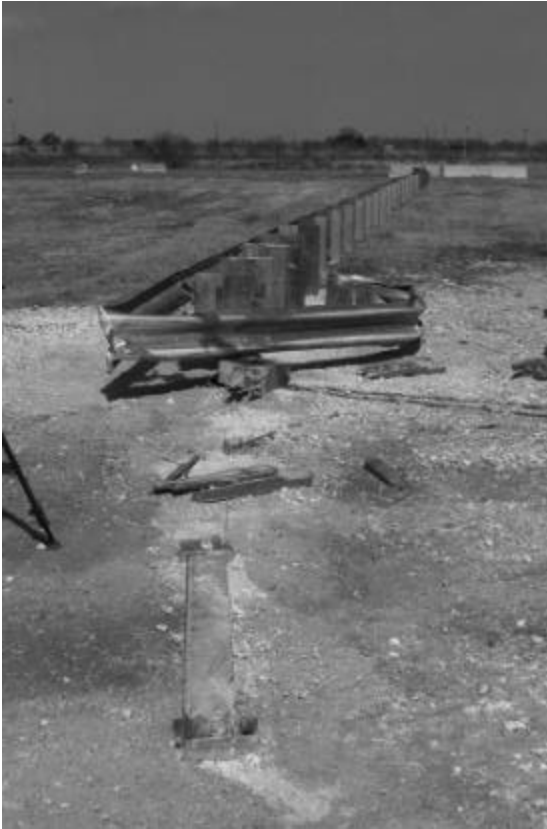
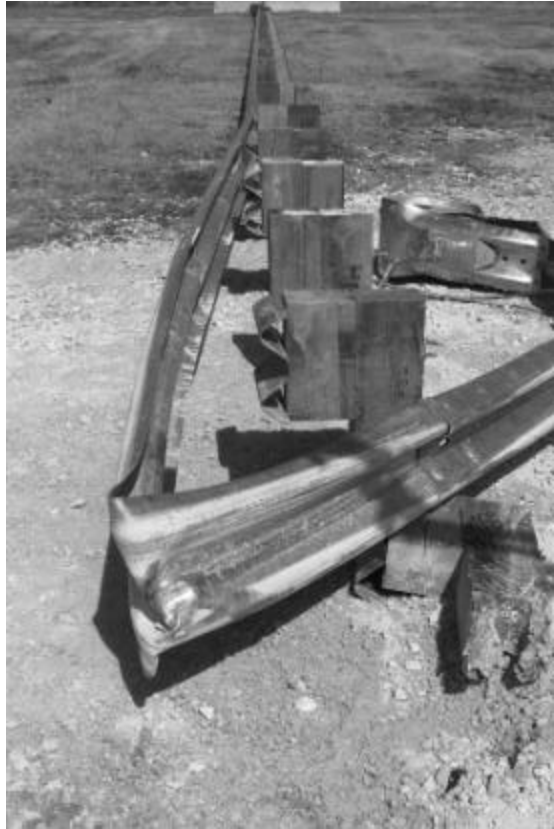
Figure 8. Installation after test 400401-1.

Posts 1 through 4 fractured at ground level as shown in figures 7 and 8. Most of the pieces followed along the vehicle path or were thrown behind the terminal. One piece came to rest 3.05 m forward of the face of the rail between posts 14 and 15. The ground strut on the upstream end moved 10 mm and no movement was noted on the downstream terminal. Three elbows formed in the terminal: one 490 mm from the beginning of the rail element, a second 2040 mm from the beginning of the rail element, and a third 1310 mm from the center of the first splice. Maximum deflection of the rail element toward traffic lanes was 1.78 m and maximum deformation occurred over a distance of 3.25 m. Working width was 5.08 m.

Results: Posts 1 through 4 fractured at ground level but did not penetrate nor show potential for penetrating the occupant compartment. Most of the pieces of the fractured posts followed along with the vehicle or were thrown behind the installation. Maximum occupant compartment deformation was 37 mm in the center front firewall area.

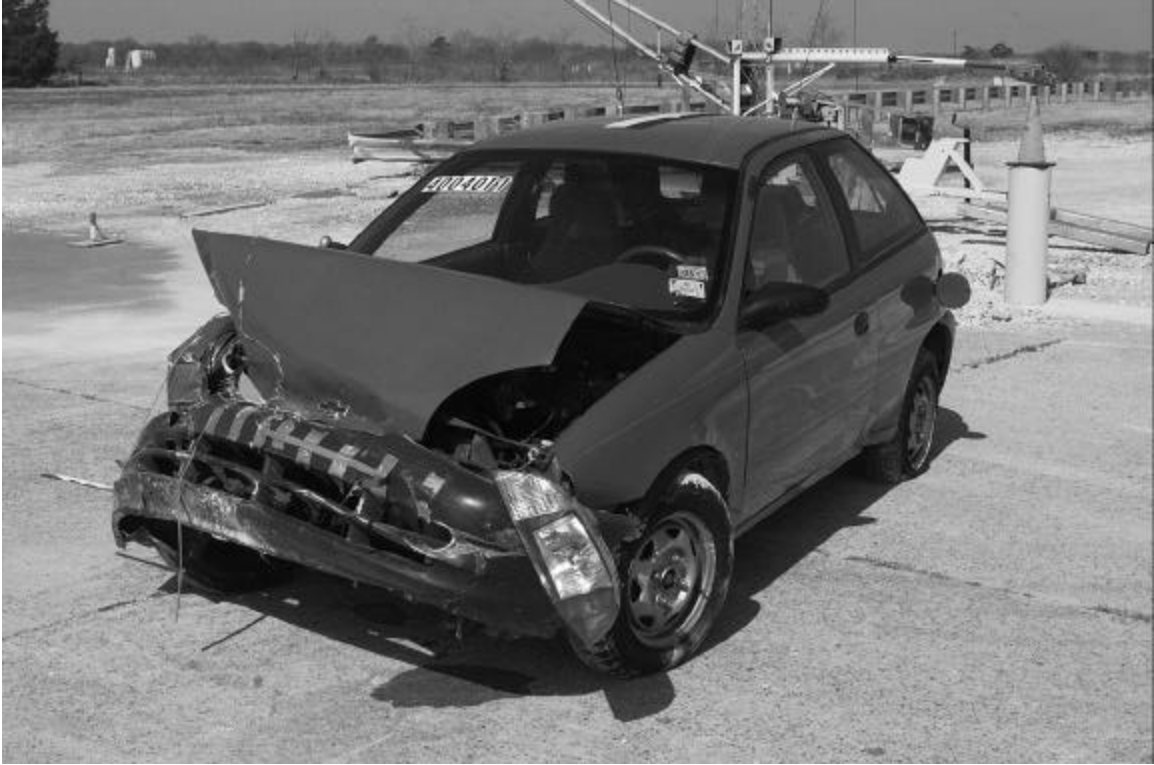
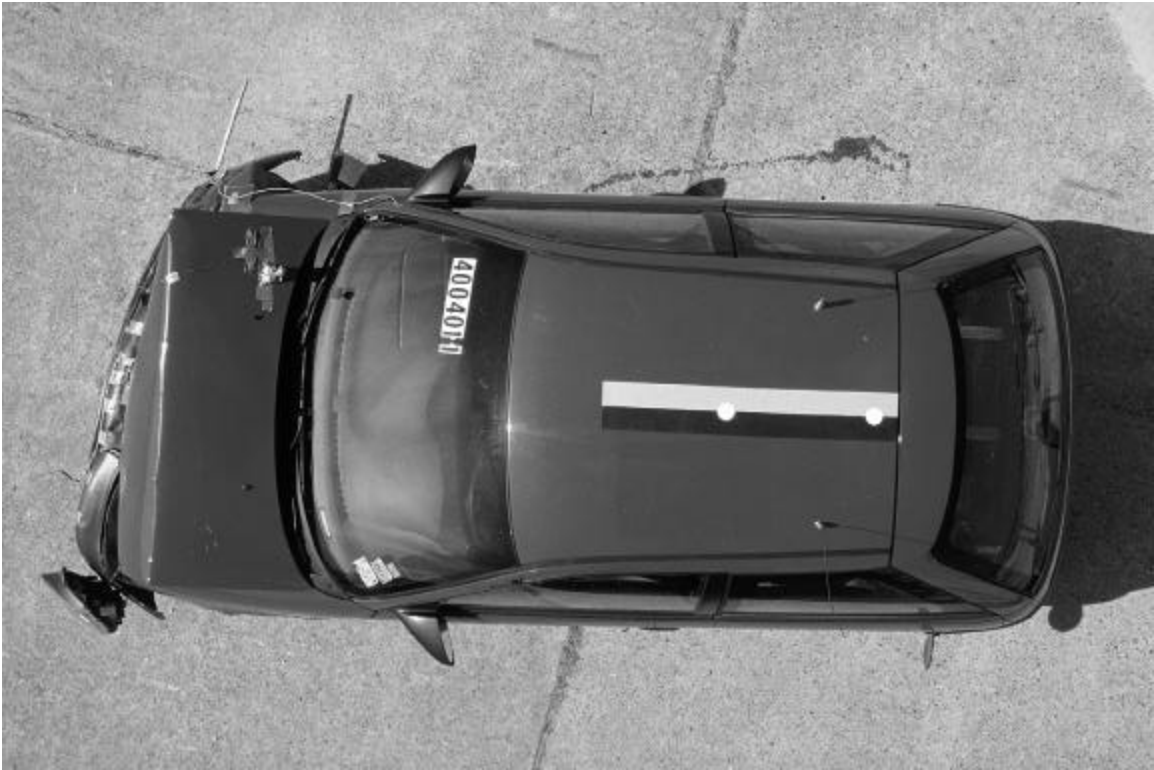
Figure 9. Vehicle after test 400401-1.

The vehicle sustained damage to the front as shown in figure 9. Structural damage was imparted to the right front strut, right front mount, and right front axle, and the firewall and floor pan were deformed. Also damaged were the front bumper, hood, fan, radiator, radiator support, right and left front quarter panels, left front tire and wheel rim, and the left rear tire. The right door was jammed and the windshield sustained stress cracking. Maximum exterior crush to the vehicle was 400 mm at the right front quarter point near bumper height. Maximum occupant compartment deformation was 37 mm just to the right of the center firewall area. Photographs of the interior of the vehicle are shown in figure 10. Exterior vehicle crush and occupant compartment measurements are shown in appendix B, tables 3 and 4.

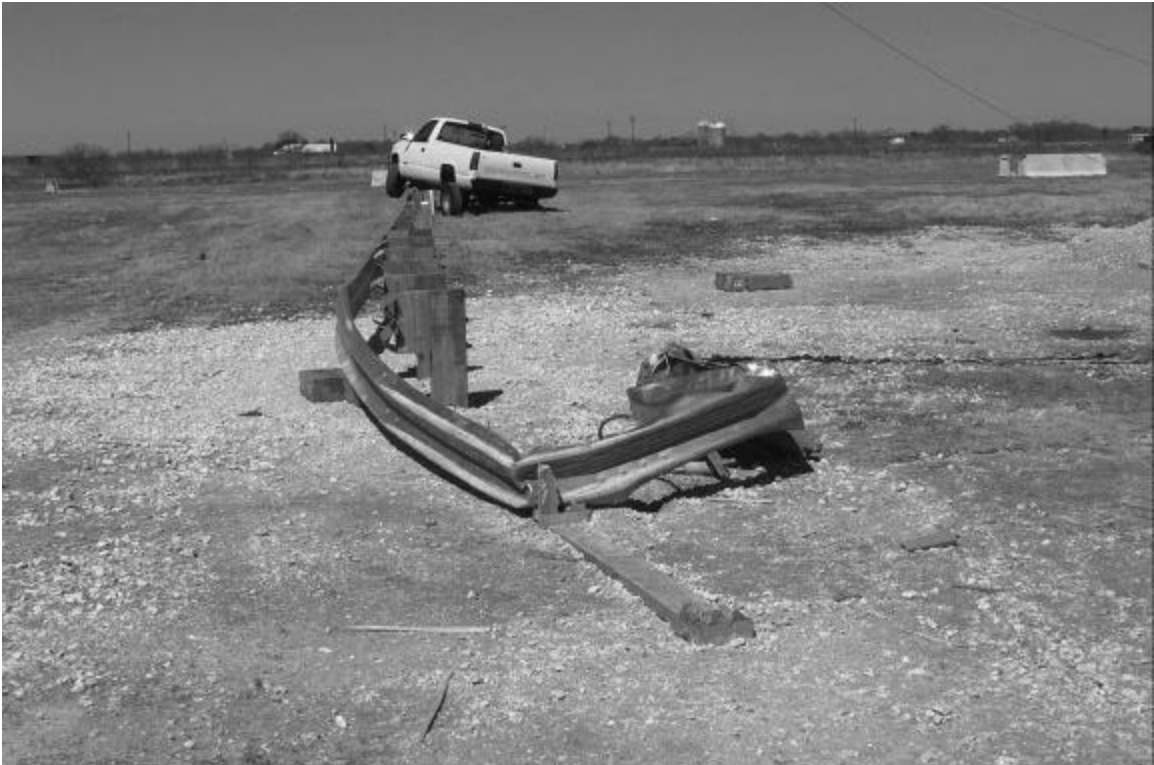
Figure 14. Vehicle trajectory after test 400401-2.

At 0.591 s, the vehicle lost contact with the rail element at 0.591 s, and was traveling at a speed of 53.8 km/h and an exit angle of 2.2 degrees. Brakes on the vehicle were not applied. As the vehicle continued forward motion, it contacted the rear of post 18 at 1.544 s. The vehicle subsequently came to rest on top of the rail element at post 21 (34.3 m downstream of impact). Sequential photographs of the test period are shown in appendix C, figures 23 and 24.

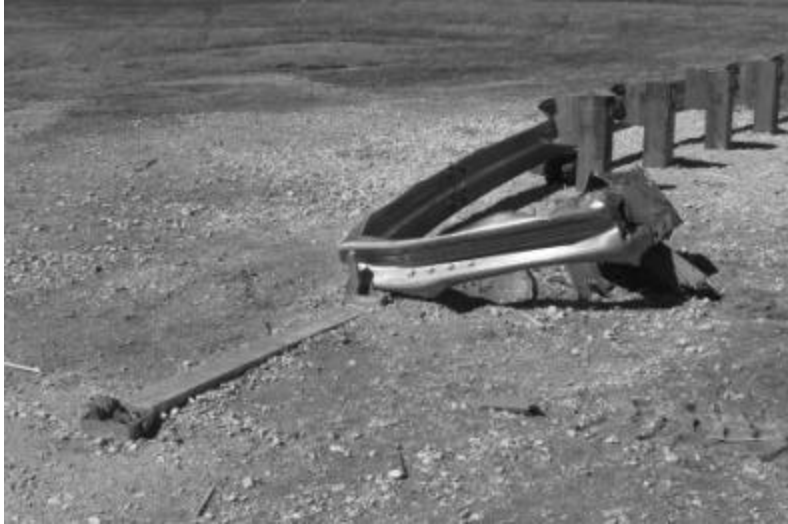
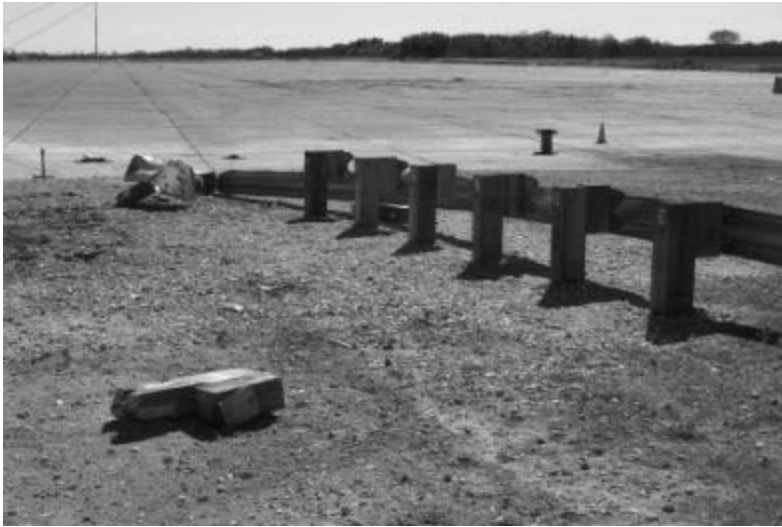
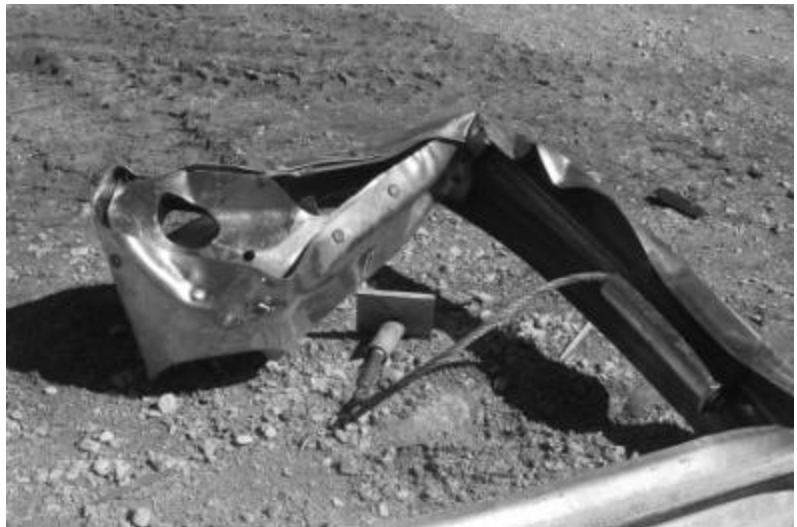
Figure 15. Installation after test 400401-2.

Posts 1 through 3 fractured at ground level, as shown in figures 14 through 15. Post 1 remained in the buffer head of the terminal and all other debris traveled along the vehicle path. Two elbows formed in the rail element: one 380 mm from the beginning of the rail element and the second 1730 mm from the beginning. The upstream ground strut moved 17 mm and no movement was noted in the downstream terminal. Posts 14 through 20 were rotated from the secondary impact.

Results: Posts 1 through 3 fractured at ground level but did not penetrate nor show potential for penetrating the occupant compartment. All of the pieces of the fractured posts followed along with the vehicle. No deformation of the occupant compartment occurred.

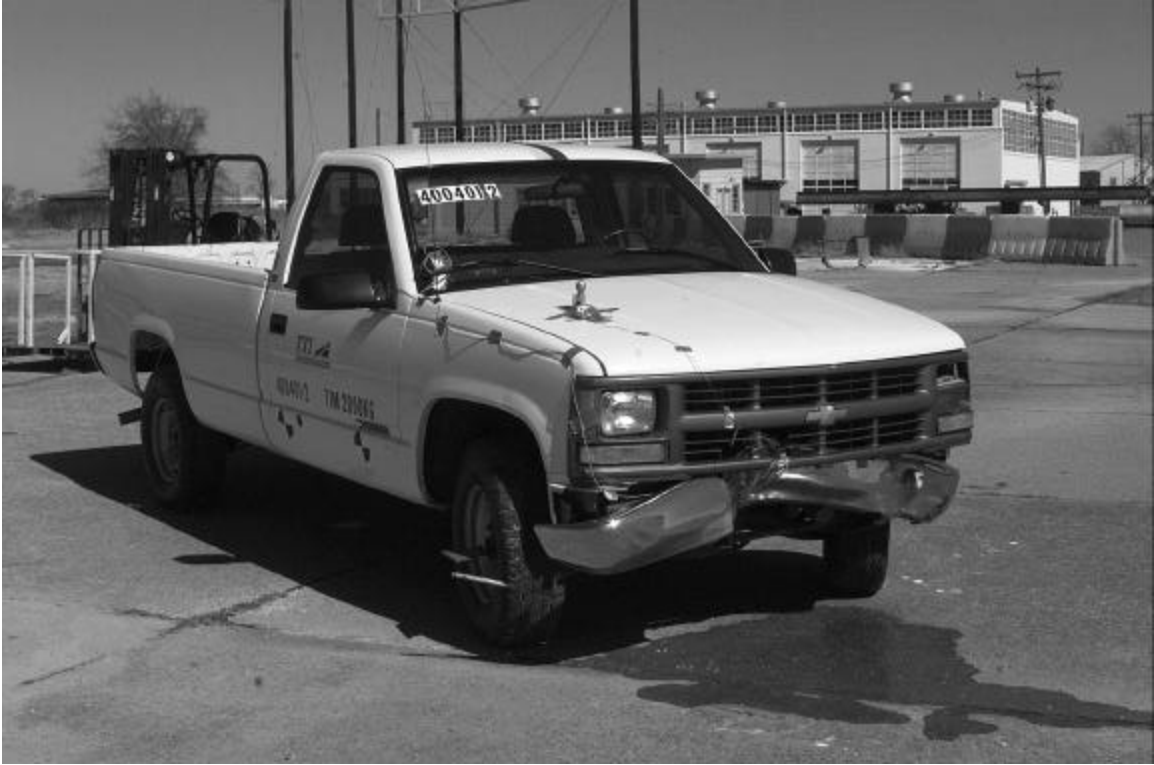
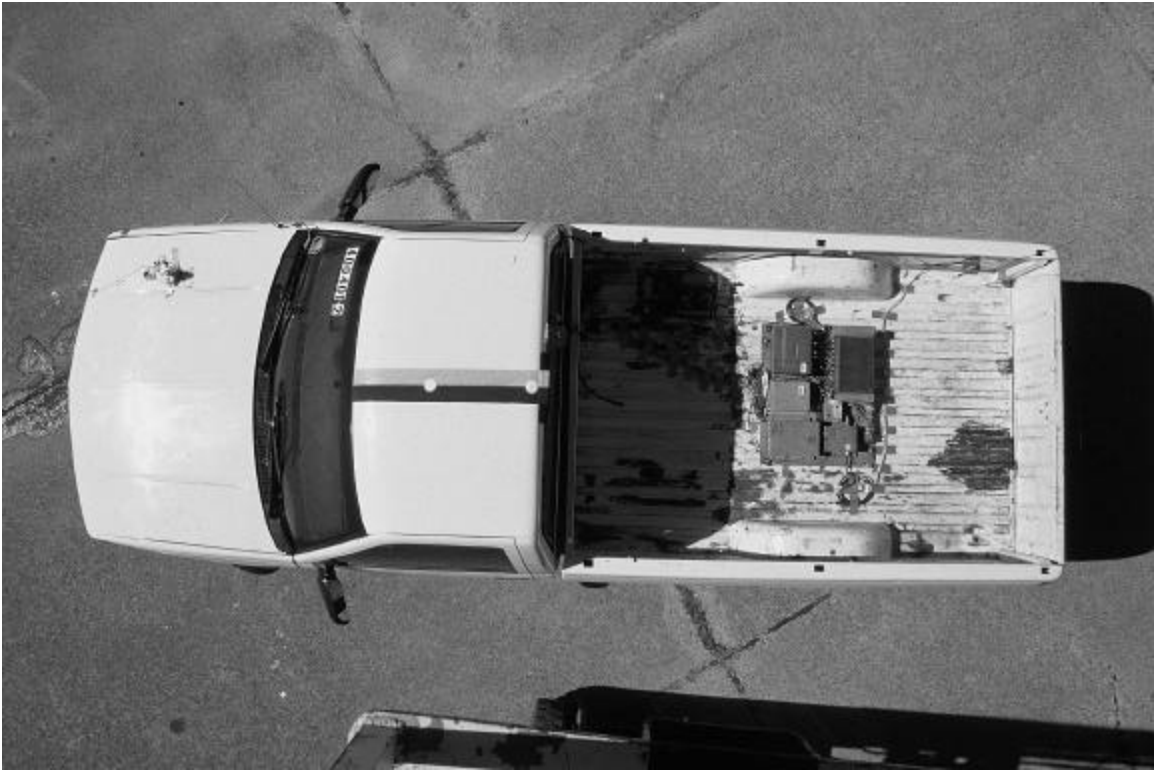
Figure 16. Vehicle after test 400401-2.

Damage to the vehicle was restricted to the front of the vehicle, as shown in figure 16. The stabilizer bar and the left and right front of the frame were deformed. Also damaged were the front bumper, fan, and radiator. Maximum exterior crush to the vehicle was 340 mm at the center front at bumper height. No deformation of the occupant compartment occurred. Photographs of the interior of the vehicle are shown in figure 17. Exterior vehicle crush and occupant compartment measurements are shown in appendix B, tables 5 and 6.
