*Hawaii Department of Transportation  
Research Project Number 67167*

# **CRASH TESTING AND EVALUATION OF THE HDOT 34-IN. TALL AESTHETIC CONCRETE BRIDGE RAIL: MASH TEST DESIGNATION NOS. 3-10 AND 3-11**

## **MIDWEST ROADSIDE SAFETY FACILITY**

MwRSF Research Report No. TRP-03-420-19

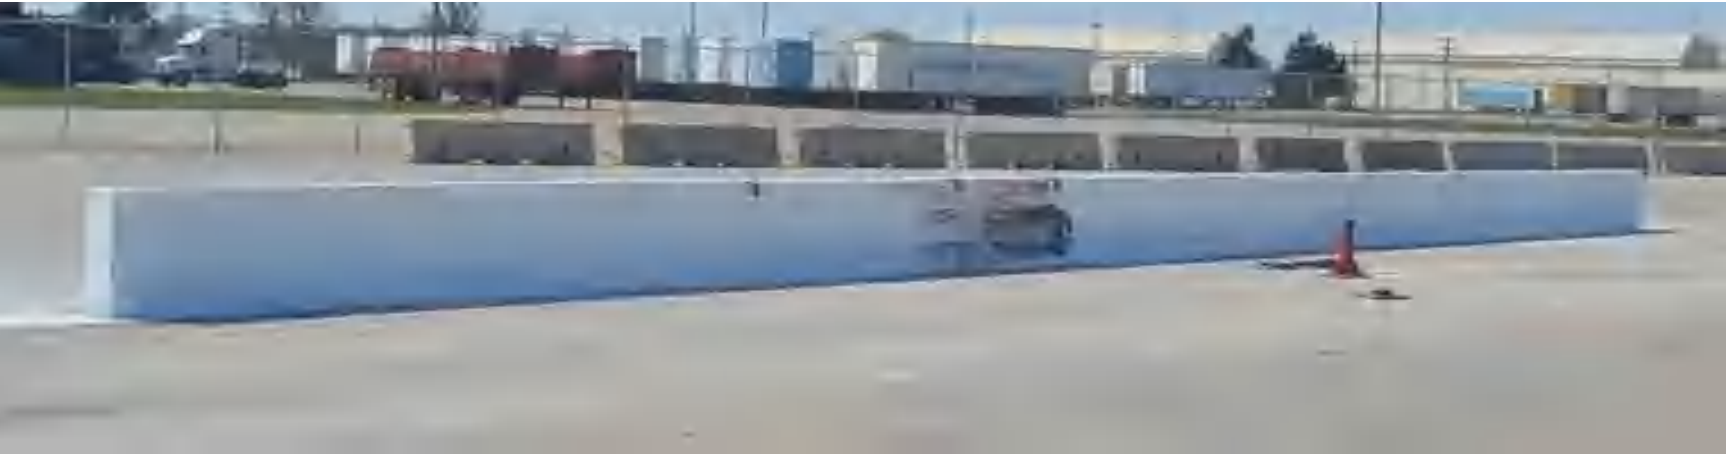
Figure 35. System Damage, Test No. H34BR-1

Damage to the barrier was minor, as shown in Figures 35 through 39. Barrier damage consisted of minor cracking, spalling, and contact marks on the parapet and minor cracking and spalling at the expansion joint between barrier nos. 3 and 4. The locations for all of the listed damage were measured from the expansion joint between barrier nos. 3 and 4 as a reference point. The length of vehicle contact along the barrier was approximately 11 ft – 3 in. which spanned from 4 ft – 9 in. upstream from the expansion joint to 6 ft – 6 in. downstream from the expansion joint.

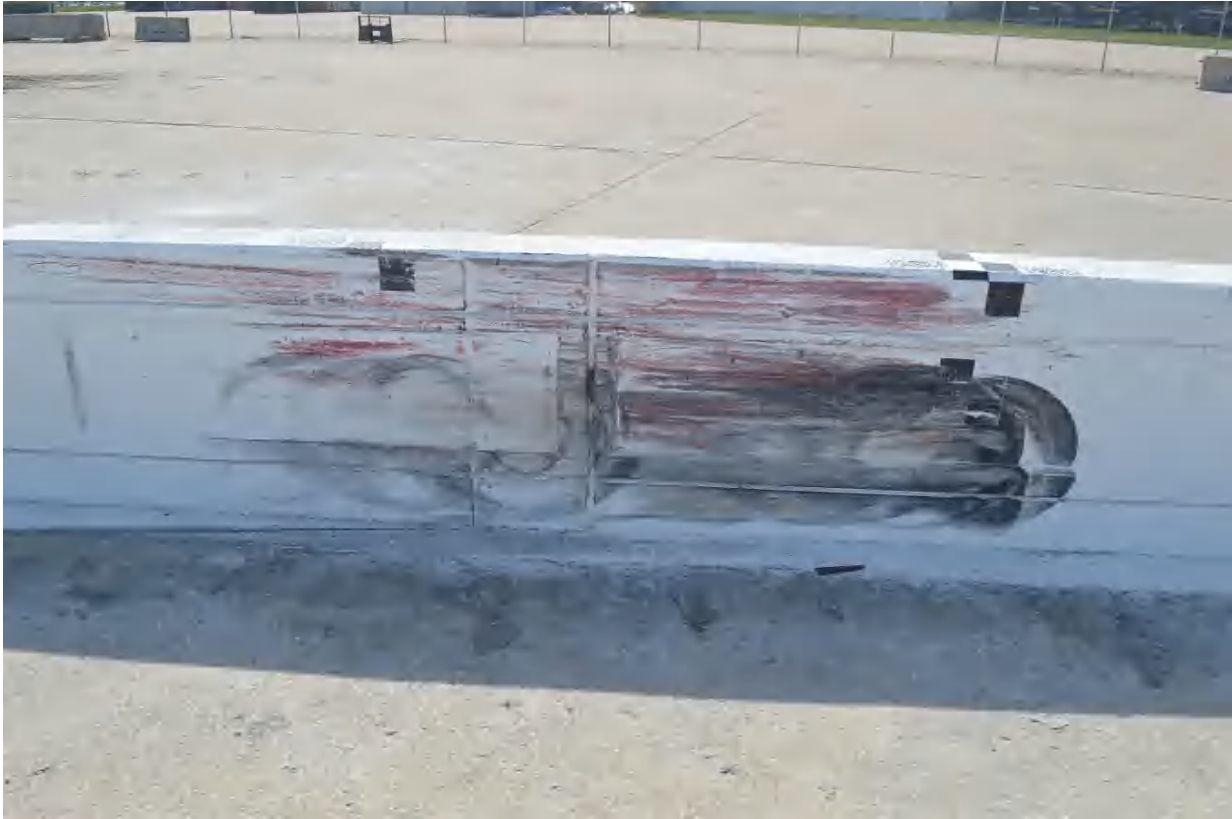
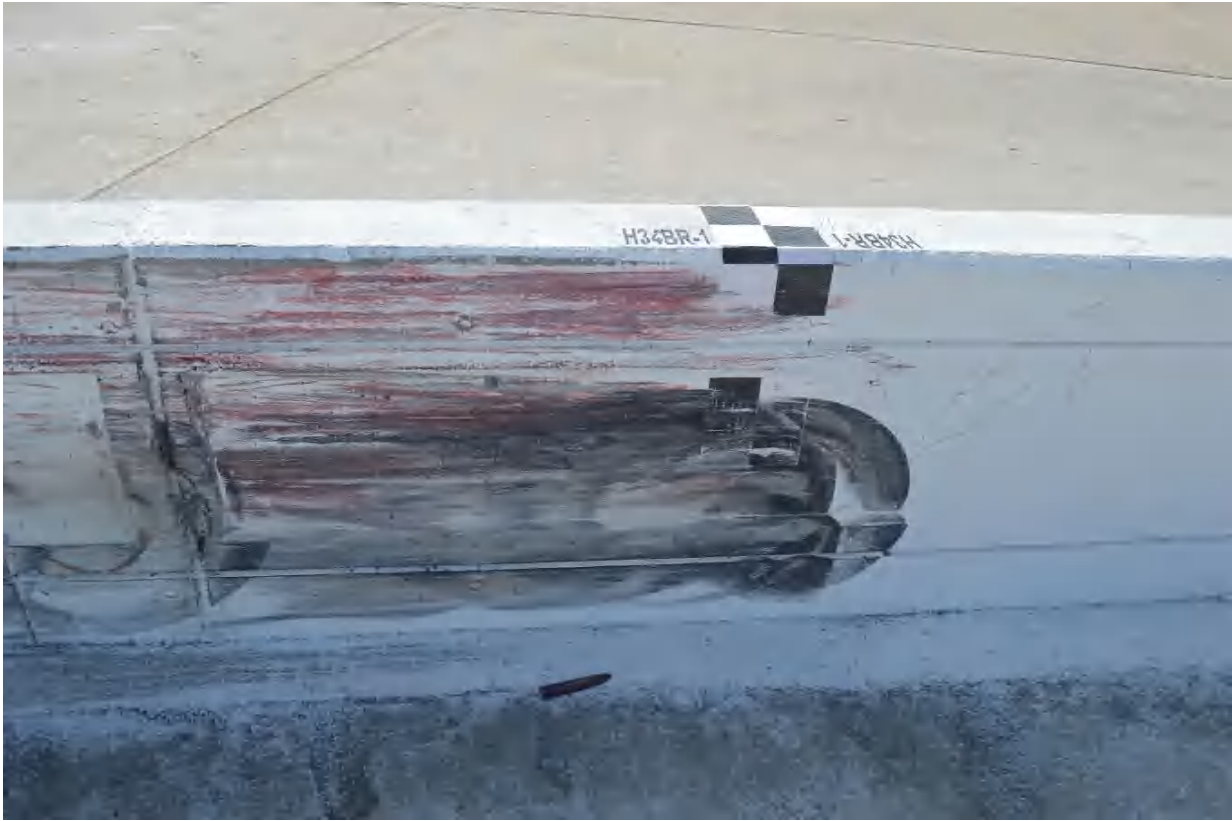
Figure 36. Traffic-Side System Damage, Test No. H34BR-1

A 45-in. long and 1½-in. tall spall on the aesthetic asperity was observed 51 in. upstream from the expansion joint. Spalling measuring 4 in. long and 2½ in. wide was found 45 in. upstream from the expansion joint and 14 in. above the ground. Spalling measuring 11 in. long and ½ in. wide was found 34 in. upstream from the expansion joint and 23 in. above the ground. Spalling measuring 5½ in. long and 2½ in. wide was found 33 in. upstream from the expansion joint and 15 in. above the ground. Spalling measuring 61½ in. long was found 32 in. upstream from the expansion joint to 29½ in. downstream of the expansion joint and 32 in. above the ground. Spalling measuring 5 in. long, 10 in. wide, and ½ in. deep was found 3 in. upstream from the expansion joint and 14 in. above the ground. Spalling measuring 6 in. long was found 2 in. upstream from the expansion joint and 24 in. above the ground. A ½-in. diameter by ½-in. deep hole was observed 53 in. upstream from the expansion joint and 17½ in. above the ground. A 1-in. diameter by ½-in. deep hole was observed 24 in. upstream from the expansion joint and 23½ in. above the ground. Grout was disengaged over a 12½ in. height at the expansion joint was observed located 9½ in. above the ground.

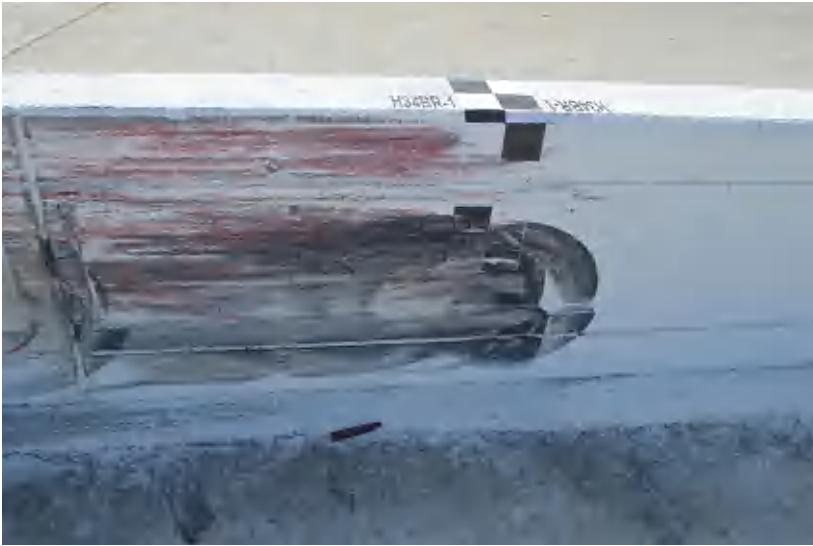
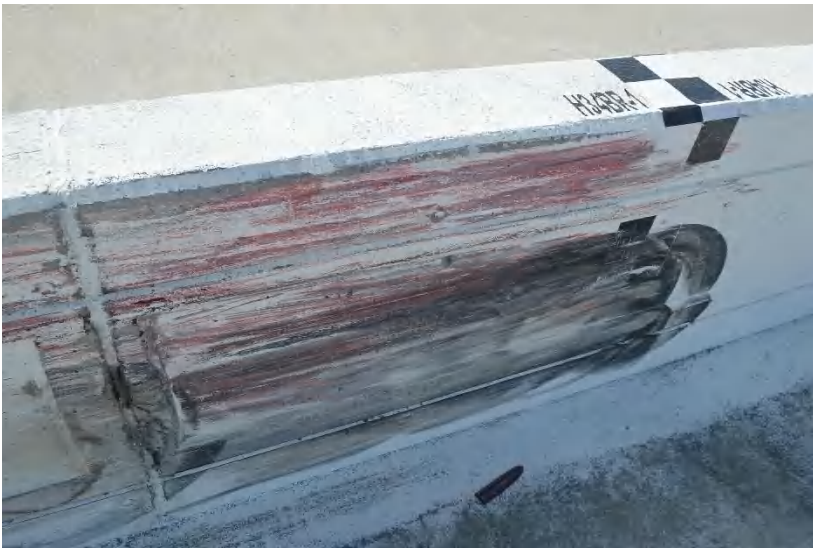
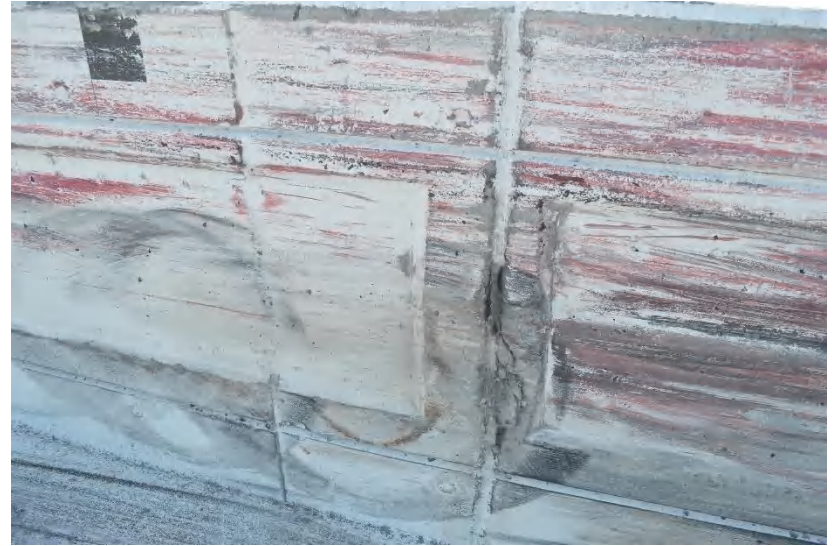
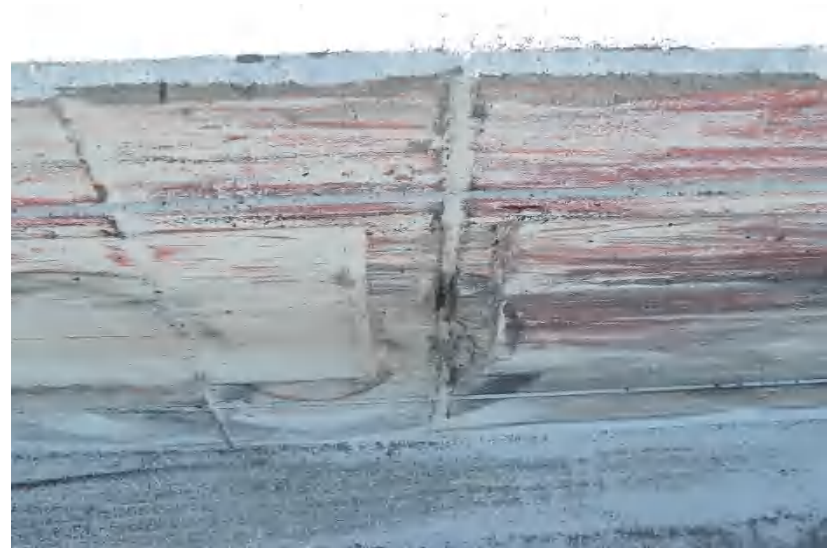
Figure 37. Traffic-Side System Damage, Test No. H34BR-1

Minor cracking of the barrier was also observed in several locations. A 19½-in. diagonal crack that started 18½ in. above the ground and ended 33½ in. above the ground was found 70½ in. upstream from the expansion joint. An 18½-in. diagonal crack that started 11 in. above the ground and ended 18½ in. above the ground was found 60 in. upstream from the expansion joint. A third smaller crack was noted on the top of the barrier starting near the middle of the expansion joint between barrier nos. 3 and 4 and extending diagonally approximately 8 in. downstream and toward the back of the barrier.

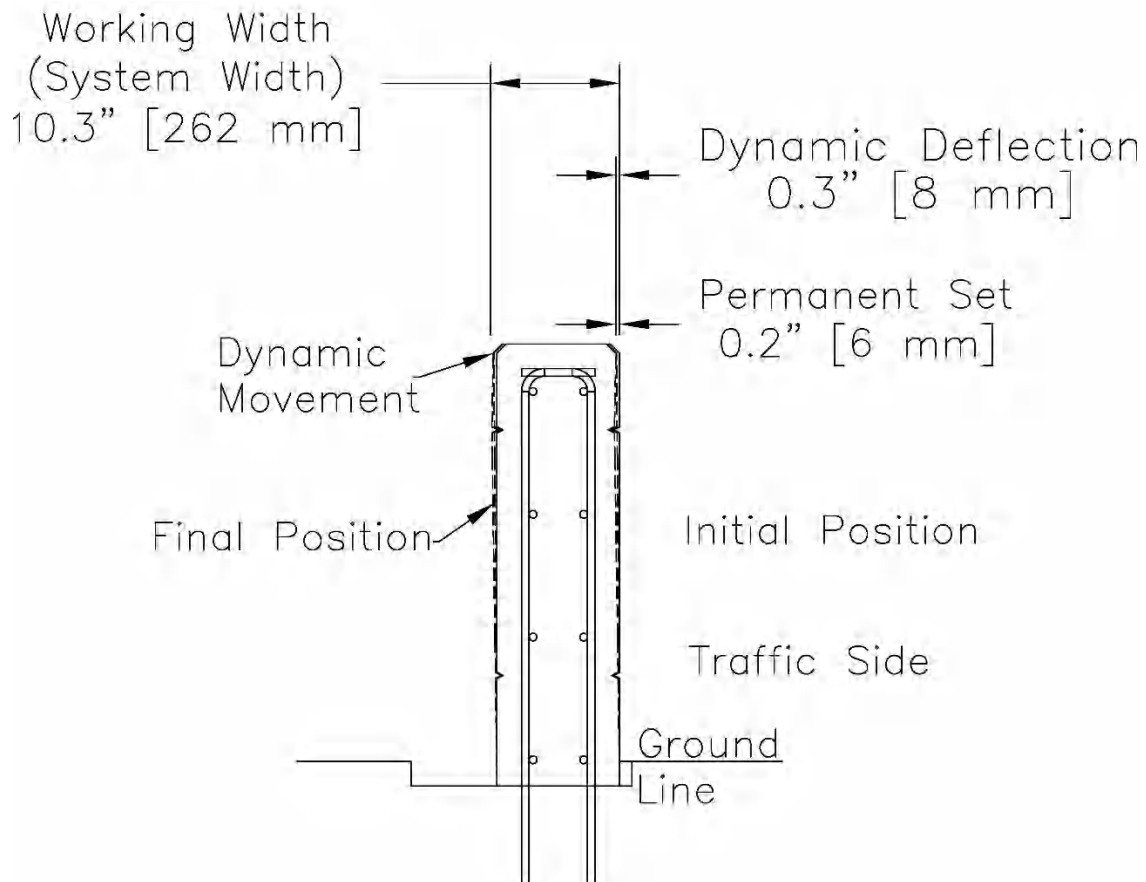
Figure 40. Permanent Set Deflection, Dynamic Deflection, and Working Width, Test No. H34BR-1

The maximum lateral permanent set of the barrier system was 0.2 in., which occurred at the downstream end of barrier no. 2, as measured in the field. The maximum lateral dynamic barrier deflection, including tipping of the barrier along the top surface, was 0.3 in. at the upstream end of barrier no. 3, as determined from high-speed digital video analysis. The working width of the system was found to be 10.3 in., also determined from high-speed digital video analysis. A schematic of the permanent set deflection, dynamic deflection, and working width is shown in Figure 40.

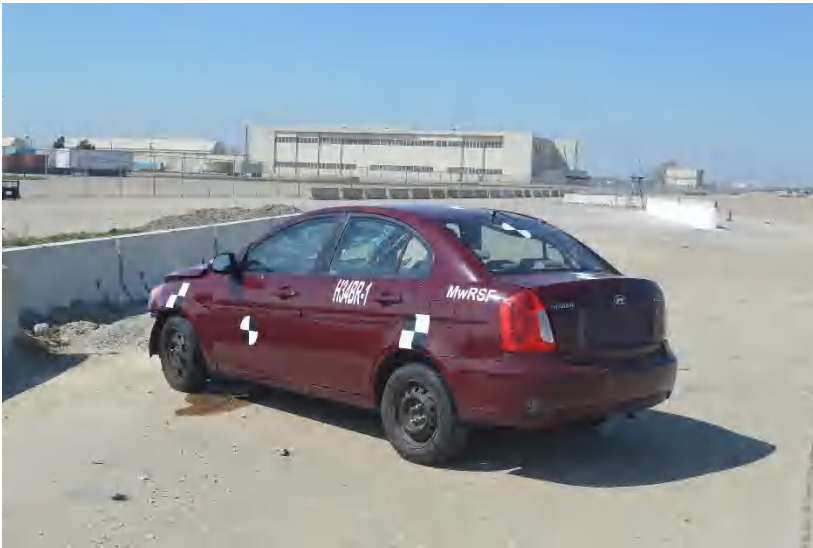
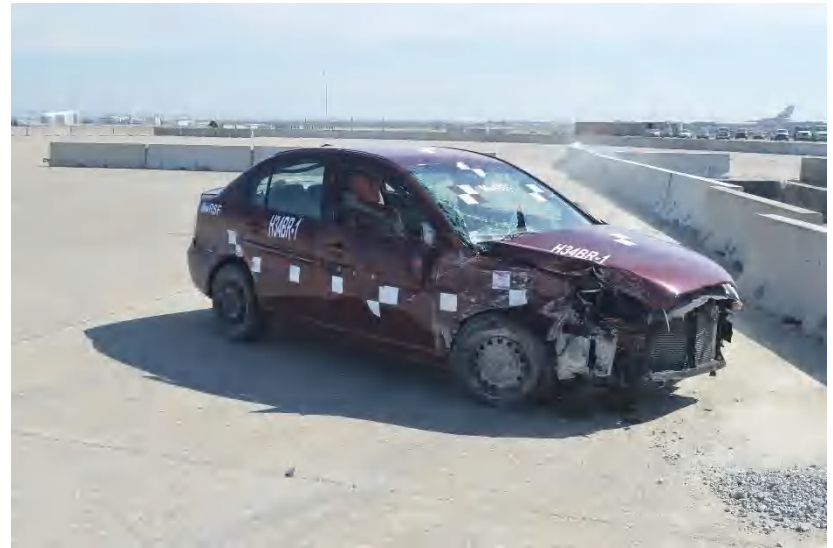
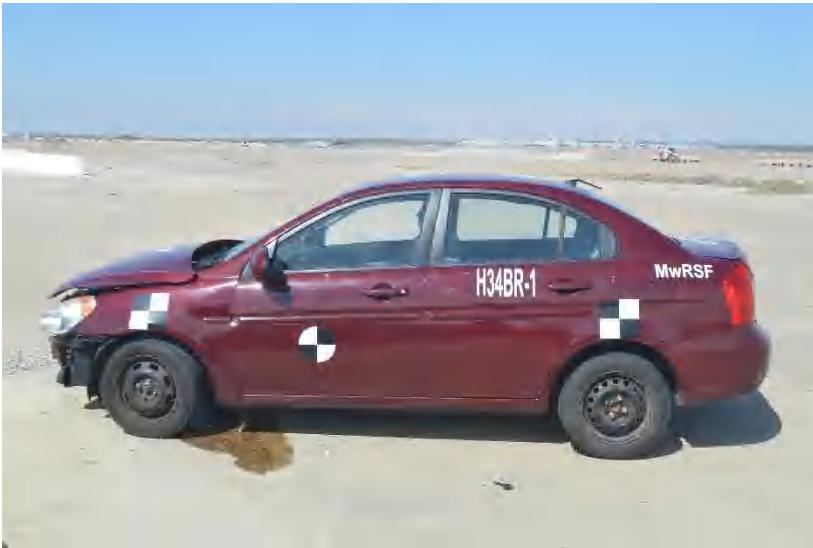
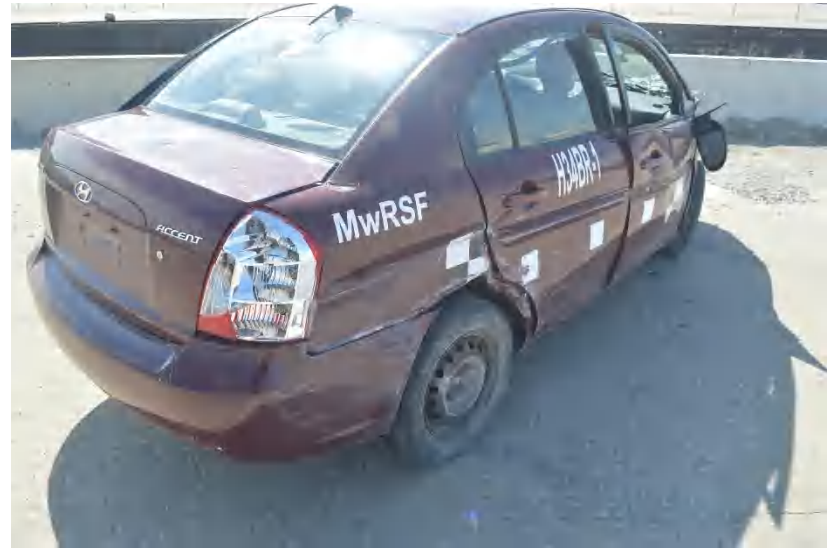
Figure 41. Vehicle Damage, Test No. H34BR-1

The damage to the vehicle was moderate, as shown in Figures 41 through 45. The maximum occupant compartment intrusions are listed in Table 5 along with the intrusion limits established in MASH 2016 for various areas of the occupant compartment. MASH 2016 defines intrusion or deformation as the occupant compartment being deformed and reduced in size with no observed penetration. Note that none of the established MASH 2016 intrusion limits were violated. The lateral B-Pillar and side door above and below the seat deformed slightly outward, which is not considered crush toward the occupant, is denoted as negative numbers in Table 5, and is not evaluated by MASH 2016 criteria. Complete occupant compartment and vehicle intrusions and the corresponding locations are provided in Appendix C.

The majority of the damage was concentrated on the right-front fender and right-front wheel of the vehicle where the impact had occurred. A small section of the seam where the floor pan and toe pan connected near the left-front corner of the right-side floor pan split due to floor pan deformation. The split seam was not due to intrusion of the barrier or a component of the vehicle. The vehicle's engine hood partially disengaged, but it remained attached to the vehicle's body. The front bumper and bumper cover disengaged from the vehicle. Kinks were found on the bottom support of the radiator, and the right radiator support was bent toward the engine compartment. A 2 $\frac{3}{8}$ -in. dent on the right side of the hood crushed 5 in. inward and toward the engine compartment. The right-front fender was crushed and had contact marks with the most significant occurring near the front of the wheel well. A 3 $\frac{8}{2}$ -in. long x 7 $\frac{1}{8}$ -in. wide x 1 $\frac{1}{2}$ -in. deep dent was found on the right-front door. The right-rear door was dented and scraped just ahead of the rear quarter panel.

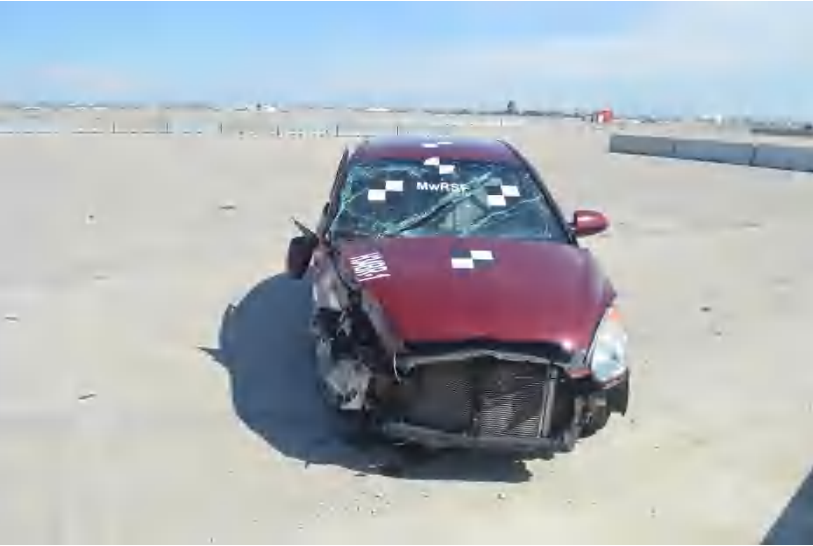
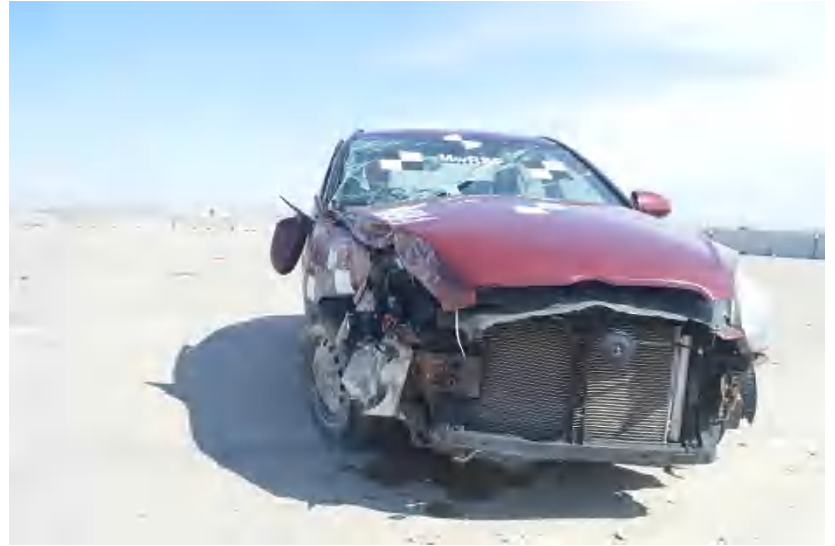
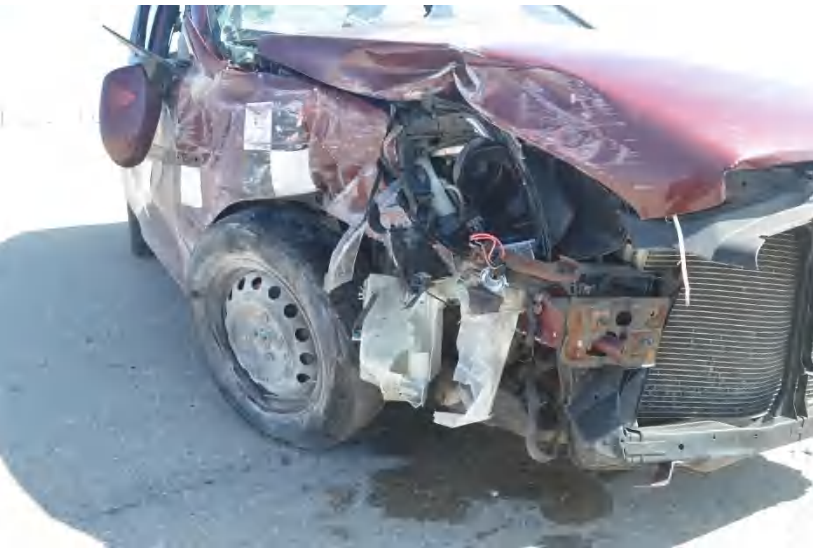
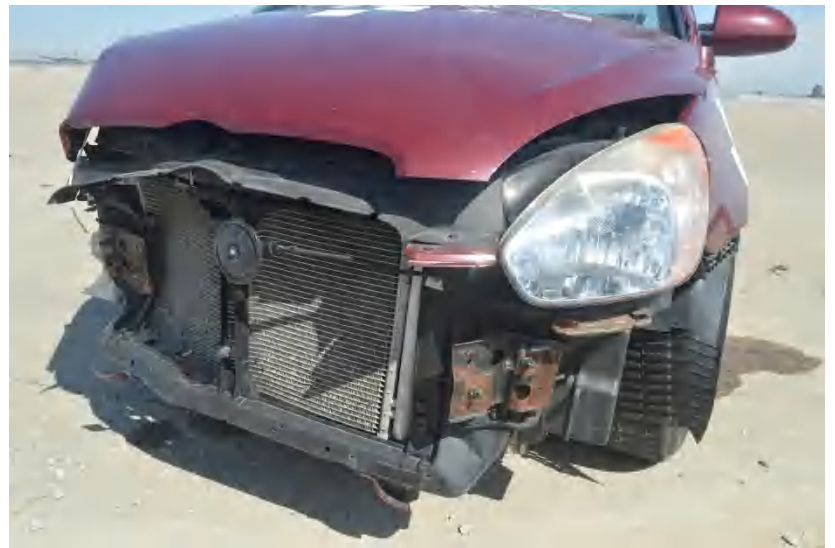
Figure 42. Vehicle Damage, Test No. H34BR-1

It should be noted that the passenger side window fractured, and a large tear was visible in the vehicle windshield. Review of the high-speed video revealed that the side window damage was due to crush of the side of the vehicle door and not due to direct contact with the test article. Similarly, the video data showed that the tearing of the windshield was formed due to crushing of the right front corner of the windshield which propagated a shear crack through the glass and the liner. Neither of these items were in violation of the MASH 2016 criteria as none of the damage occurred due to contact with the test article or debris, nor was there the potential for the barrier to intrude into the occupant compartment.

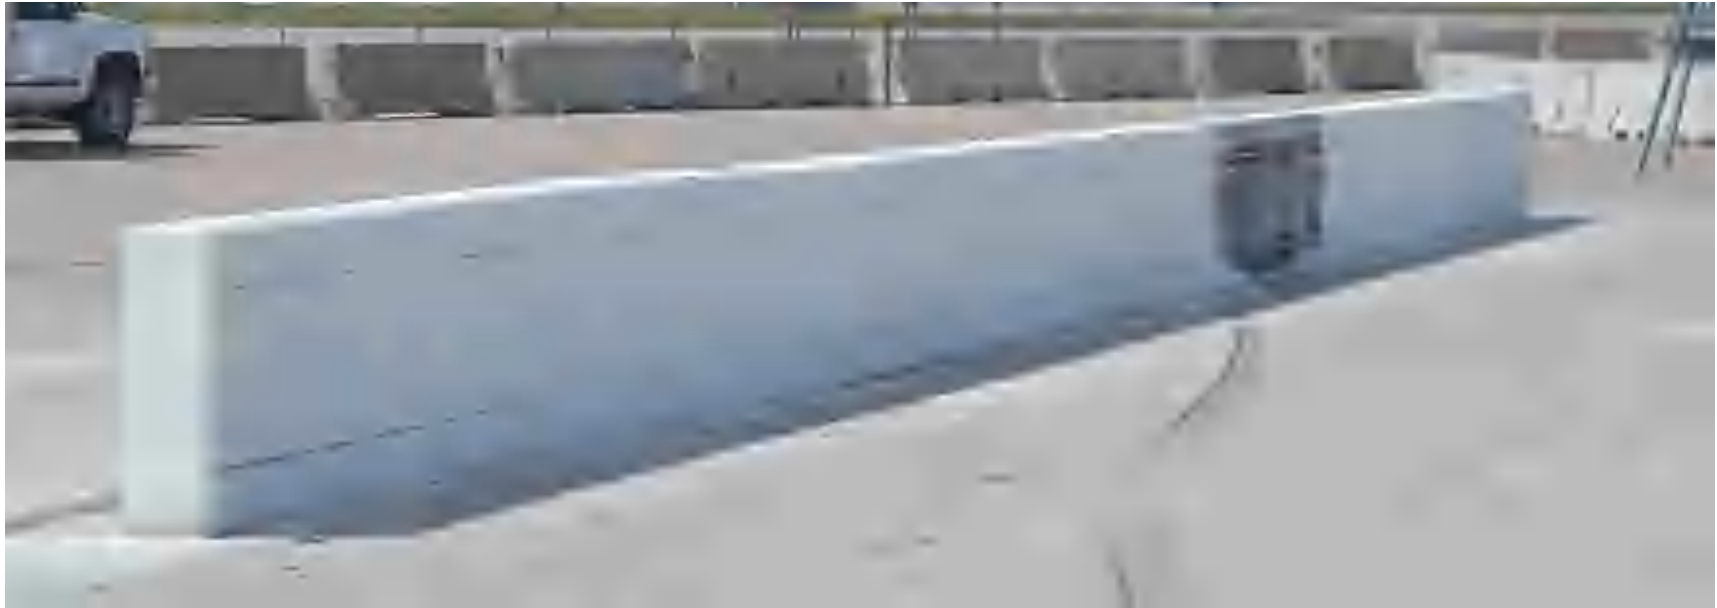
Figure 55. System Damage, Test No. H34BR-2

Damage to the barrier was minimal, as shown in Figures 55 through 58. Barrier damage consisted of contact marks on the front face of the concrete segments, spalling of the concrete, and concrete cracking. The length of vehicle contact along the barrier was approximately 12 ft – 9 in. which spanned from 5 ft – 6¼ in. upstream from the center of the joint between barrier nos. 2 and 3 to 7 ft – 3 in. downstream from the center of the joint between barrier nos. 2 and 3. The locations for all of the listed damage were measured using the expansion joint between barrier nos. 2 and 3 as a reference point.

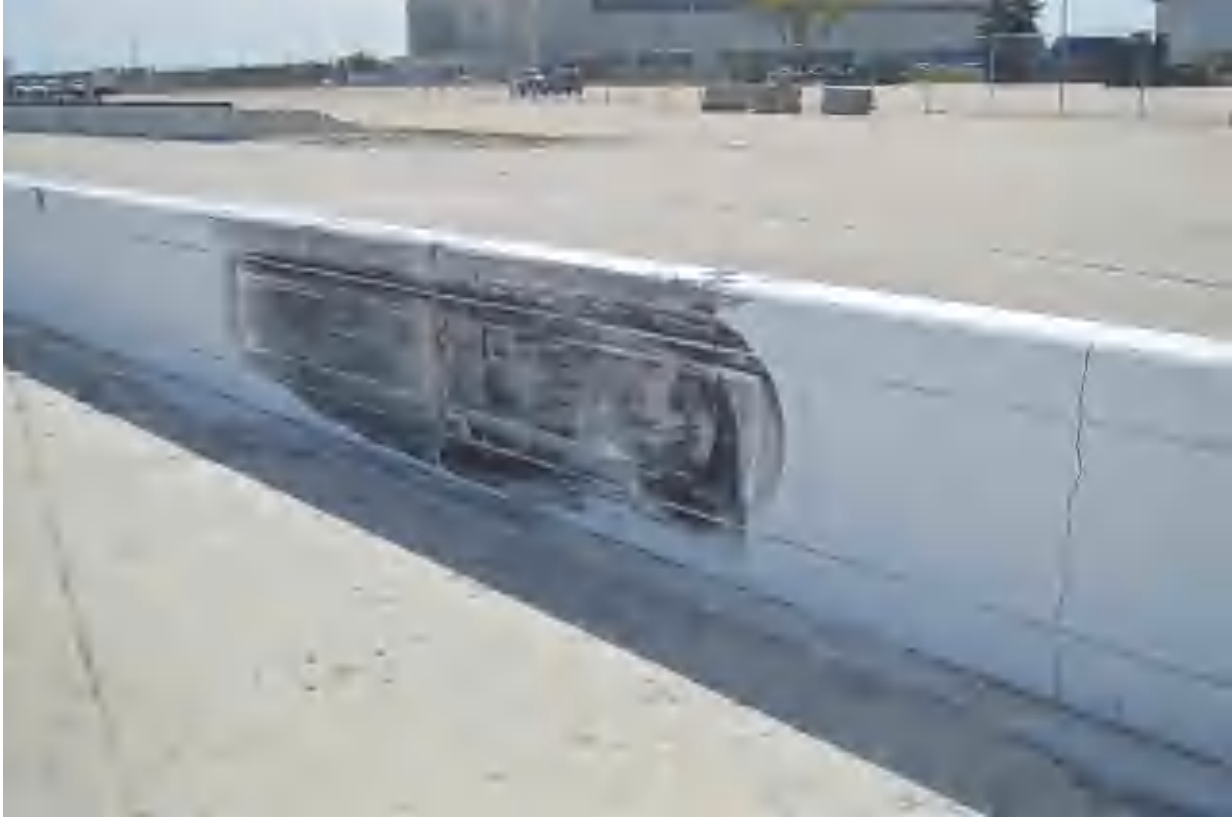
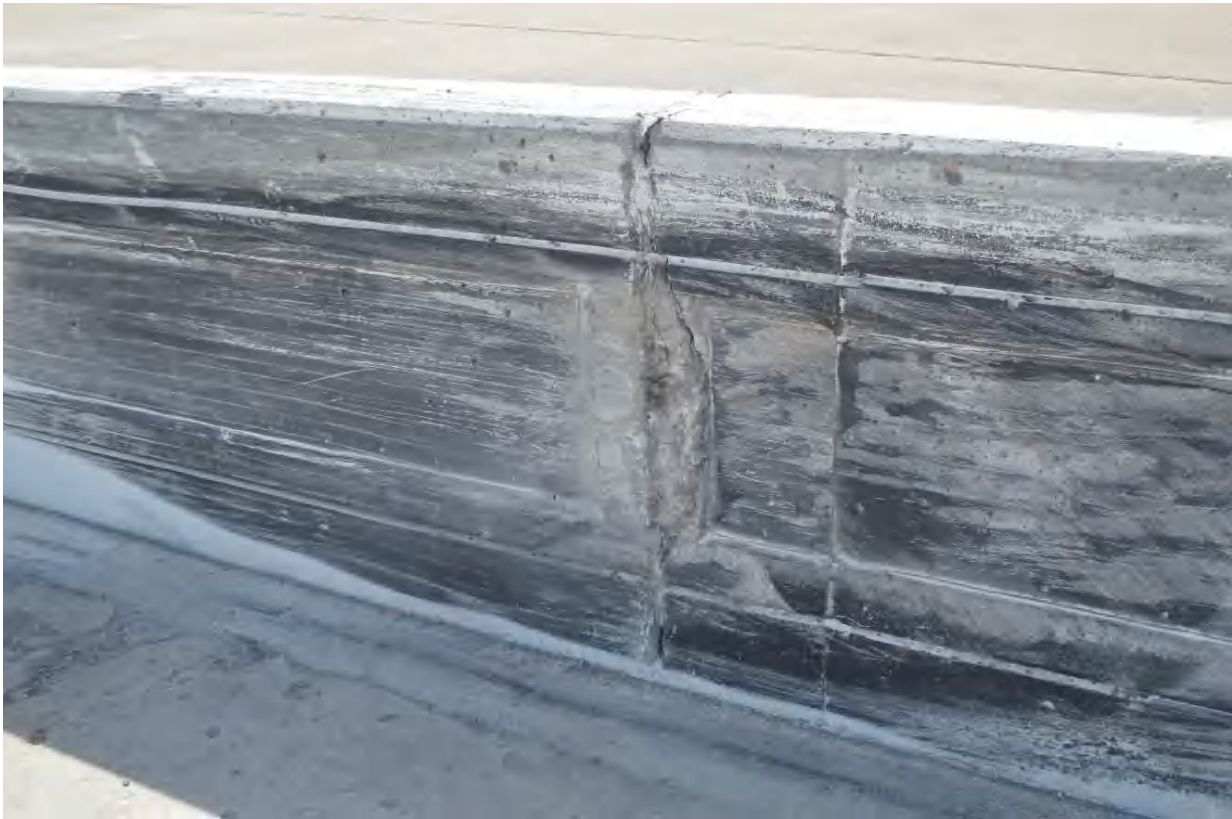
Figure 56. Traffic-Side System Damage, Test No. H34BR-2

Tire marks and scuff marks were visible on the front face of barrier nos. 2 and 3. Concrete spalling and cracking occurred at the downstream end of barrier no. 2 and upstream end of barrier no. 3. A 17½-in. x 5-in. x 1-in. piece of concrete was removed 2 in. upstream from the center of the expansion joint between barrier nos. 2 and 3. A 6½-in. long x 2½-in. wide concrete piece that was located 16½ in. from the ground was removed 54 in. upstream from the expansion joint. A 12-in. long x 9½-in. wide piece of concrete, which was located 19½ in. from the ground, was removed 46½ in. upstream from the expansion joint. An 8-in. long x 3¾-in. wide concrete piece that was located 8¾ in. from the ground was removed 4½ in. upstream from the expansion joint.

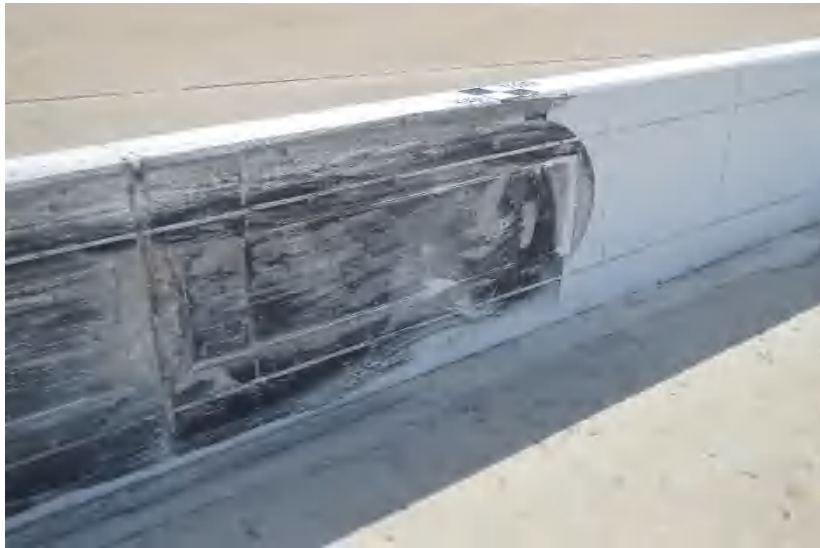
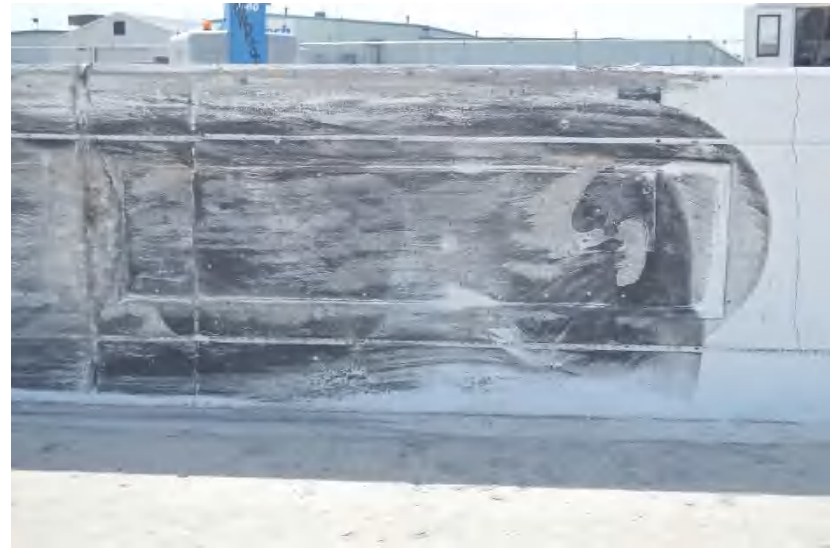
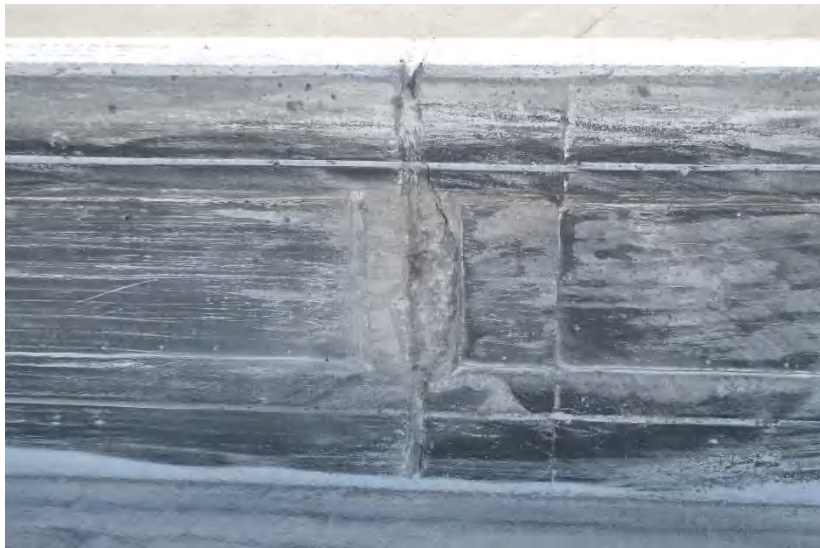
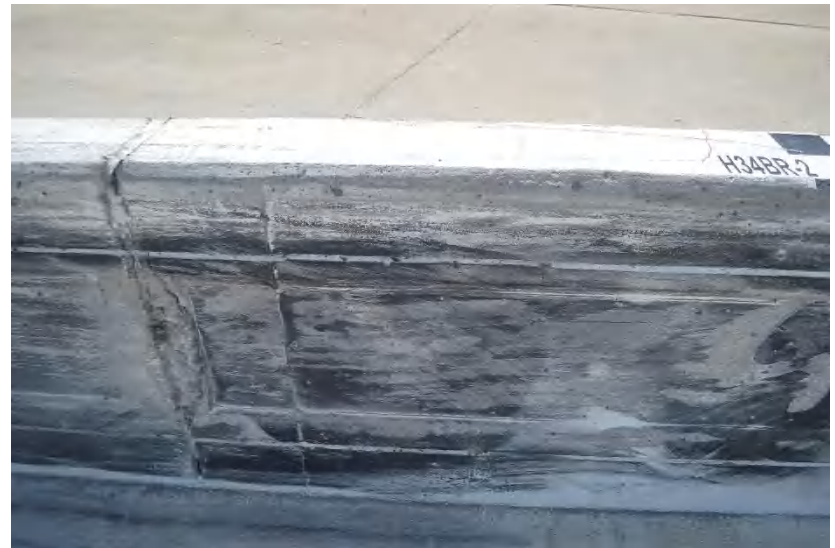
Figure 57. Traffic-Side System Damage, Test No. H34BR-2

A 2¼-in. long crack that began on the top face of the barrier was found 56½ in. upstream from the expansion joint. A longer crack was found 42 in. upstream from the expansion joint starting 6½ in. from the ground on the back side of the barrier and extending across the top face to 7 in. A crack was found 68¼ in. upstream from the expansion joint that started 29¾ in. above the ground and extended diagonally upstream and ended 18½ in. above the ground. The most significant crack formed on the back-side surface, which started at the bottom of the barrier and extended on top of the barrier. It started from the bottom and 3 in. upstream of the expansion joint, extending 6¼ in. upstream of the expansion joint and 11¼ in. above the ground, and ended at the top of the barrier and 1 in. upstream of the expansion joint.

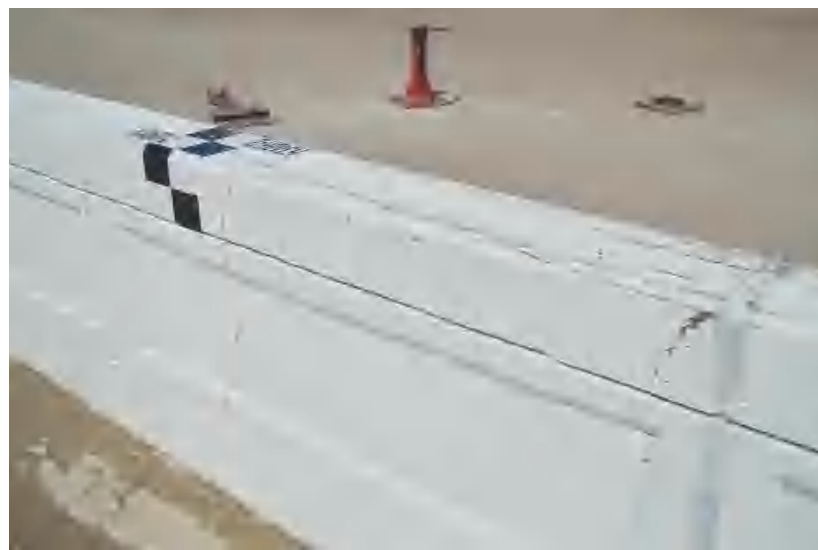
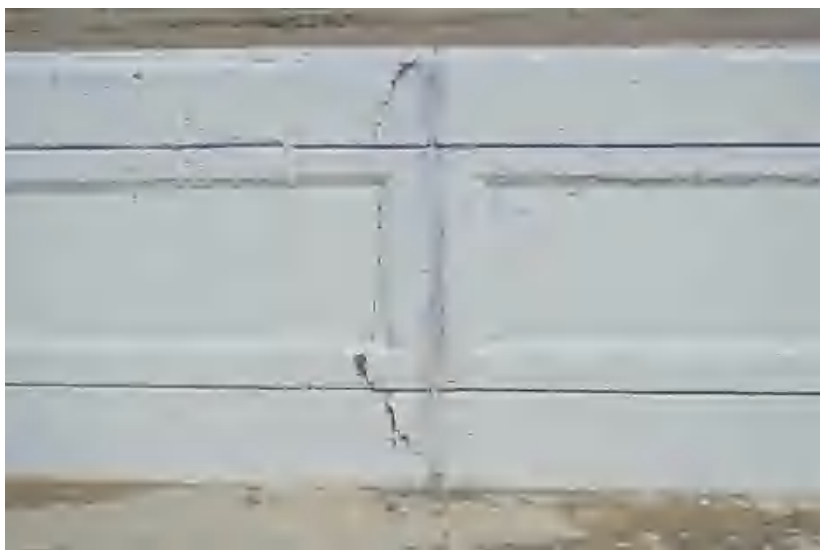
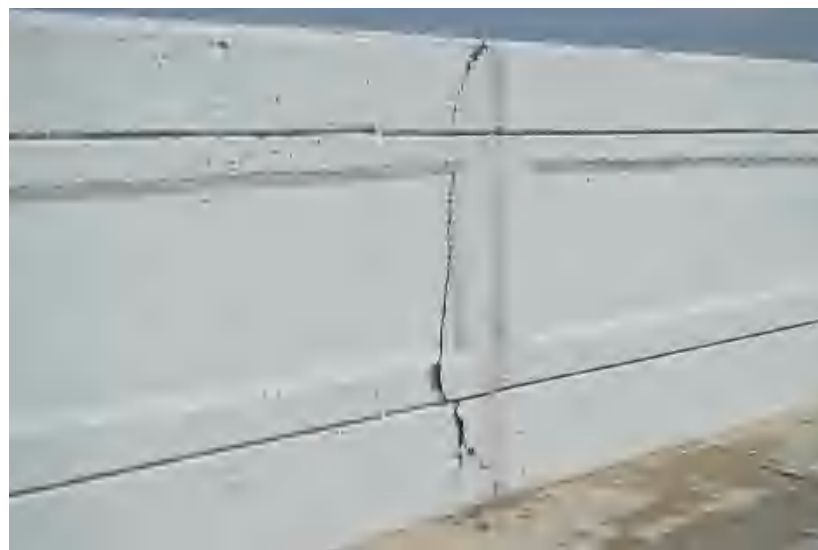
Figure 58. Back-Side System Damage, Test No. H34BR-2

on the barrier system near the ends of the bridge rail segments in both tests. Additionally, a long vertical crack that started at the bottom and extended to the top of the barrier was observed on the back side in test no. H34BR-2 due to loading of the dowel bars that transferred shear loads across the expansion joint. Cracking and damage of the barrier, especially near the expansion joint discontinuity, could weaken the bridge rail section and adversely affect its capacity and performance under secondary impacts. It is noted that reducing the spacing of the vertical reinforcement near the end sections of the barrier could potentially mitigate some of the cracking and damage that was observed in the full-scale crash tests and reduce the need for repair of the bridge rail. HDOT should consider reviewing the end sections of the bridge rail following accidents to determine if repair of the barrier is needed due to cracking similar to that observed in the testing herein.

It should be noted that both full scale crash tests were conducted on the length of need interior barrier segments, so the crashworthiness of the end segments and the transition buttresses were not evaluated in this report. It is recommended that end sections and buttresses be designed with similar or greater capacity to the bridge rail. Some minor cracking and damage was observed

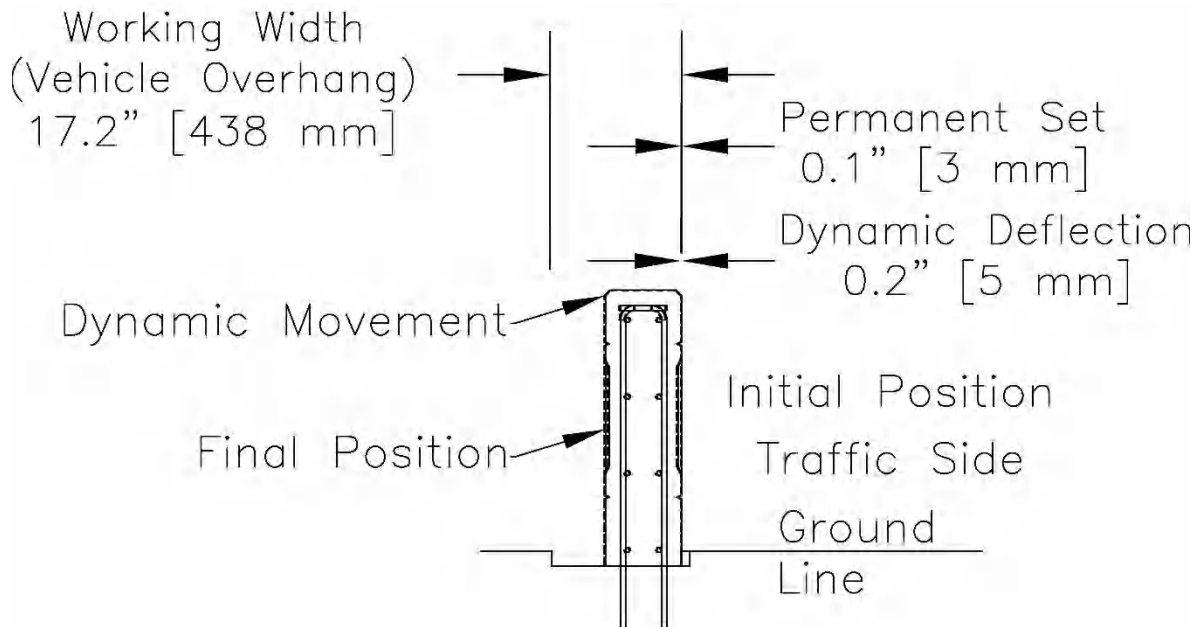
Figure 59. Permanent Set Deflection, Dynamic Deflection, and Working Width, Test No. H34BR-2

The maximum lateral permanent set of the barrier system was 0.1 in., including barrier and deck panel shift, which occurred at the downstream end of barrier no. 2, as measured in the field. The maximum lateral dynamic barrier deflection, including tipping of the barrier along the top surface, was 0.2 in. at the upstream end of barrier no. 3, as determined from high-speed digital video analysis. The working width of the system was found to be 17.2 in. also determined from high-speed digital video analysis. A schematic of the permanent set deflection, dynamic deflection, and working width is shown in Figure 59.

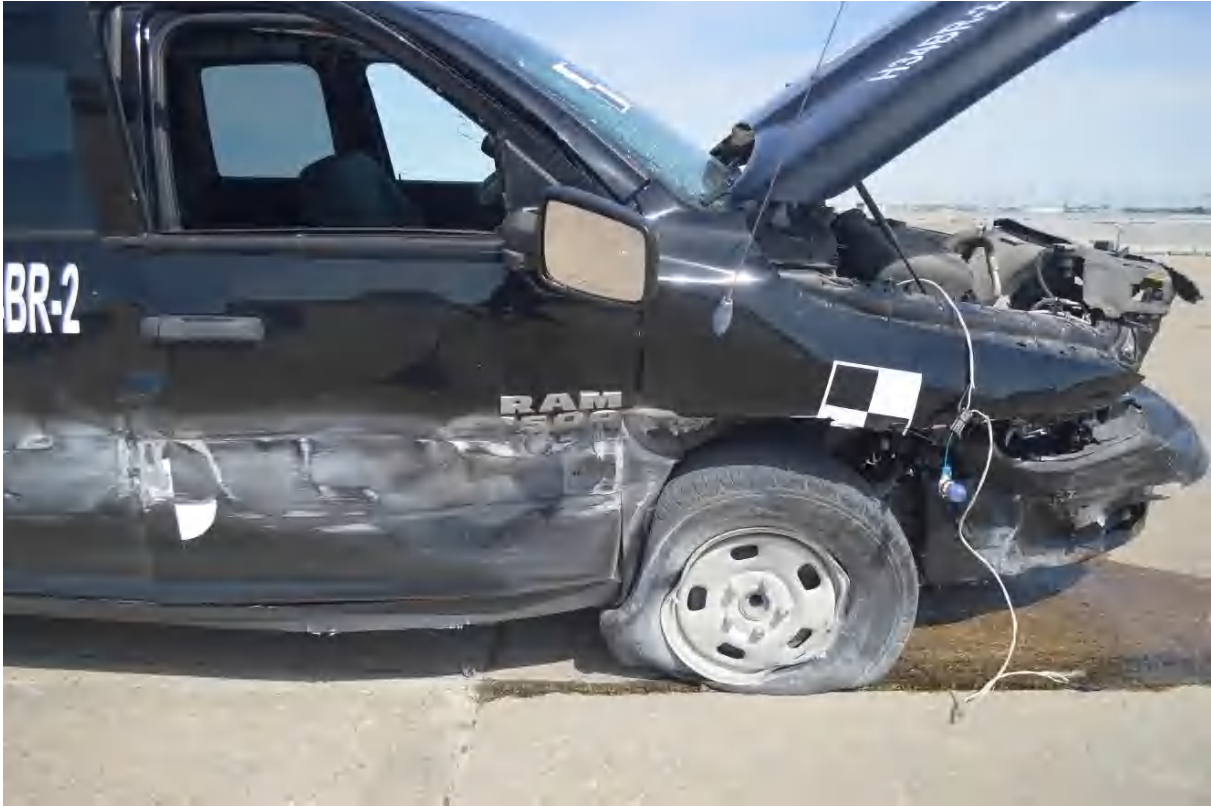
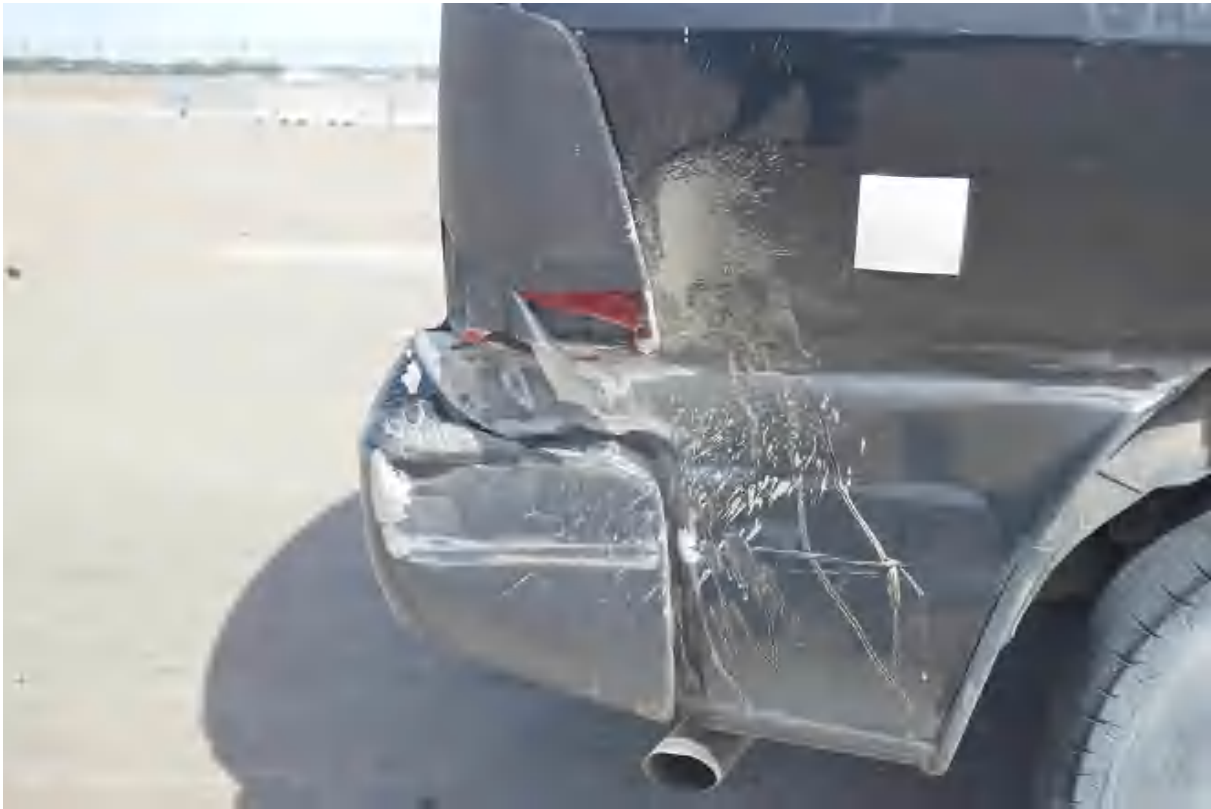
Figure 61. Vehicle Damage, Test No. H34BR-2

The majority of the damage was concentrated on the right-front corner and right side of the vehicle where the impact had occurred. The right side of the bumper was crushed inward and backward. The right-front fender was crushed inward toward the centerline of the vehicle and engine compartment. The right-front steel rim was deformed and crushed, and the right-front tire was torn and deformed. The right upper control arm was fractured. The grille was disengaged away

from the vehicle. The left-side headlight was disengaged away from the vehicle and right-side headlight and fog light were shattered. The right side of the radiator was pushed backward. A 16 $\frac{1}{2}$ -in. long x 21-in. wide x 2 $\frac{1}{2}$ -in. deep dent and scraping were observed on the entire right side. The right-front door was ajar, and creases were found in the door's sheet metal. The right-rear steel rim was crushed, and the tire was torn. The right side of the rear bumper was dented and scuffed. It should be noted that the window on the right-front side was shattered. It should be noted that the passenger side window was fractured. Review of the high-speed video revealed that the side window damage was due to crush of the side of the vehicle door and not due to direct contact with the test article. Thus, the side window damage was not in violation of the MASH criteria as it did not occur due to contact with the test article or debris. The bottom-right side of the windshield had a hairline crack, and no cracks were found on the left side of the windshield. The left-front fender was dented at the top and back. Minor scrapes and dents were found at the left-front and left-rear doors. The roof and remaining window glass remained undamaged.
