U.S. Department
of Transportation
**Federal Highway
Administration**

In Reply Refer To:
HSST-1/B-287

- Defender Barrier™ 70

The Defender Barrier™ 70 is an unanchored Test Level 2 longitudinal steel temporary barrier system consisting of:

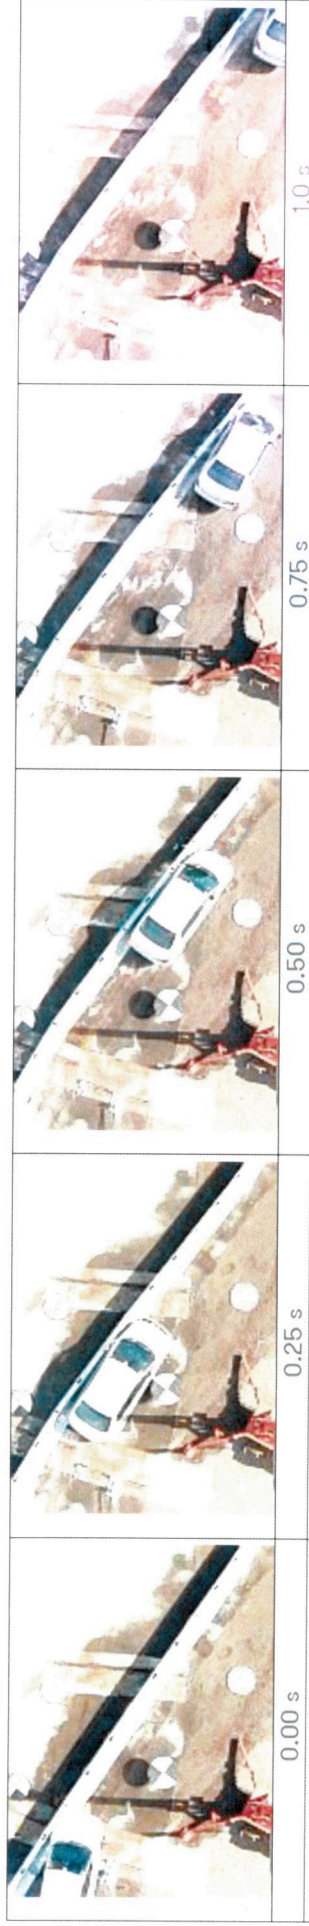
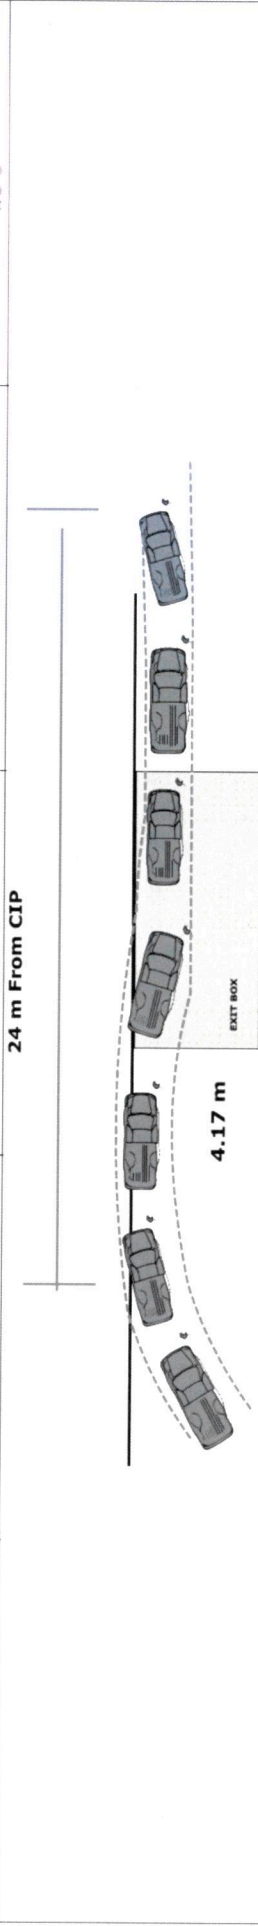
Test Article:		Safe Barriers Ballasted STBS - Defender 70		Post Impact Vehicle Behaviour	
Total Length		105.3 m		Vehicle Stability	
Key Elements - Barrier		Test 2-10		Stopping Distance	
Description		Steel Temporary Barrier System		Vehicle Snagging	
Length of Barrier Installation		105.3 m length of need		Vehicle Pocketing	
Height		0.80 m		Occupant Impact Velocity (m/s)	
Length of Barrier Segments		3.9 m		Longitudinal	
Test Vehicle				Lateral (optional)	
Designation		1100C		Occupant Ride-down Deceleration	
Make/Model		Nissan Tiida		X-direction (g)	
Dimensions (LxWxH)		4350 mm x 1695 mm x 1535 mm		Y-direction (g)	
Curb Wt		1096.0 kg		THIV (optional) (m/s)	
Test Inertial Wt		1083.0 kg		PHD (optional) (g)	
Gross Static		1158.0 kg		ASI (optional)	
Impact Conditions				Test Article Damage	
Speed		69.4 km /h		Test Article Deflections	
Angle		24.7 degrees		Dynamic	
Impact Point		1100 mm upstream of barrier joint 10B		Permanent

Exit Conditions				Working Width	
Exit Speed:		41 km/h		Vehicle Damage Exterior	
Exit Angle:		1.0° Est		VDS	
				CDC	
				Maximum Deformation

Required Test Number	Narrative Description	Evaluation Results
2-10 (1100C)	<p>Holmes Crash Test No. 131393.2-10 was performed on 27th April 2017. The Defender Barrier™ 70 successfully contained and redirected the 1100c vehicle impacting the test article at 24.7 degrees and a velocity of 69.4km/h (43.1mph). Maximum dynamic deflection during the test was 0.74m (29.1").</p> <p>The test vehicle impacted the test installation 1100mm upstream of barrier joint 10B. The CIP was chosen to maximize the potential to snag a wheel on the adjoining barriers and also to increase the Occupant Impact Velocity (OIV).</p> <p>No debris or detached elements penetrated or showed potential to penetrate the occupant compartment. No fragments were distributed outside of the vehicle trajectory. The trajectory of the vehicle was such that it did not present any undue hazard to other traffic, pedestrians or work zone personnel.</p> <p>The vehicle remained upright during and after the impact and vehicle stability was considered satisfactory. Occupant risk factors satisfied the test criteria and the vehicle exit trajectory remained within acceptable limits.</p>	PASS

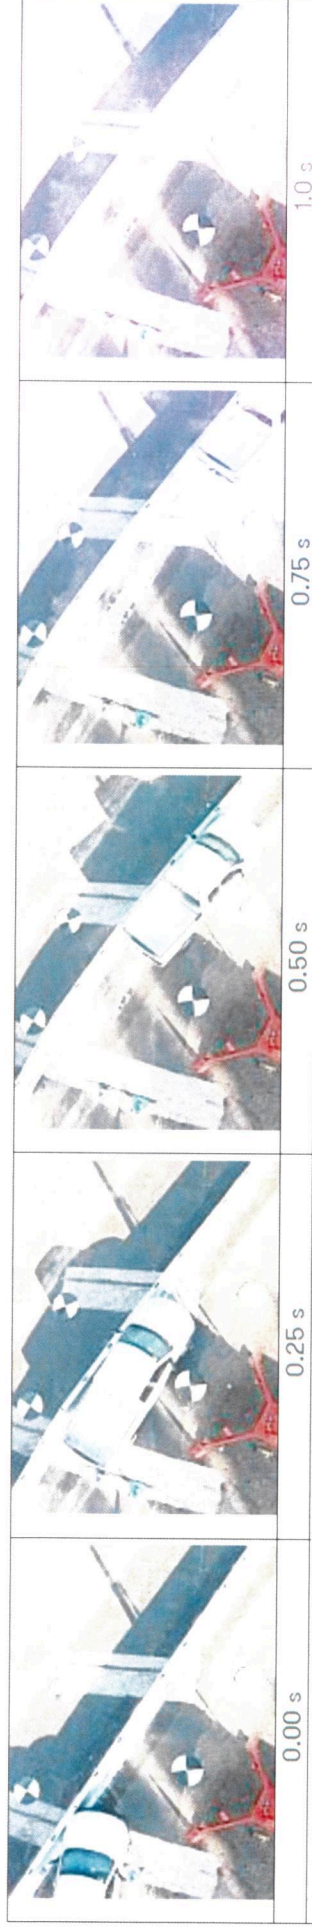
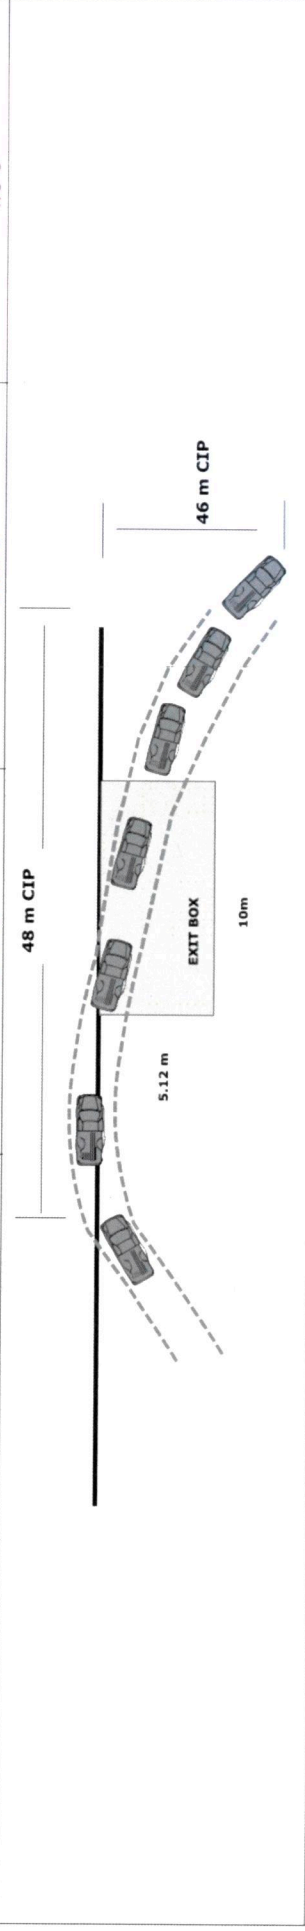
Test Article:		Safe Barriers Ballasted STBS – Defender 70		Post Impact Vehicle Behaviour	
Total Length		105.3 m		Vehicle Stability	
Key Elements - Barrier		Test 2-11		Stopping Distance	
Description		Steel Temporary Barrier System		Vehicle Snagging	
Length of Barrier Installation		105.3 m length of need		Vehicle Pooketing	
Height		0.80 m		Occupant Impact Velocity (m/s)	
Length of Barrier Segments		3.9 m		Longitudinal	
Test Vehicle				Lateral (optional)	
Designation		2270P		Occupant Ride-down Deceleration	
Make/Model		Dodge Ram 1500 Quad Cab		X-direction (g)	
Dimensions (LxWxH)		5785 mm x 1995 mm x 1890 mm		Y-direction (g)	
Curb Wt		2203.0 kg		THIV (optional) (m/s)	
Test Inertial Wt		2277.0 kg		PHD (optional) (g)	
Gross Static		2277.0 kg		ASI (optional)	
Impact Conditions				Test Article Damage	
Speed		70.2 km /h		Test Article Deflections	
Angle		24.7 degrees		Dynamic	
Impact Point		600 mm upstream of barrier joint 10B		Permanent

Exit Conditions				Working Width	
Exit Speed:		48 km/h		Vehicle Damage Exterior	
Exit Angle:		12.0° Est		VDS	
				CDC	
				Maximum Deformation

Required Test Number	Narrative Description	Evaluation Results
2-11 (2270P)	<p>Holmes Crash Test No. 131393.2-11 was performed on 27th April 2017. The Defender Barrier™ 70 successfully contained and redirected the 2270P vehicle impacting the test article at 24.7 degrees and a velocity of 70.2km/h (43.6mph). Maximum dynamic deflection during the test was 1.20m (47.2").</p> <p>The test vehicle impacted the test installation 600mm upstream of barrier joint 10B. The CIP was chosen to test the containment and vehicle stability, while also imparting the most amount of load on the connection joint.</p> <p>No debris or detached elements penetrated or showed potential to penetrate the occupant compartment. No fragments were distributed outside of the vehicle trajectory. The trajectory of the vehicle was such that it did not present any undue hazard to other traffic, pedestrians or work zone personnel.</p> <p>The vehicle remained upright during and after the impact and vehicle stability was considered satisfactory. Occupant risk factors satisfied the test criteria and the vehicle exit trajectory remained within acceptable limits.</p>	PASS

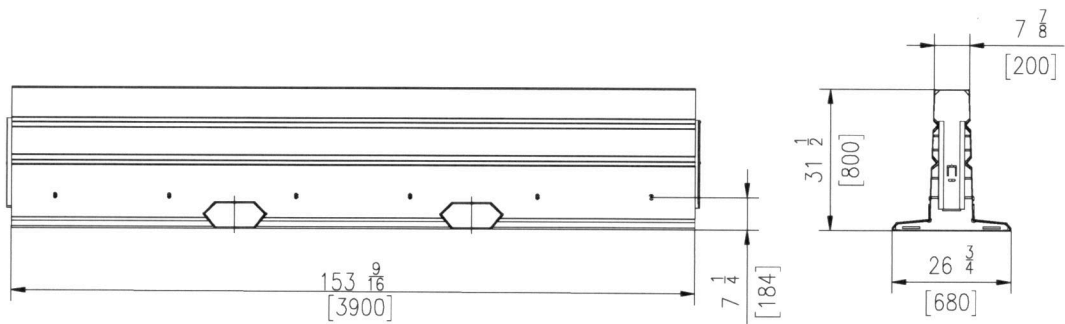
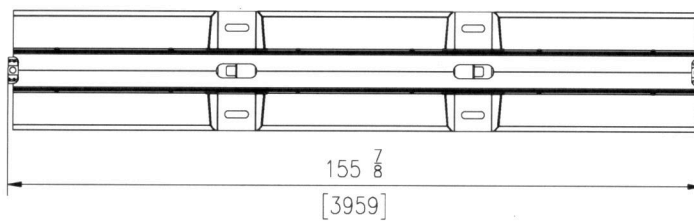
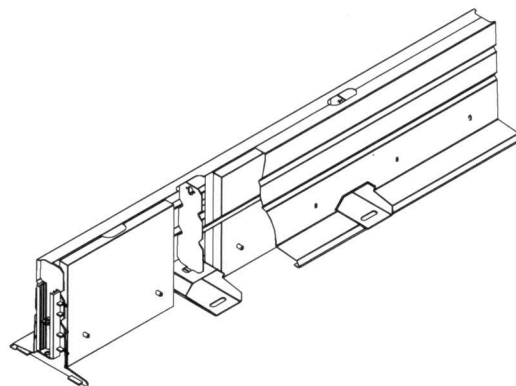
Steel Barrier Segment

Steel Barrier Segments - Barrier segments are manufactured from Q235B grade steel with a nominal 3.0mm wall thickness. Each barrier measures 3960mm (155.9") long x 800mm (31.4") high x 680mm (26.7") wide and have a dry weight of 320kg (705.6lbs). Each of the steel barriers connect together via interlocking flanges and a steel galvanized connecting pin at each end. The installed length of each barrier segment is 3900mm (153.5"). The two lifting points for the barrier are approximately 1350mm (53.15") apart.

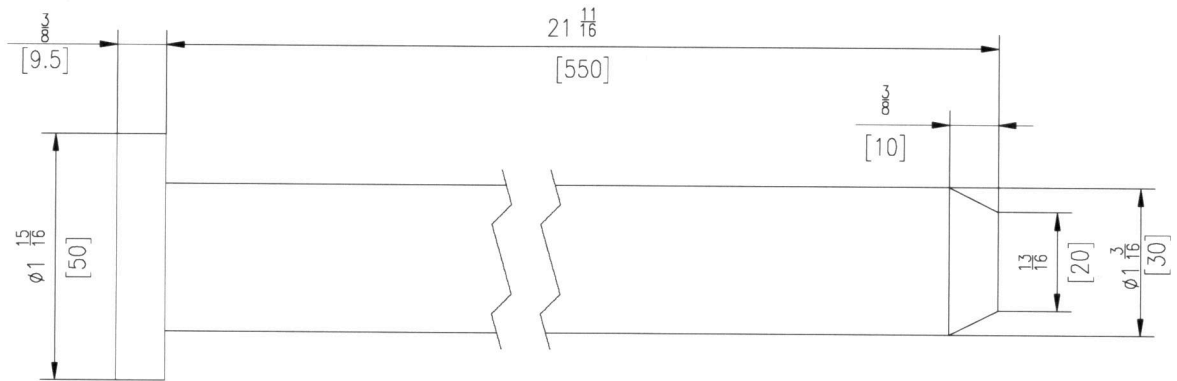
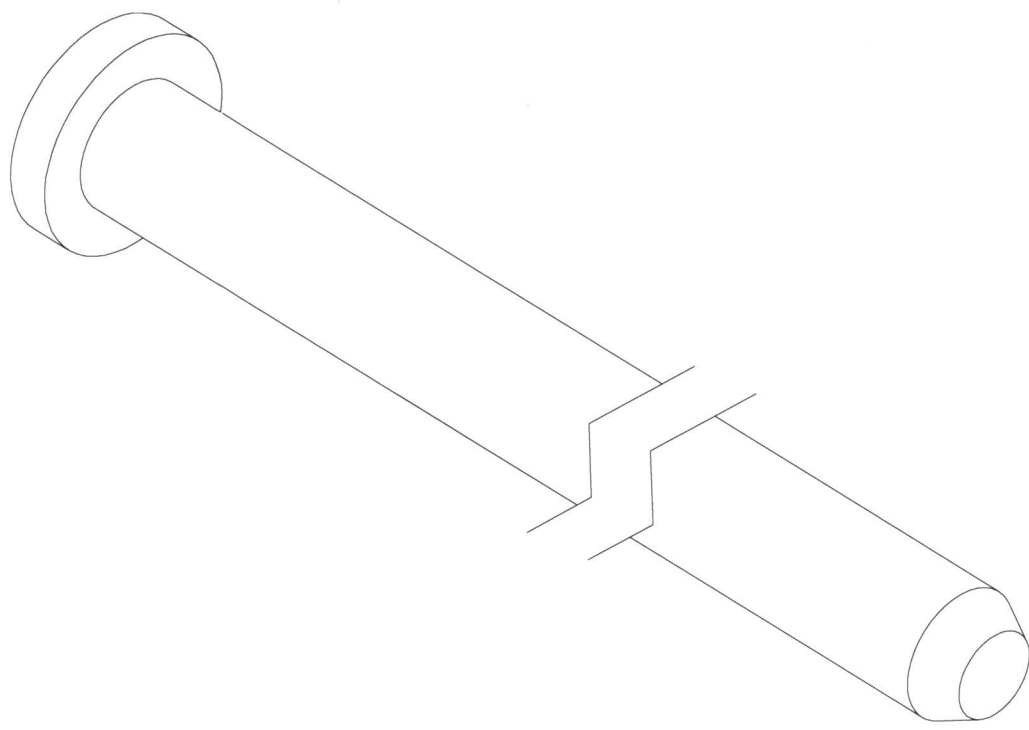
Connecting Pin

Connecting Pins - Galvanized connecting pins connecting the barrier segments are manufactured from Q235B steel and measure 30mm (1.18") diameter x 550mm (21.6") long. The top of the pin has a 50mm (2") wide x 9.5mm (0.37") thick plate welded 5mm down from the top end of the bar. Pins are fitted vertically down through interlocking lugs of the barrier segment forming a hinge type joint.

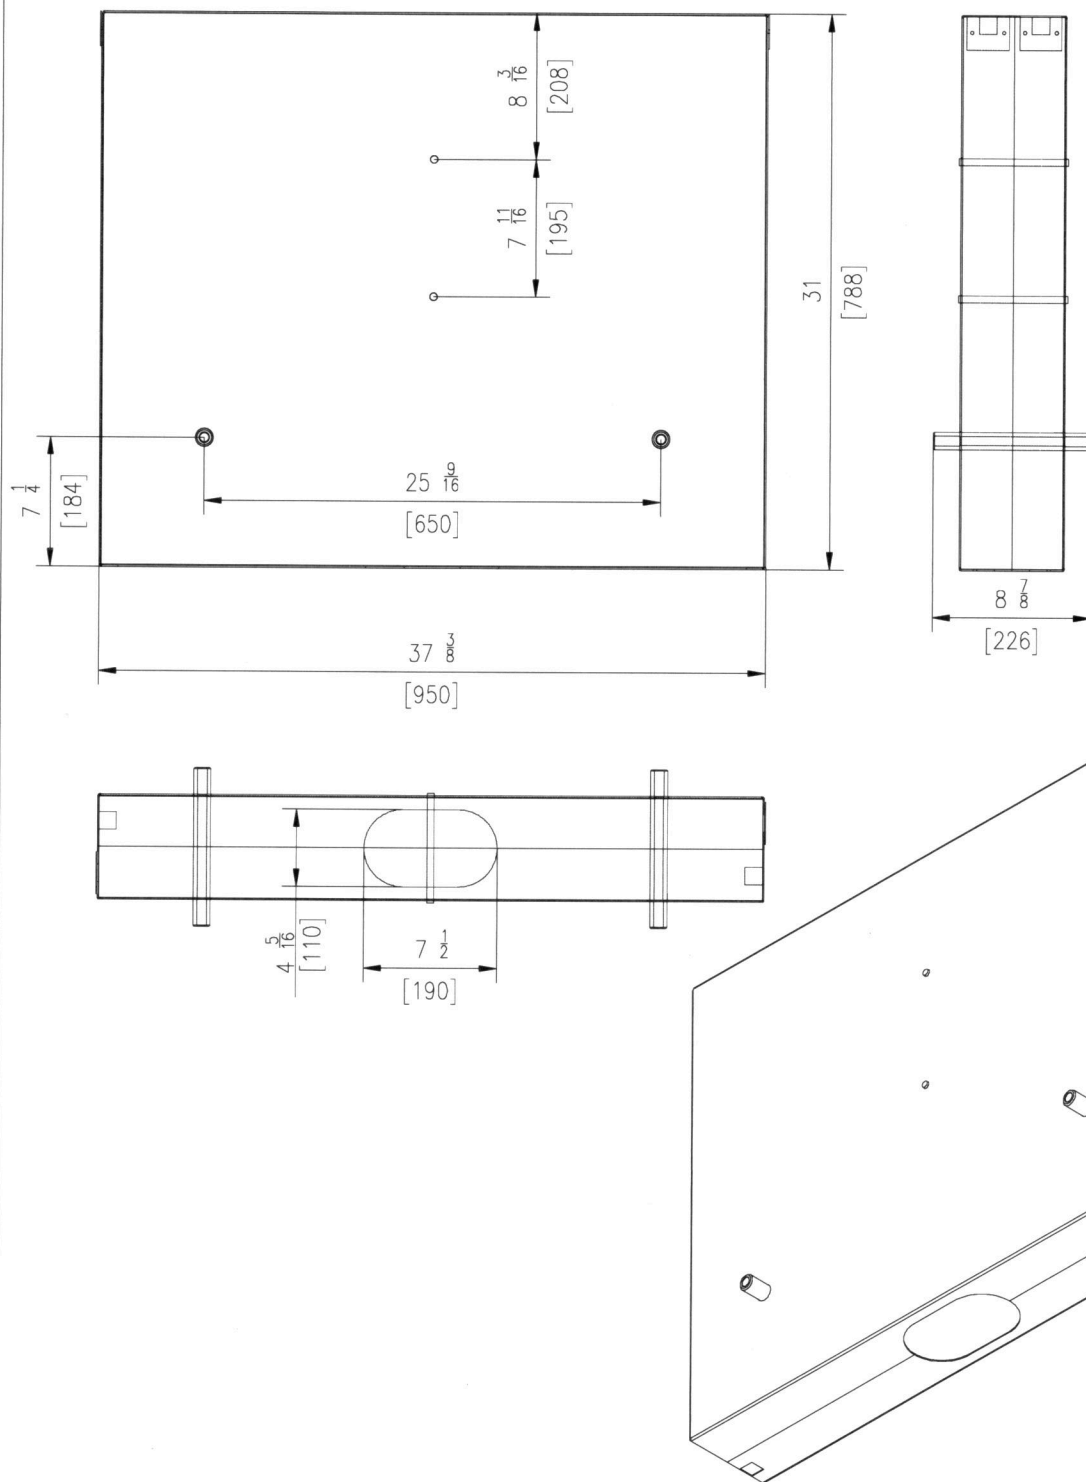
Ballast Box

Ballast Boxes - Three ballast boxes measuring 954mm (37.55") long x 788mm (31") high x 150mm (5.9") wide. Each ballast box can hold 0.1 cubic meter of concrete, approximately 240kg (529.2lbs) in weight. There is a filling hole measuring 110mm (4.33") x 190mm (7.48") for each ballast box. Each ballast box is connected to the barrier segment with four (4) M16 G8.8 bolts.
