U.S. Department
of Transportation
**Federal Highway
Administration**

- TL-3 4 Cable End Terminal

Name of system: TL-3 4 Cable End Terminal

Type of system: End Terminal

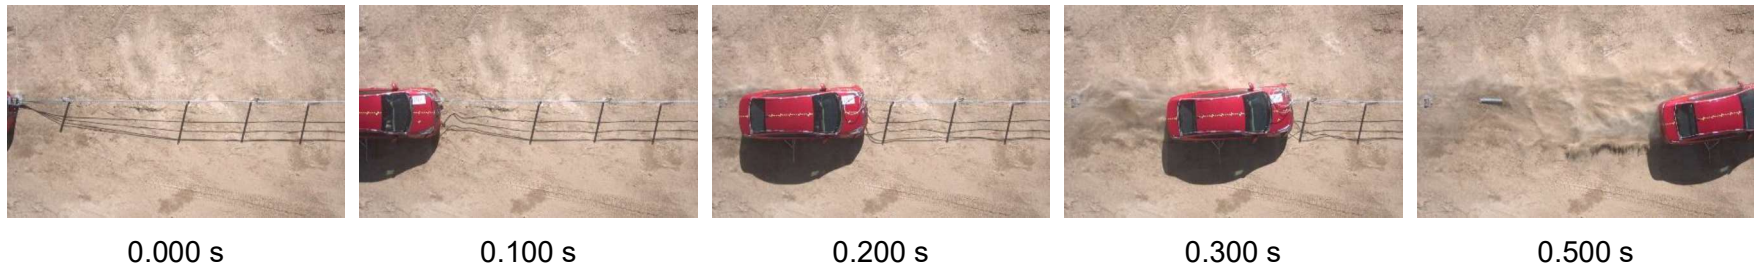
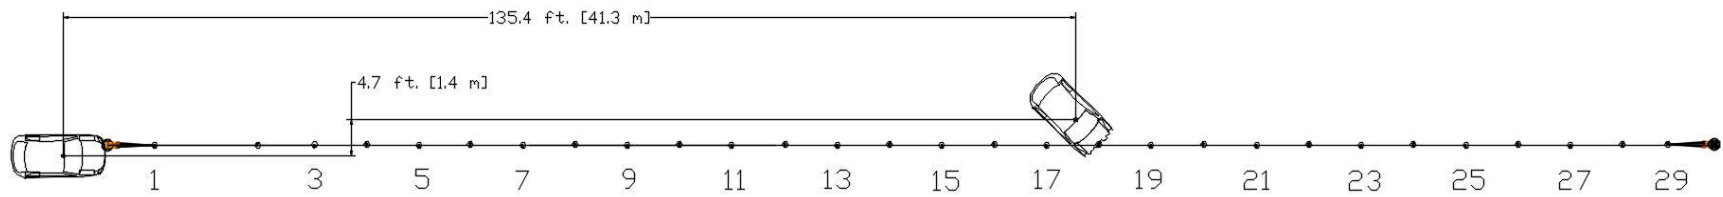
Figure 4 Summary of Test 3-30

MASH 2016 Test 3-30 Summary

GENERAL INFORMATION	
Test Agency.....	Applus IDIADA KARCO
Test No.....	P37410-01
Test Designation.....	3-30
Test Date.....	1/29/18
TEST ARTICLE	
Name / Model.....	TL-3 4 Cable Terminal
Type.....	End Terminal
Installation Length.....	214.8 ft. (65.5 m)
Terminal Length.....	27.5 ft. (8.4 m)
Road Surface.....	Compacted Soil
TEST VEHICLE	
Type / Designation.....	1100C
Year, Make, and Model....	2013 Kia Rio
Curb Mass.....	2,508.8 lbs (1,138.0 kg)
Test Inertial Mass.....	2,425.0 lbs (1,100.0 kg)
Gross Static Mass.....	2,600.3 lbs (1,179.5 kg)

Impact Conditions	
Impact Velocity.....	61.48 mph (98.95 km/h)
Impact Angle.....	0.4°
Location / Orientation.....	Offset 16.3 in. (414 mm)
Kinetic Energy.....	306.4 kip-ft (415.5 kJ)
Exit Conditions	
Exit Velocity.....	Vehicle did not exit
Exit Angle.....	N/A
Final Vehicle Position.....	135.4 ft. (41.3 m) Downstream
	4.7 ft. (1.4 m) Left
Exit Box Criteria Met.....	N/A
Vehicle Snagging.....	None
Vehicle Pocketing.....	None
Vehicle Stability.....	Satisfactory
Maximum Roll Angle.....	4.0°
Maximum Pitch Angle.....	1.7°
Maximum Yaw Angle.....	17.8°

Occupant Risk	
Longitudinal OIV.....	8.9 ft/s (2.7 m/s)
Lateral OIV.....	1.0 ft/s (0.3 m/s)
Longitudinal RA.....	-5.6 g
Lateral RA.....	-3.9 g
THIV.....	8.9 ft/s (2.7 m/s)
PHD.....	5.8 g
ASI.....	0.21
Test Article Deflections	
Static.....	N/A
Dynamic.....	5.6 ft. (1.7 m)
Working Width.....	5.6 ft. (1.7 m)
Debris Field.....	129.4 ft. (39.4 m) Downstream
	5.3 ft. (1.6 m) Left
Vehicle Damage	
Vehicle Damage Scale.....	12-FD-3
CDC.....	12FDEW2
Maximum Intrusion.....	0.2 in. (5 mm)

Required Test Number	Narrative Description	Evaluation Results
3-30 (1100C)	<p>Applus IDIADA KARCOTest No. P37410-01. An 1100C test vehicle impacting the terminal end at a nominal speed and angle of 62 mph and 0°, respectively, with the quarter point of the vehicle aligned with the centerline of the terminal. This test is primarily intended to evaluate structural adequacy, occupant risk, and vehicle trajectory. A 2013 Kia Rio 4-door sedan with a test inertial mass of 2425.0 lbs (1100.0 kg) impacted the terminal at a velocity of 61.48 mph (98.95 km/h) and an angle of 0.4°.</p> <p>The impact activated the cable release post and the vehicle was allowed to penetrate the system in a controlled manner. The occupant compartment was not penetrated and deformation limits were not exceeded. The Occupant Impact Velocities (OIV) were 8.9 ft/s (2.7 m/s) and 1.0 ft/s (0.3 m/s) in the x- and y-directions, respectively. The Ridedown Accelerations were -5.6 g and -3.9 g, respectively. The Gibraltar Global TL-3 4 Cable Terminal met all of the requirements for MASHTest 3-30.</p>	PASS

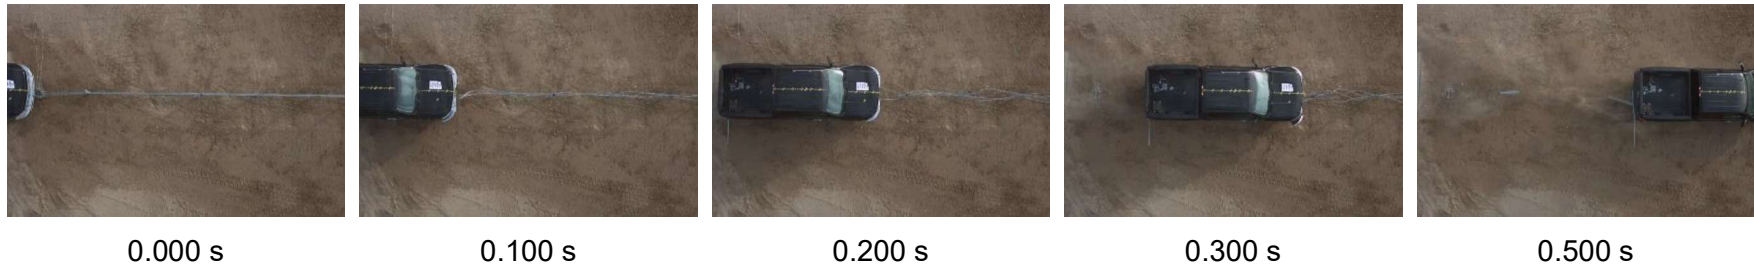
Figure 4 Summary of Test 3-31

MASH 2016 Test 3-31 Summary

<u>GENERAL INFORMATION</u>	
Test Agency.....	Applus IDIADA KARCO
Test No.....	P37411-01
Test Designation.....	3-31
Test Date.....	1/29/18
<u>TEST ARTICLE</u>	
Name / Model.....	TL-3 4 Cable Terminal
Type.....	Emd Terminal
Installation Length.....	214.8 ft. (65.5 m)
Terminal Length.....	27.5 ft. (8.4 m)
Road Surface.....	Compacted Soil
<u>TEST VEHICLE</u>	
Type / Designation.....	2270P
Year, Make, and Model...	2012 Chevrolet Silverado 1500
Curb Mass.....	4,898.6 lbs (2,222.0 kg)
Test Inertial Mass.....	4,992.3 lbs (2,264.5 kg)
Gross Static Mass.....	4,992.3 lbs (2,264.5 kg)

<u>Impact Conditions</u>	
Impact Velocity.....	60.11 mph (96.74 km/h)
Impact Angle.....	1.1°
Location / Orientation.....	1.4 in (36 mm) Left
Kinetic Energy.....	603.0 kip-ft (817.6 kJ)
<u>Exit Conditions</u>	
Exit Velocity.....	Vehicle did not exit
Exit Angle.....	N/A
Final Vehicle Position.....	227.9 ft. (69.5 m) Left
	1.4 ft. (0.4 m) Downstream
Exit Box Criteria Met.....	N/A
Vehicle Snagging.....	None
Vehicle Pocketing.....	None
Vehicle Stability.....	Satisfactory
Maximum Roll Angle.....	2.3°
Maximum Pitch Angle.....	-2.5°
Maximum Yaw Angle.....	4.4°

<u>Occupant Risk</u>	
Longitudinal OIV.....	2.6 ft/s (0.8 m/s)
Lateral OIV.....	3.9 ft/s (1.2 m/s)
Longitudinal RA.....	-2.0 g
Lateral RA.....	1.7 g
THIV.....	4.9 ft/s (1.5 m/s)
PHD.....	2.2 g
ASI.....	0.1
<u>Test Article Deflections</u>	
Static.....	N/A
Dynamic.....	3.3 ft. (1.0 m)
Working Width.....	3.3 ft. (1.0 m)
Debris Field Lateral.....	6.7 ft. (2.0 m)
<u>Vehicle Damage</u>	
Vehicle Damage Scale....	12-FD-2
CDC.....	12FDEW2
Maximum Intrusion.....	0.3 in. (8 mm)

3-31 (2270P)	<p>Applus IDIADA KARCOTest No. P37411-01. A 2270P test vehicle impacting the terminal end at a nominal speed and angle of 62 mph and 0°, respectively, with the centerline of the vehicle aligned with the centerline of the terminal. This test is primarily intended to evaluate structural adequacy, occupant risk, and vehicle trajectory. A 2012 Chevrolet Silverado 1500 4-door pickup truck with a test inertial mass of 4992.3 lbs (2264.5 kg) impacted the terminal at a velocity of 60.11 mph (96.74 km/h) and an angle of 1.1°.</p> <p>The impact activated the cable release post and the vehicle was allowed to penetrate the system in a controlled manner. The occupant compartment was not penetrated and deformation limits were not exceeded. The Occupant Impact Velocities (OIV) were 2.6 ft/s (0.8 m/s) and 3.9 ft/s (1.2 m/s) in the x- and y-directions, respectively. The Ridedown Accelerations were -2.0 g and 1.7 g, respectively. The Gibraltar Global TL-3 4 Cable Terminal met all of the requirements for MASHTest 3-31.</p>	PASS

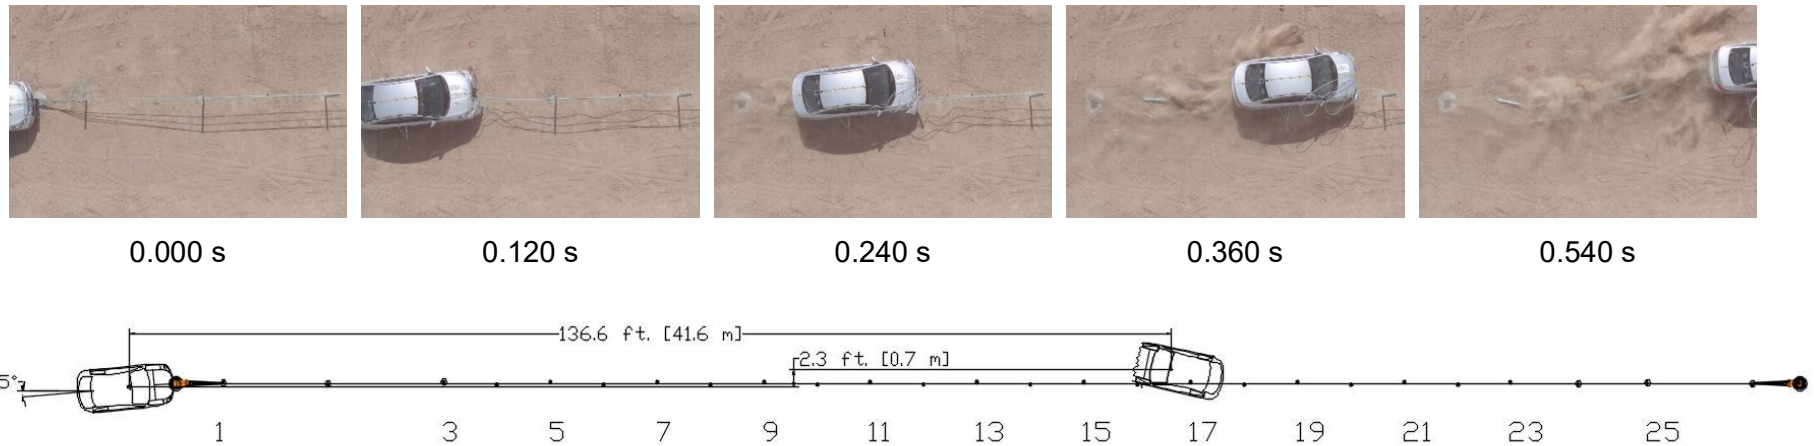
Figure 3 Summary of Test 3-32

MASH 2016 Test 3-32 Summary

GENERAL INFORMATION	
Test Agency.....	Applus IDIADA KARCO
Test No.....	P37403-01
Test Designation.....	3-32
Test Date.....	2/12/18
TEST ARTICLE	
Name / Model.....	TL-3 4 Cable Terminal
Type.....	End Terminal
Installation Length.....	213.0 ft. (64.9 m)
Terminal Length.....	27.5 ft. (8.4 m)
Road Surface.....	Compacted Soil
TEST VEHICLE	
Type / Designation.....	1100C
Year, Make, and Model....	2013 Hyundai Accent
Curb Mass.....	2,489.0 lbs (1,129.0 kg)
Test Inertial Mass.....	2,425.0 lbs (1,100.0 kg)
Gross Static Mass.....	2,592.6 lbs (1,176.0 kg)

Impact Conditions	
Impact Velocity.....	62.53 mph (100.64 km/h)
Impact Angle.....	5.3°
Location / Orientation.....	1.5 in. (38 mm) Right of CL
Kinetic Energy.....	317.0 kip-ft (429.8 kJ)
Exit Conditions	
Exit Velocity.....	Vehicle did not exit
Exit Angle.....	N/A
Final Vehicle Position.....	136.6 ft. (41.6 m) Downstream
	2.3 ft. (0.7 m) Left
Exit Box Criteria Met.....	N/A
Vehicle Snagging.....	None
Vehicle Pocketing.....	None
Vehicle Stability.....	Satisfactory
Maximum Roll Angle.....	-3.6°
Maximum Pitch Angle.....	6.3°
Maximum Yaw Angle.....	-12.9°

Occupant Risk	
Longitudinal OIV.....	8.9 ft/s (2.7 m/s)
Lateral OIV.....	1.3 ft/s (0.4 m/s)
Longitudinal RA.....	-4.0 g
Lateral RA.....	-5.0 g
THIV.....	8.9 ft/s (2.7 m/s)
PHD.....	6.3 g
ASI.....	0.23
Test Article Deflections	
Static.....	N/A
Dynamic.....	5.6 ft. (1.7 m)
Working Width.....	11.1 ft. (3.4 m)
Debris Field.....	119.1 ft. (36.3 m) Downstream
	14.0 ft. (4.3 m) Left
Vehicle Damage	
Vehicle Damage Scale.....	12-FR-4
CDC.....	12FZEW2
Maximum Intrusion.....	Negligible

Required Test Number	Narrative Description	Evaluation Results
3-32 (1100C)	<p>Applus IDIADA KARCOTest No. P37403-01. An 1100C test vehicle impacting the terminal end at a nominal speed and angle of 62 mph and 5°, respectively, with the centerline of the vehicle aligned with the centerline of the terminal. This test is primarily intended to evaluate structural adequacy, occupant risk, and vehicle trajectory. A 2013 Hyundai Accent 4-door sedan with a test inertial mass of 2425.0 lbs (1100.0 kg) impacted the terminal at a velocity of 62.53 mph (100.64 km/h) and an angle of 5.3°.</p> <p>The impact activated the cable release post and the vehicle was allowed to penetrate the system in a controlled manner. The occupant compartment was not penetrated and deformation limits were not exceeded. The Occupant Impact Velocities (OIV) were 8.9 ft/s (2.7 m/s) and 1.3 ft/s (0.4 m/s) in the x- and y-directions, respectively. The Ridedown Accelerations were -4.0 g and -5.0 g, respectively. The Gibraltar Global TL-3 4 Cable Terminal met all of the requirements for MASH Test 3-32.</p>	PASS

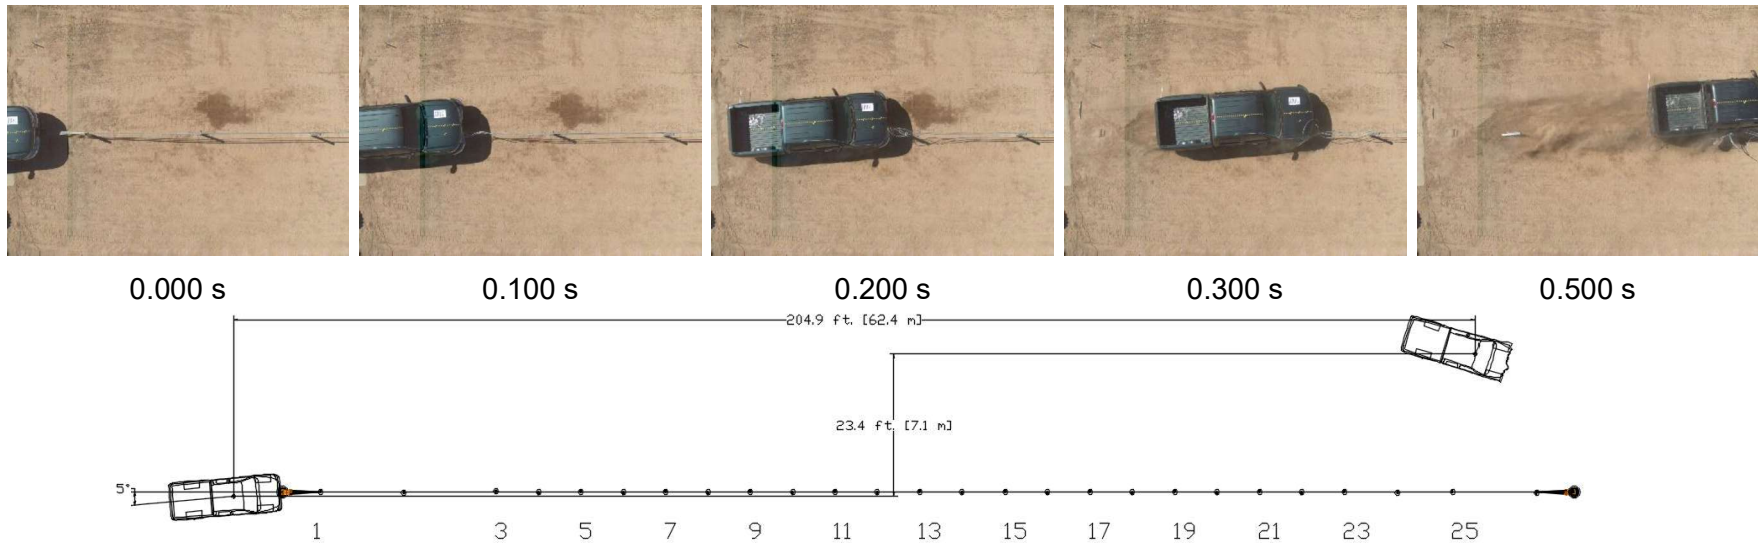
Figure 4 Summary of Test 3-33

MASH 2016 Test 3-33 Summary

GENERAL INFORMATION	
Test Agency.....	IDIADA KARCO Engineering
Test No.....	P38257-01
Test Designation.....	3-33
Test Date.....	8/31/18
TEST ARTICLE	
Name / Model.....	TL-3 4 Cable Terminal
Type.....	End Terminal
Installation Length.....	213.0 ft. (64.9 m)
Terminal Length.....	27.5 ft. (8.4 m)
Road Surface.....	Compacted Soil
TEST VEHICLE	
Type / Designation.....	2270P
Year, Make, and Model....	2012 Chevrolet Silverado 1500
Curb Mass.....	5,060.6 lbs (2,295.5 kg)
Test Inertial Mass.....	4,946.0 lbs (2,243.5 kg)
Gross Static Mass.....	4,946.0 lbs (2,243.5 kg)

Impact Conditions	
Impact Velocity.....	61.60 mph (99.14 km/h)
Impact Angle.....	5.2°
Location / Orientation.....	0.75 in. (19 mm) left of CL
Kinetic Energy.....	615.8 kip-ft (835.0 kJ)
Exit Conditions	
Exit Velocity.....	59.36 mph (95.53 km/h)
Exit Angle.....	3.4°
Final Vehicle Position.....	204.9 ft. (62.5 m) Downstream
	23.4 ft. (7.1 m) Left
Exit Box Criteria Met.....	N/A
Vehicle Snagging.....	None
Vehicle Pocketing.....	None
Vehicle Stability.....	Satisfactory
Maximum Roll Angle.....	-0.7 °
Maximum Pitch Angle.....	1.9 °
Maximum Yaw Angle.....	-3.3 °

Occupant Risk	
Longitudinal OIV.....	0.3 ft/s (0.1 m/s)
Lateral OIV.....	3.0 ft/s (0.9 m/s)
Longitudinal RA.....	-1.4 g
Lateral RA.....	0.8 g
THIV.....	3.6 ft/s (1.1 m/s)
PHD.....	1.6 g
ASI.....	0.09
Test Article Deflections	
Static.....	N/A
Dynamic.....	3.3 ft. (1.0 m)
Working Width.....	3.3 ft. (1.0 m)
Debris Field.....	64.3 ft. (19.6 m) Downstream
	7.9 ft. (2.4 m) Left
Vehicle Damage	
Vehicle Damage Scale.....	12-FD-2*
CDC.....	12FDLW1*
Maximum Intrusion.....	Negligible*

3-33 (2270P)	<p>Applus IDIADA KARCOTest No. P38257-01. A 2270P test vehicle impacting the terminal end at a nominal speed and angle of 62 mph and 5°, respectively, with the centerline of the vehicle aligned with the centerline of the terminal. This test is primarily intended to evaluate structural adequacy, occupant risk, and vehicle trajectory. A 2012 Chevrolet Silverado 1500 4-door pickup truck with a test inertial mass of 4946.0 lbs (2243.5 kg) impacted the terminal at a velocity of 61.60 mph (99.14 km/h) and an angle of 5.2°.</p> <p>The impact activated the cable release post and the vehicle was allowed to penetrate the system in a controlled manner. The occupant compartment was not penetrated and deformation limits were not exceeded. The Occupant Impact Velocities (OIV) were 0.3 ft/s (0.1 m/s) and 3.0 ft/s (0.9 m/s) in the x- and y-directions, respectively. The Ridedown Accelerations were -1.4 g and 0.8 g, respectively. The Gibraltar Global TL-3 4 Cable Terminal met all of the requirements for MASH Test 3-33.</p>	PASS

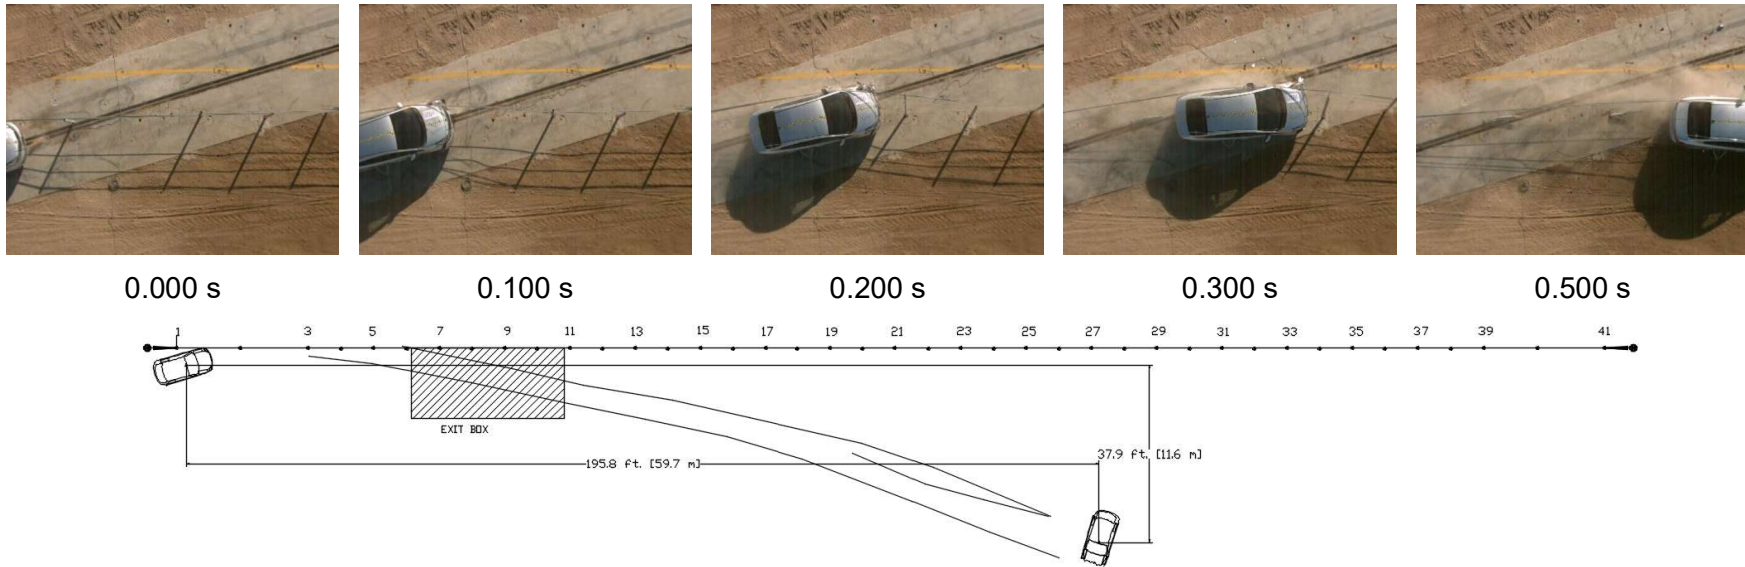
Figure 3 Summary of Test 3-34

MASH 2016 Test 3-34 Summary

GENERAL INFORMATION	
Test Agency.....	Applus IDIADA KARCO
Test No.....	P38333-01
Test Designation.....	3-34
Test Date.....	11/20/18
TEST ARTICLE	
Name / Model.....	TL-3 4 Cable Terminal
Type.....	End Terminal
Installation Length.....	318.3 ft. (97.0 m)
Terminal Length.....	27.5 ft. (8.4 m)
Road Surface.....	Compacted soil
TEST VEHICLE	
Type / Designation.....	1100C
Year, Make, and Model....	2013 Kia Rio
Curb Mass.....	2,554.0 lbs (1,158.5 kg)
Test Inertial Mass.....	2,432.8 lbs (1,103.5 kg)
Gross Static Mass.....	2,637.8 lbs (1,196.5 kg)

Impact Conditions	
Impact Velocity.....	62.33 mph (100.31 km/h)
Impact Angle.....	15.6°
Location / Orientation.....	3.4 in. (86 mm) from midspan
Impact Severity.....	22.8 kip-ft (31.0 kJ)
Exit Conditions	
Exit Velocity.....	48.09 mph (77.39 km/h)
Exit Angle.....	4.5°
Final Vehicle Position.....	195.8 ft. (59.7 m) Downstream
	37.9 ft. (11.6 m) Right
Exit Box Criteria Met.....	Yes
Vehicle Snagging.....	None
Vehicle Pocketing.....	None
Vehicle Stability.....	Satisfactory
Maximum Roll Angle.....	2.9°
Maximum Pitch Angle.....	8.9°
Maximum Yaw Angle.....	-19.5°

Occupant Risk	
Longitudinal OIV.....	10.8 ft/s (3.3 m/s)
Lateral OIV.....	12.1 ft/s (3.7 m/s)
Longitudinal RA.....	-6.1 g
Lateral RA.....	-8.0 g
THIV.....	18.0 ft/s (5.5 m/s)
PHD.....	9.8 g
ASI.....	0.41
Test Article Deflections	
Static.....	N/A
Dynamic.....	3.2 ft. (1.0 m)
Working Width.....	3.7 ft. (1.1 m)
Debris Field.....	100.1 ft. (30.5 m) Downstream
	24.7 ft. (7.5 m) Lateral
Vehicle Damage	
Vehicle Damage Scale.....	11-LFQ-4
CDC.....	11LYEW3
Maximum Intrusion.....	0.6 in. (15 mm)

3-34 (1100C)	<p>ApplusIDIADA KARCOTest No. P38333-01. An 1100C test vehicle impacting the terminal at a nominal speed and angle of 62 mph and 15°, respectively, with the corner of the vehicle bumper aligned with the Critical Impact Point (CIP) of the Length of Need (LON) of the terminal. This test is primarily intended to evaluate structural adequacy, occupant risk, and vehicle trajectory. A 2013 Kia Rio 4-door sedan with a test inertial mass of 2432.8 lbs (1103.5 kg) impacted the terminal at a velocity of 62.33 mph (100.31 km/h) and an angle of 15.6°. The system contained and redirected the vehicle within the exit box and with a Working Width of 3.7 ft. (1.1 m). The occupant compartment was not penetrated and deformation limits were not exceeded. The Occupant Impact Velocities (OIV) were 10.8 ft/s (3.3 m/s) and 12.1 ft/s (3.7 m/s) in the x- and y-directions, respectively. The Ridedown Accelerations were -6.1 g and -8.0 g, respectively. The Gibraltar Global TL-3 4 Cable Terminal met all of the requirements for MASH Test 3-34.</p>	PASS

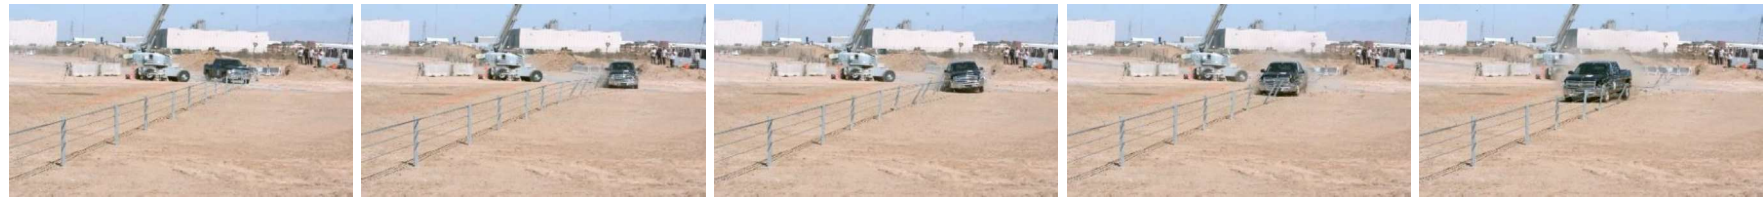
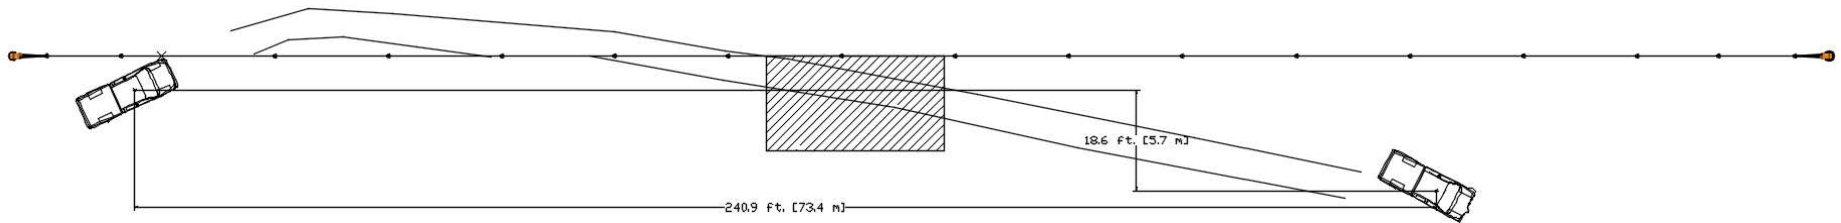
Figure 4 Summary of Test 3-35

MASH 2016 Test 3-35 Summary

Name / Model..... TL-3 4 Cable Terminal
 Type..... End Terminal
 Installation Length..... 335.7 ft. (102.3 m)
 Terminal Length..... 27.5 ft. (8.4 m)
 Road Surface..... Concrete and compacted soil

Impact Velocity..... 63.23 mph (101.76 km/h)
 Impact Angle..... 25.2°
 Location / Orientation..... LON Point
 Impact Severity..... 121.4 kip-ft (164.5 kJ)

Static..... 3.4 ft. (1.0 m)
 Dynamic..... 9.7 ft. (3.0 m)
 Working Width..... 9.7 ft. (3.0 m)
 Debris Field..... 172.8 ft. (52.7 m) Downstream
 37.0 ft. (11.3 m) Field Side

Vehicle Damage Scale..... 11-LFQ-3
 CDC..... 11FRMN2
 Maximum Intrusion..... Negligible

3-35 (2270P)	<p>ApplusIDIADA KARCOTest No. P38194-01. A 2270P test vehicle impacting the terminal at a nominal speed and angle of 62 mph and 25°, respectively, with the corner of the vehicle bumper aligned with the beginning of the Length of Need (LON) of the terminal. This test is primarily intended to evaluate structural adequacy, occupant risk, and vehicle trajectory. A 2012 Chevrolet Silverado 1500 4-door pickup truck with a test inertial mass of 5008.8 lbs (2272.0 kg) impacted the terminal at a velocity of 63.23 mph (101.76 km/h) and an angle of 25.2°. The system contained and redirected the vehicle within the exit box and with a Working Width of 9.7 ft. (3.0 m). The occupant compartment was not penetrated and deformation limits were not exceeded. The Occupant Impact Velocities (OIV) were 3.9 ft/s (1.2 m/s) and 10.5 ft/s (3.2 m/s) in the x- and y-directions, respectively. The Ridedown Accelerations were -3.7 g and 4.4 g, respectively. The Gibraltar Global TL-3 4 Cable Terminal met all of the requirements for MASH Test 3-35.</p>	PASS

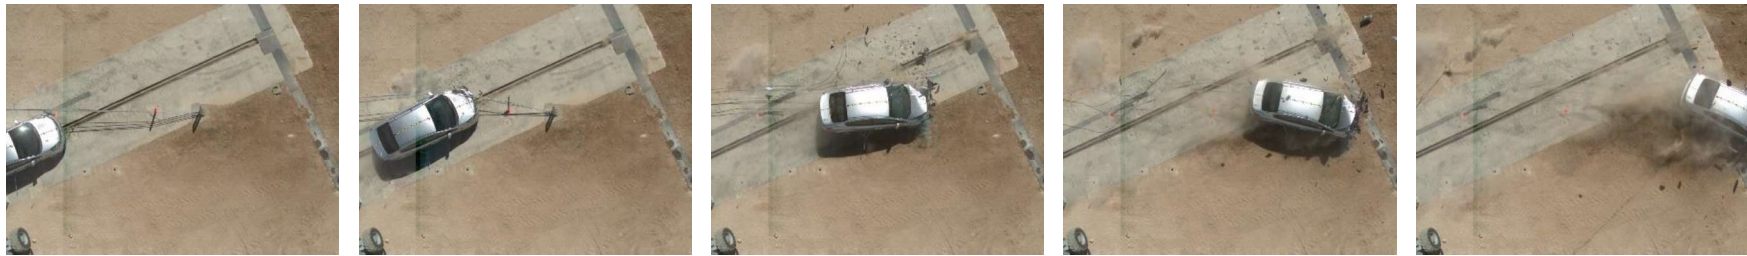
Figure 4 Summary of Test 3-37b

MASH 2016 Test 3-37b Summary

GENERAL INFORMATION	
Test Agency.....	Applus IDIADA KARCO
Test No.....	P38236-01
Test Designation.....	3-37b
Test Date.....	9/17/18
TEST ARTICLE	
Name / Model.....	TL-3 4 Cable Terminal
Type.....	End Terminal
Installation Length.....	314.8 ft. (96 m)
Terminal Length.....	27.5 ft. (8.4 m)
Road Surface.....	Compacted soil
TEST VEHICLE	
Type / Designation.....	1100C
Year, Make, and Model....	2012 Kia Rio
Curb Mass.....	2,417.3 lbs (1,096.5 kg)
Test Inertial Mass.....	2,448.2 lbs (1,110.5 kg)
Gross Static Mass.....	2,613.5 lbs (1,185.5 kg)

Impact Conditions	
Impact Velocity.....	62.53 mph (100.63 km/h)
Impact Angle.....	24.9°
Location / Orientation.....	Terminal Post 2
Impact Severity.....	56.7 kip-ft (76.9 kJ)
Exit Conditions	
Exit Velocity.....	32.06 mph (51.60 km/h)
Exit Angle.....	3.2°
Final Vehicle Position.....	107.4 ft. (32.7 m) Downstream
	16.4 ft. (5.0 m) Right
Exit Box Criteria Met.....	N/A
Vehicle Snagging.....	None
Vehicle Pocketing.....	None
Vehicle Stability.....	Satisfactory
Maximum Roll Angle.....	-7.1 °
Maximum Pitch Angle.....	3.7 °
Maximum Yaw Angle.....	-62.6 °

Occupant Risk	
Longitudinal OIV.....	23.3 ft/s (7.1 m/s)
Lateral OIV.....	19.7 ft/s (6.0 m/s)
Longitudinal RA.....	-16.0 g
Lateral RA.....	12.9 g
THIV.....	39.7 ft/s (12.1 m/s)
PHD.....	20.1 g
ASI.....	1.39
Test Article Deflections	
Static.....	N/A
Dynamic.....	4.3 ft. (1.3 m)
Working Width.....	16.0 ft. (4.9 m)
Debris Field.....	146.1 ft. (44.5 m) Downstream
	32.8 ft. (10 m) Lateral
Vehicle Damage	
Vehicle Damage Scale.....	01-LFQ-4
CDC.....	01FDEW3
Maximum Intrusion.....	0.7 in. (18 mm)

3-36 (2270P)	<p>MASH Test Designation 3-36. A 2270P test vehicle impacting the terminal at a nominal impact speed and angle of 62 mph and 25°, respectively, with the corner of the vehicle bumper aligned with the Critical Impact Point (CIP) with respect to the transition to a stiff barrier or backup structure. This test is primarily intended to evaluate the performance of the terminal when connected to a stiff barrier or a backup structure.</p> <p>As a cable barrier terminal, the Gibraltar Global TL-3 4 Cable Terminal is not designed to be transition into a stiff barrier or backup structure and therefore Test 36 is not relevant and was not conducted.</p>	Non-Relevant Test, not conducted
3-37 (2270P)	<p>Applus IDIADA KARCOTest No. P38236-01. An 1100C test vehicle impacting the terminal at a nominal speed and angle of 62 mph and 25°, respectively, with the corner of the vehicle bumper aligned with the Critical Impact Point (CIP) of the terminal for reverse direction impacts. This test is primarily intended to evaluate structural adequacy, occupant risk, and vehicle trajectory in a reverse direction impact. A 2012 Kia Rio 4-door sedan with a test inertial mass of 2448.2 lbs (1110.5 kg) impacted the terminal at a velocity of 62.53 mph (100.63 km/h) and an angle of 24.9°.</p> <p>Upon impact, cables released and allowed the vehicle to gate through the system in a controlled manner. The occupant compartment was not penetrated and deformation limits were not exceeded. The Occupant Impact Velocities (OIV) were 23.3 ft/s (7.1 m/s) and 19.7 ft/s (6.0 m/s) in the x- and y-directions, respectively. The Ride-down Accelerations were -16.0 g and 12.9 g, respectively. The Gibraltar Global TL-3 4 Cable Terminal met all of the requirements for MASH Test 3-37b.</p>	PASS

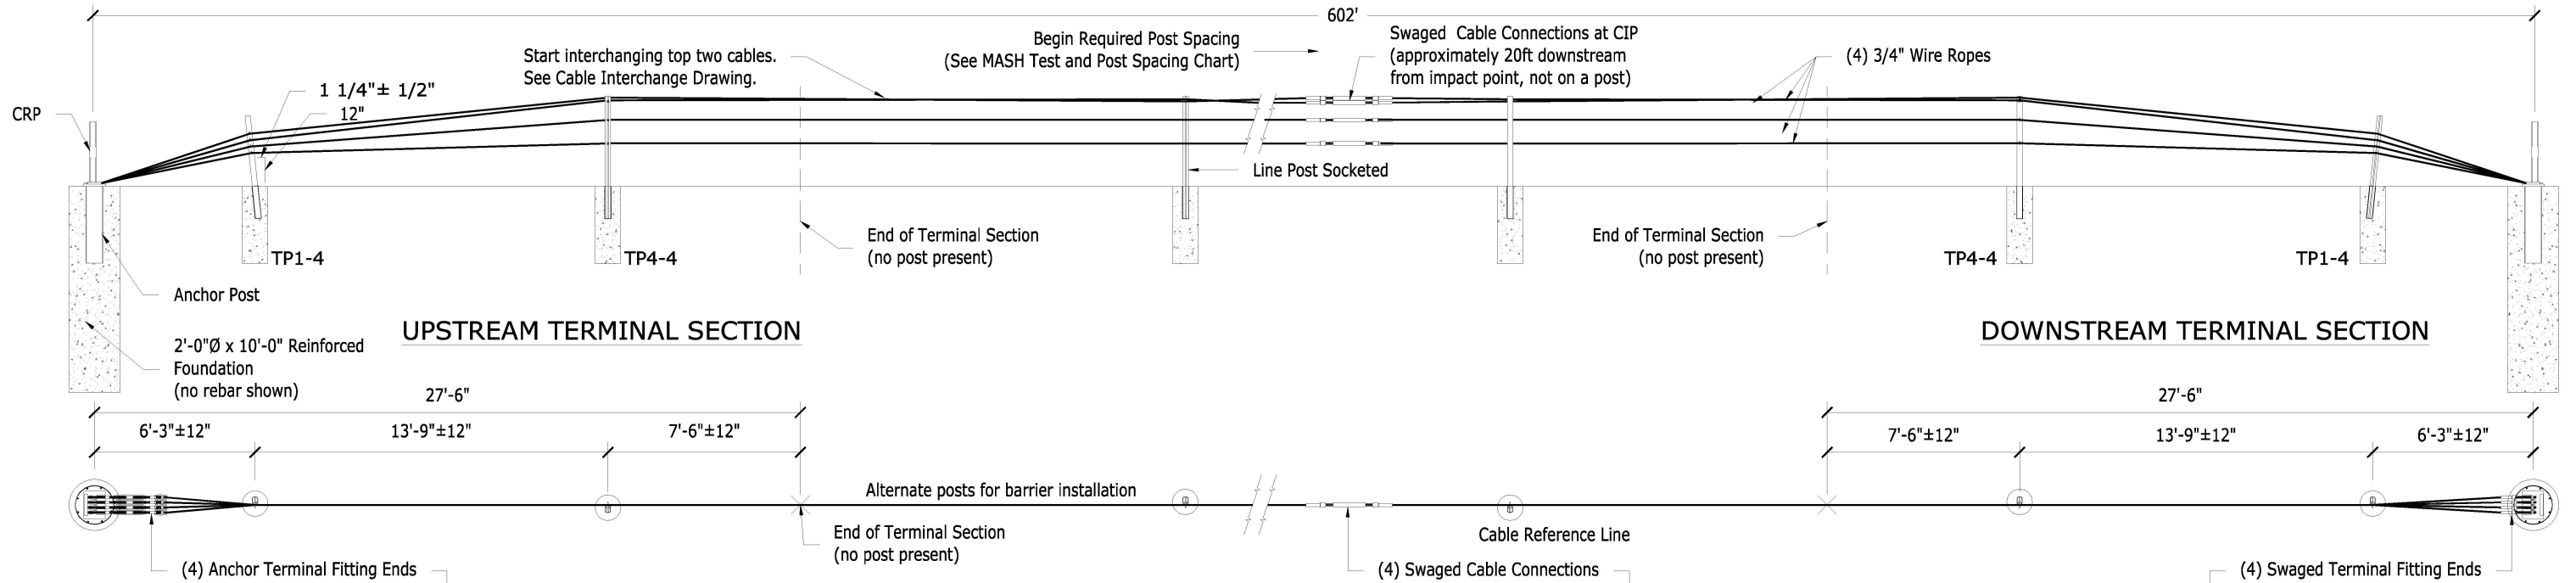
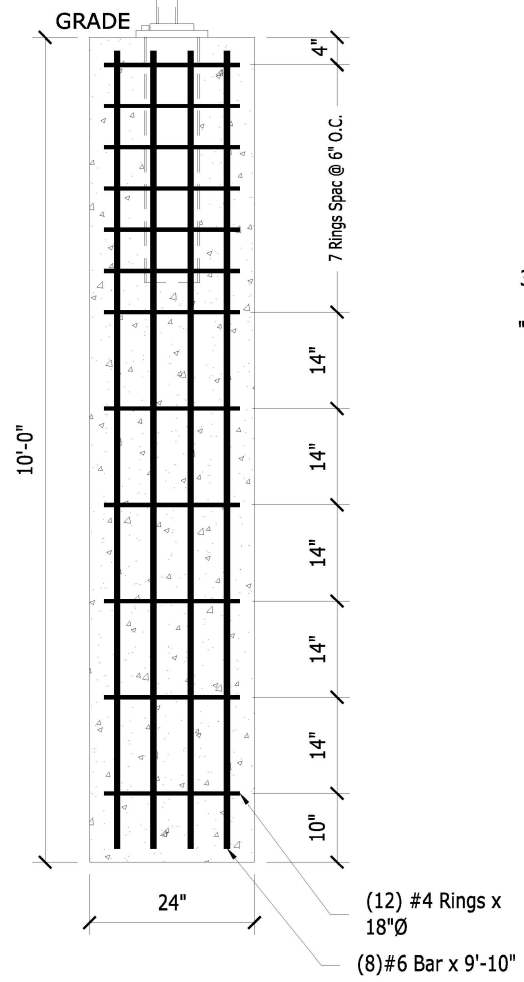
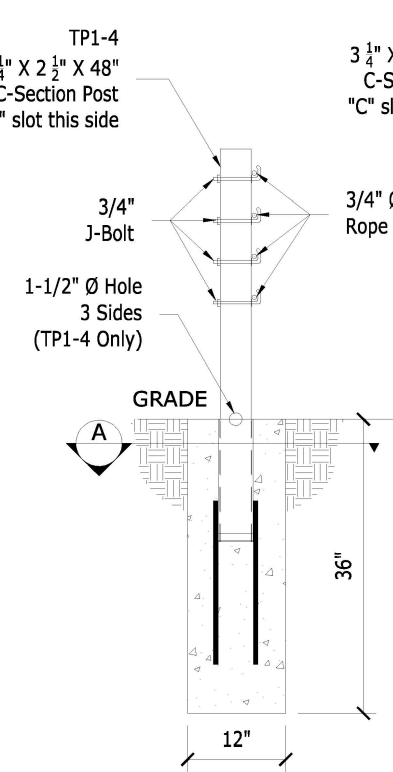
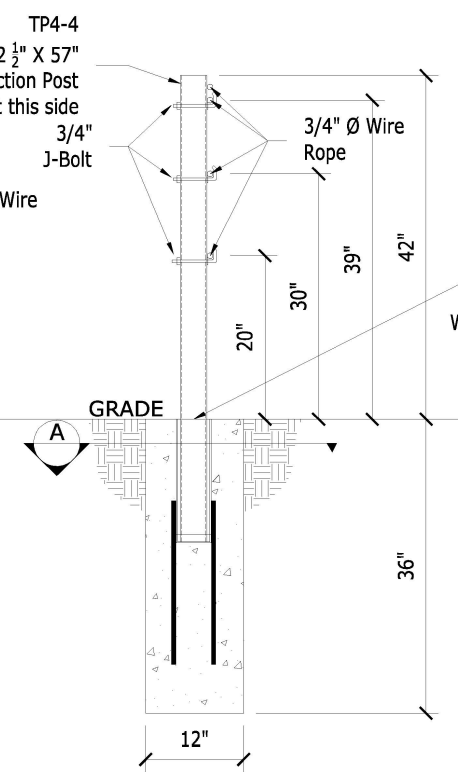
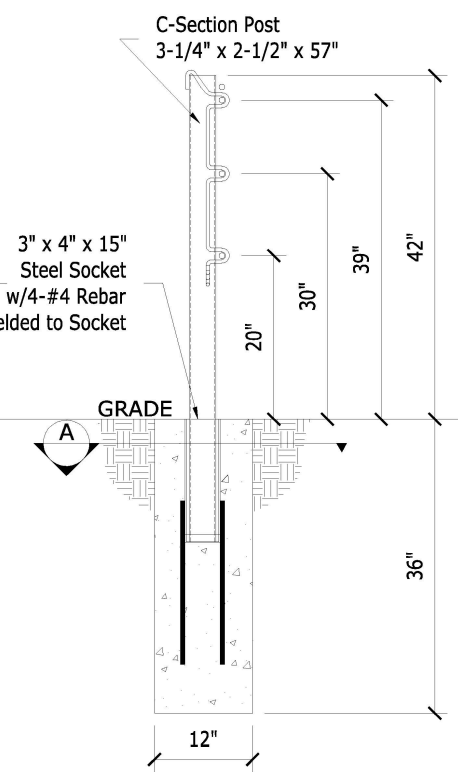
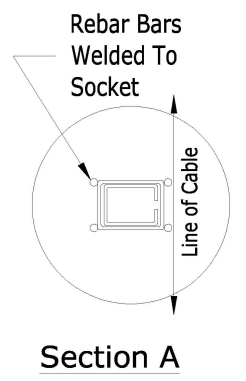
TL-4 4 Cable System Layout

TL-4 4 Cable MASH Test and Post Spacing Chart

MASH TEST	Line Post Spacing*
3-10	7'-0"
3-11	7'-0"
3-11	21'-0"
4-12**	21'-0"

-10 °F	8600
0 °F	8200
10 °F	7800
20 °F	7400
30 °F	7000
40 °F	6600
50 °F	6200
60 °F	5800
70 °F	5400
80 °F	5000
90 °F	4600
100 °F	4200
110 °F	3800

Cable Release & Anchor Post

Terminal Post (Welded Rebar Socket)

Line Post (Welded Rebar Socket)

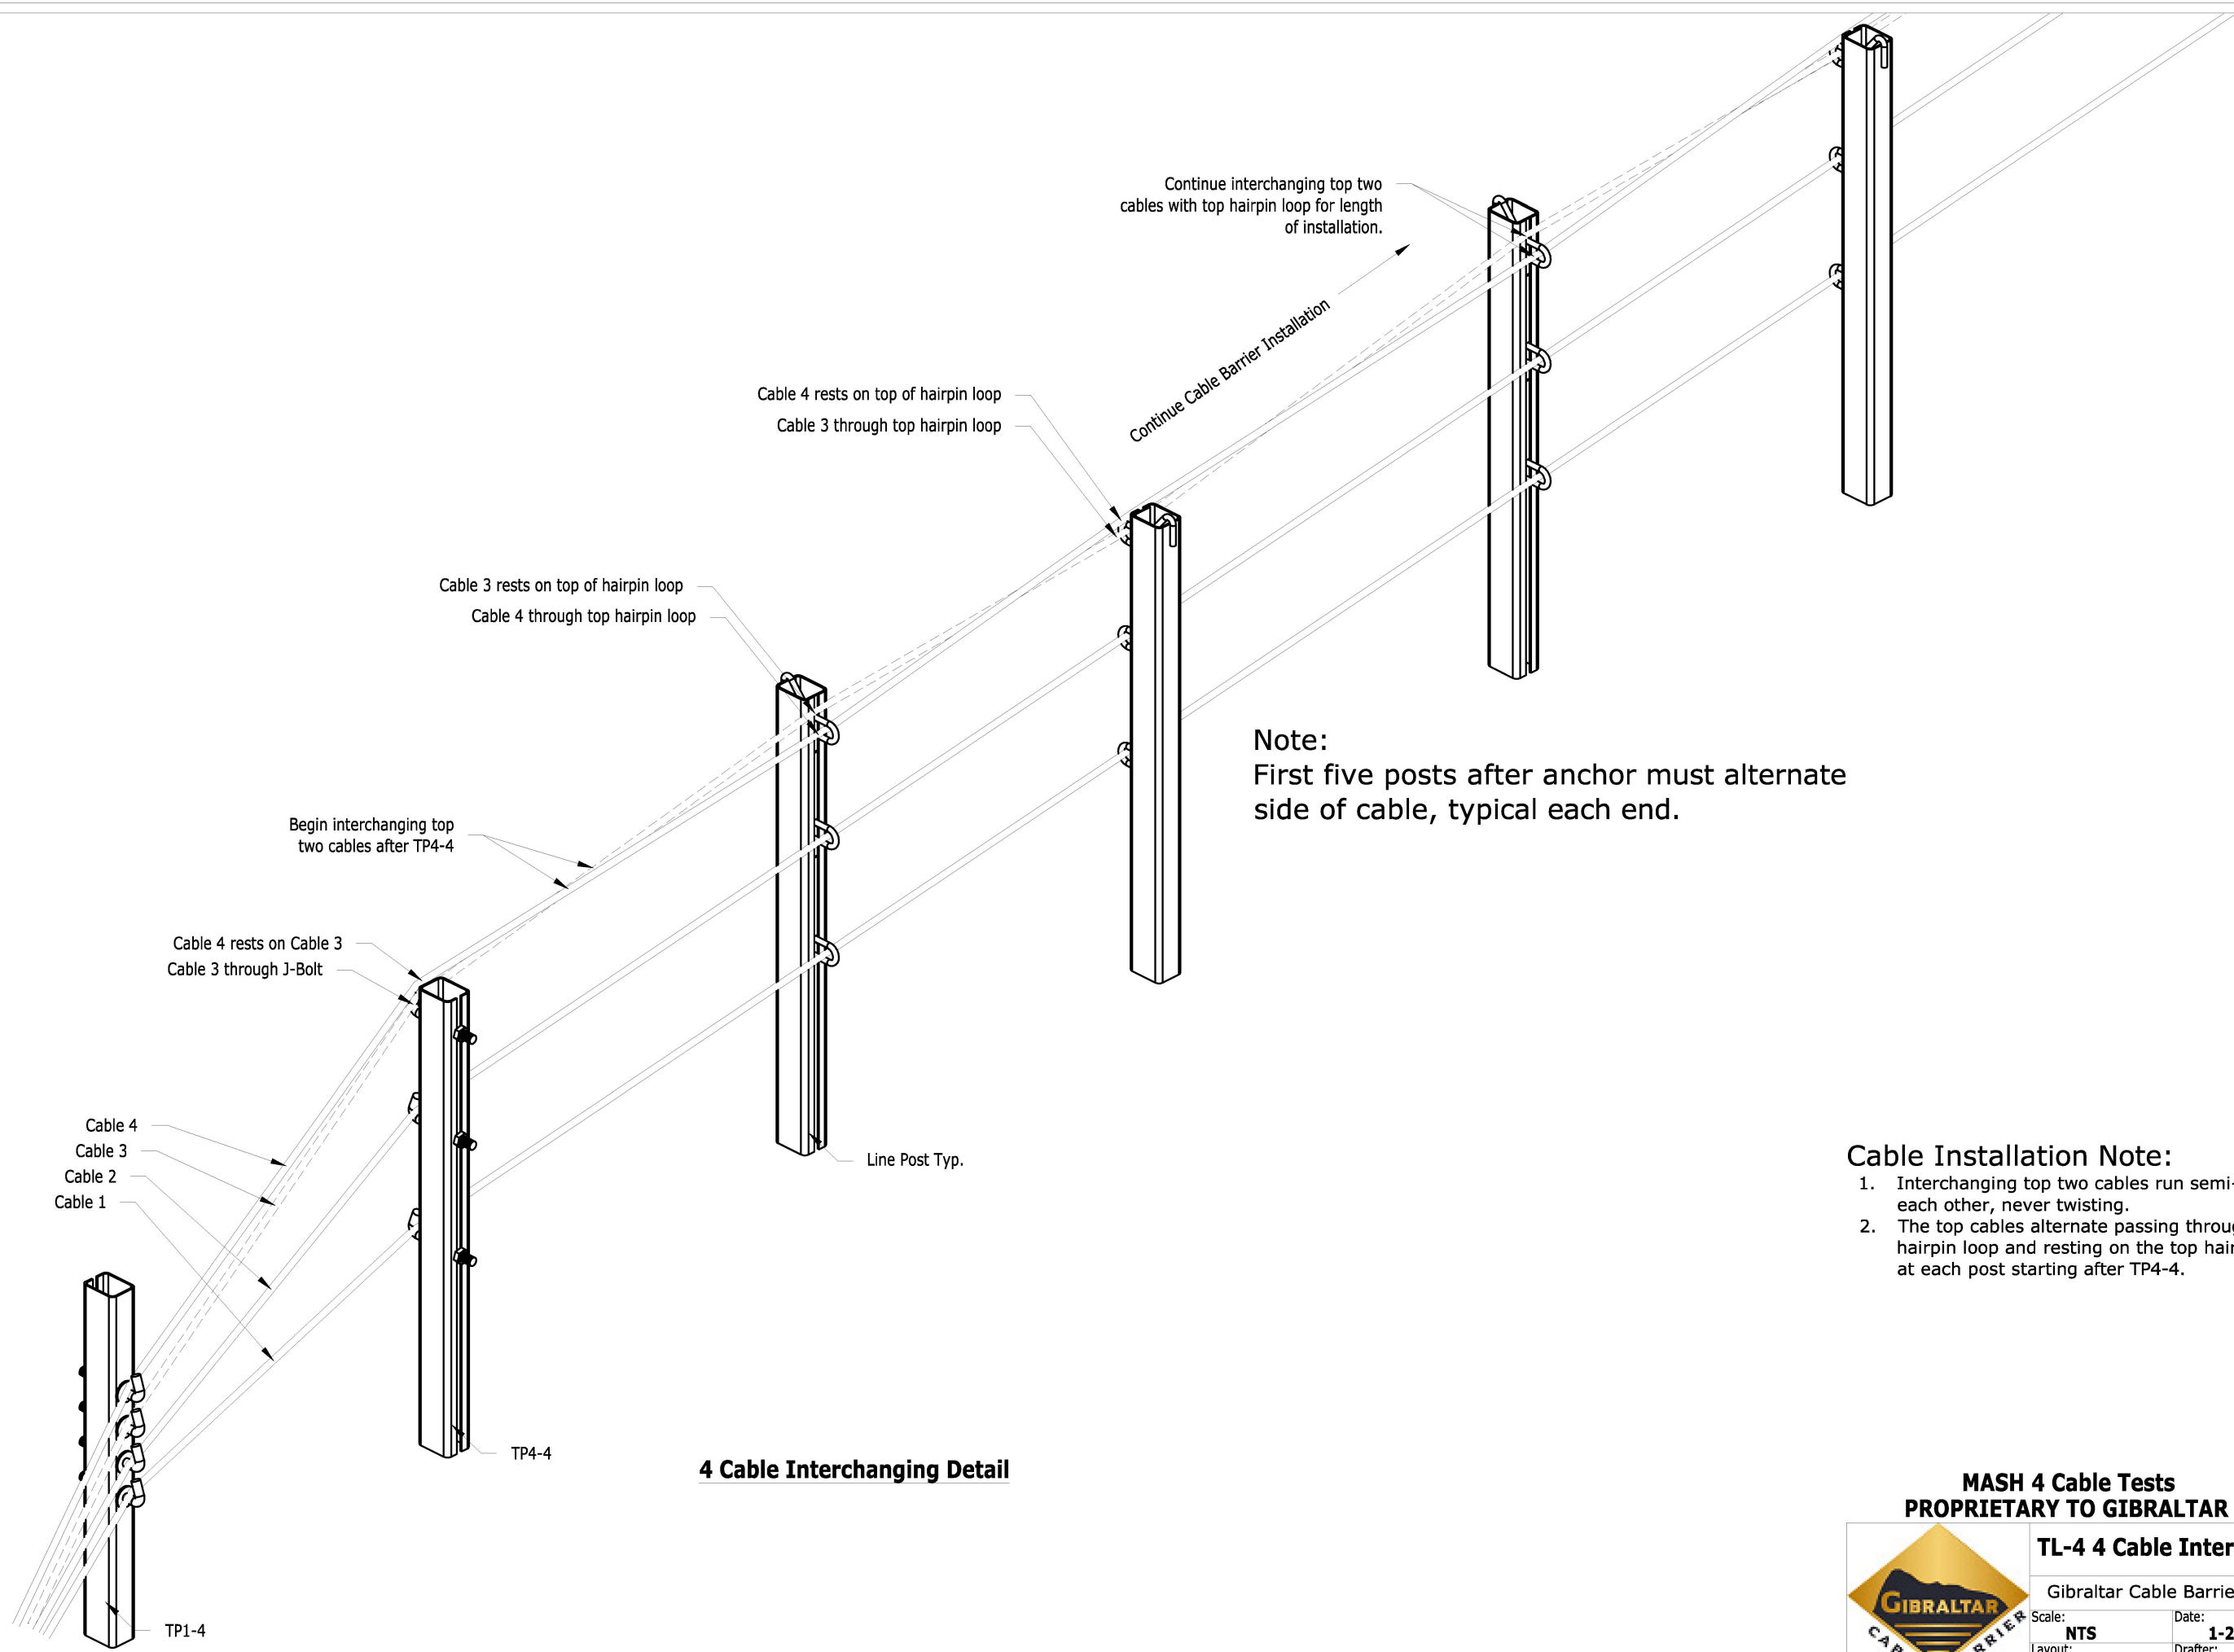
4 Cable Interchanging Detail

Note:
 First five posts after anchor must alternate side of cable, typical each end.

- Cable Installation Note:**
1. Interchanging top two cables run semi-parallel to each other, never twisting.
 2. The top cables alternate passing through the top hairpin loop and resting on the top hairpin loop at each post starting after TP4-4.

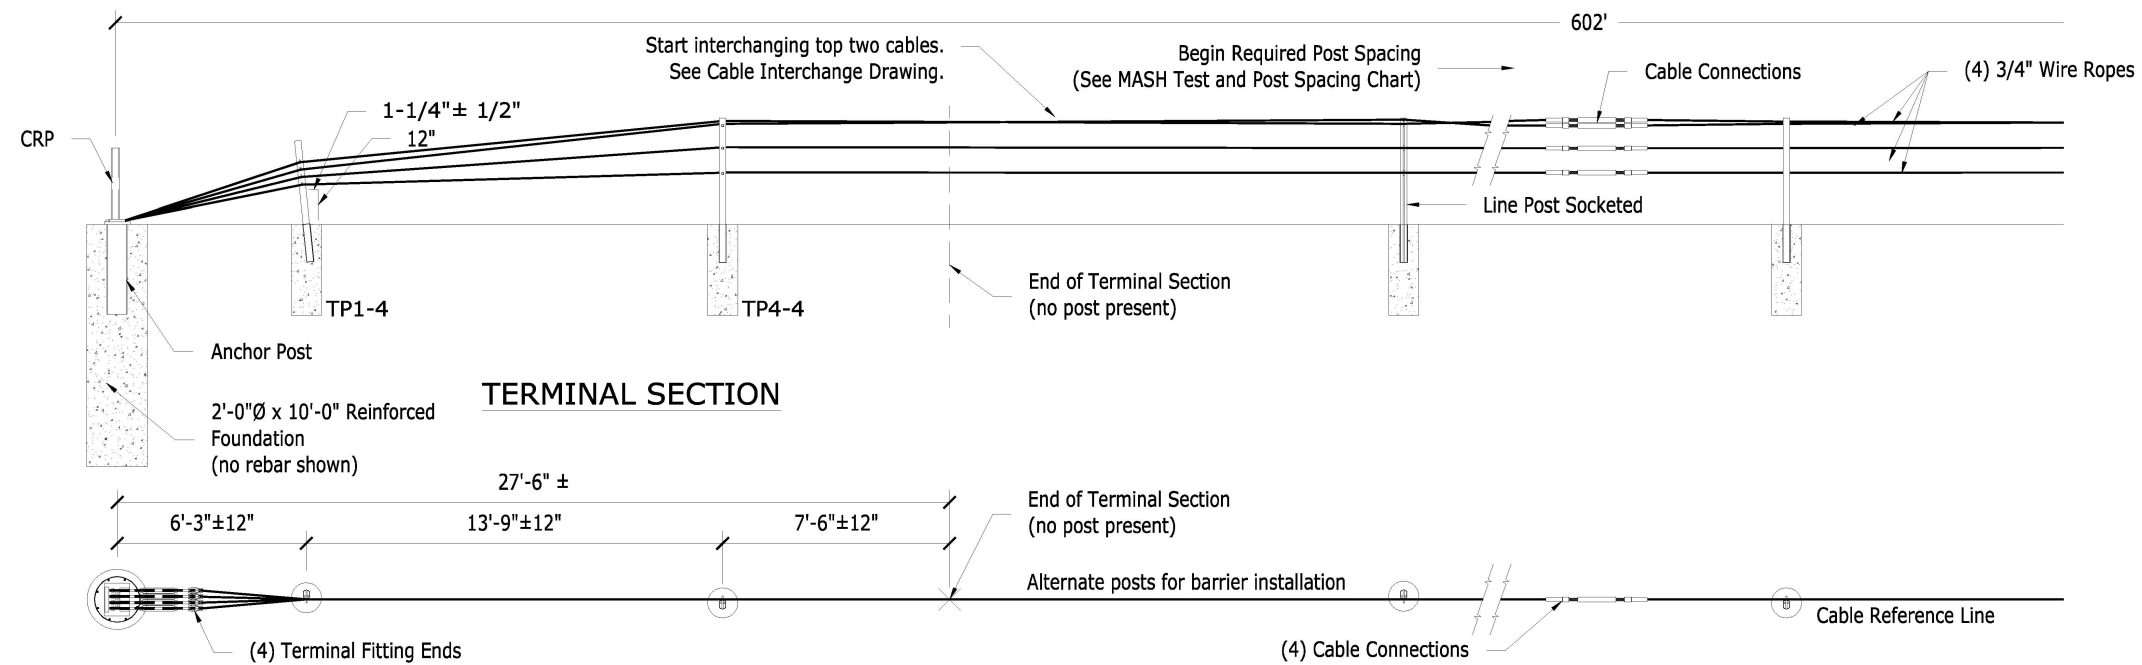
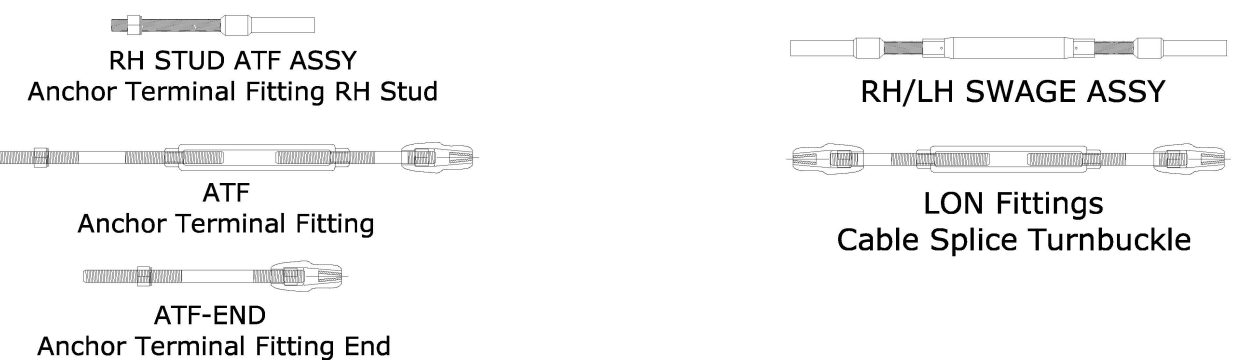
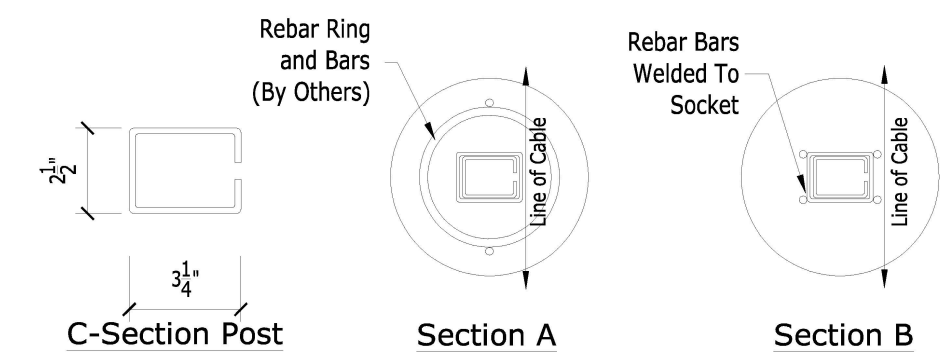
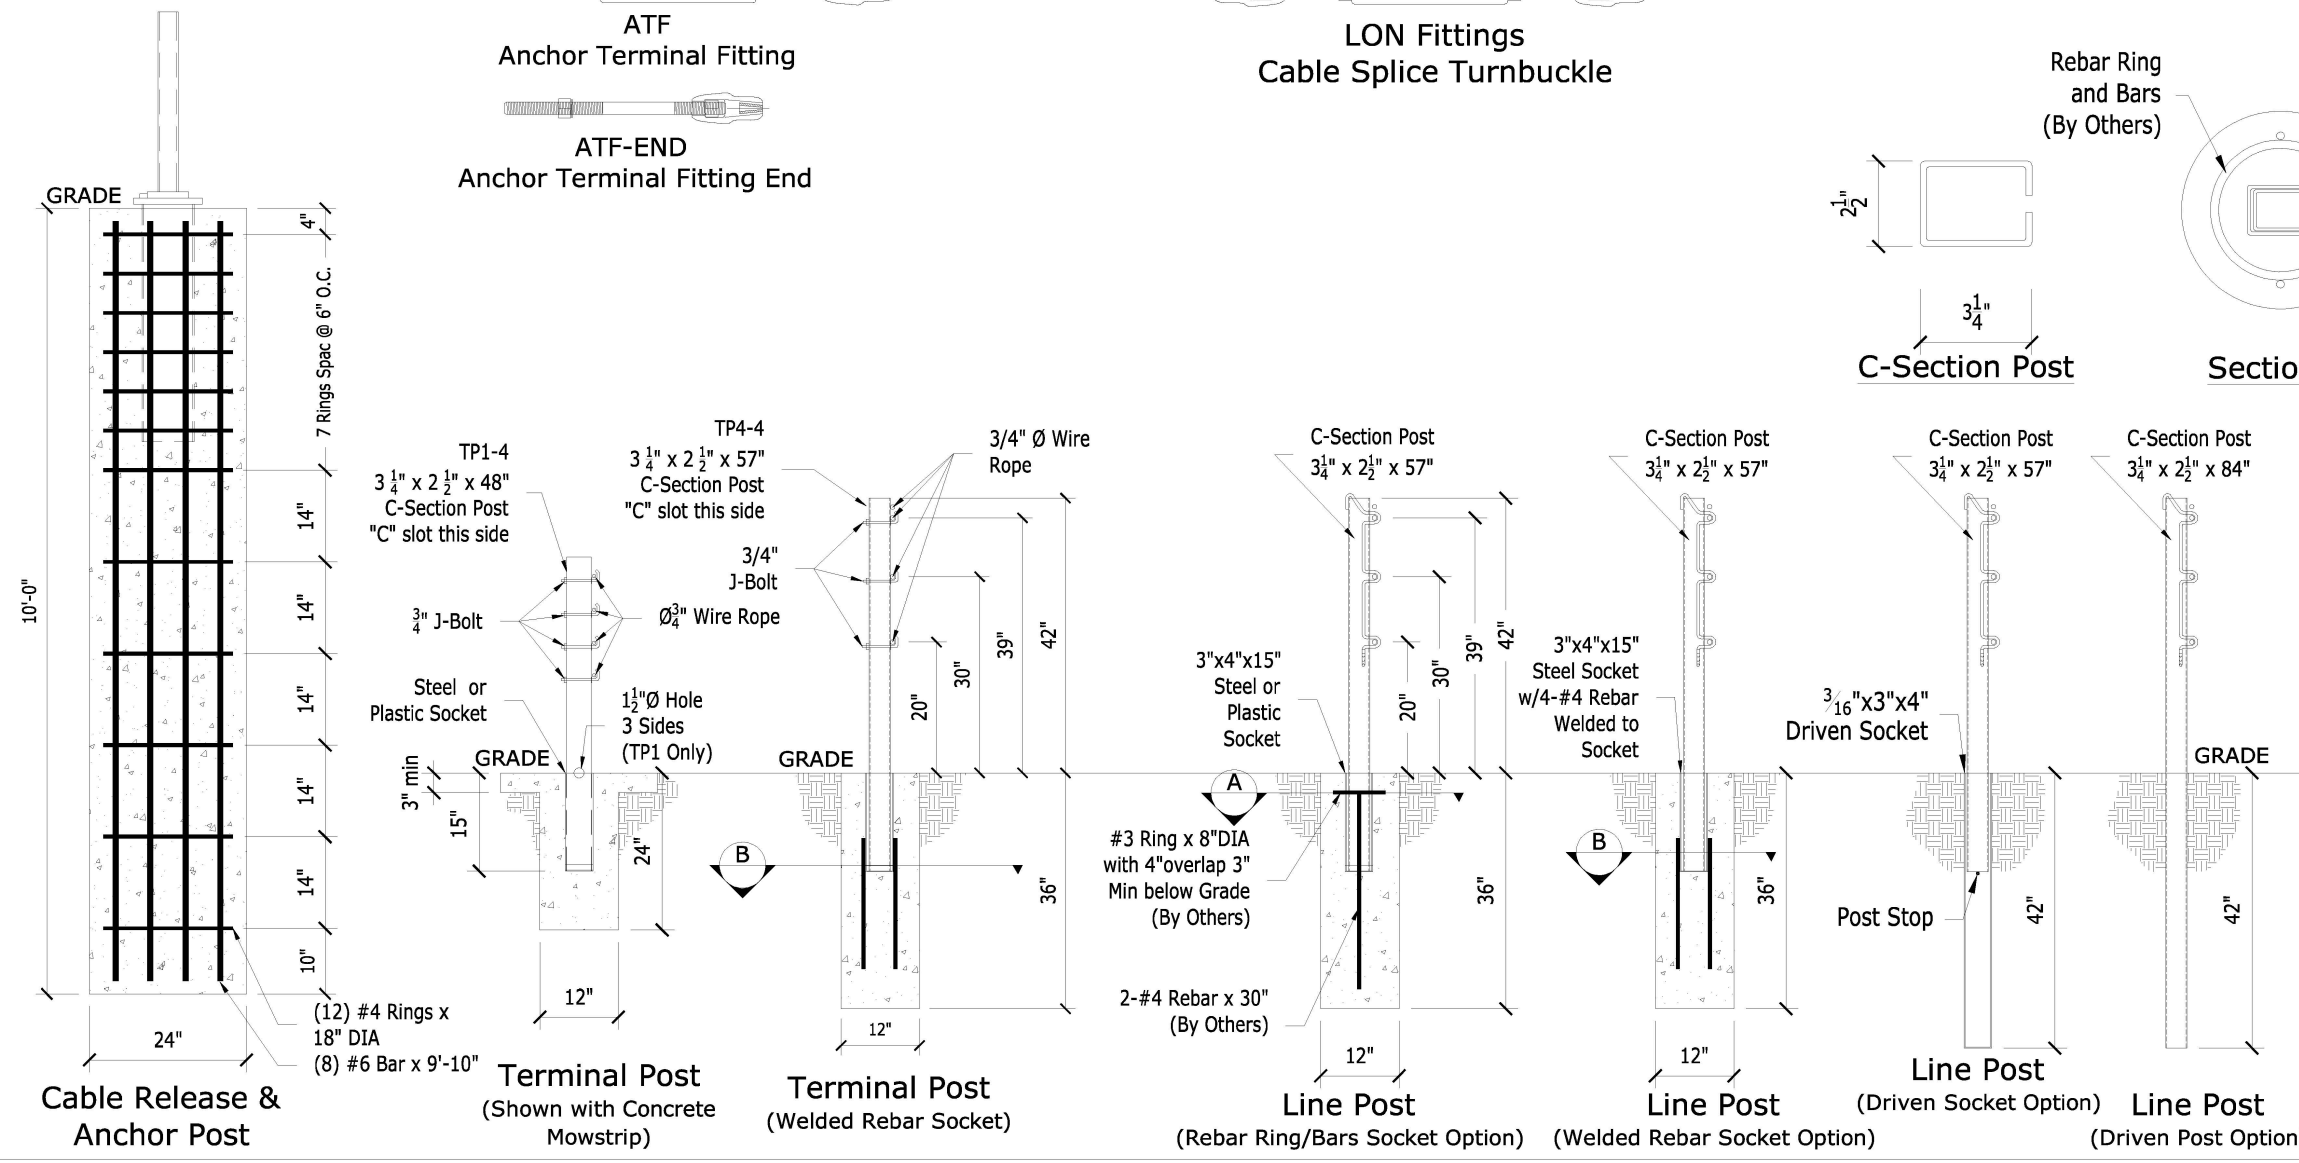
TL-4 4M Cable System Layout

Temperature (°F)	Tension (lb)
-10 °F	8600
0 °F	8200
10 °F	7800
20 °F	7400
30 °F	7000
40 °F	6600
50 °F	6200
60 °F	5800
70 °F	5400
80 °F	5000
90 °F	4600
100 °F	4200
110 °F	3800

MASH TEST	Line Post Spacing
3-10	7'-0"
3-11	7'-0"
3-11	21'-0"
4-12	21'-0"

*±6" post spacing tolerance *Allowable Deviation from Chart +/- 10%
