Safety Performance Evaluation of the Foothills Parkway Bridge Rail

Midwest Roadside Safety Facility
Civil Engineering Department
University of Nebraska-Lincoln
1901 'Y' Street, Bldg. C
Lincoln, Nebraska 68588-0601

Federal Highway Administration
Eastern Federal Lands Highway Division
21400 Ridgetop Circle
Sterling, Virginia 22170

Transportation Research Report TRP-03-41-94

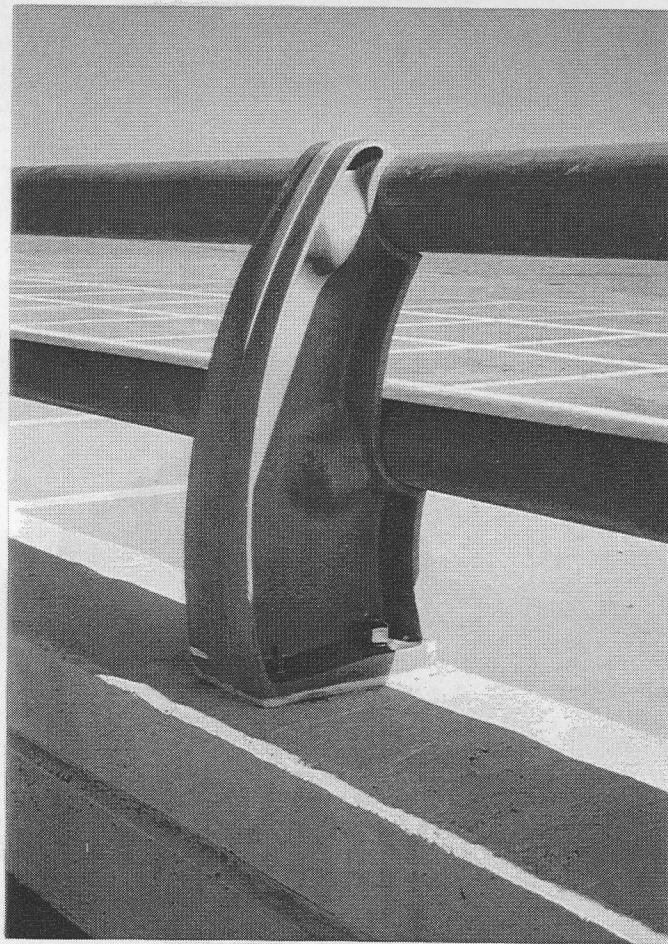
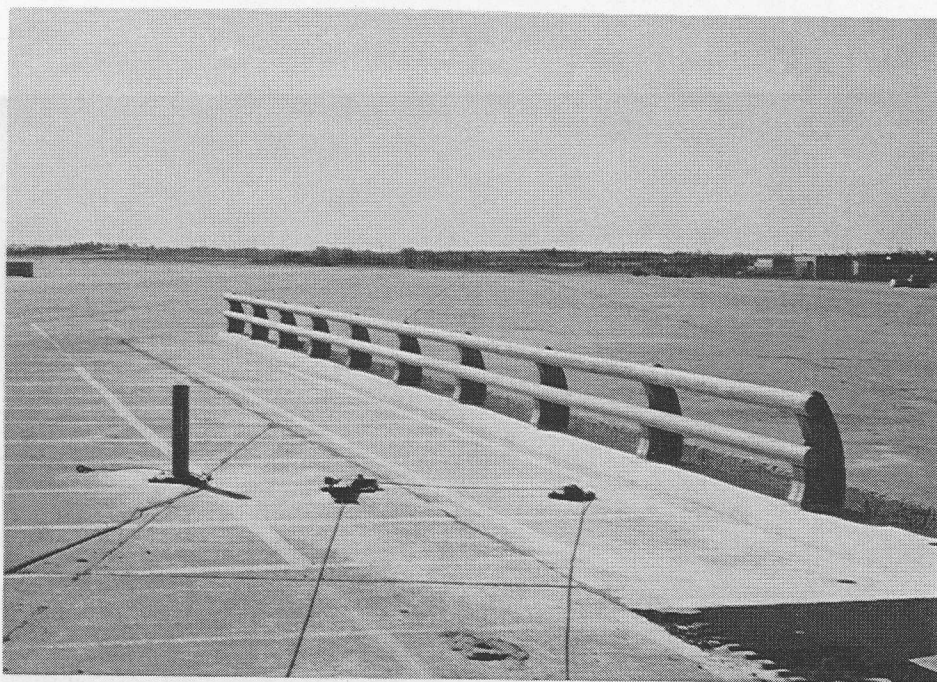
Figure 1. The Foothills Parkway Bridge Rail

Photographs of the Foothills Parkway Bridge Rail are shown in Figures 1 and 2. This system consists of cast aluminum posts mounted on a 6 in. (15.2 cm) curb, supporting two aluminum rails. Throughout the course of the safety evaluation of this system, the design was changed twice. The original design, shown in Figure 3, was evaluated during Test FPAR-1. The system was modified for Test FPAR-2 by adding longitudinal steel to the curb as shown in Figure 4. The final design evaluated in Test FPAR-3 is shown in Figure 5. The reasons for these design changes are discussed in the *Test Results* section.

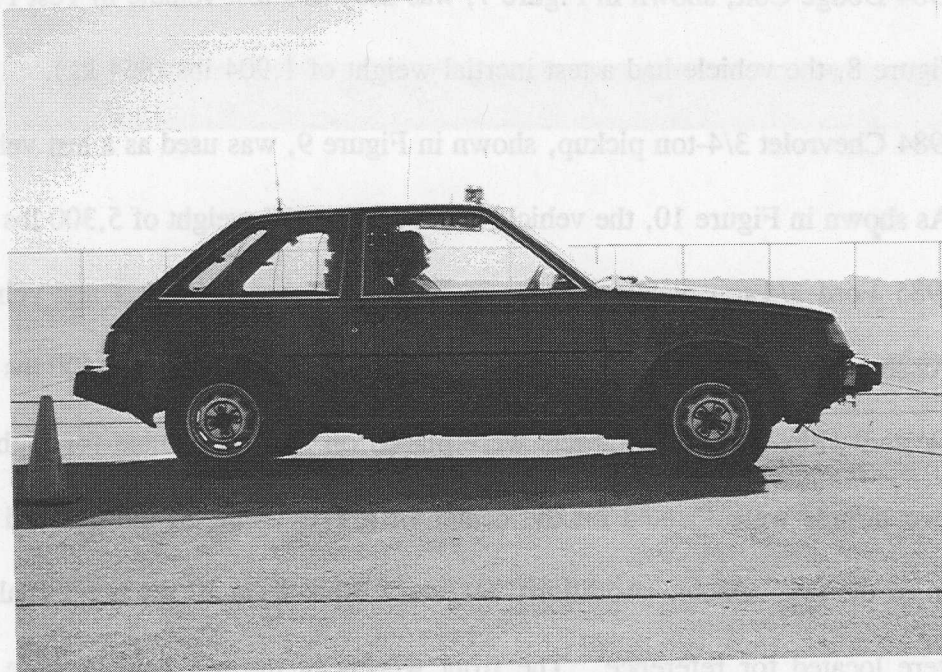
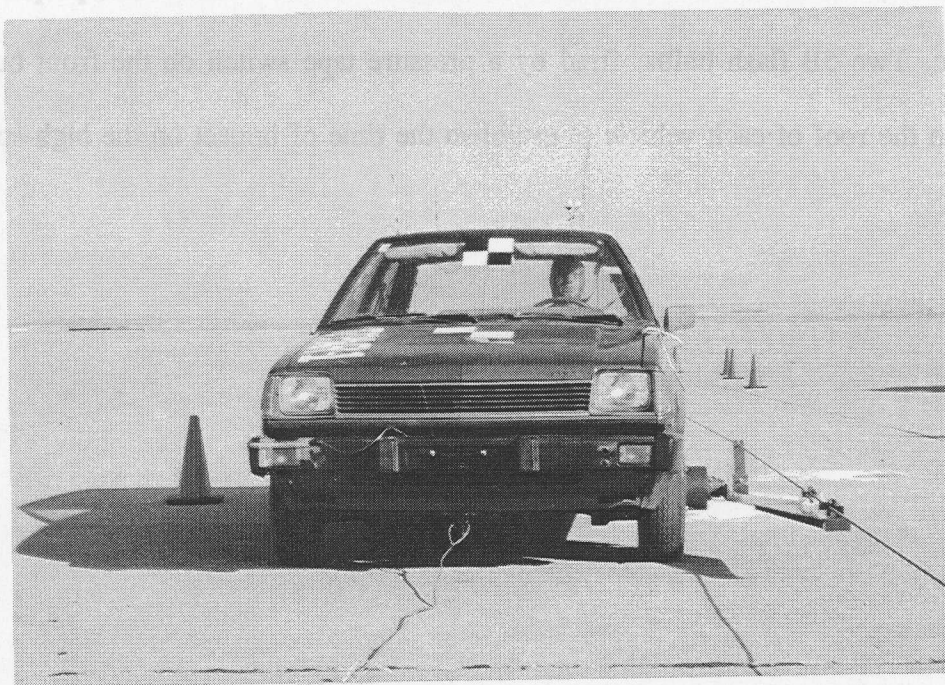
Figure 7. Test Vehicle, Test FPAR-1

A 1984 Dodge Colt, shown in Figure 7, was used as a test vehicle in Test FPAR-1. As shown in Figure 8, the vehicle had a test inertial weight of 1,904 lbs (864 kg).

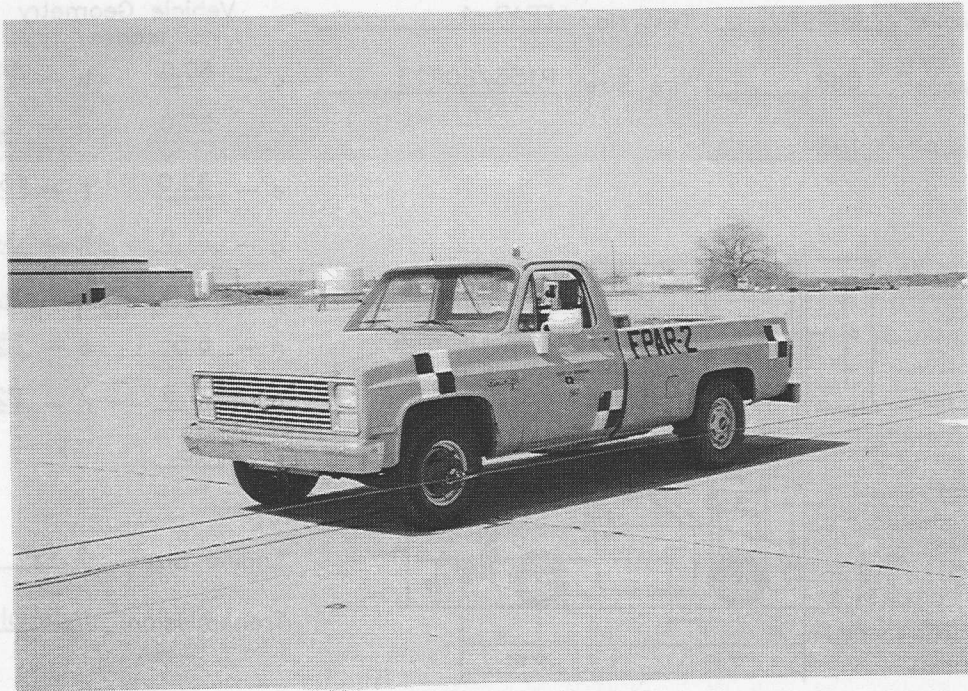
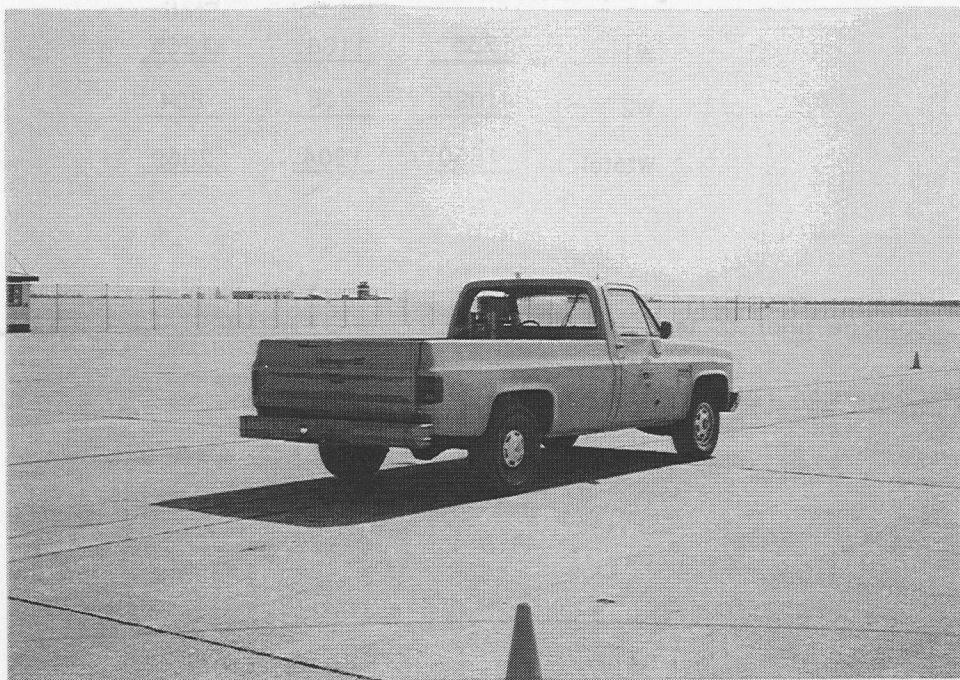
Figure 9. Test Vehicle, Test FPAR-2

A 1984 Chevrolet 3/4-ton pickup, shown in Figure 9, was used as a test vehicle in Test FPAR-2. As shown in Figure 10, the vehicle had a test inertial weight of 5,300 lbs (2,300 kg).

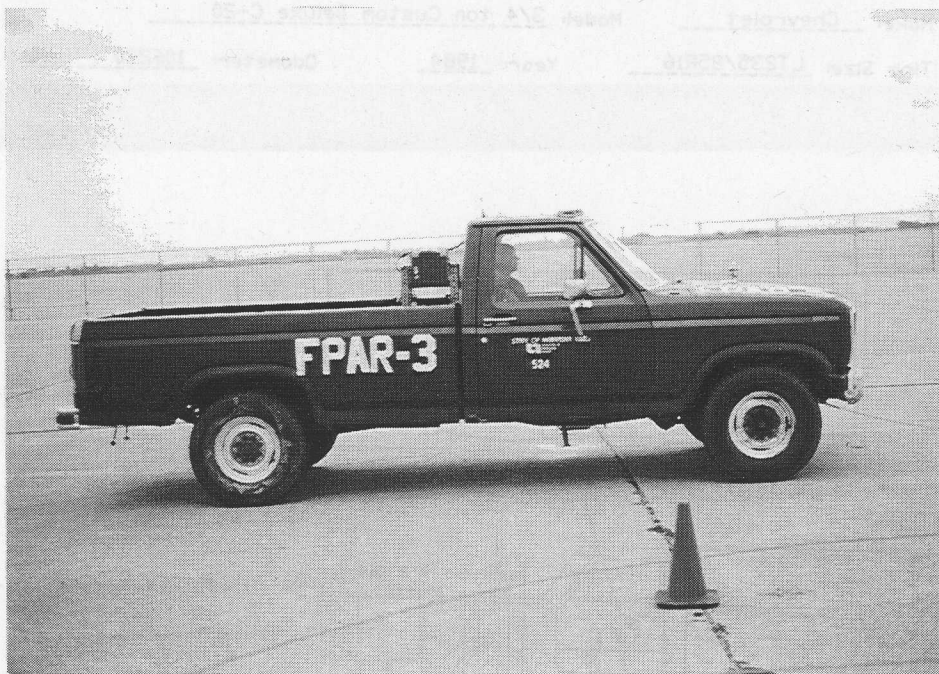
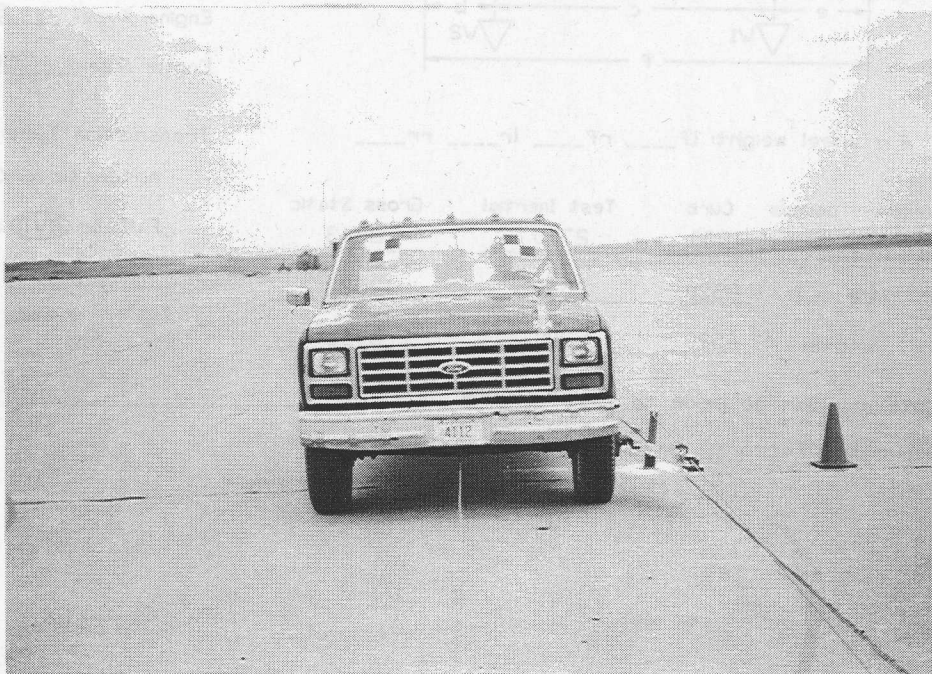
Figure 11. Test Vehicle, Test FPAR-3

A 1985 Ford 3/4-ton pickup, shown in Figure 11, was used as a test vehicle in Test FPAR-3. As shown in Figure 12, the vehicle had a test inertial weight of 5,400 lbs (2,452 kg).

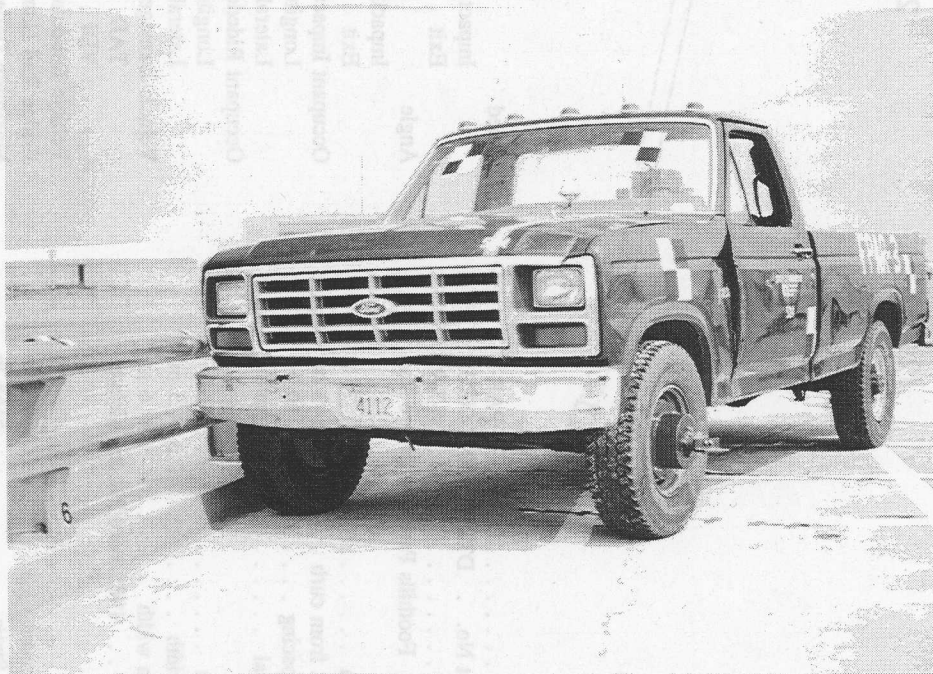
Figure 29. Impact Location, Test FPAR-3.

The 1985 Ford 3/4 ton pickup was directed into the Foothills Parkway Bridge Rail using a reverse tow and cable guidance system (3). The vehicle was released from the tow cable and guidance system and was free wheeling at impact. The speed of the vehicle at impact was 45.7 mph (73.5 km/h) and the angle of impact was 22.7 degrees. The impact point was located midspan between the 5th and 6th posts from the upstream end of the installation as shown in Figure 29. A summary of the test results and sequential photographs is shown in Figure 30. Additional sequential photographs are shown in Figure 31.

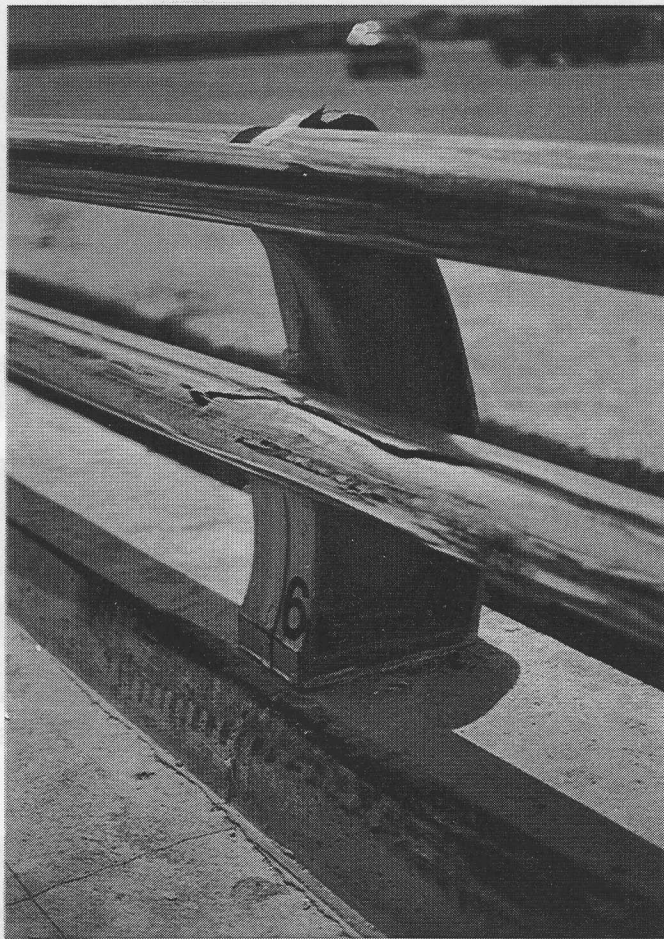
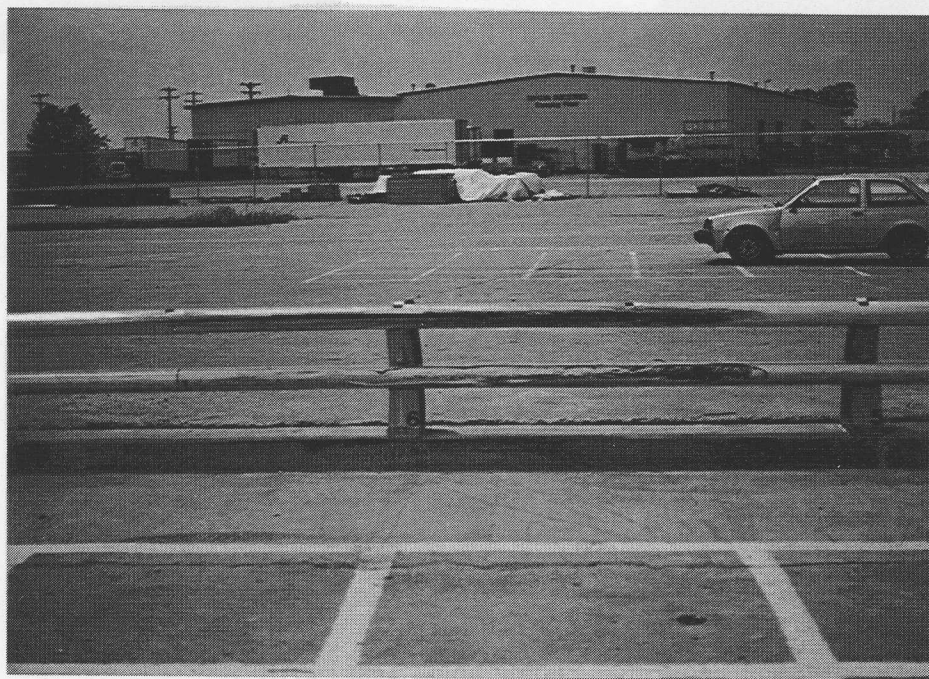
Figure 32. Bridge Rail Damage, Test FPAR-3

The vehicle was smoothly redirected by the bridge railing, with a relatively small amount of damage to the rail and vehicle. There was no snagging of the vehicle or any evidence of cracking in the deck or curb. The maximum permanent set deflection of 1.9 in. (4.8 cm) occurred at the midspan of post Nos 5 and 6. The damage to the bridge rail is shown in Figure 32, and the vehicle trajectory is shown in Figure 33.

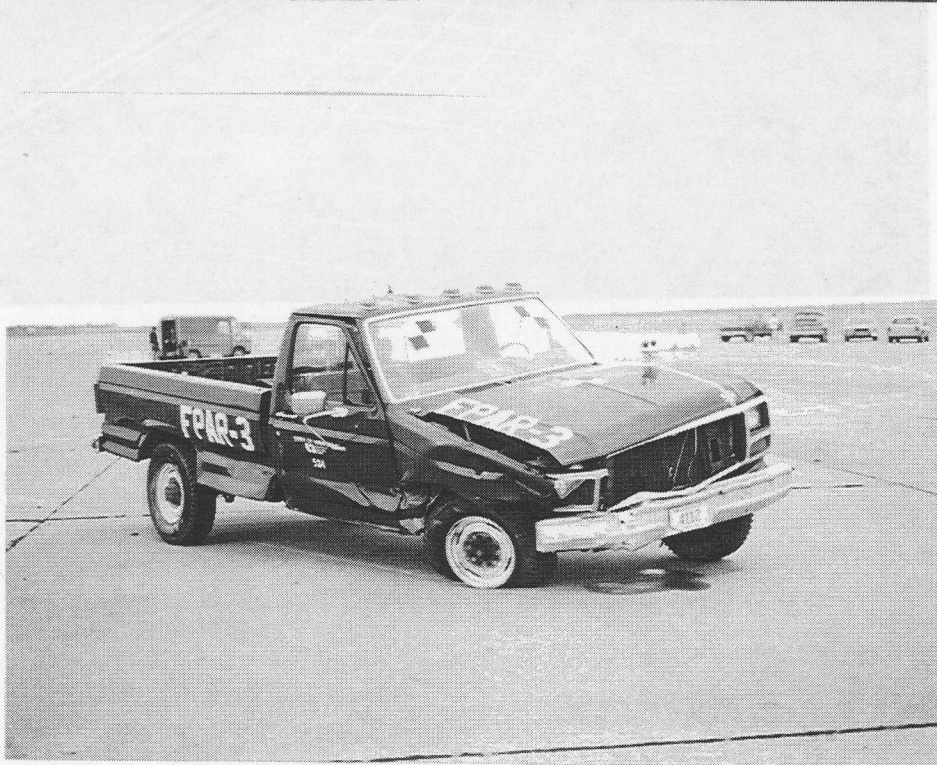
Figure 34. Vehicle Damage, Test FPAR-3

The vehicle damage, shown in Figure 34, included the crushing of the right front corner of the vehicle, and scrapes and dents along the length of the passenger side. The right front tire was blown out and the rim was bent. The maximum crush deformation of 10.75 in. (27.3 cm) is shown in Figure 35.
