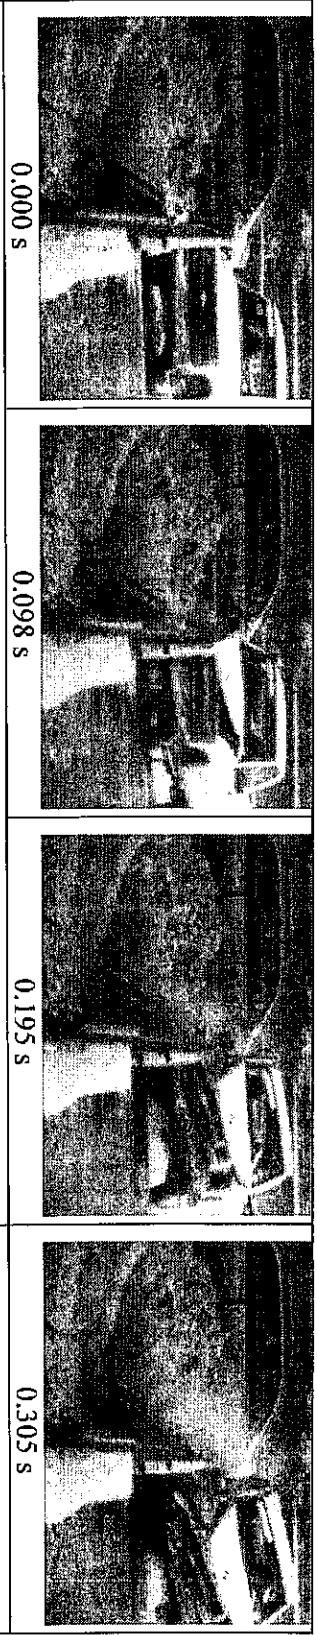
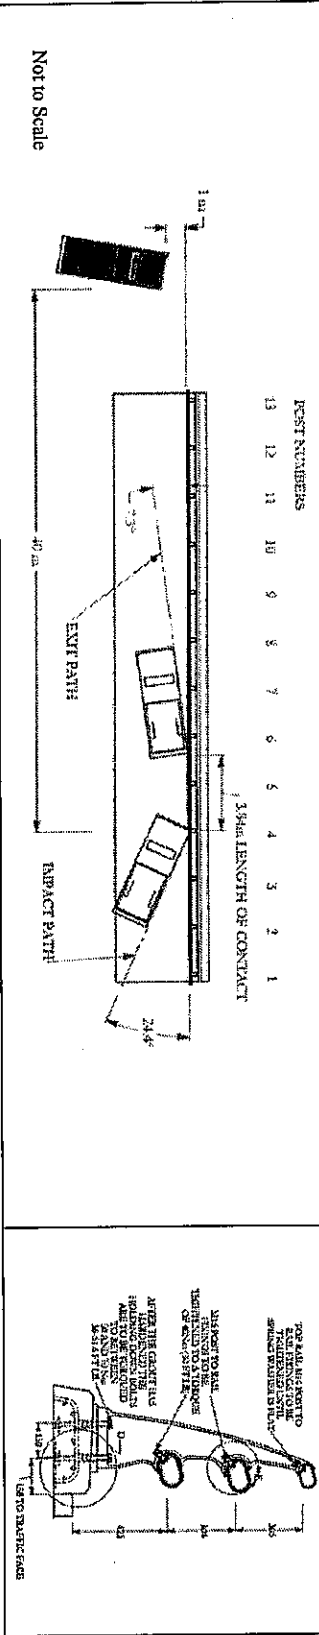
General Information		Impact Conditions		Post-Impact Trajectory	
Test Agency	Texas Transportation Institute	Speed	100.7 km/h	Stopping Distance	40.2 m downstrm
Testing Standard Test No.	NCHRP Report 350 4-11	Angle	24.4 degrees		1 m twd traffic
Test No.	401761-VGL2	Location/Orientation	At post 4		
Date	2010-04-28	Exit Conditions			
Test Article		Speed	68.5 km/h		
Type	Bridge Rail	Angle	7.2 degrees		
Name	VGAN 300 Aluminum Bridge Parapet	Occupant Risk Values			
Installation Length	30.3 m	Impact Velocity	6.6 m/s		
Material or Key Elements	3 horizontal extruded 6082 T6 aluminum tubes spaced at 2.44 m	Longitudinal	7.5 m/s		
Soil Type and Condition		Lateral	-18.2 G		
	Concrete Deck, Dry	Ridedown Accelerations	-12.6 G		
Test Vehicle		Longitudinal	-12.6 G		
Type/Designation	2000P	Lateral	35.7 km/h		
Make and Model	1997 Chevrolet C2500 Pickup	THIV	9.9 G		
Curb	2174 kg	PHD	1.48		
Test Inertial	2083 kg	ASI	1.48		
Dummy	No dummy	Max. 0.050-s Average	-10.7 G

Gross Static	2083 kg	Longitudinal	-11.7 G		
		Lateral	5.7 G		
		Vertical	5.7 G		
		Vehicle Stability			
		Maximum Yaw Angle	114 degrees		
		Maximum Pitch Angle	19 degrees		
		Maximum Roll Angle	-27 degrees		
		Vehicle Snagging	No		
		Vehicle Pocketing	No		
		Test Article Deflections			
		Dynamic	360 mm		
		Permanent	190 mm		
		Working Width	520 mm		
		Vehicle Damage			
		VDS	01RFQ4		
		CDC	01RFEW3		
		Max. Exterior Deformation	600 mm		
		Max. Occupant Compartment Deformation	100 mm

Figure 17. Summary of results for NCHRP Report 350 test 4-11 on the VGAN 300 aluminum bridge rail.
