# Test Level 4 Evaluation of the Minnesota Combination Bridge Rail

TRANSPORTATION RESEARCH REPORT TRP-03-53-96

Midwest Roadside Safety Facility (MwRSF)  
Center for Infrastructure Research  
Civil Engineering Department  
University of Nebraska-Lincoln  
1901 Y Street, Building C  
Lincoln, Nebraska 68588-0601

March 1996

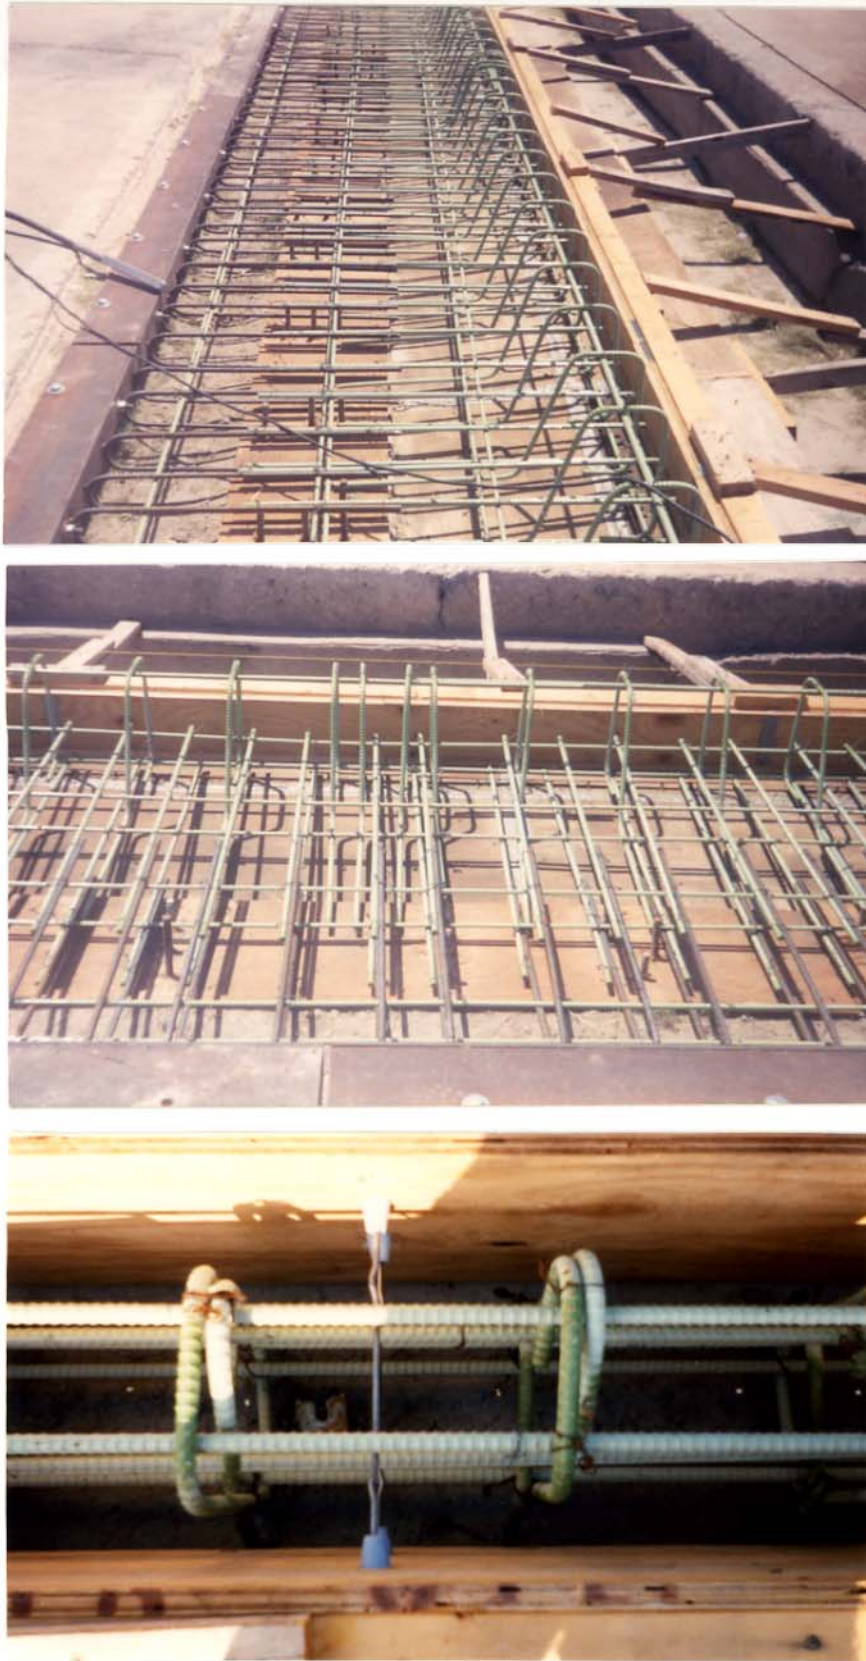
**Figure 4.** Reinforcement layout for bridge deck and parapet.

Figure 4, and photographs of the completed installation are shown in Figure 5.

The concrete specified for use in the bridge deck parapet required a minimum 28-day compressive strength of 4,300 psi (29.7 MPa). The 35-day concrete compressive strength for the simulated bridge deck was approximately 4,580 psi (31.6 MPa), and the 7-day concrete compressive strength for the parapet was approximately 4,300 psi (29.7 MPa).

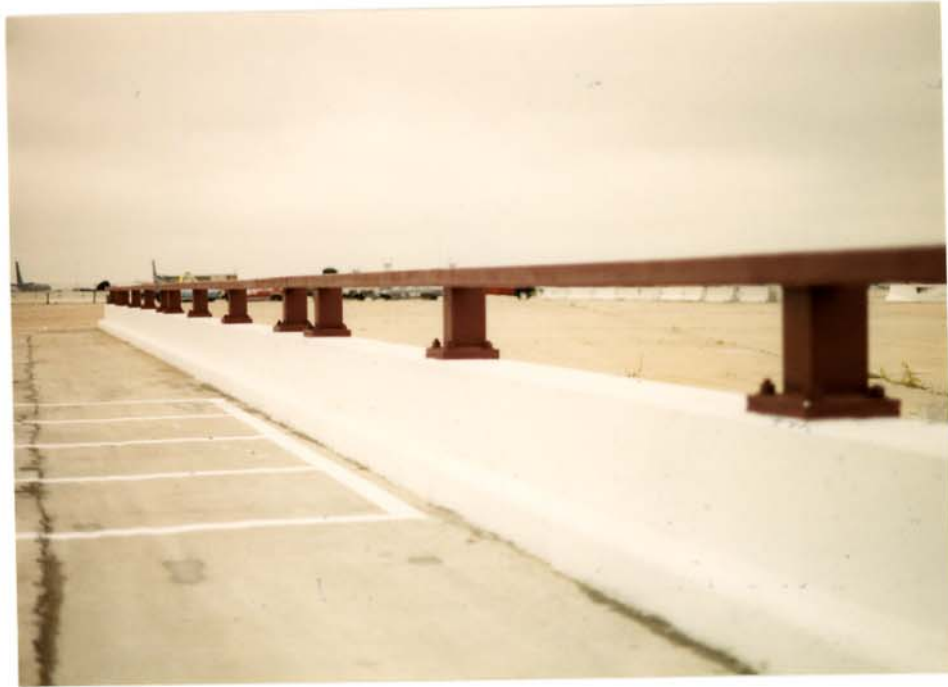
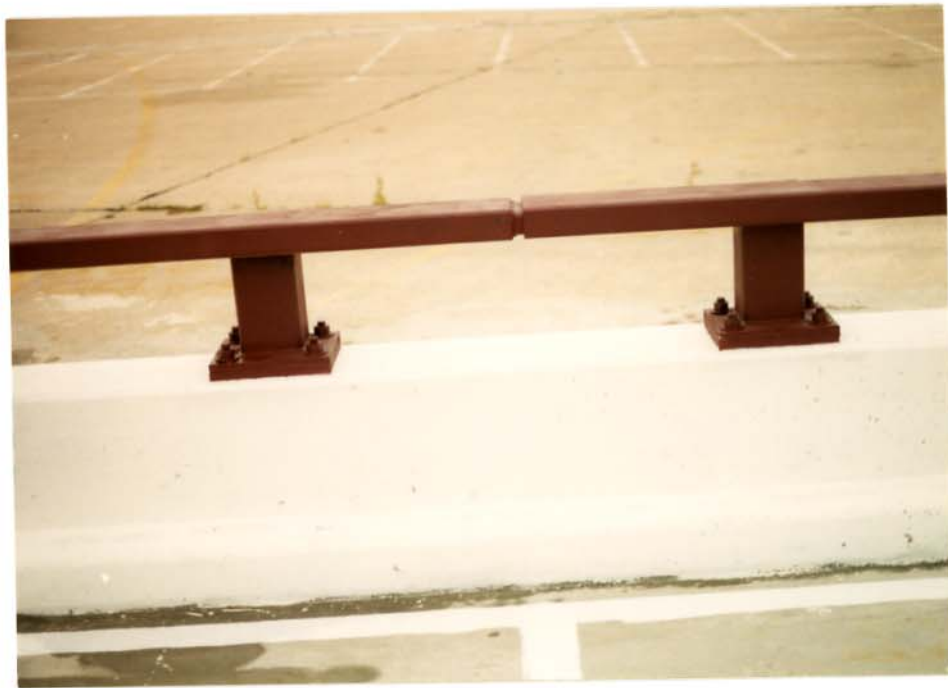
**Figure 5.** The Minnesota Combination Bridge Rail.

The total length of the installation was 116 ft (35.4 m). This installation consisted of four major structural components: (1) simulated concrete bridge deck; (2) 6 in. (152 mm) high concrete curb; (3) 20 in. (508 mm) high concrete parapet; and (4) a TS 6 x 3 x ¼ in. (structural tube) steel rail mounted on 10¼ in. (260 mm) high TS 6 x 6 x ¼ in. steel posts. The simulated concrete bridge deck was anchored to the existing concrete apron as shown in Figure 6.

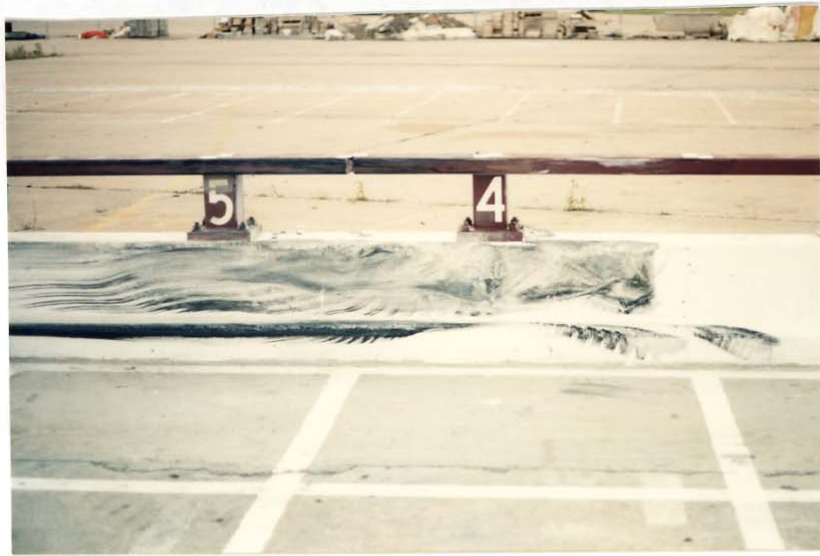
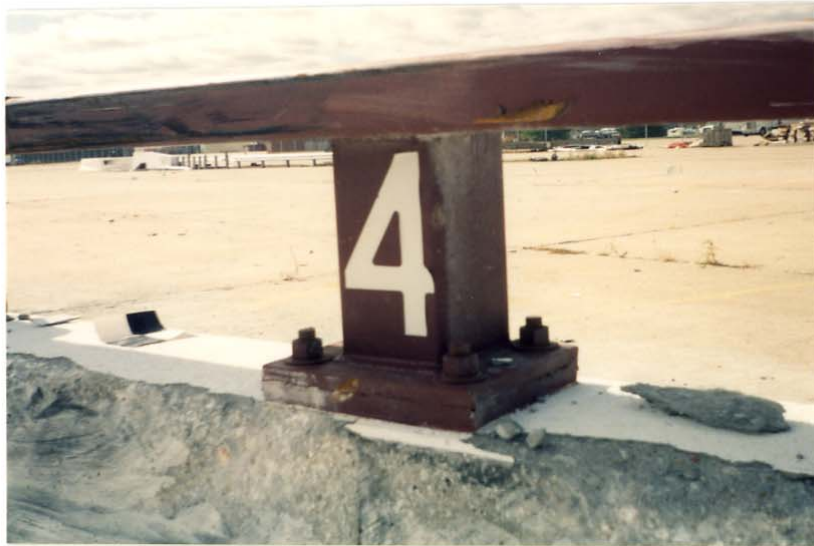
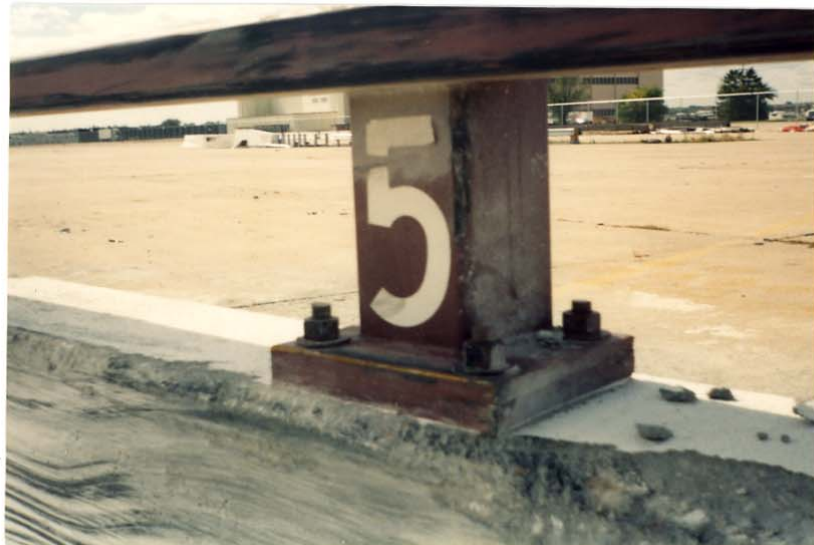
Figure 15. Bridge Rail Damage, Test MN-1.

Damage to the bridge rail included tire marks, as well as concrete gouging and spalling along the length of the concrete curb and parapet. Damage to the steel rail and posts included scrapes and gouges along the rail and posts, as well as a maximum permanent set deformation of 5/16 in. (8 mm) in the lateral direction, and 1/2 in. (13 mm) downward. This damage is shown in Figure 15.

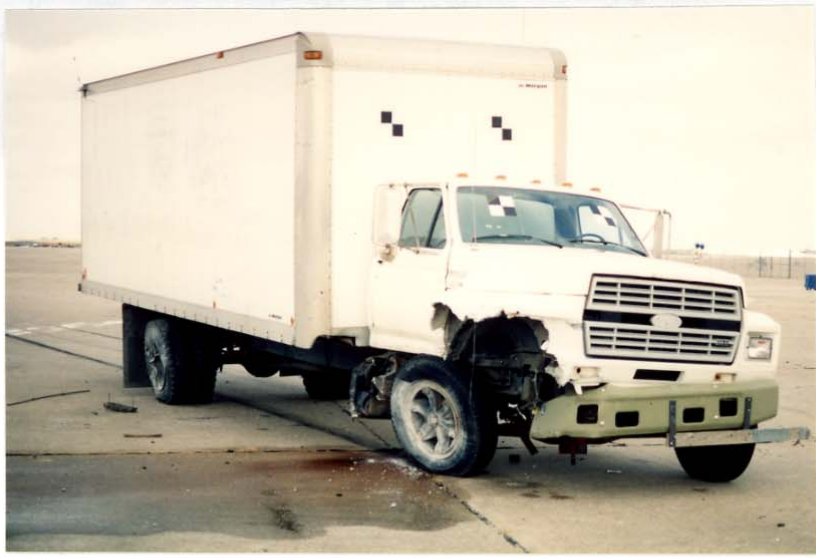
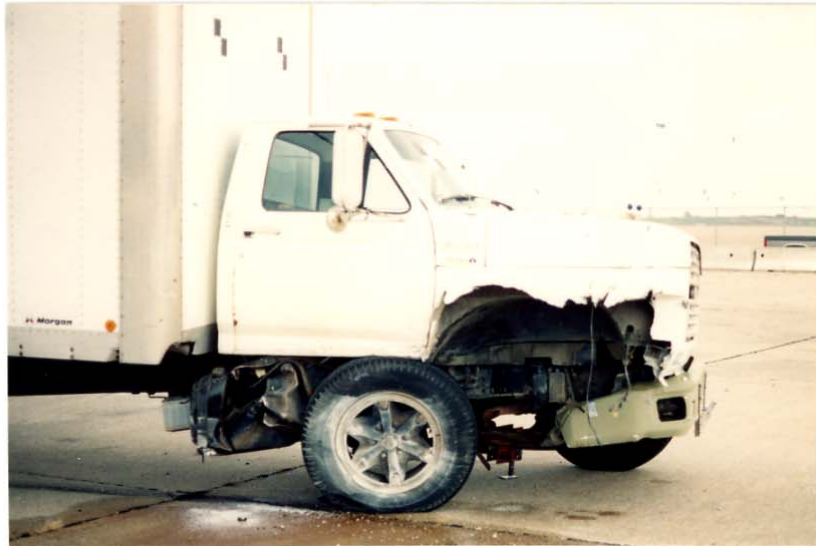
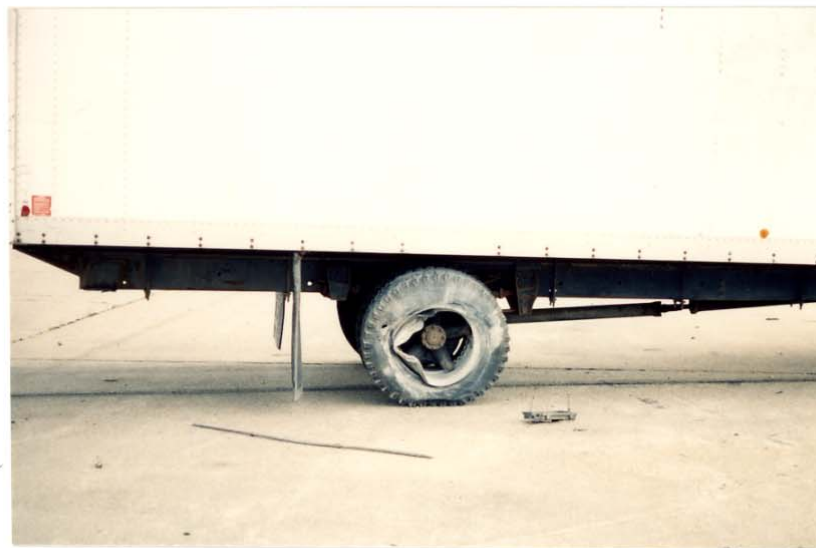
Figure 16. Test Vehicle Damage, Test MN-1.

Damage to the test vehicle was minimal considering the impact conditions, as can be seen in Figure 16. There was very little damage to the van box, and all of the glass in the truck remained intact. There was no occupant compartment damage, and no visible damage to the truck on the drivers side. There was damage to the right-front fender and the right side of the front bumper. The front axle was pushed back and the frame was bent. There was considerable deformation of the right-rear wheel which resulted from contact with bridge rail. The gas tank (which had been purged and filled with water before the test) was punctured and deformed considerably.

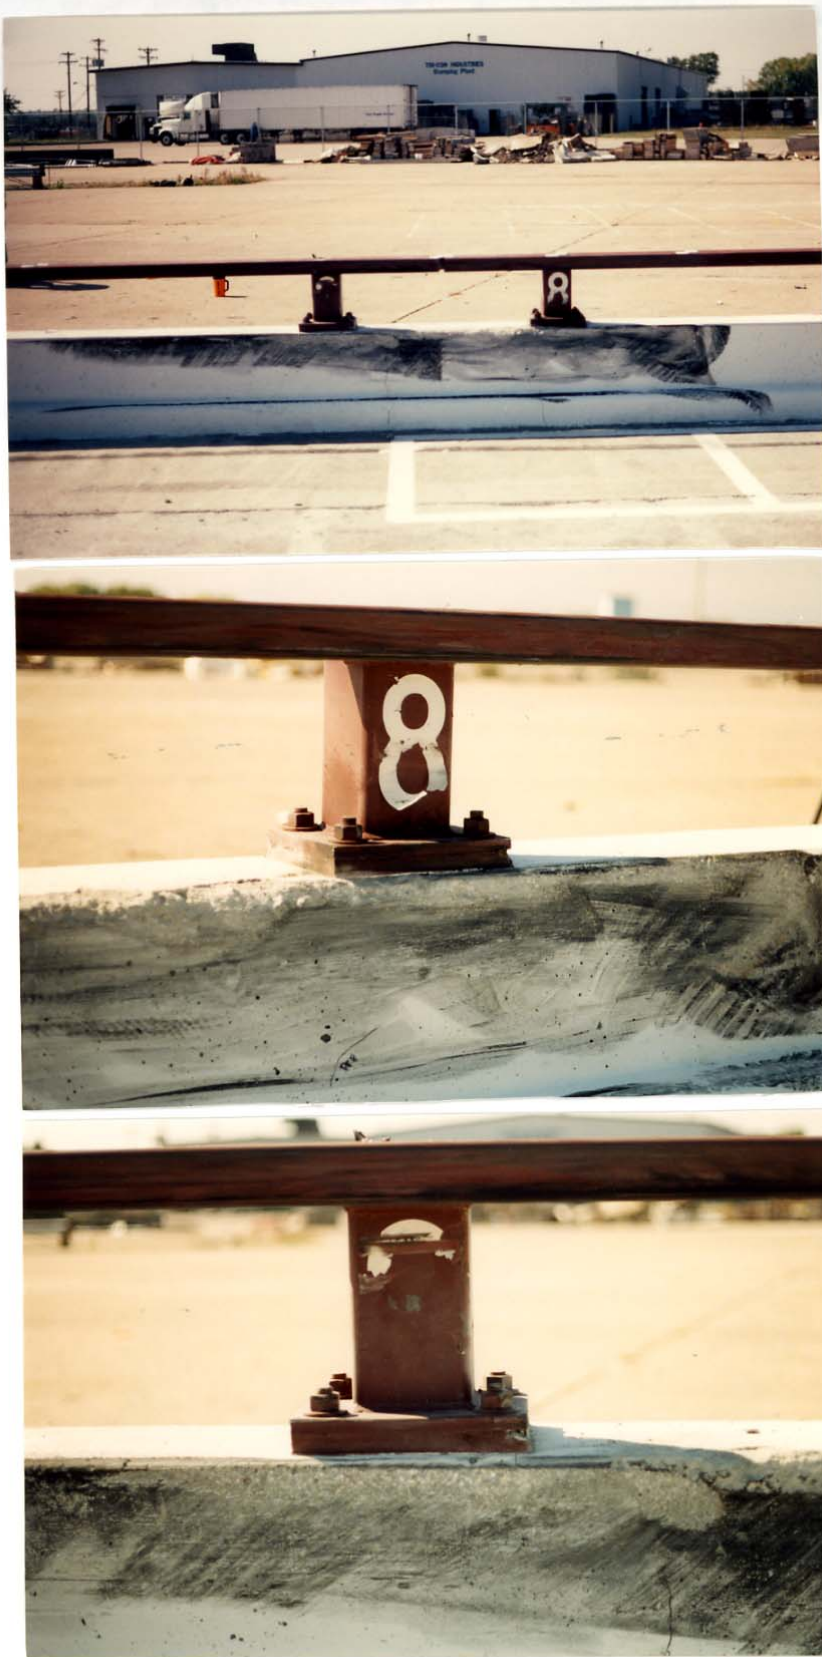
Figure 21. Bridge Rail Damage, Test MN-2.

and tires climbed the 6-in. (152 mm) high barrier curb, causing the vehicle bumper to rise up between the concrete parapet and structural steel tube rail. This penetration allowed the bumper to snag on the epoxy grout pad, steel base plate, steel nuts, anchor bolt ends, and structural steel tube post. Contact marks extended in approximately 1 in. (25 mm) on the upstream side of Post No. 9, indicating that the vehicle penetrated approximately 4.5 in. (114 mm) from the traffic-side face of the concrete parapet. It is noted that the top and bottom height of the vehicle's front bumper is 26.5 in. (673 mm) and 15 in. (381 mm), respectively. The total height to the top of the concrete parapet is 20 in. (508 mm). The distance from the front face of the post to the front face of the concrete parapet is 3.5 in. (89 mm).

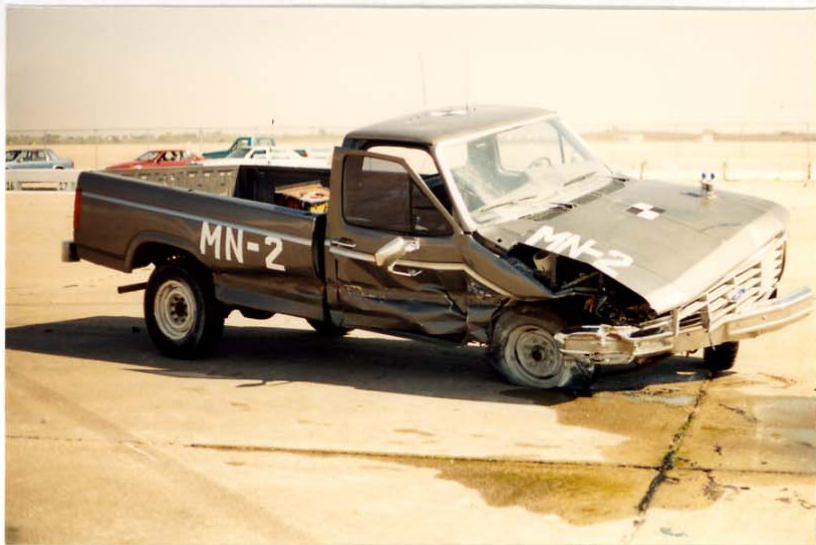
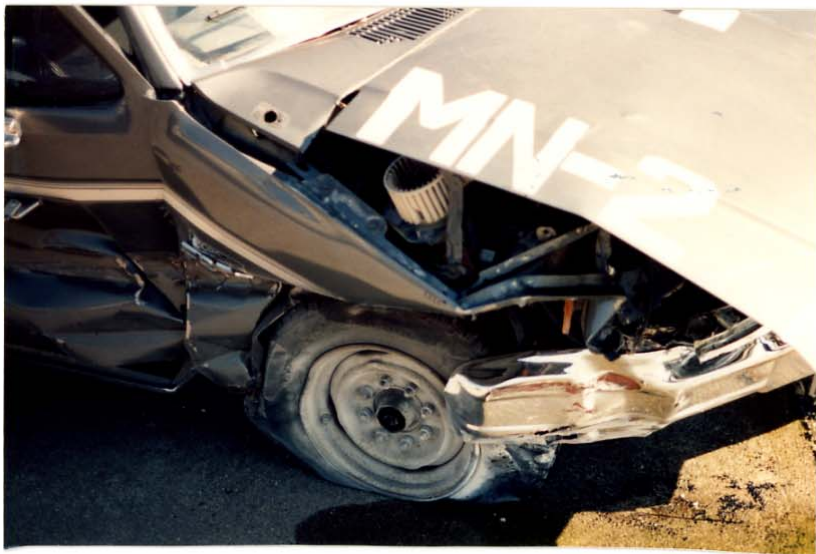
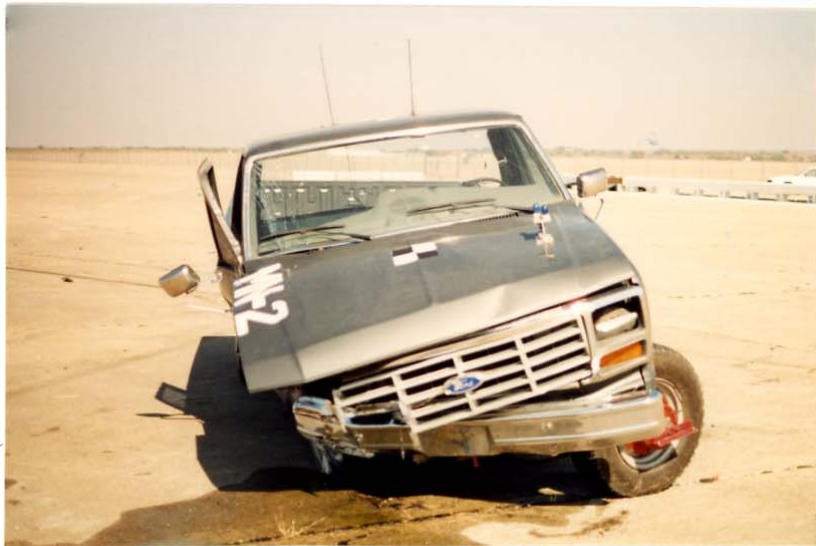
Figure 22. Vehicle Damage, Test MN-2.

Evidence of snagging was also found on the damaged vehicle, as can be seen in Figure 22. The front bumper had several tears and gouges near the lower right-side end. In addition, the right-side bumper support and adjacent frame were pushed backward and deformed, causing the left-side of the front bumper to push outward. The deformed bumper contacted the right-front tire, pushing the tire into the right-side floorboard. The backward movement of the tire assembly caused the right-side door and lower body to buckle. Significant undercarriage damage and deformation to the frame was observed, causing the right-side floorboard to be pushed toward the center of the vehicle.

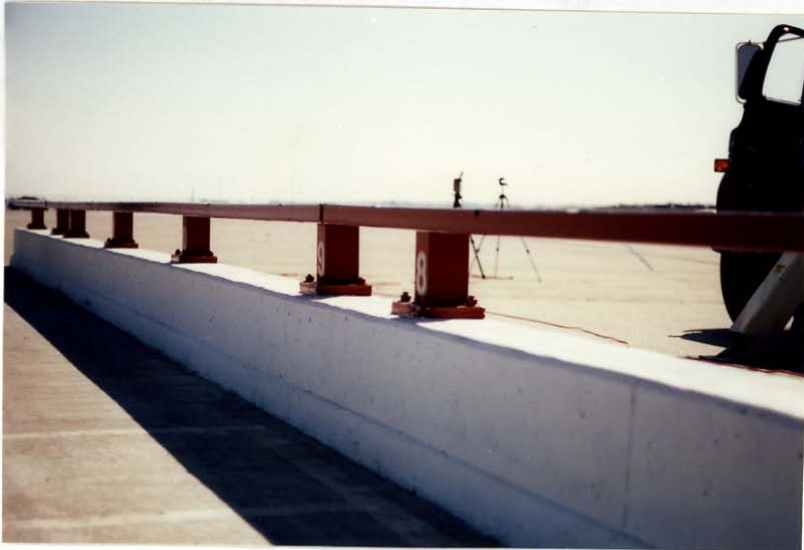
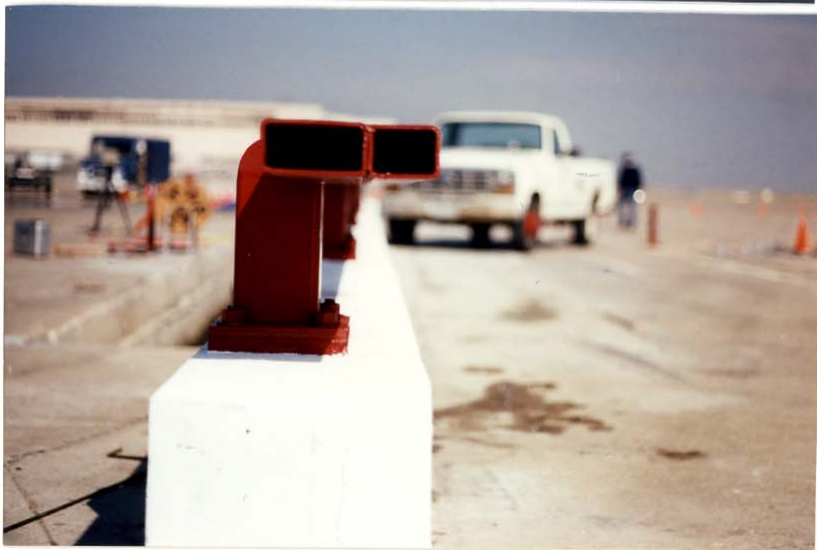
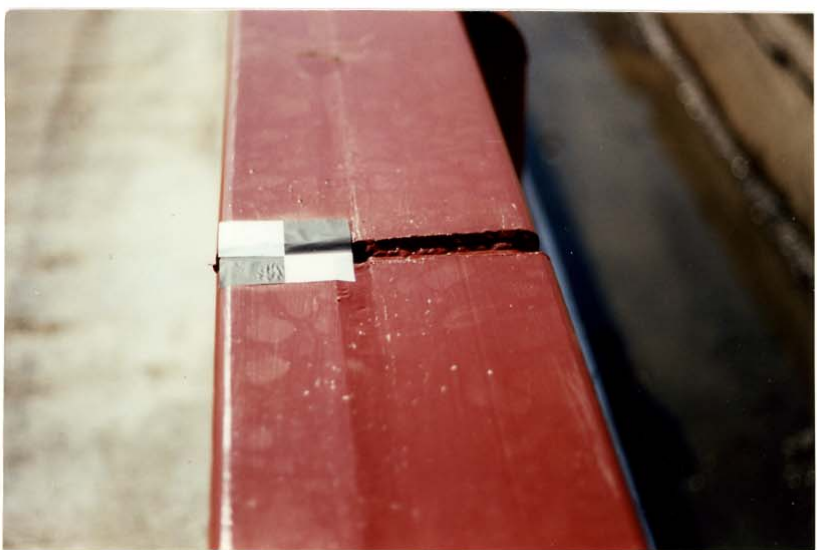
**Figure 23.** Retrofit of Minnesota Combination Bridge Rail for tests MN-3 and MN-4.

Following this test, several retrofit options were considered to reduce the potential of the vehicle snagging on the steel posts. The retrofit option chosen for Test MN-3 is shown in Figure 7 and described in Section 2.2. This retrofit option included extending the structural steel rail and concrete parapet 4 in. toward the roadway to reduce the potential of the vehicle snagging on the posts. This also minimized the

amount of curb extending from the parapet, reducing the potential for this curb to cause the vehicle to ride up and cause the bumper to snag on the posts.

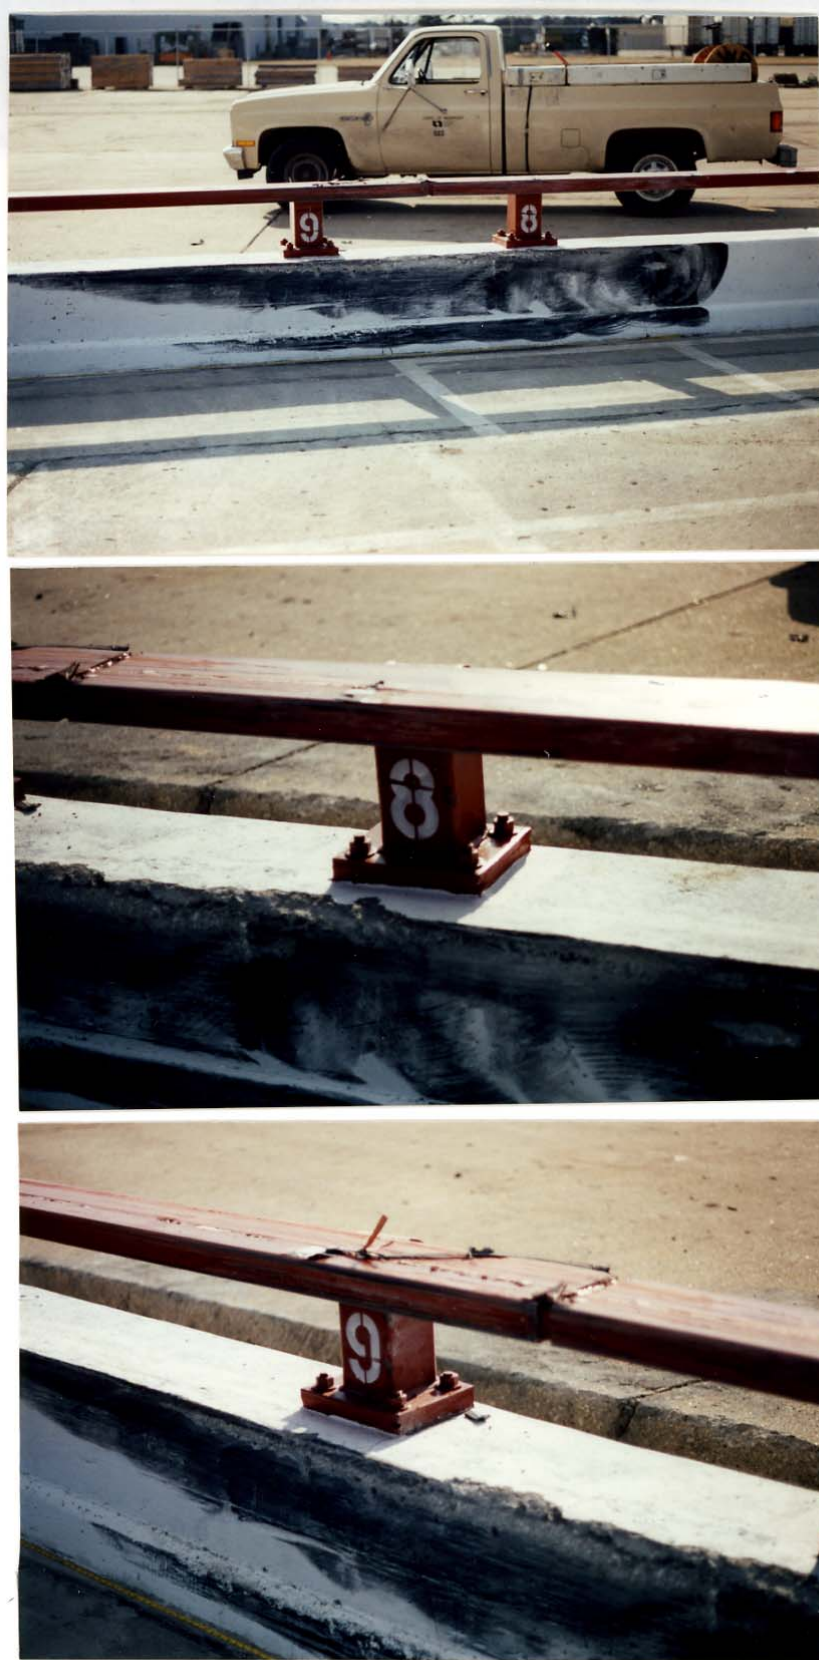
Figure 26. Bridge Rail Damage, Test MN-3.

The damage to the bridge rail was relatively minor, as can be seen in Figure 26. This damage consisted mainly of tire marks along the rail, and minor spalling of the concrete parapet. The maximum permanent set deflection of the rail was  $\frac{1}{8}$  in. (3 mm) at post No. 7.

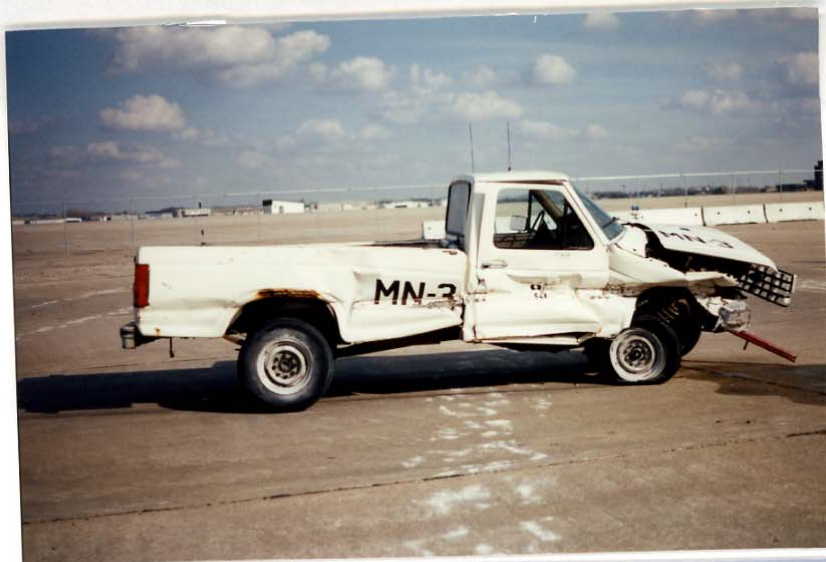
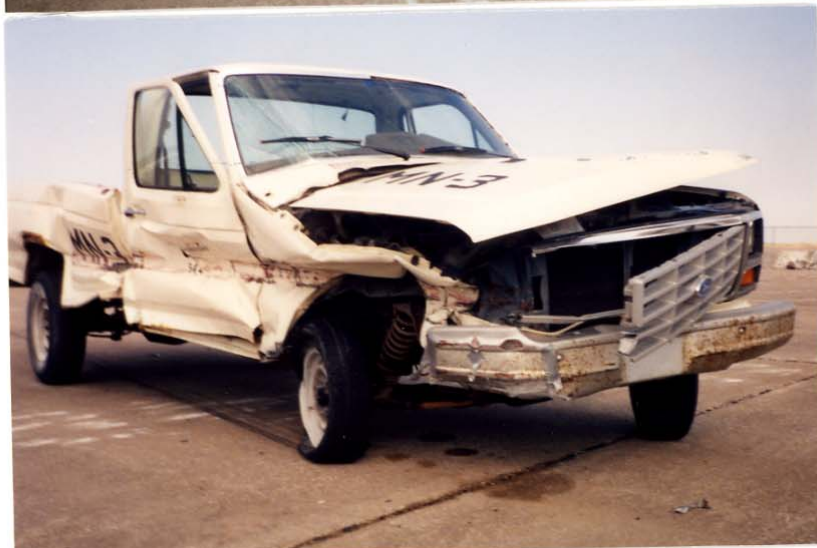
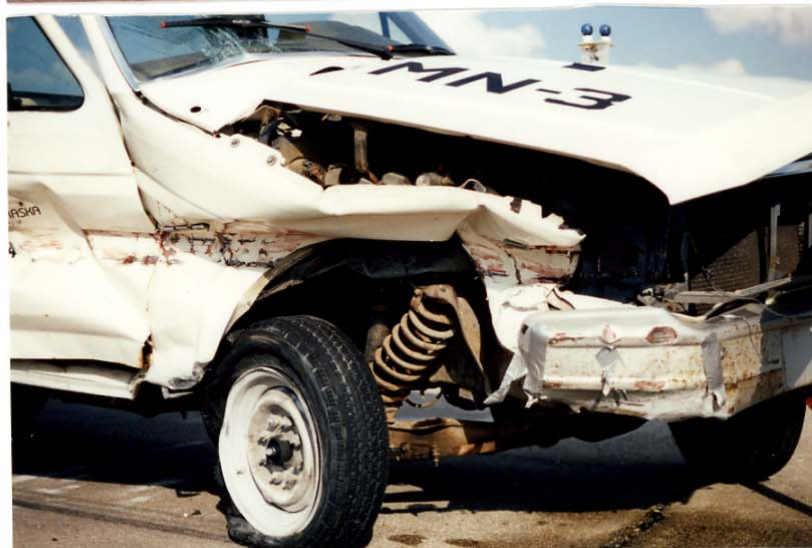
Figure 27. Vehicle Damage, Test MN-3.

Although snagging between the test vehicle's bumper and the steel posts was again observed, the extent of overlap was reduced to approximately  $\frac{1}{2}$  in. (12 mm), and the snag forces were therefore judged to be relatively small. However, lateral forces generated between the concrete parapet and the vehicle's

front wheel and floor pan again caused deformations in the floor pan area with some deformation of the dash board and kick panel. The extent of deformation and the locations thereof are expected to cause injuries to an occupants foot and ankles and are probably not life threatening. Careful review of the high-speed films indicate that the source of the occupant compartment deformations can be contributed largely to lateral forces generated by the vertical concrete parapet. Also, prior testing of a Nebraska open concrete bridge railing (7) exhibited similar damage patterns during an impact at 60 mph (96.5 km/h) and an angle of 20 degrees. Thus, vehicle deformations observed during this test and shown in Figure 27 are believed to be representative of any impact into a rigid rail with a 2000P vehicle at a speed of 62.2 mph (100 km/h) and an angle of 25 degrees. Note that the impact speed and angle associated with this test have been shown to be extremely rare and therefore the extent of occupant compartment deformation observed during this test will seldom be replicated in the field. There was a notable improvement in the performance of the system between tests MN-2 and MN-3, as the retrofit reduced the amount of snagging on the rail posts. This was evident in the analysis of the high-speed film, as well as in the reduced degree of occupant compartment deformation.

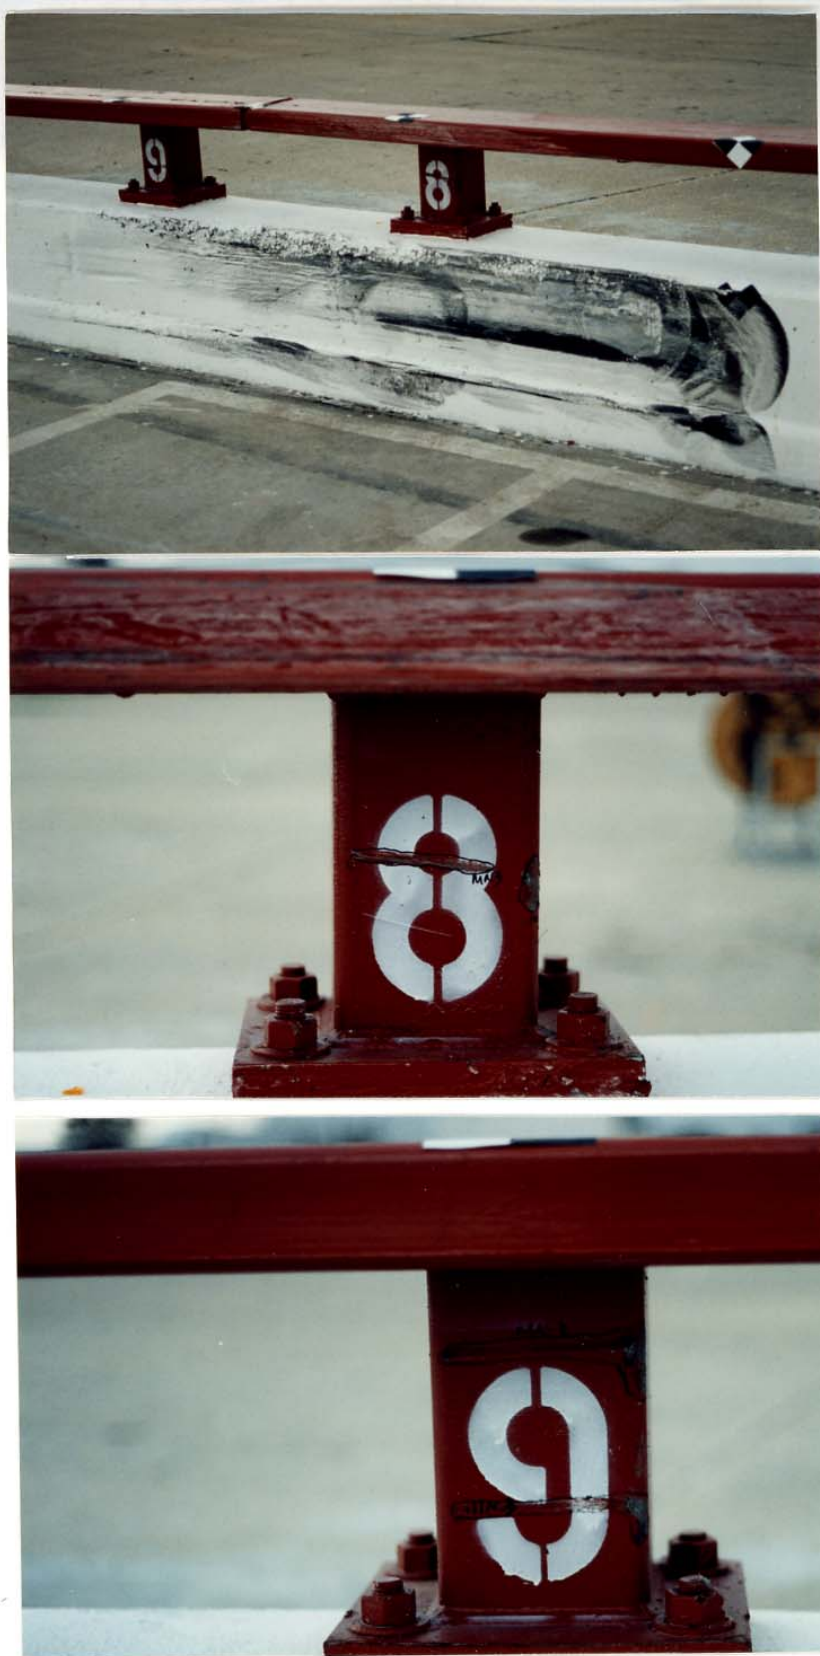
Figure 30. Bridge Rail Damage, Test MN-4.

There was virtually no damage to the bridge rail, as seen in Figure 30. The vehicle damage was deemed to be relatively light for this type of impact, as shown in Figure 31.

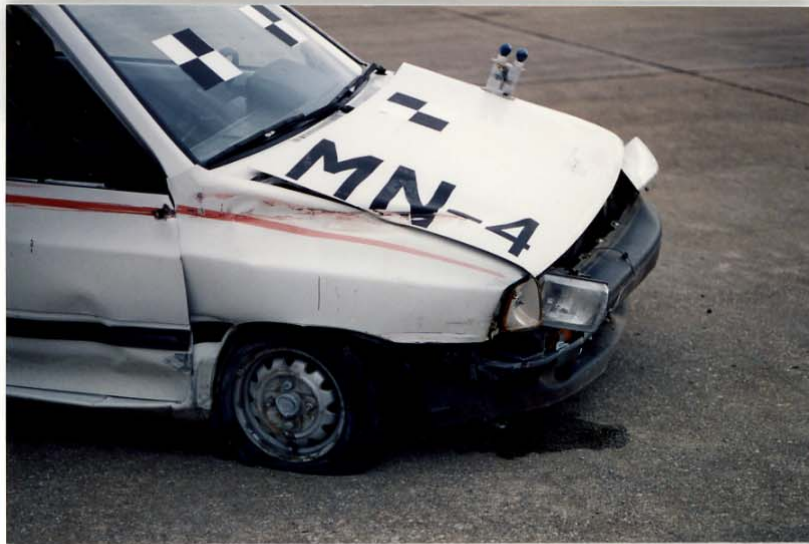
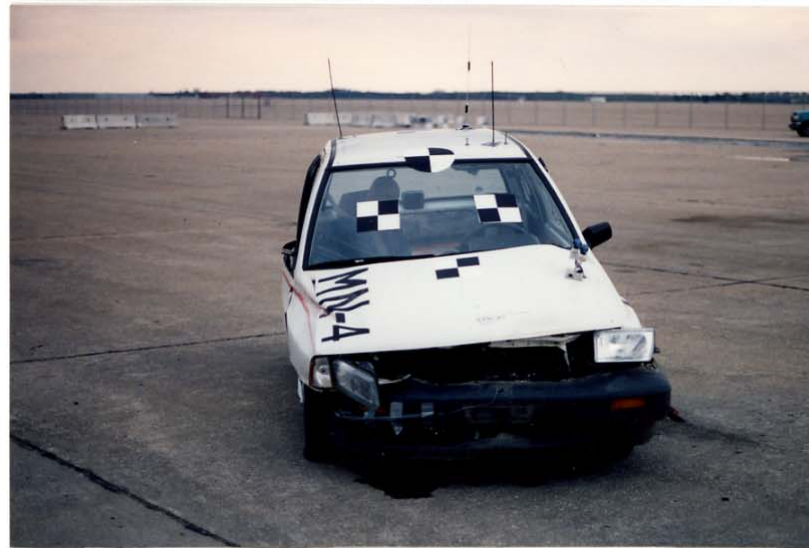
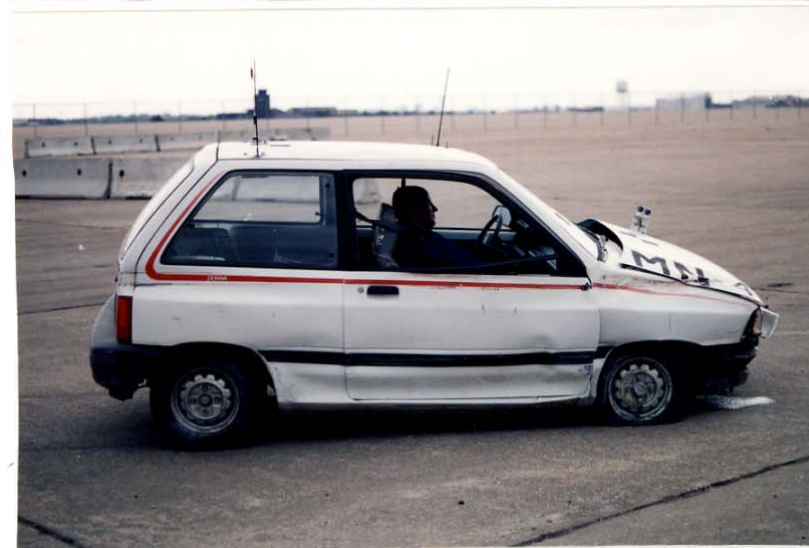
Figure 31. Vehicle Damage, Test MN-4.

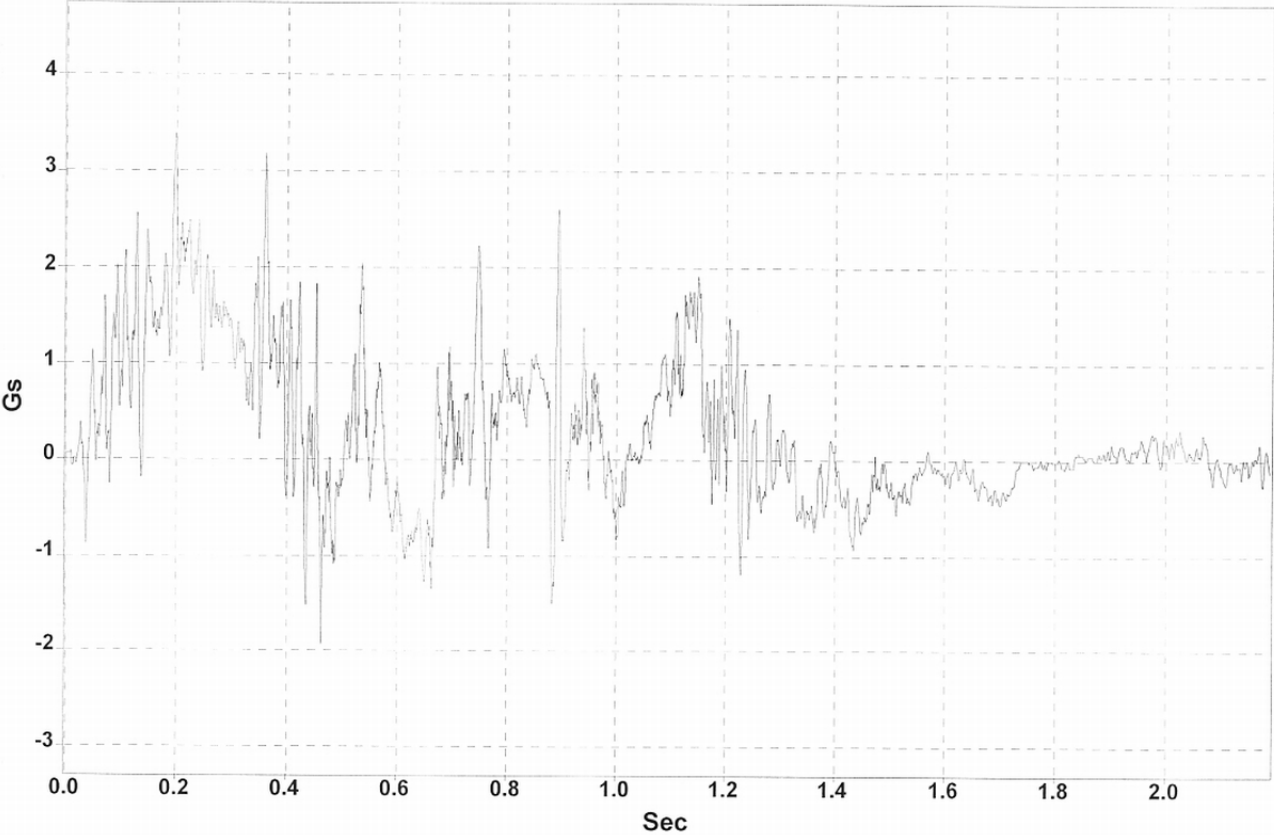
Figure B-1. Lateral Deceleration, Test MN-1.

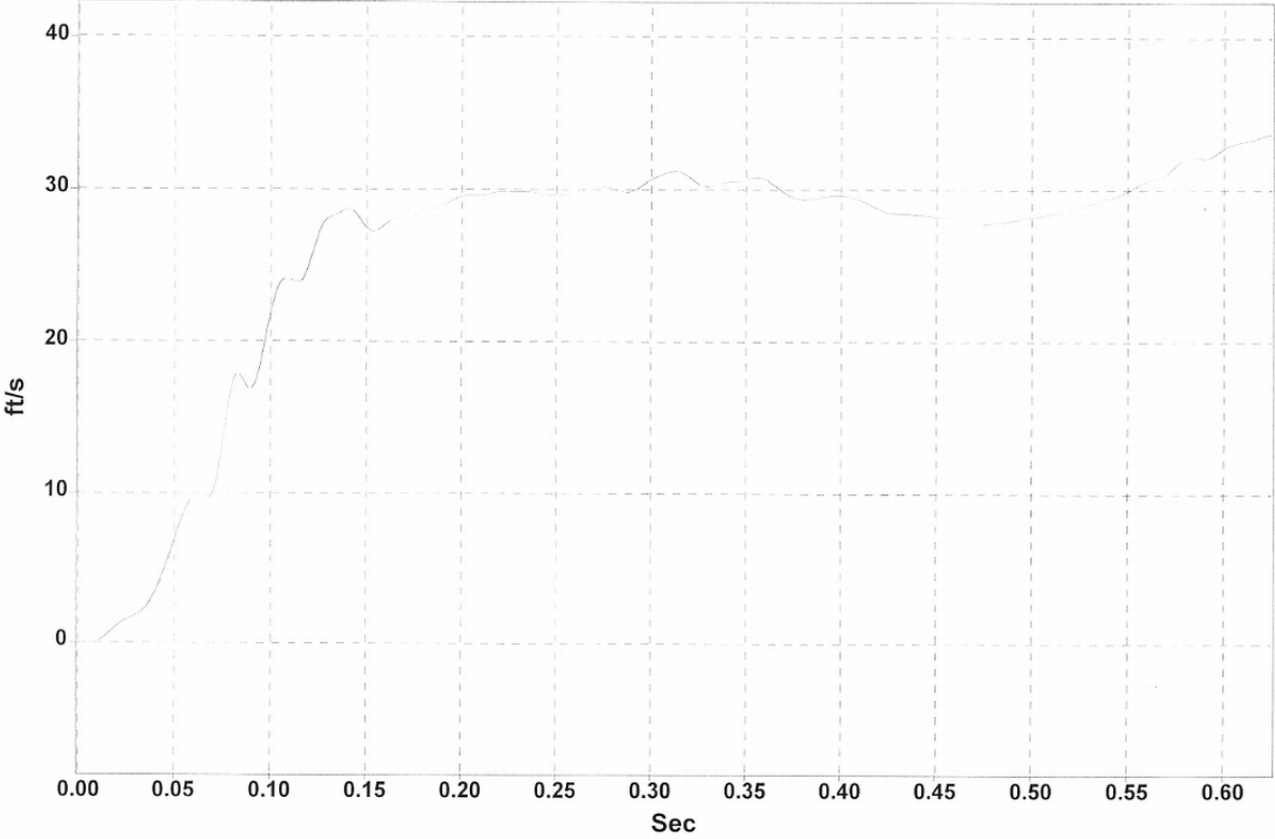
Figure C-4. Relative Longitudinal Change in Velocity, Test MN-2.

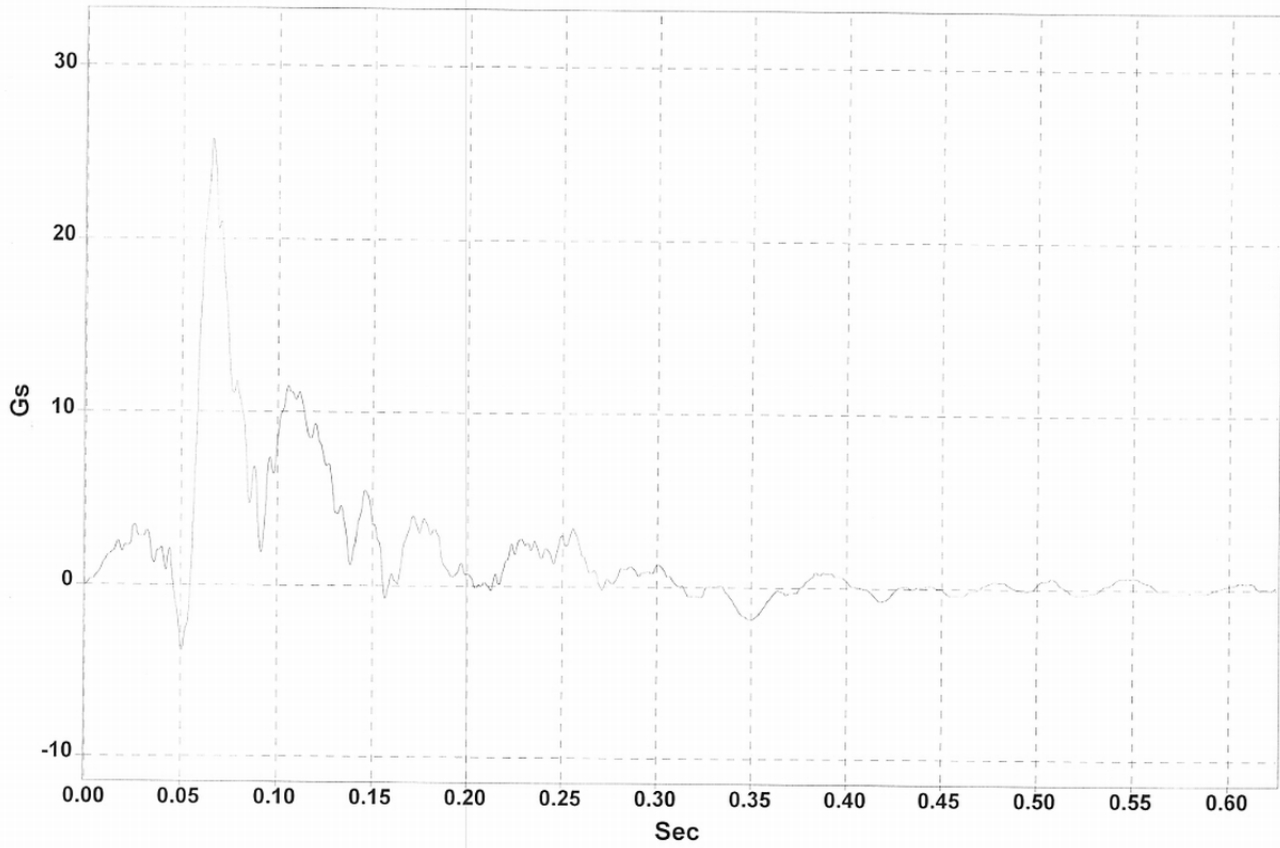
Figure D-1. Lateral Deceleration, Test MN-3.
