1. Report No. FHWA/TX-99/1804-7		2. Government Accession No.		3. Recipient's Catalog No.	
4. Title and Subtitle TEST 7: NCHRP REPORT 350 TEST 3-11 OF THE TEXAS TYPE T4(A) BRIDGE RAIL				5. Report Date April 1999

**TEST 7: NCHRP REPORT 350 TEST 3-11
OF THE TEXAS TYPE T4(A) BRIDGE RAIL**

Report 1804-7
Project Number 0-1804
Research Project Title: Evaluation and Testing of Bridge Rails
and Transitions to NCHRP Report 350 Criteria

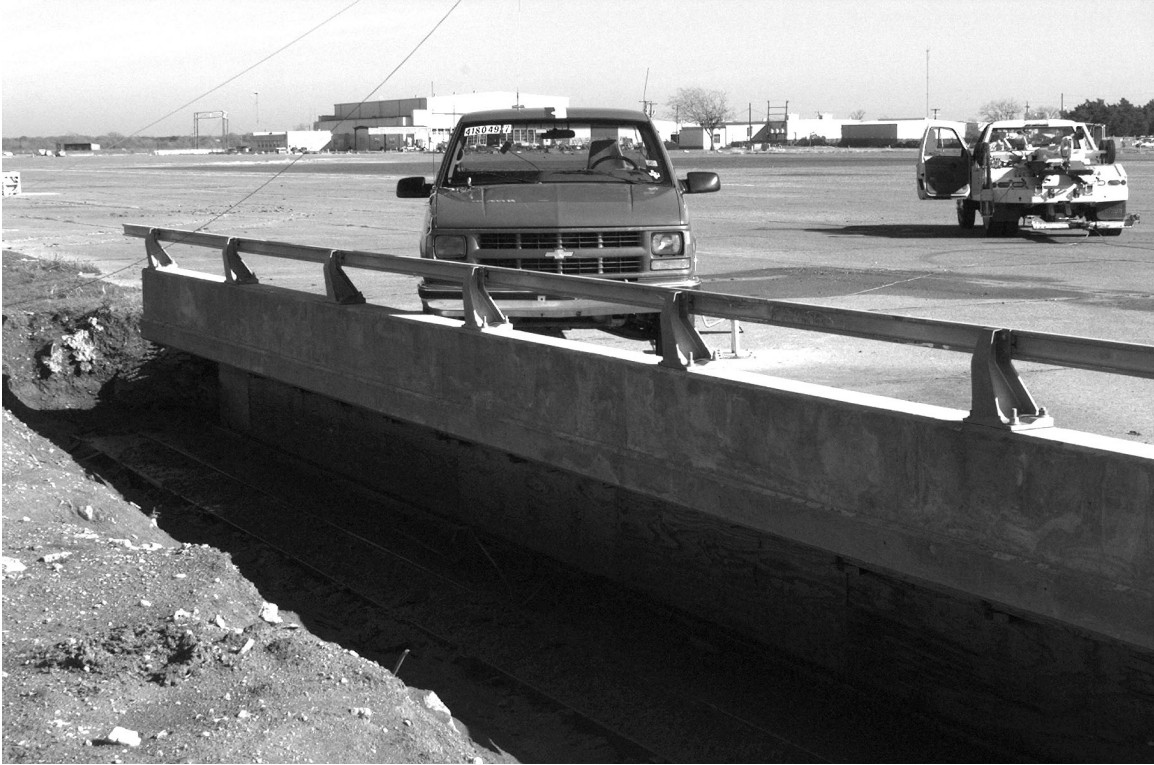
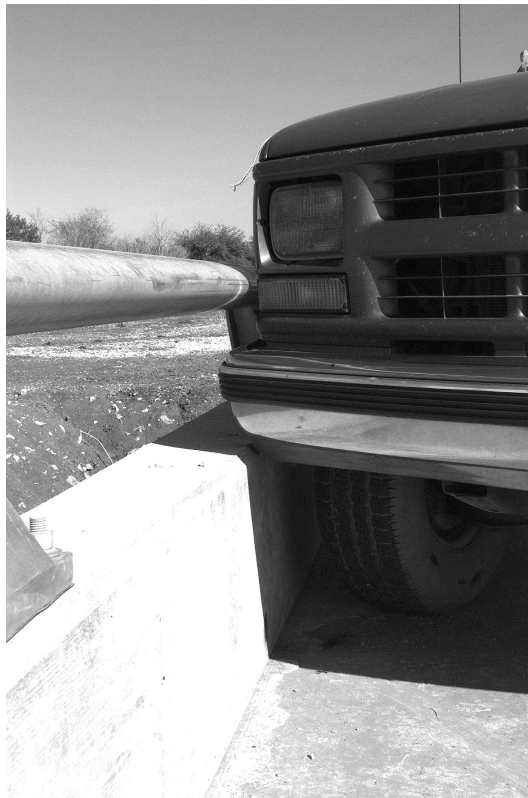
Figure 4. Vehicle/Installation Geometrics for Test 418049-7.

A 1995 Chevrolet 2500 pickup, shown in Figures 4 and 5, was used for the crash test. Test inertia weight of the vehicle was 2000 kg and its gross static weight was 2000 kg. The height to the lower edge of the vehicle bumper was 440 mm and it was 665 mm to the upper edge of the bumper. Additional dimensions and information on the vehicle are given in Appendix B, Figure 11. The vehicle was directed into the installation using the cable reverse tow and guidance system, and was released to be free-wheeling and unrestrained just prior to impact.

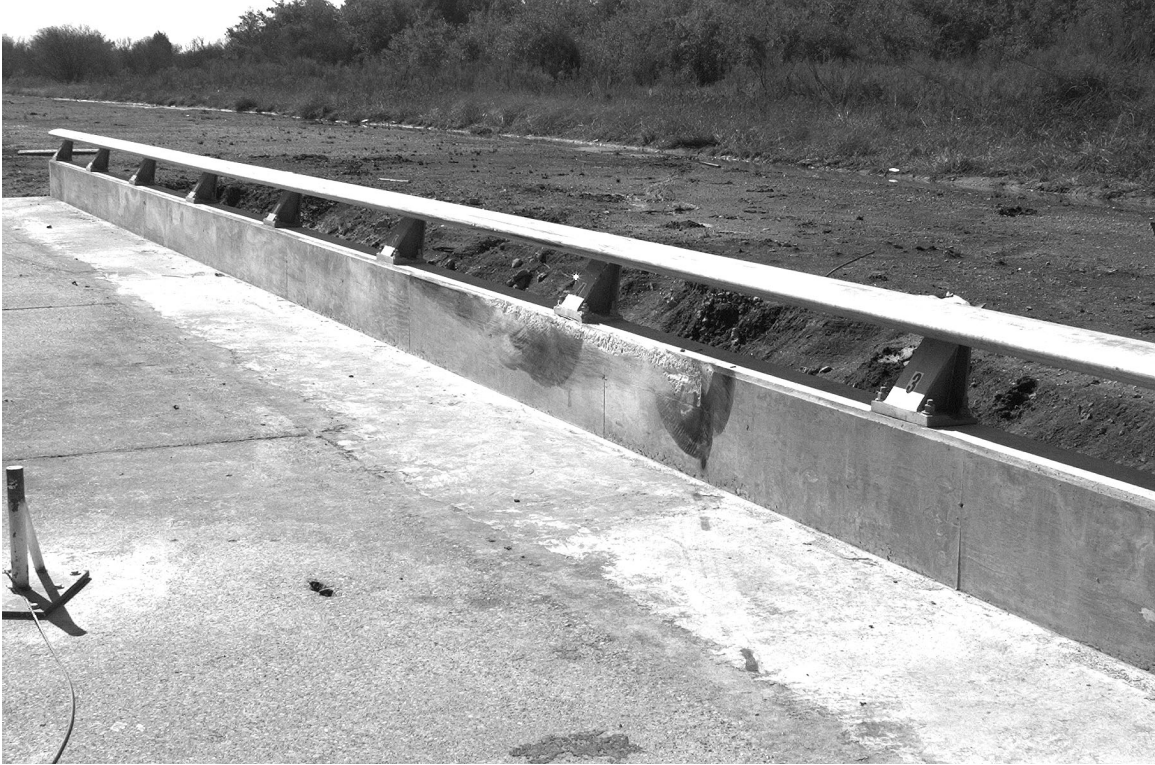
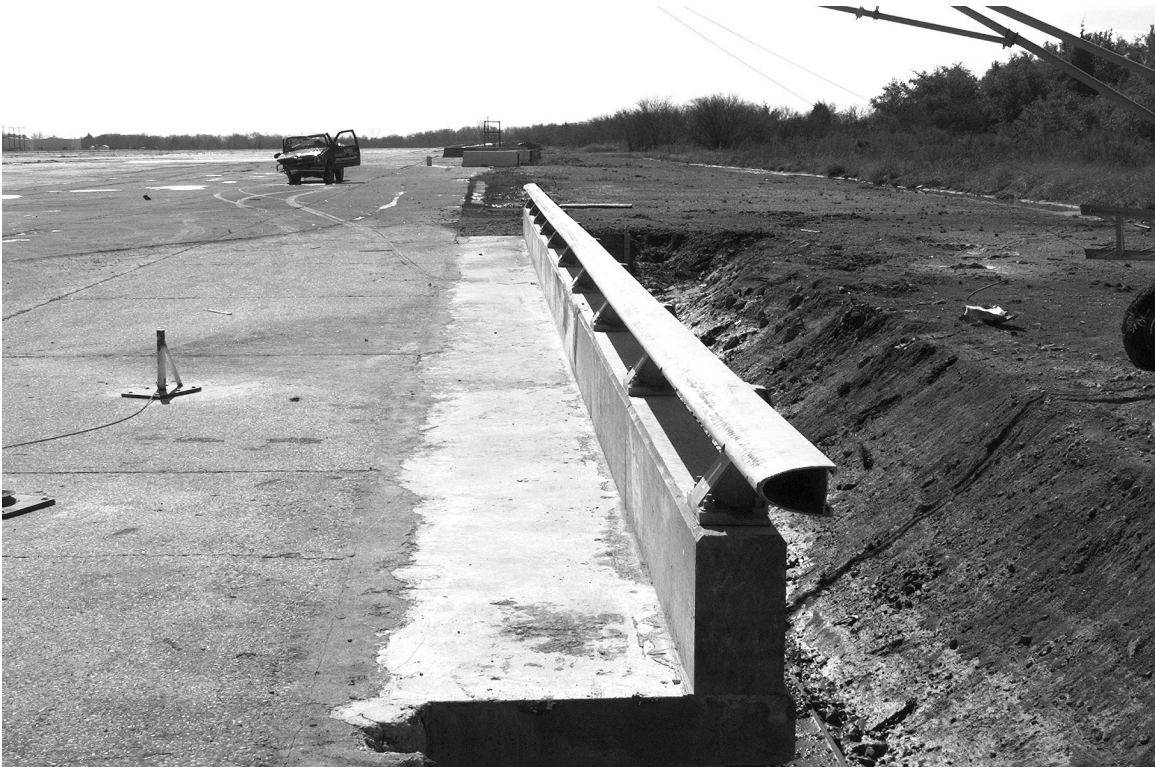
Figure 6. After Impact Trajectory for Test 418049-7.

The vehicle, traveling at 101.4 km/h, impacted the Texas T4(A) bridge rail at a 24.8 degree angle 1.24 m upstream of post 4. Shortly after impact, the right front tire contacted the bridge rail. At 0.013 s, the right front tire steered away from the bridge rail, and at 0.028, the right front tire was traveling parallel with the bridge rail. Redirection began at 0.031 s. The left front tire steered toward the bridge rail at 0.063 s. By 0.078 s, the front windshield shattered, and by 0.093 s, the left front tire lost contact with the ground. The left and right rear tires lost contact with the ground at 0.154 s and 0.157 s, respectively. At 0.236 s, the right rear side of the vehicle contacted the bridge railing. The vehicle was traveling parallel to the installation at 0.237 s at a speed of 75.6 km/h. The vehicle lost contact with the bridge railing at 0.534 s traveling at 71.7 km/h and an exit angle of 11.3 degrees. The left front, right rear, and left rear tires returned to the ground at 0.835 s, 0.865 s, and 0.911 s, respectively. Brakes on the vehicle were applied 1.8 s after impact. The vehicle yawed almost 180 degrees and subsequently came to rest 51.8 m down from impact and 6.1 m toward traffic lanes. Sequential photographs of the test period are shown in Appendix C, Figures 13 and 14.

The vehicle trajectory may intrude into adjacent traffic lanes as it came to rest 6.1 m toward traffic lanes.

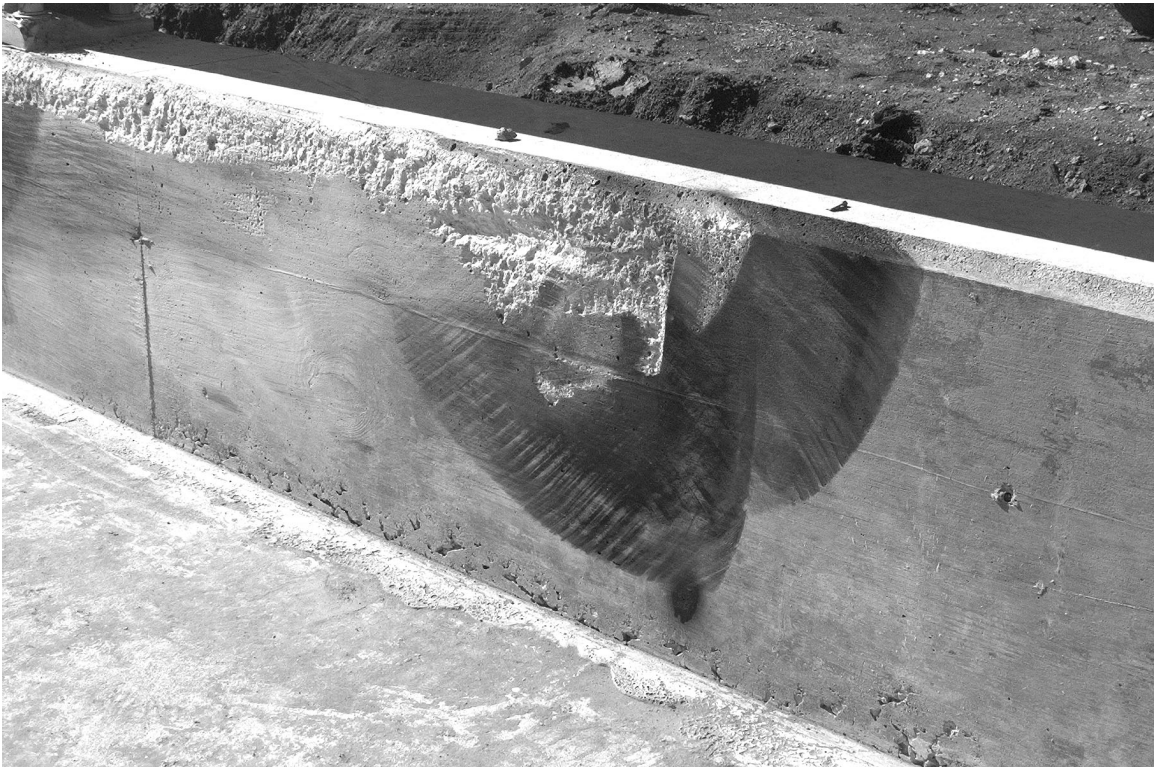
Figure 7. Installation after Test 418049-7.

Damage to the Texas T4(A) bridge rail is shown in Figures 6 through 8. The flange on the impact side of post 4 was marred and chipped as were the base plate and front bolts. Both the top and bottom of the rail element were scarred to a distance of 190 mm from the impact face of the rail. Structural cracks in the concrete portion of the rail occurred 400 mm from the center of post 4. One extended 85 mm down the field side of the concrete parapet and another radiated from the right rear bolt and extended 95 mm down the rear. A section of concrete (200 mm x 390 mm) broke out of the rear of the concrete beam deck under the bolt on the upstream field side and exposed the bolt. Maximum dynamic deflection of the rail during the test was not attainable and maximum permanent deformation of the metal rail element was 5 mm. Total length of contact of the vehicle with the bridge rail was 4.3 m.

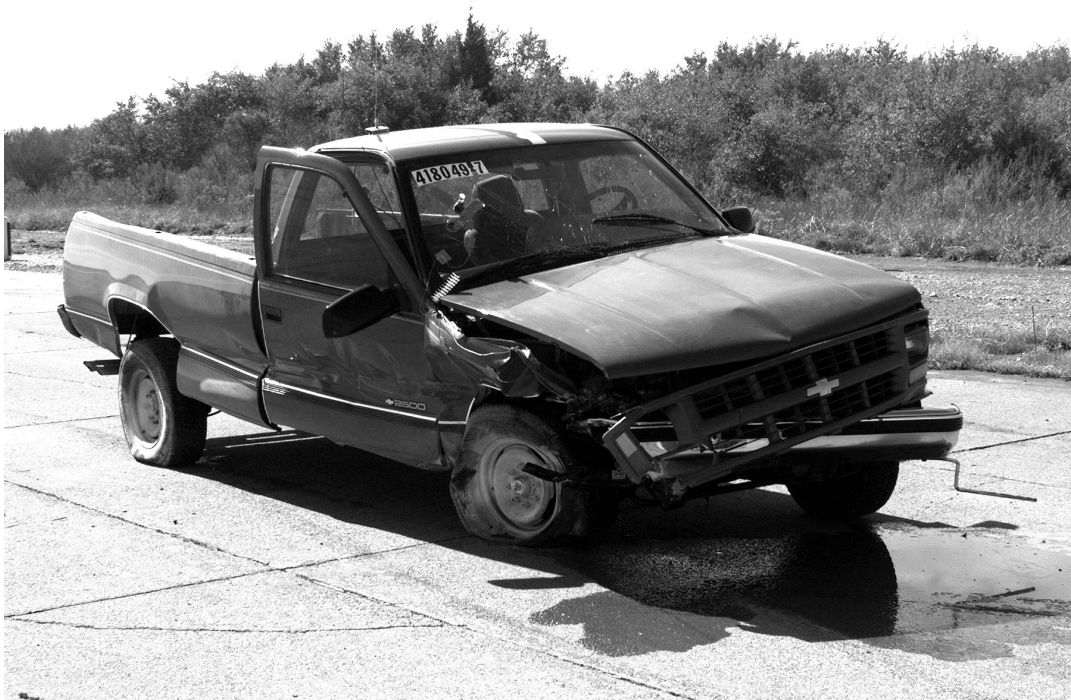
Figure 9. Vehicle after Test 418049-7.

The vehicle sustained extensive damage to the front and right side as shown in Figure 9. Structural damage occurred to the stabilizer bar, right tie rods, right upper and lower A-arms, right front frame, and front cross member. The right A-pillar was deformed and the windshield was shattered. Also damaged were the front bumper, hood, grill, fan, radiator, right front quarter panel, right door, and right front and rear tires and rims. Maximum crush to the exterior of the vehicle was 600 mm at the front right corner near bumper height. Maximum occupant compartment deformation was 158 mm (49.7 percent reduction of space) in the right floor pan to instrument panel location and 130 mm (7.2 percent reduction of space) in the right side floor pan to roof area. The interior of the vehicle is shown in Figure 10. Exterior vehicle crush and occupant compartment deformation is shown in Appendix B, Tables 2 and 3.

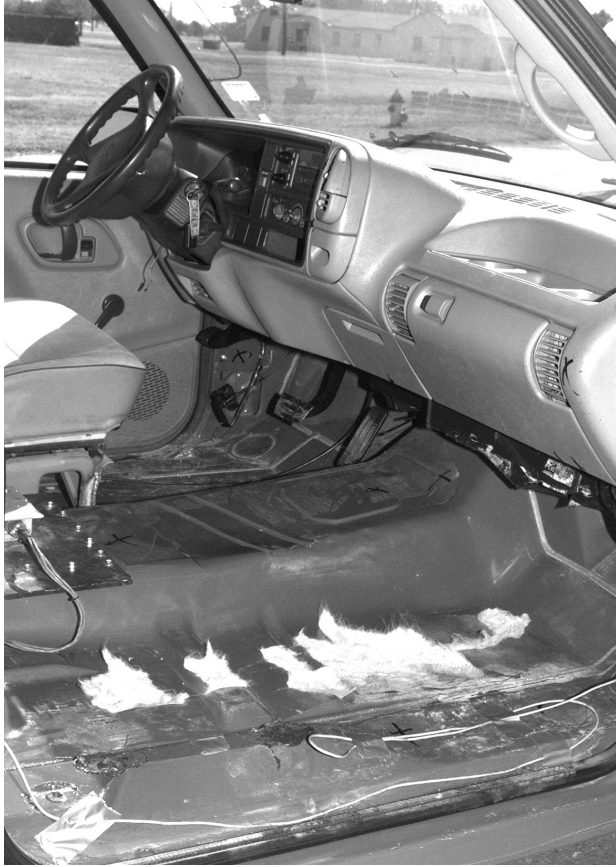
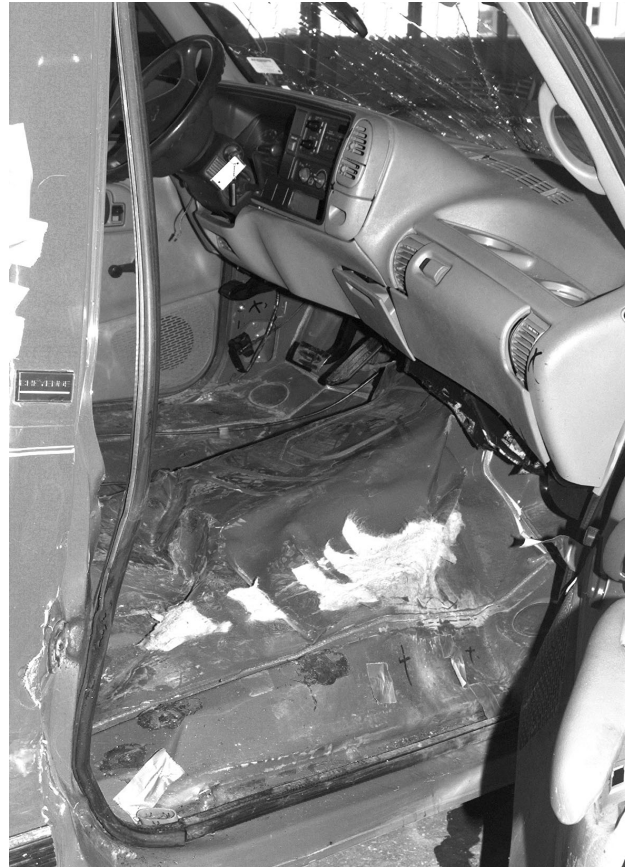
Figure 10. Interior of Vehicle for Test 418049-7.

Before test

After test

No detached elements, fragments, or other debris were present to penetrate the occupant compartment, or to show potential for penetrating the occupant compartment, nor to present undue hazard to others in the area. Maximum occupant compartment deformation was 158 mm (49.7 percent reduction of space) in the right floor pan to instrument panel location and 130 mm (7.2 percent reduction of space) in the right side floor pan to roof area. This deformation was considered marginal as to whether or not serious injury would be incurred by the occupants.
