**NCHRP REPORT 350 TEST 4-11 OF THE
TACOMA NARROWS BRIDGE RAIL**

Contract No. P2002314 (Subcontract C2002314)
Project No. 400001-TNB1

July 2003

**TEXAS TRANSPORTATION INSTITUTE
THE TEXAS A&M UNIVERSITY SYSTEM
COLLEGE STATION, TEXAS 77843**

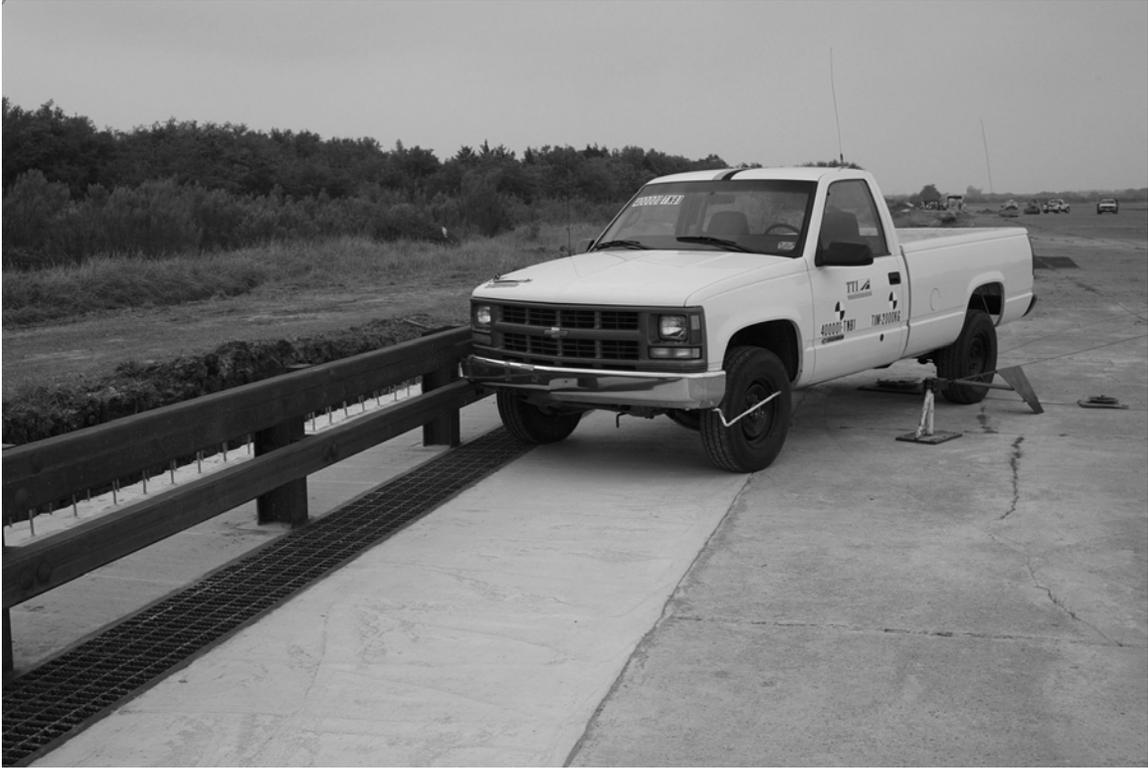
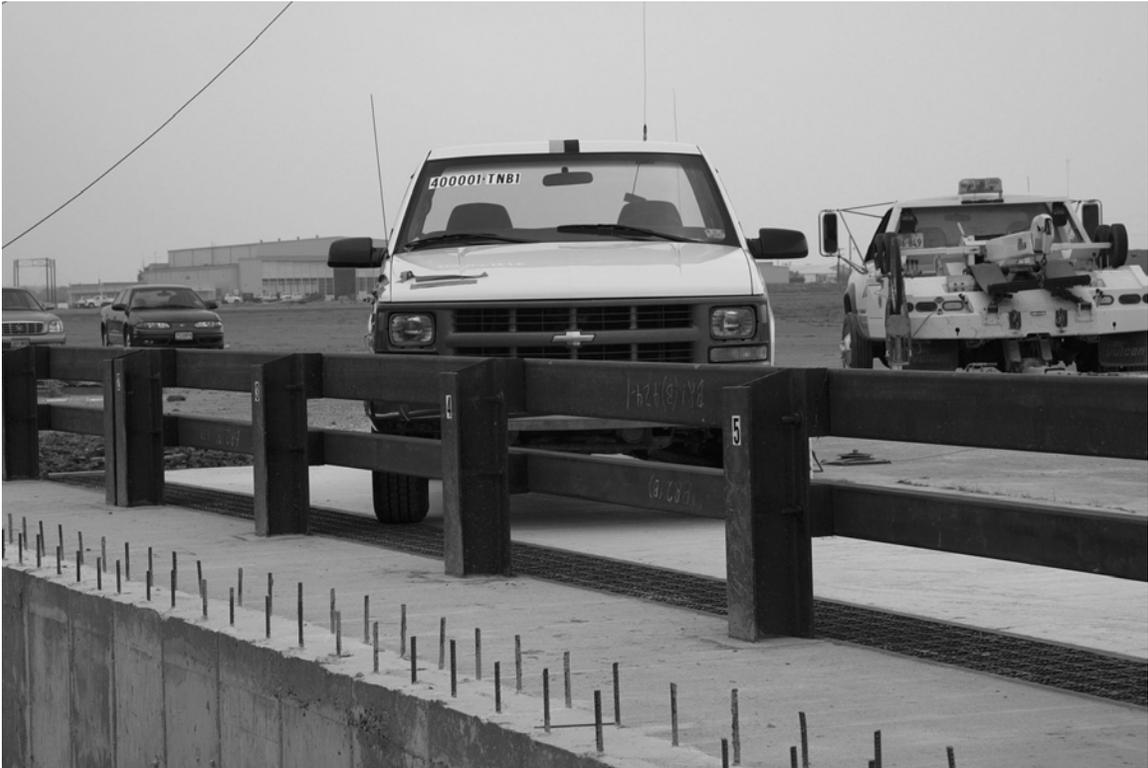
Figure 3. Vehicle/installation geometrics for test 400001-TNB1.

A 1999 Chevrolet Cheyenne 2500 pickup truck, shown in figures 3 and 4, was used for the crash test. Test inertia weight of the vehicle was 2067 kg, and its gross static weight was 2067 kg. The height to the lower edge of the vehicle front bumper was 415 mm, and the height to the upper edge of the front bumper was 635 mm. Additional dimensions and information on the vehicle are given in appendix B, figure 10. The vehicle was directed into the installation using the cable reverse tow and guidance system, and was released to be free-wheeling and unrestrained just prior to impact.

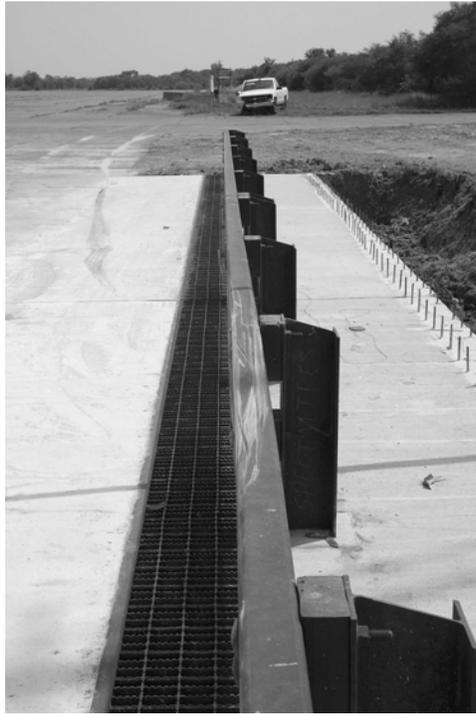
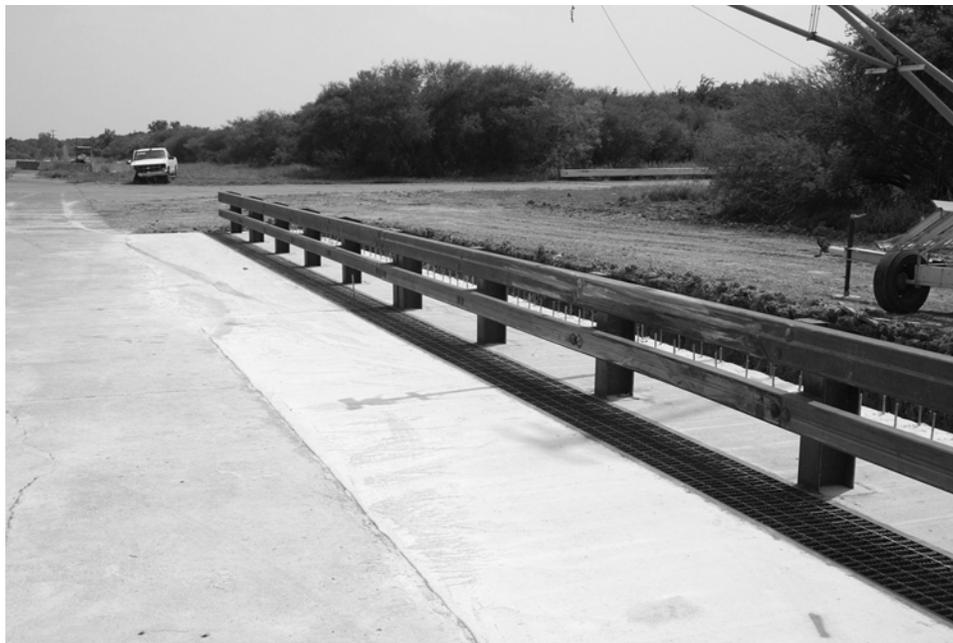
Figure 5. Vehicle trajectory after test 400001-TNB1.

Damage to the bridge rail was minor, as shown in figures 5 and 6. There were tire marks and scrapes along the face of the tubular rail elements from the point of impact (2.0 m upstream of post 4) for a distance of the length of contact of the vehicle with the rail elements of 3.88 m. No residual measurable movement was noted in the posts or the rail elements after the test.

Results: The pickup came to rest 10.3 m downstream of impact and 0.8 m forward of the traffic face of the bridge rail.

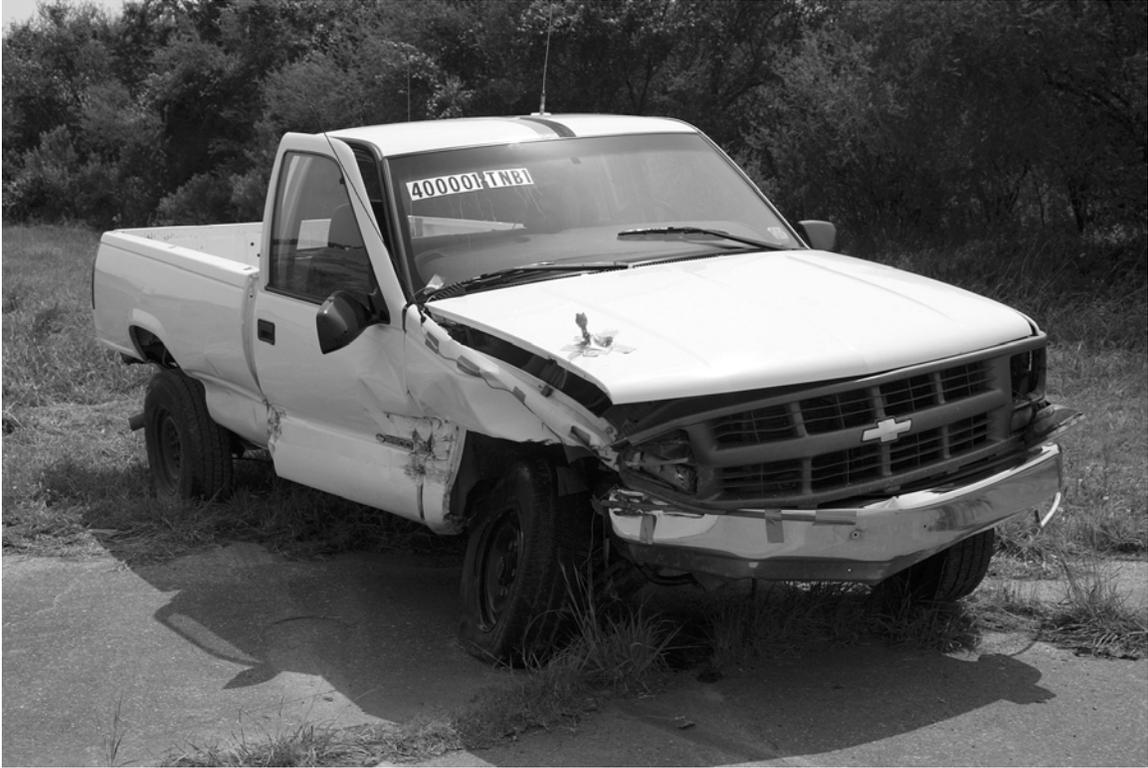
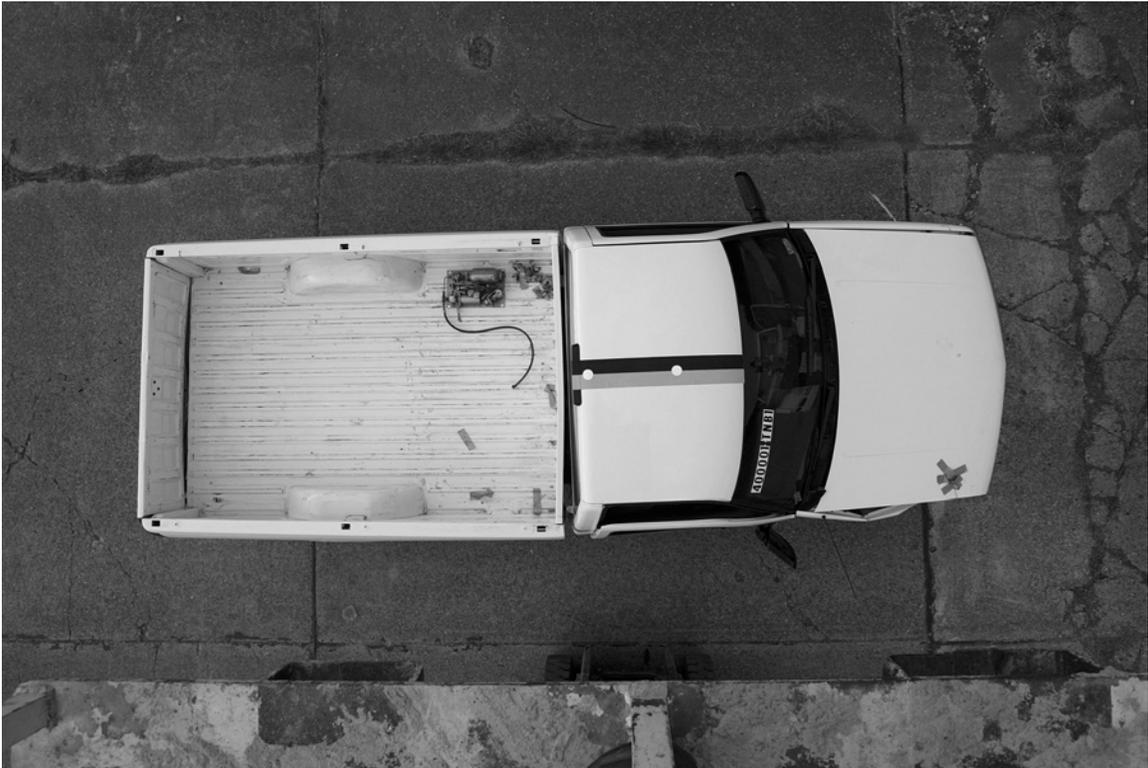
Figure 7. Vehicle after test 400001-TNB1.

Damage to the pickup is shown in figure 7. Structural damage was imparted to the right upper and lower A-arm, right front frame rail, and the floor pan. Also damaged were the front bumper, grill, hood, radiator, right front quarter panel, right door, right rear exterior bed, and rear bumper. The right front and right rear wheel rims were deformed and both tires were deflated. Maximum exterior crush to the pickup was 560 mm in the frontal plane at the right front corner at bumper height. Maximum occupant compartment deformation was 84 mm in the right side kickpanel area. Photographs of the interior of the pickup are shown in figure 8. Exterior vehicle crush and occupant compartment measurements are shown in appendix B, tables 2 and 3.

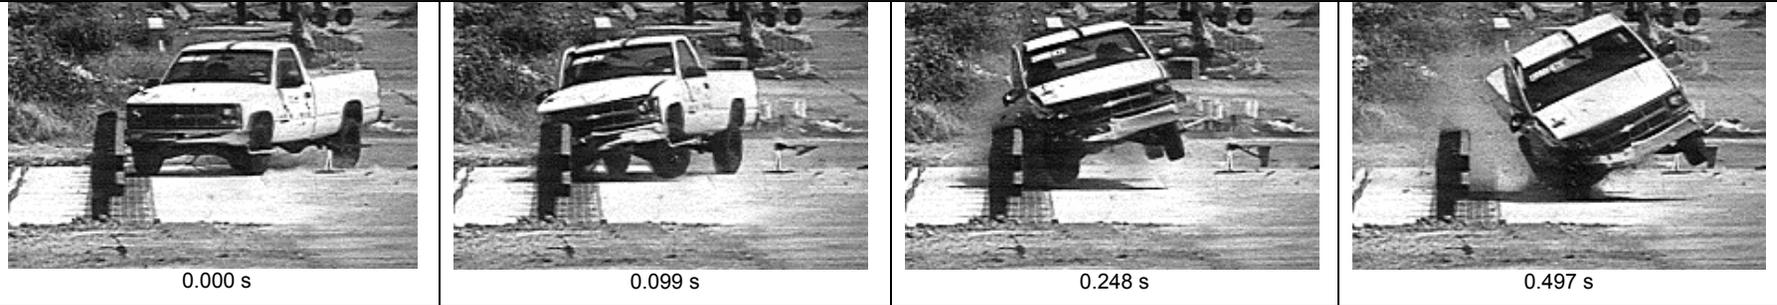
Figure 9. Summary of results for test 400001-TNB1, NCHRP Report 350 test 4-11.

Type Retrofit Bridge Rail
 Name Tacoma Narrows Bridge Rail
 Installation Length (m) 24.4
 Material or Key Elements TS200x100x8 & TS150x100x6 Rails on W200x36 Posts

Speed (km/h)..... 98.5
 Angle (deg)..... 24.4

Speed (km/h)..... 80.4
 Angle (deg)..... 5.6

Impact Velocity (m/s)
 x-direction 5.4
 y-direction 7.5
 THIV (km/h)..... 32.6
 Ridedown Accelerations (g's)
 x-direction -7.8
 y-direction -10.7
 PHD (g's)..... 10.9
 ASI 1.57
 Max. 0.050-s Average (g's)
 x-direction -9.3
 y-direction -12.0
 z-direction -5.6

Dynamic..... N/A
 Permanent 0.045
 Working Width 0.50

Exterior
 VDS 01LFQ5
 CDC 11FYEW3
 Maximum Exterior
 Vehicle Crush (mm)..... 560
 Interior
 OCDI FS0112000
 Max. Occ. Compartment
 Deformation (mm)..... 84

(during 2.7 s after impact)
 Max. Yaw Angle (deg) 49.4
 Max. Pitch Angle (deg) -6.9
 Max. Roll Angle (deg) 24.7

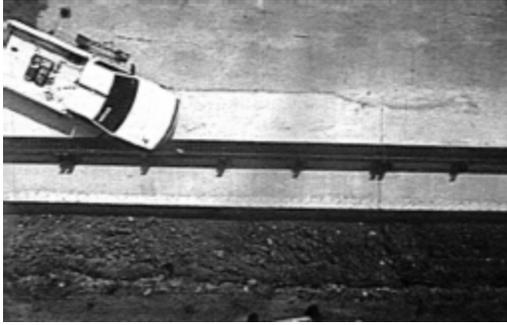
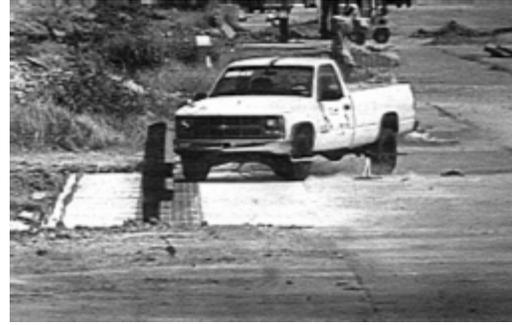
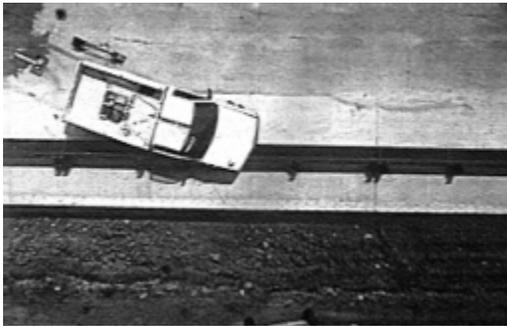
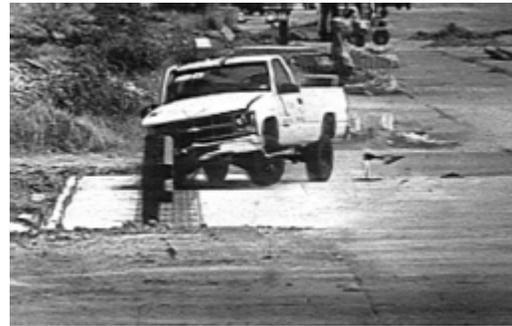
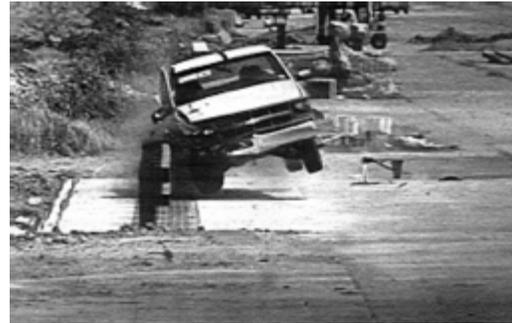
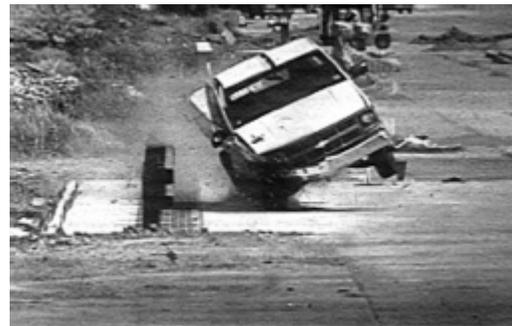
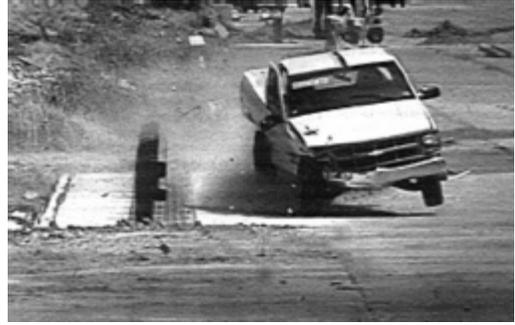
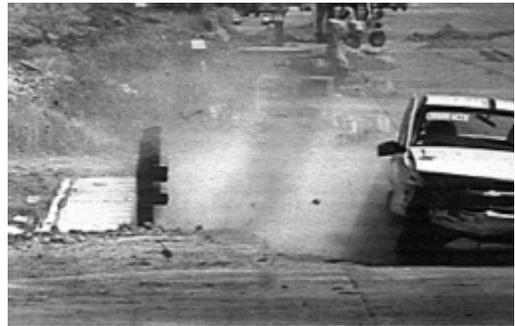
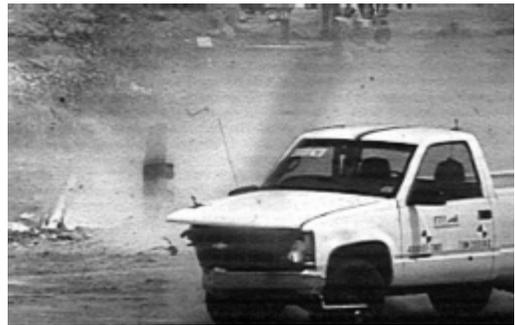
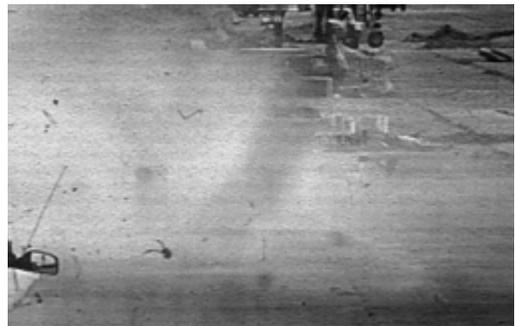
Figure 11. Sequential photographs for test 400001-TNB1 (overhead and frontal views).

The pickup truck, traveling at a speed of 98.5 km/h, impacted the Tacoma Narrows Bridge Rail 2.0 m upstream of post 4, at an impact angle of 24.4 degrees. At 0.017 s after impact, post 3 deflected slightly toward the field side, and at 0.032 s, post 4 deflected slightly to the field side. The pickup began to redirect at 0.040 s, and the left front wheel steered toward the bridge rail at 0.062 s. The rear of the pickup contacted the bridge rail at 0.181 s. At 0.184 s, the pickup was traveling parallel with the bridge rail at a speed of 82.5 km/h. At 0.299 s, the pickup lost contact with the bridge rail and was traveling at a speed of 80.4 km/h and an exit angle of 5.6 degrees. Brakes on the pickup were applied 1.5 s after impact. The pickup subsequently yawed clockwise and came to rest facing the installation 61.8 m downstream of the point of impact and 0.8 m forward of the face of the bridge rail. Sequential photographs of the test period are shown in appendix C, figures 11 and 12.
