1. Report No. FHWA/TX-03/4288-1		2. Government Accession No.		3. Recipient's Catalog No.	
4. Title and Subtitle DESIGN AND EVALUATION OF THE TXDOT F411 AND T77 AESTHETIC BRIDGE RAILS				5. Report Date October 2002

**DESIGN AND EVALUATION OF THE TxDOT
F411 AND T77 AESTHETIC BRIDGE RAILS**

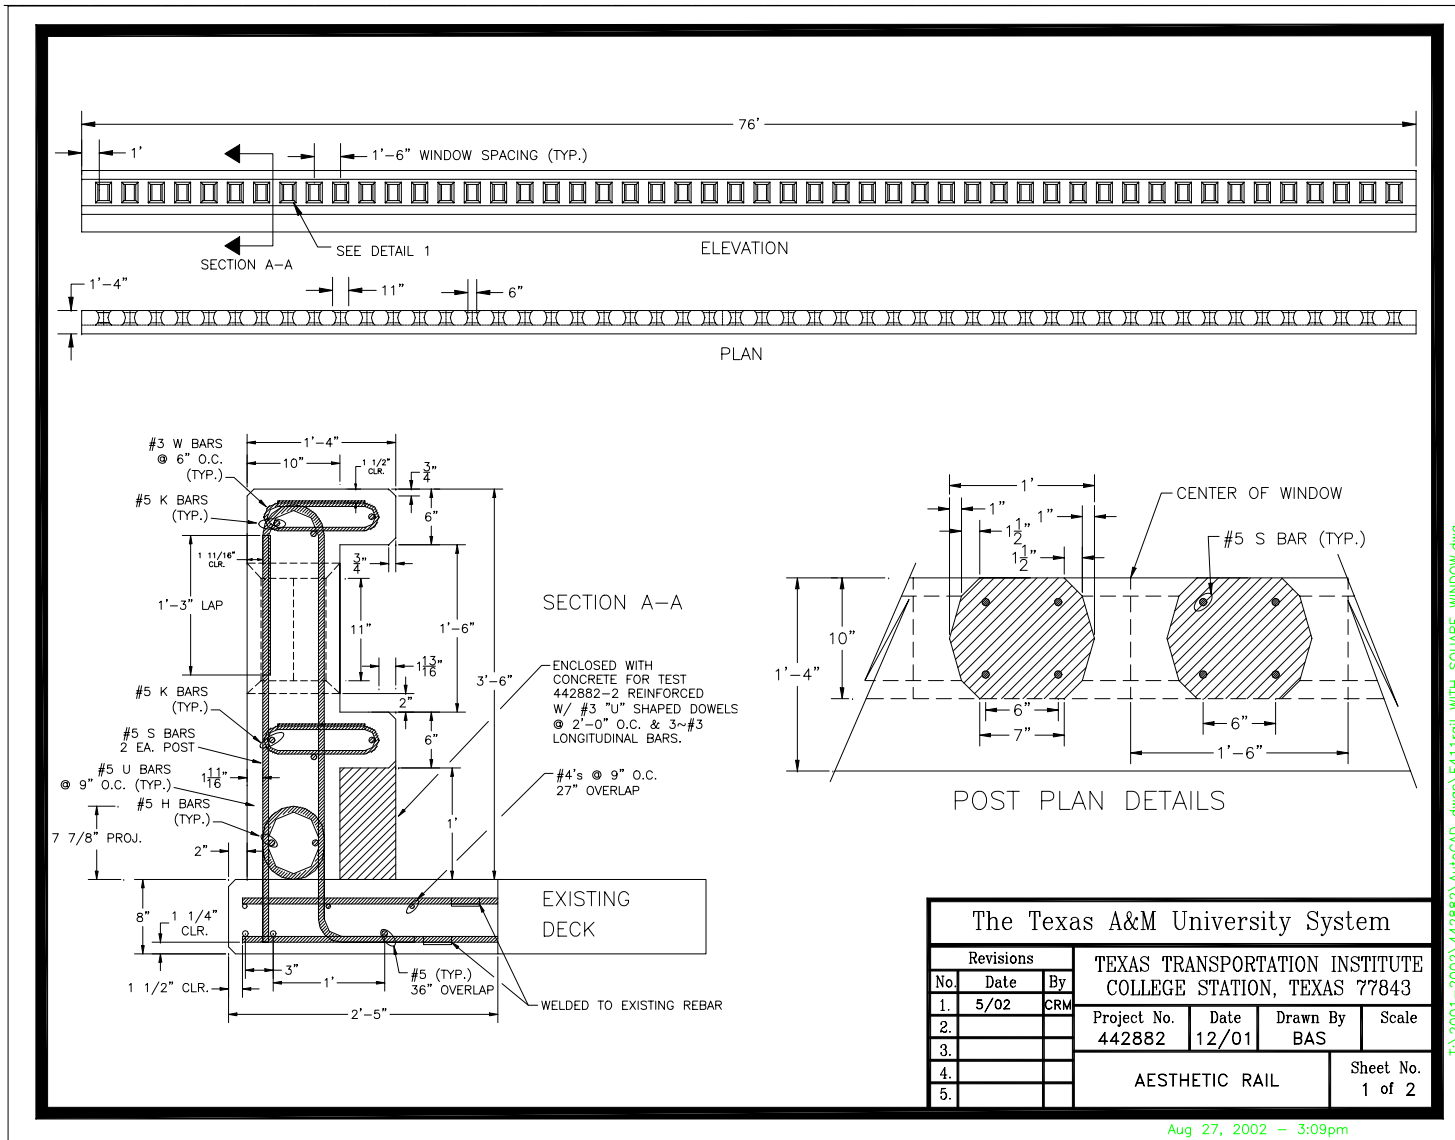
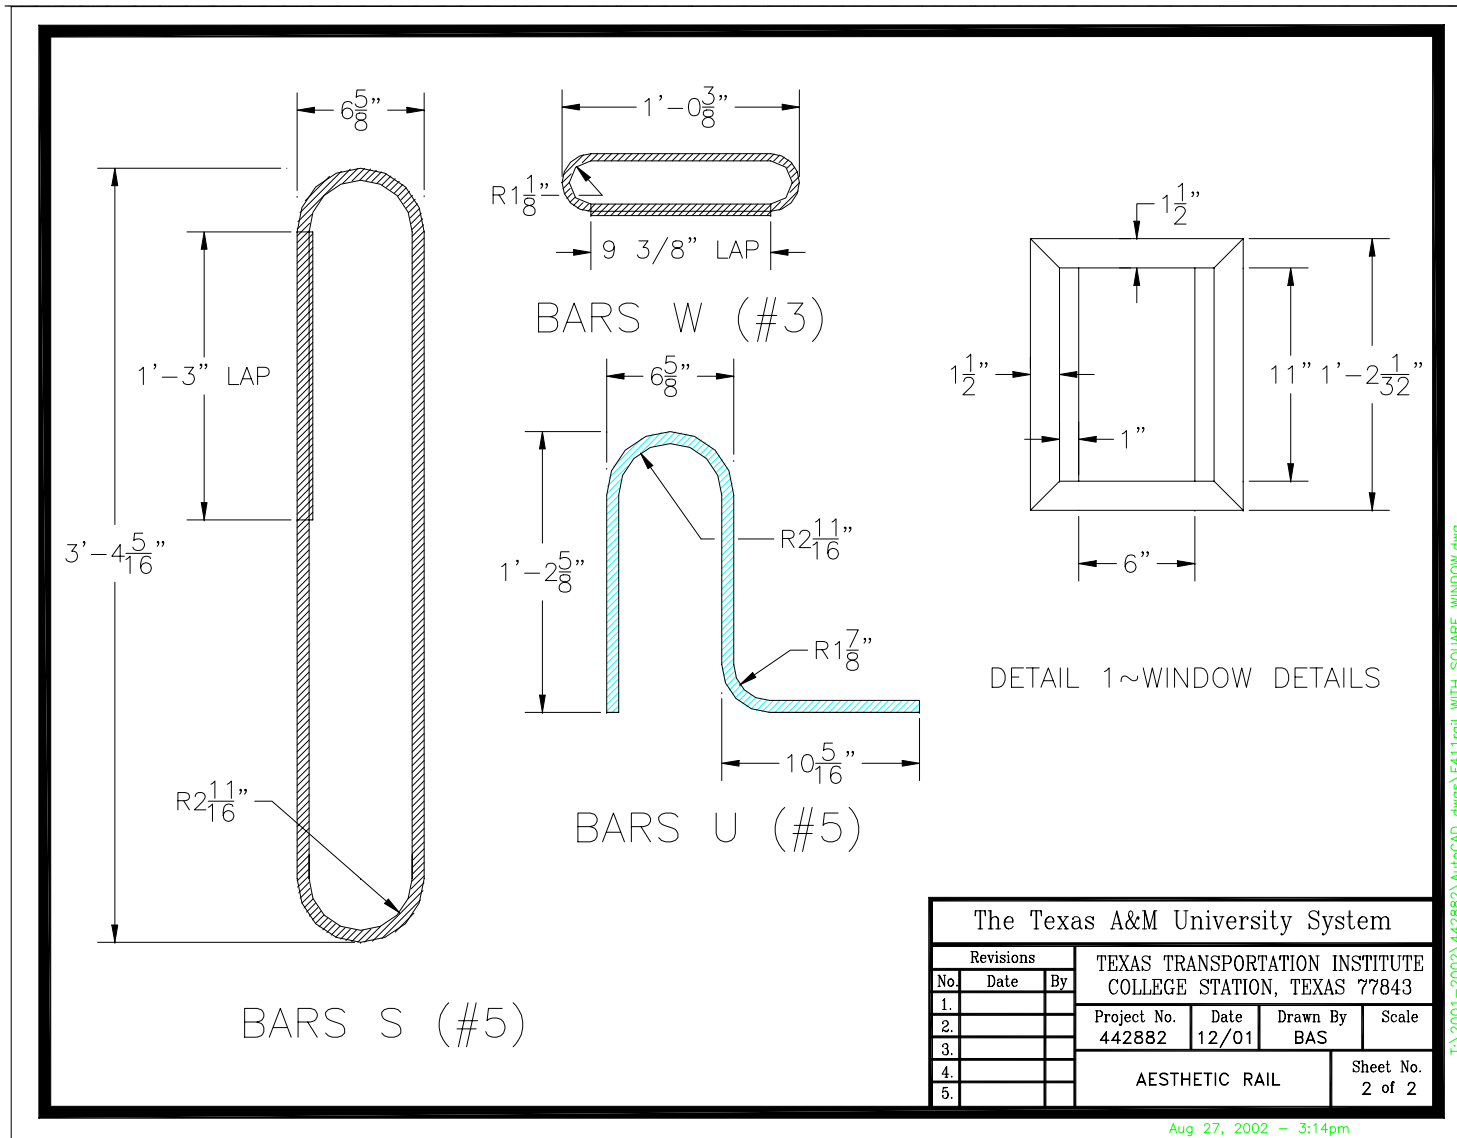
Figure 1. Details of the TxDOT F411 Bridge Rail.

Figure 1. Details of the TxDOT F411 Bridge Rail (Continued).

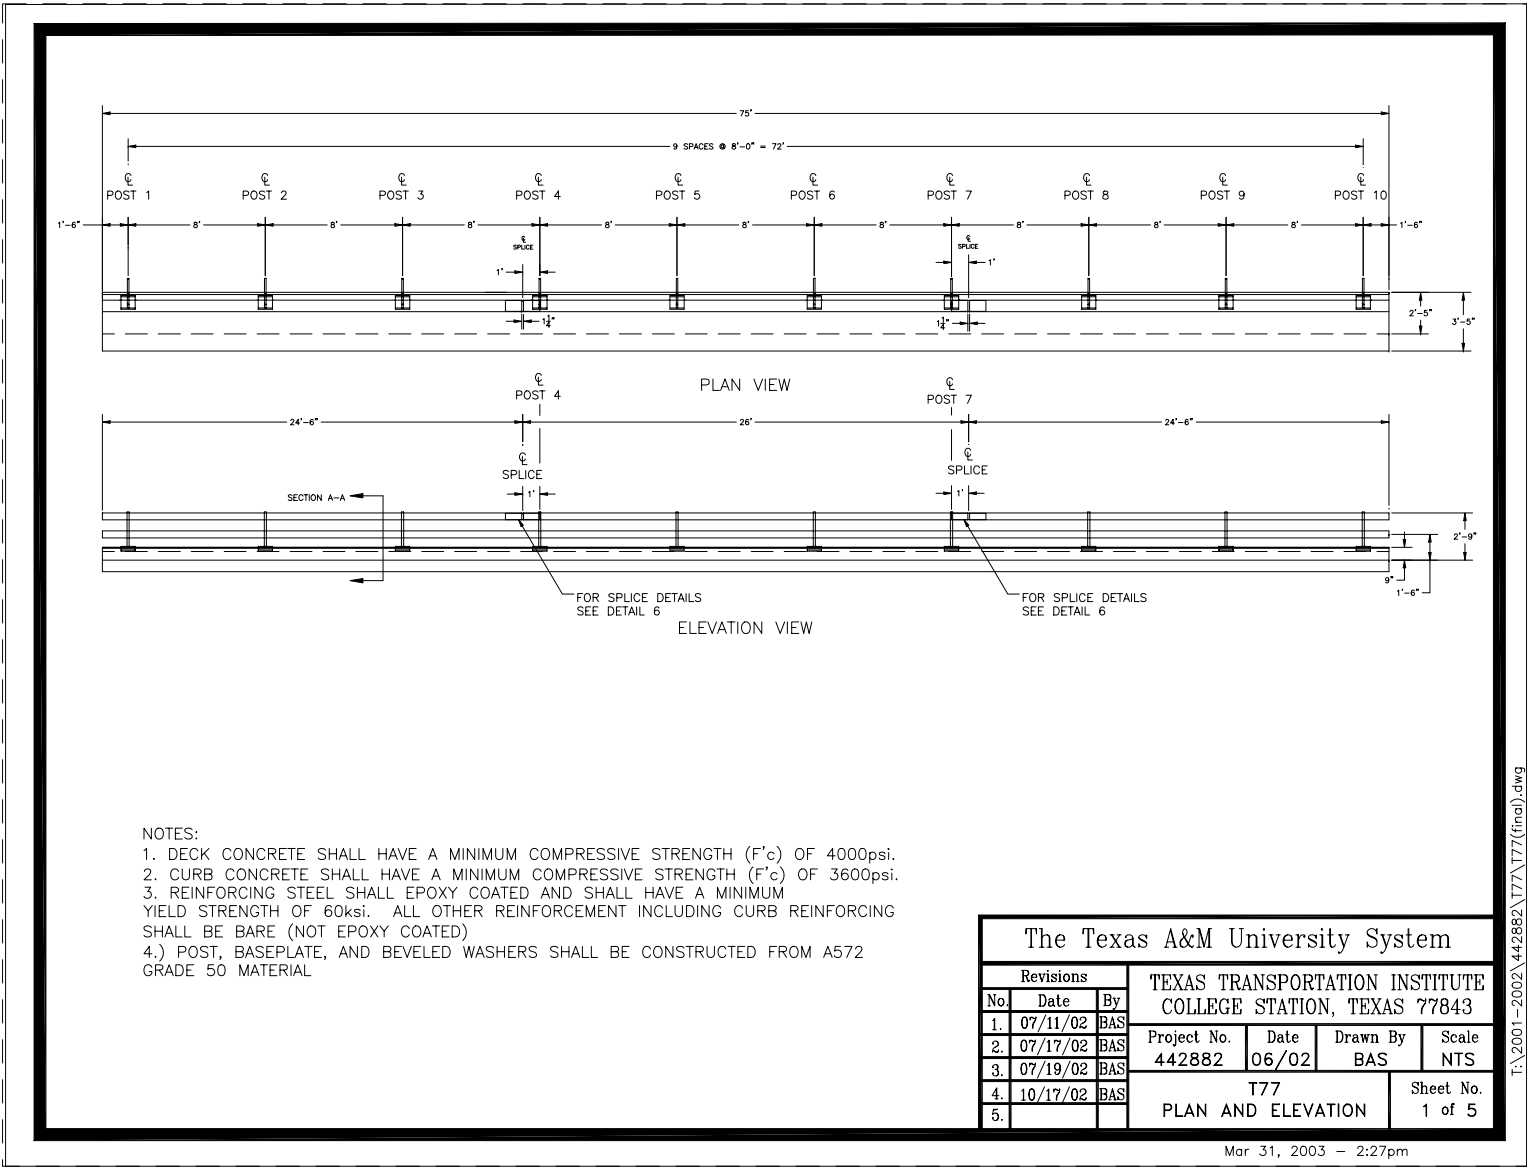
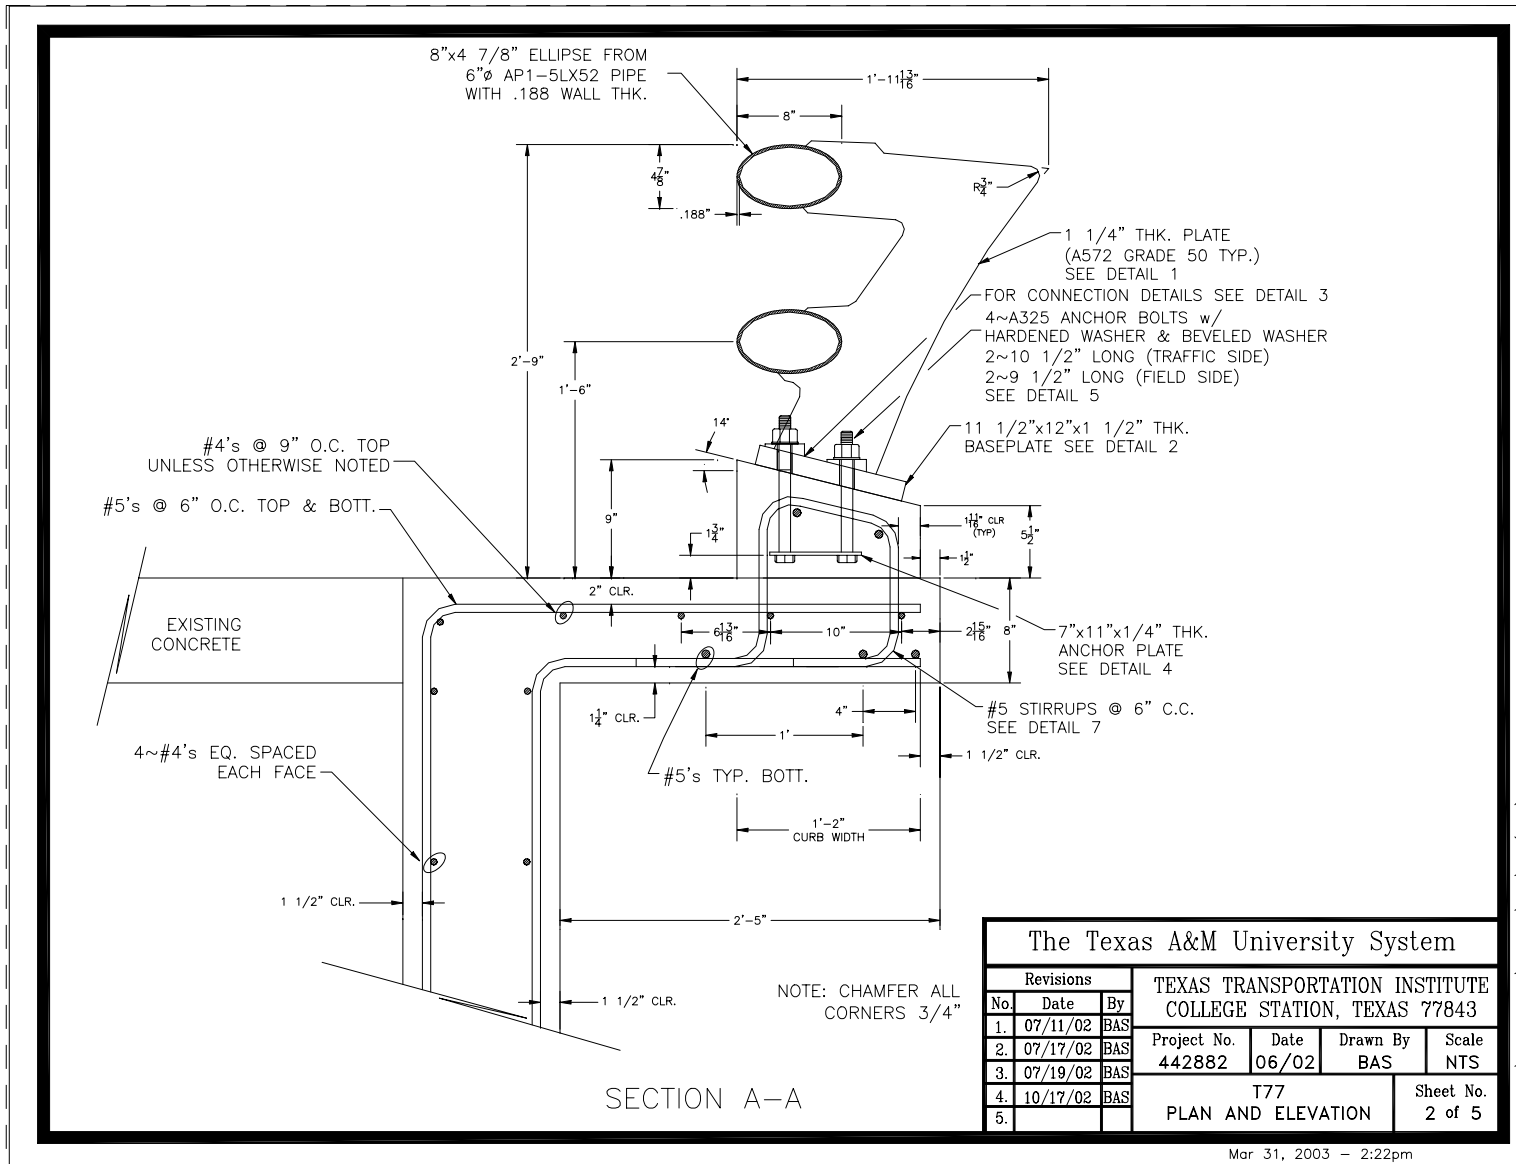
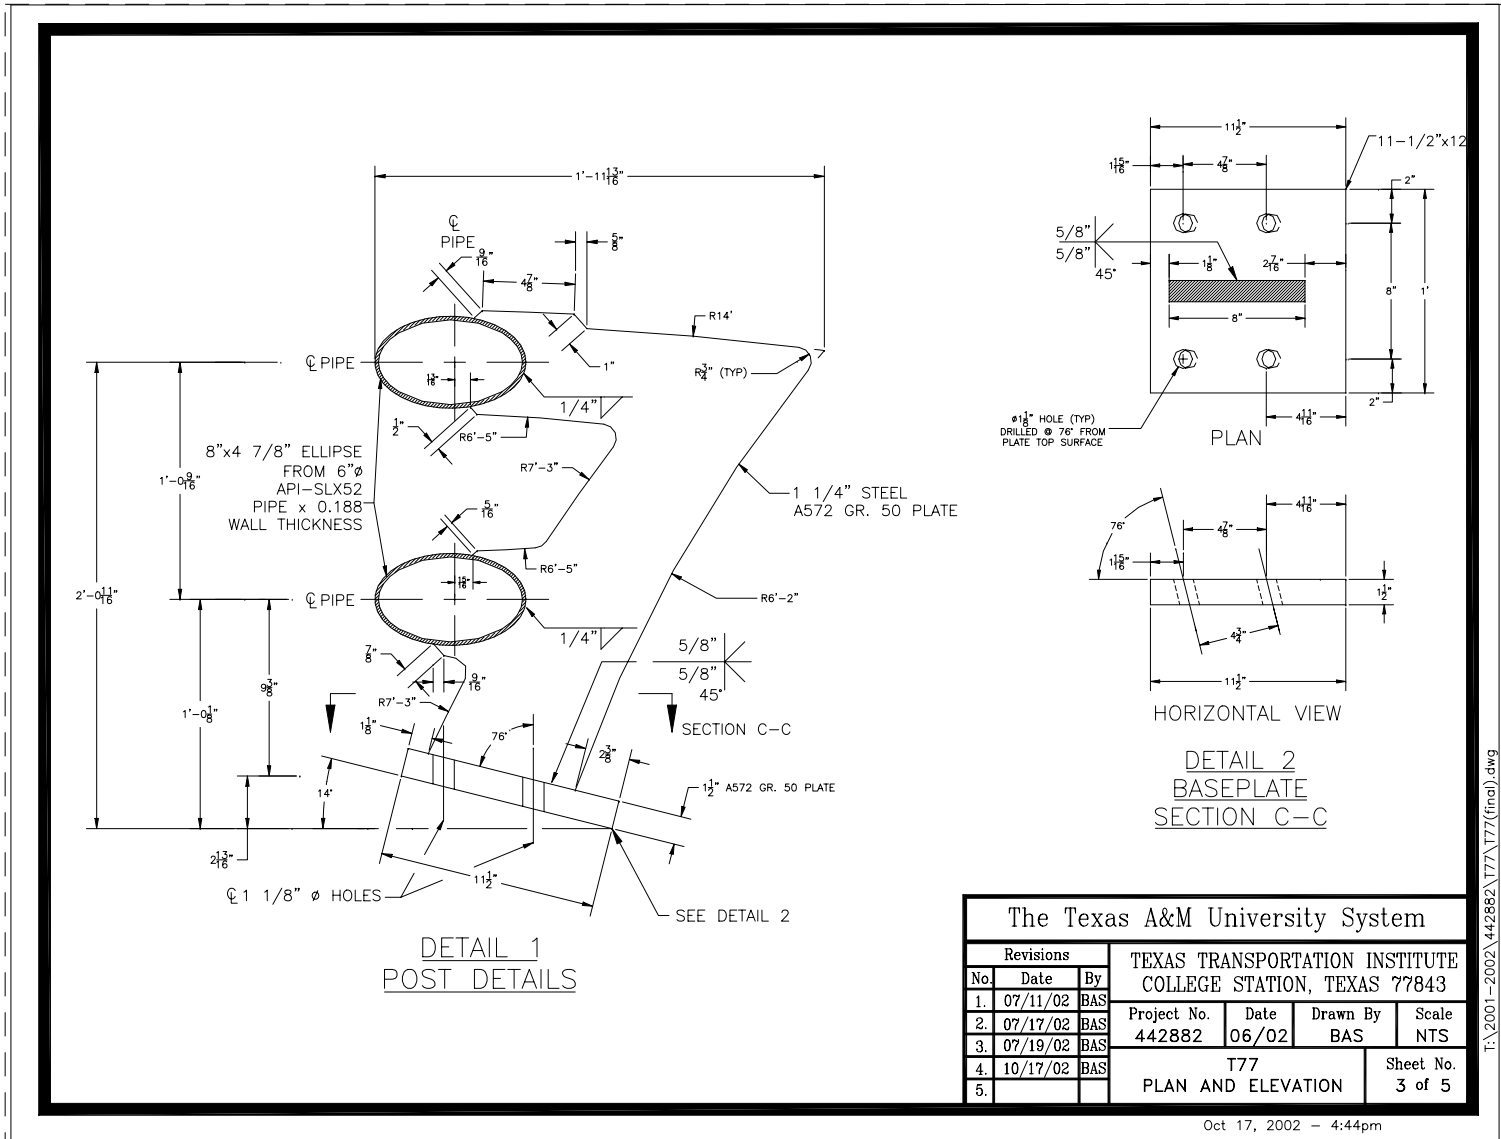
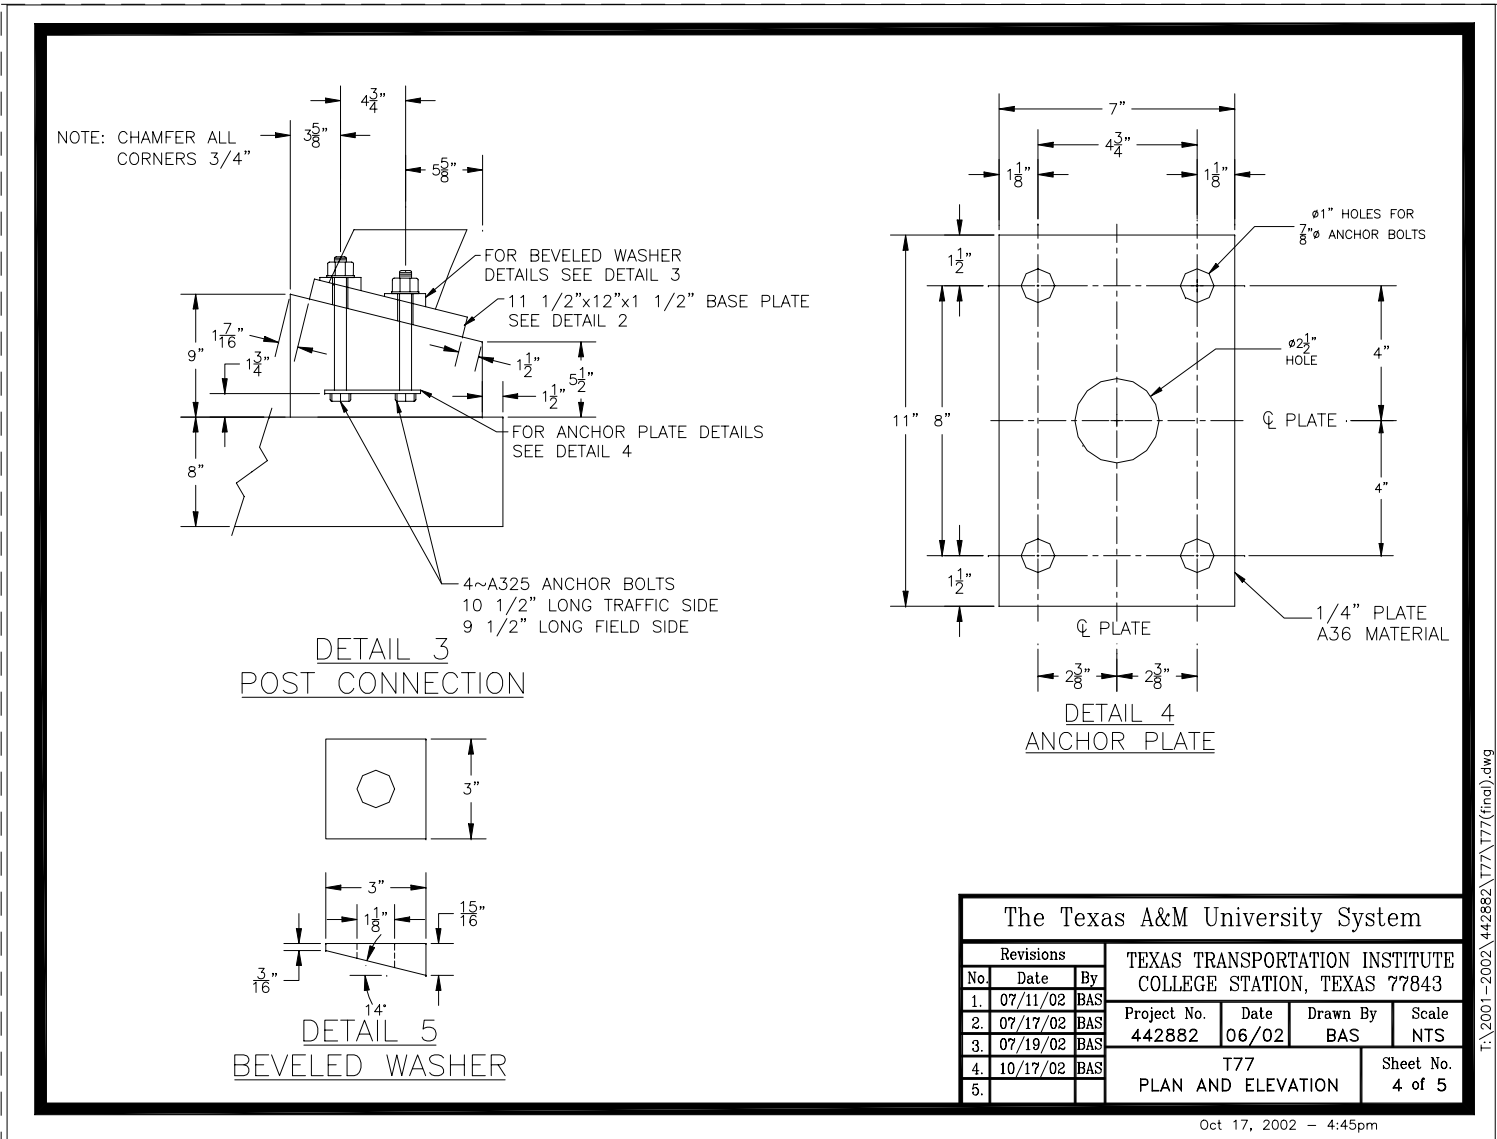
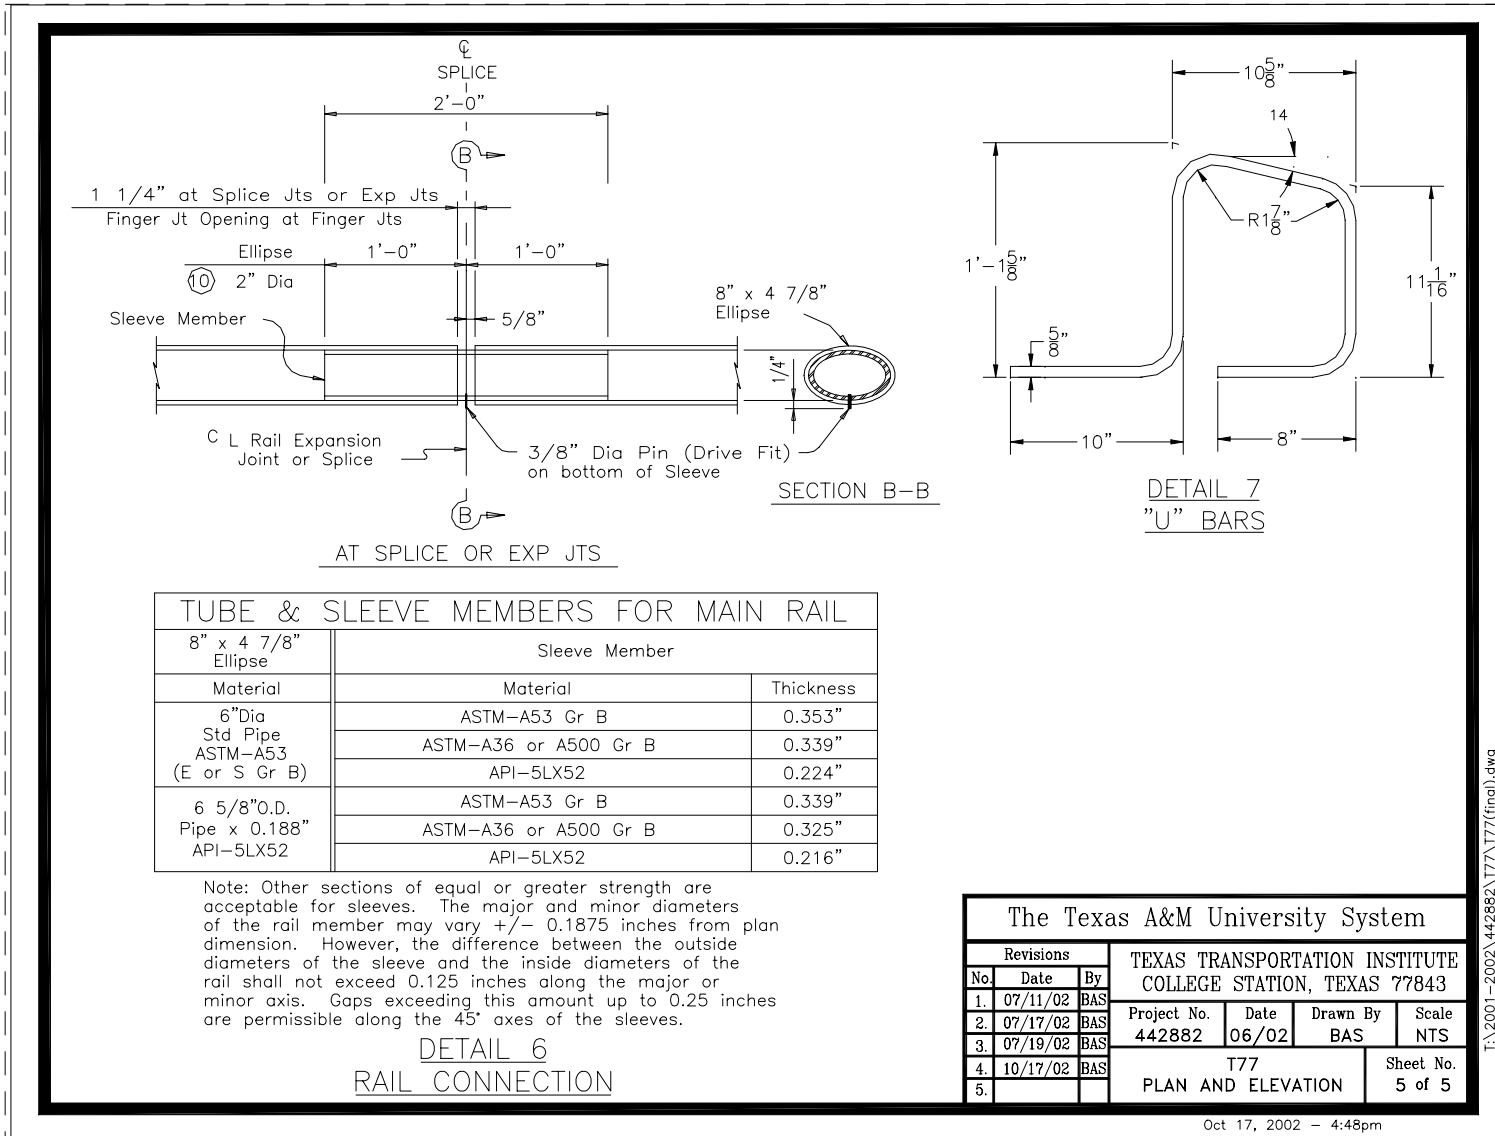
The Texas A&M University System			
TEXAS TRANSPORTATION INSTITUTE COLLEGE STATION, TEXAS 77843			
Project No.		Date	Drawn By
442882		06/02	BAS
Scale		NTS	
T77 PLAN AND ELEVATION			Sheet No. 2 of 5

Figure 4. Details of the TxDOT T77 Bridge Rail.

Figure 4. Details of the TxDOT T77 Bridge Rail (Continued).

TTI designed, constructed, and crash tested a prototype steel aesthetic bridge rail designated as TxDOT Type T77. [Appendix B](#) presents design calculations for the bridge rail. The total length of the railing installation was 75 ft (22.7 m). The T77 bridge railing system is a steel rail and post system consisting of two tubular steel rail elements mounted on 1-1/4 inch (32 mm) thick steel plate posts spaced 8 ft (2.4 m) apart. The elliptical-shaped rails were 8 inch × 4-7/8 inch (203 mm × 124 mm) and were manufactured from 6 inch (152 mm) diameter, API-5LX52 pipe with a wall thickness of 0.188 inch (20 mm). The center of the lower rail and the top of the upper rail measured 1 ft-6-inches (0.45 m) and 2 ft-9 inches (0.8 m), respectively, from

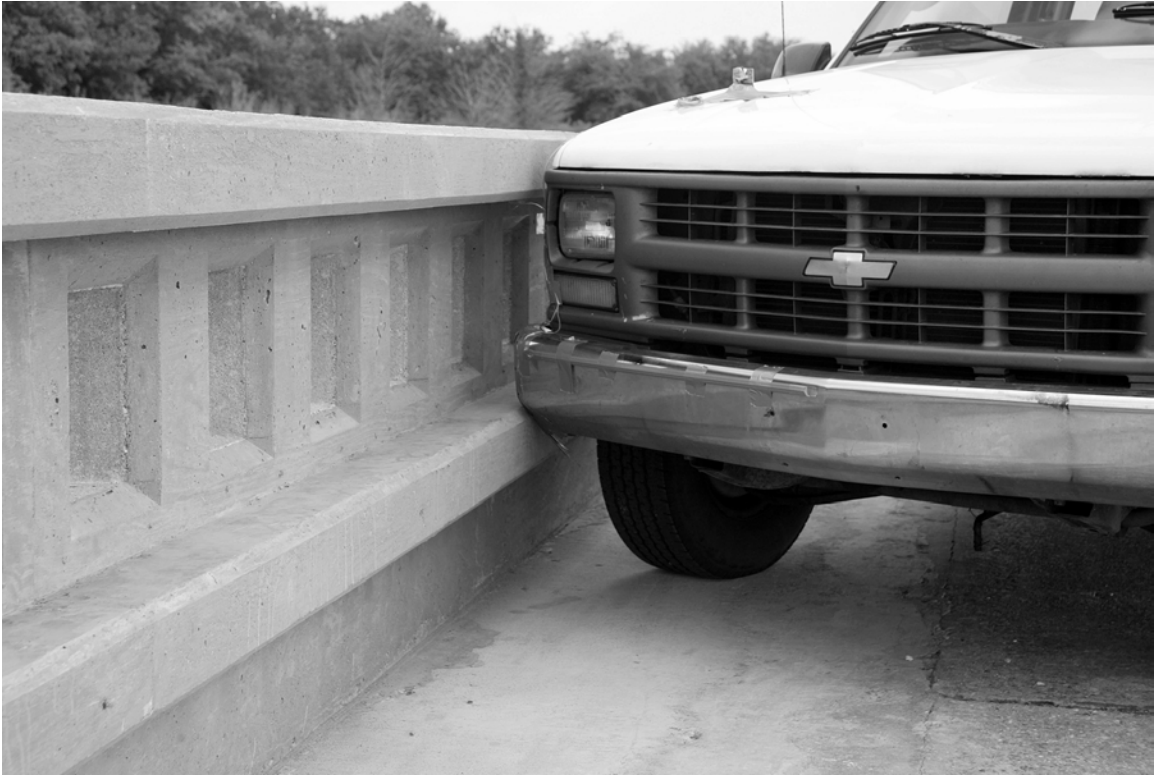
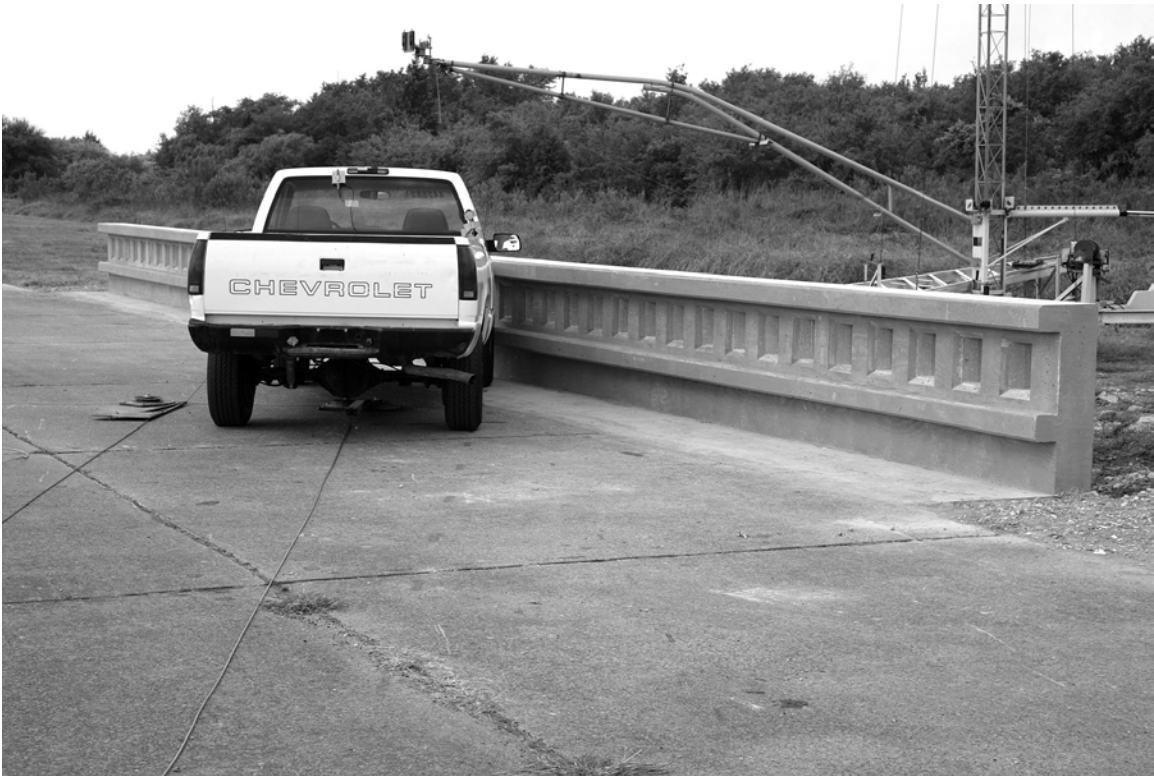
Figure 6. Vehicle/Bridge Rail Geometrics for Test 442882-1.

The vehicle, traveling at a speed of 61.4 mi/h (98.8 km/h), impacted the TxDOT F411 at an impact angle of 24.8 degrees at 5.1 inches (130 mm) upstream of opening 17. Shortly after impact, the vehicle hood deformed and at 0.018 s after impact, the vehicle began to redirect. The door on the passenger side separated slightly from the cab at 0.031 s and at 0.108 s, the left front tire became airborne. At 0.233 s, the vehicle became parallel with the bridge rail and was traveling at a speed of 42.1 mi/h (67.7 km/h). The left front tire returned to the ground at 0.304 s. At 0.386 s, the vehicle lost contact with the bridge rail and was traveling at a speed of 36.0 mi/h (57.9 km/h) and an exit angle of 7.3 degrees. Brakes on the vehicle were applied at 1.45 s after impact, and the vehicle subsequently came to rest 157.5 ft (48.0 m) downstream of impact and 7.5 ft (2.3 m) behind the traffic face of the rail. Sequential photographs of the test period are shown in Appendix E, Figures 38 and 39.

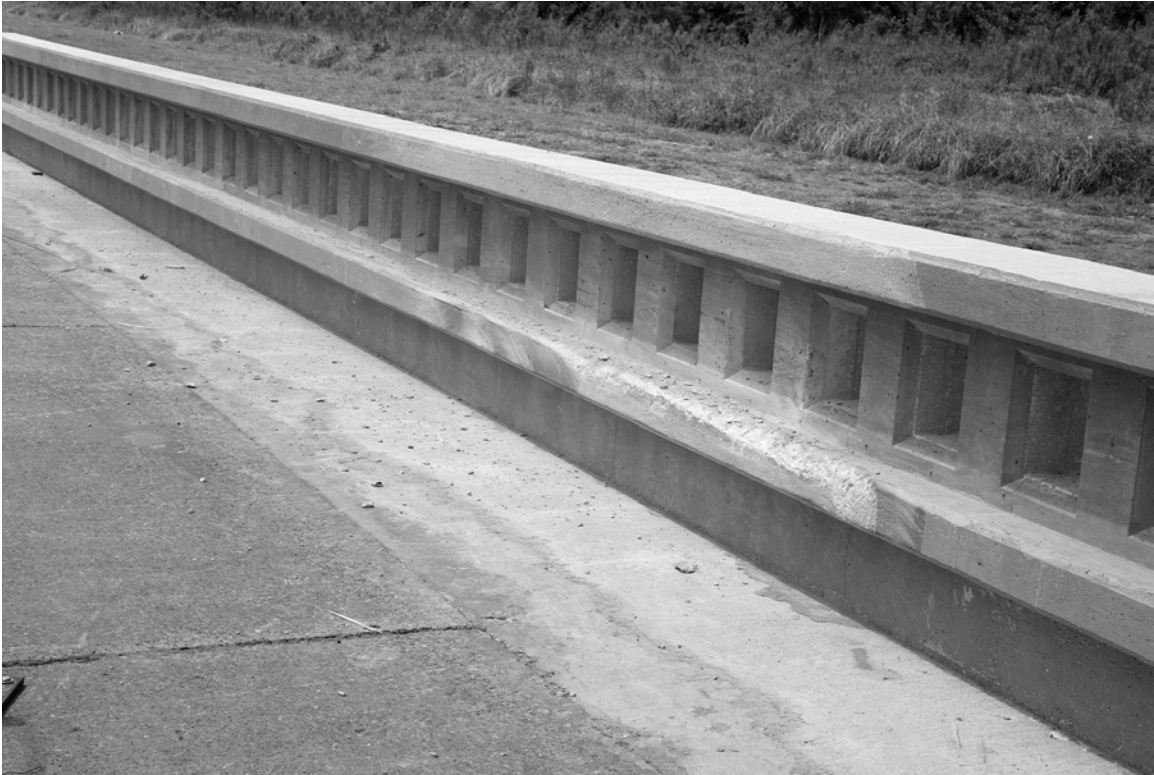
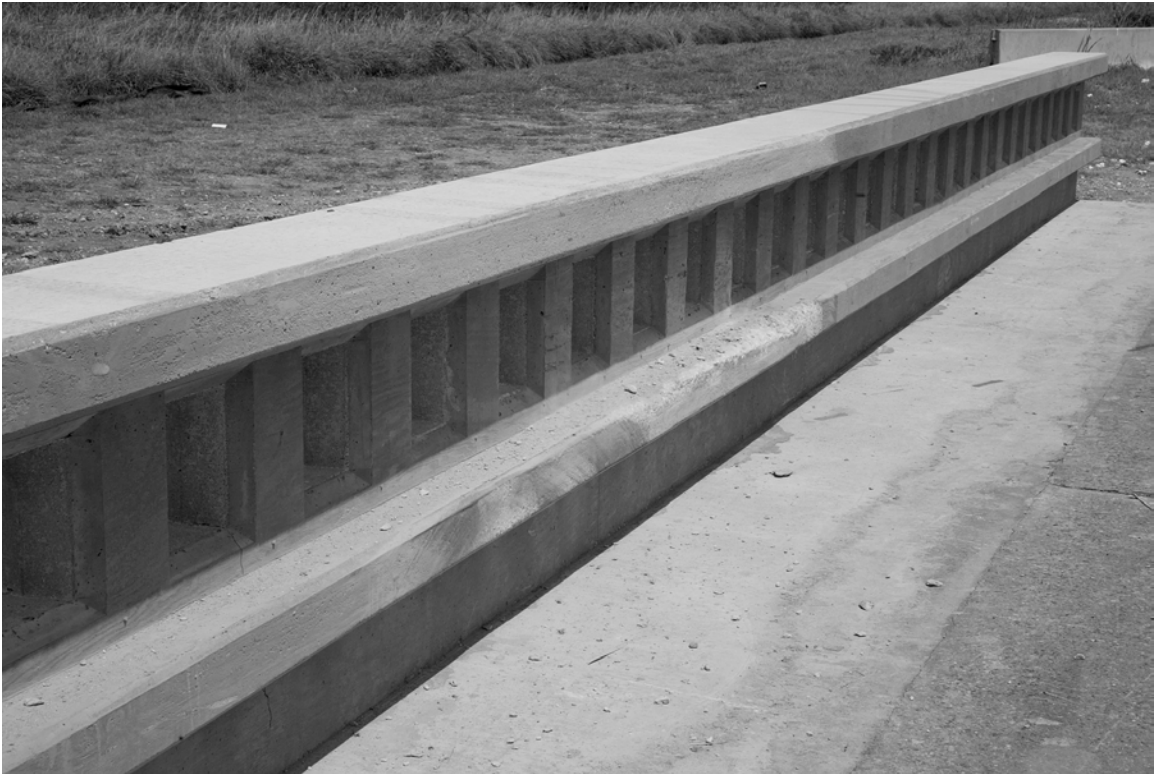
Figure 9. Installation after Test 442882-1.

The TxDOT F411 bridge rail sustained minimal cosmetic damage as shown in Figures 8 and 9. There were tire marks and scrapes along the face of the bridge rail for a distance of 11.4 ft (3.5 m). No cracks were noted in the beam rail, window frames, or deck. No measurable deformation occurred, and the working width was 1.4 ft. (0.4 m).

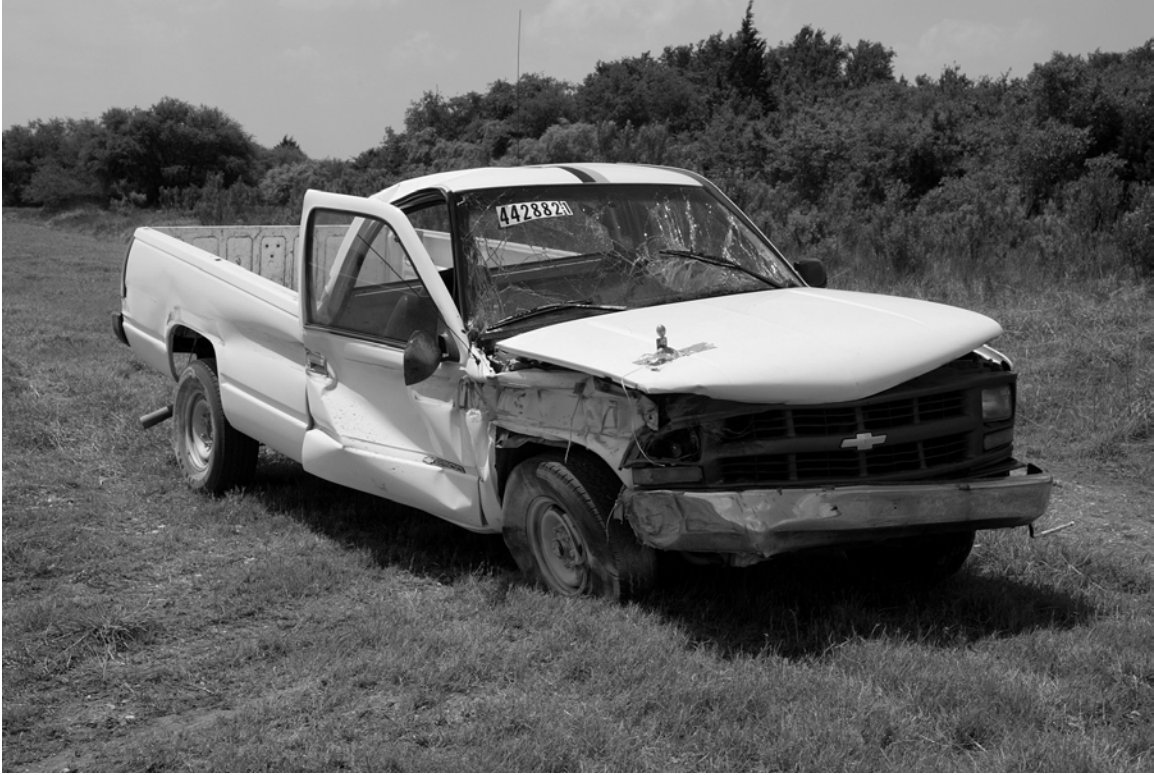
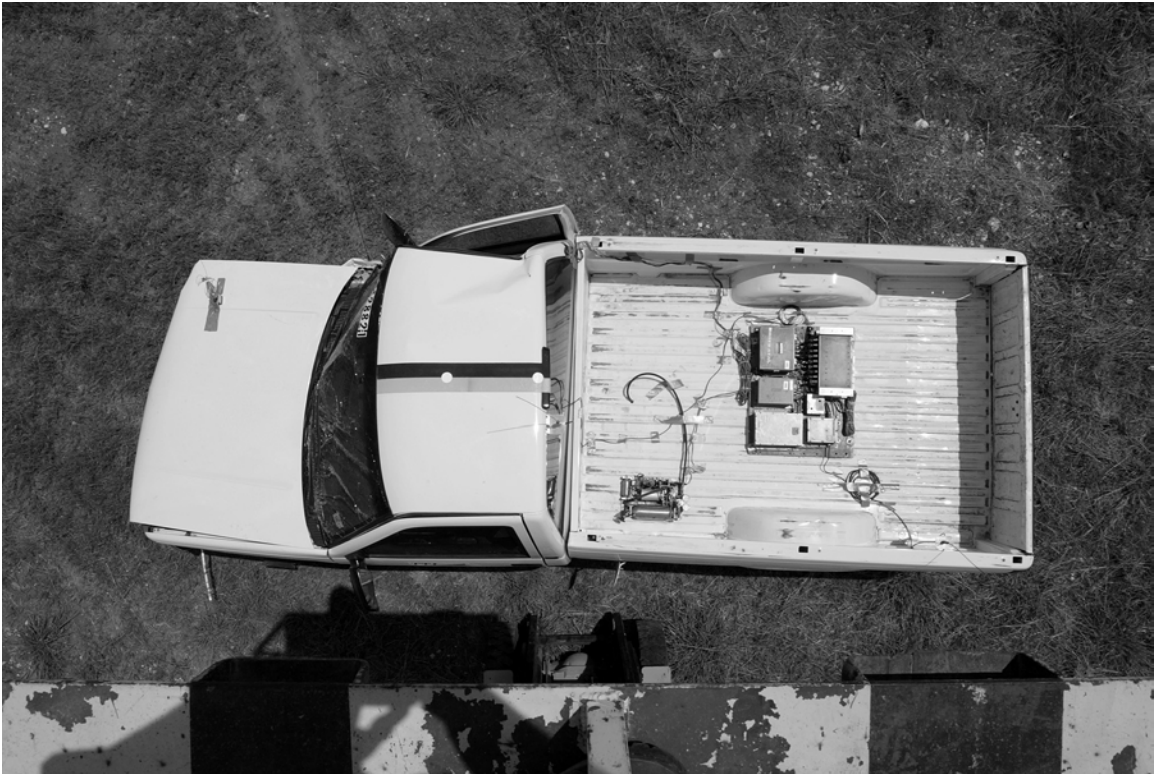
Figure 10. Vehicle after Test 442882-1.

Figure 10 shows damage imparted to the vehicle. Structural damage included deformation of the right upper and lower A-arms, right spindle and tie rod ends, stabilizer bar, right front of the frame, A and B pillars, floor pan, and firewall. Also damaged were the front bumper, hood, radiator and fan, right front tire and wheel, right front quarter panel, right door and window glass, and right side bed. The roof was deformed and the windshield was cracked. Maximum exterior crush to the vehicle was 25.6 inches (650 mm) in the front plane at the right front corner near bumper height. The vehicle was also crushed 20.9 inches (530 mm) in the side plane at the right front corner near bumper height. Maximum occupant compartment deformation was 8.3 inches (210 mm) in the right side door area. The right side floor pan area was deformed inward 7.3 inches (186 mm), and the right side firewall area was deformed inward 6.9 inches (175 mm). Figure 11 shows photographs of the interior of the vehicle. Exterior vehicle crush and occupant compartment deformation are shown in Appendix D, Tables 5 and 6.

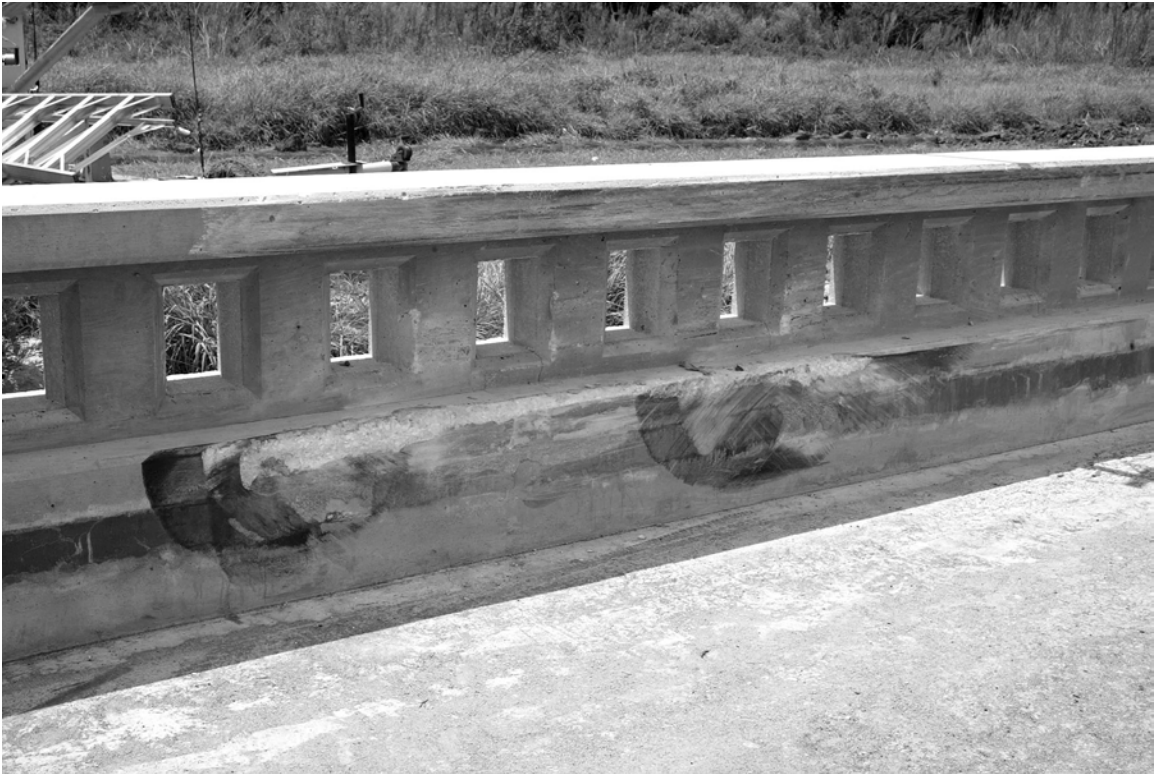
Figure 16. Installation after Test 442882-2.

The modified TxDOT F411 bridge rail sustained minimal cosmetic damage as shown in Figures 15 and 16. There were tire marks and scrapes along the face of the lower beam of the bridge rail for a distance of 9.8 ft (3.0 m). No cracks were noted in the beam rail, window frames, or deck. No measurable deformation occurred, and the working width was 1.7 ft (0.5 m).

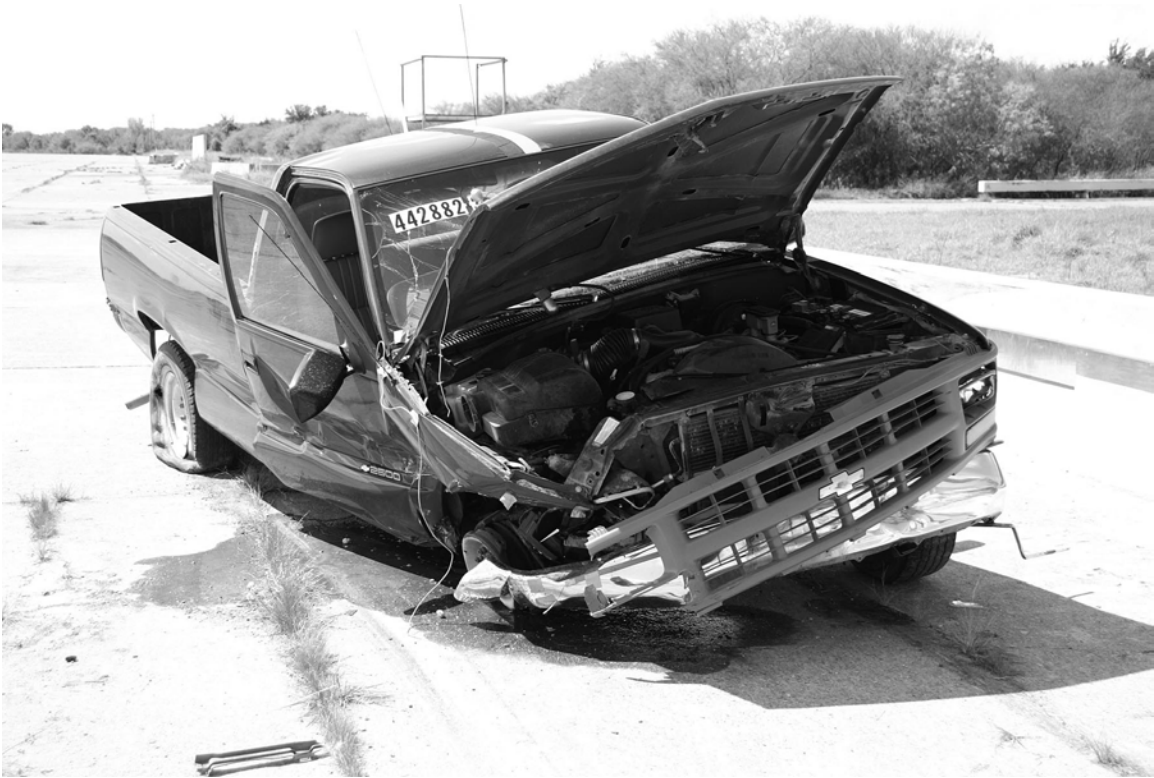
Figure 24. Vehicle after Test 442882-3.

The vehicle sustained damage as shown in [Figure 24](#). The right side A-arms, sway bar, and right front of the frame rail were deformed. The A-pillar was deformed, there was a crease in the top right side of the cab, and the top of the right door was pulled away from the cab 11.4 inches (290 mm). Also damaged were the front bumper, hood, grill, radiator, fan, right front and left front quarter panel, right side bed, rear bumper, and right rear tire and wheel. The right front tire and exterior part of the wheel rim separated from the center part of the wheel rim (at the pop rivets). Small pieces of sheet metal were torn from the lower section of the cab and the right rear side of the bed (2.4 inches × 5.9 inches [60 mm × 150 mm]). Maximum exterior crush to the vehicle was 30.7 inches (780 mm) in the front plane at the right front corner at bumper height. Maximum occupant compartment deformation was 8.7 inches (222 mm) in the right front firewall. Photographs of the interior of the vehicle are shown in [Figure 25](#). Exterior vehicle crush and occupant compartment deformations are shown in [Appendix D](#), Tables 9 and 10.

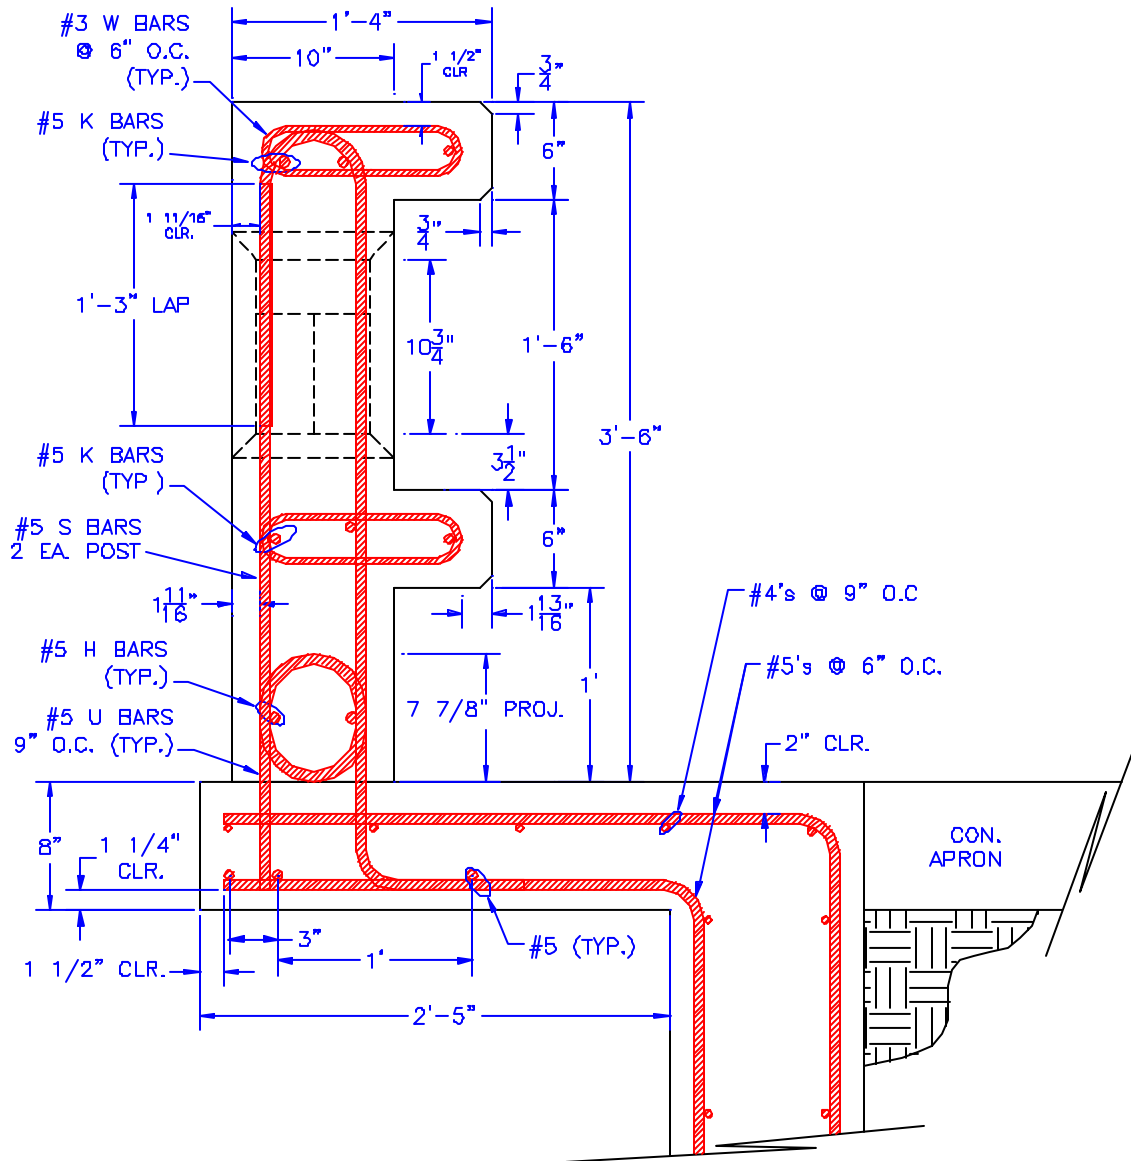
Given: 1.) Given the Following Cross Section, Calculate the Total Transverse Resistance (R_w) of the railing based on AASHTO LRFD, Section 13 Specifications:

SUBJECT TxDOT F411 Bridge Rail
