1. Report No. FHWA/TX-03/4288-1		2. Government Accession No.		3. Recipient's Catalog No.	
4. Title and Subtitle DESIGN AND EVALUATION OF THE TXDOT F411 AND T77 AESTHETIC BRIDGE RAILS				5. Report Date October 2002

**DESIGN AND EVALUATION OF THE TxDOT
F411 AND T77 AESTHETIC BRIDGE RAILS**

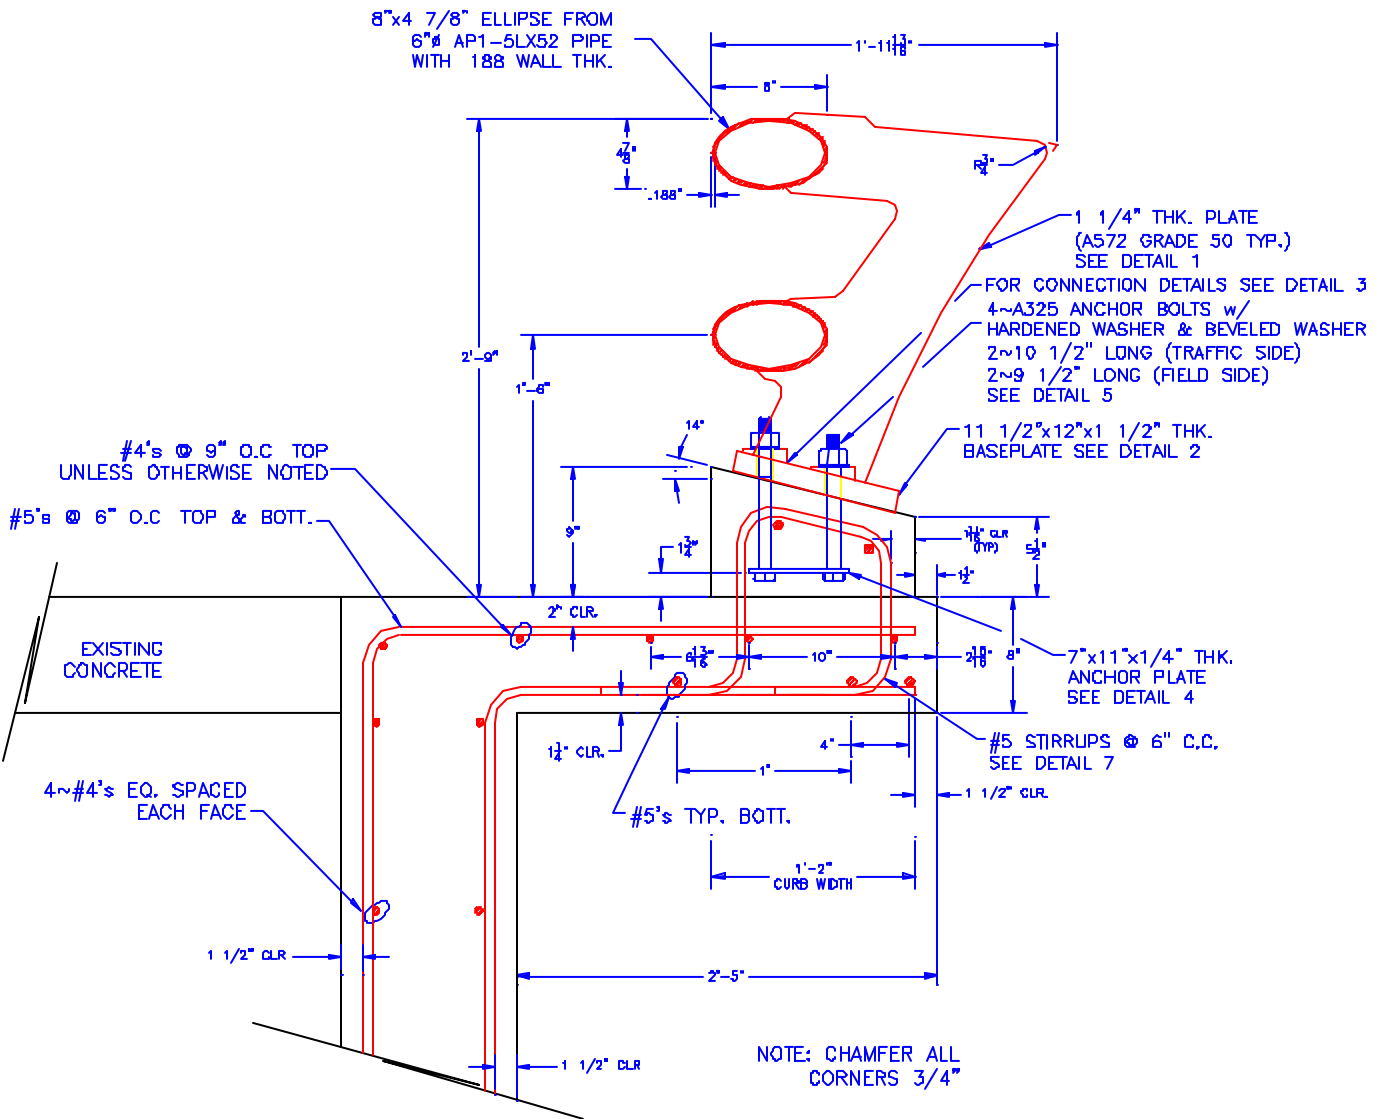
- 1.) **Given:** 1.) The following T77 Aesthetic Steel Bridge Rail: Rev. 3
Find: Check Bridge Rail Design to Meet TL-4 Requirements w/ **8-ft Post Spacing:**

SUBJECT Texas Type T77 Aesthetic Bridge Rail

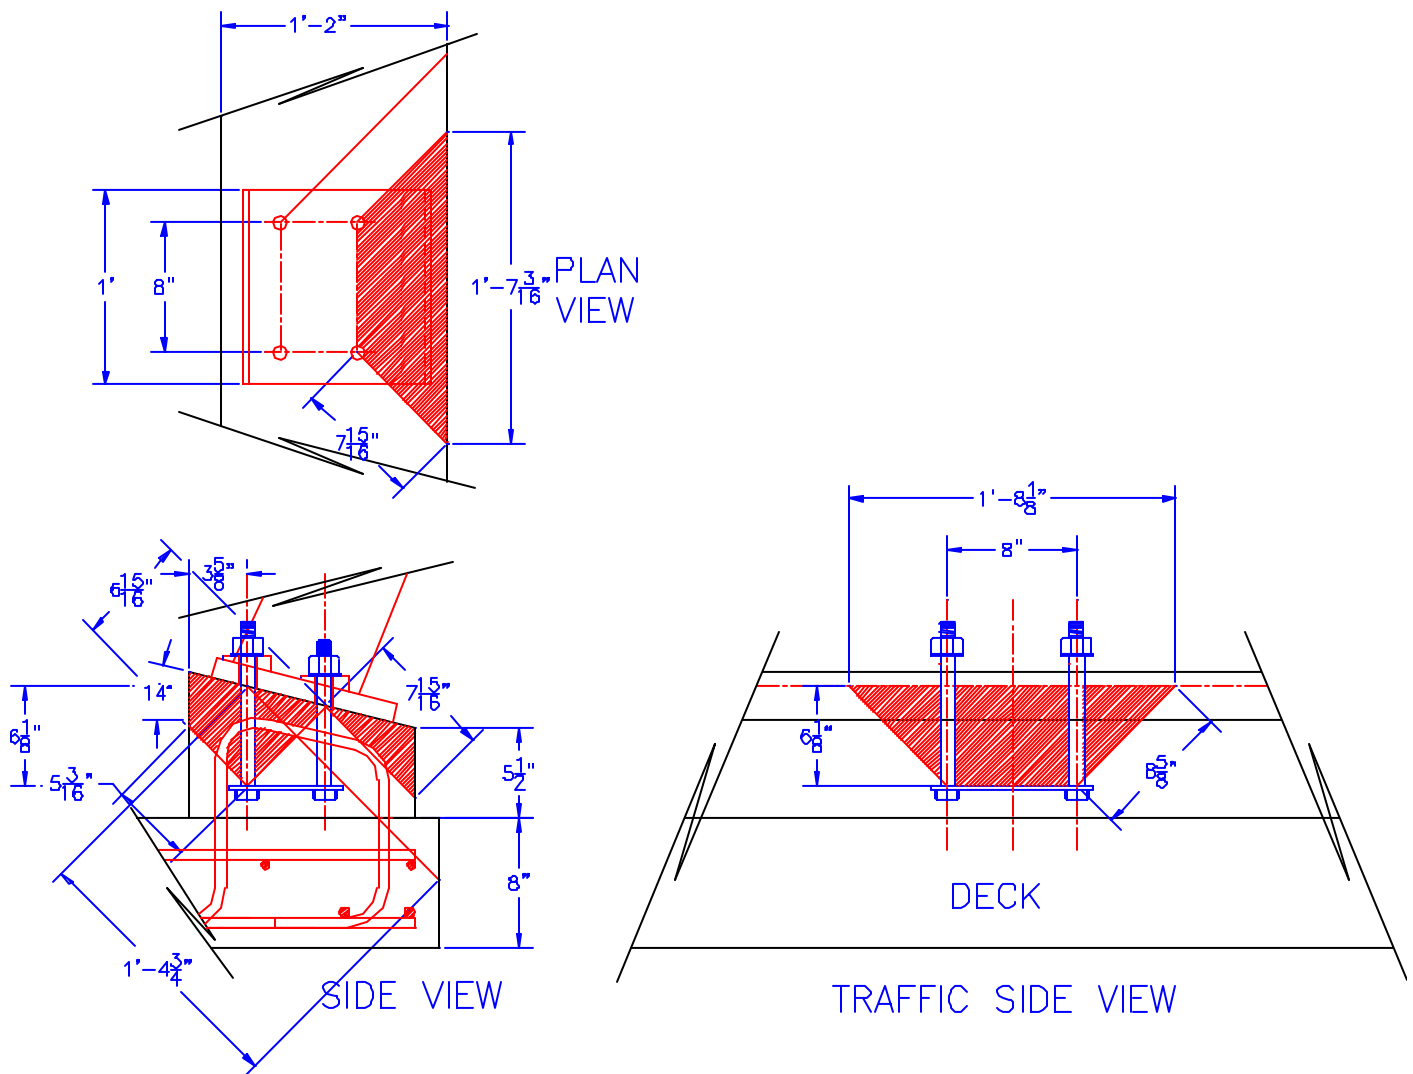
8.) Lateral Block Shear Failure Due to Bolt Shear (P_{Post4}):

Reference: Specification for the Design of Anchor Bolts (Rev. 0) S&B ES-3140
 From Figure 4 ~ "Shear Cone for Overlapping Cones"

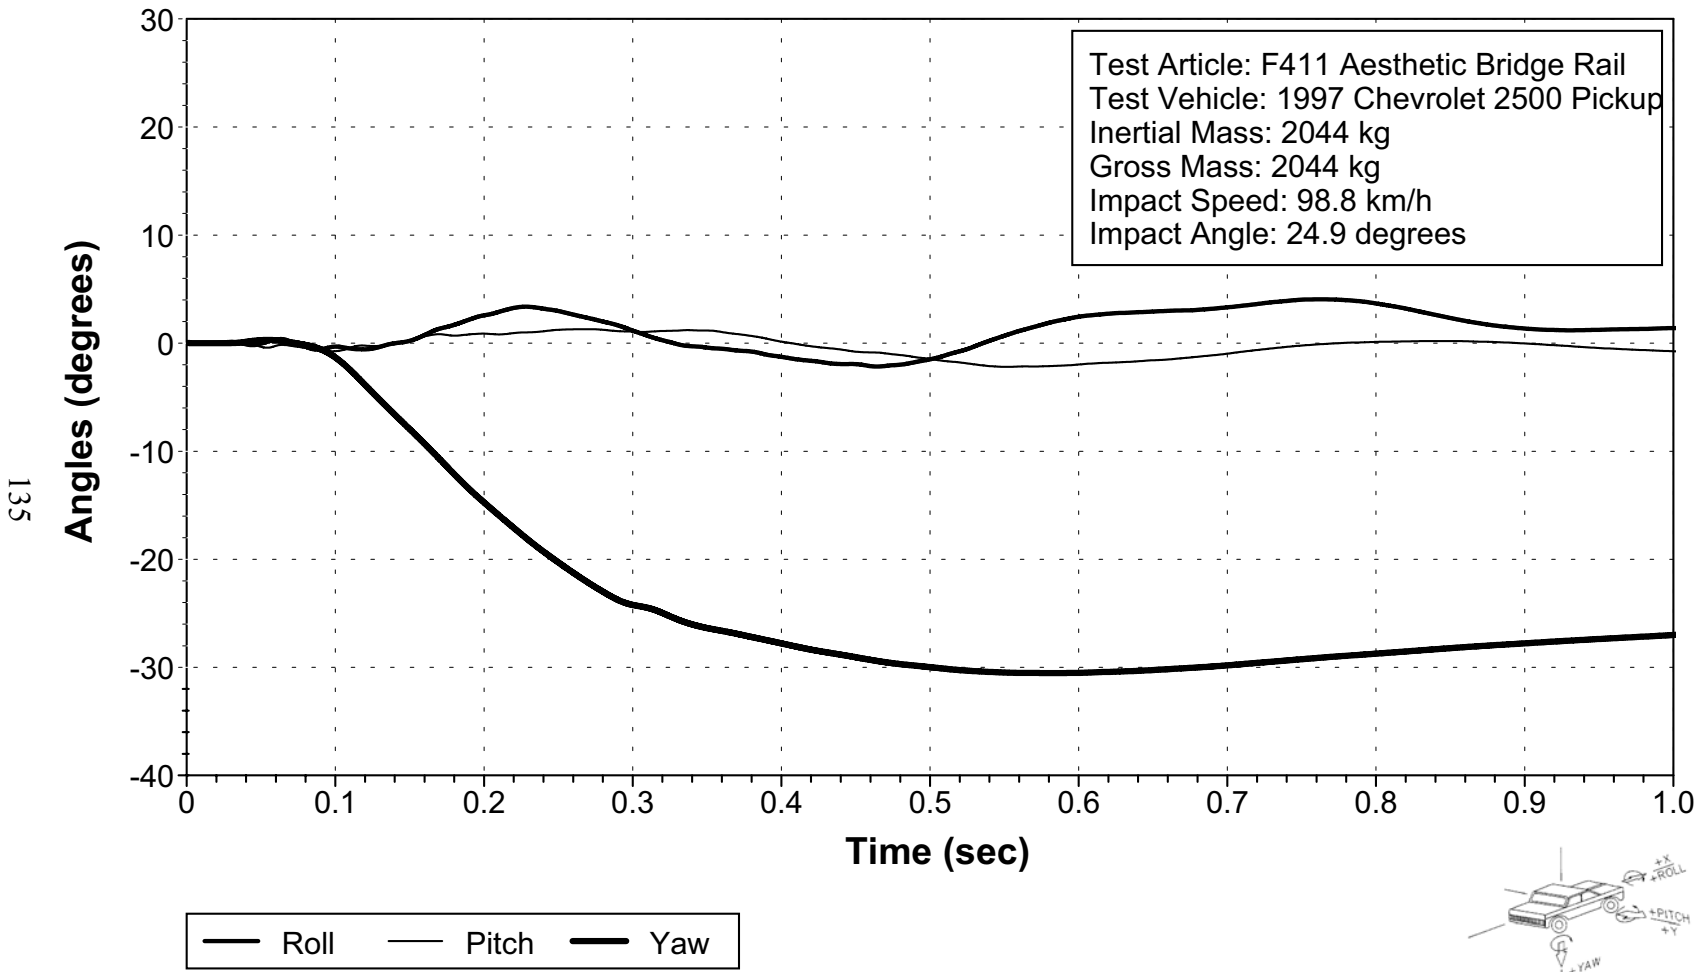
Figure 46. Vehicular Angular Displacements for Test 442882-1.

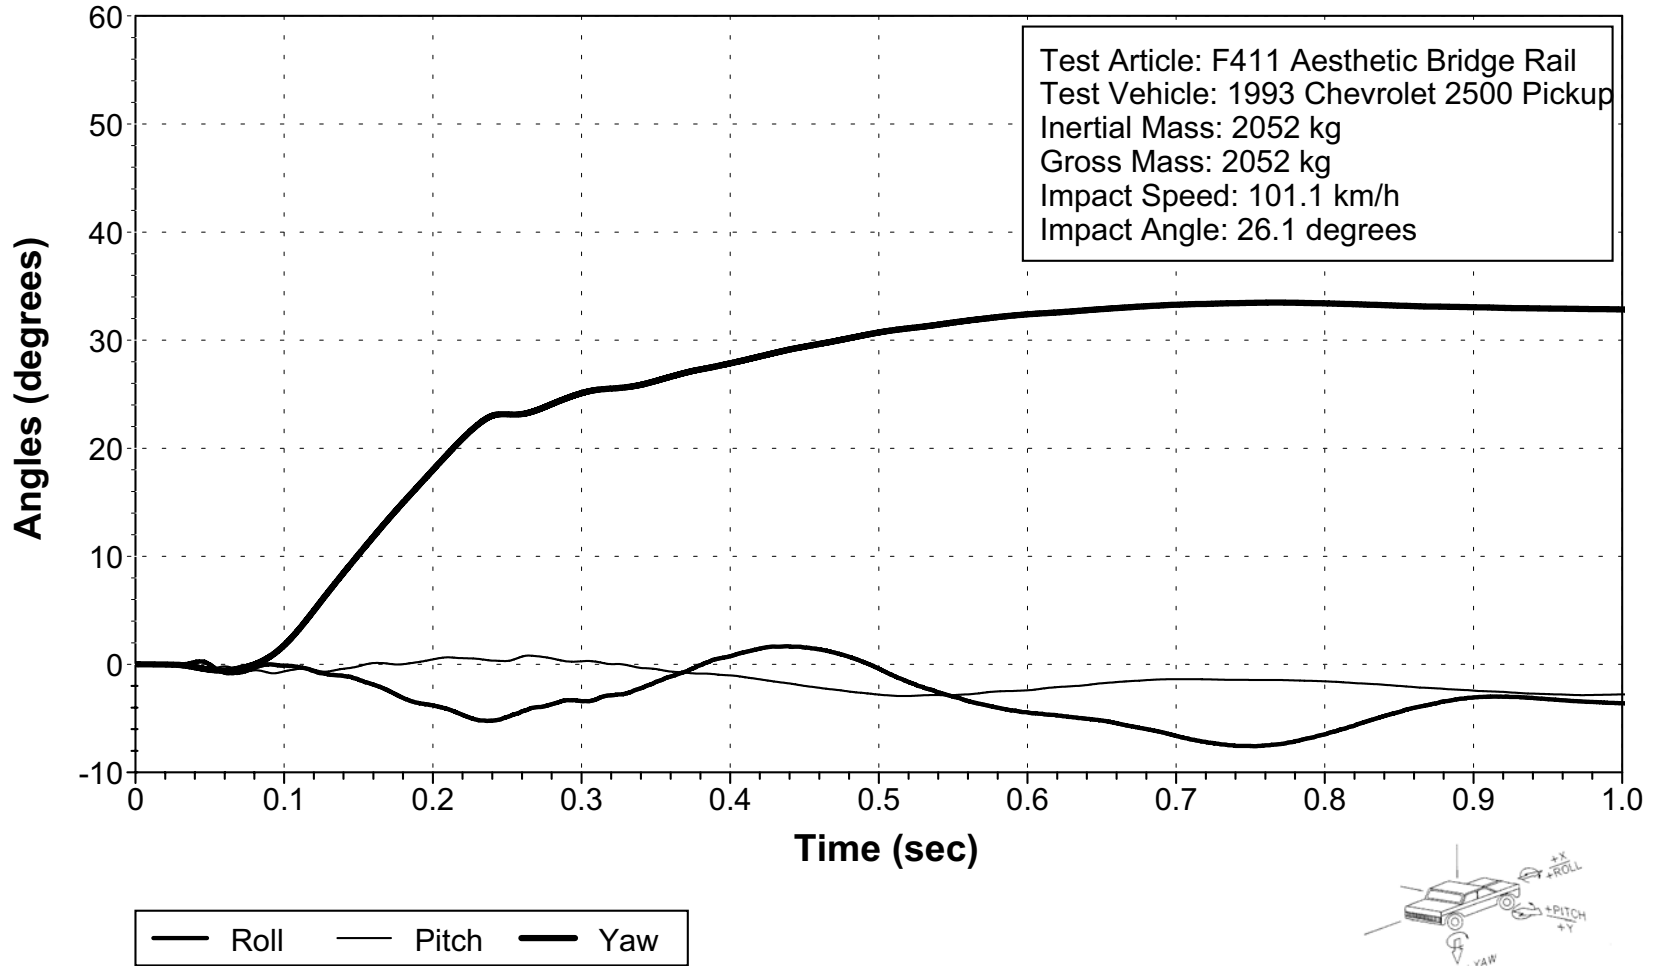
Figure 47. Vehicular Angular Displacements for Test 442882-2.

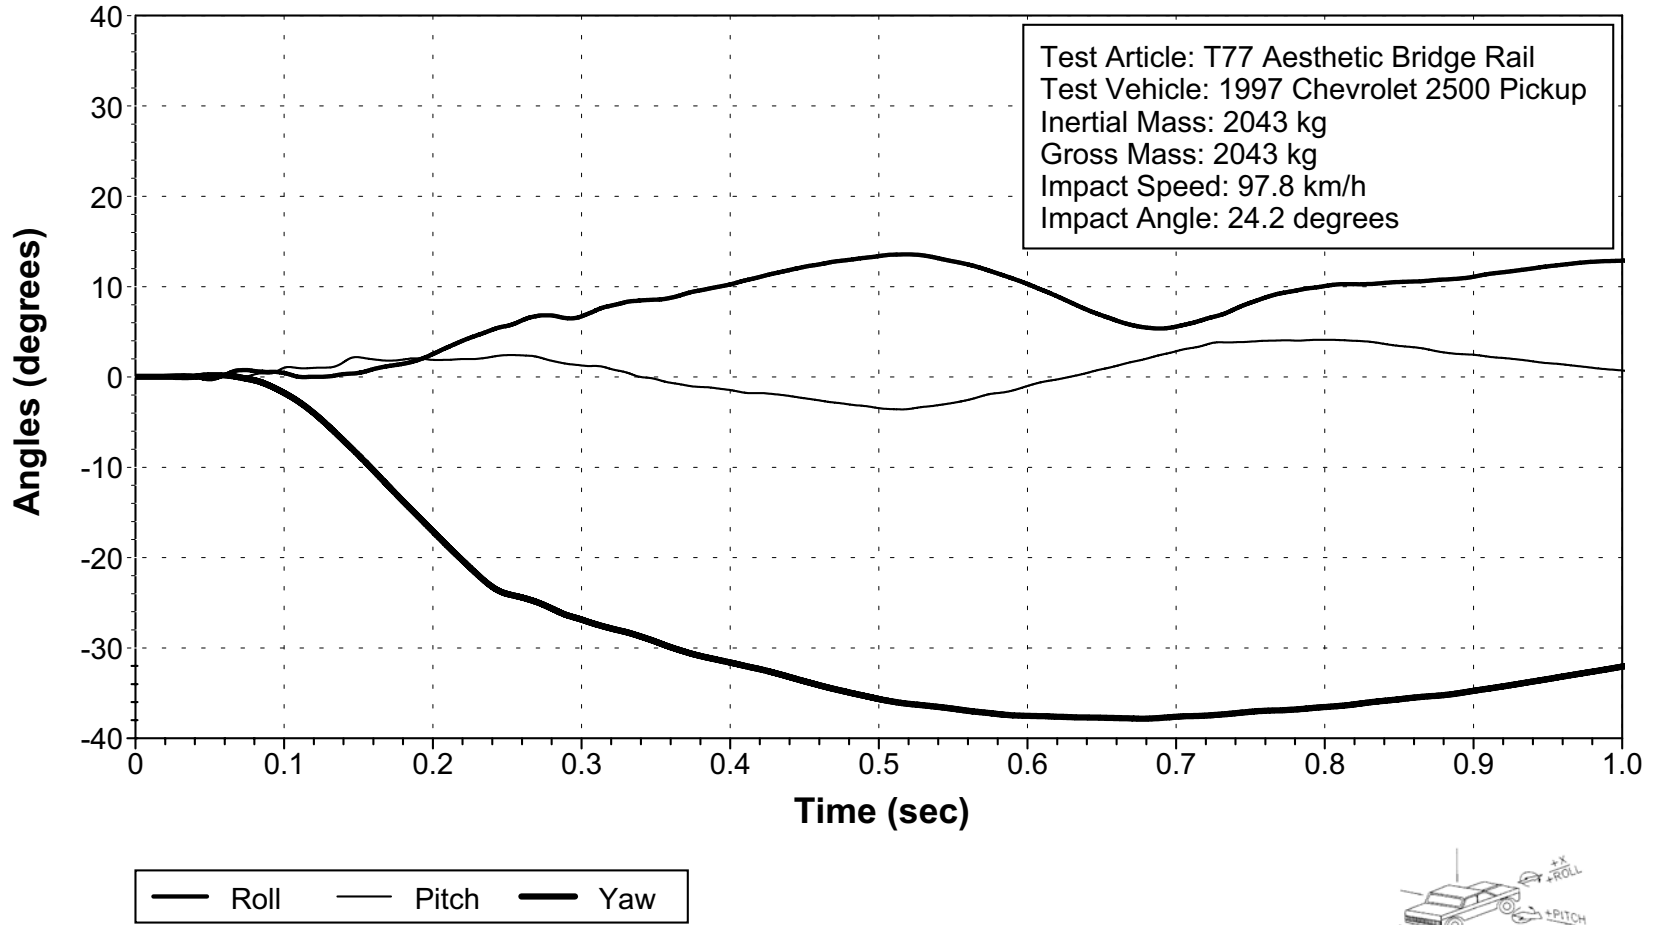
Figure 48. Vehicular Angular Displacements for Test 442882-3.

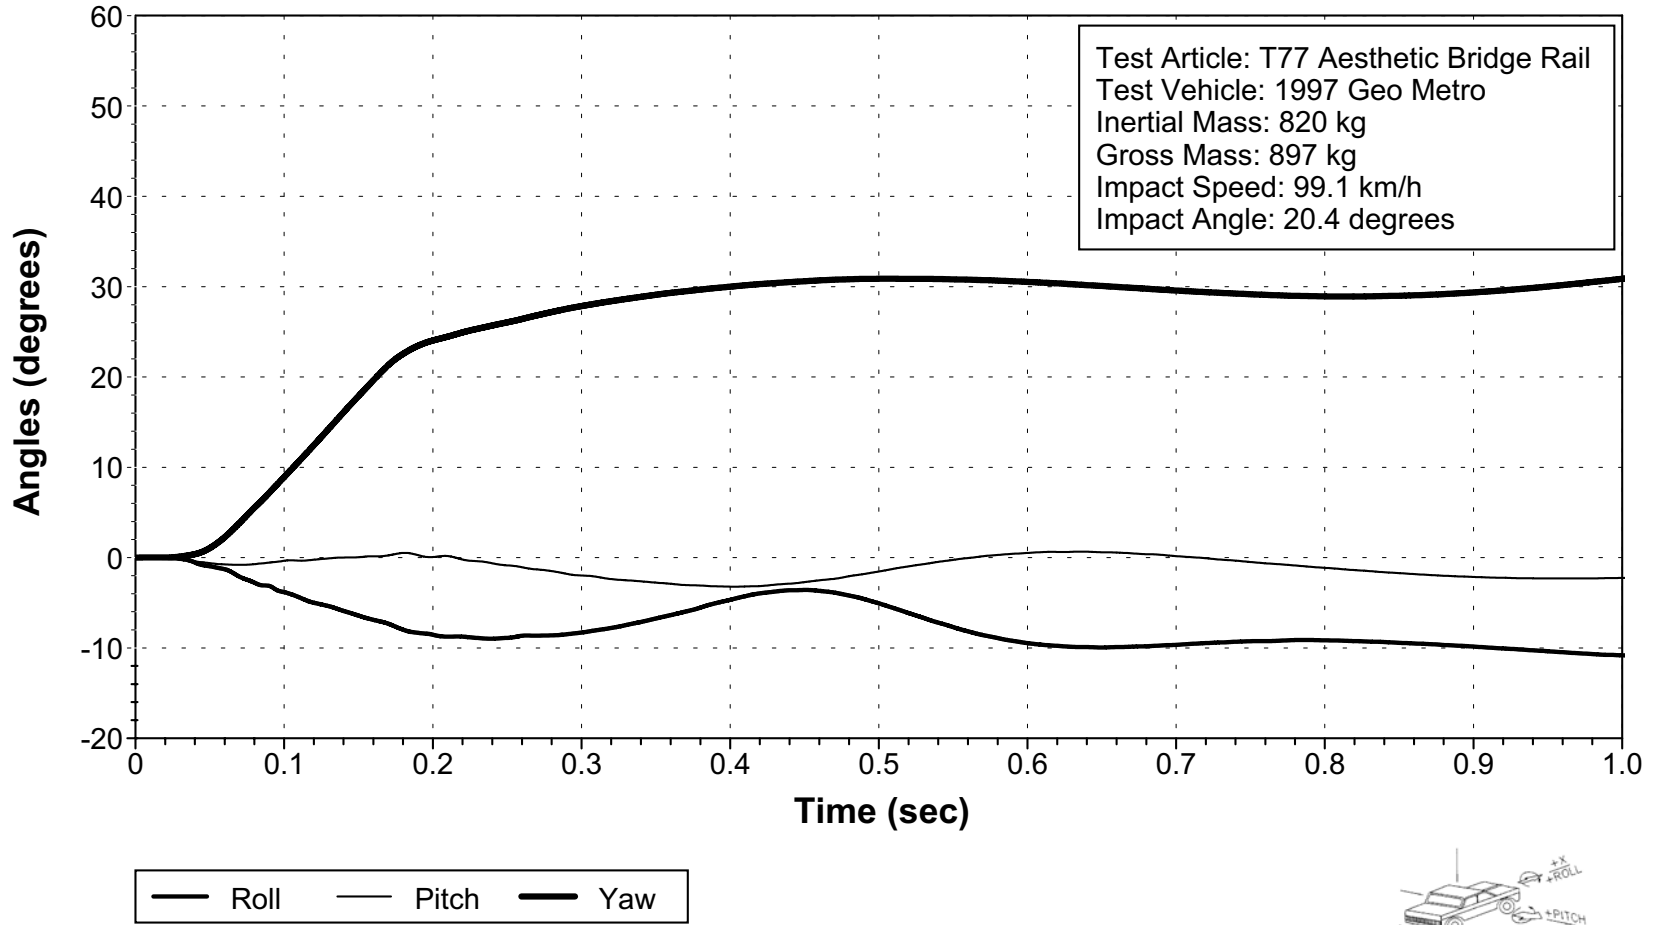
Figure 49. Vehicular Angular Displacements for Test 442882-4.
