1. Report No. FHWA/TX-98/1804-3		2. Government Accession No.		3. Recipient's Catalog No.	
4. Title and Subtitle NCHRP REPORT 350 TEST 3-11 OF THE TEXAS TYPE T411 BRIDGE RAIL				5. Report Date May 1998

**NCHRP REPORT 350 TEST 3-11 OF
THE TEXAS TYPE T411 BRIDGE RAIL**

Letter Report 1804-3
Research Project Number 0-1804
Research Project Title: Evaluation and Testing of Bridge Rails
and Transitions to NCHRP Report 350 Criteria

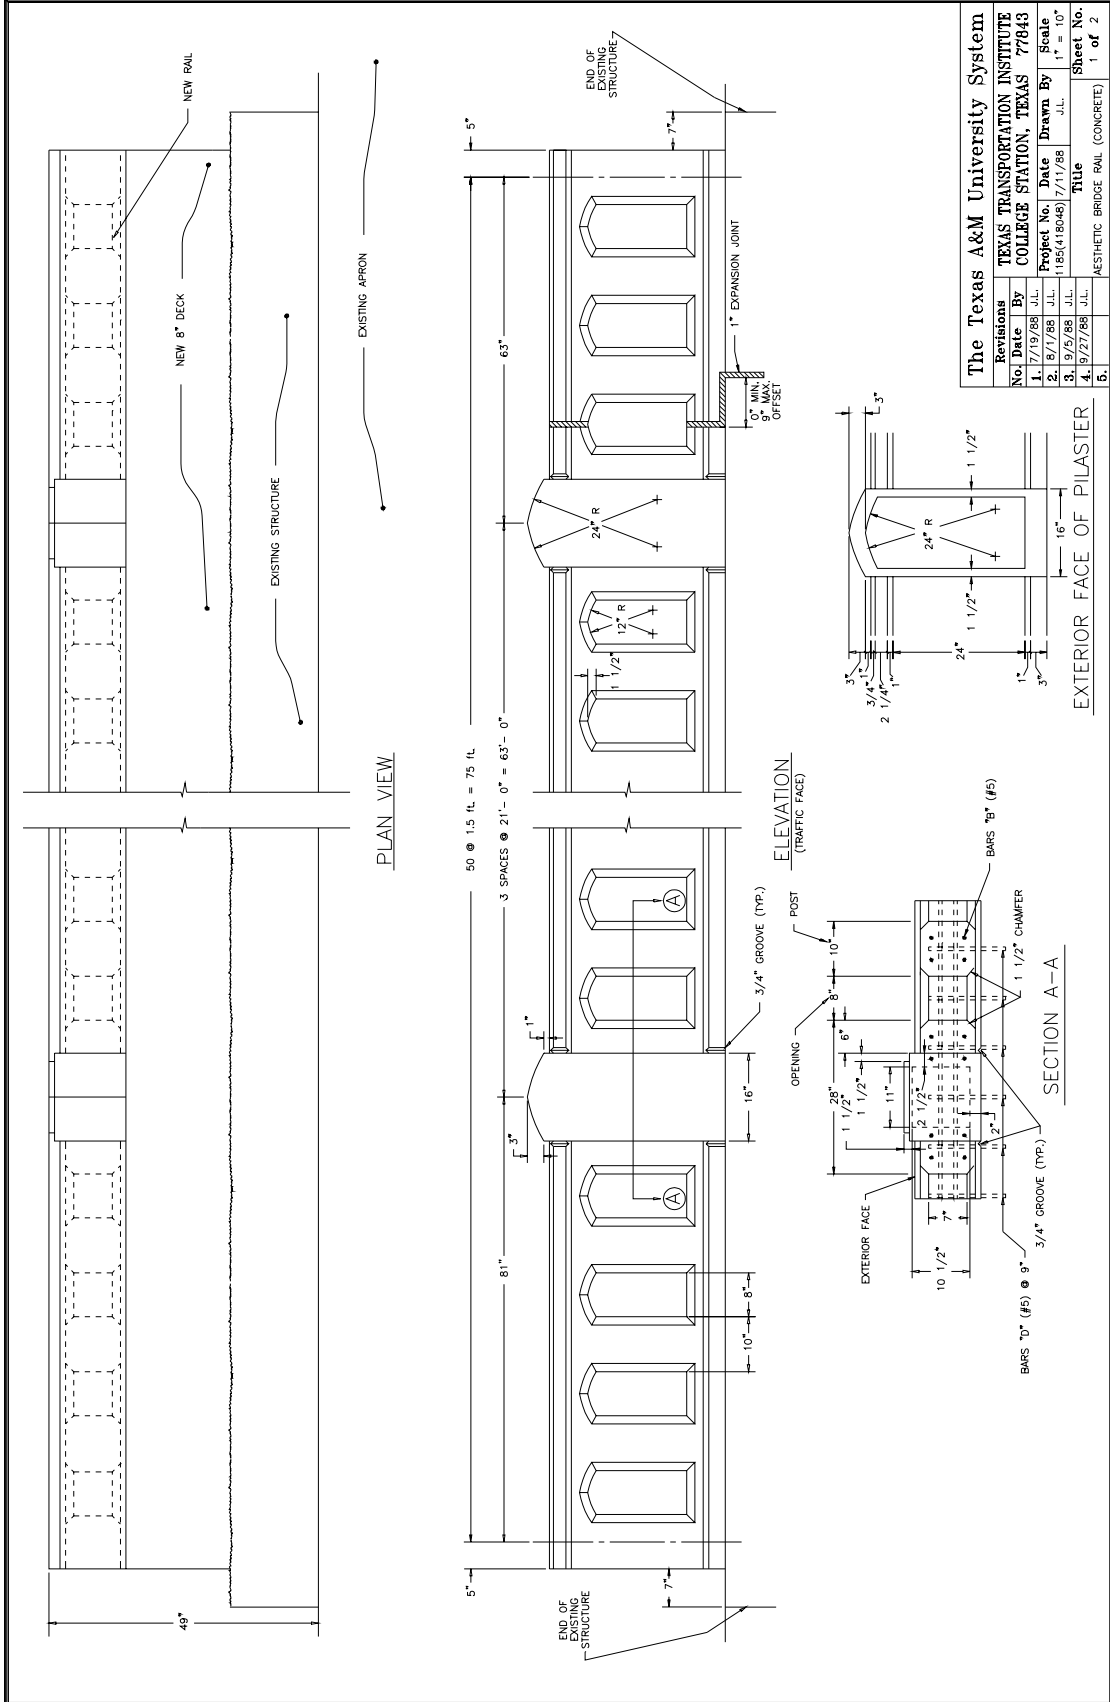
Figure 1. Details of the Texas Type 411 Bridge Rail -- Plan and Elevation

This bridge rail is constructed of reinforced concrete 813 mm high by 305 mm thick and contains 203 mm wide by 457 mm high openings at 457 mm center-to-center longitudinal spacing. Figures 1 and 2 present a plan view, elevation, and cross section of the T411 rail. The bridge deck is a 203-mm thick, typical Texas bridge slab design in accordance with AASHTO specifications (6).

This bridge rail was designed using a failure mechanism (or yield line) method of analysis (7). The design strength of the concrete was $f_c = 24.8$ MPa, and the yield strength of reinforcing steel was $f_y = 413.7$ MPa. The top beam was nominally 178 mm wide and 279 mm thick ($b = 178$ mm and $d = 210$ mm), yielding an ultimate moment capacity of 27.9 kN-m. With a moment arm of 0.67 m, each post could resist a lateral load of about 42.3 kN. The failure load would be about 293.1 kN or more. Five posts would crack, and a 2.7 m length of bridge rail would be involved.

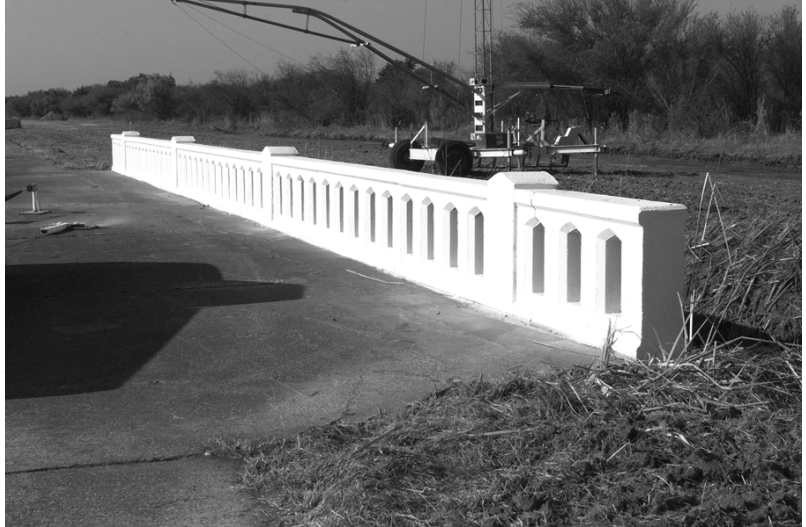
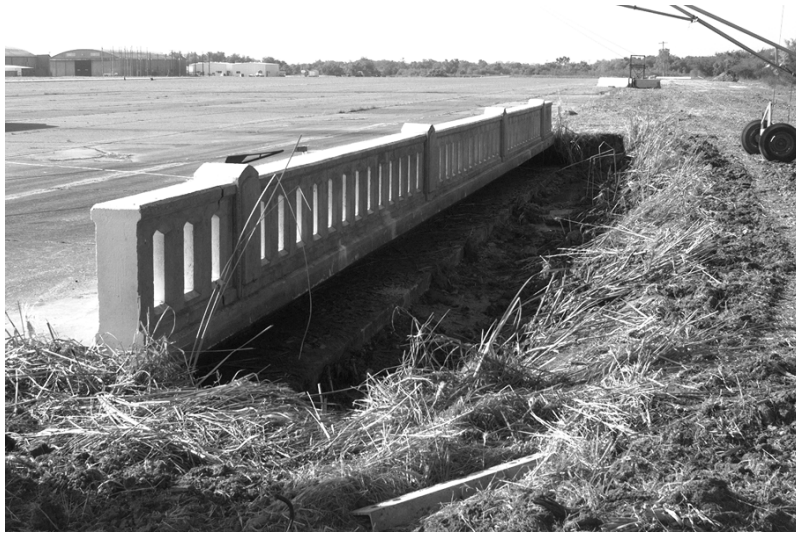
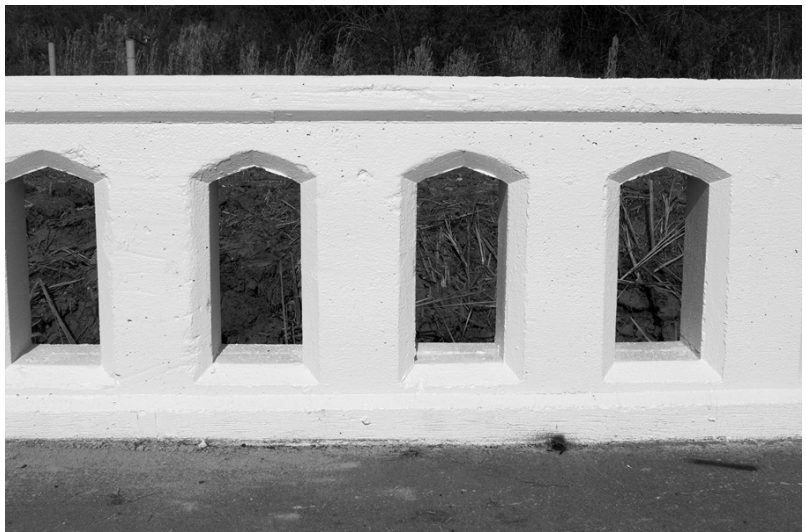
Figure 3. Texas Type T411 Bridge Railing Installation before Test 418048-1

Figure 3 shows photographs of the 23.1 m bridge rail installation prior to crash testing. The four pilasters are not truly strong posts, as they appear to be. They contain styrofoam blocks 267 mm by 330 mm by 533 mm (void), which means the pilasters are similar in strength to the 203 mm by 457 mm openings. The use of the pilasters is, thus, optional since they do not contribute to the bridge rail strength as built and crash tested.

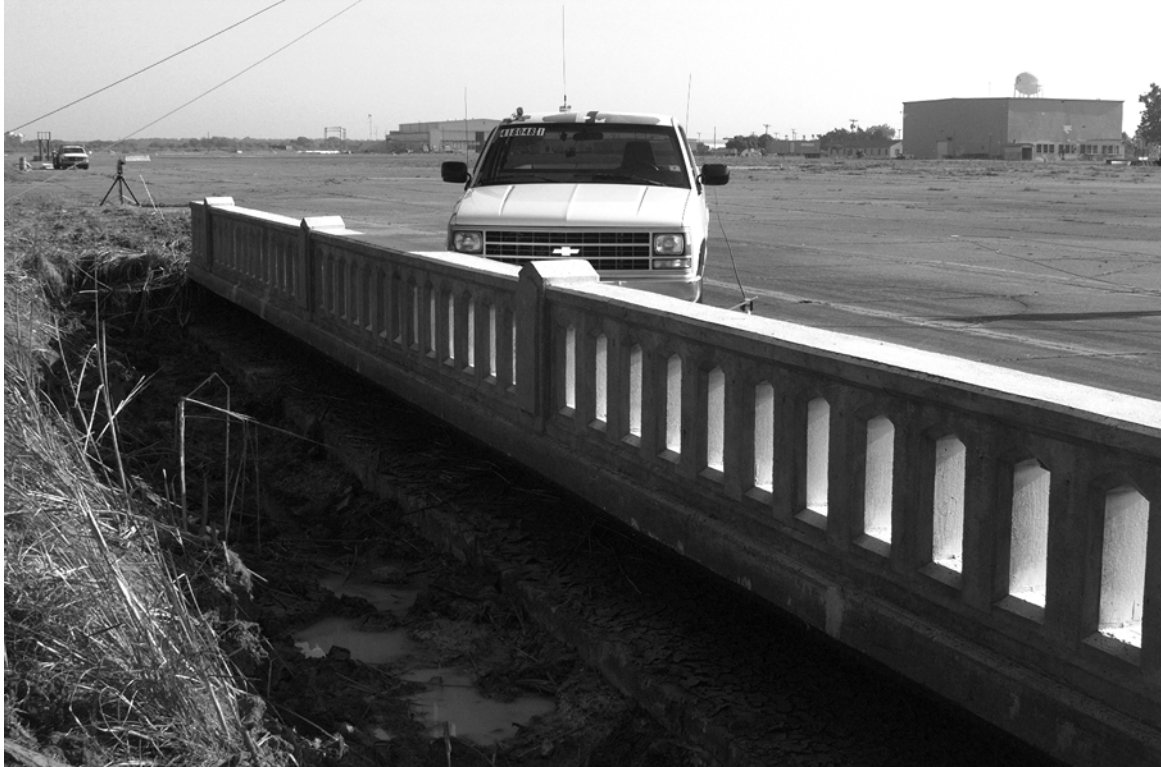
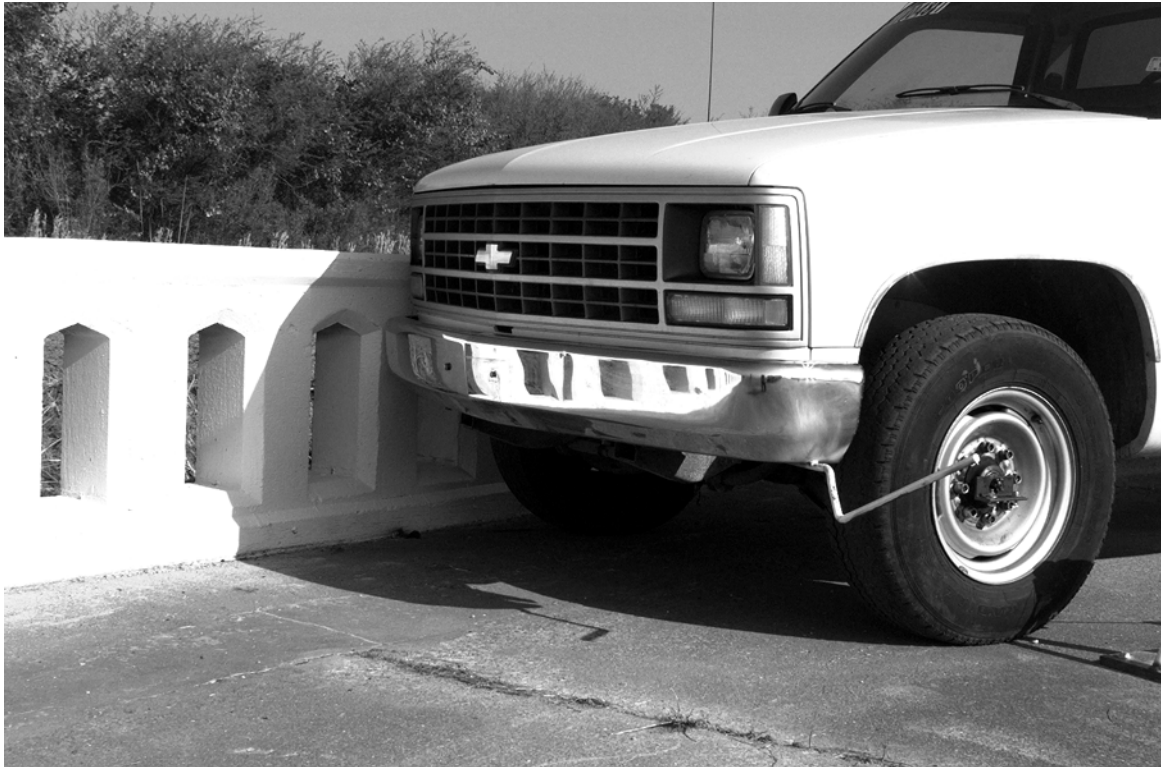
Figure 4. Vehicle/Installation Geometrics for Test 418048-1

A 1993 Chevrolet 2500 pickup truck, shown in figures 4 and 5, was used for the crash test. Test inertia weight of the vehicle was 2000 kg, and its gross static weight was 2000 kg. The height to the lower edge of the vehicle bumper was 410 mm, and it was 630 mm to the upper edge of the bumper. Additional dimensions and information on the vehicle are given in figure 6. The vehicle was directed into the installation using the cable reverse tow and guidance system, and was released to be free-wheeling and unrestrained just prior to impact.

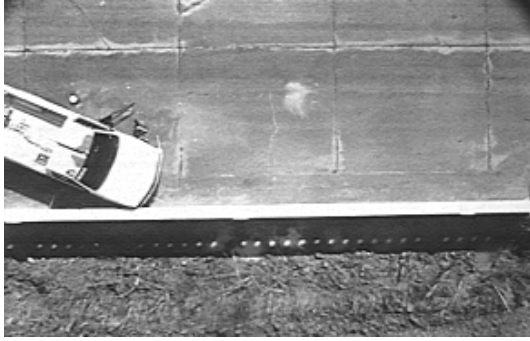
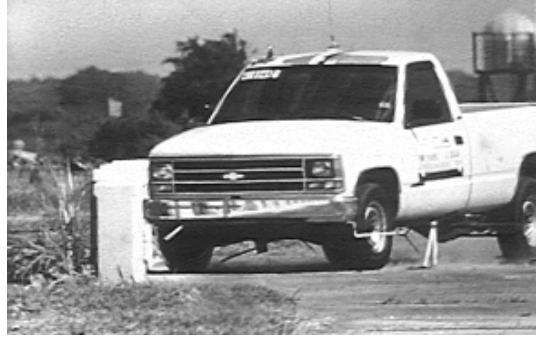
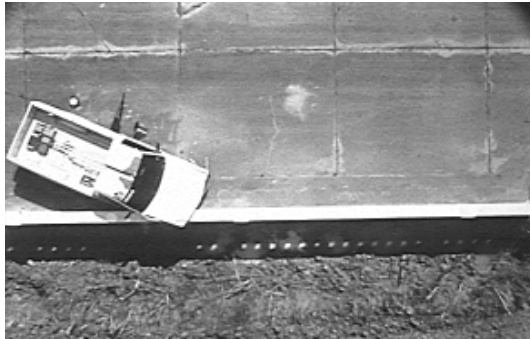
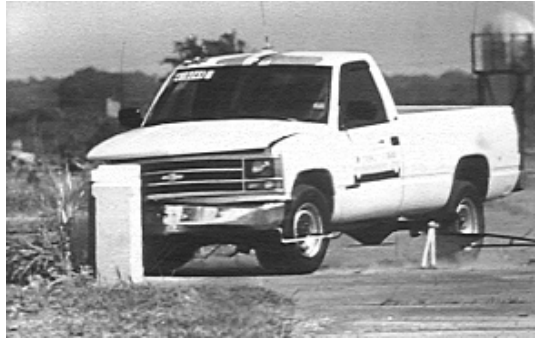
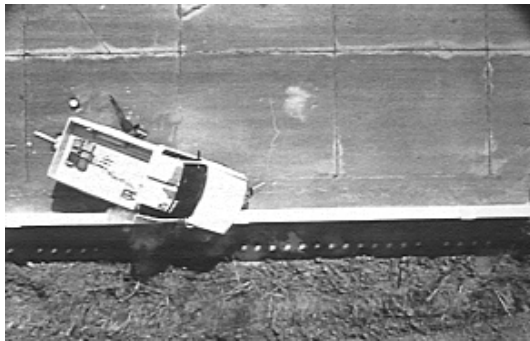
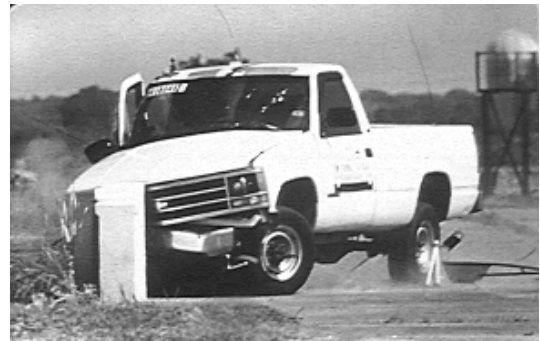
**Figure 7. Sequential Photographs for Test 418048-1
(Overhead and Frontal Views)**

The vehicle, traveling at 101.3 km/h, impacted the Texas Type T411 bridge rail at 24.9 degrees, 11.6 m down from the end of the installation. Shortly after impact, the right front wheel steered away from the bridge rail, and then at 0.032 s, the tire entered the opening just down from impact. The left front wheel steered toward the rail at 0.040 s, and the right door deformed at 0.052 s. Redirection of the vehicle began at 0.052 s. At 0.062 s, stress cracks appeared in the windshield, and at 0.075 s the right door glass shattered. The rear of the vehicle contacted the bridge rail at 0.254 s. At 0.263 s, the vehicle was traveling parallel with the bridge rail at a speed of 69.7 km/h. The vehicle remained in contact with the bridge rail for a distance of 3.7 m and lost contact with the bridge rail at 0.392 s. As the vehicle exited the rail, it was traveling at a speed of 69.5 km/h and an exit angle of 11.5 deg. Brakes on the vehicle were applied 2.0 s after impact. The vehicle subsequently came to rest 44.2 m down from impact and 3.6 m behind the installation. Sequential photographs of the test period are shown in figures 7 and 8.

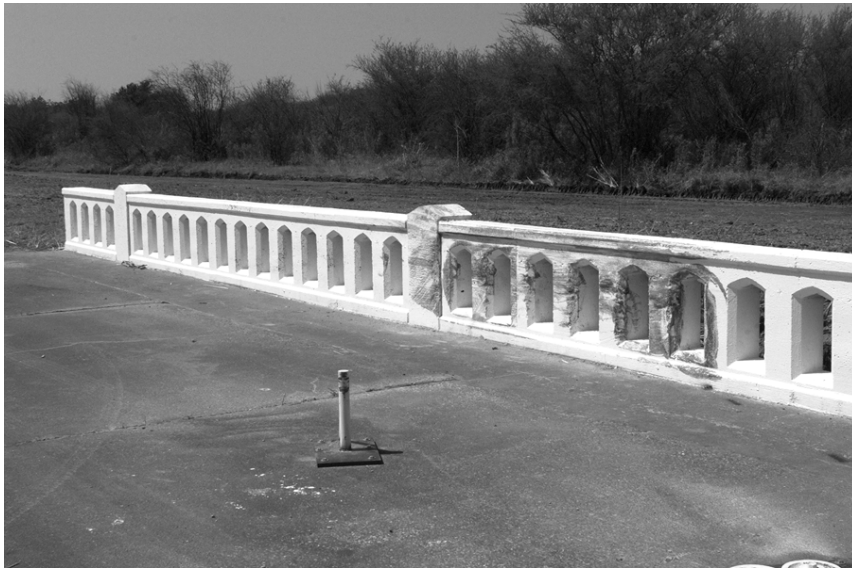
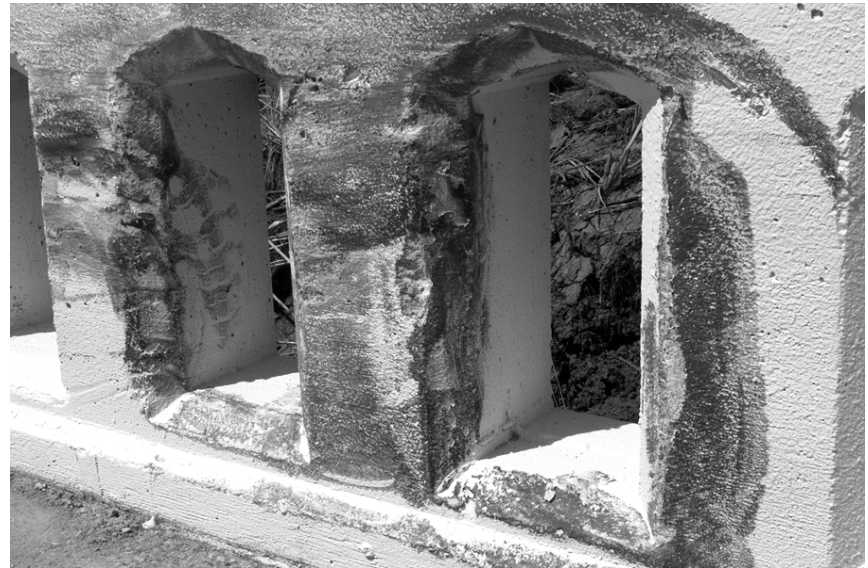
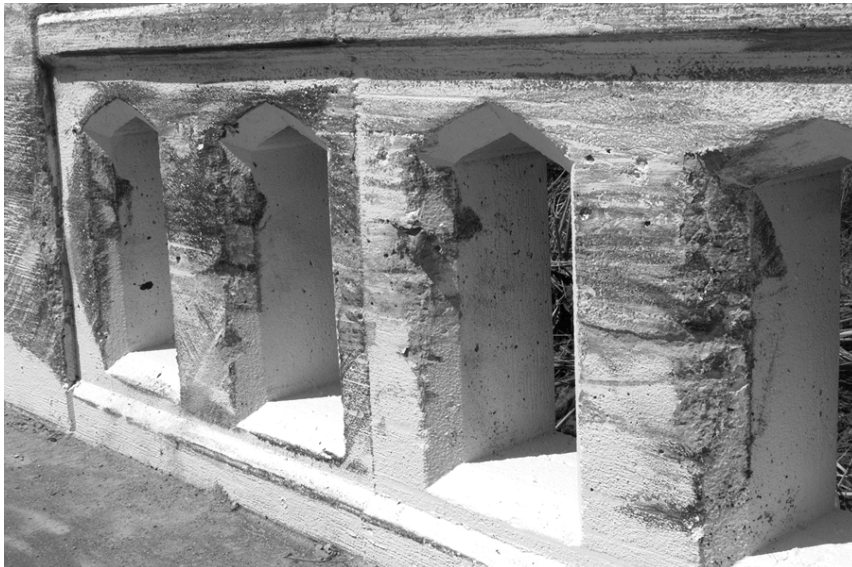
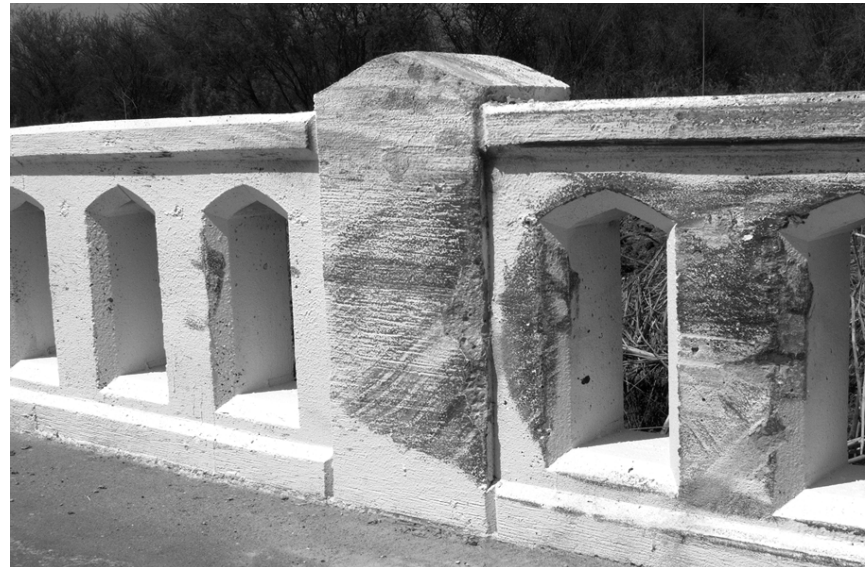
Figure 10. Installation after Test 418048-1

Damage to the Texas Type T411 bridge rail is shown in figures 9 and 10. Most of the damage was cosmetic, consisting of tire marks and scuffs. Tire marks extended 45 mm into the first window up from impact, 230 mm into the second, 70 mm into the third, 52 mm into the fourth, 25 mm into the fifth, and 40 mm into the sixth. A hairline stress crack occurred 390 mm down from impact. The edge of the concrete on the large pilaster upstream of impact was spalled. The vehicle was in contact with the bridge rail a total of 3.7 m.

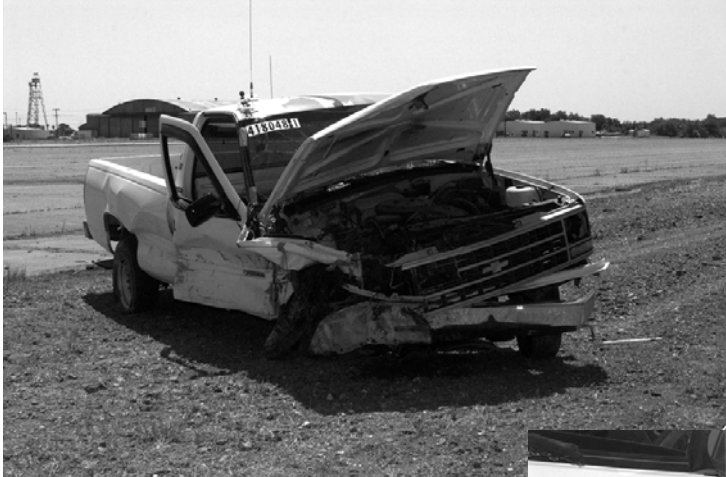
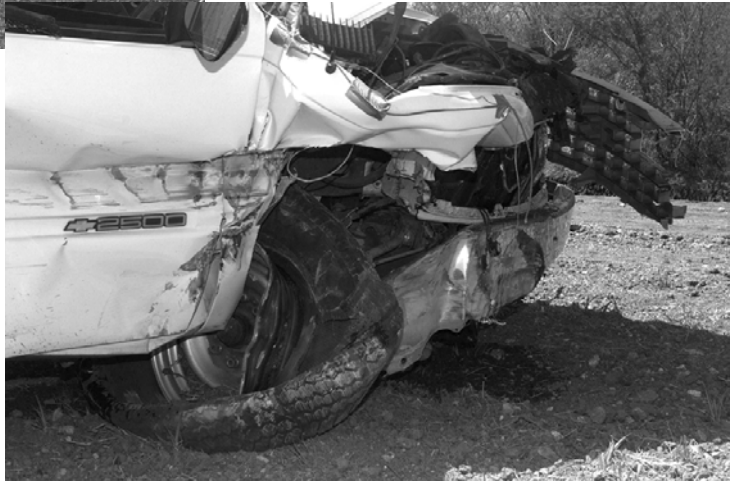
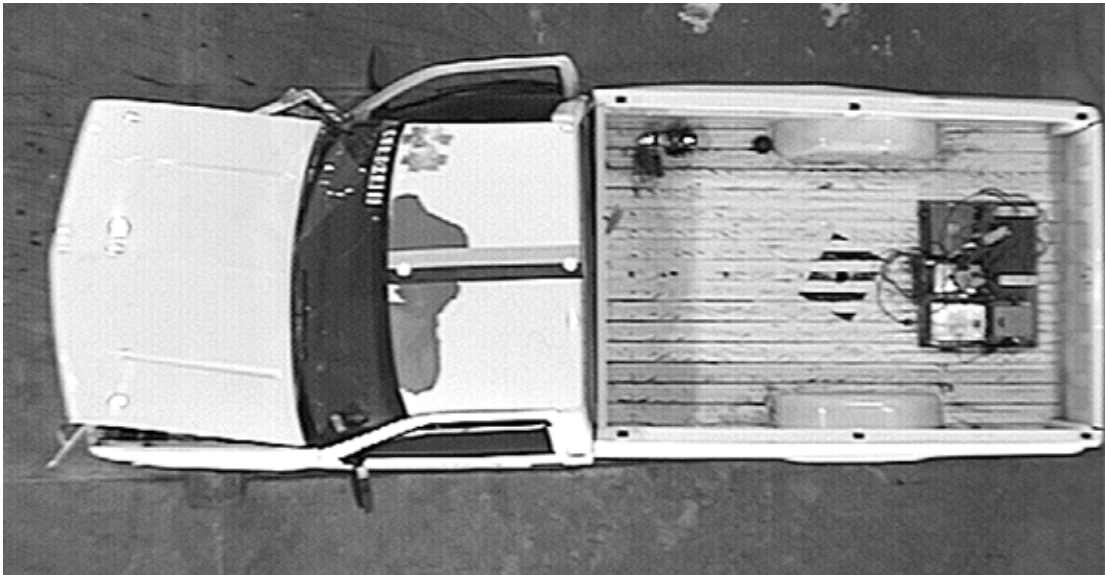
Figure 11. Vehicle after Test 418048-1

The vehicle after impact with the Texas Type T411 bridge rail is shown in figure 11. Structural damage to the vehicle included deformation of the right front of the frame, right front spindle, A-arms, rod ends, idler arm, right side engine support, and the firewall and floor pan. The A-pillar on the right side was deformed, and the windshield shattered. The bumper, hood, grill, fan, radiator, right front and rear quarter panels, right door and window, and the right front and rear wheels also received damage. Maximum crush to the vehicle was 1040 mm at the front right corner at bumper height. Maximum measurable occupant compartment deformation was 117 mm (8.5 percent reduction in space) in the right side firewall area, and a maximum reduction of 9.7 percent occurred in the occupant compartment at floor pan area. These measurements were taken at points of reference taken prior to the test and do not accurately represent the maximum deformations. As can be seen in figure 12, considerable deformation occurred to the passenger side of the occupant compartment. The floor pan was separated at the seams in several places. An accurate measurement was not attainable. Exterior crush and occupant compartment measurements are shown in tables 1 and 2.

According to the specifications set for NCHRP Report 350 test designation 3-11, the Texas Type T411 met all requirements, except occupant risk. Significant occupant compartment deformation occurred on the center and right side of the vehicle, which was judged to have the potential to cause serious injury.

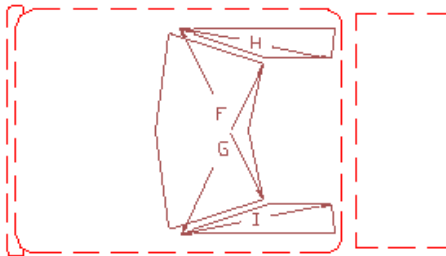
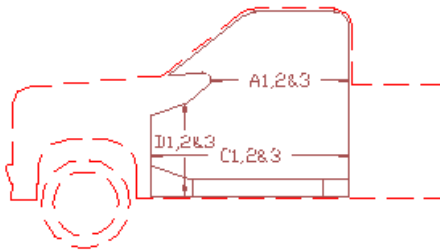
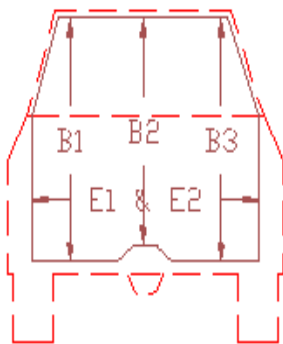
Table 2. Occupant Compartment Measurements for Test 418048-1

BEFORE	AFTER
A1	1040	1048
A2	1083	1040
A3	1044	977
B1	1080	1080
B2	1047	1140
B3	1072	1060
C1	1373	1373
C2	1250	1165
C3	1372	1255
D1	306	324
D2	155	140
D3	315	290
E1	1600	1645
E2	1595	1616
F	1475	1445
G	1475	1475
H	900	865
I	900	900

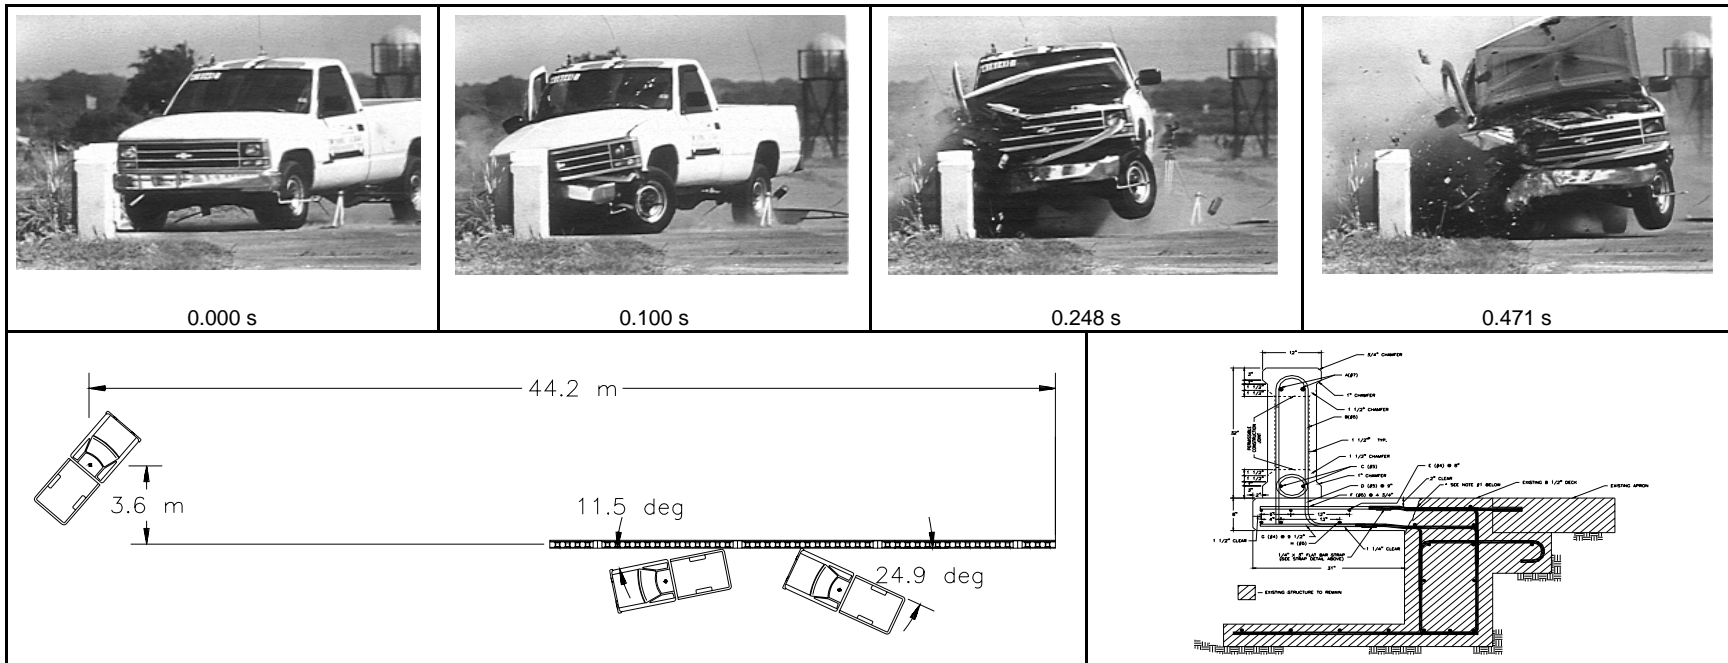
Figure 13. Summary of Results for Test 418048-1

General Information		Impact Conditions		Test Article Deflections (m)	
Test Agency	Texas Transportation Institute	Speed (km/h)	101.3	Dynamic	nil
Test No.	418048-1	Angle (deg)	24.9	Permanent	nil
Date	04/20/98	Exit Conditions		Vehicle Damage	
Test Article		Speed (km/h)	69.5	Exterior	
Type	Bridge Rail	Angle (deg)	11.5	VDS	01FR6
Name or Manufacturer	Texas Type T411	Occupant Risk Values		CDC	01FREW6
Installation Length (m)	23.1	Impact Velocity (m/s)		Maximum Exterior	
Material or Key Elements	Concrete Beam and Posts	x-direction	9.5	Vehicle Crush (mm)	1040
Soil Type and Condition	Concrete deck, dry	THIV (km/h)	37.4	Interior	
Test Vehicle		Ridedown Accelerations (g's)		OCDI	FS1012000
Type	Production	x-direction	-11.7	Max. Occ. Compart.	
Designation	2000P	y-direction	-9.2	Deformation (mm)	117
Model	1993 Chevrolet pickup truck	PHD (g's)	15.4	Post-Impact Behavior	
Mass (kg) Curb	2142	ASI	1.4	(during 1.0 s after impact)

Test Inertial	2000	Max. 0.050-s Average (g's)		Max. Yaw Angle (deg)	-32
Dummy	No dummy	x-direction	-11.5	Max. Pitch Angle (deg)	3
Gross Static	2000	y-direction	-10.9	Max. Roll Angle (deg)	7
		z-direction	5.0

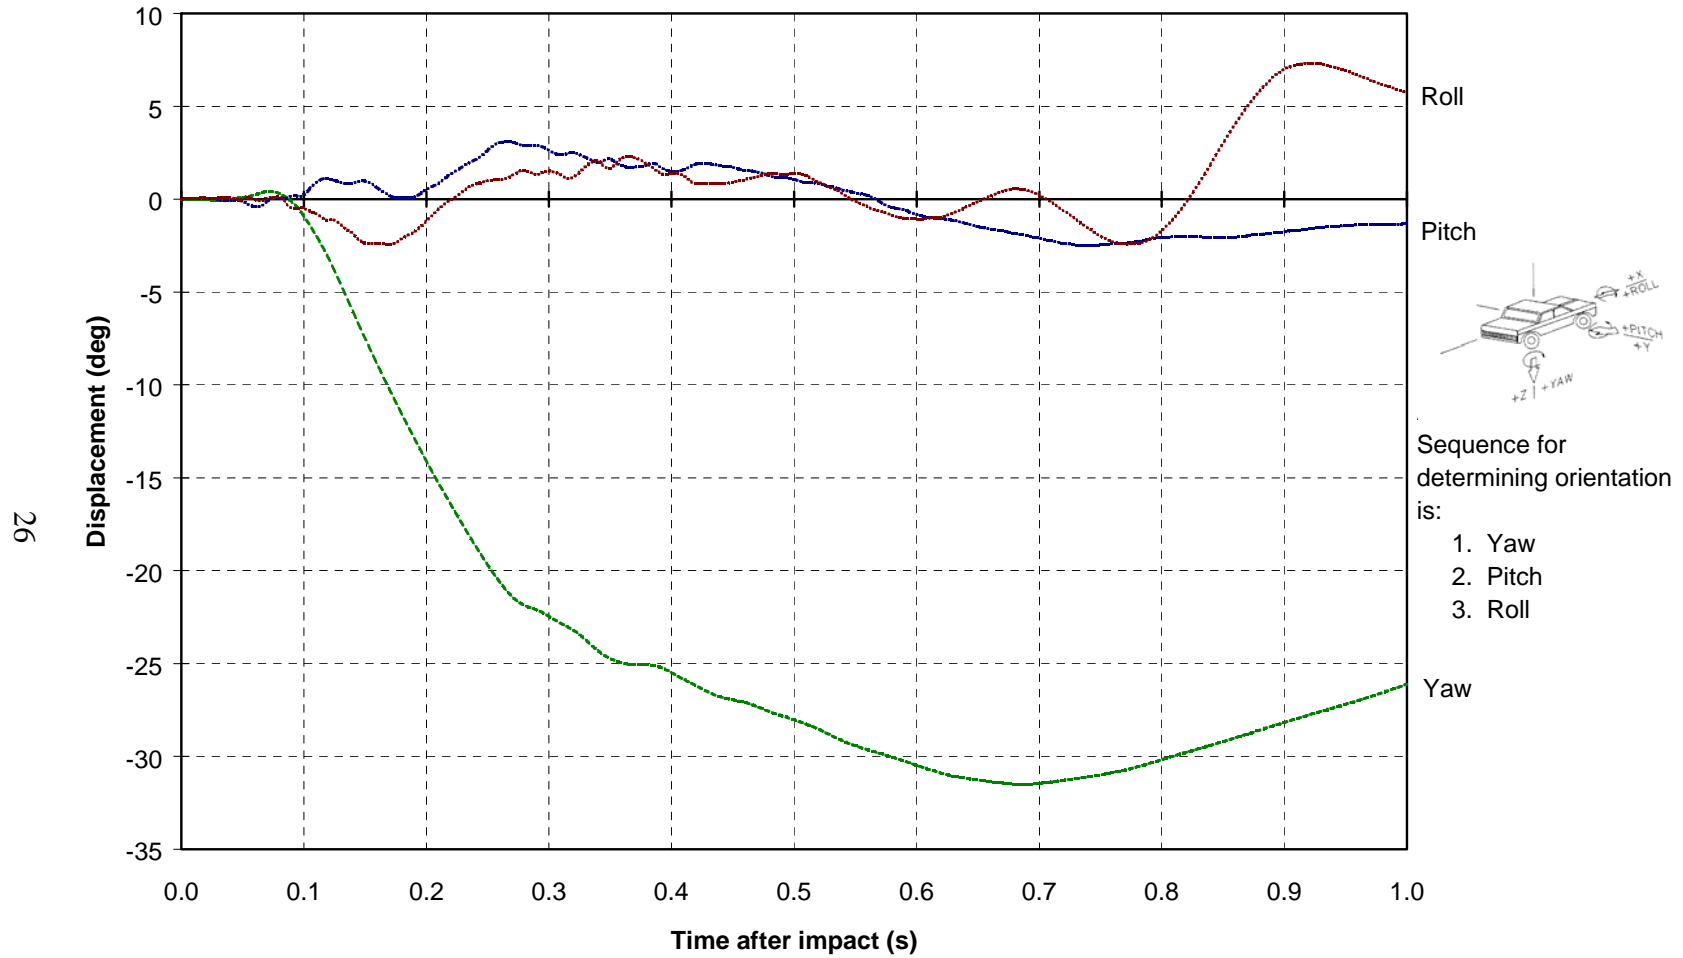
Figure 14. Vehicle Angular Displacements for Test 418048-1

Data from the accelerometer located at the vehicle center of gravity were digitized for evaluation of occupant risk and were computed as follows. In the longitudinal direction, the occupant impact velocity was 9.5 m/s at 0.140 s; the highest 0.010-s occupant ridedown acceleration was -11.3 g's from 0.109 to 0.119 s, and the maximum 0.050-s average acceleration was -11.5 g's between 0.070 and 0.120 s. In the lateral direction, the occupant impact velocity was 7.0 m/s at 0.109 s; the highest 0.010-s occupant ridedown acceleration was -9.2 g's from 0.284 to 0.294 s, and the maximum 0.050-s average was -10.9 g's between 0.049 and 0.099 s. Figure 13 summarizes these data and other pertinent information from the test. Figure 14 displays vehicle angular displacements. Figures 15 and 16 present vehicular accelerations versus time traces.
