**GUARDRAIL TESTING PROGRAM IV  
VOLUME II: APPENDICES**

**U.S. Department of Transportation  
Federal Highway Administration**

**September 2004**

1. Report No. FHWA-HRT-04-087		2. Government Accession No.		3. Recipient's Catalog No.	
4. Title and Subtitle Guardrail Testing Program IV Volume II: Appendices				5. Report Date September 2004

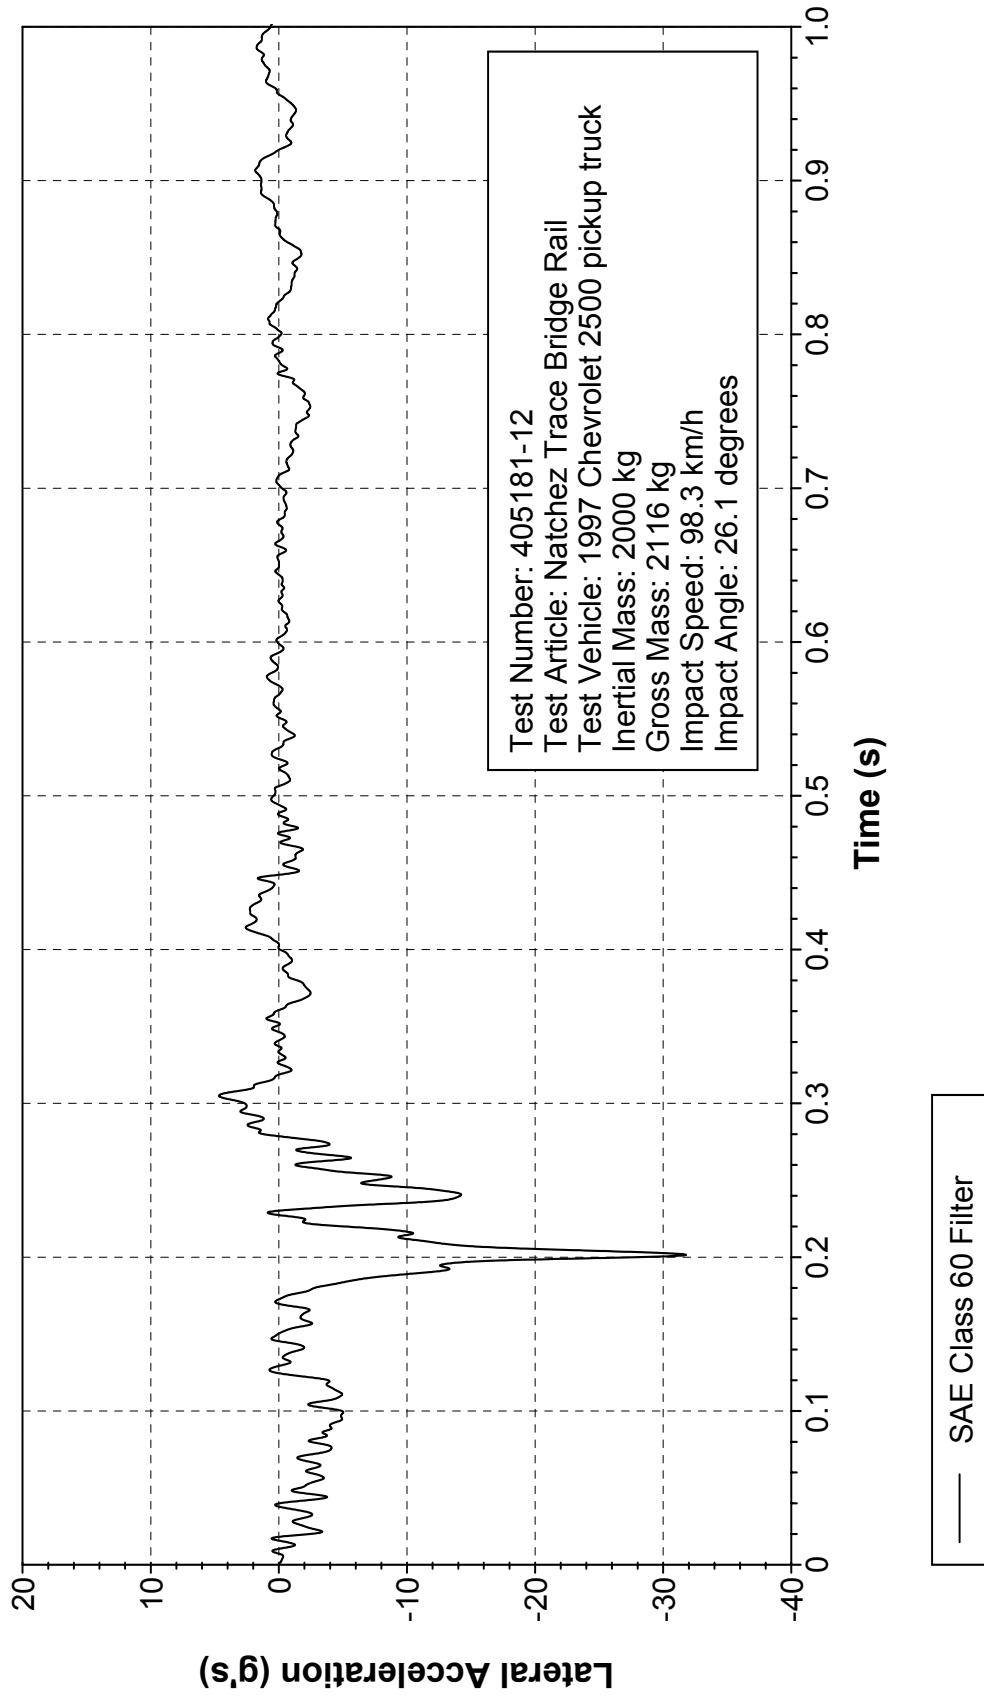
Figure 326. Vehicle lateral accelerometer trace for test 405181-12 (accelerometer located over rear axle).
