**AASHTO PL-1 PERFORMANCE LEVEL CRASH TESTS  
ON THE NATCHEZ TRACE PARKWAY BRIDGE RAIL**

Transportation Research Report No. TRP-03-34-92

**FHWA Contract No. DTFH71-90-C-00035**

October, 1992

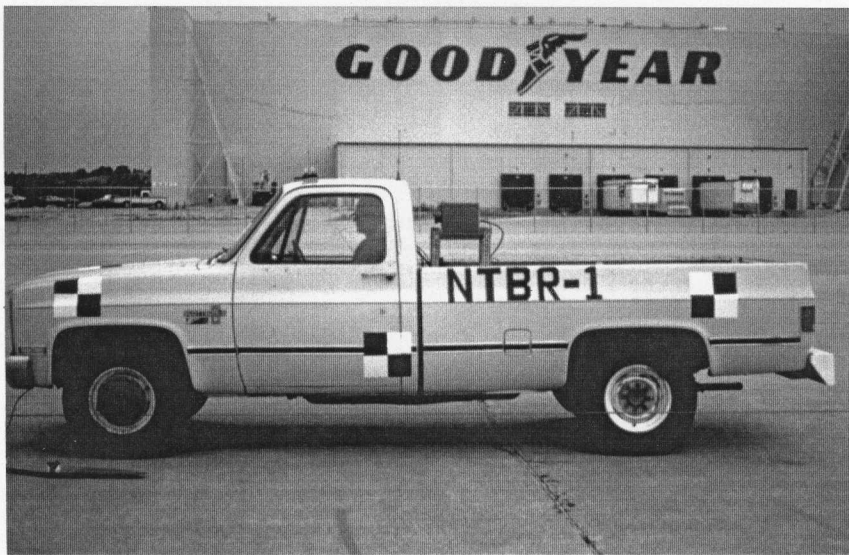
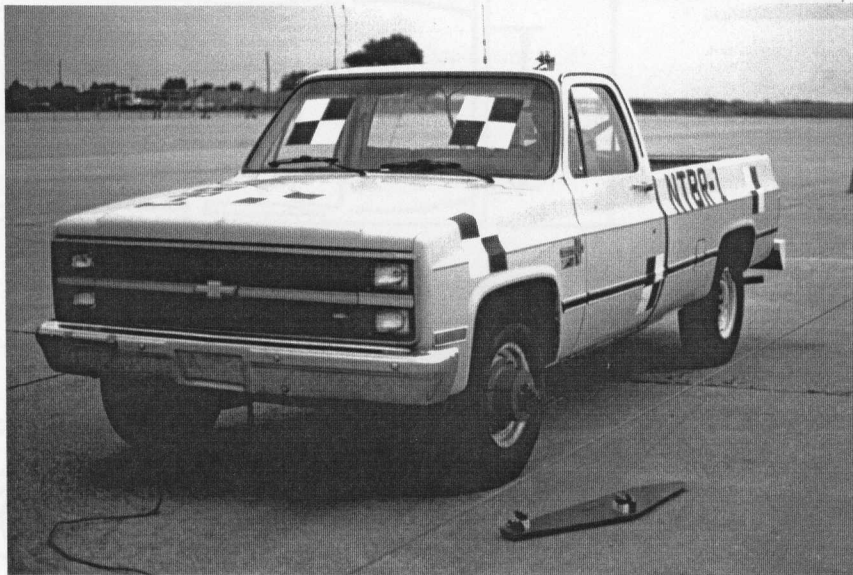
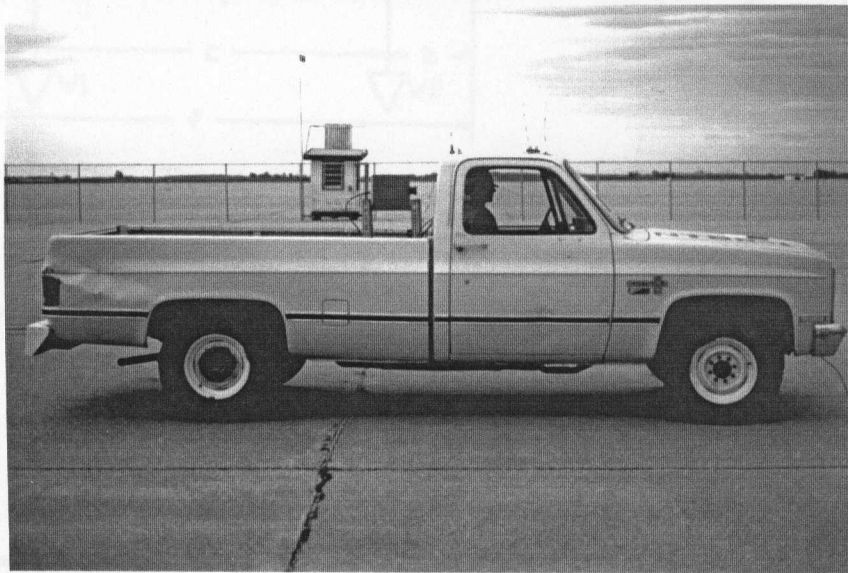
FIGURE 8. Test Vehicle, Test NTBR-1

A 1984 Chevrolet Custom Deluxe 20 pickup, shown in Figure 8, was used as a test vehicle in Test NTBR-1. As shown in Figure 9, the vehicle had a test inertial and a gross static weight of 5,400 lbs and 5,565 lbs, respectively.

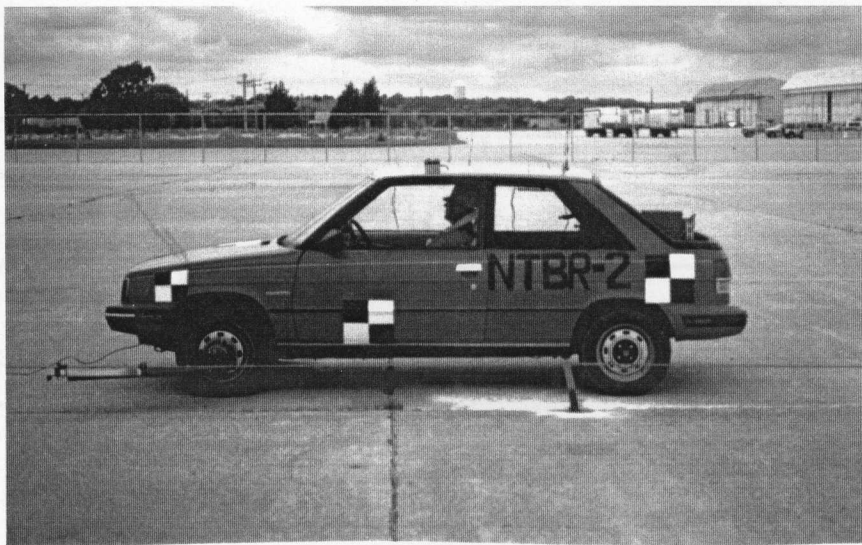
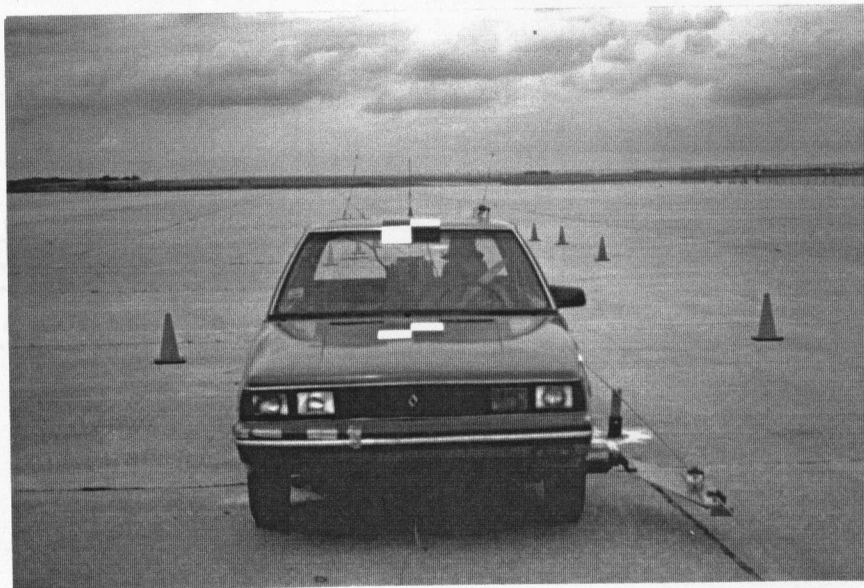
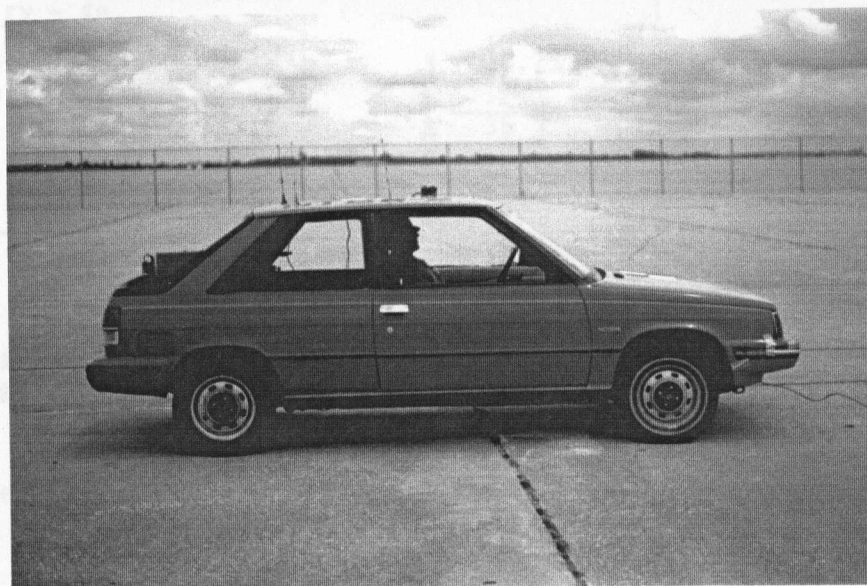
FIGURE 10. Test Vehicle, Test NTBR-2

A 1984 Renault Encore, shown in Figure 10, was used as a test vehicle in Test NTBR-2. This vehicle had test inertial and gross static weights of 1,850 lbs and 2,015 lbs, respectively. Vehicle weights and dimensions are shown in Figure 11.

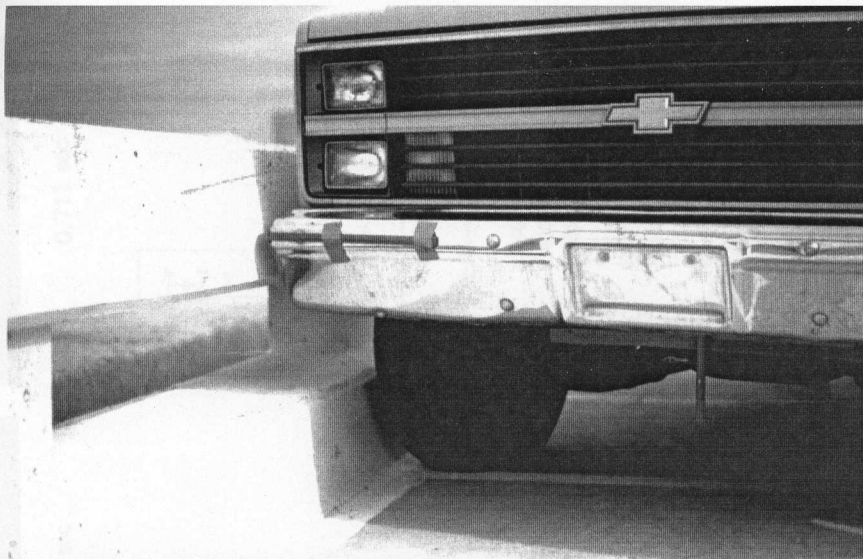
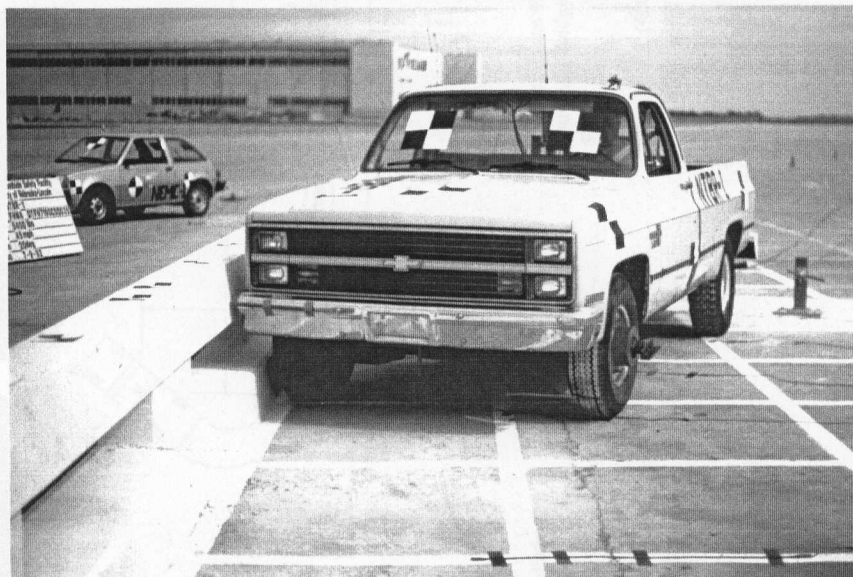
FIGURE 13. Vehicle Impact Location, Test NTBR-1

The 1984 Chevrolet Custom Deluxe 20 pickup was directed into the Natchez Trace Parkway bridge railing using a reverse tow and cable guidance system (4). The vehicle was released from the tow cable and guidance system and was free wheeling at impact. The speed of the vehicle at impact was 45.2 mph and the angle of impact was 22.4 degrees. The impact point, shown in Figure 13, was located at midspan between posts 5 and 6, or 4-ft 6 5/8-in. upstream from the center of the bridge rail expansion joint. A summary of the test results and sequential photographs is shown in Figure 14. Additional sequential photographs are shown in Figures 15 through 18.

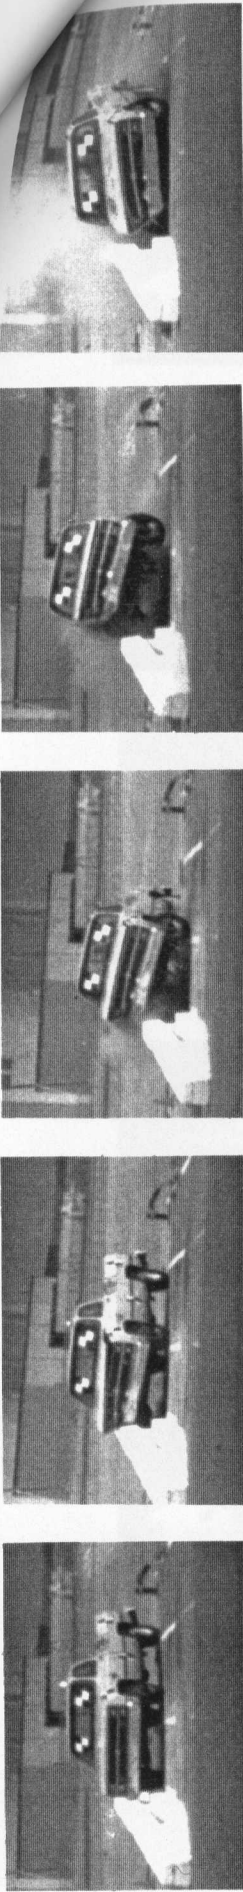
FIGURE 14. Test NTBR-1 Summary

Test Number	NTBR-1
Date	7/9/92
Bridge Rail Installation	Natchez Trace Parkway
	Curb and Bridge Rail
Total Length (ft)	93.6
Material	Concrete
	Reinforcing Steel
Concrete Curb	Class A AE (4000 psi)
	Grade 60 Epoxy Coated
Length (ft)	93.6
Bottom Width (in.)	18
Top Width (in.)	16.5
Height (in.)	10
Concrete Rail	Length (ft)
	Bottom Width (in.)
	Top Width (in.)
	Bottom Height (in.)
	Top Height (in.)
Concrete Posts	Length (in.)
	Width (in.)
	Depth (in.)
Vehicle Model	1984 Chevrolet
	Custom Deluxe 20

Vehicle Weight	Curb (lb)	4,610
	Test Inertial (lb)	5,400
	Gross Static (lb)	5,565
Vehicle Speed	Impact (mph)	45.2
	Exit (mph)	37.0
Vehicle Angle	Impact (deg)	22.4
	Exit (deg)	1.6
Vehicle Snagging		None
Vehicle Stability		Satisfactory
Effective Coefficient of Friction ( $\mu$ )		0.28 (Fair)
Occupant Impact Velocity	Longitudinal (fps)	10.8 (30)
	Lateral (fps)	22.2 (25)
Occupant Ridedown Deceleration	Longitudinal ( $g$ 's)	6.3 (15)
	Lateral ( $g$ 's)	9.5 (15)
Vehicle Damage	Minor	
	TAD	I-RFQ-3
	VDI	01RFEW2
Bridge Rail Damage		Tire marks and minor concrete spalling
Maximum Vehicle Rebound Distance (ft)		0.83

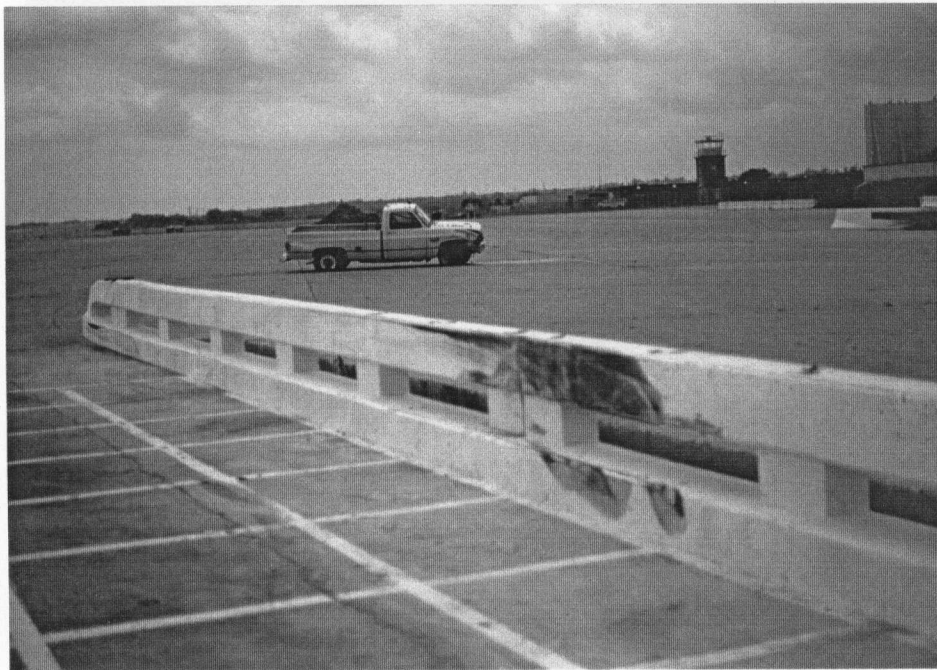
**FIGURE 19.** Vehicle Trajectory, Test NTBR-1

Upon impact the right front corner of the test vehicle crushed inward and the right-front tire began climbing onto the curb. Approximately 32 ms after impact, the right-front tire became wedged under the concrete rail. The right-front corner of the vehicle began to move upward at 56 ms due to compression of the front suspension. At 75 ms, the right-front corner of the vehicle reached the bridge rail expansion joint. The vehicle became parallel with the bridge rail at approximately 250 ms at a velocity of 37 mph. The left-front tire lost contact with the roadway surface at 255 ms after impact. The right-rear tire blew out when it contacted the expansion joint between the two railings at approximately 310 ms. The vehicle exited the bridge rail at approximately 335 ms with an angle of 1.6 deg and at speed of 37.0 mph. The left-front tire returned to the roadway surface at 474 ms. Damage to the suspension and tires caused the vehicle to steer back into the bridge and a second impact occurred at the downstream end of the bridge rail and wingwall section. The vehicle came to a stop approximately 105 ft downstream from impact as shown in Figure 19. The maximum perpendicular distance between the right-

side of the test vehicle and the barrier face was approximately 0.83 ft at a point 30 ft downstream from impact. The effective coefficient of friction was found to be 0.28 and would be classified as "fair" according to the AASHTO Guide Specifications for Bridge Railings (5).

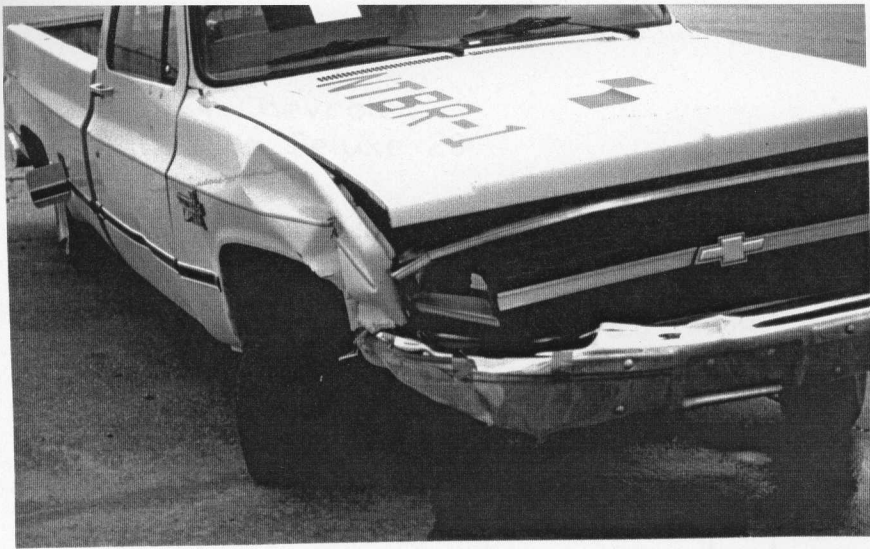
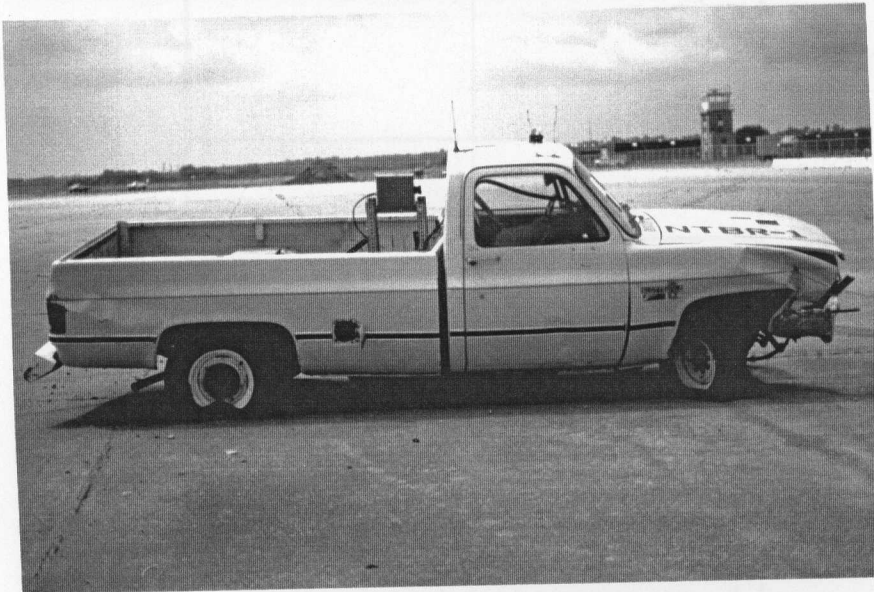
FIGURE 20. Vehicle Damage, Test NTBR-1

Test vehicle damage was relatively minor and was largely limited to the right-front quarter panel and front bumper, as shown in Figure 20. Both right-side tires were blown out and the rims were damaged during the impact. The right-rear bumper also received minor damage. There was no intrusion or deformation of the occupant compartment. TAD (6) and VDI (7) damage classifications are shown in Figure 14. Vehicle crush measurements are shown in Figure 21. The bridge rail received superficial damage, as shown in Figure 22. Heavy tire marks and deep scrapes on the rail indicating large contact forces were found over a 13-ft 11-in. length of the bridge rail. Lighter tire marks and small scrapes were observed over a 13 ft. length of the rail. Evidence of impact with the curb was limited to 4-ft 8-in. of tire marks.

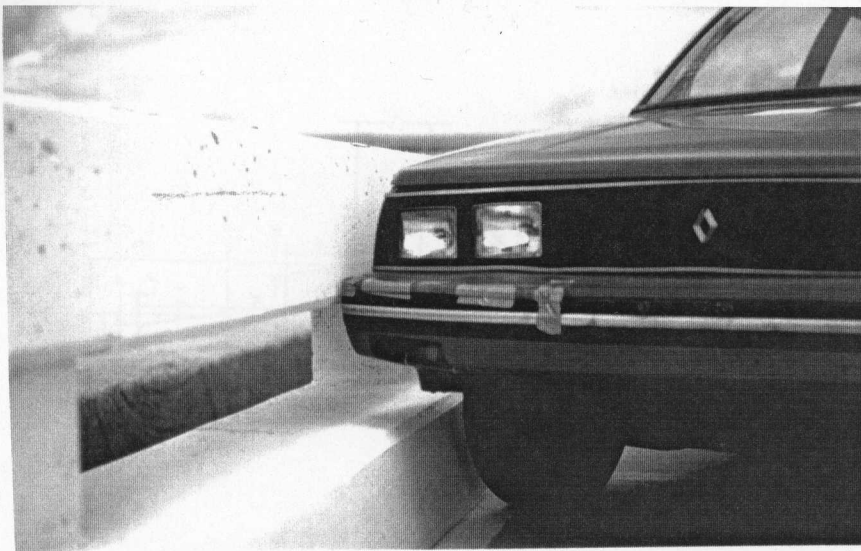
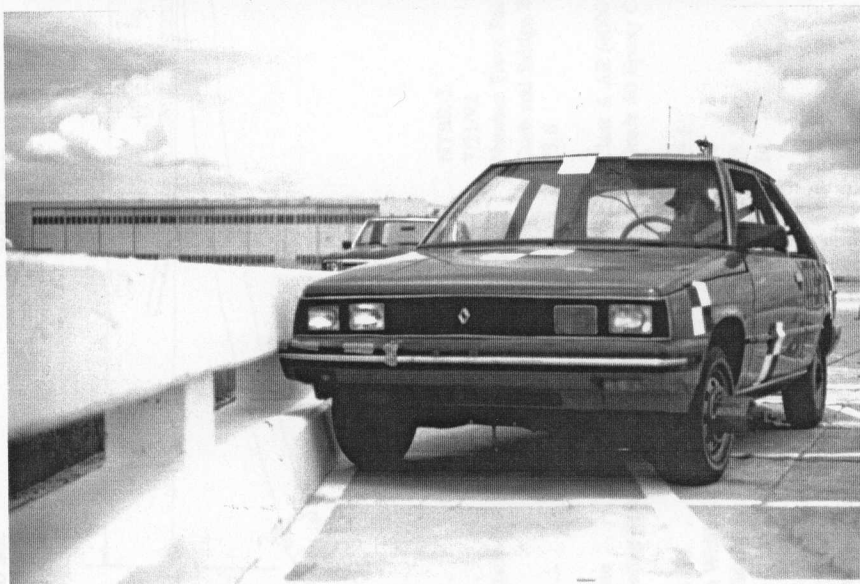
FIGURE 23. Vehicle Impact Location, Test NTBR-2

The 1984 Renault Encore was directed into the Natchez Trace Parkway bridge railing using a reverse tow and cable guidance system (4). The vehicle was released from the tow cable and guidance system and was free wheeling at impact. The speed of the vehicle at impact was 51.5 mph and the angle of impact was 19.5 degrees. The impact point, shown in Figure 23, was located at midspan between posts 4 and 5. A summary of the test results and sequential photographs is shown in Figure 24. Additional sequential photographs are shown in Figures 25 through 28.

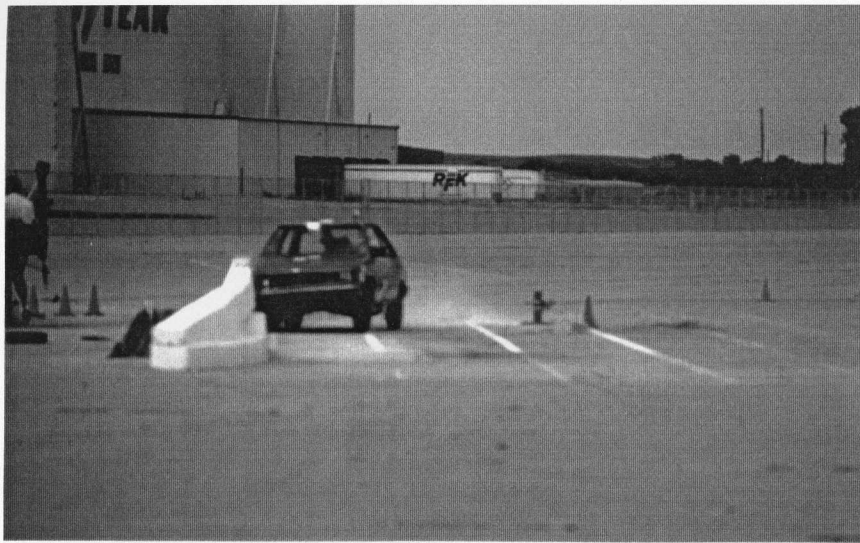
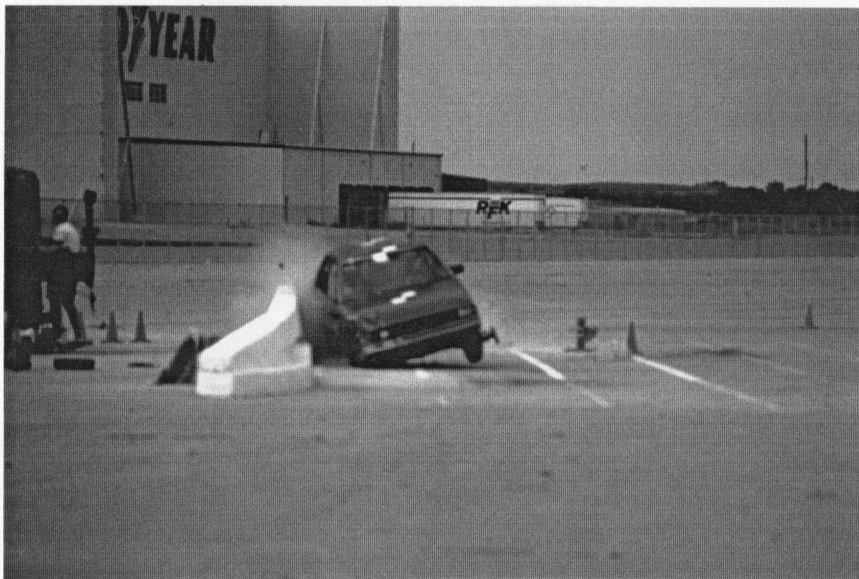
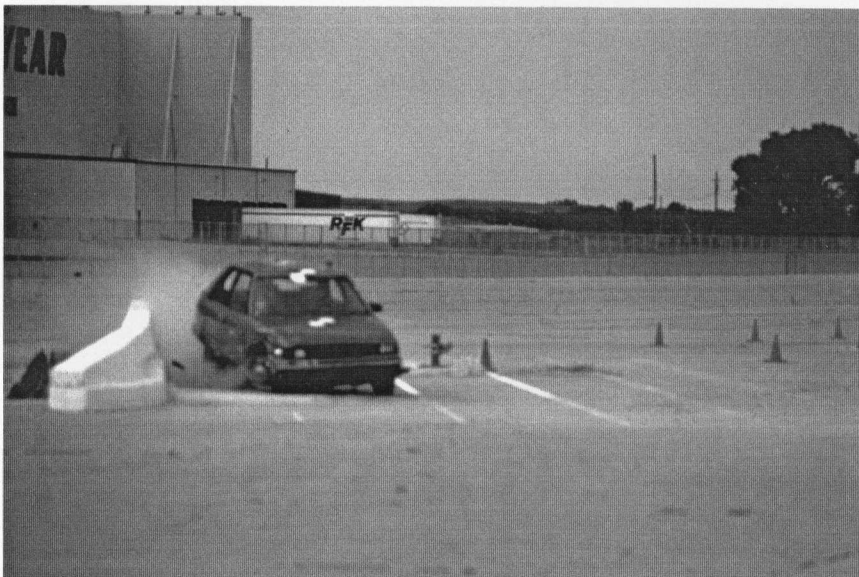
**FIGURE 27.** Full-Scale Vehicle Crash Test, Test NTBR-2

After the initial impact with the bridge rail, the right-front corner of the vehicle crushed inward, causing the bumper to penetrate between the curb and the rail. Simultaneously, the right-front tire was deformed against the face of the curb. This interaction of the curb and the wheel caused the tire to blow out. The vehicle became parallel with the bridge rail at approximately 164 ms with a velocity of 38.3 mph. During redirection, the left-rear tire began to uplift, causing the vehicle to roll clockwise toward the rail. The vehicle exited the rail at approximately 345 ms with an angle of 8.5 degrees and an speed of 32.4 mph. Both left-side tires contacted the ground at 760 ms as the vehicle yawed away from the rail. The vehicle's trajectory is shown in Figure 29. The maximum rebound distance was approximately 25.3 ft which is higher than the desired value of 20 ft. The effective coefficient of friction was found to be 0.60, and would be classified as "fair" according to the AASHTO Guide Specifications for Bridge Railings (5).

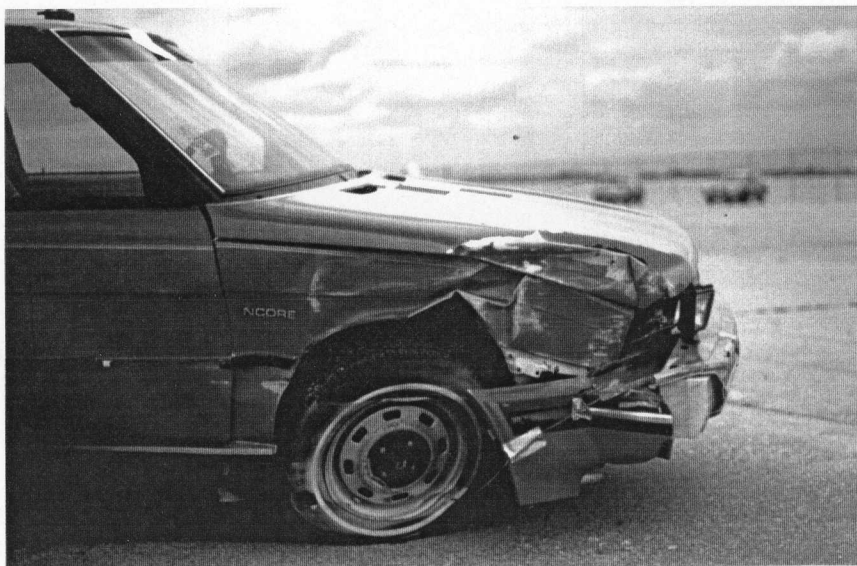
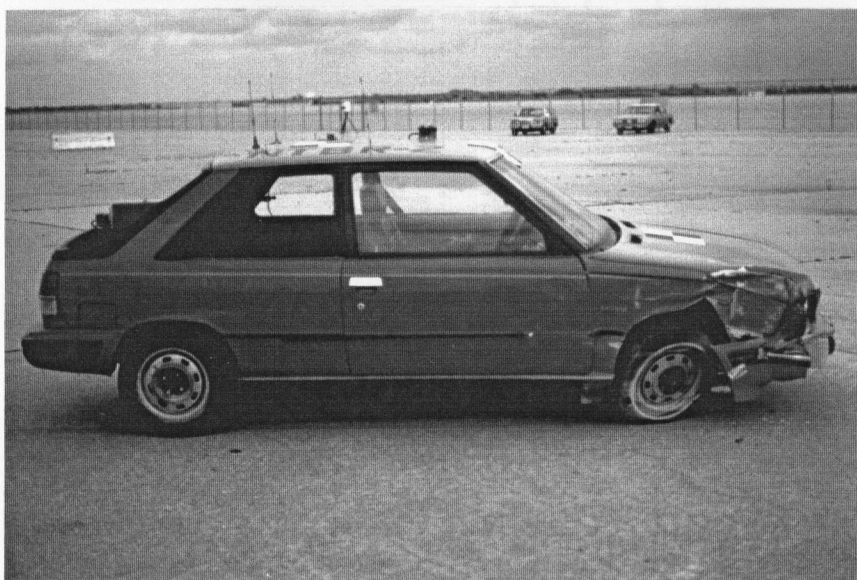
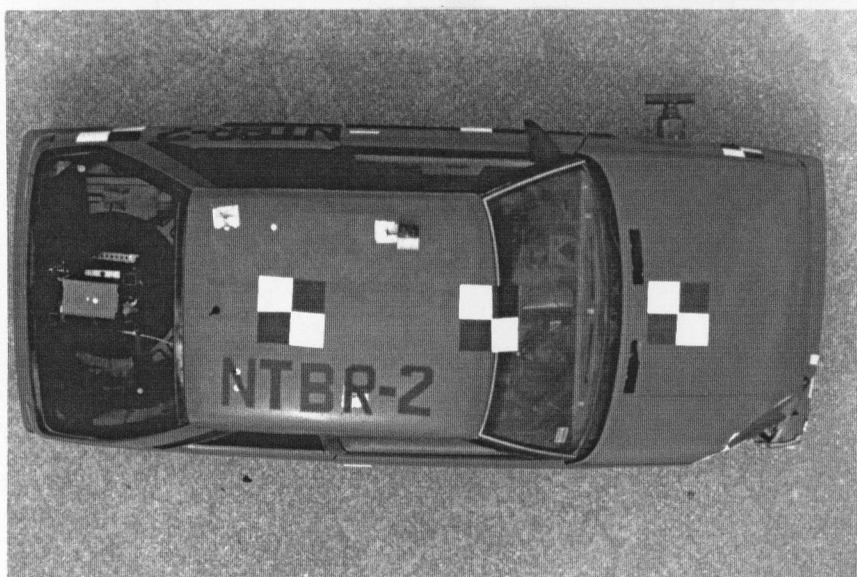
**FIGURE 30.** Vehicle Damage, Test NTBR-2

Test vehicle damage was relatively minor and was largely limited to the right-front quarter panel and wheel, and front bumper, as shown in Figure 30. There was slight buckling of the right-front floorboard and roof due to the force of the impact. The vehicle remained upright both during and after the test, and there was no intrusion of the occupant compartment.

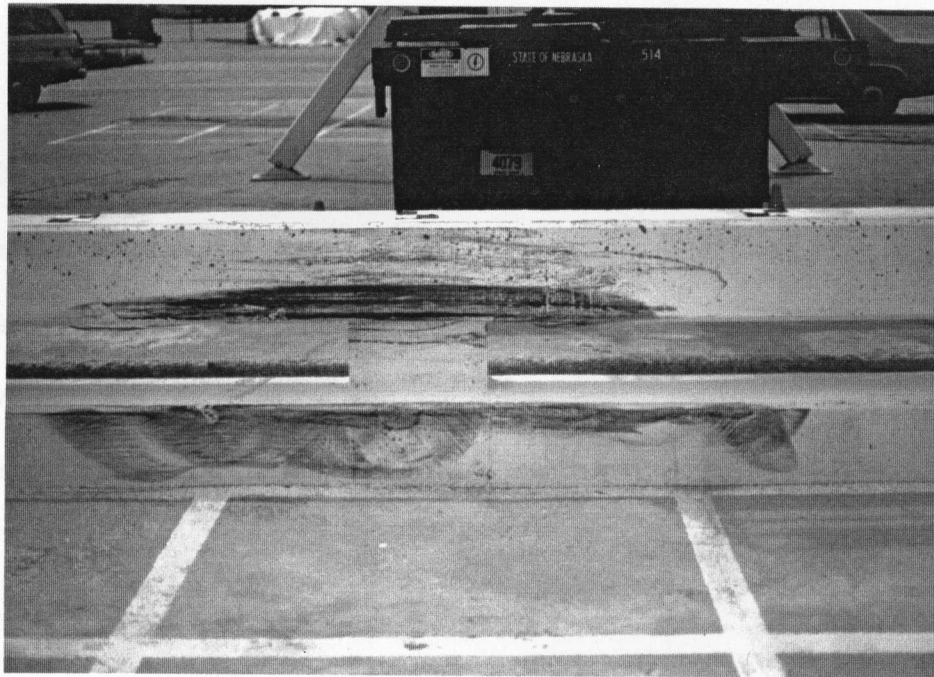
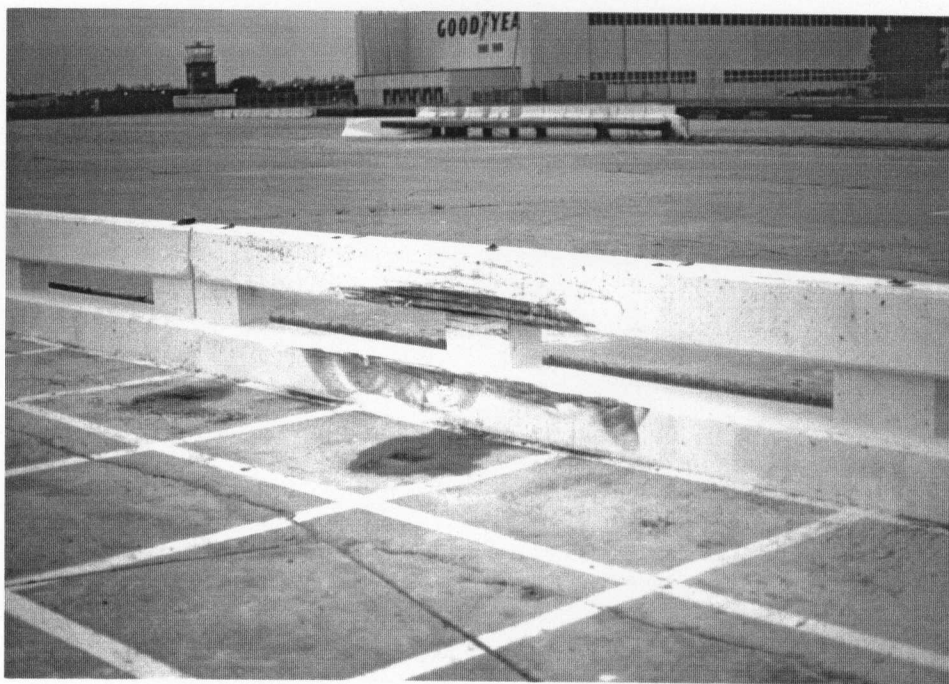
**FIGURE 32.** Bridge Rail Damage, Test NTBR-2

Bridge rail damage is shown in Figure 32. Tire marks and minor concrete spalling accounted for the majority of the damage. The length of the markings on the rail were approximately 7.5 ft, caused by the scraping of the bumper and the fender. The length of the markings on the curb were 8.5 ft, caused by the rubbing of the right-front tire which blew out at impact.
