1. Report No. FHWA/TX-03/4288-1		2. Government Accession No.		3. Recipient's Catalog No.	
4. Title and Subtitle DESIGN AND EVALUATION OF THE TXDOT F411 AND T77 AESTHETIC BRIDGE RAILS				5. Report Date October 2002

**DESIGN AND EVALUATION OF THE TxDOT
F411 AND T77 AESTHETIC BRIDGE RAILS**

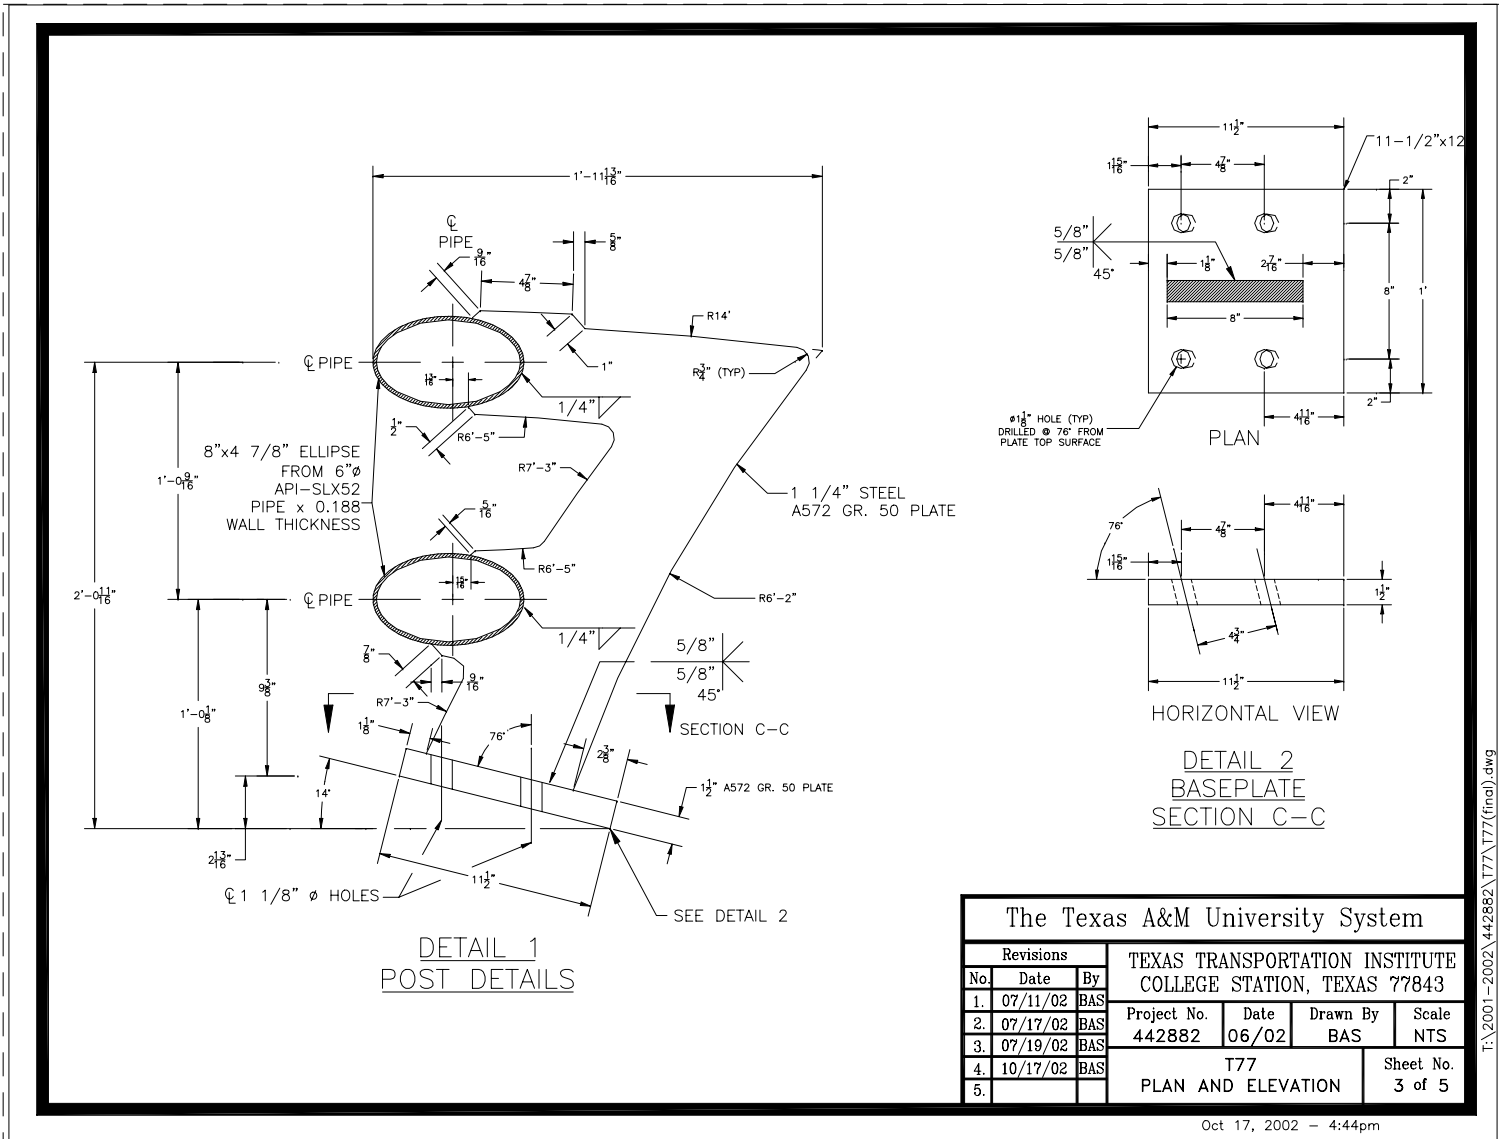
Figure 4. Details of the TxDOT T77 Bridge Rail.

Figure 4. Details of the TxDOT T77 Bridge Rail (Continued).

TTI designed, constructed, and crash tested a prototype steel aesthetic bridge rail designated as TxDOT Type T77. [Appendix B](#) presents design calculations for the bridge rail. The total length of the railing installation was 75 ft (22.7 m). The T77 bridge railing system is a steel rail and post system consisting of two tubular steel rail elements mounted on 1-1/4 inch (32 mm) thick steel plate posts spaced 8 ft (2.4 m) apart. The elliptical-shaped rails were 8 inch × 4-7/8 inch (203 mm × 124 mm) and were manufactured from 6 inch (152 mm) diameter, API-5LX52 pipe with a wall thickness of 0.188 inch (20 mm). The center of the lower rail and the top of the upper rail measured 1 ft-6-inches (0.45 m) and 2 ft-9 inches (0.8 m), respectively, from

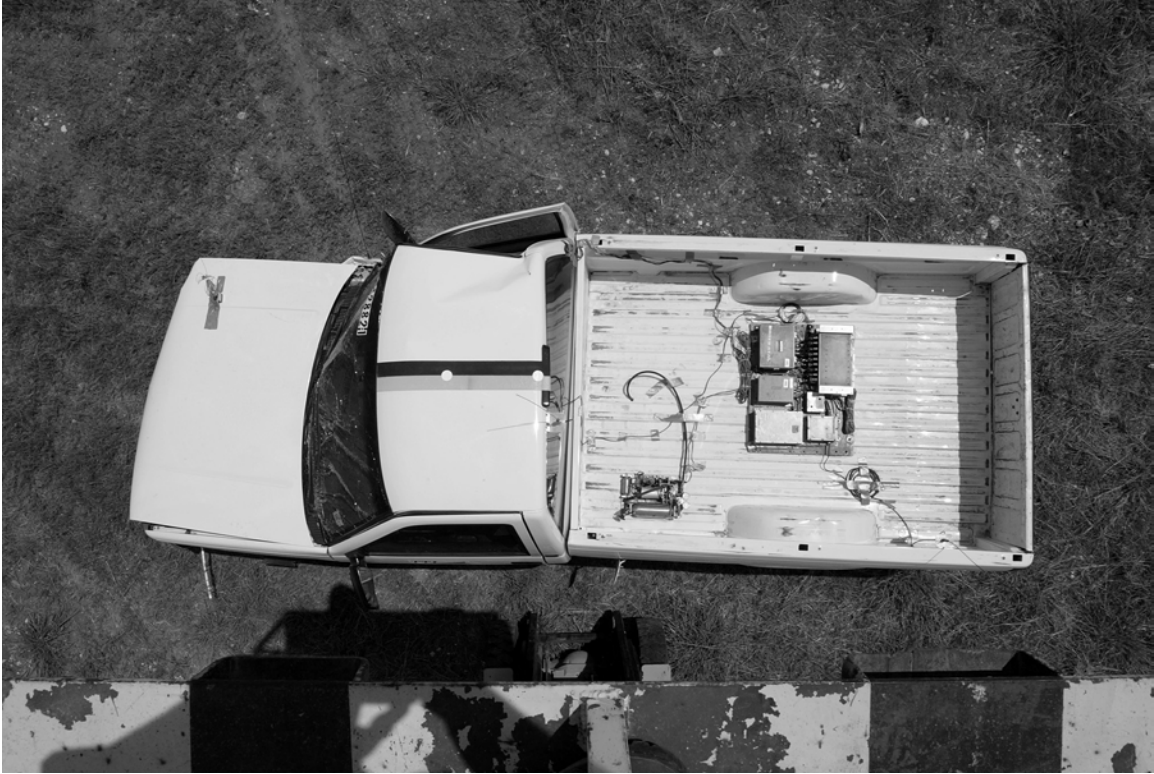
Figure 10. Vehicle after Test 442882-1.

Figure 10 shows damage imparted to the vehicle. Structural damage included deformation of the right upper and lower A-arms, right spindle and tie rod ends, stabilizer bar, right front of the frame, A and B pillars, floor pan, and firewall. Also damaged were the front bumper, hood, radiator and fan, right front tire and wheel, right front quarter panel, right door and window glass, and right side bed. The roof was deformed and the windshield was cracked. Maximum exterior crush to the vehicle was 25.6 inches (650 mm) in the front plane at the right front corner near bumper height. The vehicle was also crushed 20.9 inches (530 mm) in the side plane at the right front corner near bumper height. Maximum occupant compartment deformation was 8.3 inches (210 mm) in the right side door area. The right side floor pan area was deformed inward 7.3 inches (186 mm), and the right side firewall area was deformed inward 6.9 inches (175 mm). Figure 11 shows photographs of the interior of the vehicle. Exterior vehicle crush and occupant compartment deformation are shown in Appendix D, Tables 5 and 6.

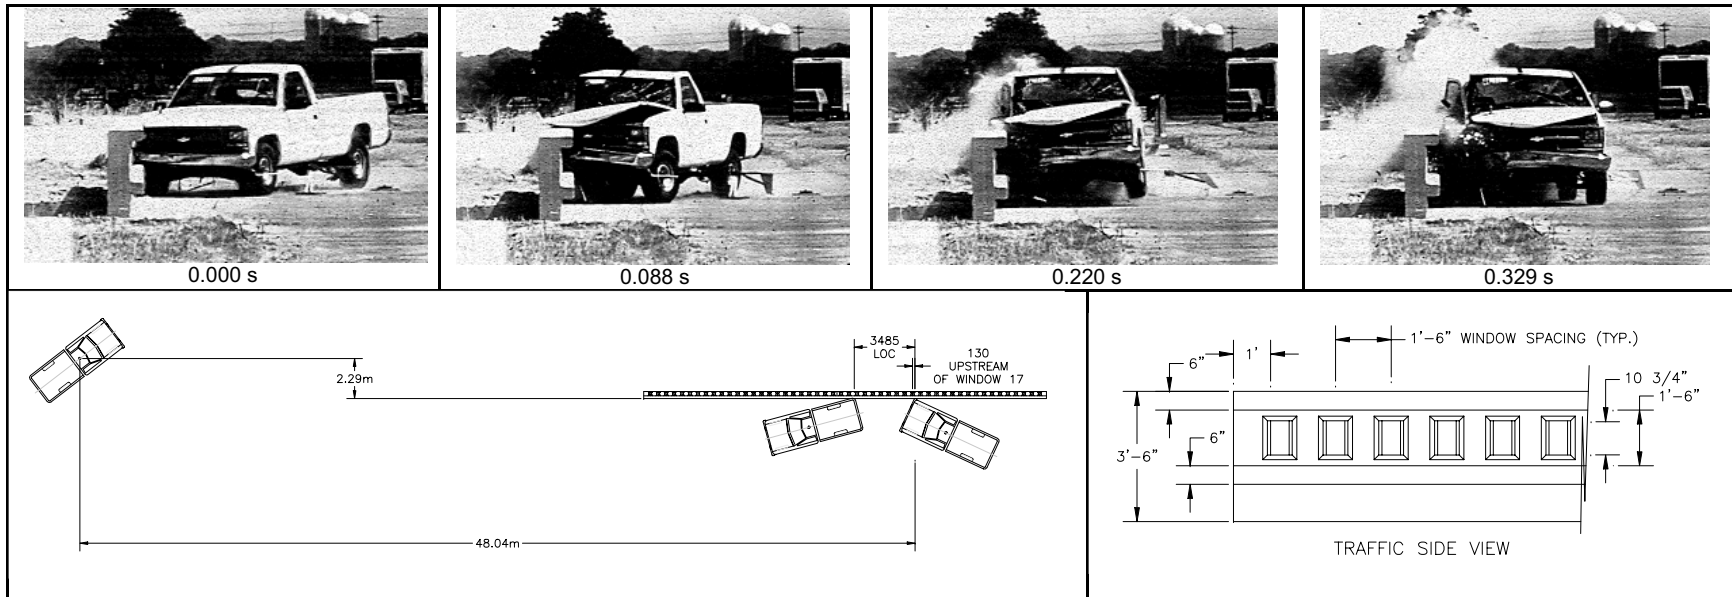
General Information Test Agency Texas Transportation Institute Test No. 442882-1 Date 05/06/02		Impact Conditions Speed (mi/h) 61.4 (98.8 km/h) Angle (deg) 24.8		Test Article Deflections (ft) Dynamic None Permanent None Working Width 1.41 (0.43 m)	
Test Article Type Bridge Rail Name F411 Aesthetic Bridge Rail Installation Length (ft) 76 (23.2 m) Material or Key Elements Concrete Bridge Rail With Two Concrete Rails And Aesthetic Openings		Exit Conditions Speed (mi/h) 36.0 (57.9 km/h) Angle (deg) 7.3		Vehicle Damage Exterior VDS 01FR2 CDC 01RFAW3 Maximum Exterior Vehicle Crush (in) 25.6 (650 mm)	
Soil Type and Condition Concrete Footing, Dry		Occupant Risk Values Impact Velocity (ft/s) x-direction 26.2 (8.0 m/s) y-direction 23.0 (7.0 m/s) THIV (mph) 23.5 (37.8 km/h)		Interior OCDI RF2222010 Max. Occ. Compart. Deformation (in) 8.3 (210 mm)	
Test Vehicle Type Production Designation 2000P Model 1997 Chevrolet 2500 Pickup Mass (lbs) Curb 4778 (2170 kg) Test Inertial 4502 (2044 kg) Dummy N/A Gross Static 4502 (2044 kg)		Ridedown Accelerations (g's) x-direction -6.0 y-direction -5.4 PHD (g's) 6.8 ASI 1.50 Max. 0.050-s Average (g's) x-direction -12.3 y-direction -10.5 z-direction 5.2		Post-Impact Behavior (during 1.0 s after impact) Max. Yaw Angle (deg) -30.5 Max. Pitch Angle (deg) -2.2 Max. Roll Angle (deg) 4.1

Figure 12. Summary of Results for Test 442882-1, NCHRP Report 350 Test 3-11.

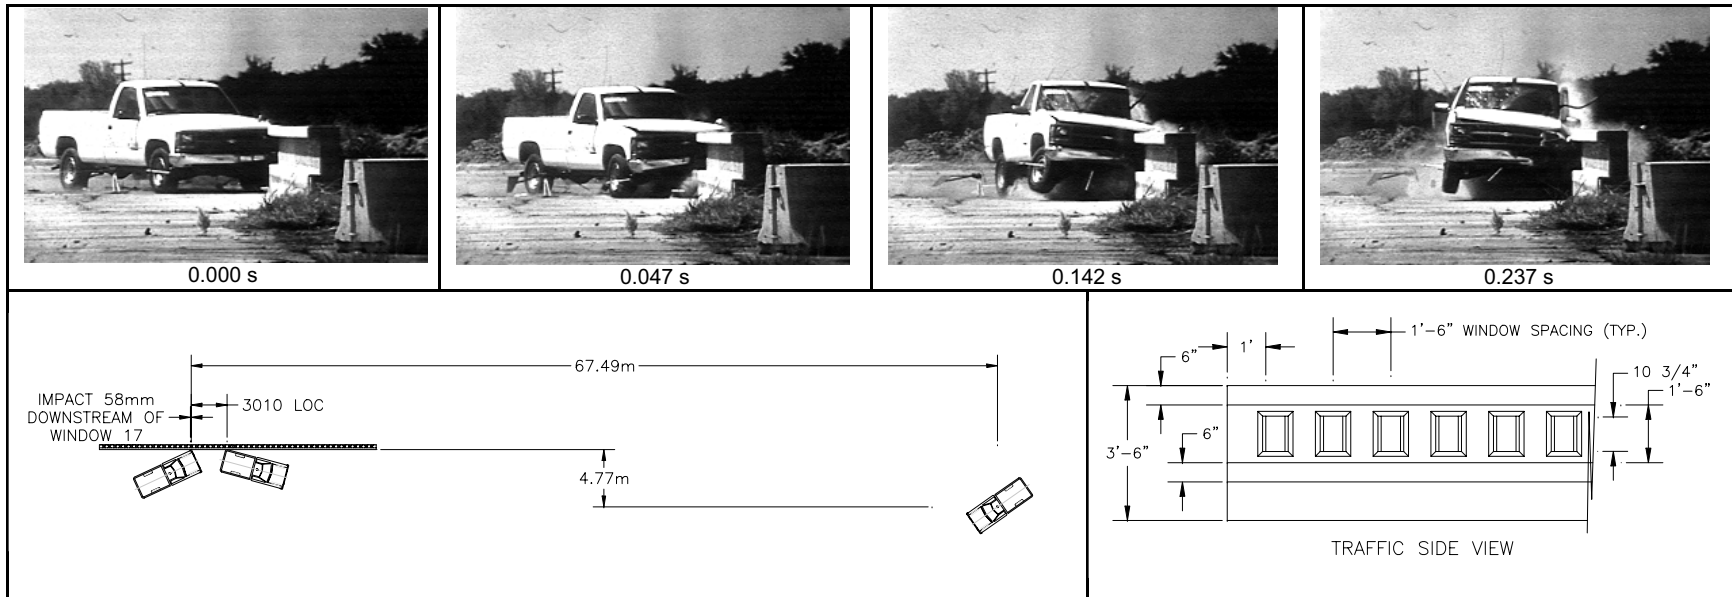
General Information		Impact Conditions		Test Article Deflections (ft)	
Test Agency	Texas Transportation Institute	Speed (mi/h)	62.8 (101.1 km/h)	Dynamic	None
Test No.	442882-2	Angle (deg)	26.1	Permanent	None
Date	07/18/02	Exit Conditions		Working Width	1.71 (0.52 m)
Test Article		Speed (mi/h)	49.6 (79.9 km/h)	Vehicle Damage	
Type	Bridge Rail	Angle (deg)	4.5	Exterior	
Name	F411 Aesthetic Bridge Rail	Occupant Risk Values		VDS	
Installation Length (ft)	76 (23.2 m)	Impact Velocity (ft/s)		CDC	
Material or Key Elements	Concrete Bridge Rail With Two Concrete Rails And Aesthetic Openings	x-direction	24.6 (7.5 m/s)	Maximum Exterior	
Soil Type and Condition	Concrete Footing	y-direction	28.5 (8.7 m/s)	Vehicle Crush (in)	
Test Vehicle		THIV (mph)	25.5 (41.0 km/h)	Interior	
Type	Production	Ridedown Accelerations (g's)		OCDI	
Designation	2000P	x-direction	-6.7	Max. Occ. Compart.	
Model	1998 Chevrolet 2500 Pickup	y-direction	8.0	Deformation (in)

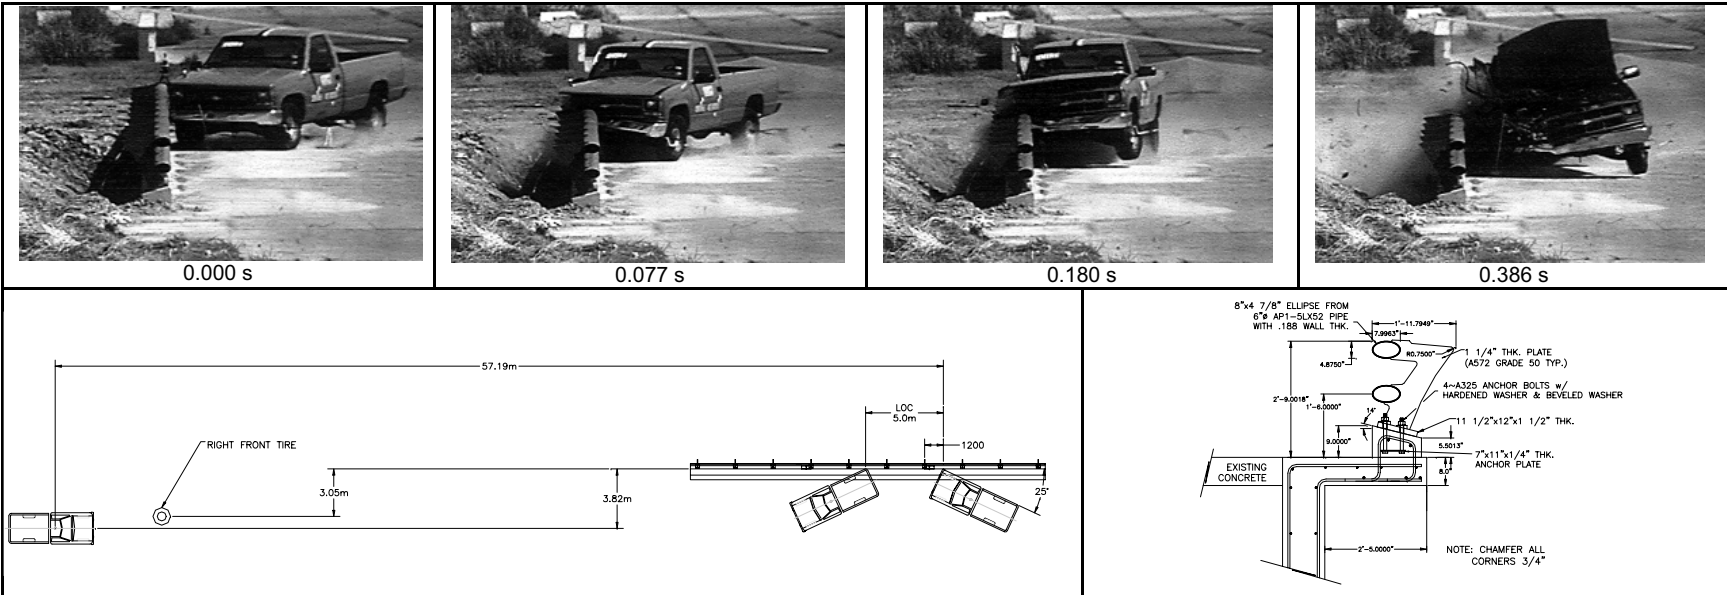
General Information		Impact Conditions		Test Article Deflections (ft)	
Test Agency	Texas Transportation Institute	Speed (mi/h)	60.8 (97.8 km/h)	Dynamic	0.18 (0.05 m)
Test No.	442882-3	Angle (deg)	24.2	Permanent	0.04 (0.01 m)
Date	08/23/02	Exit Conditions		Working Width	2.10 (0.64 m)
Test Article		Speed (mi/h)	44.7 (71.9 km/h)	Vehicle Damage	
Type	Bridge Rail	Angle (deg)	10.8	Exterior	
Name	T77 Aesthetic Bridge Rail	Occupant Risk Values		VDS	
Installation Length (ft)	75 (22.7 m)	Impact Velocity (ft/s)		CDC	
Material or Key Elements	Tubular Steel Rail Elements Mounted On Steel "7" Shaped Posts	x-direction	21.6 (6.6 m/s)	Maximum Exterior	
Soil Type and Condition	Concrete Footing	y-direction	21.0 (6.4 m/s)	Vehicle Crush (in)	
Test Vehicle		THIV (mph)	19.9 (32.1 km/h)	Interior	
Type	Production	Ridedown Accelerations (g's)		OCDI	
Designation	2000P	x-direction	-5.6	Max. Occ. Comp.	
Model	1997 Chevrolet 2500 Pickup	y-direction	-13.5	Deformation (in)

Mass (lbs)		PHD (g's)	14.2	Post-Impact Behavior	
Curb	4723 (2145 kg)	ASI	1.23	(during 1.0 s after impact)	
Test Inertial	4500 (2043 kg)	Max. 0.050-s Average (g's)		Max. Yaw Angle (deg)	
Dummy	N/A	x-direction	-9.8	Max. Pitch Angle (deg)	
Gross Static	4500 (2043 kg)	y-direction	-9.4	Max. Roll Angle (deg)	
		z-direction	-4.7

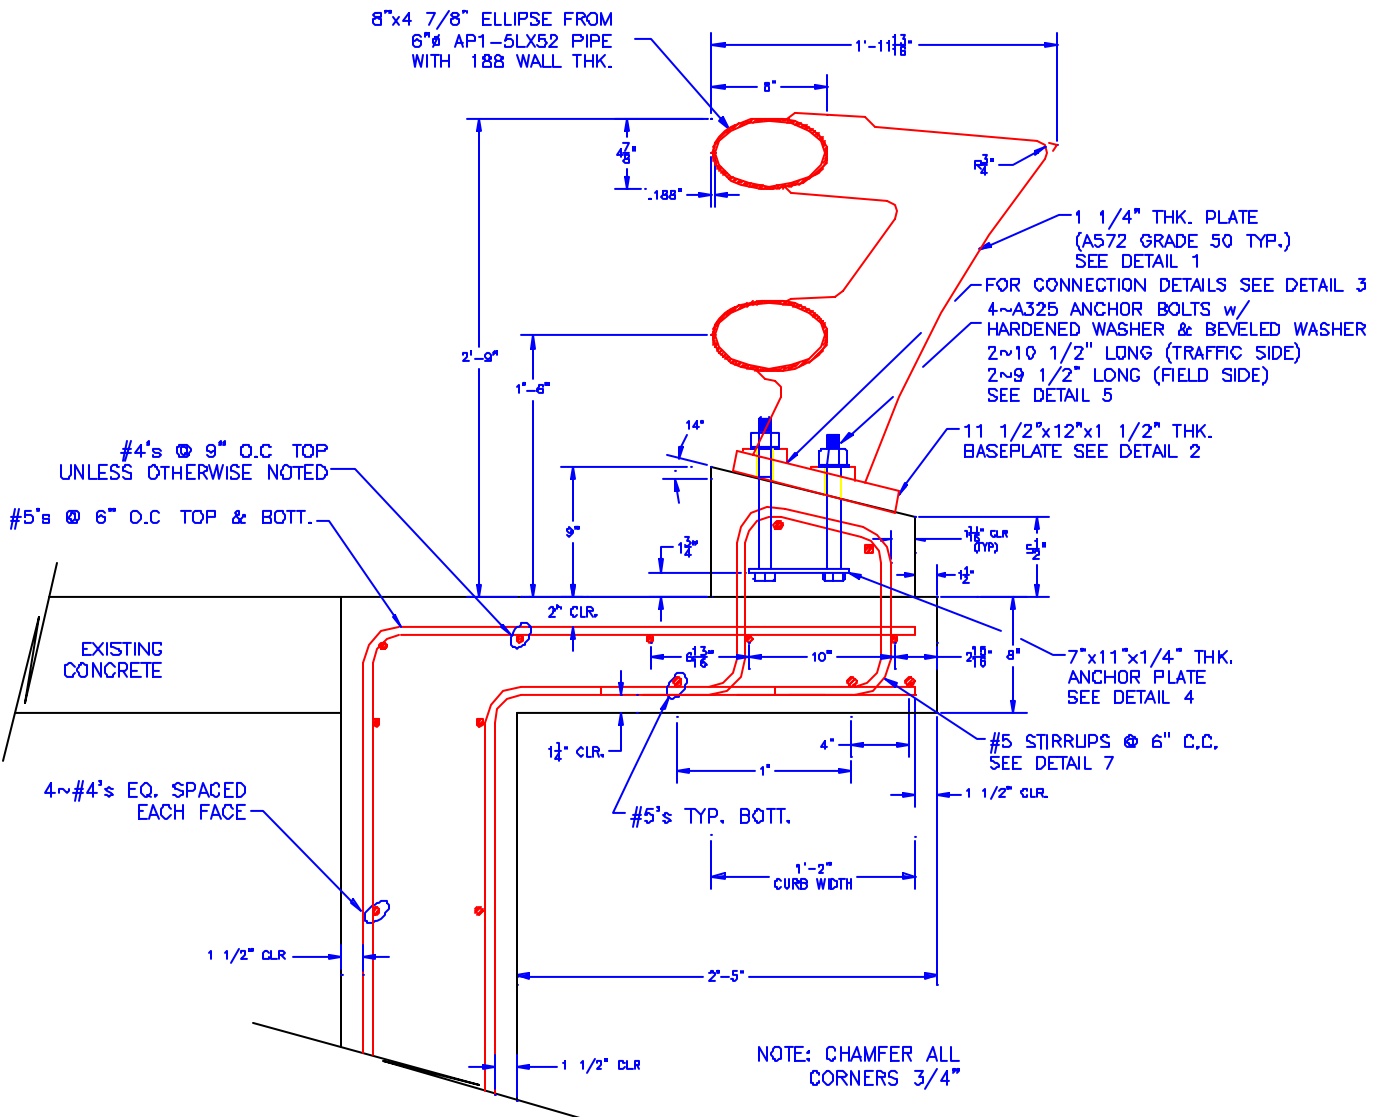
Find: Check Bridge Rail Design to Meet TL-4 Requirements w/ **8-ft Post Spacing:**

SUBJECT Texas Type T77 Aesthetic Bridge Rail

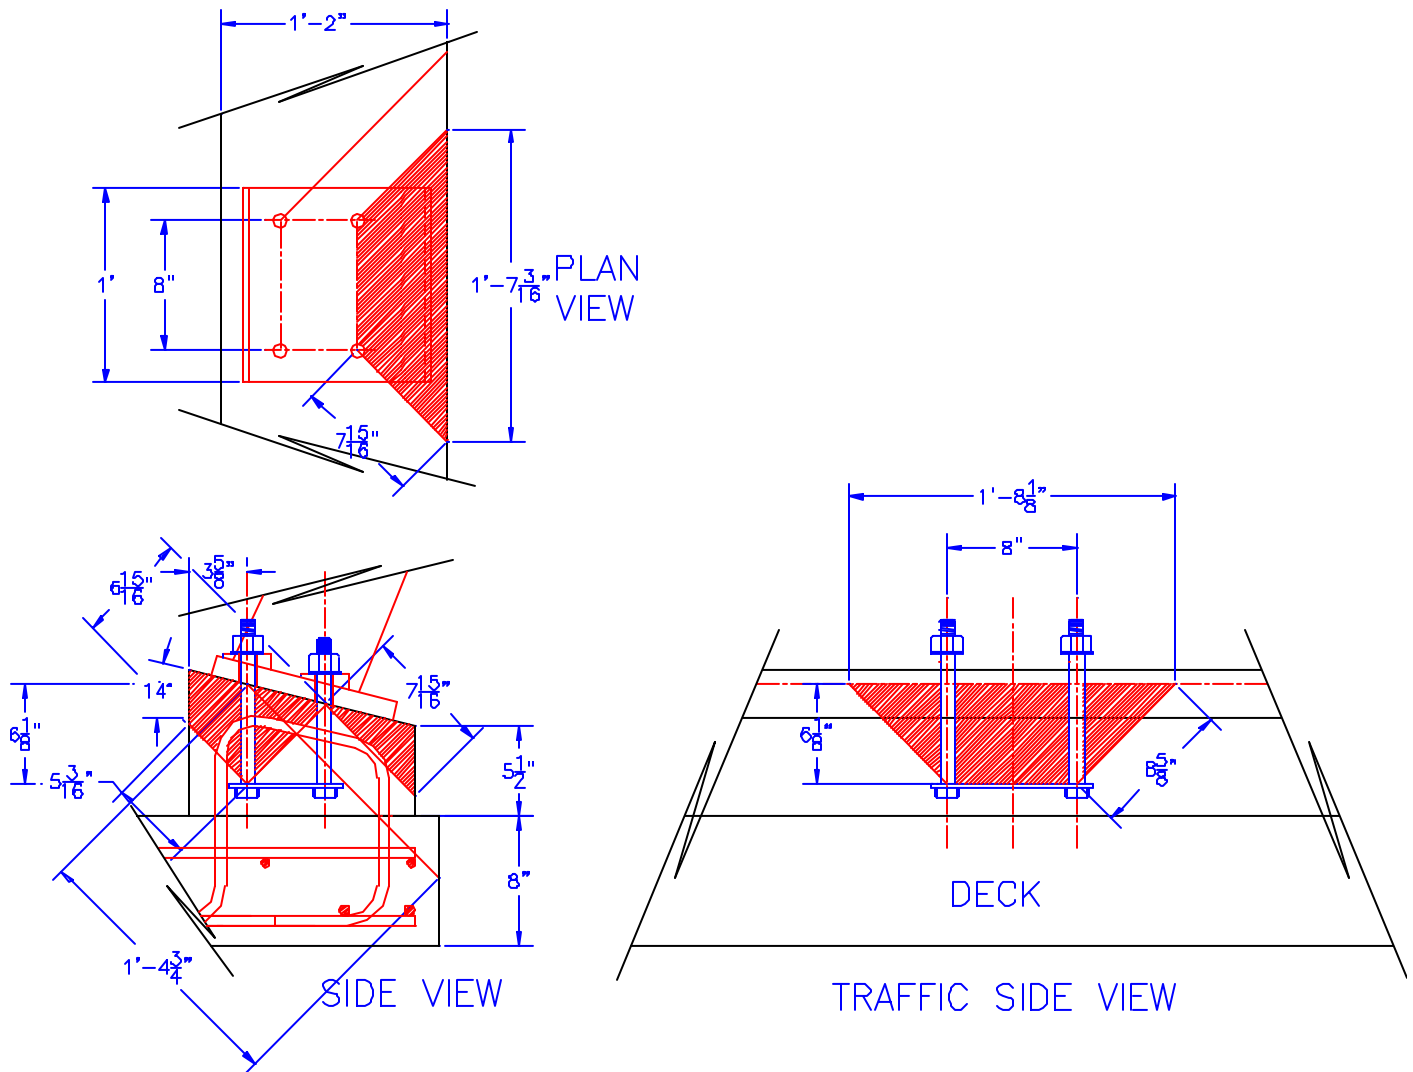
8.) Lateral Block Shear Failure Due to Bolt Shear (P_{Post4}):

Reference: Specification for the Design of Anchor Bolts (Rev. 0) S&B ES-3140
 From Figure 4 ~ "Shear Cone for Overlapping Cones"

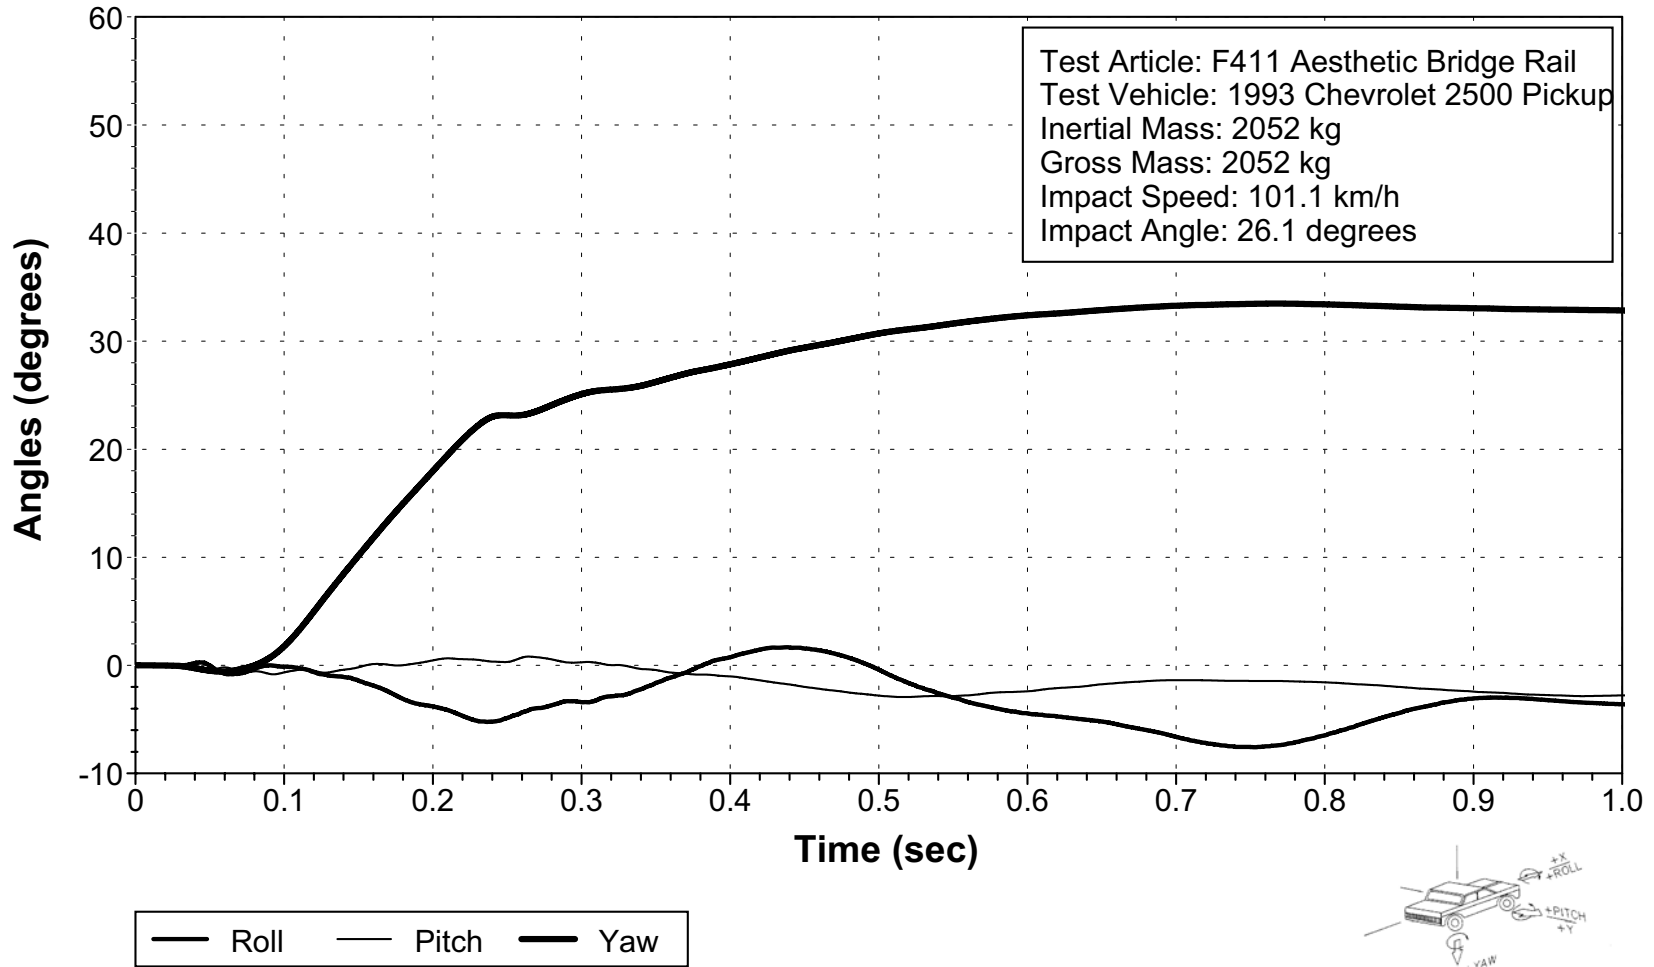
Figure 47. Vehicular Angular Displacements for Test 442882-2.

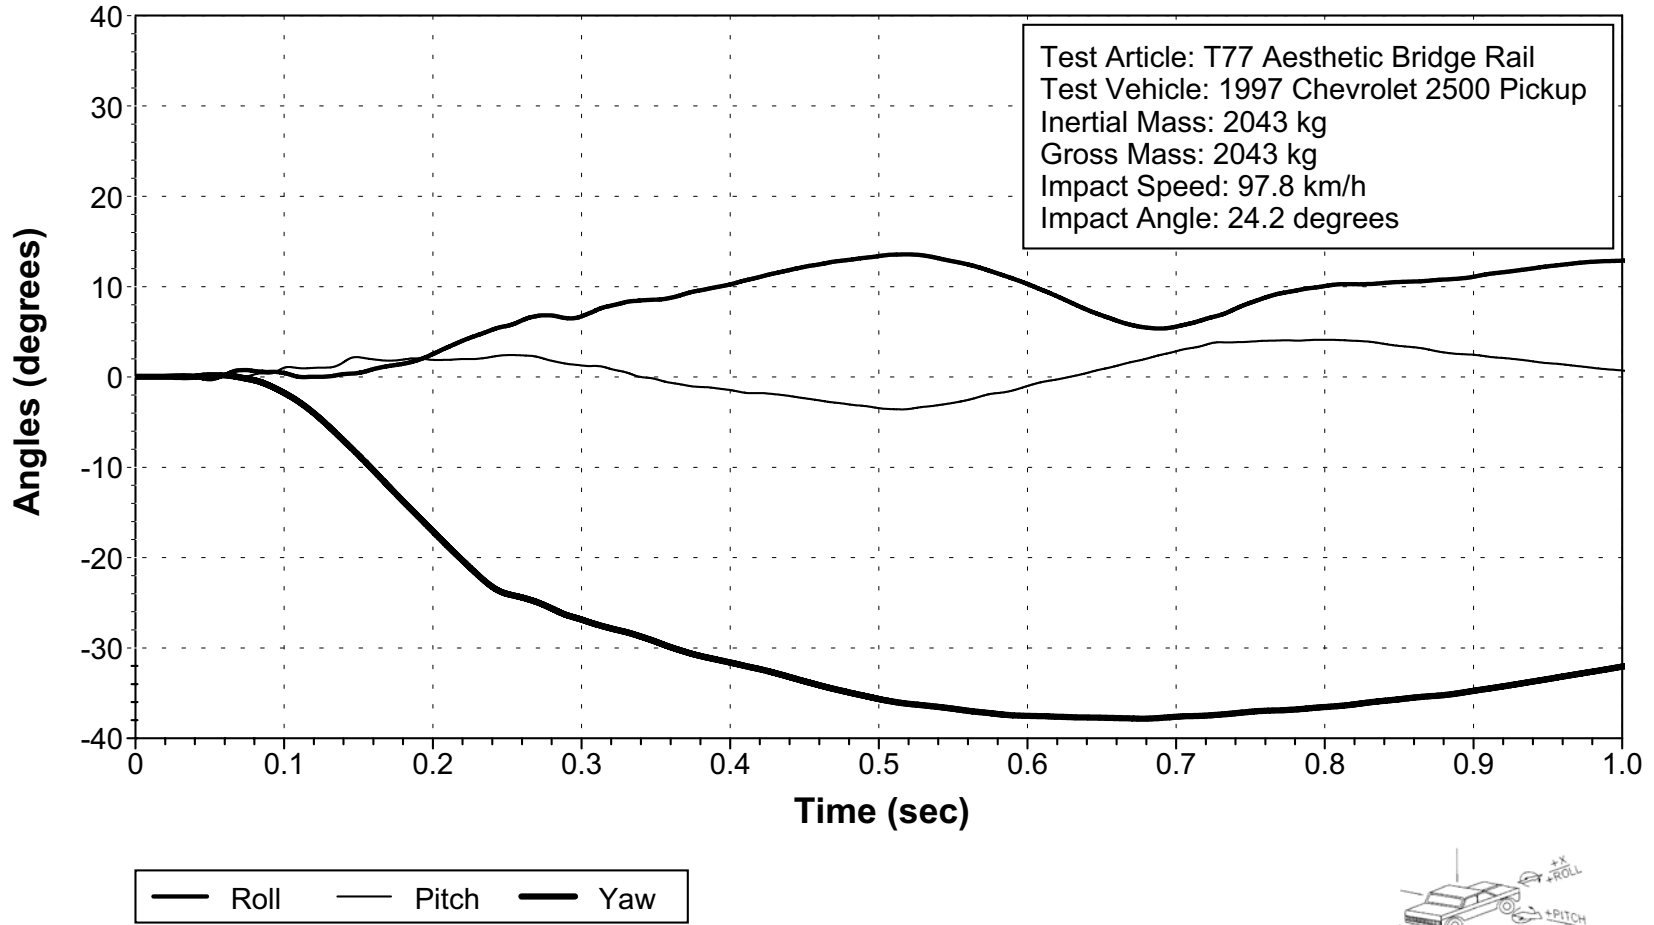
Figure 48. Vehicular Angular Displacements for Test 442882-3.

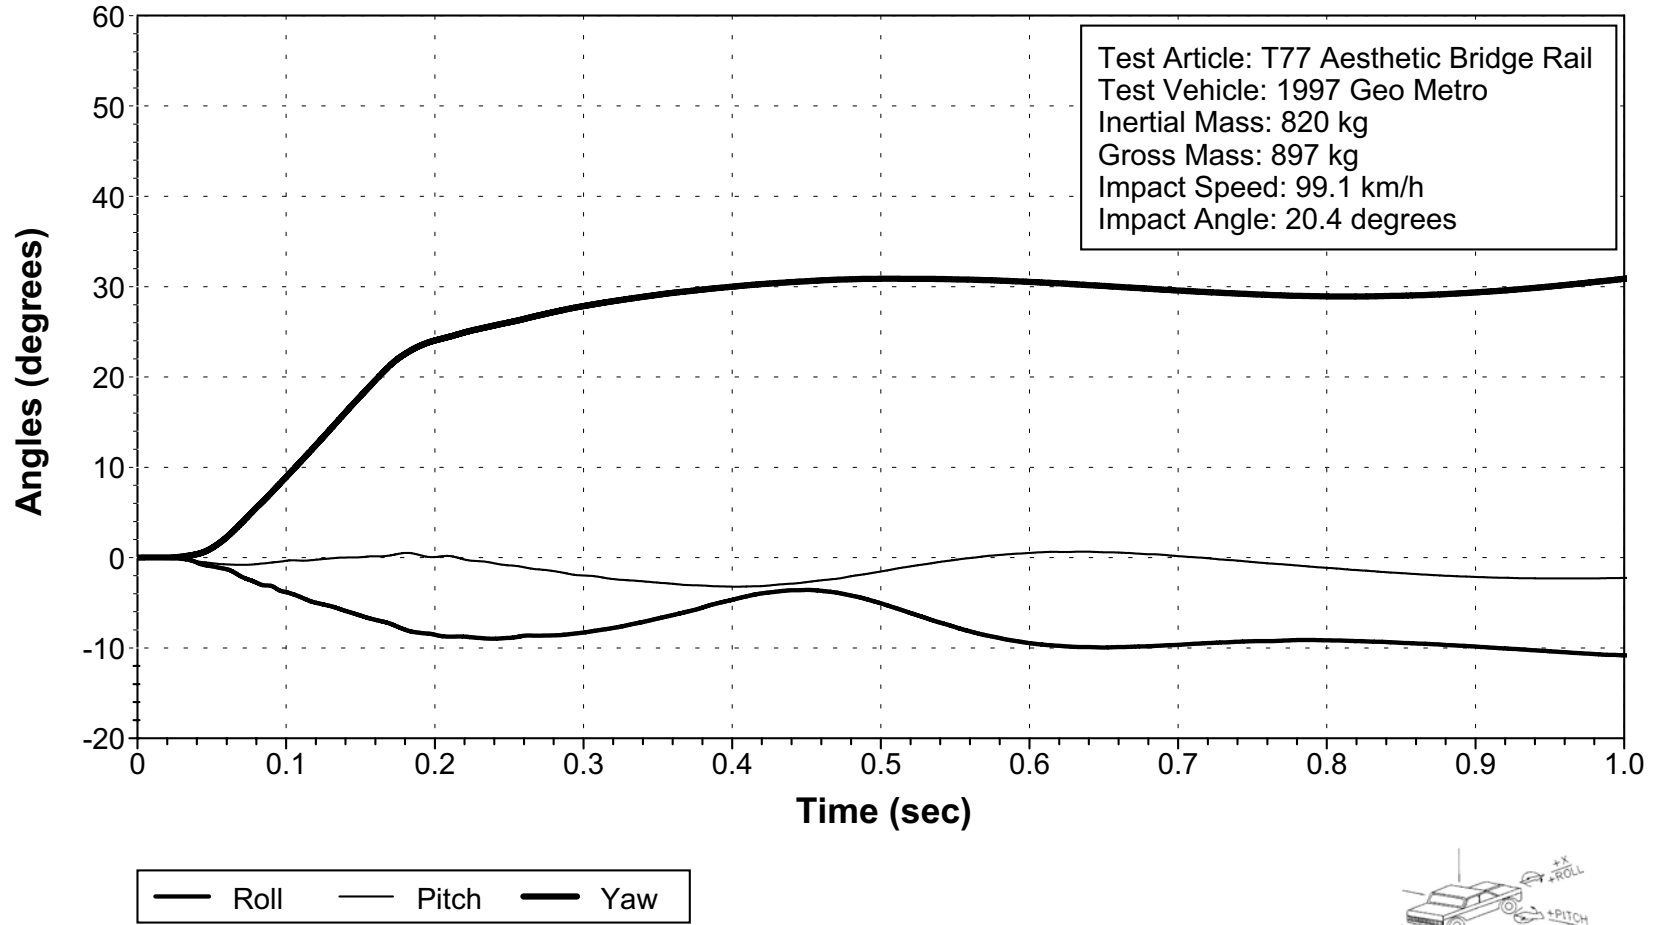
Figure 49. Vehicular Angular Displacements for Test 442882-4.

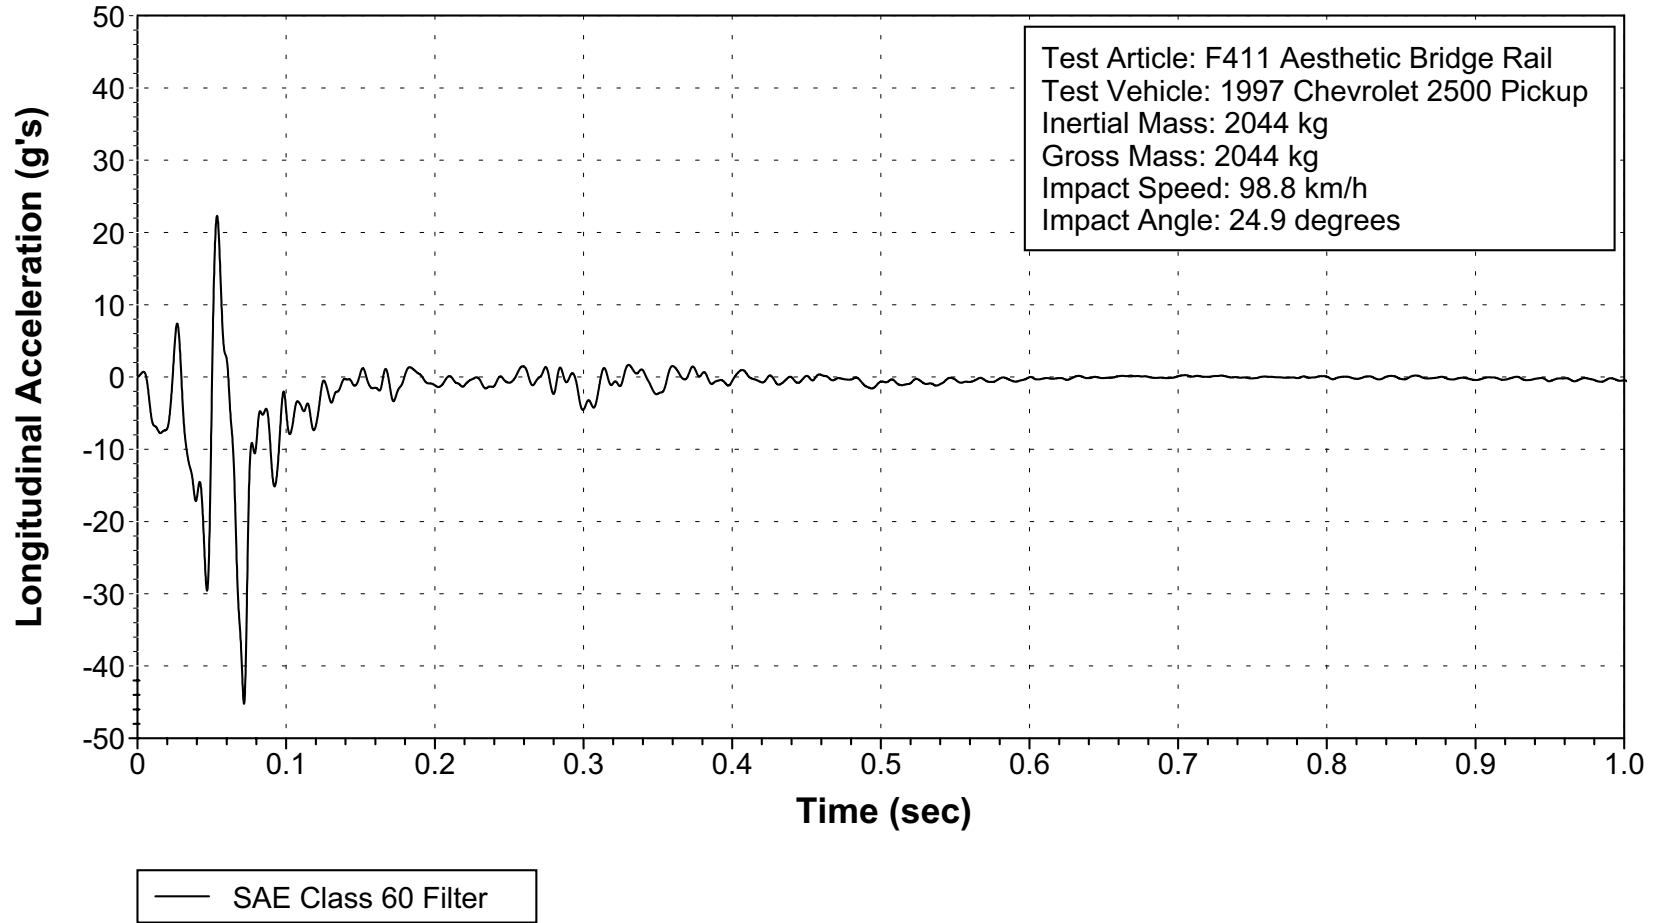
Figure 50. Vehicle Longitudinal Accelerometer Trace for Test 442882-1 (Accelerometer Located at Center of Gravity).

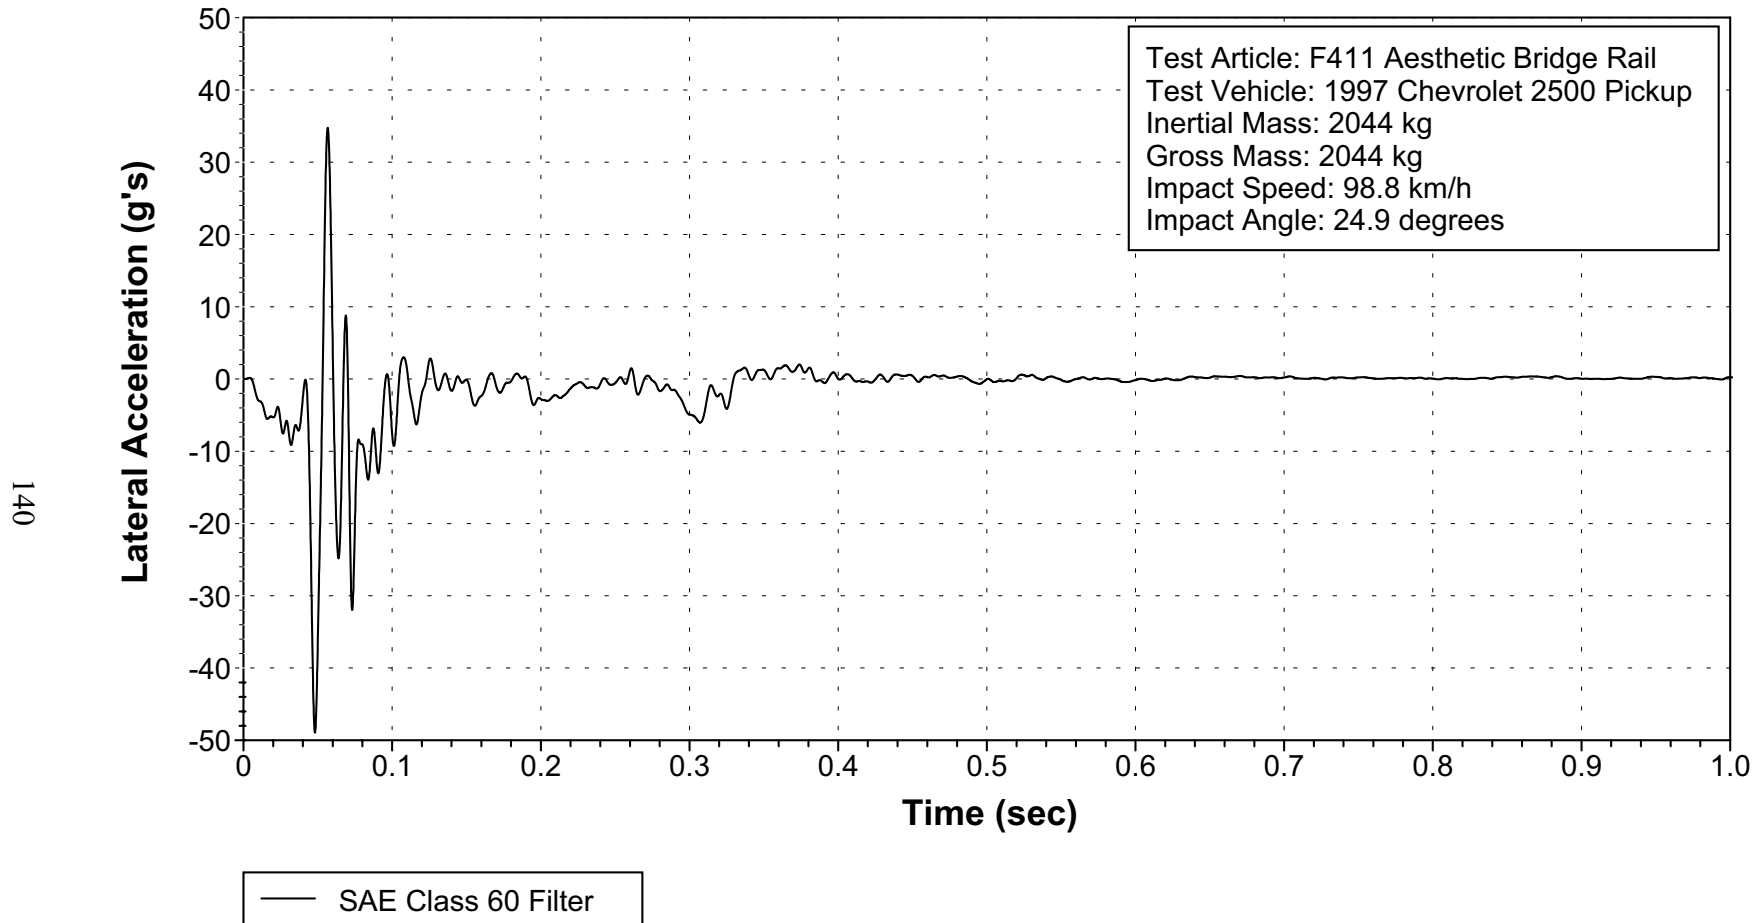
**Figure 51. Vehicle Lateral Accelerometer Trace for Test 442882-1
(Accelerometer Located at Center of Gravity).**

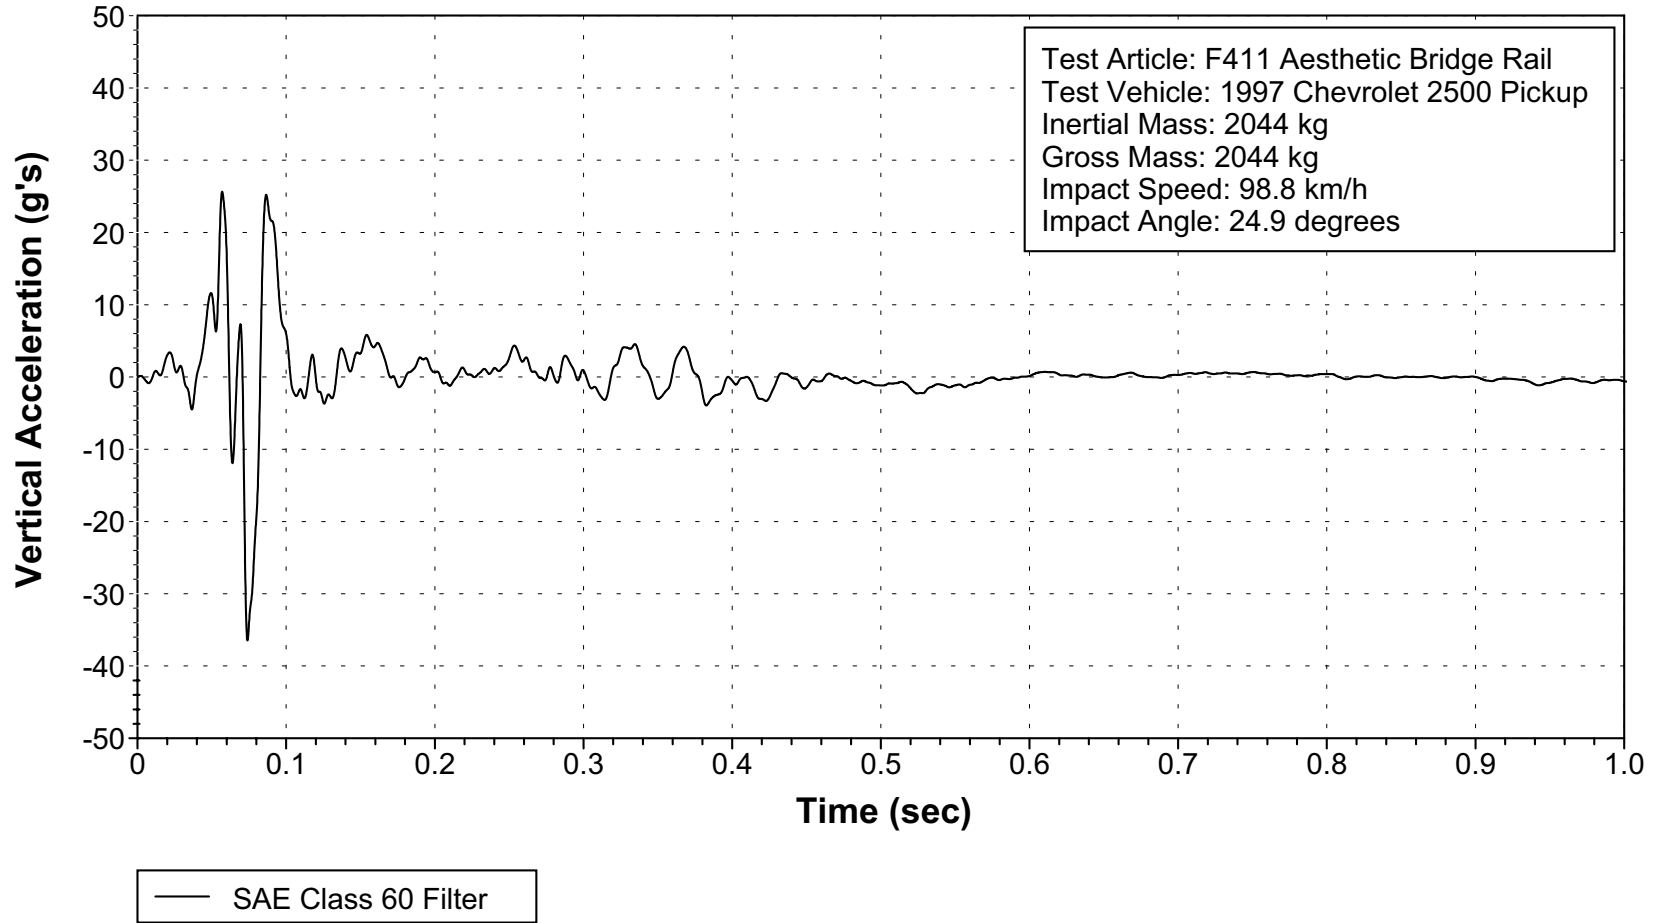
Figure 52. Vehicle Vertical Accelerometer Trace for Test 442882-1 (Accelerometer Located at Center of Gravity).

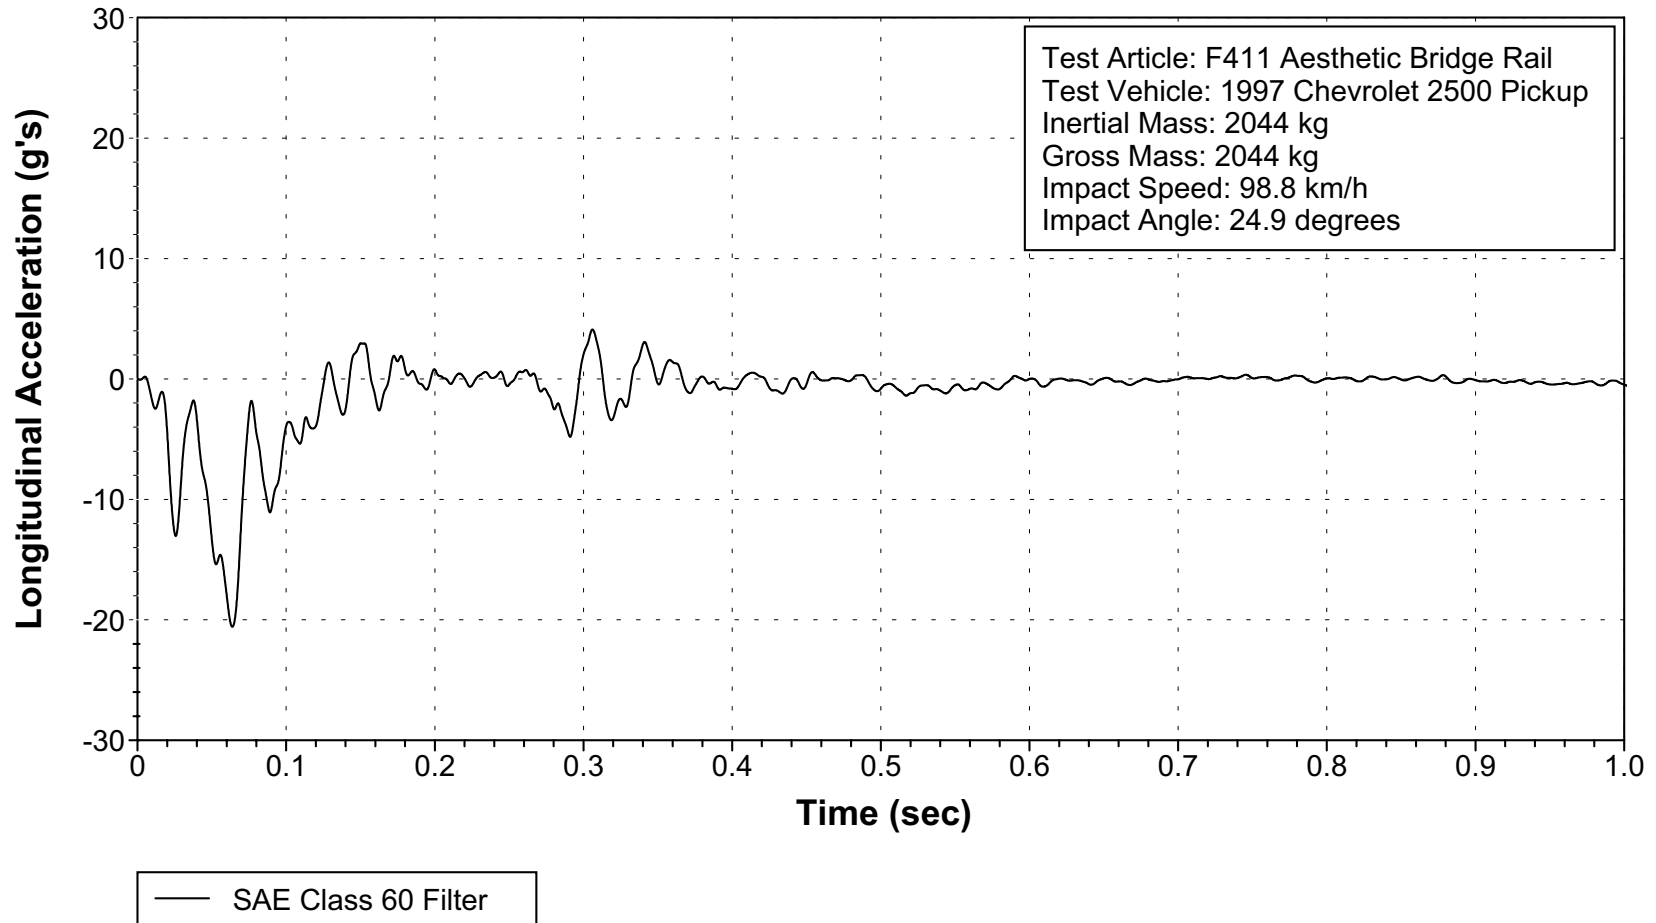
Figure 53. Vehicle Longitudinal Accelerometer Trace for Test 442882-1
(Accelerometer Located Over Rear Axle).

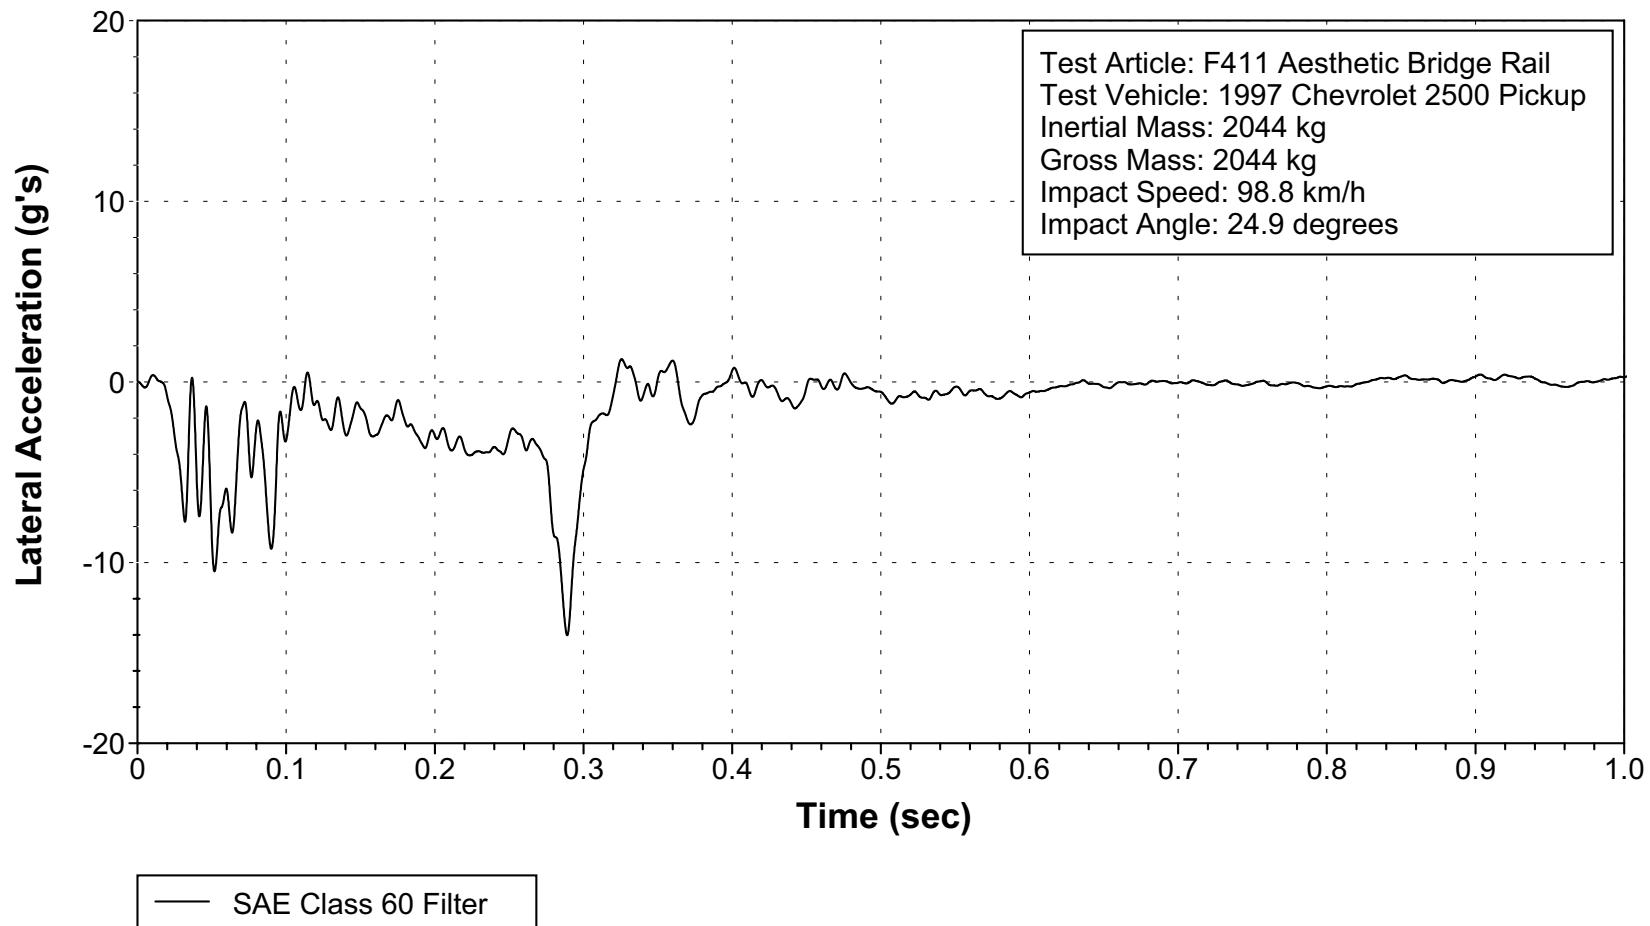
Figure 54. Vehicle Lateral Accelerometer Trace for Test 442882-1 (Accelerometer Located Over Rear Axle).
