1. Report No. FHWA/TX-03/4288-1		2. Government Accession No.		3. Recipient's Catalog No.	
4. Title and Subtitle DESIGN AND EVALUATION OF THE TXDOT F411 AND T77 AESTHETIC BRIDGE RAILS				5. Report Date October 2002

**DESIGN AND EVALUATION OF THE TxDOT
F411 AND T77 AESTHETIC BRIDGE RAILS**

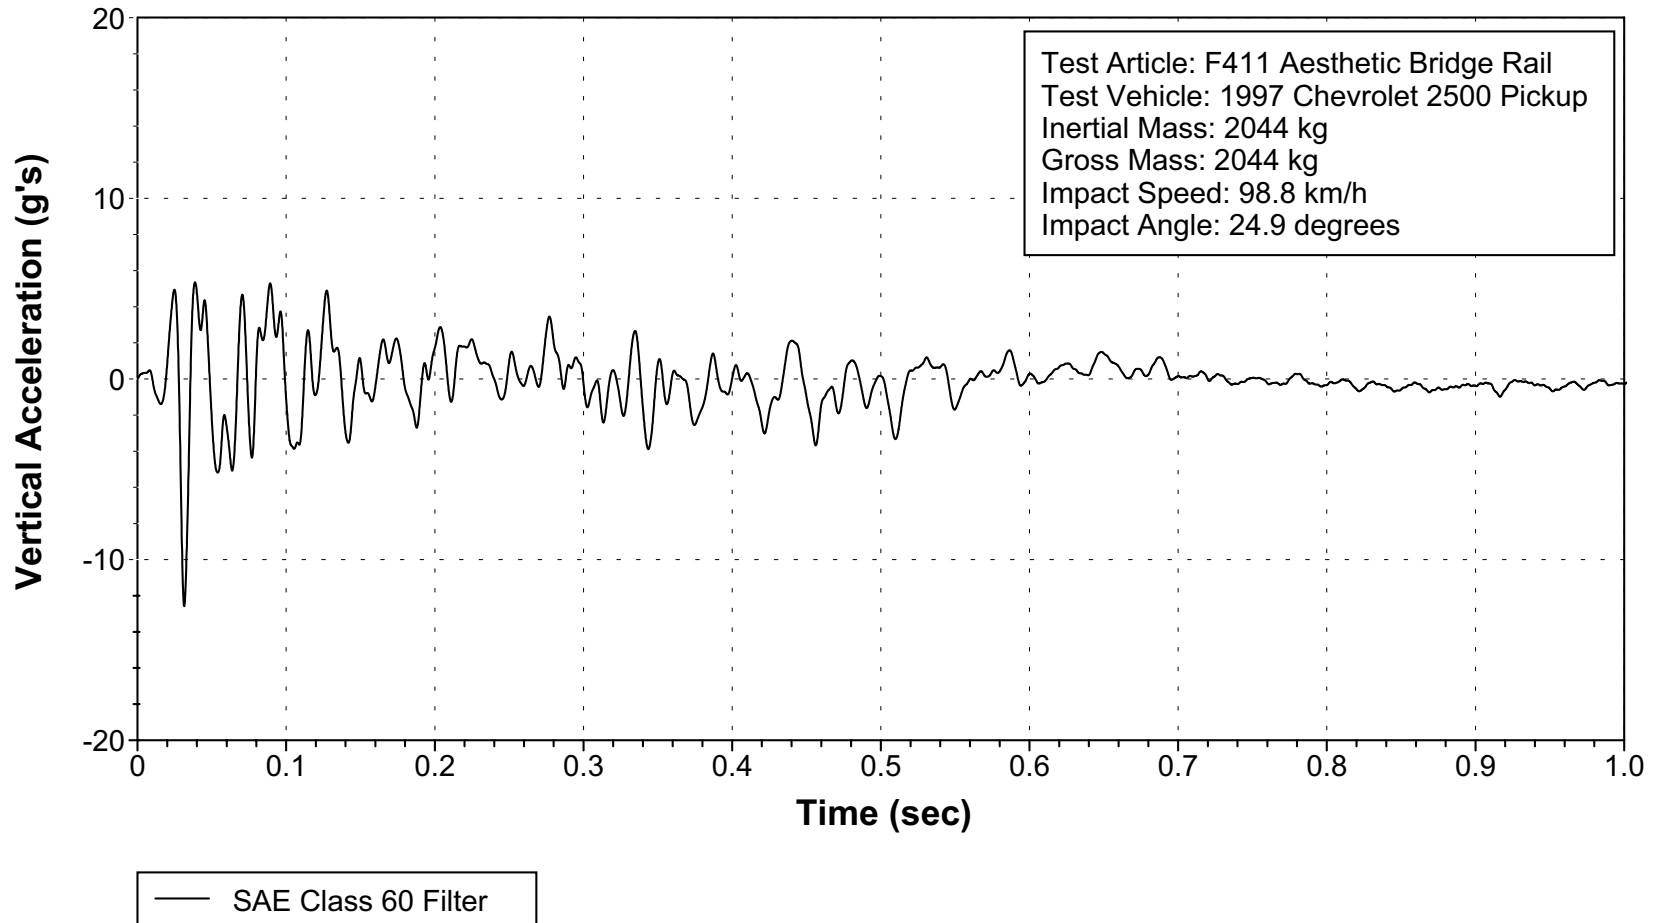
**Figure 55. Vehicle Vertical Accelerometer Trace for Test 442882-1
(Accelerometer Located Over Rear Axle).**

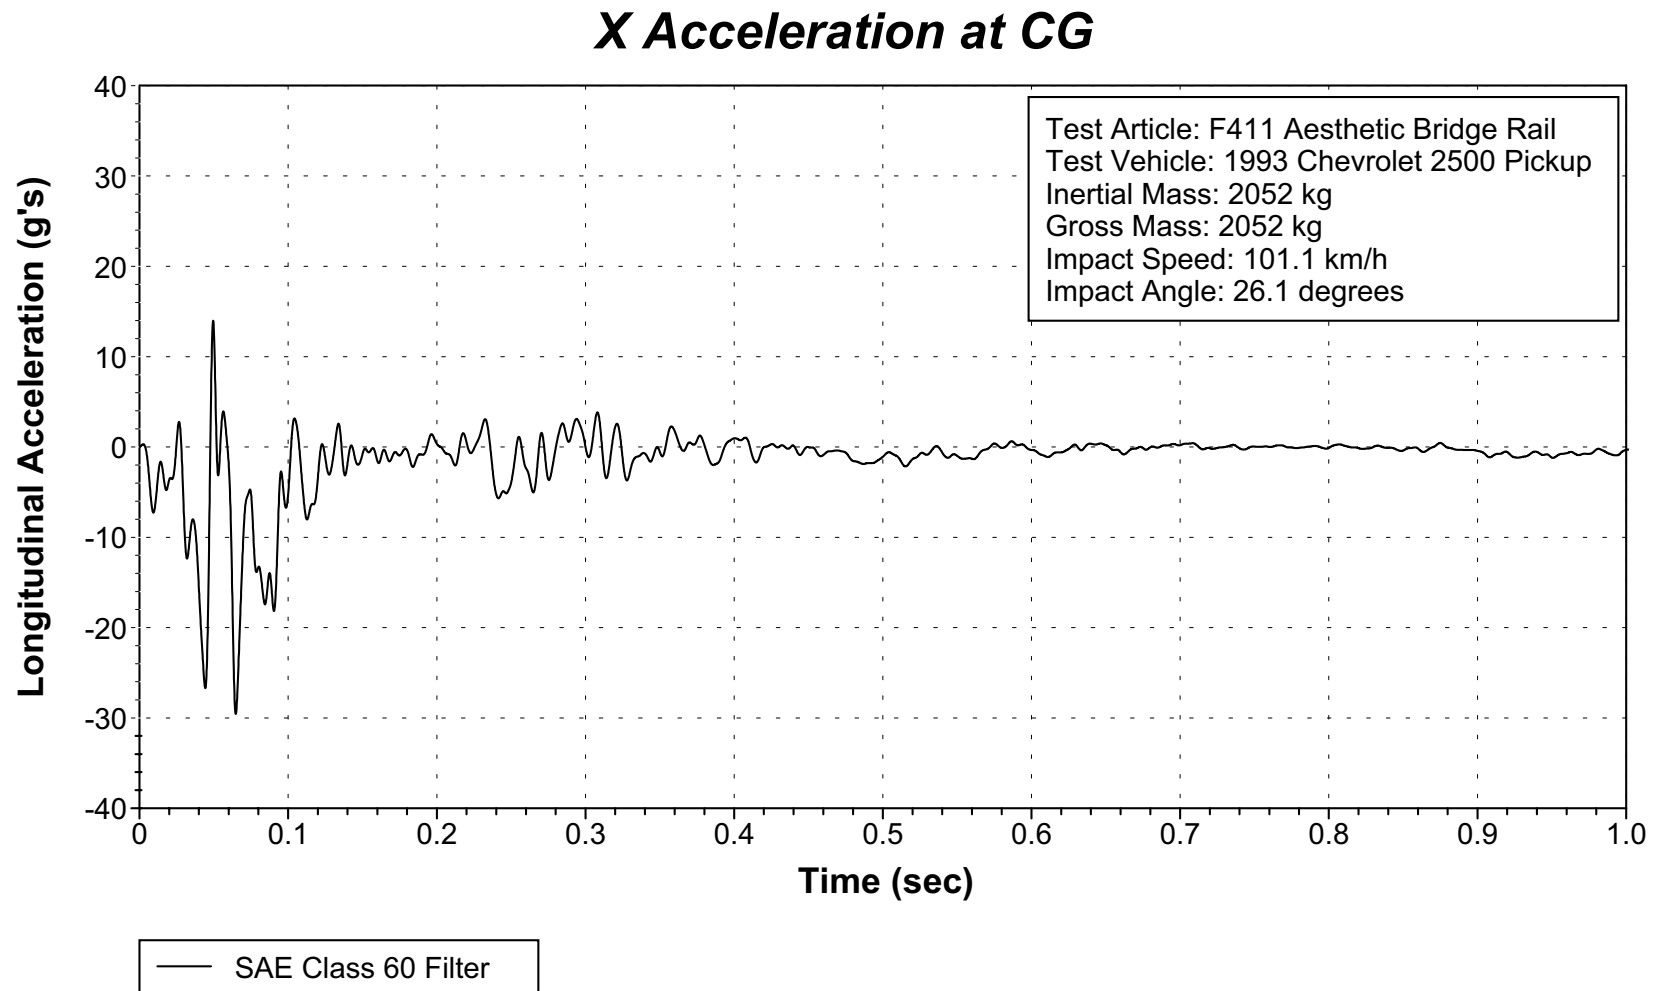
**Figure 56. Vehicle Longitudinal Accelerometer Trace for Test 442882-2
(Accelerometer Located at Center of Gravity).**

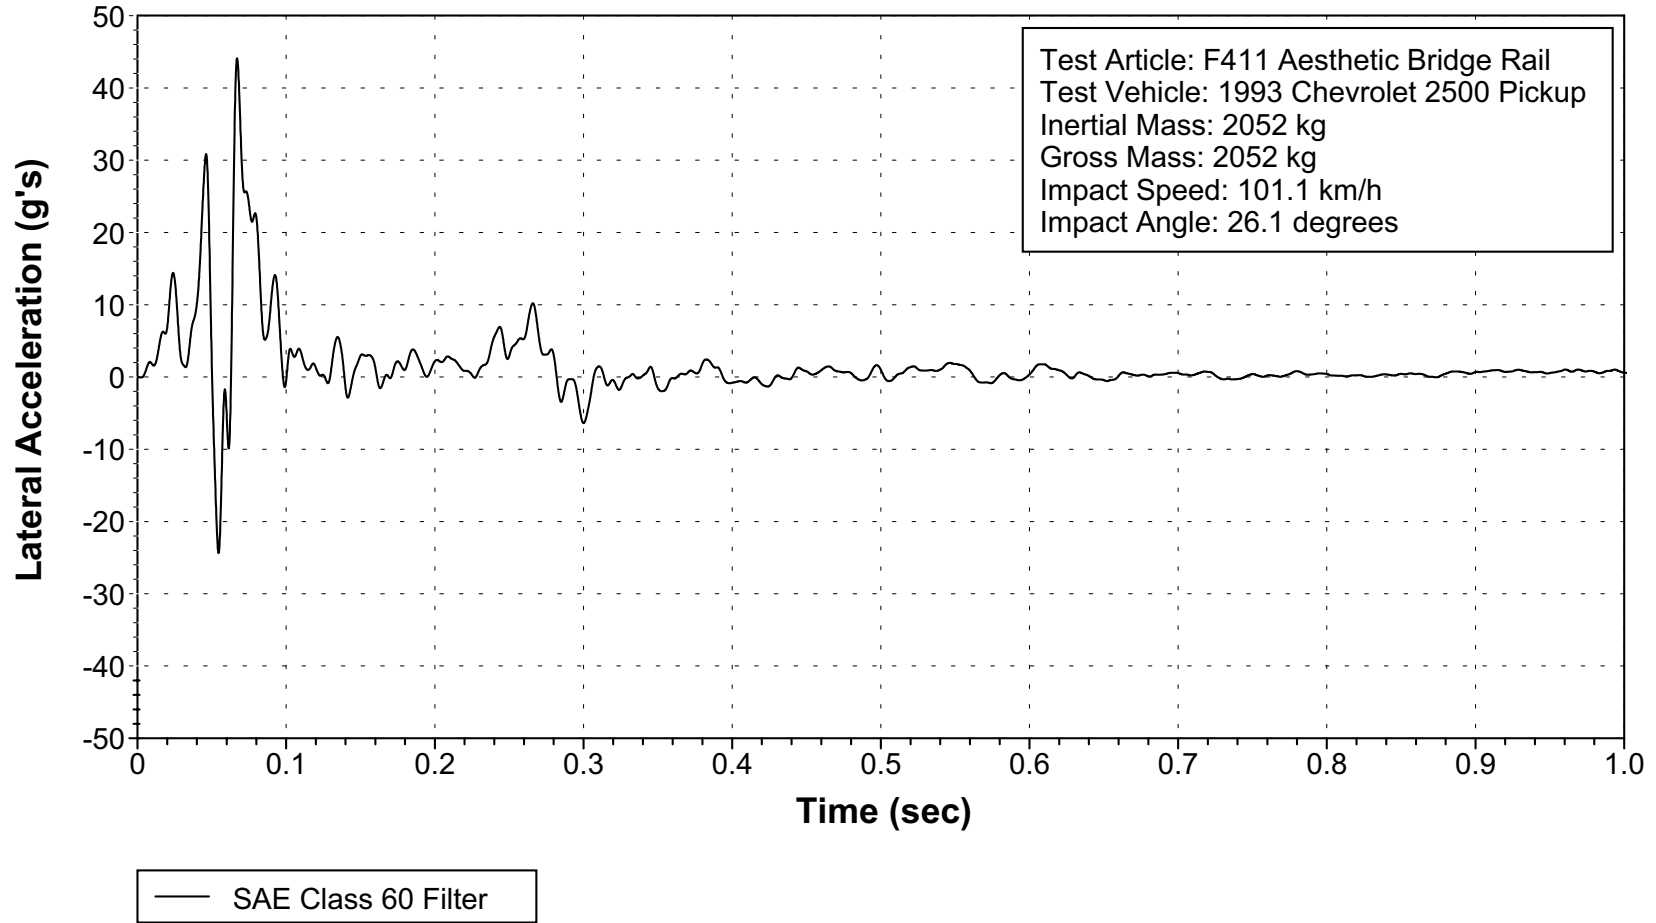
Figure 57. Vehicle Lateral Accelerometer Trace for Test 442882-2 (Accelerometer Located at Center of Gravity).

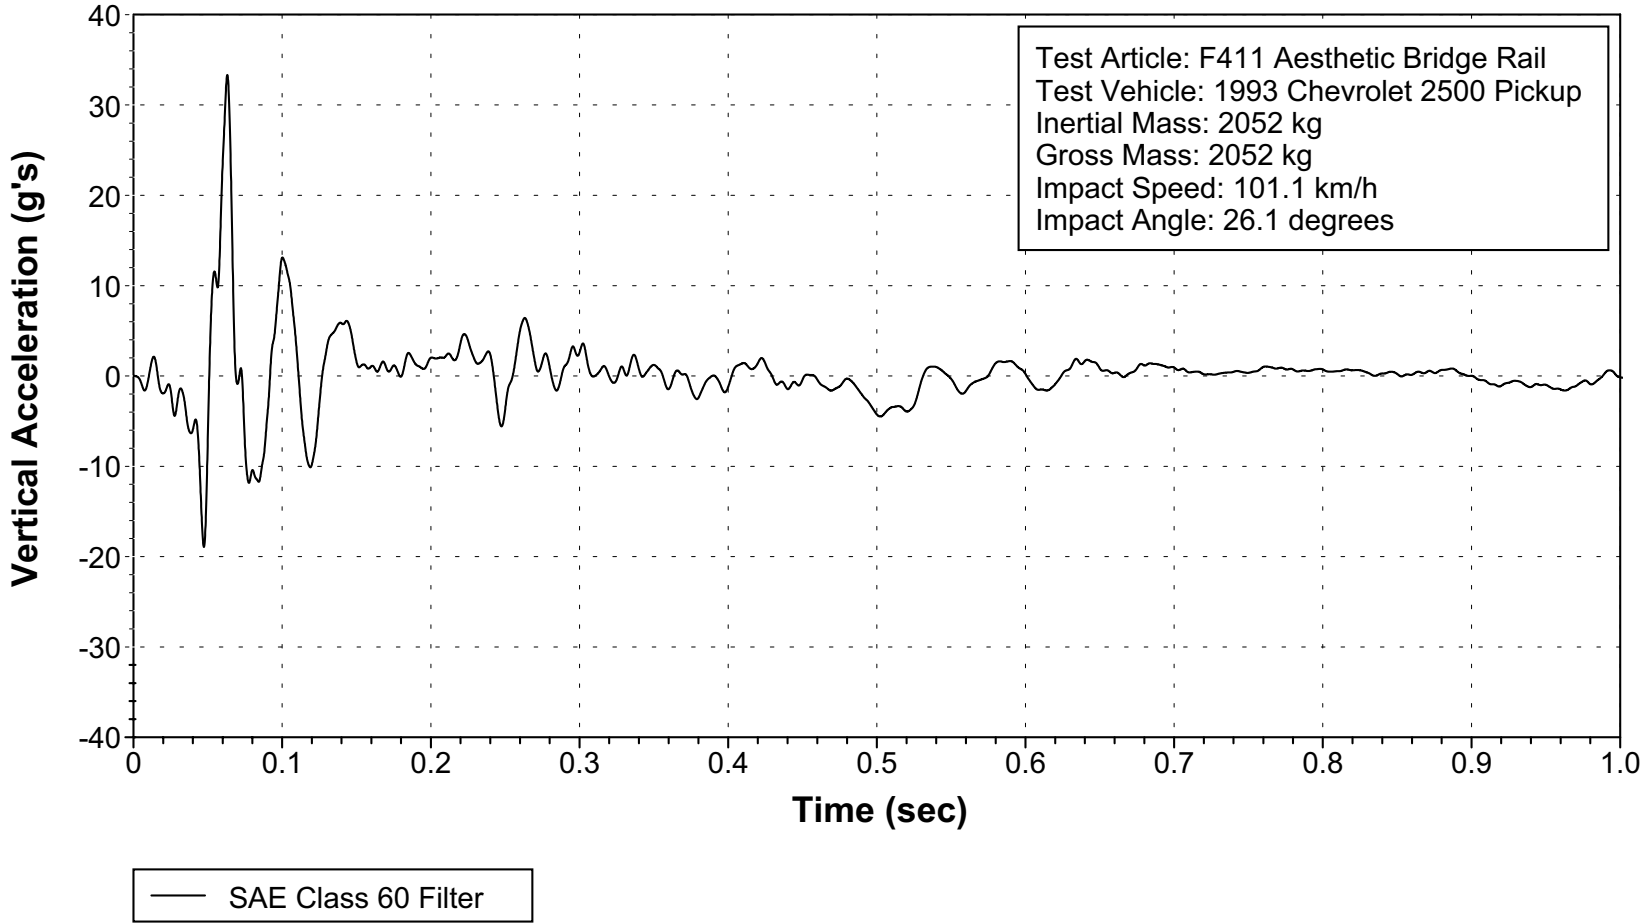
Figure 58. Vehicle Vertical Accelerometer Trace for Test 442882-2 (Accelerometer Located at Center of Gravity).

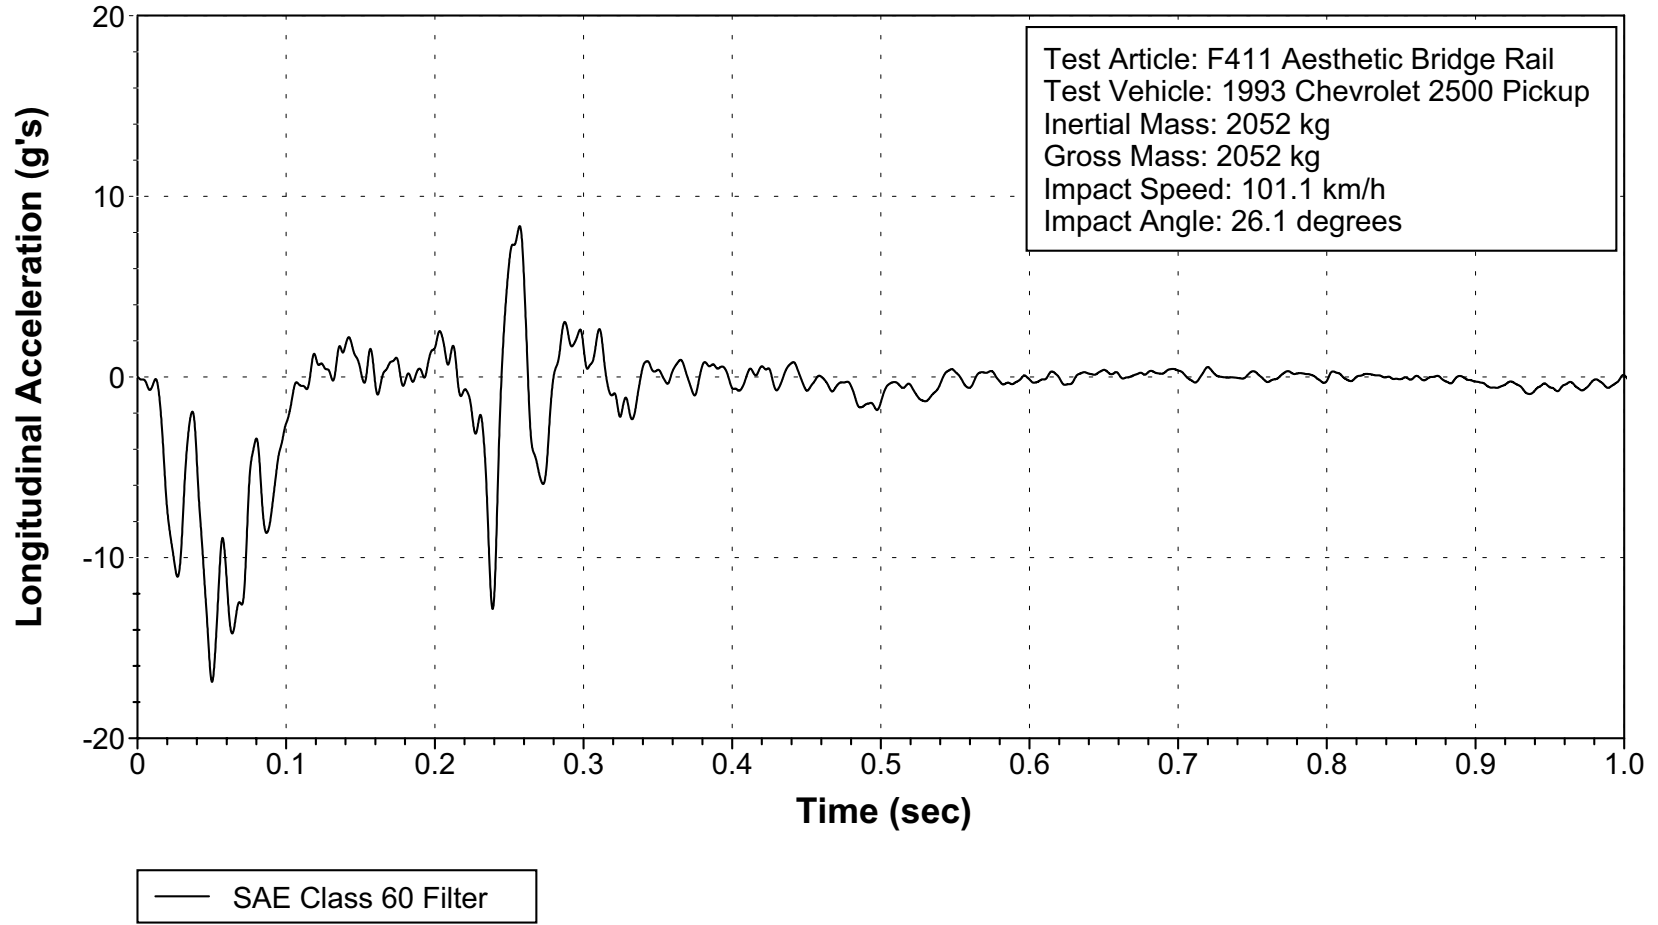
Figure 59. Vehicle Longitudinal Accelerometer Trace for Test 442882-2 (Accelerometer Located Over Rear Axle).

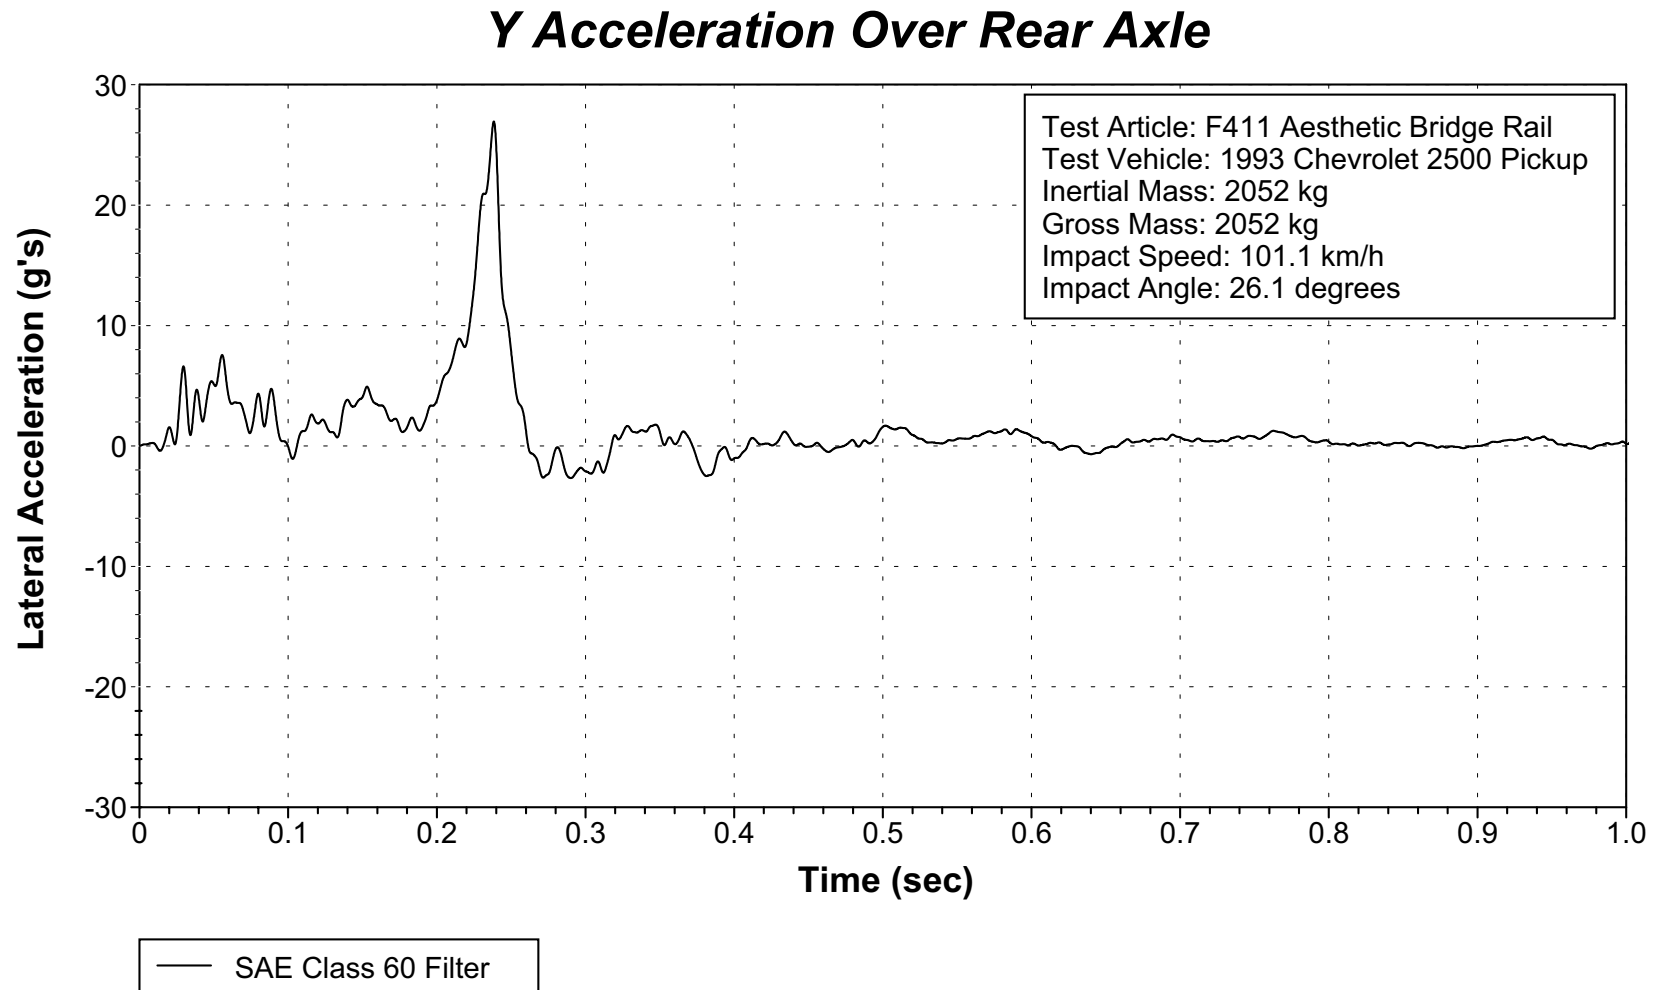
**Figure 60. Vehicle Lateral Accelerometer Trace for Test 442882-2
(Accelerometer Located Over Rear Axle).**

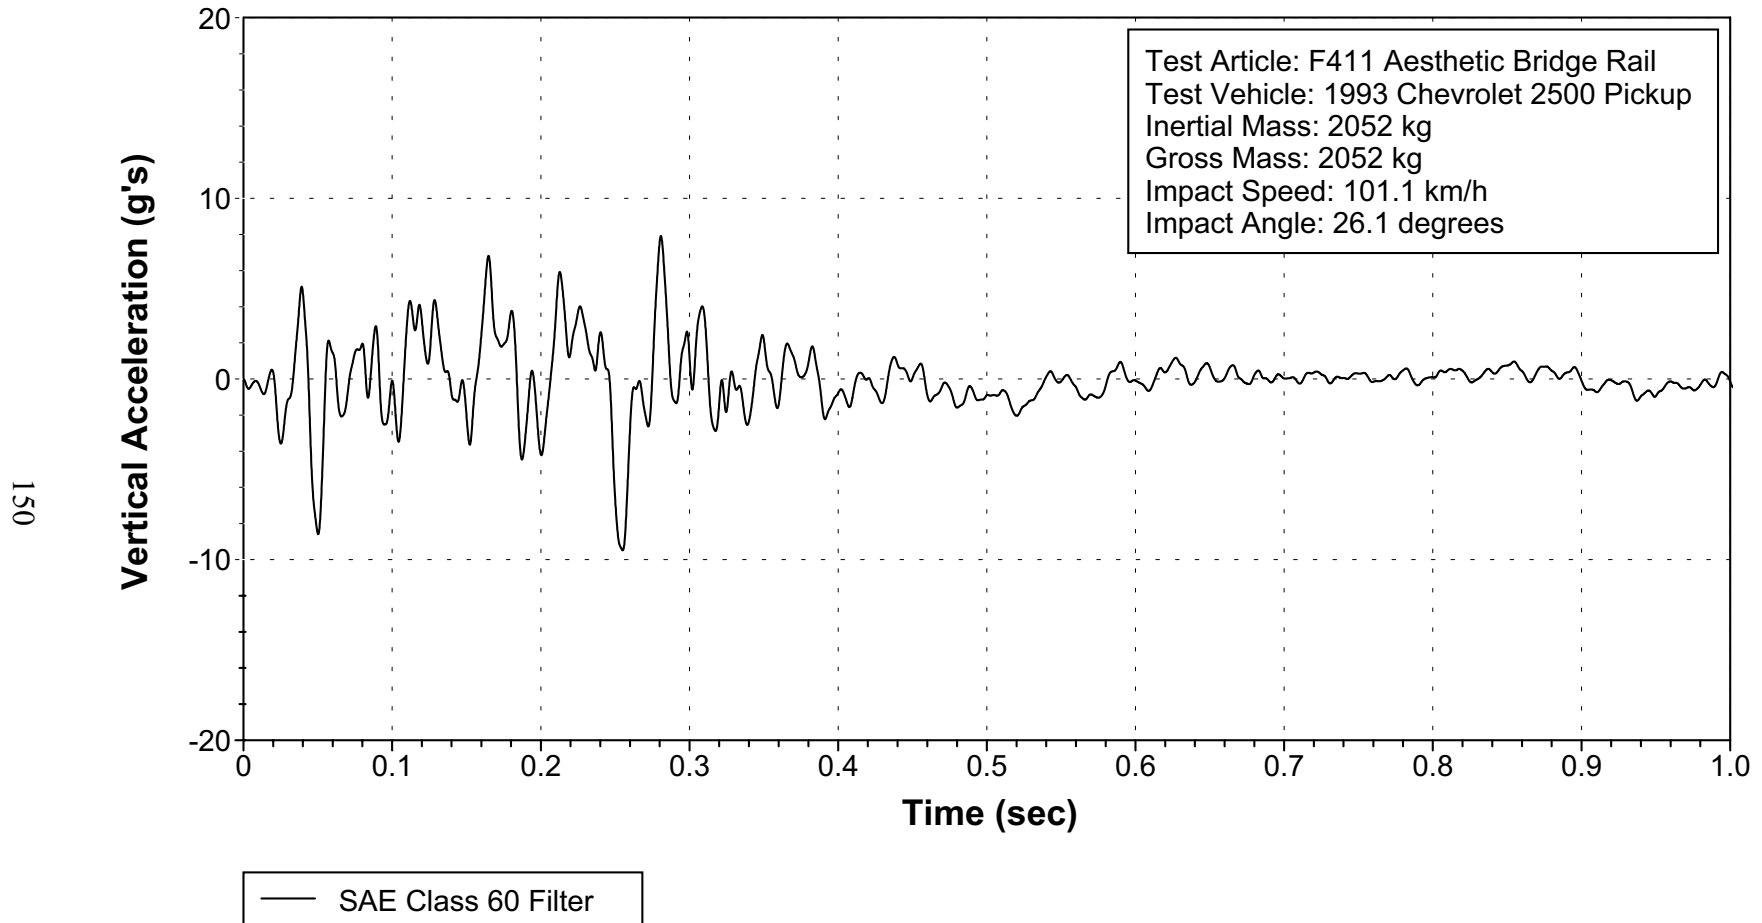
**Figure 61. Vehicle Vertical Accelerometer Trace for Test 442882-2
(Accelerometer Located Over Rear Axle).**

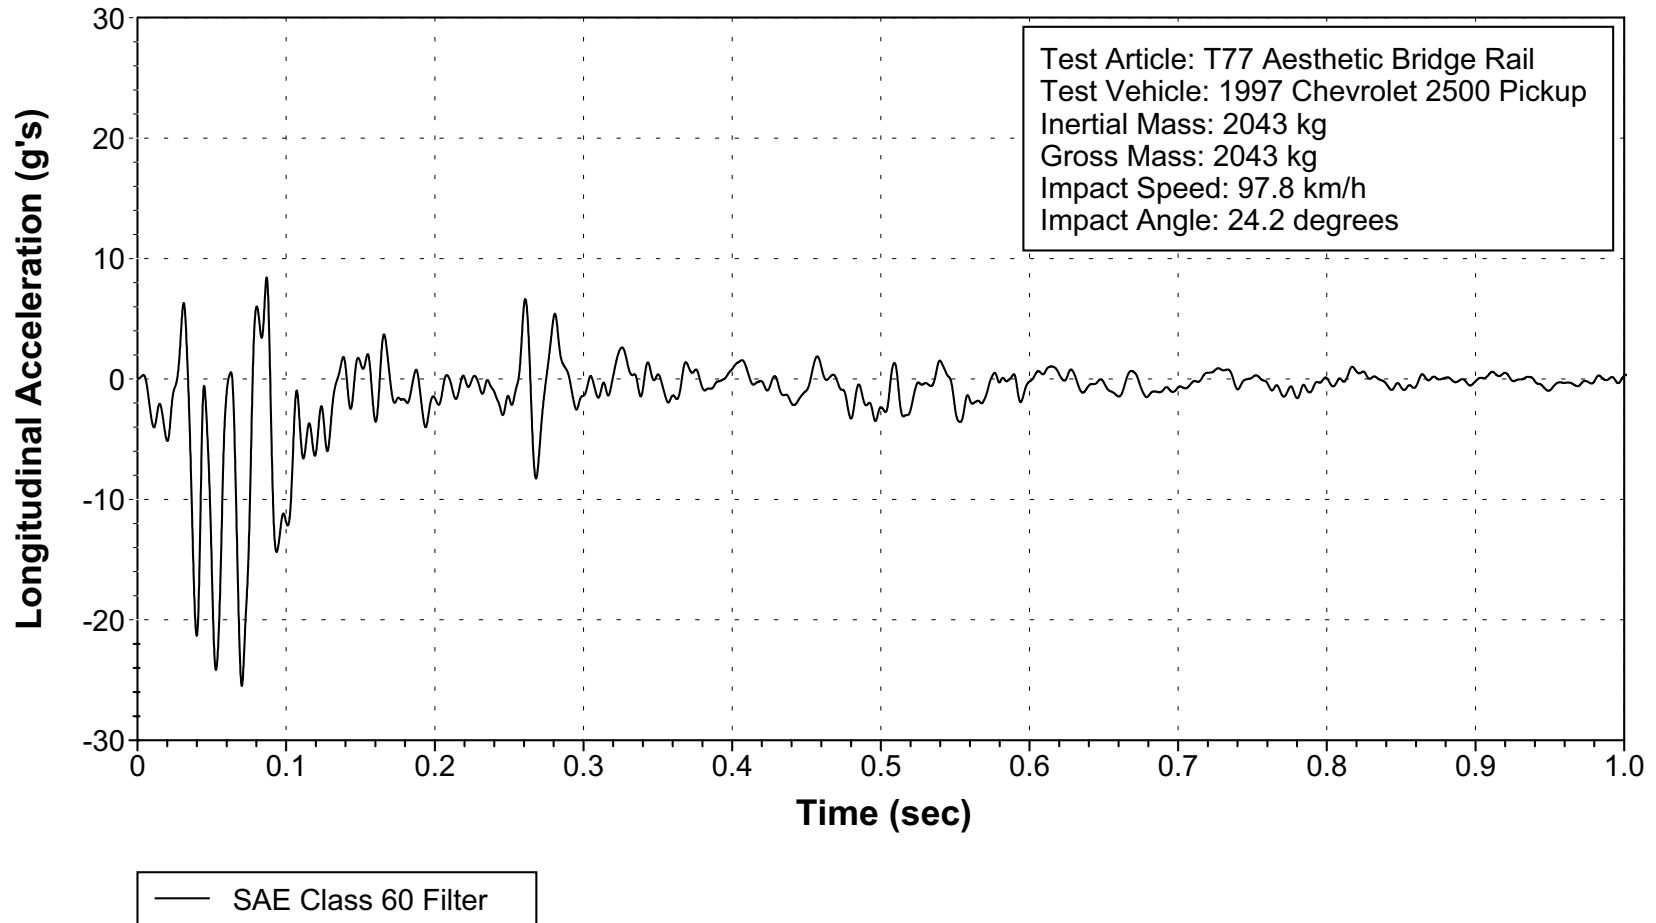
**Figure 62. Vehicle Longitudinal Accelerometer Trace for Test 442882-3
(Accelerometer Located at Center of Gravity).**

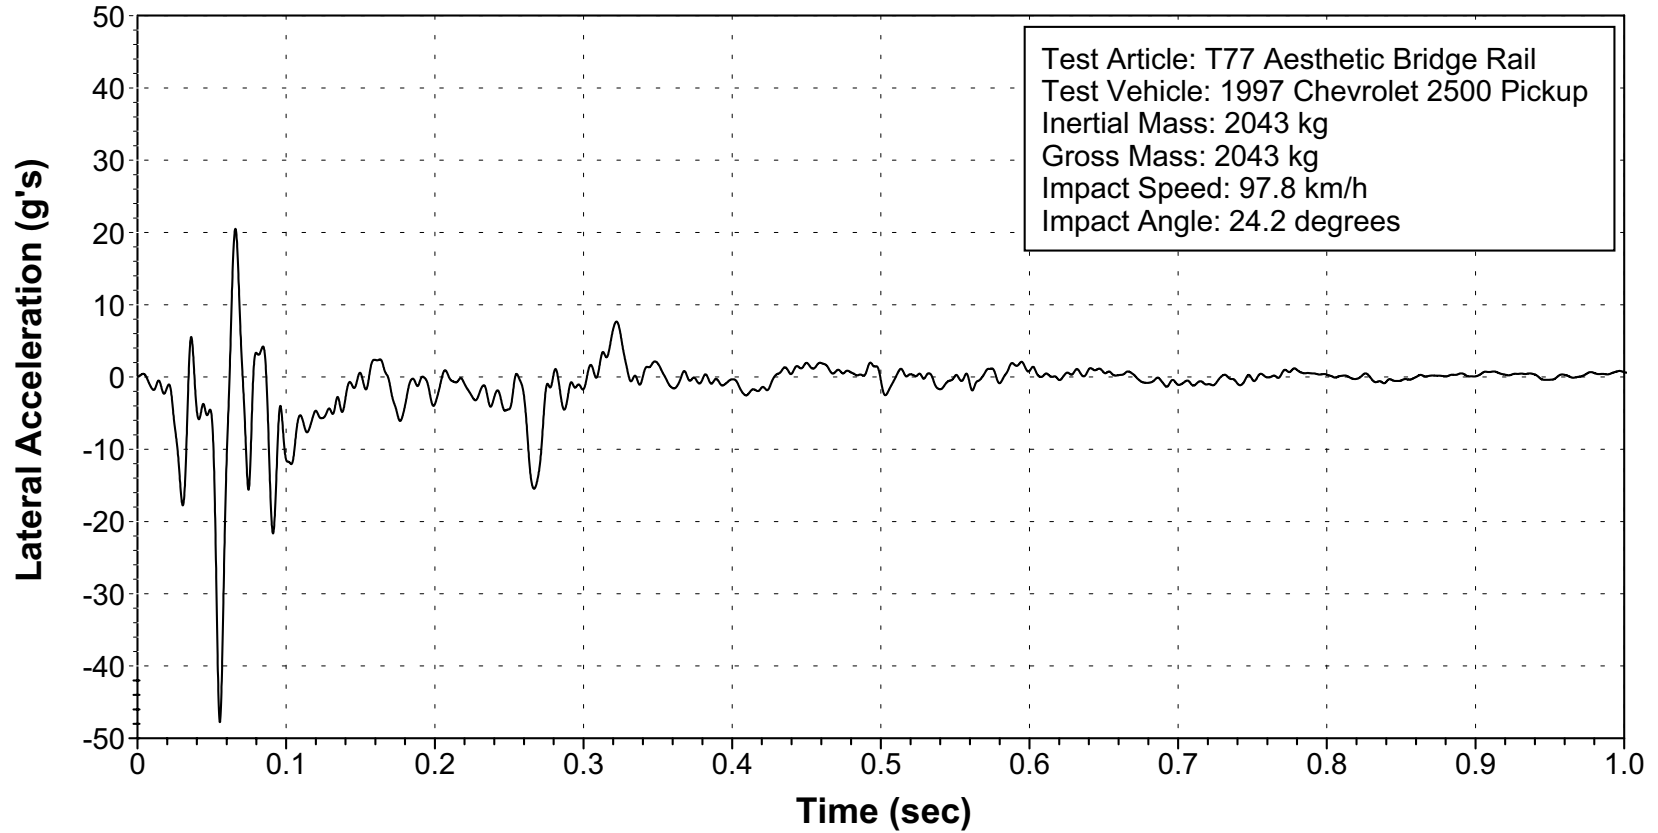
Figure 63. Vehicle Lateral Accelerometer Trace for Test 442882-3 (Accelerometer Located at Center of Gravity).

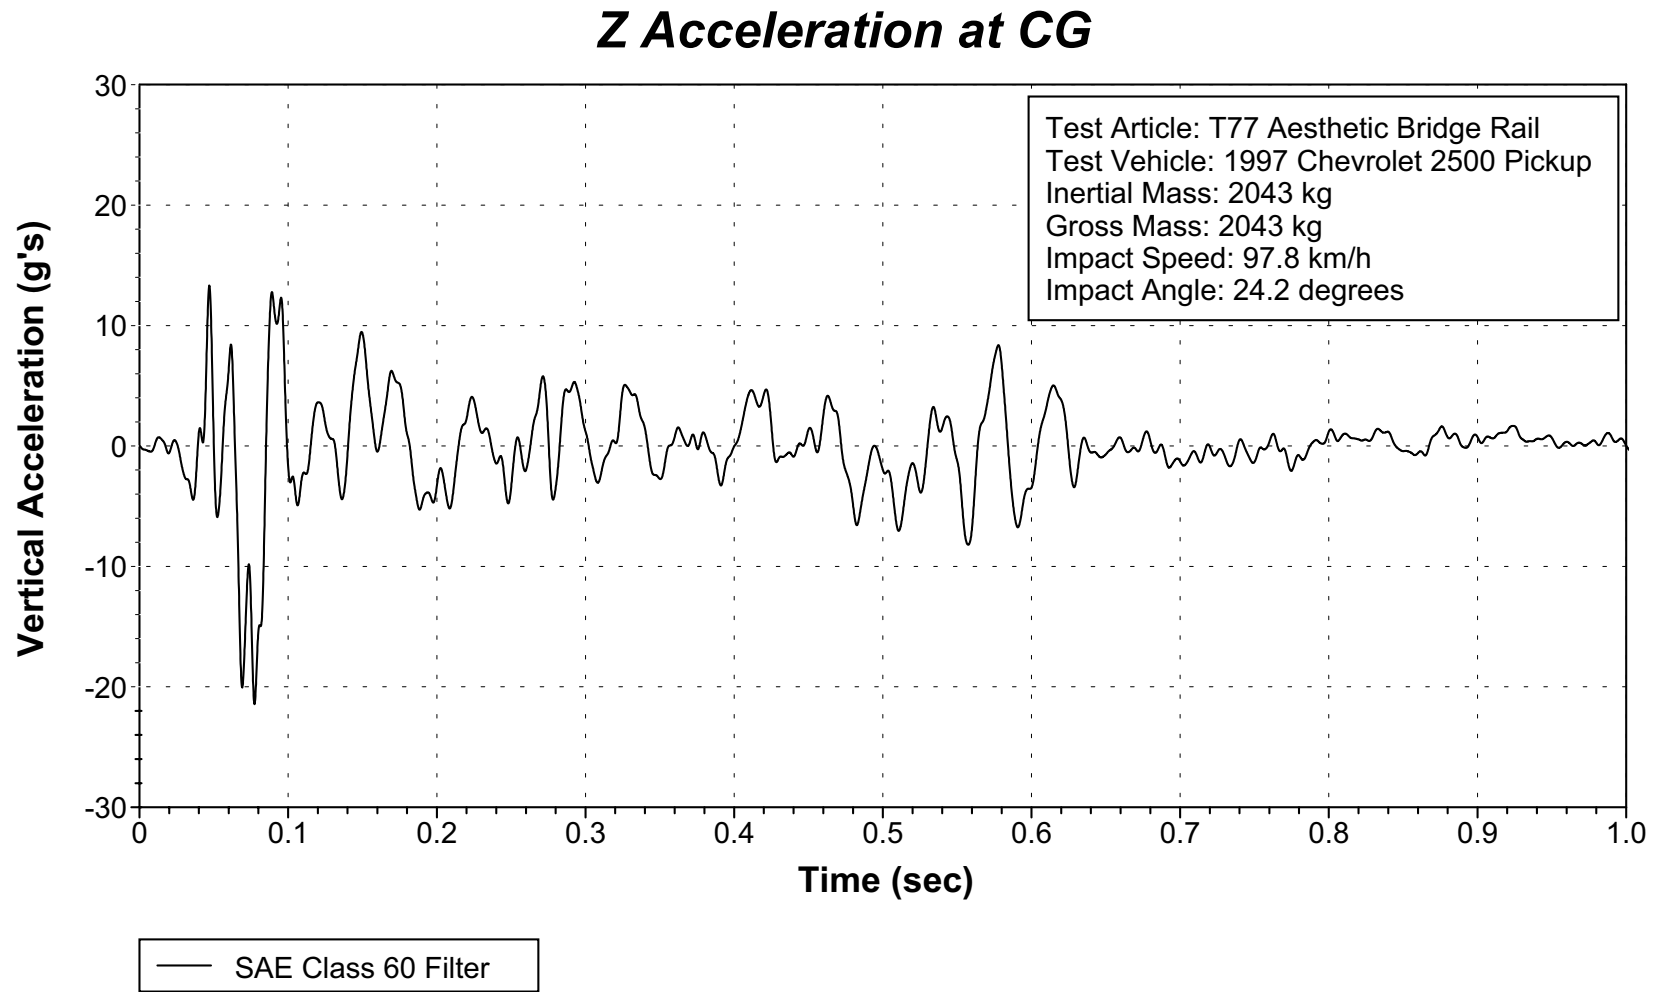
**Figure 64. Vehicle Vertical Accelerometer Trace for Test 442882-3
(Accelerometer Located at Center of Gravity).**

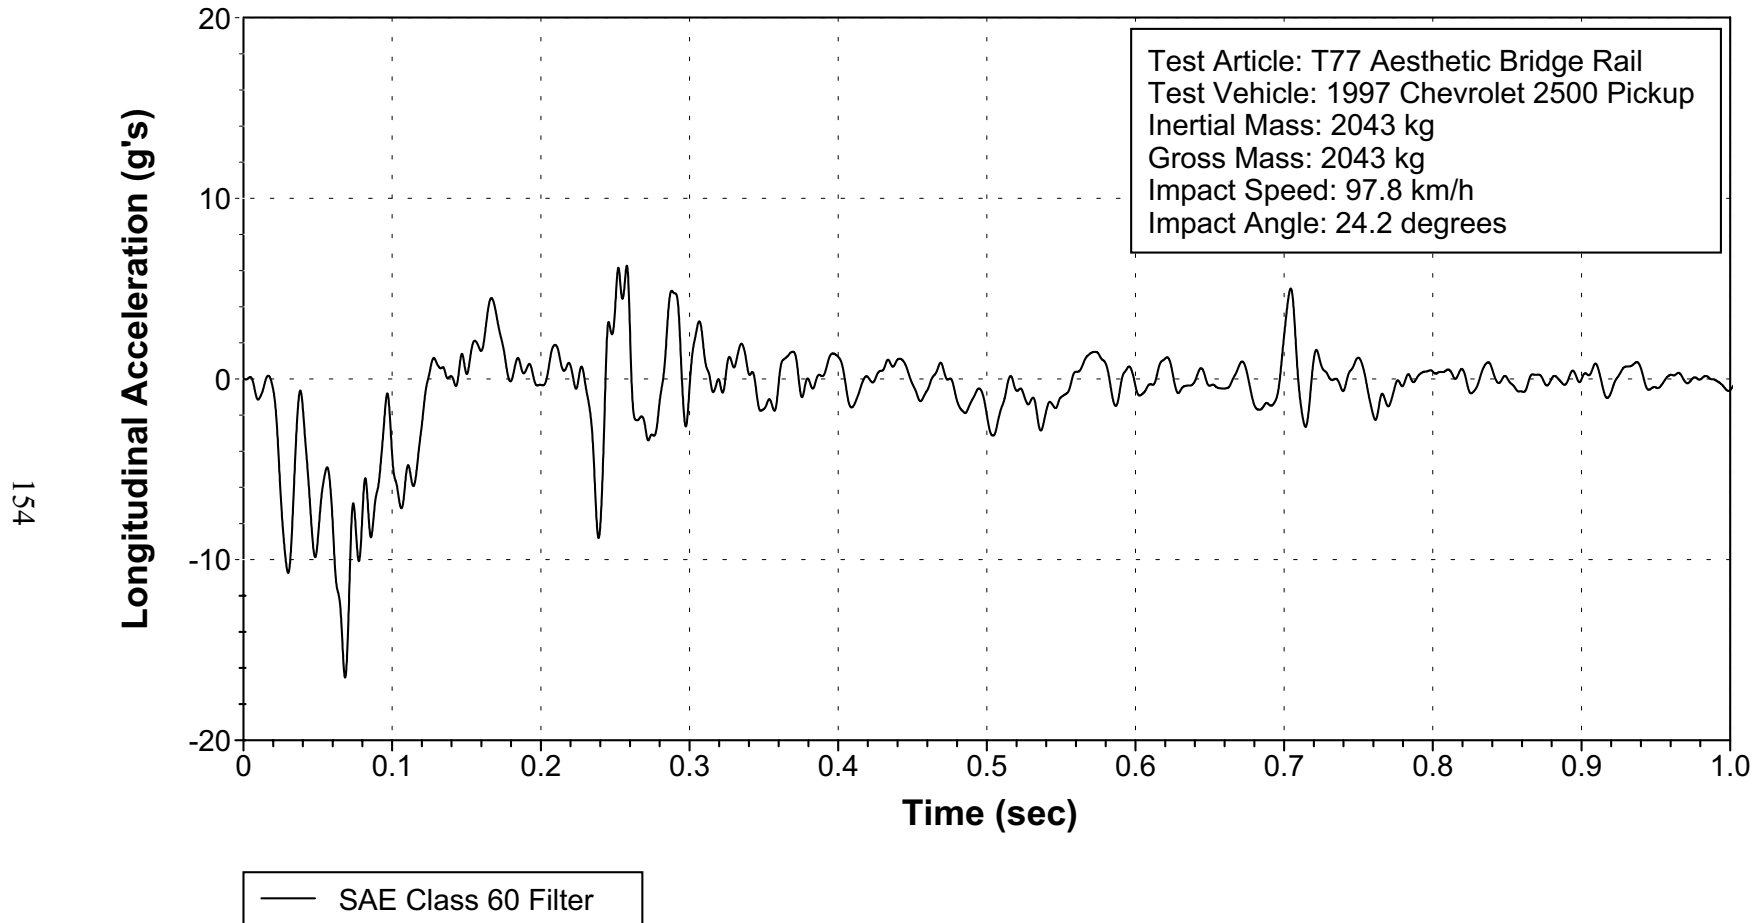
**Figure 65. Vehicle Longitudinal Accelerometer Trace for Test 442882-3
(Accelerometer Located Over Rear Axle).**

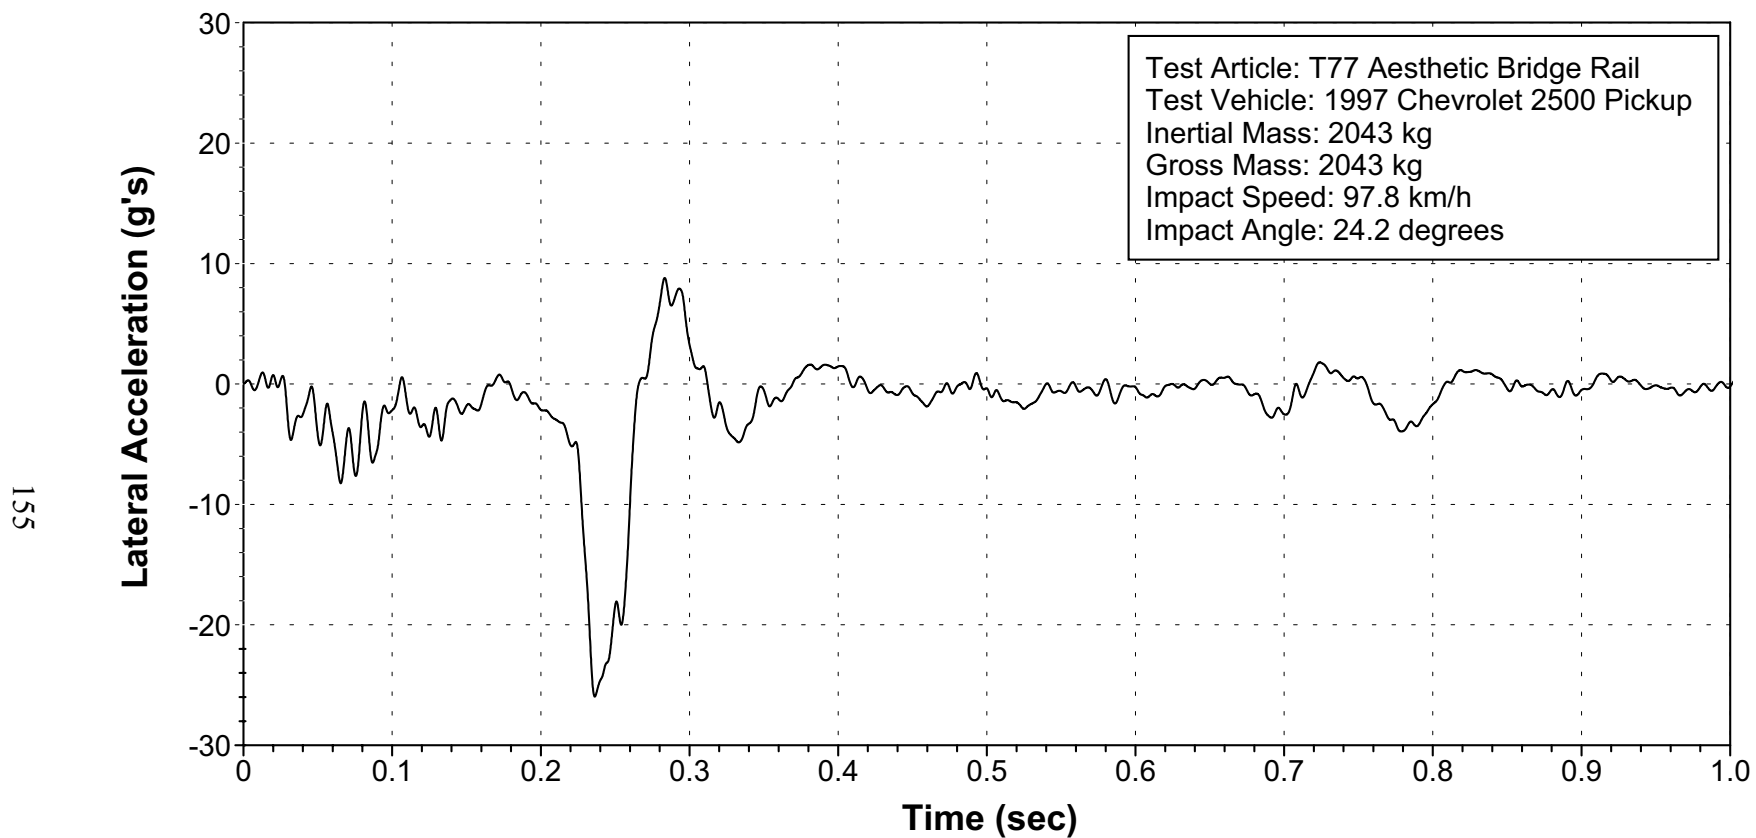
Figure 66. Vehicle Lateral Accelerometer Trace for Test 442882-3
(Accelerometer Located Over Rear Axle).

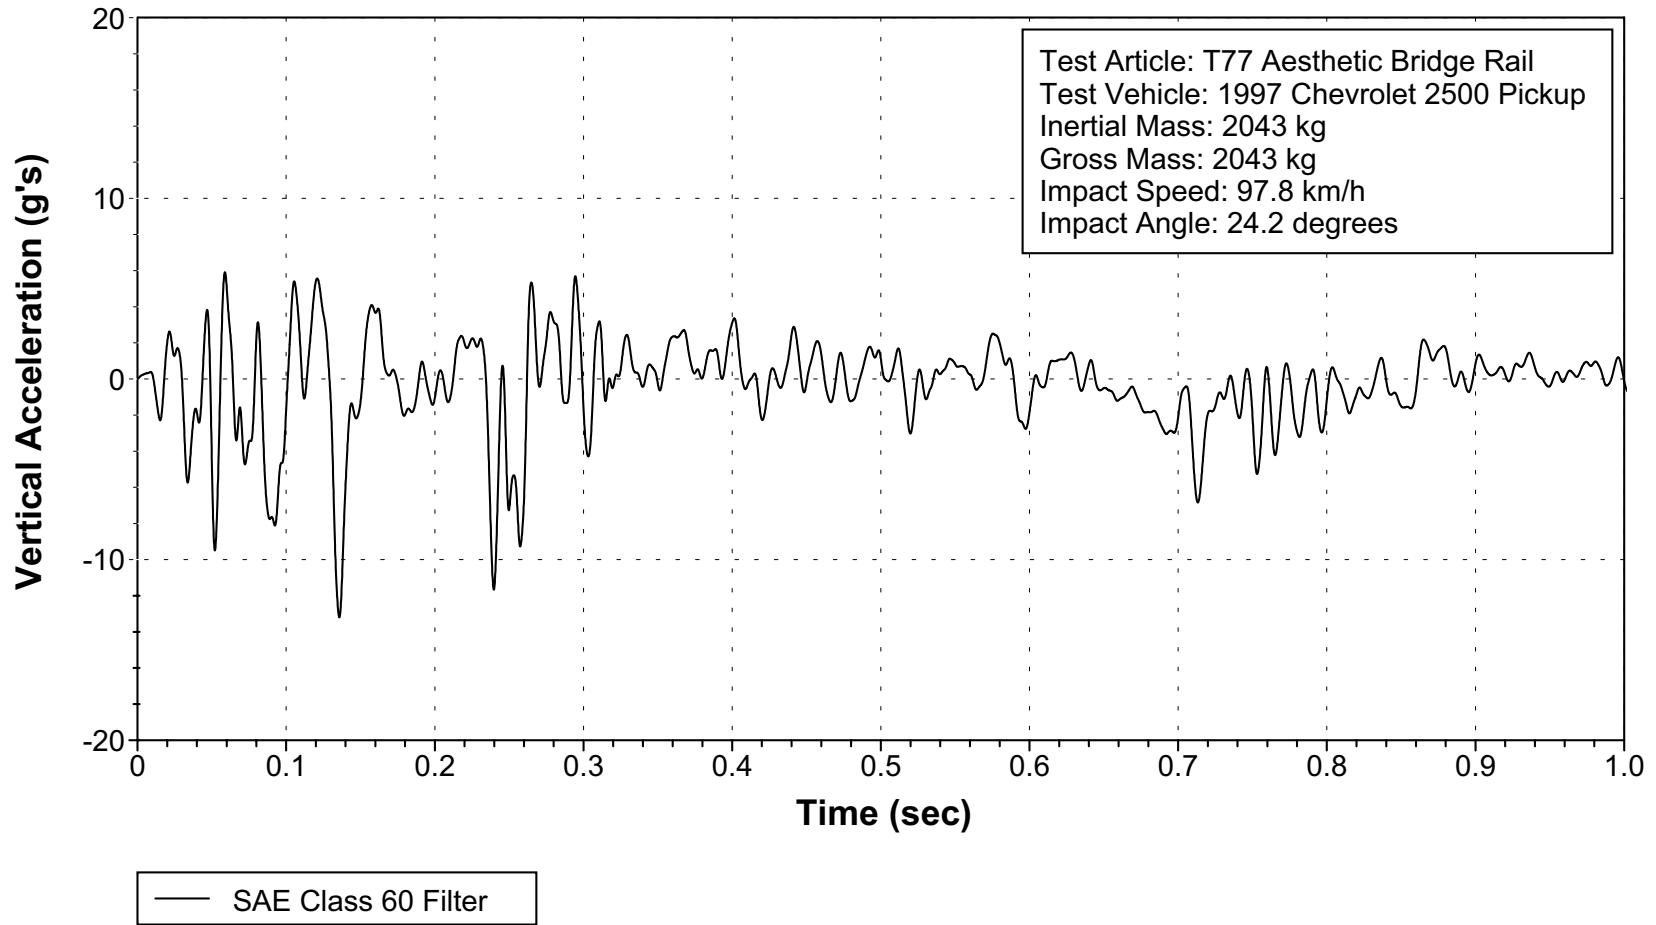
**Figure 67. Vehicle Vertical Accelerometer Trace for Test 442882-3
(Accelerometer Located Over Rear Axle).**

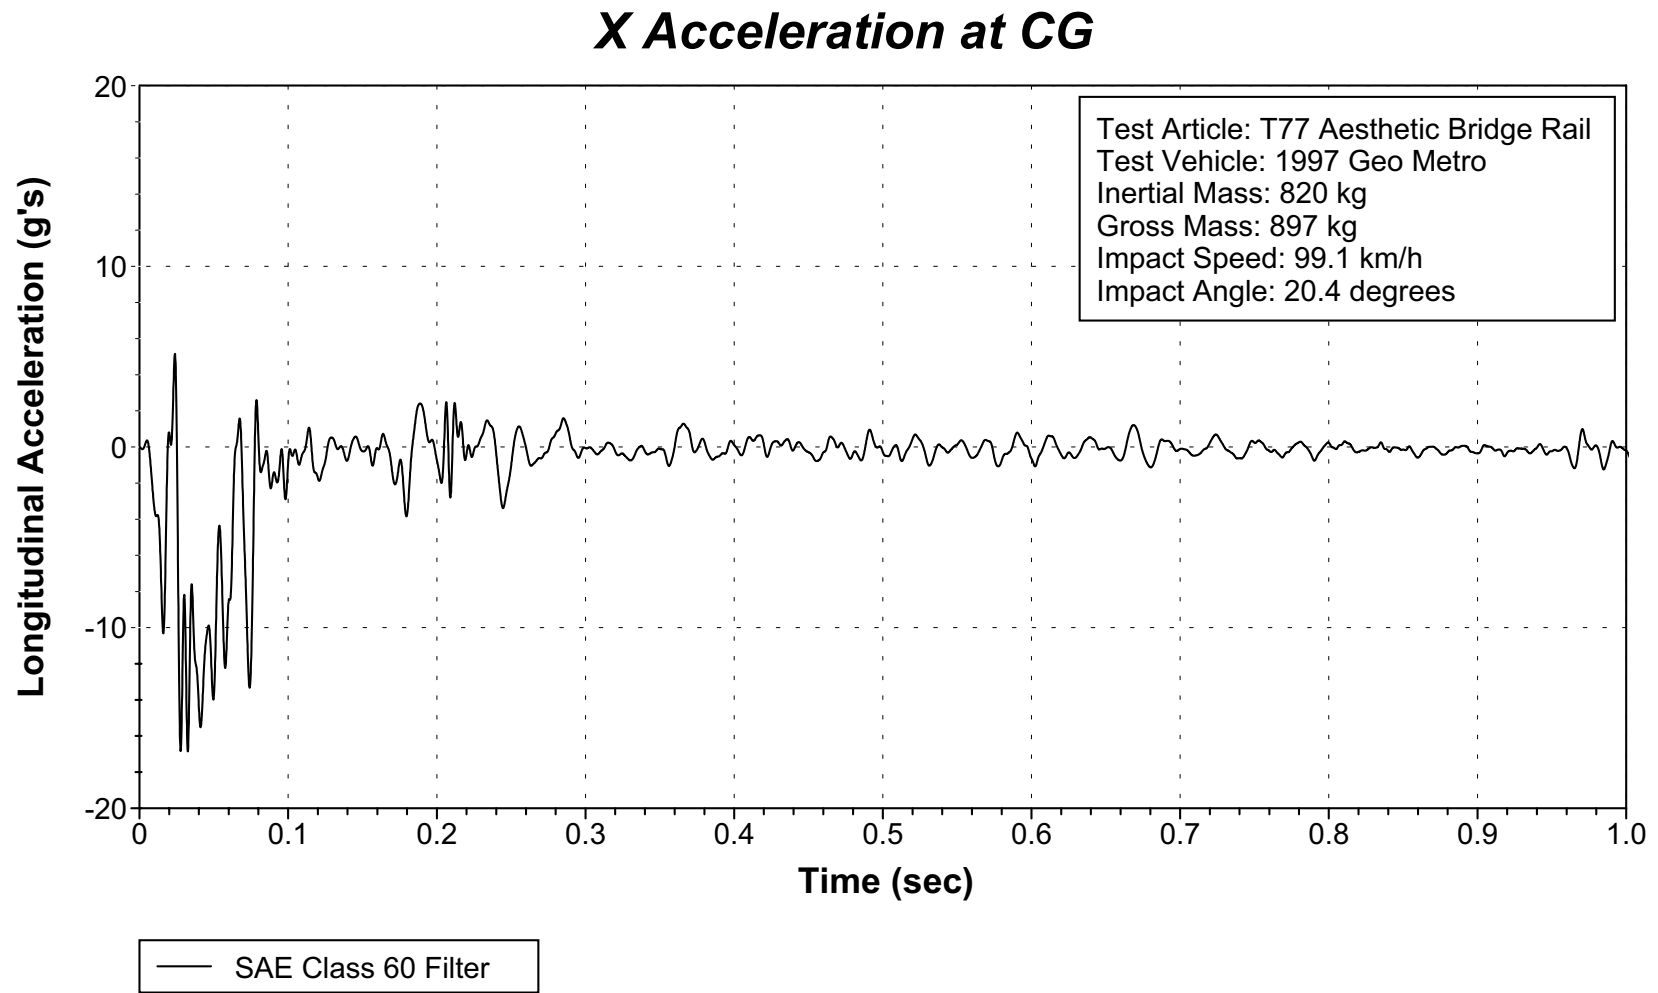
**Figure 68. Vehicle Longitudinal Accelerometer Trace for Test 442882-4
(Accelerometer Located at Center of Gravity).**
