1. Report No. FHWA/TX-03/4288-1		2. Government Accession No.		3. Recipient's Catalog No.	
4. Title and Subtitle DESIGN AND EVALUATION OF THE TXDOT F411 AND T77 AESTHETIC BRIDGE RAILS				5. Report Date October 2002

**DESIGN AND EVALUATION OF THE TxDOT
F411 AND T77 AESTHETIC BRIDGE RAILS**

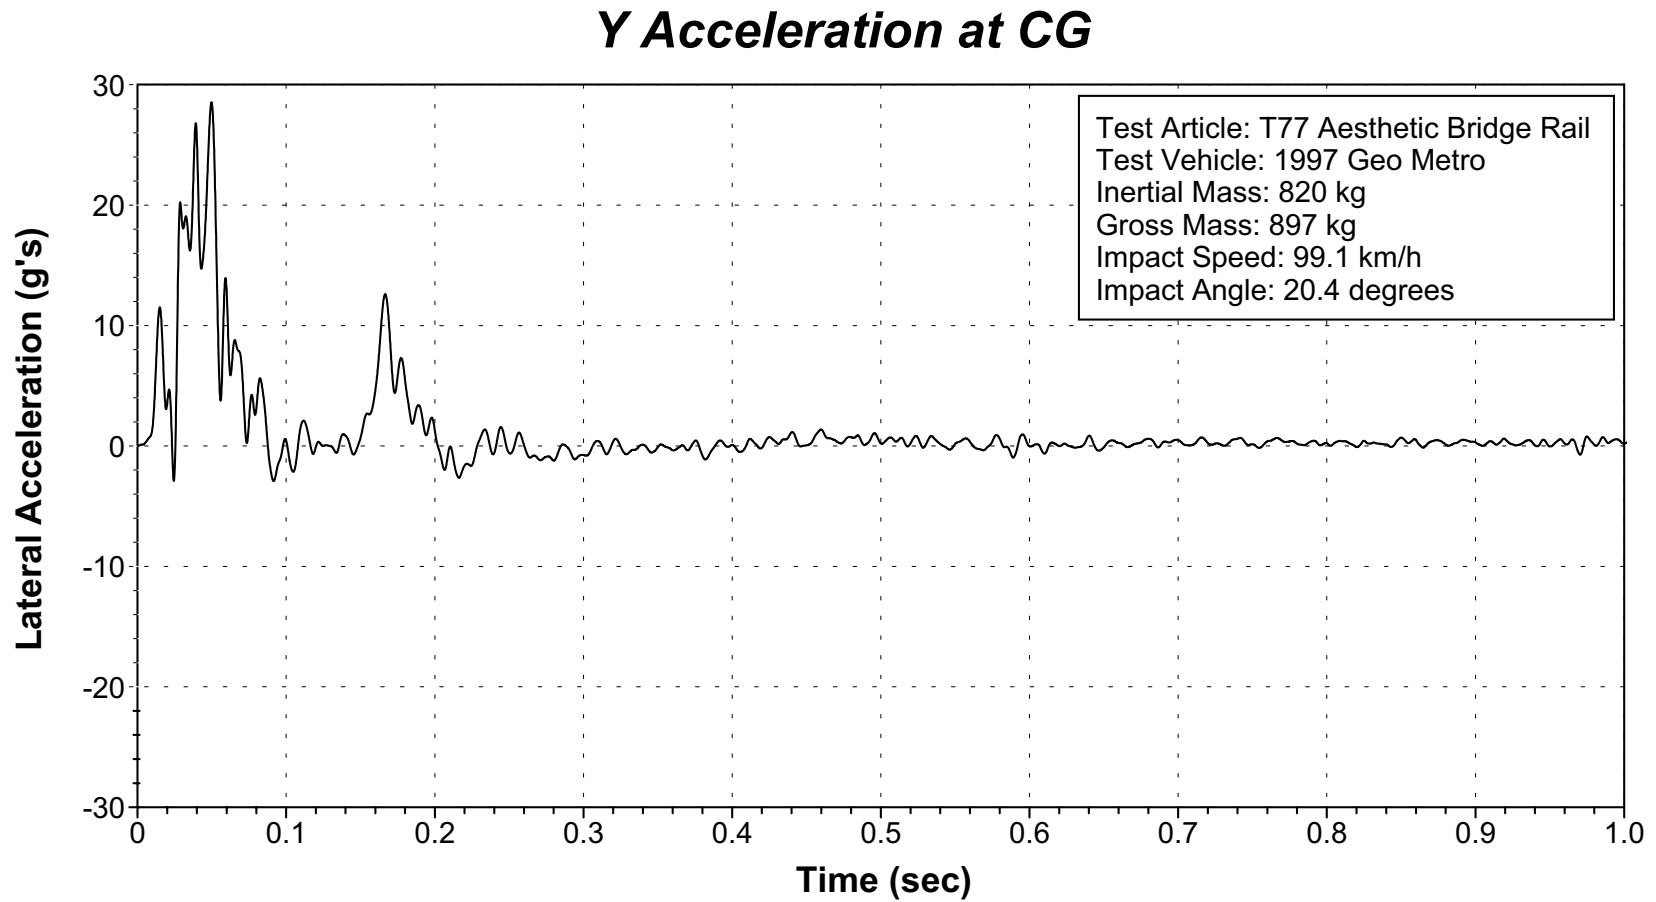
**Figure 69. Vehicle Lateral Accelerometer Trace for Test 442882-4
(Accelerometer Located at Center of Gravity).**

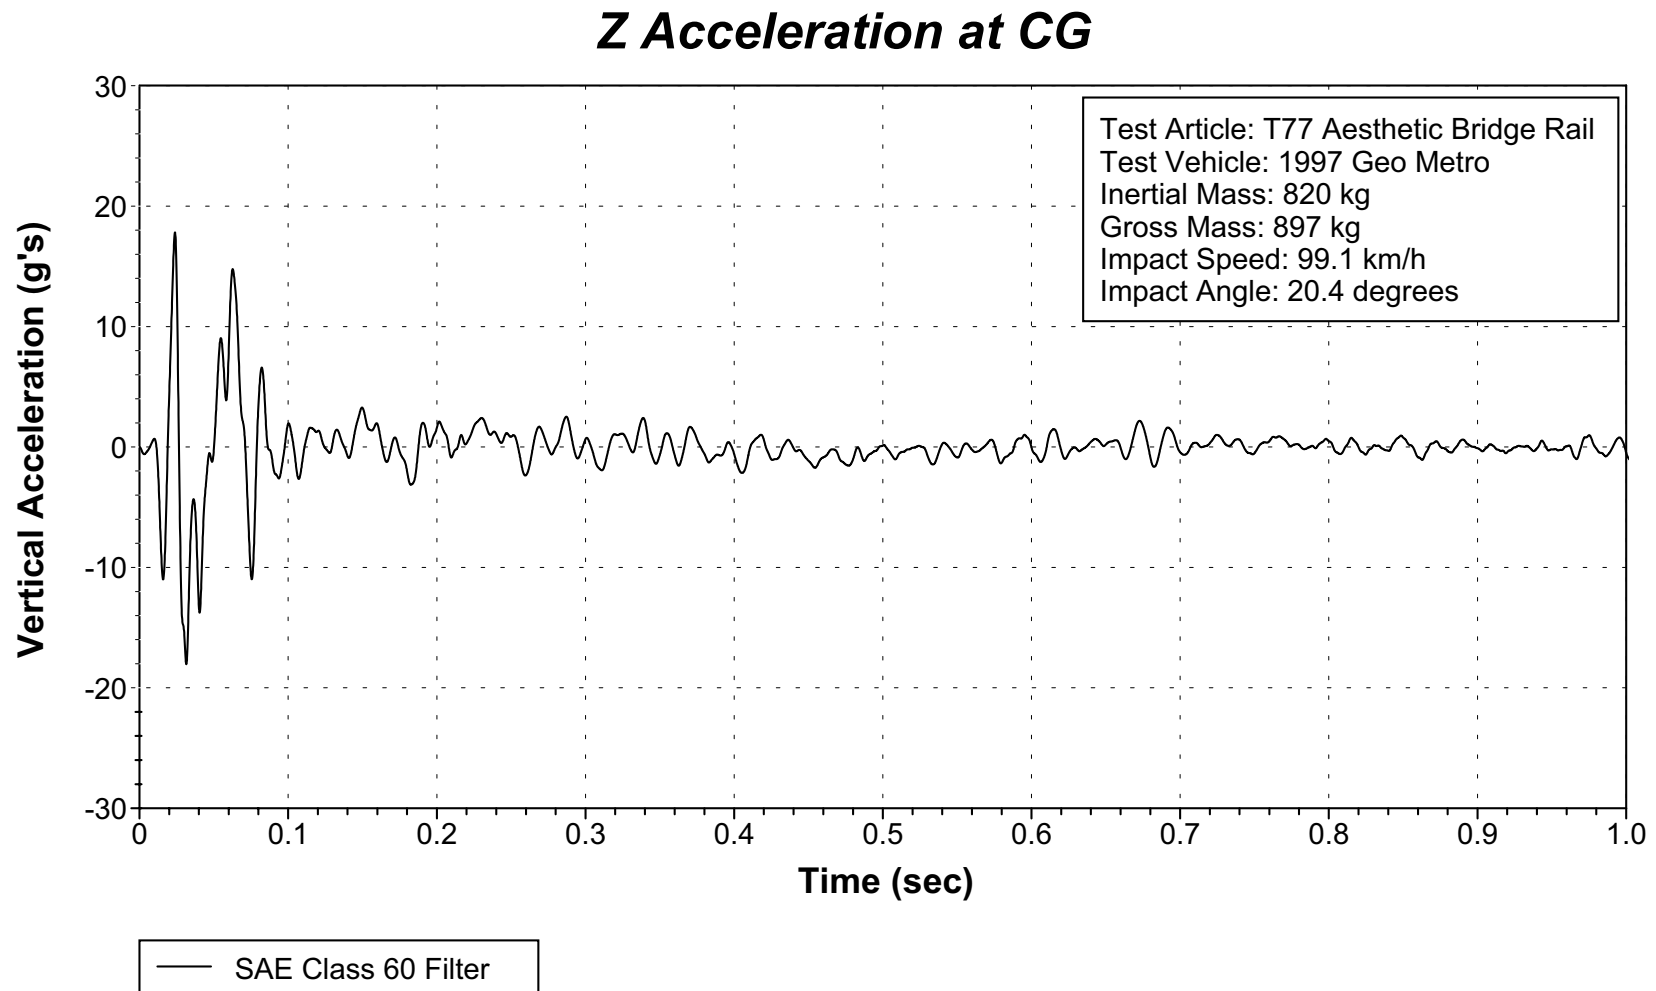
**Figure 70. Vehicle Vertical Accelerometer Trace for Test 442882-4
(Accelerometer Located at Center of Gravity).**

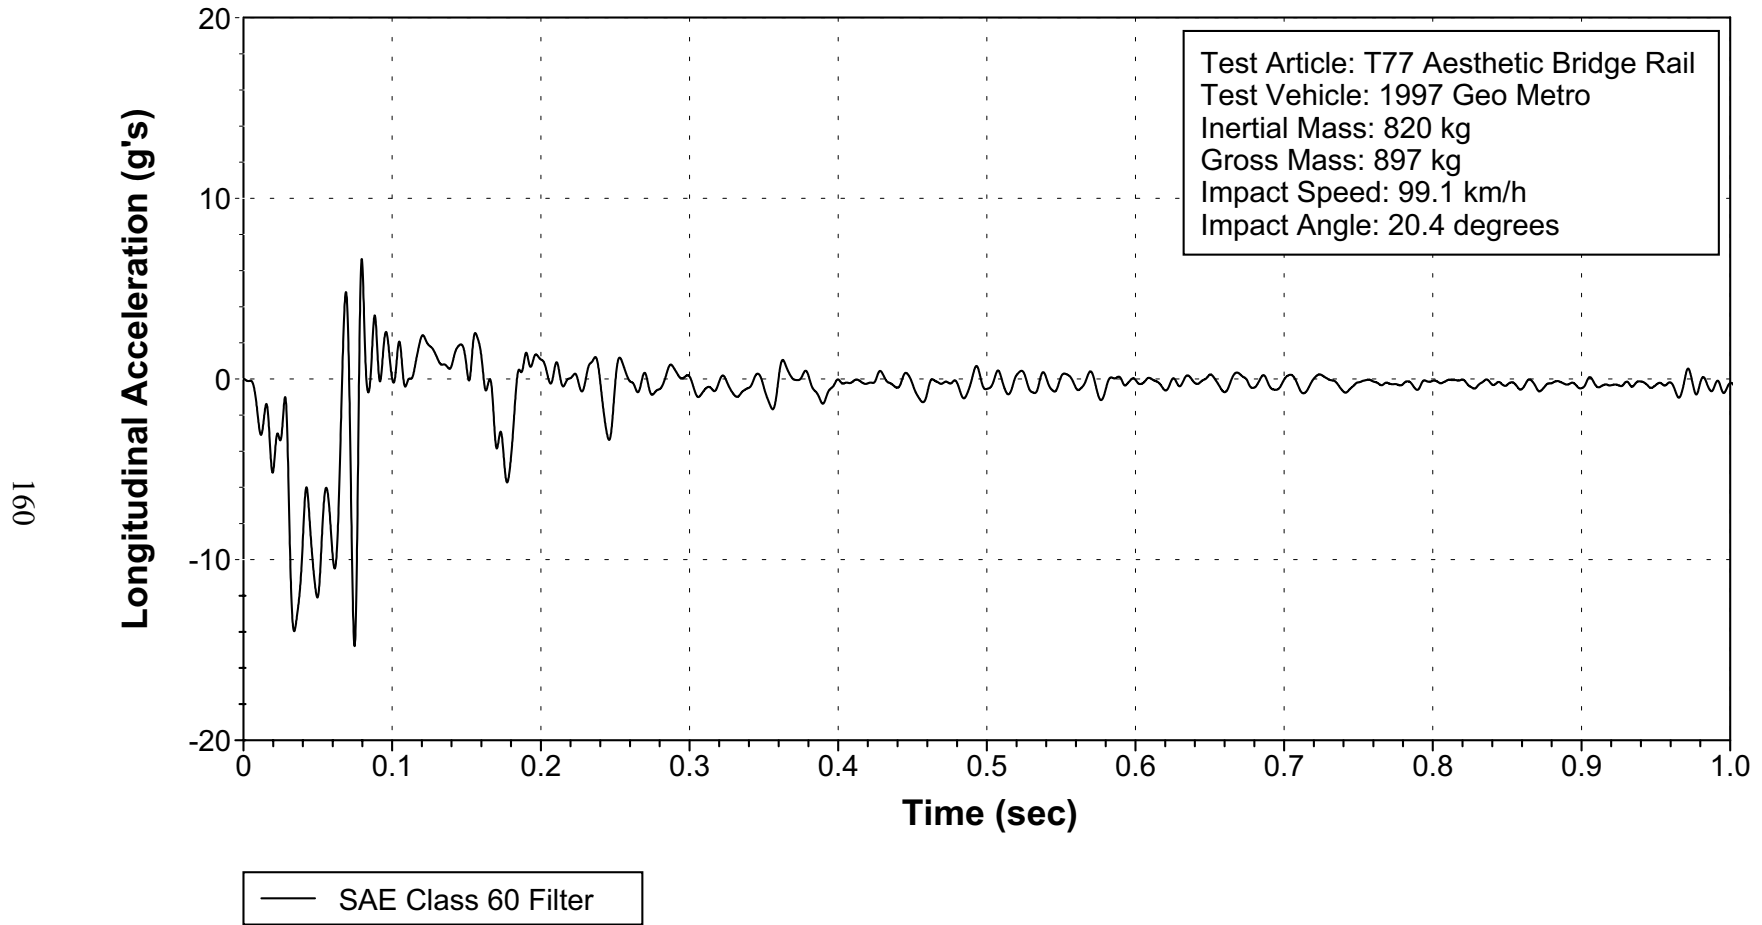
**Figure 71. Vehicle Longitudinal Accelerometer Trace for Test 442882-4
(Accelerometer Located Over Rear Axle).**

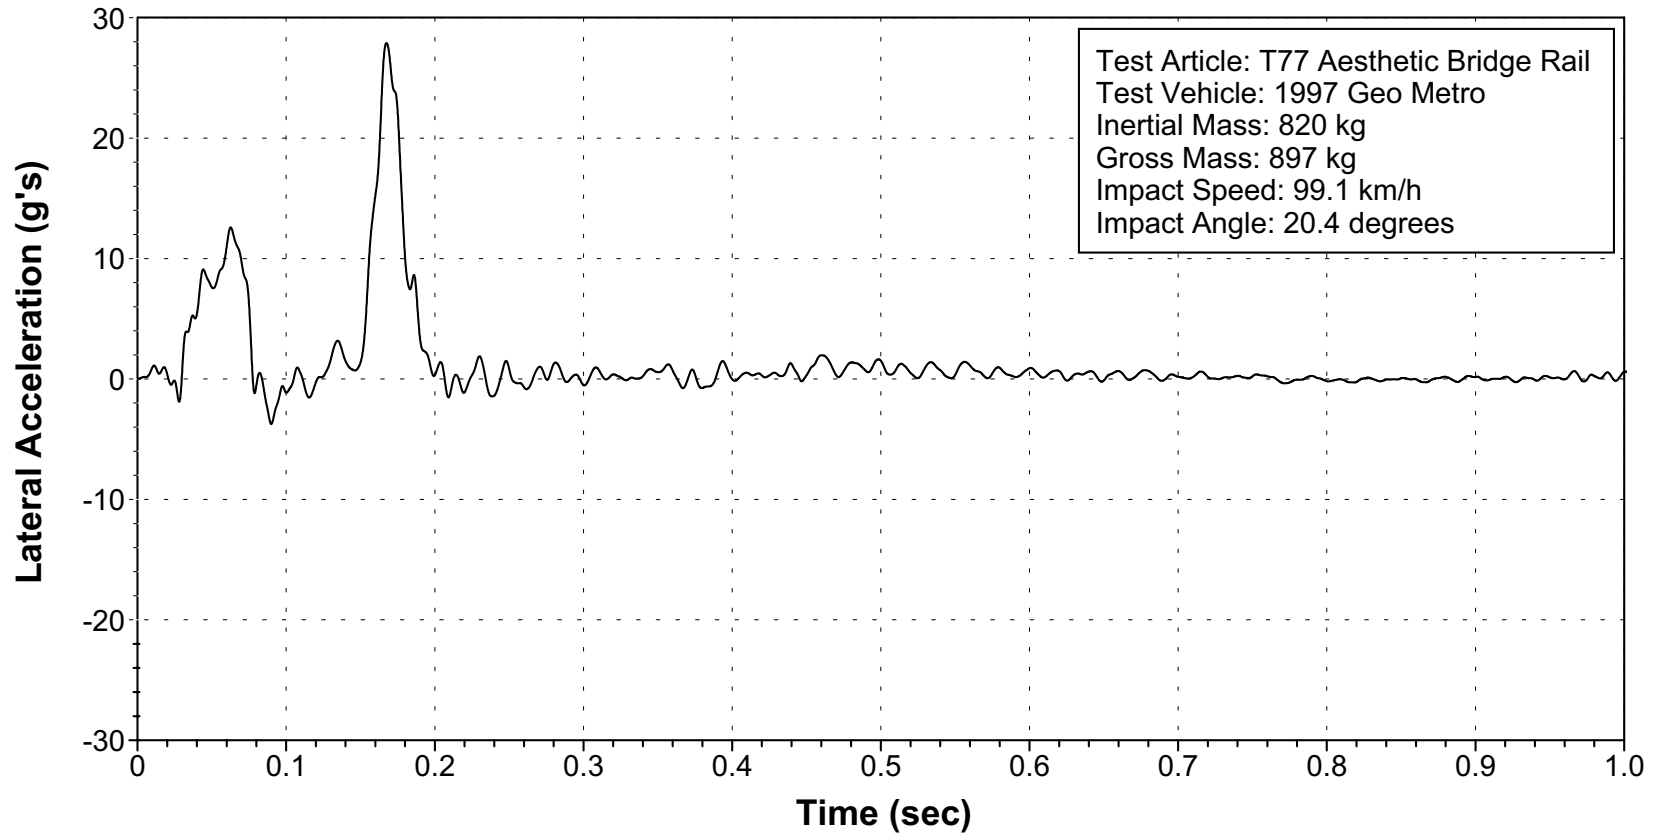
Figure 72. Vehicle Lateral Accelerometer Trace for Test 442882-4
(Accelerometer Located Over Rear Axle).

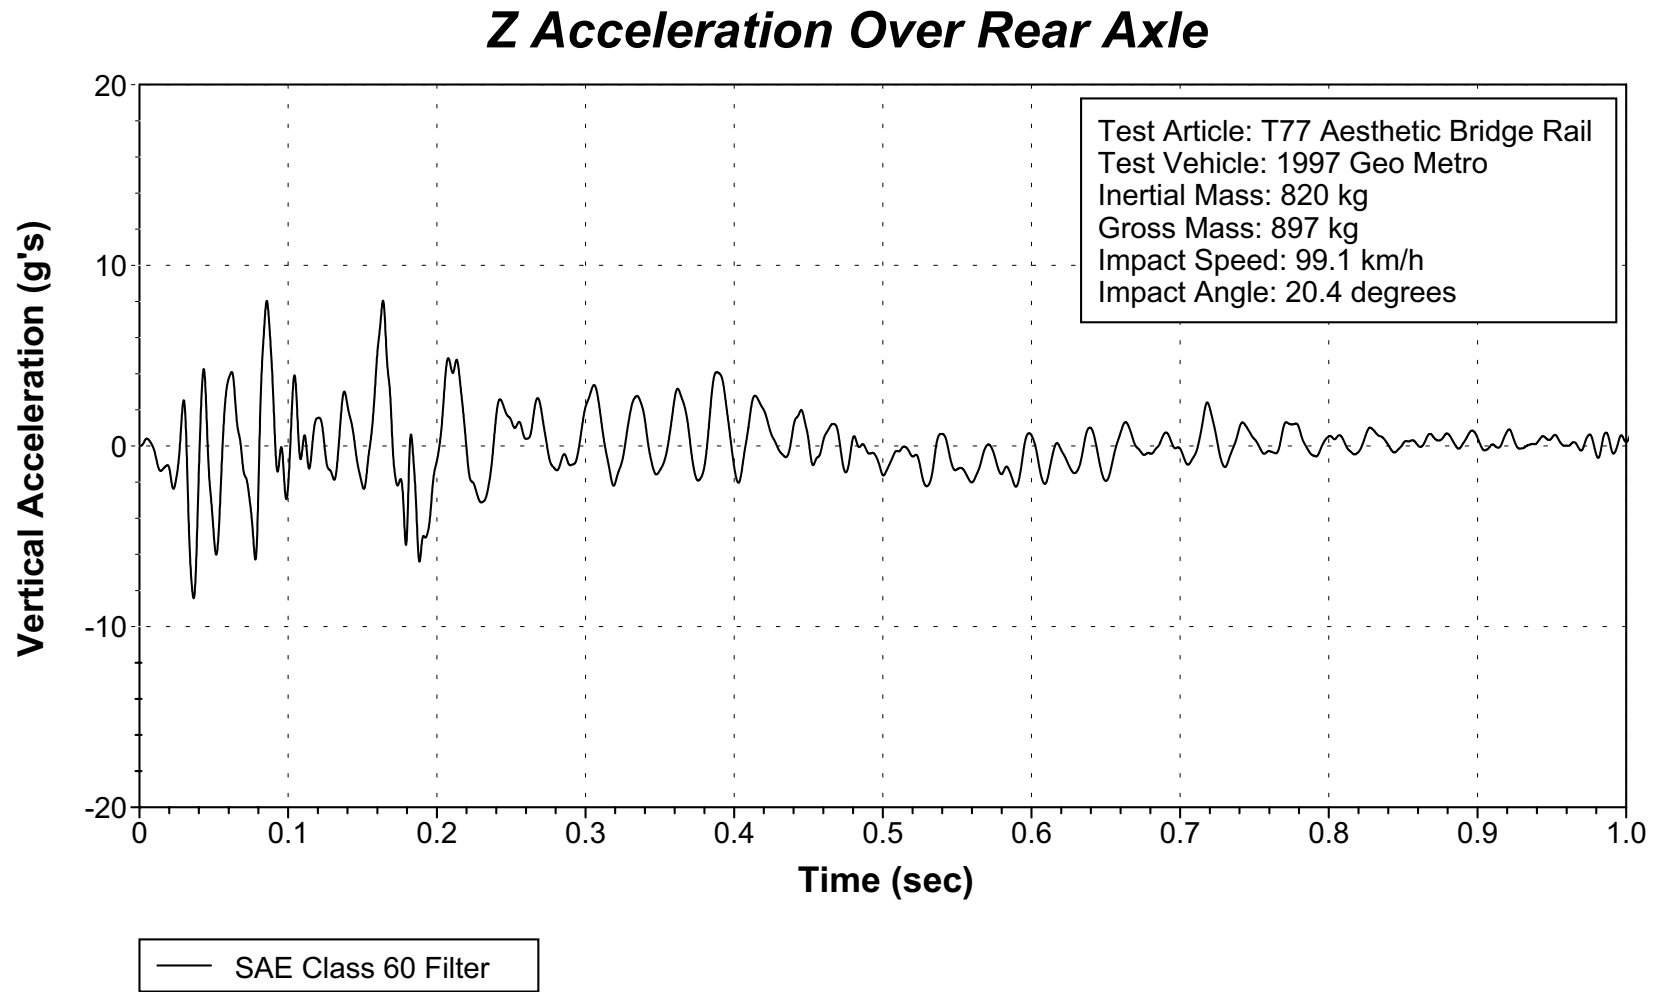
**Figure 73. Vehicle Vertical Accelerometer Trace for Test 442882-4
(Accelerometer Located Over Rear Axle).**
