## **TL-4 CRASH TESTING OF THE F411 BRIDGE RAIL**

Contract No. 9-8132  
Report No. 9-8132-P7

Product 9-8132-P7  
Project 9-8132  
Project Title: FDOT Bridge Rails

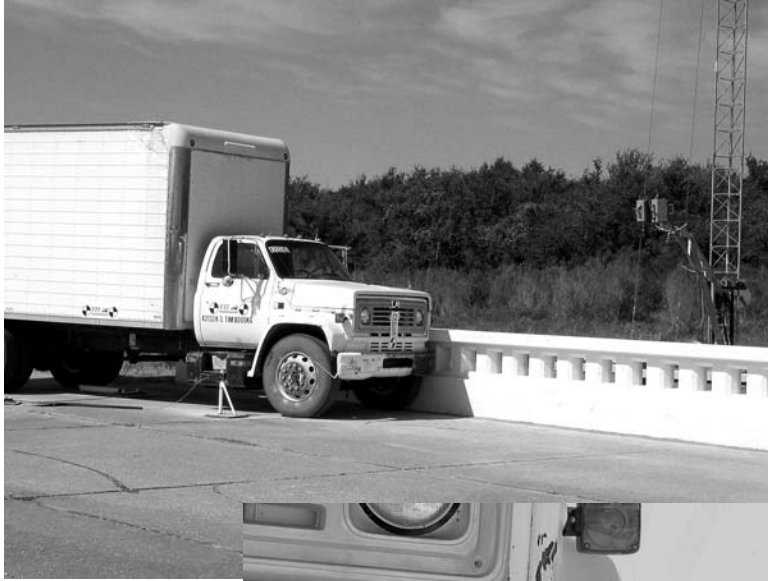
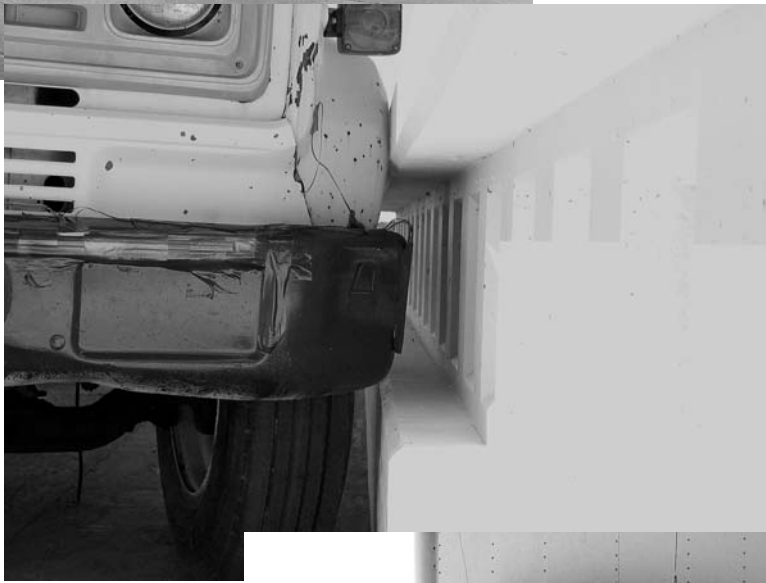
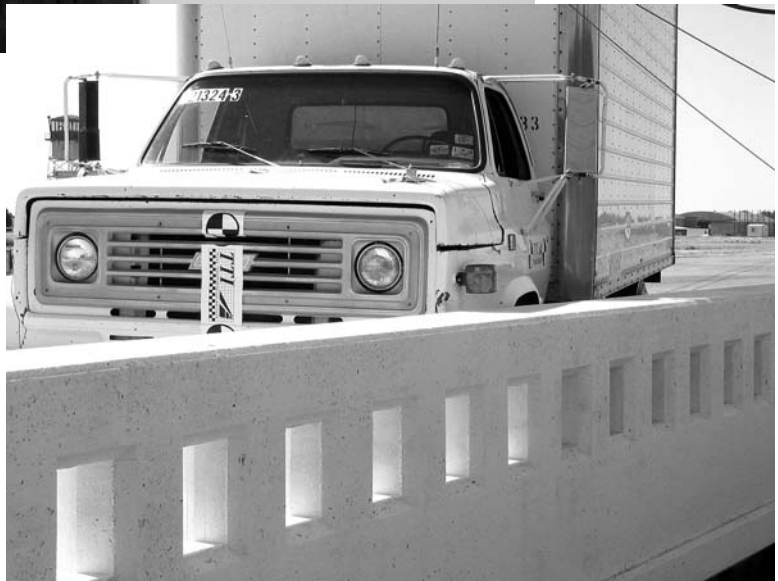
**Figure 3. Vehicle/Installation Geometrics for Test No. 421324-3.**

A 1984 Chevrolet C-60 single-unit box van, shown in Figures 3 and 4, was used for the crash test. Test inertia weight of the vehicle was 17,770 lb (8068 kg), and its gross static weight was 17,770 lb (8068 kg). The height to the lower edge of the vehicle bumper was 19.75 inches (502 mm), and it was 32.0 inches (813 mm) to the upper edge of the bumper. Figure 9 in Appendix B gives additional dimensions and information on the vehicle. The vehicle was directed into the installation using the cable reverse tow and guidance system, and was released to be free-wheeling and unrestrained just prior to impact.

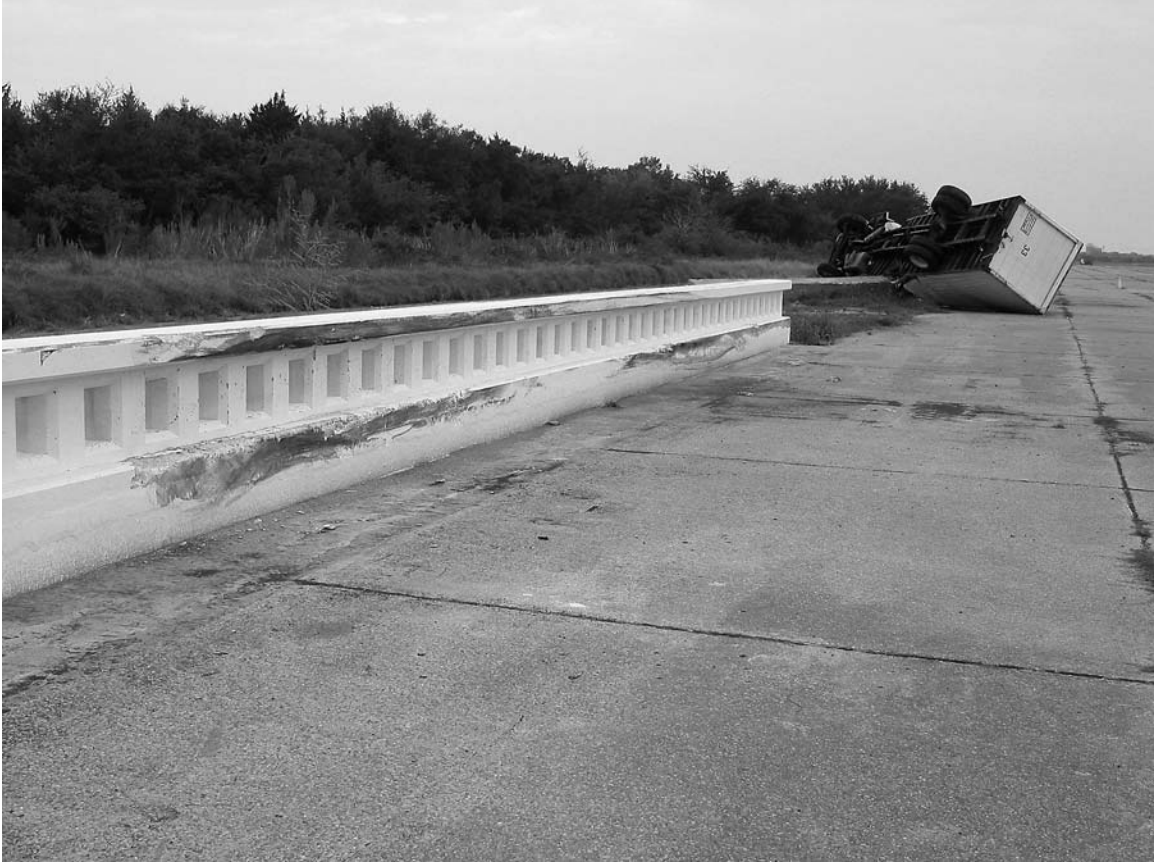
**Figure 5. After Impact Trajectory Path for Test No. 421324-3.**

The C-60 single-unit truck, traveling at a speed of 50.0 mi/h (80.5 km/h), impacted the TxDOT F411 bridge rail 19.5 ft downstream of the upstream end of the bridge rail at an impact angle of 16.8 degrees. At approximately 0.014 s after impact, the left front quarter panel of the vehicle began to deform. The vehicle began to redirect at 0.020 s. At 0.050 s, the left front wheel rim began to gouge into the rail, and at 0.117 s, the left front corner of the van box began to deform. At 0.314 s, the left rear of the van box contacted the rail, and the vehicle began traveling parallel to the rail at a speed of 43.5 mi/h (70.1 km/h). As the vehicle exited the view of the cameras at 0.594 s, the vehicle was traveling at a speed of 45.3 mi/h (72.9 km/h) and an exit angle of 1.6 degrees. The vehicle subsequently contacted a second barrier 135 ft (41 m) downstream of impact at 1.876 s after impact, where the vehicle came to rest. Figures 10 and 11 in Appendix C show sequential photographs of the test period.

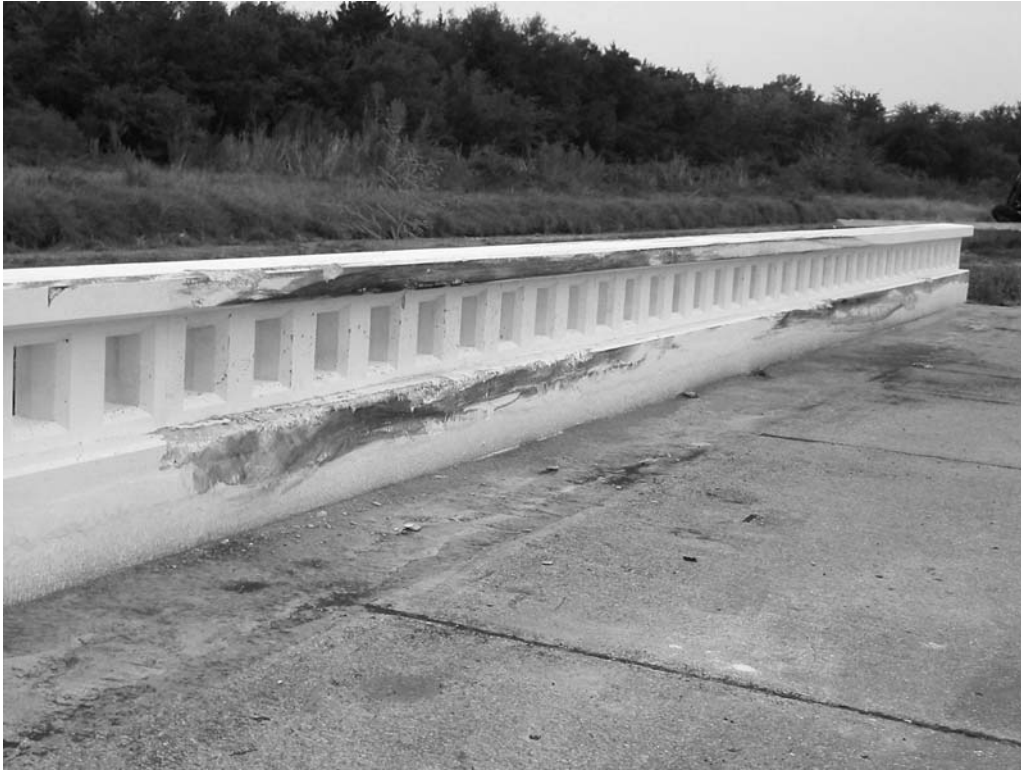
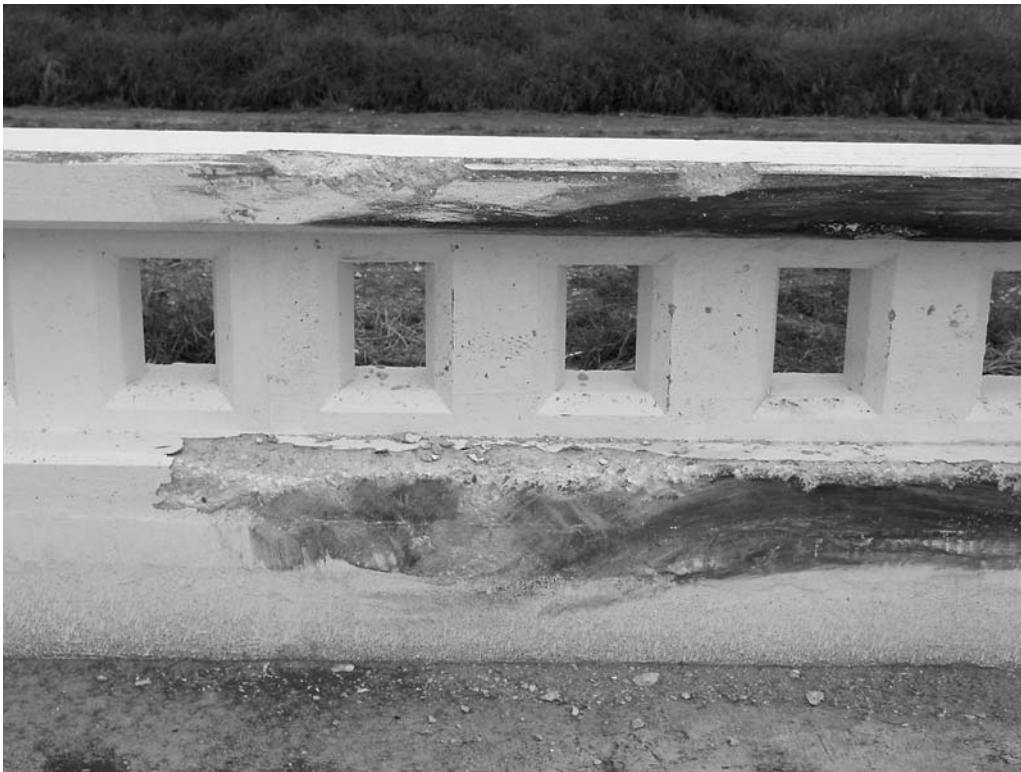
**Figure 6. Installation after Test No. 421324-3.**

The TxDOT F411 bridge rail sustained cosmetic damage from contact with the vehicle. Figures 5 and 6 show damage to the bridge rail. There was spalling of concrete on the curb and upper rail from point of impact and extending for 39 inches (991 mm) downstream. The vehicle was in contact with the rail from point of impact until the end of the bridge rail. No measurable deflection of the rail was noted, and working width was 30.6 inches (777 mm).

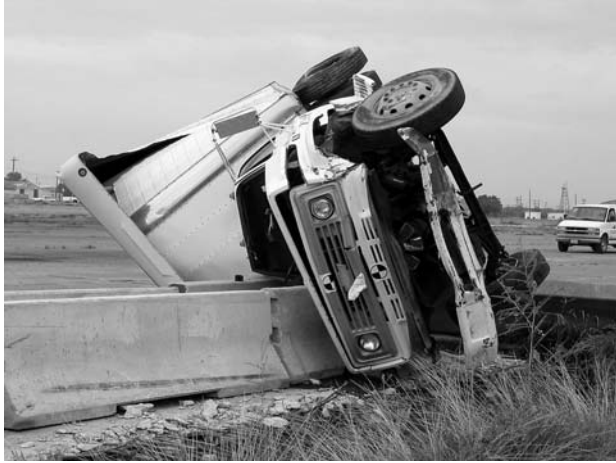
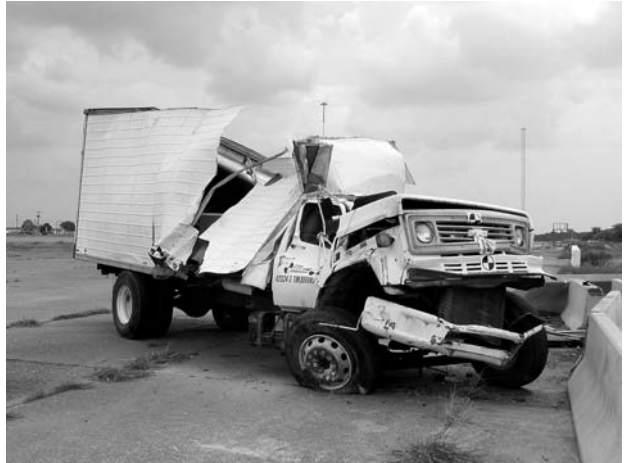
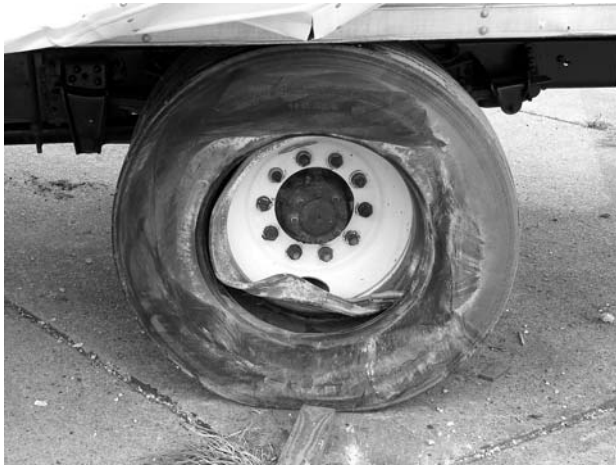
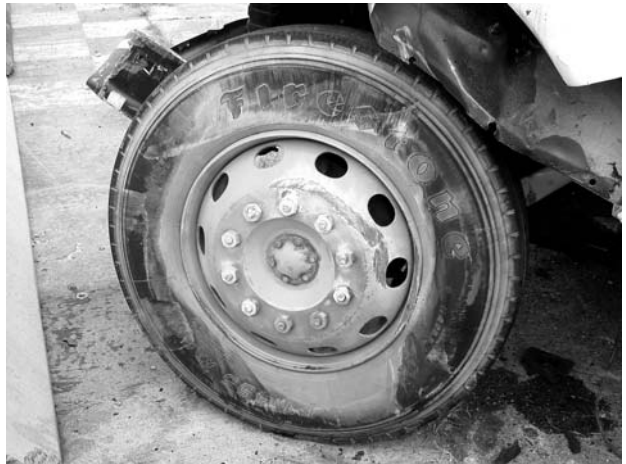
**Figure 7. Vehicle after Test No. 421324-3.**

Much of the damage to the vehicle was due to the contact with the second barrier downstream of impact. Figure 7 shows the vehicle after impact.

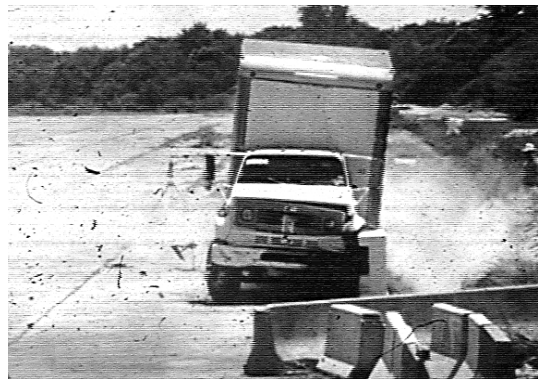
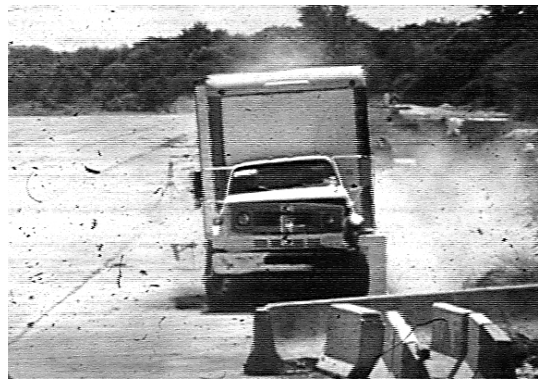
**Figure 10. Sequential Photographs for Test No. 421324-3  
(Overhead and Frontal Views) (Continued).**

0.801 s

0.981 s

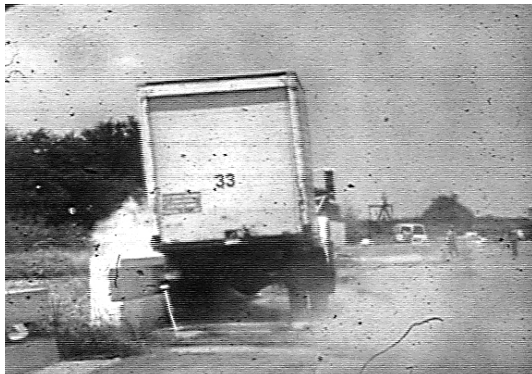
0.801 s

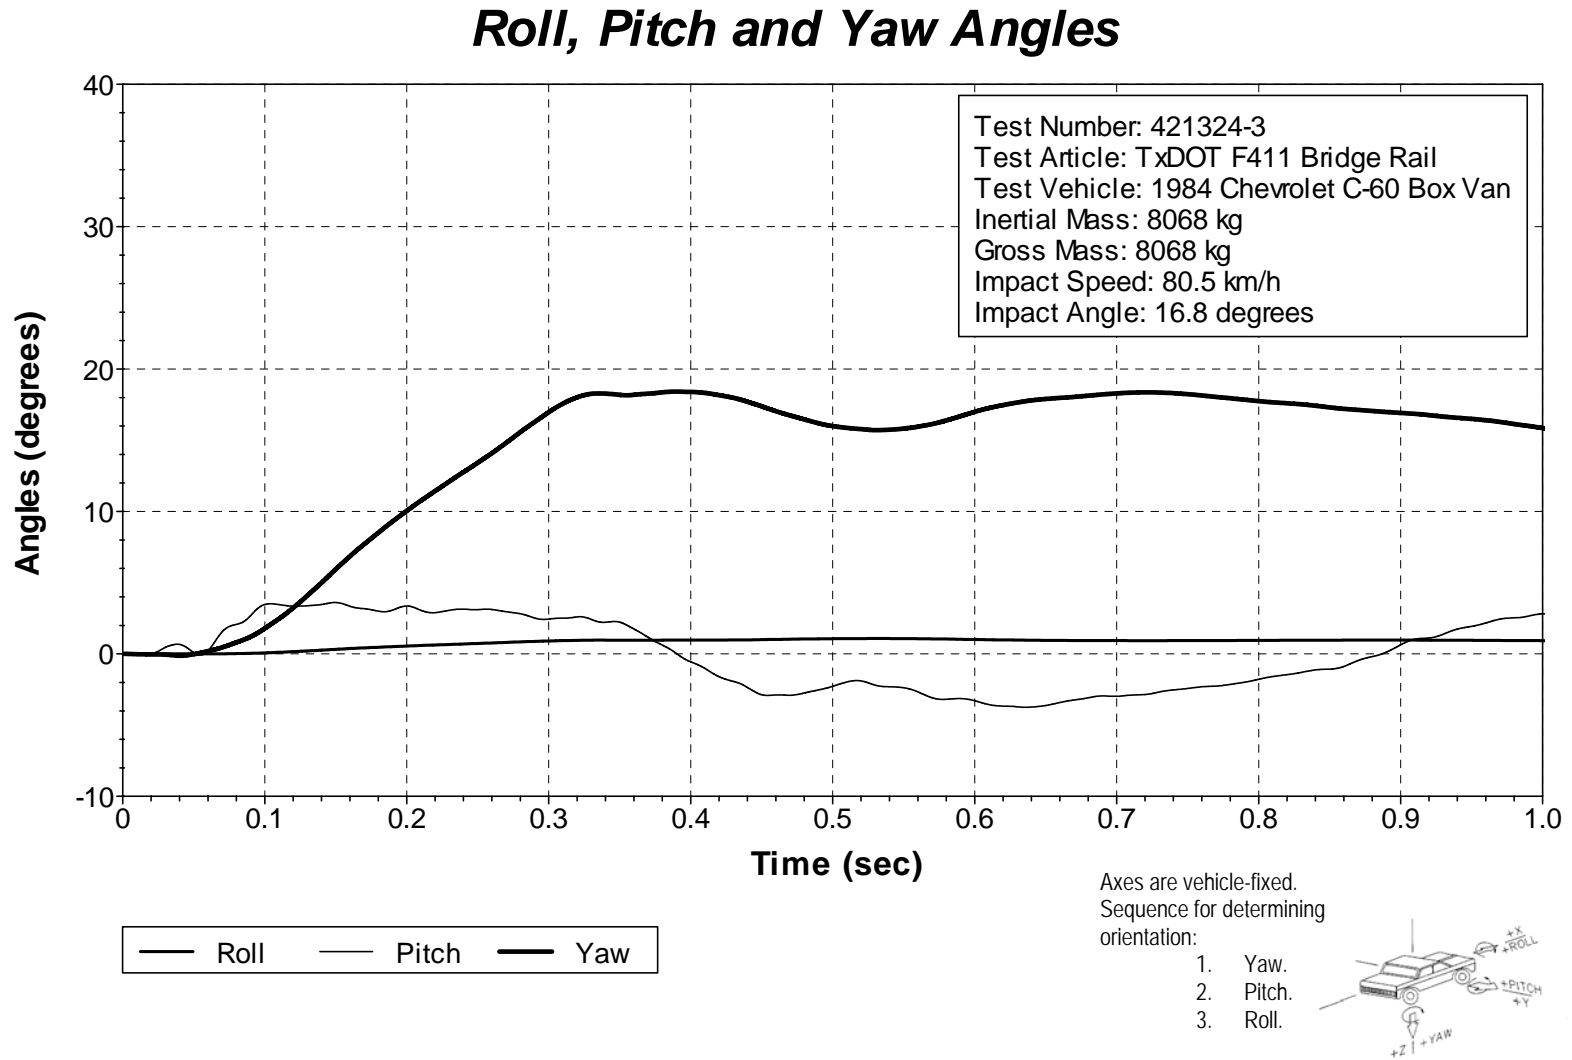
Figure 12. Vehicle Angular Displacements for Test No. 421324-3.

Data from the triaxial accelerometer, located at the vehicle center of gravity, were digitized to compute occupant impact velocity and ridedown accelerations. These factors are not required for evaluation of this test and are provided for information purposes only. In the longitudinal direction, occupant impact velocity was 15.1 ft/s (4.6 m/s) at 0.244 s, maximum 0.010-s ridedown acceleration was -4.2 g's from 0.973 to 0.983 s, and the maximum 0.050-s average was -2.8 g's between 0.082 and 0.132 s. In the lateral direction, the occupant impact velocity was 9.2 ft/s (2.8 m/s) at 0.244 s, the highest 0.010-s occupant ridedown acceleration was 21.5 g's from 0.285 to 0.295 s, and the maximum 0.050-s average was -5.3 g's between 0.296 and 0.346 s. Figure 8 presents these data and other pertinent information from the test. Figures 12 through 19 in Appendix D present vehicle angular displacements and accelerations versus time traces.
