DESIGN AND EVALUATION OF THE TL-4 MINNESOTA COMBINATION TRAFFIC/BICYCLE BRIDGE RAIL

MIDWEST ROADSIDE SAFETY FACILITY

MwRSF Research Report No. TRP-03-74-98

November 30, 1998

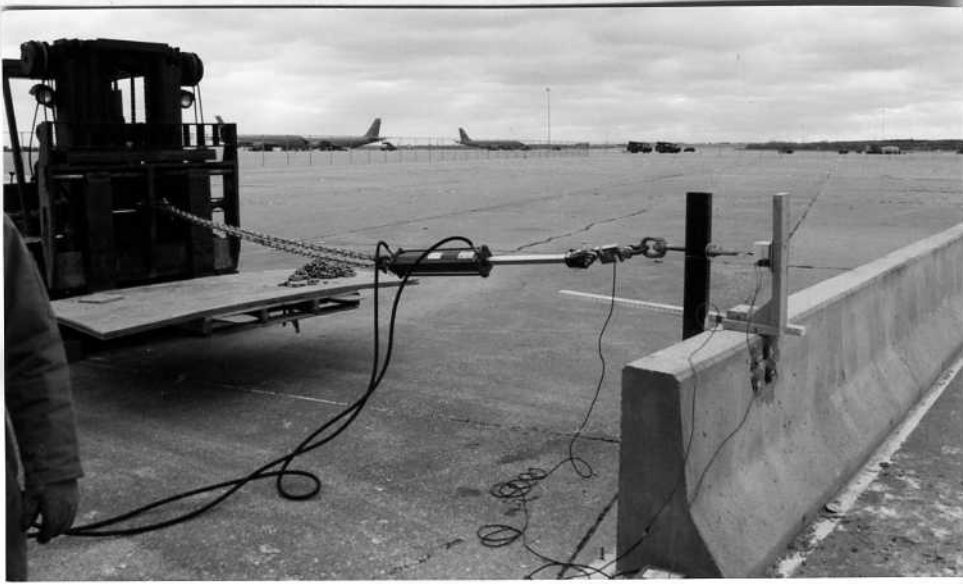
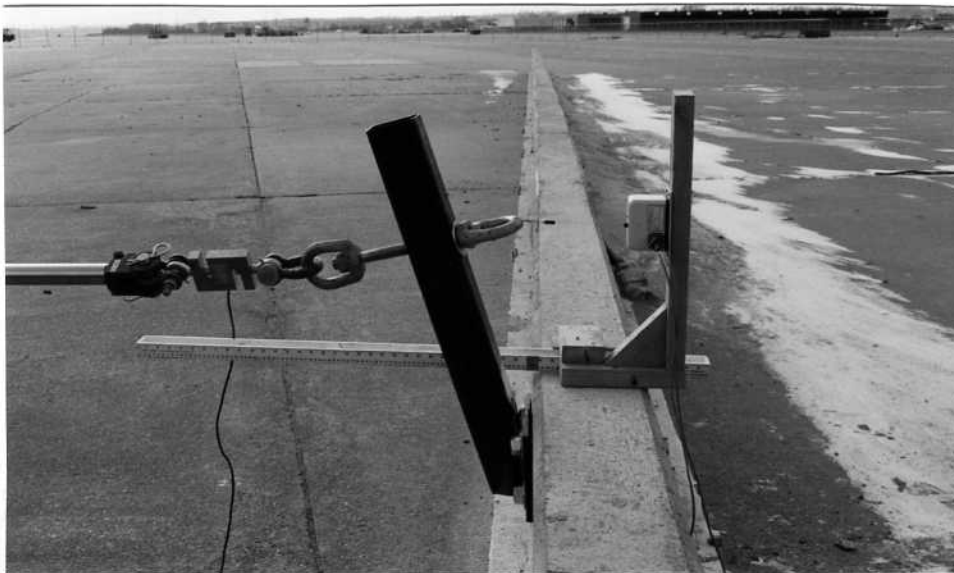
Figure 1. Static Testing Setup

Tubular steel posts were tested under a static load to determine the force-deflection characteristics of several post-weakening alternatives. Each post was fabricated using TS 102 x 51 x 3.2 ASTM A500 Grade B steel and was welded to an 12.7-mm thick steel plate. The posts were attached to the back-side vertical face of the safety shape concrete barrier using four 22.2-mm diameter ASTM A307 bolts, as shown in Figure 1. As given in Figure 1, a load cell was attached to the back-side face of the post while a string potentiometer was attached to the traffic-side face of the post. Finally, various hole sizes and cut lengths were examined during the static testing phase to determine the optimum post weakening alternative. The distance between the applied load and the drilled hole or sawcut was 362 mm.

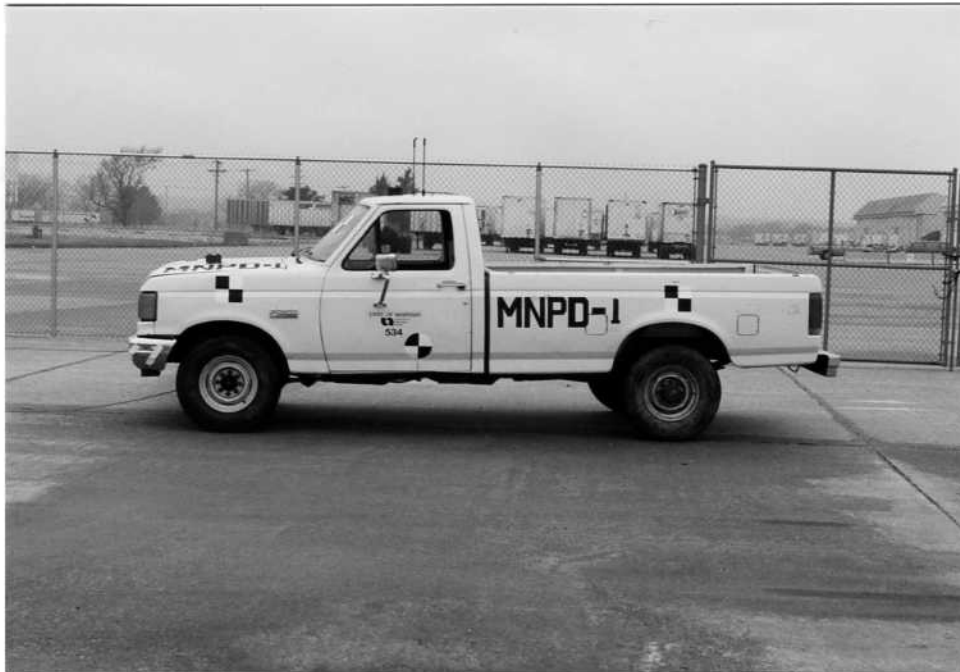
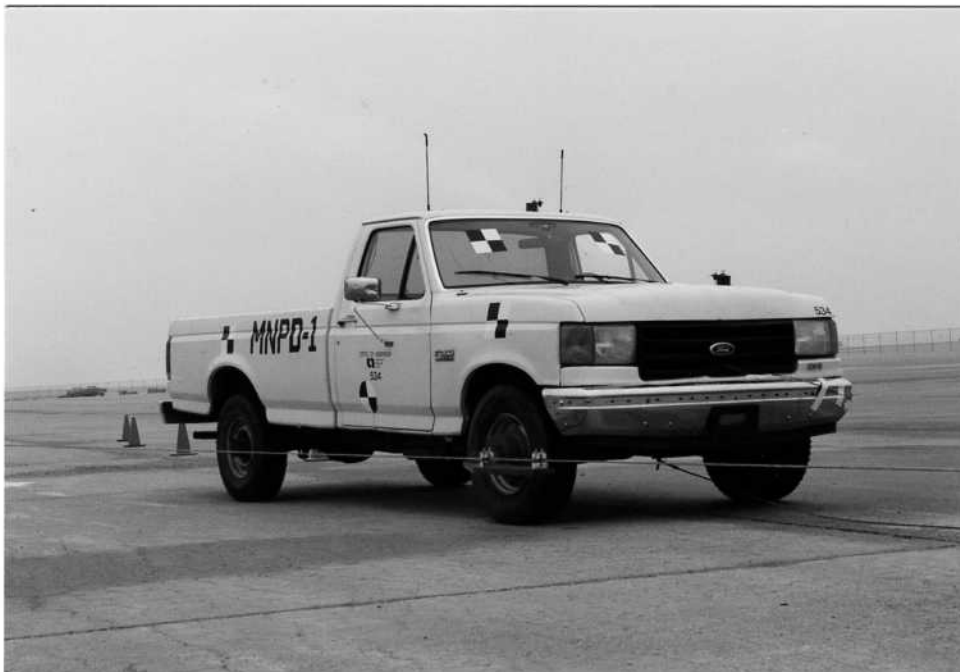
Figure 10. Test Vehicle, Test MNP0-1

For test MNPD-1, a 1988 Ford F-250 ¾-ton pickup truck, test vehicle designation 2000P, was used as the test vehicle. The test inertial and gross static weights were 2,001 kg. The test vehicle is shown in Figure 10, and vehicle dimensions are shown in Figure 11.

Square, black and white-checked targets were placed on the vehicle to aid in the viewing and analysis of the high-speed film, as shown in Figures 10, 12, and 14 through 15. Round, checked targets were placed on the center of gravity on the driver's side, the passenger's side, and on the roof of the vehicle. The other square targets were located at convenient reference locations for viewing from the high-speed cameras for film analysis.

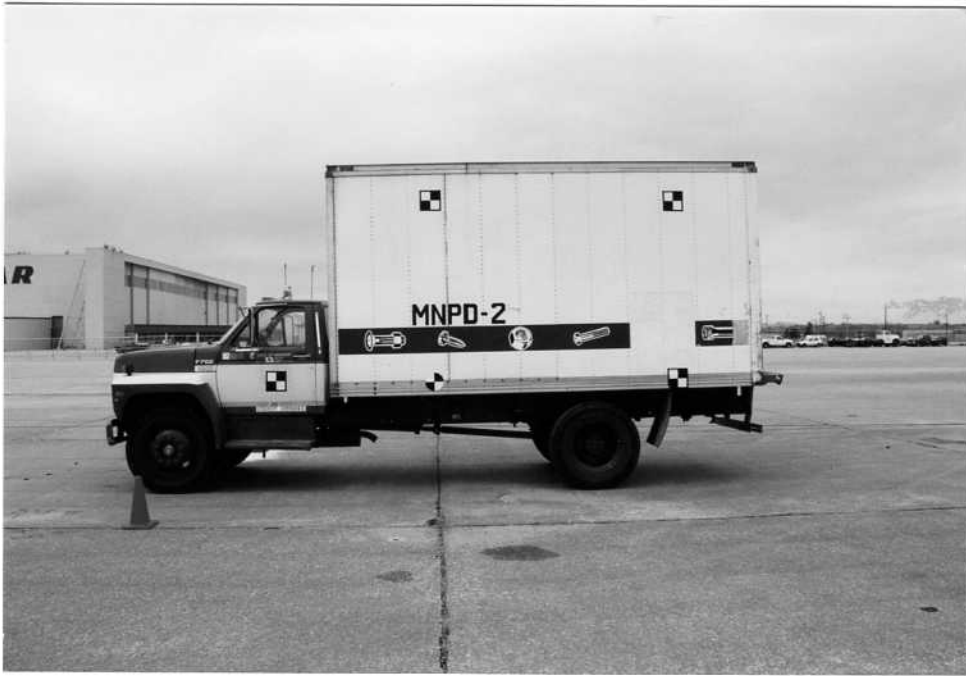
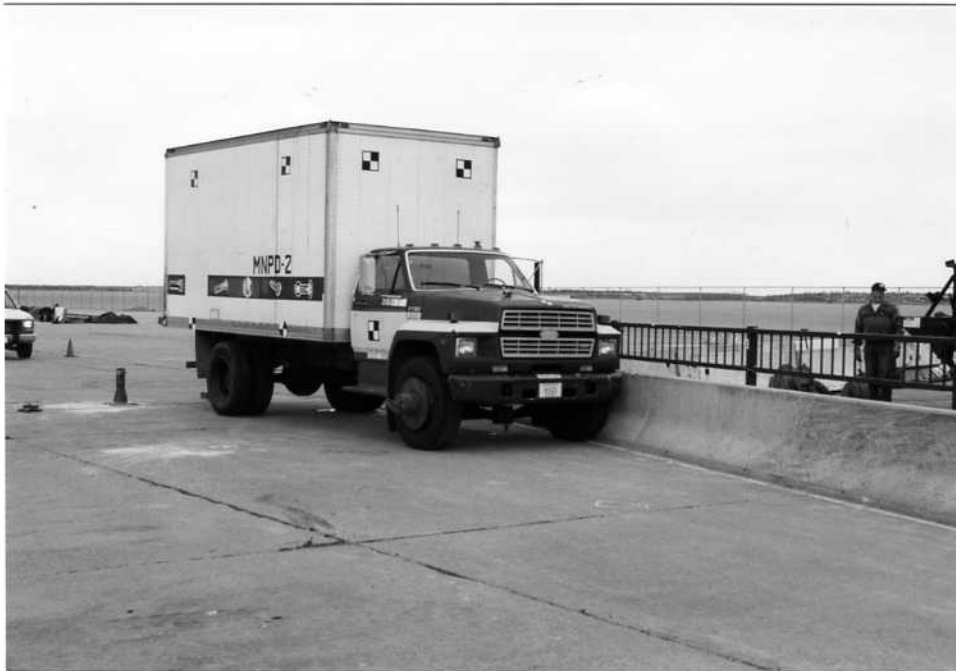
Figure 12. Test Vehicle, Test MNPD-2

For test MNPD-2, a 1988 Ford F-800 single unit truck, test vehicle designation 8000S, was used as the test vehicle. The test inertial and gross static weights were 8,002 kg. The test vehicle is shown in Figure 12, and vehicle dimensions are shown in Figure 13.

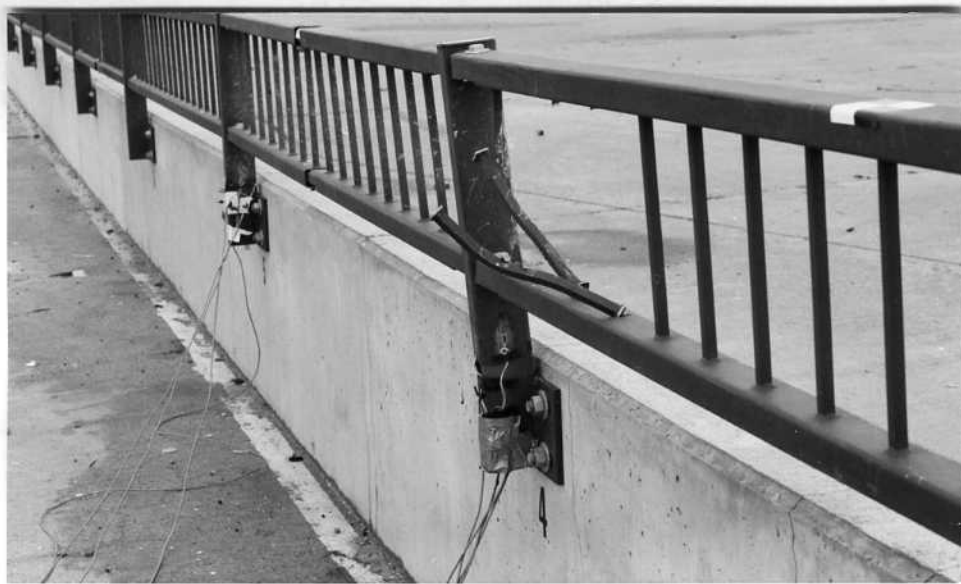
Figure 18. Strain Gauge Locations, Tests MNPD-1 and MNPD-2

For test MNPD-1, eight strain gauges were installed on the two critical posts, nos. 4 and 5, to measure post strain at selected regions. The four gauges on each critical post were centered on each side at 38-mm above the top of the breakaway hole in the post. Two additional gauges were mounted on the cable turnbuckles to measure cable tension. The strain gauge positions are shown in Figure 18. For test MNPD-2, two strain gauges were installed on the turnbuckles to monitor the cable tension. The strain gauge positions are shown in Figure 18.

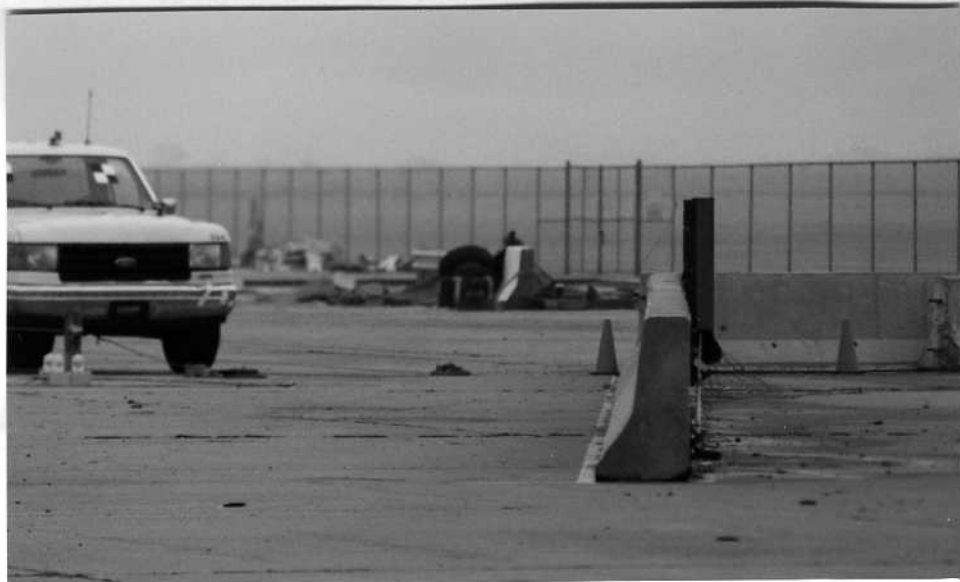
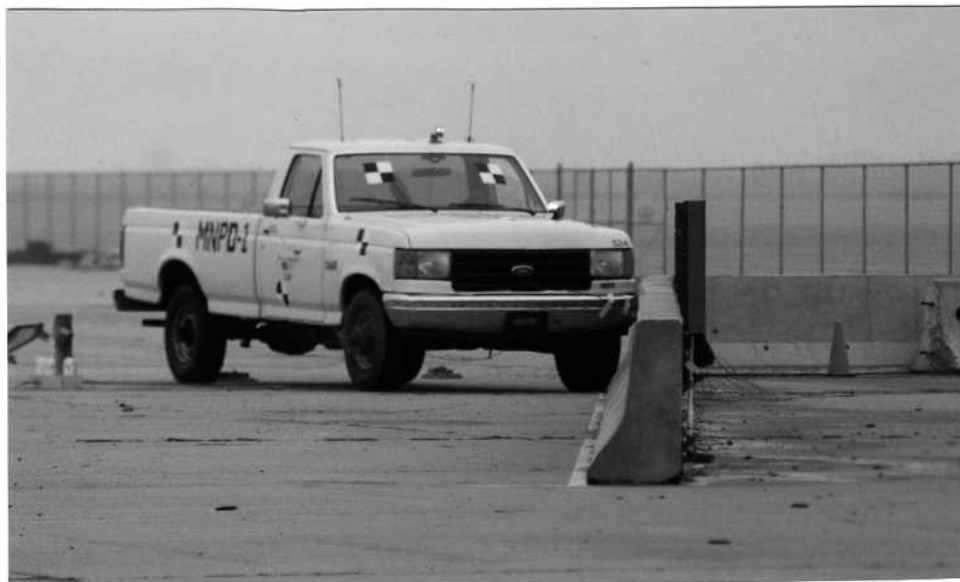
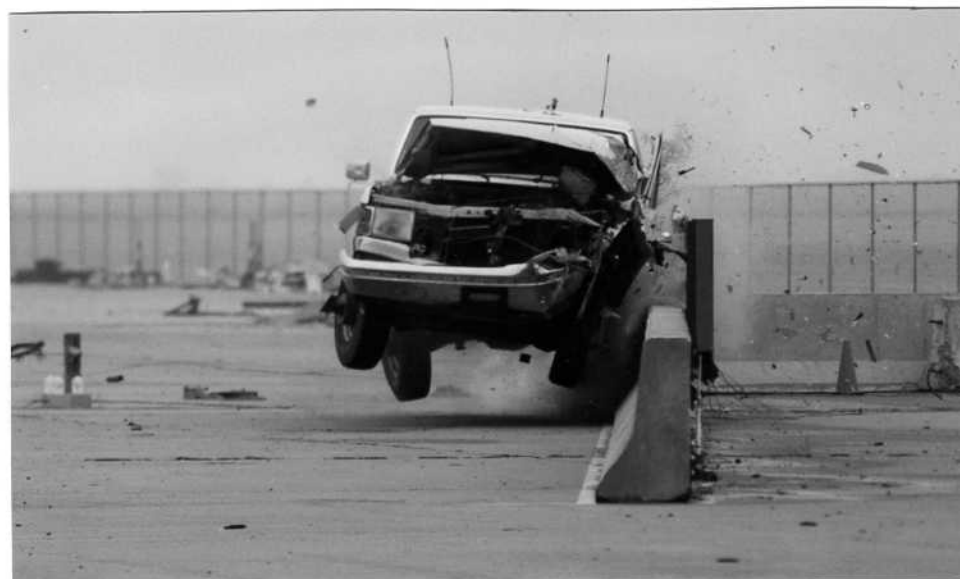
Figure 21. Documentary Photographs, Test MNPD-1

The 2,001-kg pickup truck impacted the combination traffic/bicycle bridge rail at a speed of 105.2 km/hr and an angle of 25.5 degrees. A summary of the test results and the sequential photographs are shown in Figure 19. Additional sequential photographs are shown in Figure 20. Documentary photographs of the crash test are shown in Figures 21 and 22.

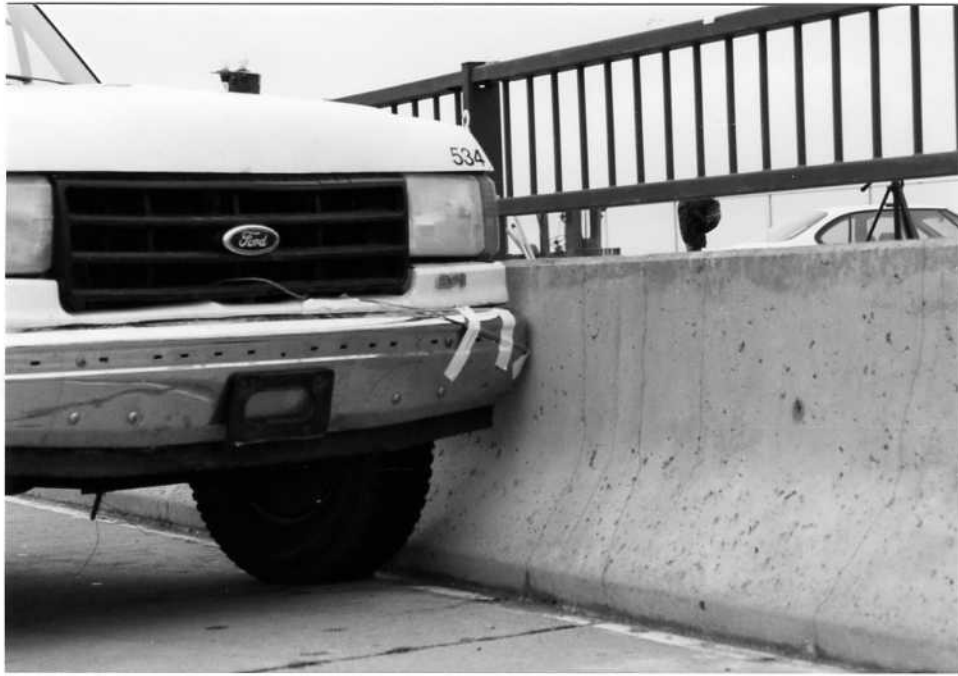
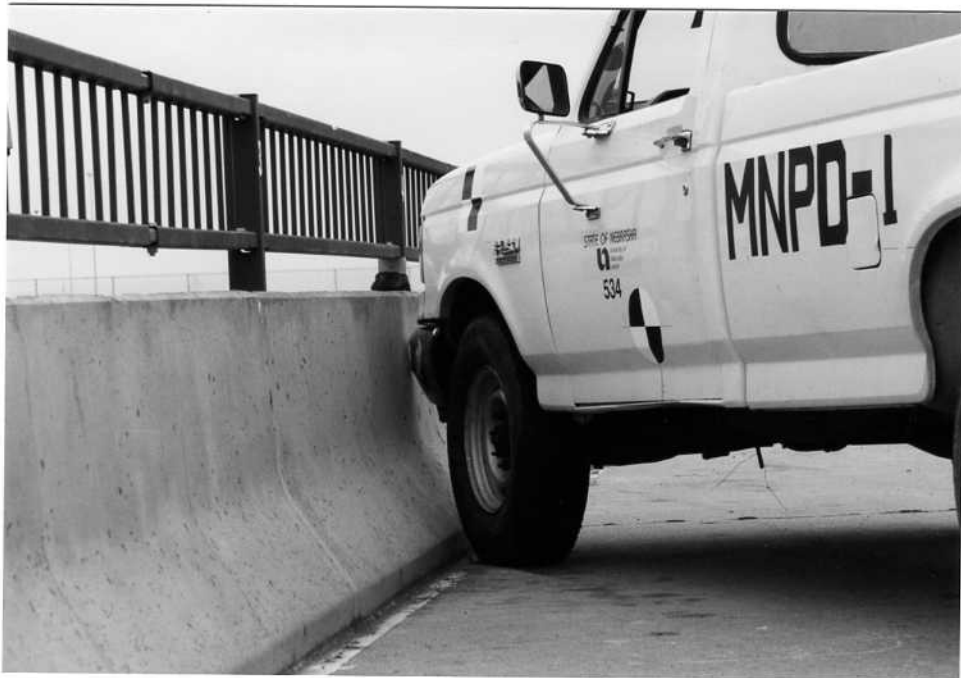
Figure 23. Impact Location, Test MNPD-1

Initial impact occurred 2-m upstream from the center of post no. 4, as shown in Figure 23. Upon impact with the bridge rail, the left-front corner of the pickup crushed inward, except for the engine hood which protruded over the top of the bridge rail. At 0.038 sec after impact, the left-front tire climbed up the face of the concrete rail, and the hood protruded into the plane of the bicycle portion of the bridge rail. At 0.056 sec, the engine hood snagged on post no. 4. This contact twisted the hood and pushed it back into the windshield, thus causing it to crack. After 0.112 sec into the crash event, the top of the driver's side door opened, and the left-rear tire impacted the bridge rail and became airborne. At 0.226 sec, the truck was parallel with the bridge rail and had a velocity of 40.91 km/hr. At that same instance, the right-rear tire became airborne, resulting in the entire truck being airborne. At 0.360 sec, the pickup truck reached a maximum height above the concrete surface with the hood popped open and rotated upward. At this same time, the truck exited the bridge rail at a speed of 15.34 km/hr and an angle of 1.7 degrees. By 0.620 sec, both front tires landed on the ground, and at 0.888 sec the rear of the truck contacted the ground. At 1.024 sec, the truck reached its maximum roll angle of 7.2 degrees. The vehicle's post-impact trajectory is shown in Figure 19. The vehicle came to rest 63.8 m downstream from impact and 9.8 m laterally behind a line projected parallel to the traffic side of the bridge rail.

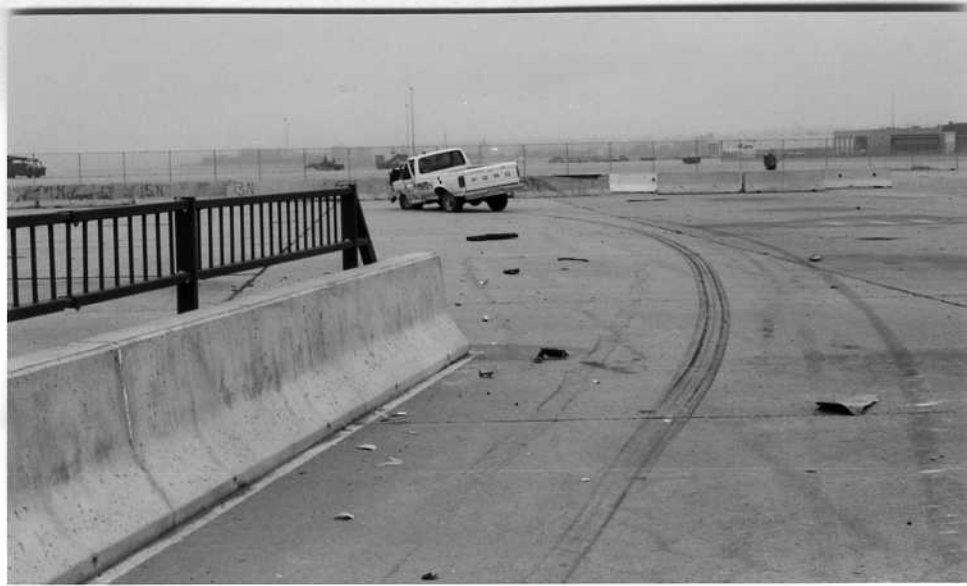
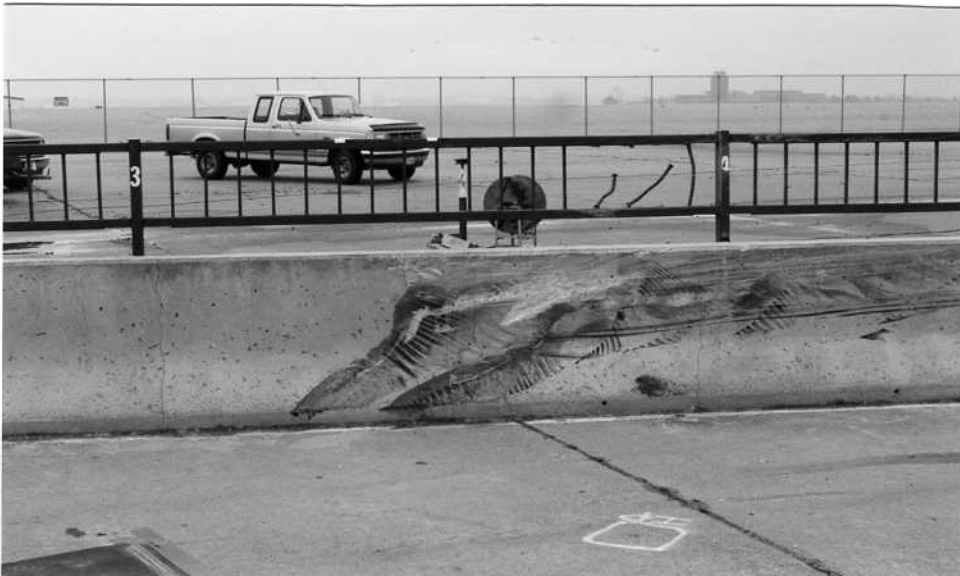
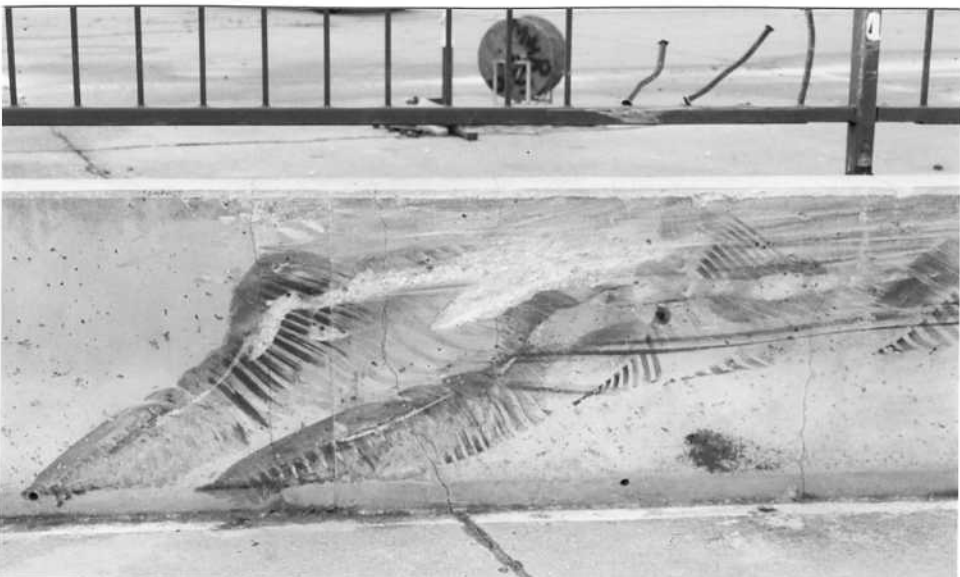
Figure 24. Barrier Damage, Test MNPD-1

Damage to the combination traffic/bicycle bridge rail was minimal, as shown in Figures 24 and 25. Damage to the concrete rail consisted of tire marks and minor gouging. No concrete cracking was found to have occurred during the crash test. The damage to the bicycle rail included light contact marks on the rail between the downstream side of post nos. 3 to the downstream side of post no. 4. Plastic deformations were observed in post nos. 3 and 4. Damage to spindles on the upstream side of post no. 4 ranged from moderate deformations to complete fracture of the welds at the top and bottom of one spindle. The cables inside the upper and lower rails of the bicycle rail did not fracture during the crash test and were found to be taut. The maximum dynamic deflections for posts and rail were 69 mm at post no. 4 and 55 mm at the midspan between post nos. 4 and 5, respectively.

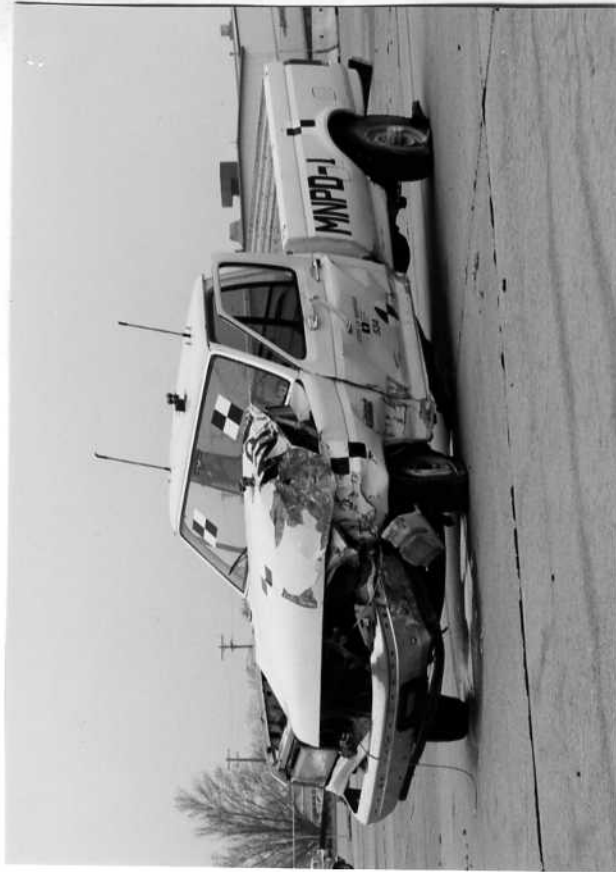
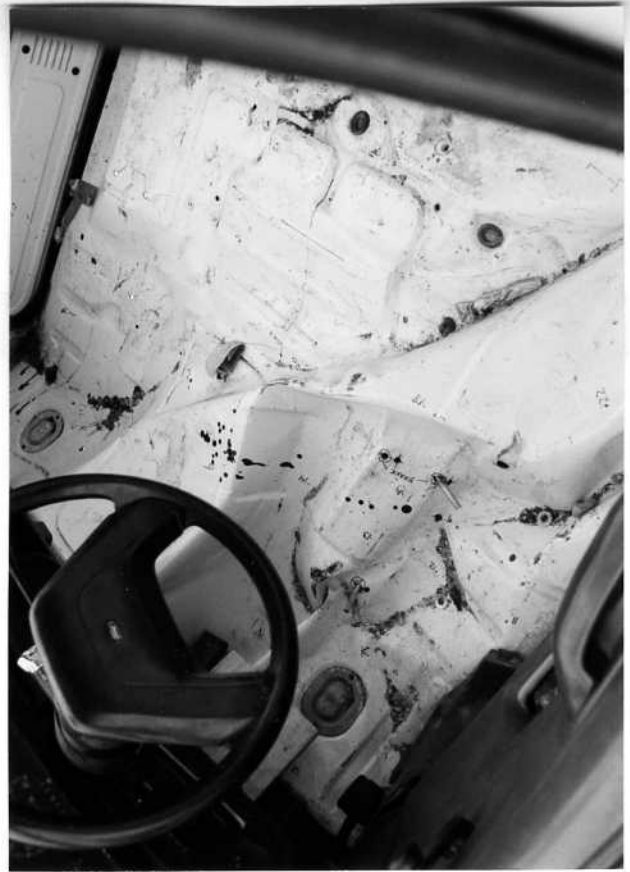
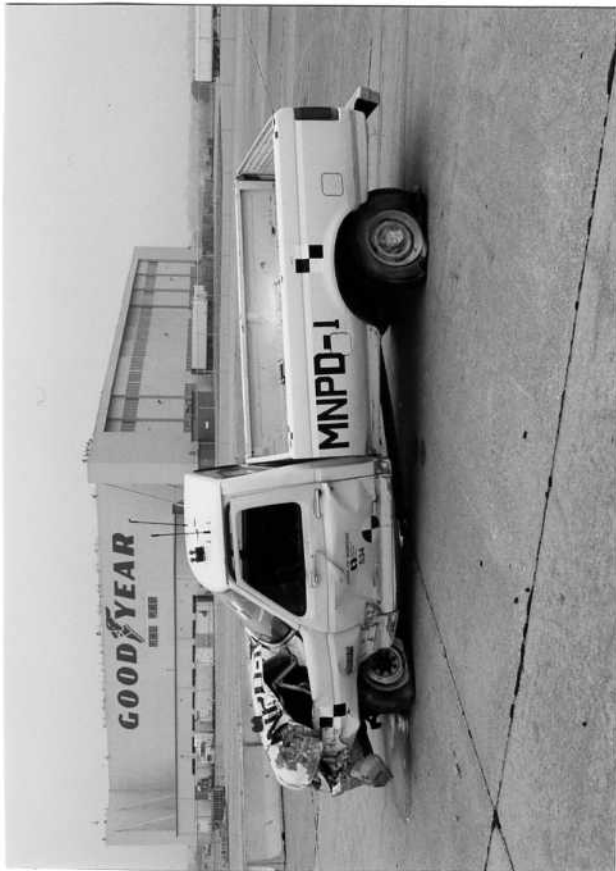
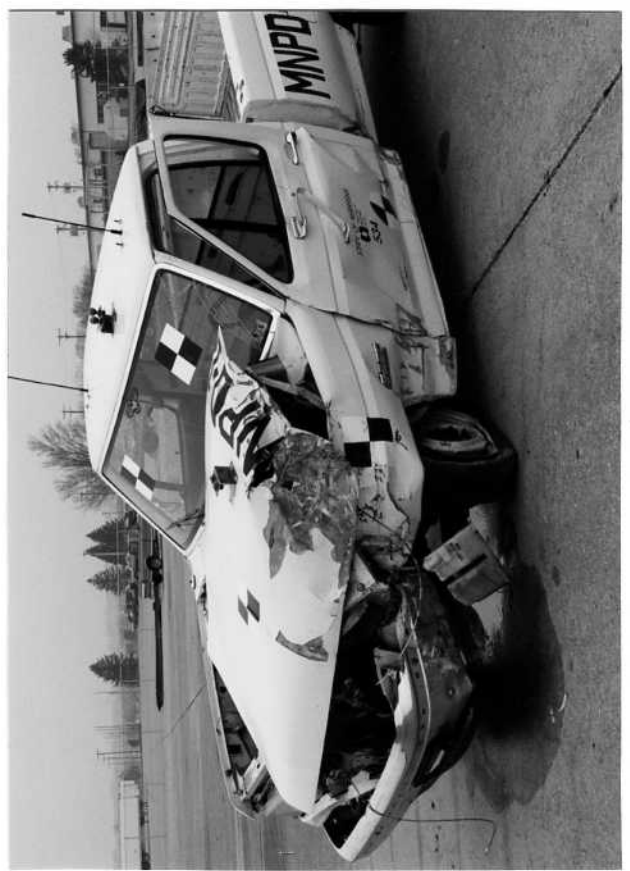
Figure 26. Vehicle Damage, Test MNPD-1

Vehicle damage was moderate, as shown in Figures 26 and 27. The front bumper, left-front quarter panel, and left-front inner fender well were crushed inward. The engine was twisted and shoved toward the right side of the vehicle. During impact, the left-front wheel assembly became dislodged as the outer steel rim fractured away from the inner region attached to the wheel hub. The tire was ripped and deflated. The left door bent outward at the top, causing a crease near the keyhole. The hood disengaged at the right-side attachment, was crushed severely on the left side, and shoved into the left side of the windshield which cracked. Longitudinal deformations, due to vehicle-rail interlock, were observed along the vehicle's left side. The steel frame was bent and twisted along its entire length, causing the box to contact and crease at the right rear of the cab. Maximum occupant compartment deformations to the floorboard and/or firewall in the lateral, longitudinal, and vertical directions were 203 mm, 146 mm, and 108 mm, respectively, as shown in Figure 26.

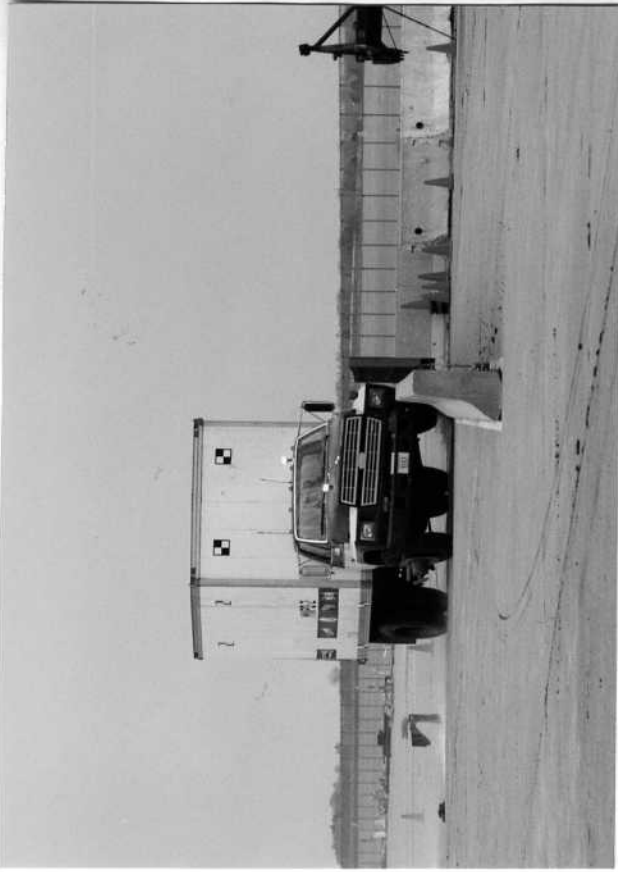
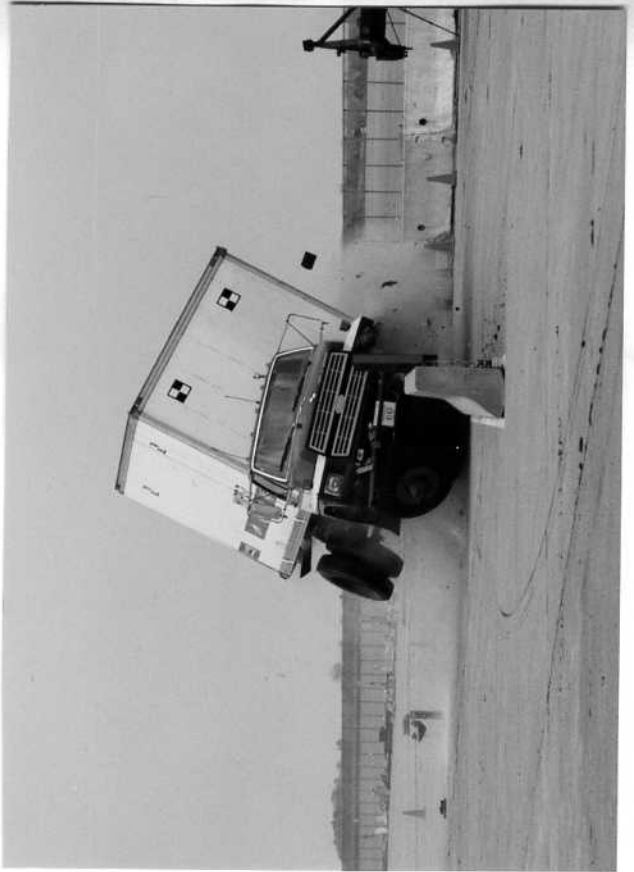
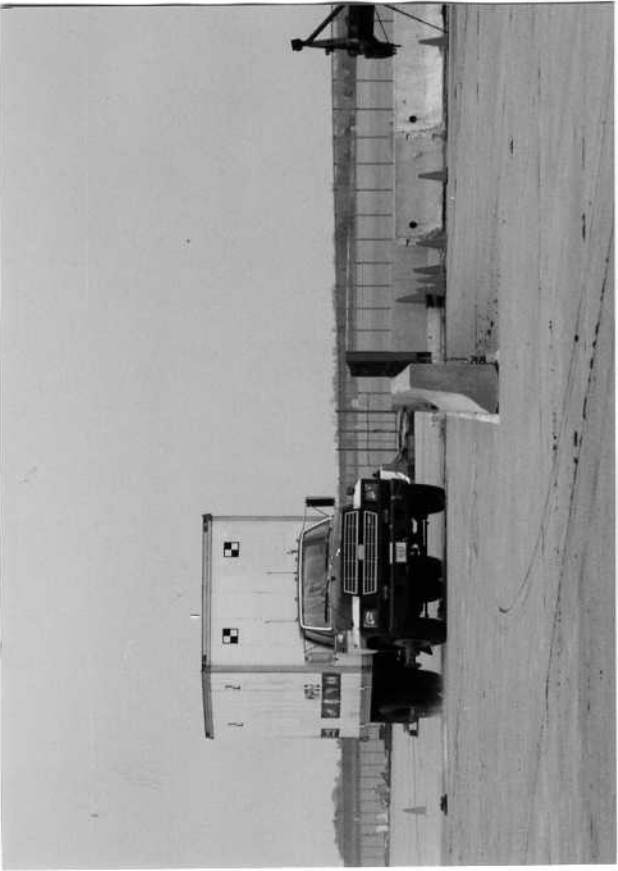
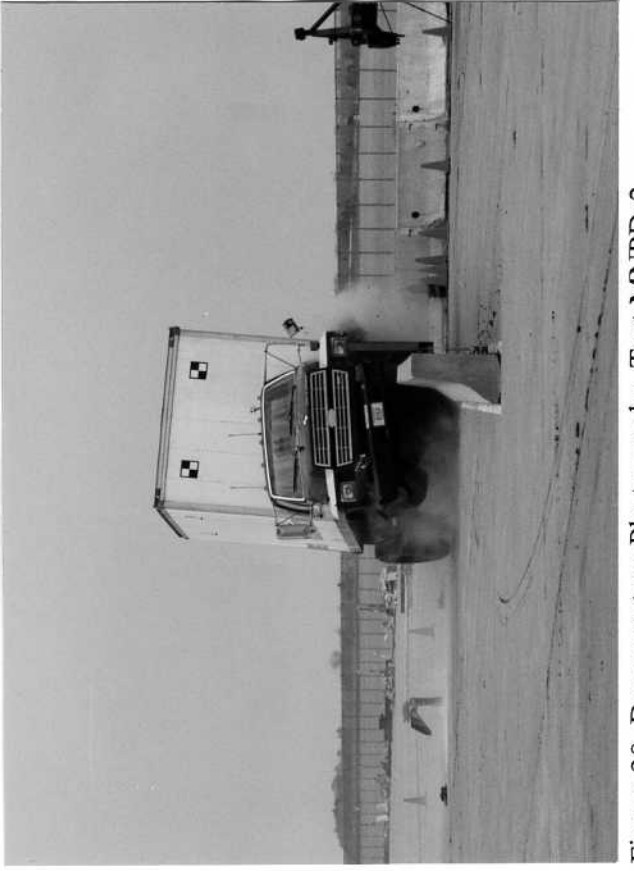
Figure 30. Documentary Photographs, Test MNPD-2

The 8,002-kg single-unit truck impacted the combination traffic/bicycle bridge rail at a speed of 82.1 km/hr and an angle of 14.7 degrees. A summary of the test results and the sequential photographs are shown in Figure 28. Additional sequential photographs are shown in Figure 29. Documentary photographs of the crash test are shown in Figures 30 through 32.

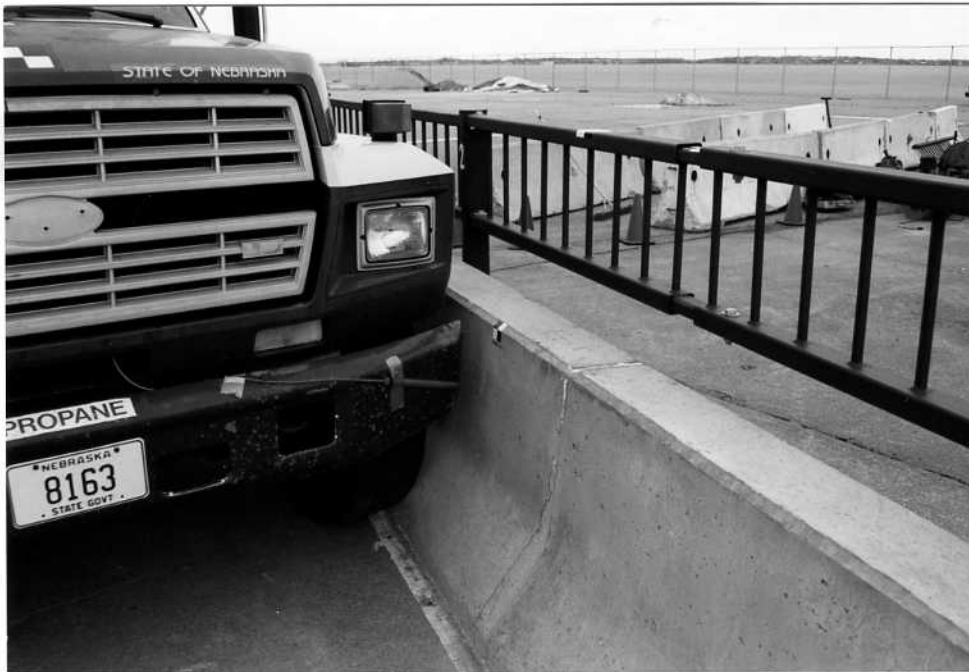
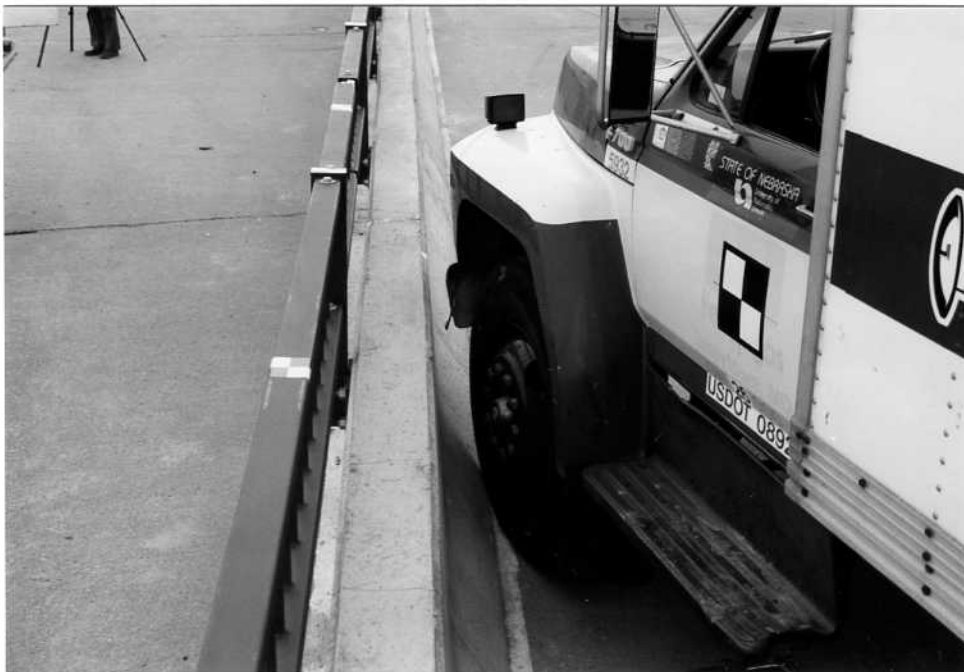
Figure 33. Impact Location, Test MNPD-2

Initial impact occurred 2-m upstream from the center of post no.3, or 0.56-m upstream from the first bridge rail splice, as shown in Figure 33. Upon impact, the left-front tire and bumper corner began to deform. After 0.043 sec after impact, the left-front tire climbed to its maximum height on the face of the concrete bridge rail, and the left-front fender rode on top of the concrete bridge rail as the front bumper crushed inward. At 0.118 sec, the front of the truck pitched upward, the left-front fender raised off the top of the bridge rail, and the right-front tire became airborne. At the same time, the left-front fender began to contact the bicycle railing. At 0.204 sec after impact, the left-rear tire contacted the bridge rail while the truck box rolled toward the rail, thus causing the right-front tire to become airborne. At 0.212 sec, the right-front fender was elevated to a height above the top of the bicycle rail. At that time, the left-front corner of the box impacted and deformed the bicycle rail, thereby causing most of the damage to the bicycle rail. At 0.427 sec, the truck rolled counterclockwise toward the rail while the right-rear tire came off the ground. Simultaneously, the left-front tire was pushed back and inward, twisting the front axle and turning the right-front tire nearly perpendicular to the truck's path of travel. At 0.702 sec, the twisted right-front tire struck the ground, and at 0.756 sec the truck box reached its maximum roll angle of 26.9 degrees while leaning

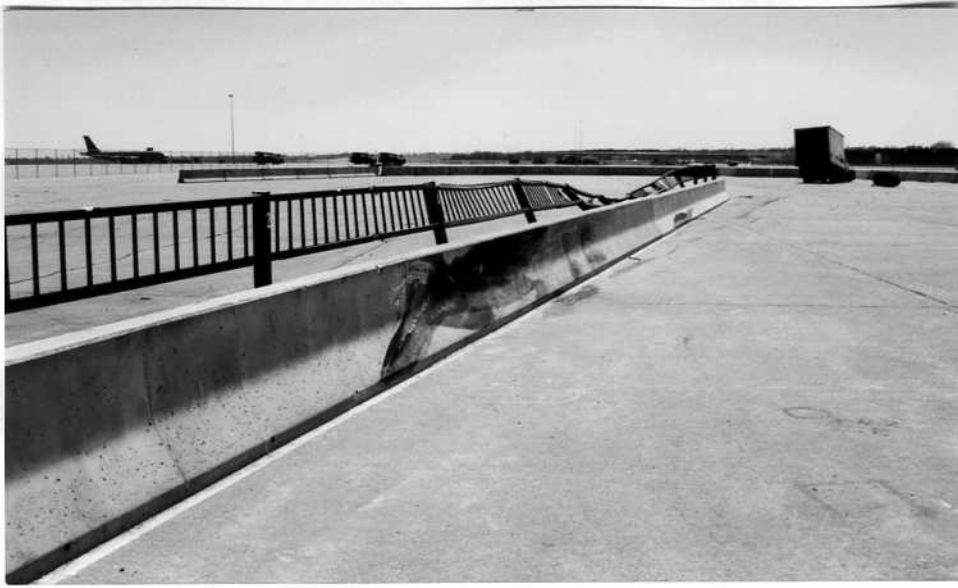
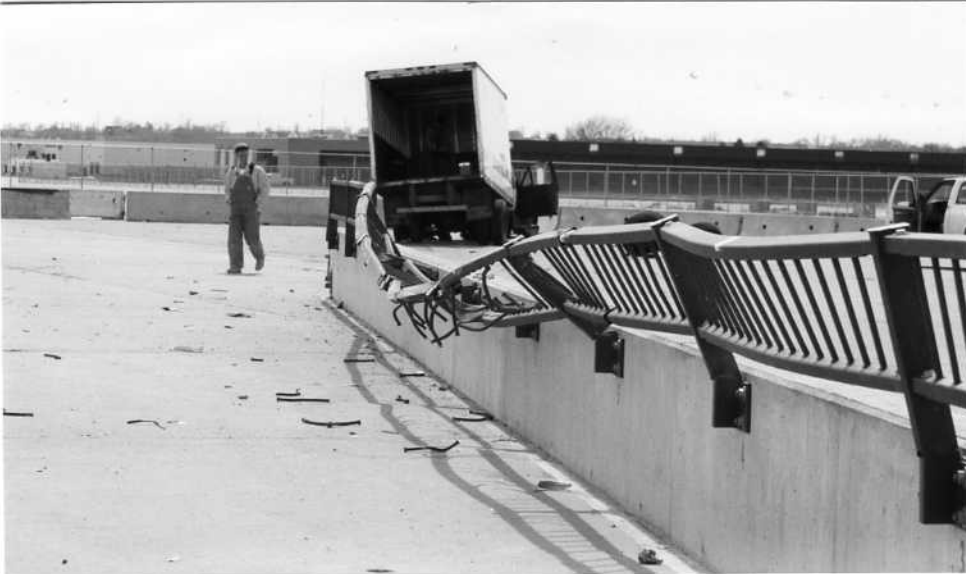
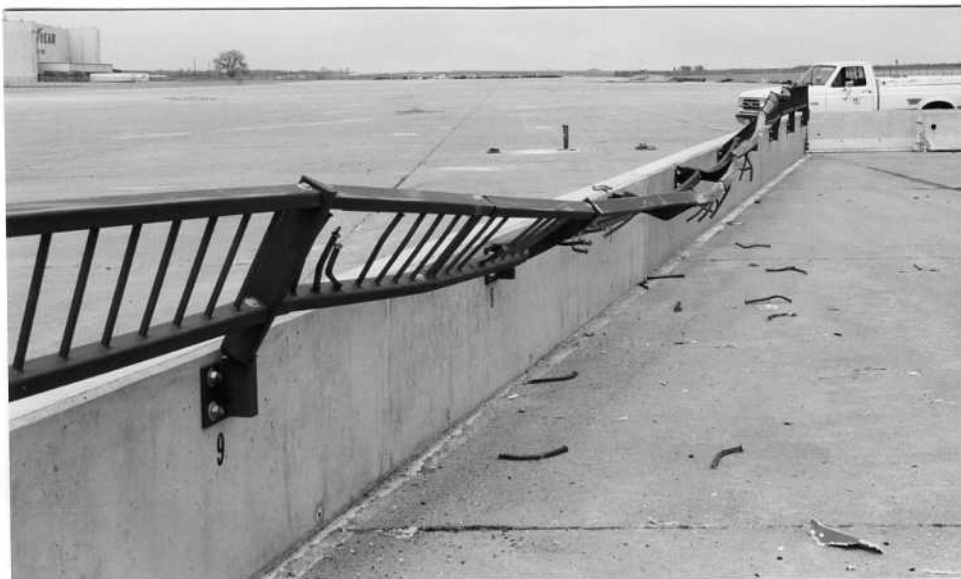
Figure 34. Barrier Damage, Test MNPD-2

Damage to the combination traffic/bicycle bridge rail was moderate, as shown in Figures 34 through 38. The damage consisted of tire and gouge marks on the concrete bridge rail, permanent deformations in the steel bicycle rail, and permanent set in the steel posts. Contact marks were found on both the concrete and the steel rail. Deformation to the steel rail included spindle deformations, fracture of the spindles away from the rail tubes, and extension of the gaps between rail splices. As measured in the field, the maximum gaps between rail splices in the top and bottom rails were 241 mm and 203 mm, respectively.

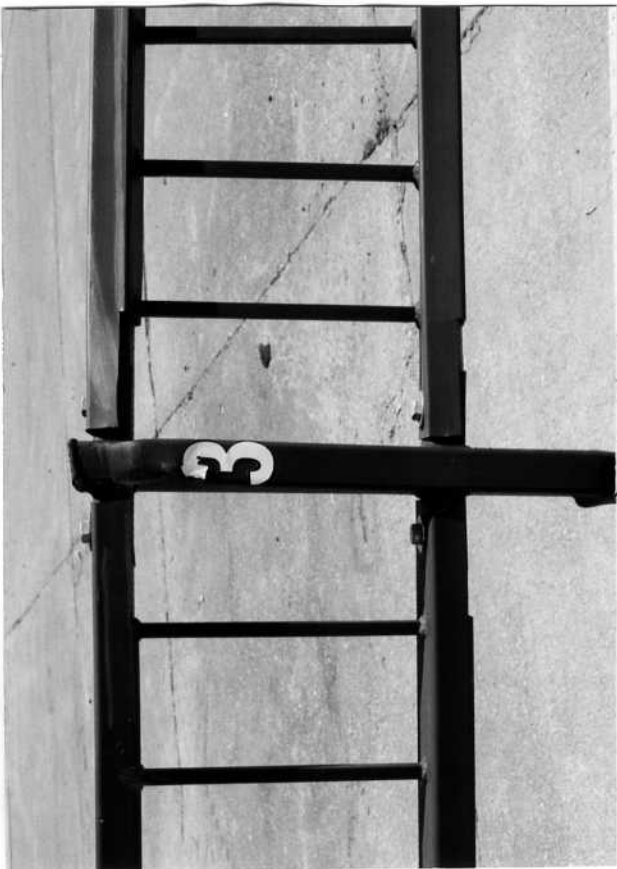
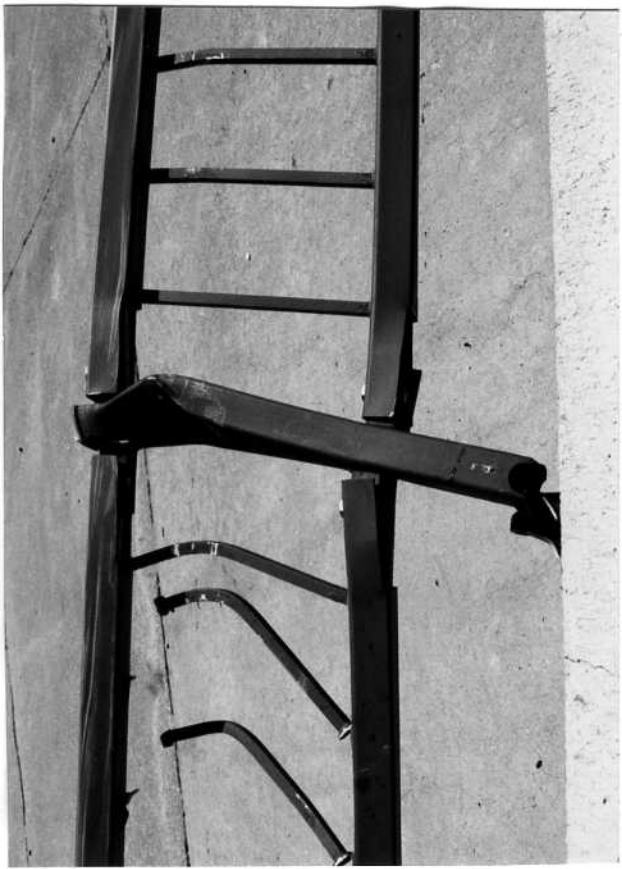
Figure 37. Post Damage, Test MNPD-2

Post damage occurred to all posts, except nos. 1, 2, 11, and 12. Contact marks were found on the bicycle rail between post no. 3 through 11. Post no. 3 fractured on the traffic-side face near the breakaway hole. Post no. 4 also fractured on the traffic-side at the breakaway hole and was bent backward. Post nos. 5 and 6 ruptured almost through the entire depth and bent nearly 90 degrees from the vertical. Post no. 7 sustained the most damage as it was completely broken off. Post no. 8 ruptured along the welds connecting the post to the steel plate. Post no. 9 fractured halfway through the breakaway hole while post no. 10 bent at the breakaway hole. The cables inside the upper and lower steel rails exhibited no damage and constrained the large pieces of loose steel rail. A total of nineteen spindles were detached from the bicycle railing - seventeen on the back side and two on the

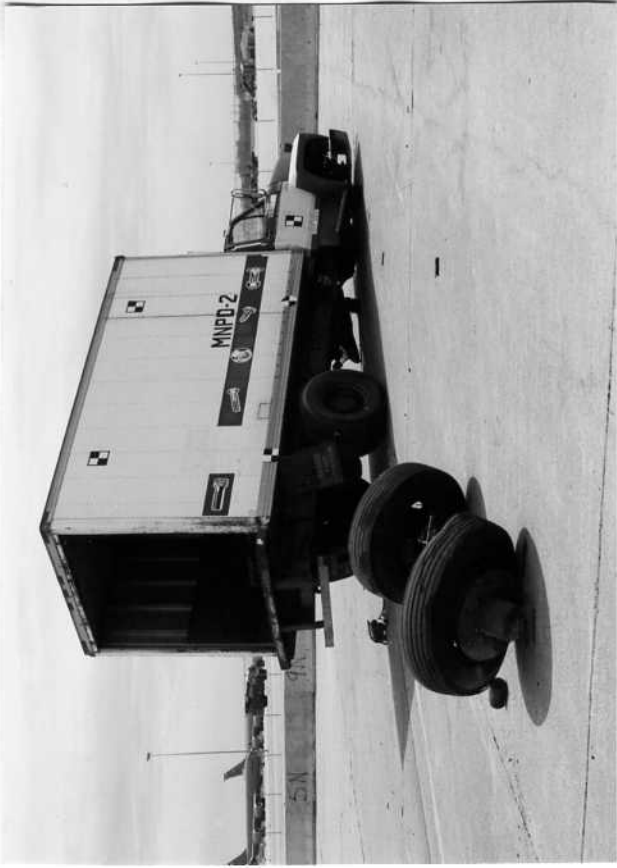
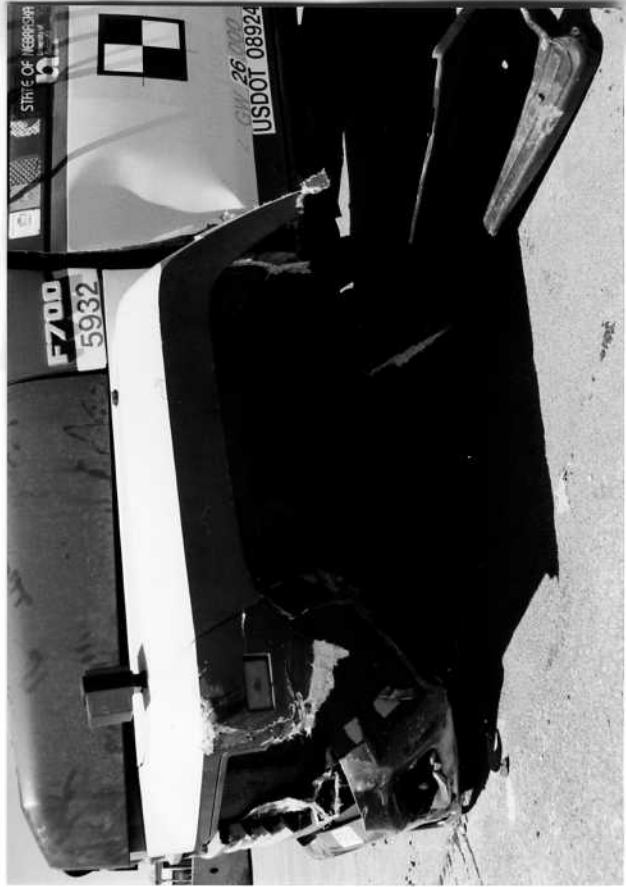
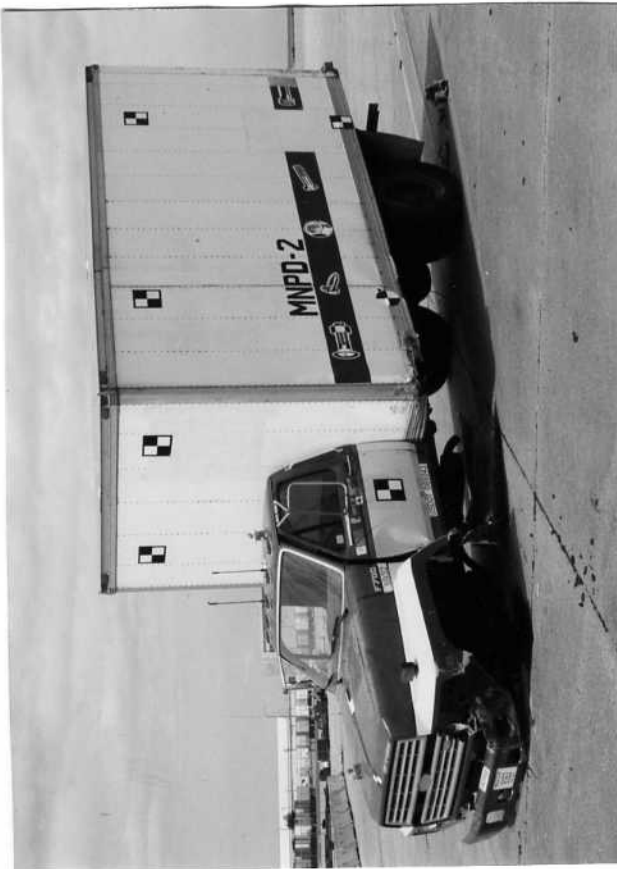
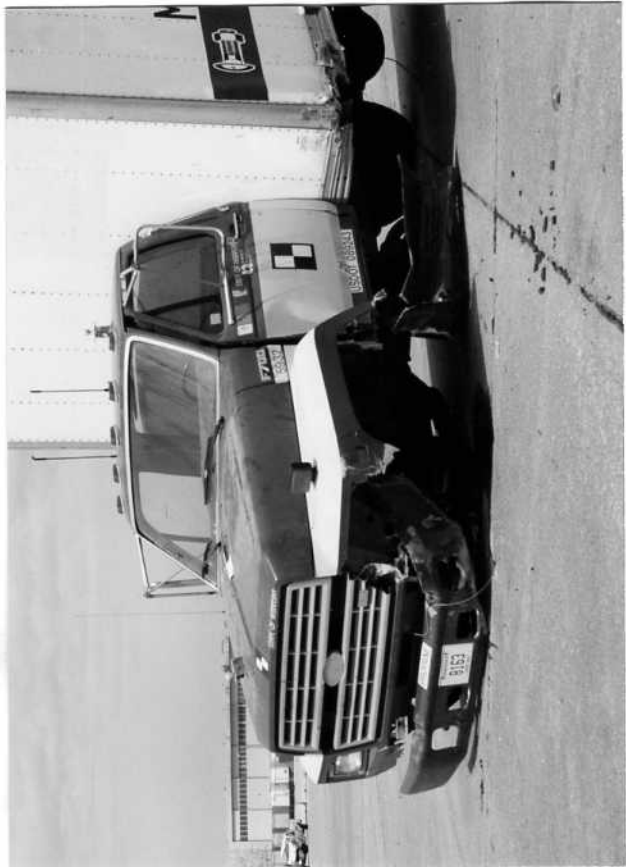
Figure 39. Vehicle Damage, Test MNP-2

Vehicle damage was moderate, as shown in Figure 39. Most of the vehicle damage occurred near the left-front corner of the vehicle, consisting primarily of damage to the fender, hood, bumper, and running board. This damage also included disengagement of the front axle assembly, resulting in the vehicle coming to a stop on the front springs. The left-front corner of the truck box was severely worn due to contact with the bridge rail. The truck rail under the left side of the box was twisted and bent. In addition, the truck box was pushed forward against the cab. There was no occupant compartment deformations to the interior of the cab nor fracture of the windshield.
