Performance Level 2 Tests on a 29-in. Open Concrete Bridge Rail

Midwest Roadside Safety Facility (MwRSF) Center for Infrastructure Research

Transportation Research Report TRP-03-51-95

June 1996

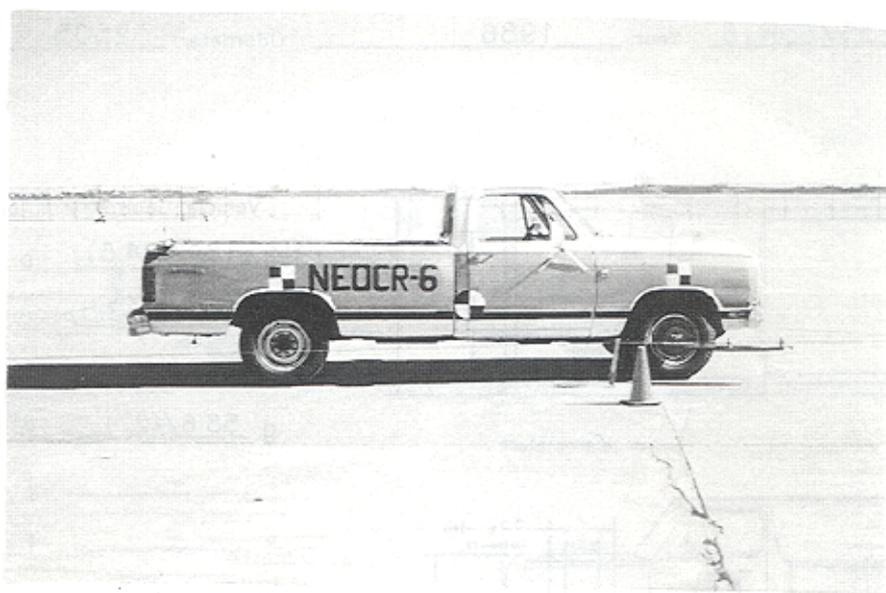
FIGURE 14. Test Vehicle, Test NEOCR-6

The test vehicle used for Test NEOCR-6 was a 1985 Dodge Ram 250. This test vehicle had a test inertial and gross static weight of 2449 kg (5,399 lb). The test vehicle is shown in Figure 14, and its dimensions are shown in Figure 15.

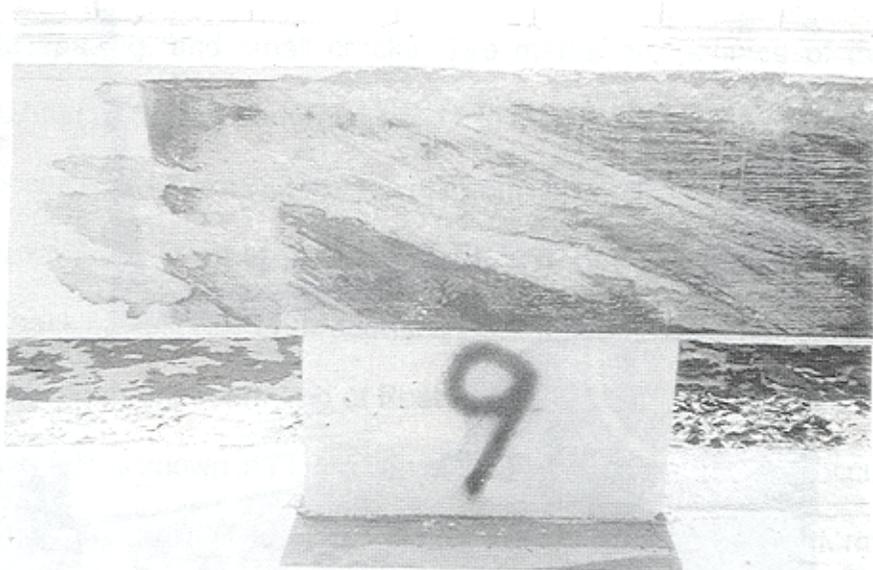
Bridge rail damage is shown in Figure 27. The damage was minor, consisting of tire marks and minor concrete spalling. Tire marks indicated that actual impact was 35.6-cm (14-in.) upstream of the upstream edge of Post No. 9. Concrete spalling occurred at the top of rail at Post No. 8 and gouges were visible from actual impact to downstream end of Post. No. 9. The maximum dynamic deflection obtained from high speed film analysis was 2.9 cm (1.13 in.) at Post No. 9. The maximum permanent set deflection was 1.1 cm (7/16 in.), also at Post. No. 9.

FIGURE 27. Bridge Rail Damage, Test NEOCR-4

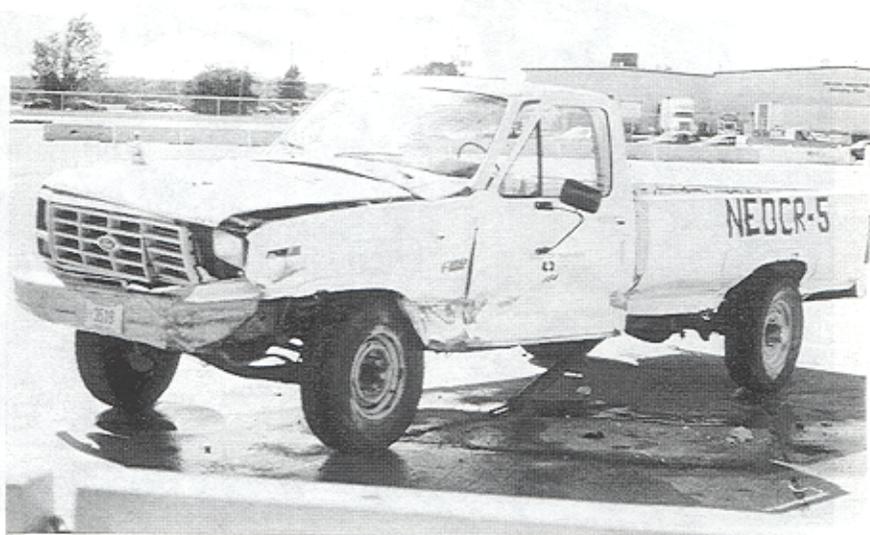
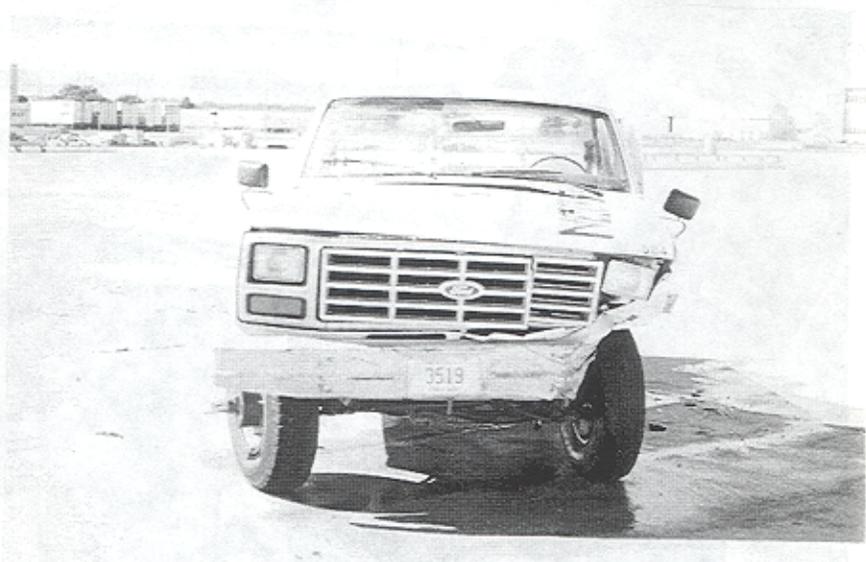
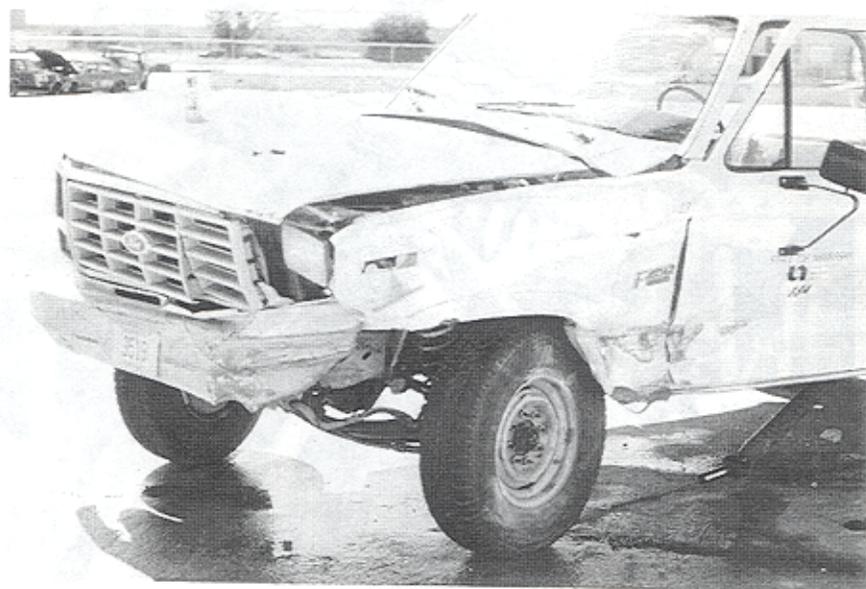
Vehicle damage is shown in Figure 35. Most of the vehicle damage occurred on the left-side, consisting primarily of fender, bumper, and undercarriage deformation. The

undercarriage damage consisted of the left front wheel assembly being shoved inward, which caused damage to many key suspension members, including the buckling of the left control arm and the bending of the right control arm, which caused the frame to be twisted. Undercarriage damage is shown in Figure 36. Other damage included deformation inward of the door panel that caused the door to jar out at the top, a cracked windshield on the driver's side, and buckling of the rear bumper. Occupant compartment damage is shown in Figure 37. Damage included an inward crush of the rear of the cab, buckling of the dash, outward buckling of the floor at the driver's side seat location, and downward buckling at driver's side floorboard area. The maximum occupant compartment crush, near the center of the cab compartment floor pan, was approximately 13.3 cm (5 1/4-in.). The center of the dash buckled upward approximately 64 mm (2.5 in.) higher than its original orientation. These occupant compartment deformations were judged to be acceptable, based on the extent and location of the deformations, as discussed in Section 5. The vehicle remained upright both during and after the impact. The vehicle damage was assessed by the traffic accident scale (TAD) (7) and the vehicle damage index (VDI) (8), as shown in Figure 30.

FIGURE 35. Vehicle Damage, Test NEOCR-5

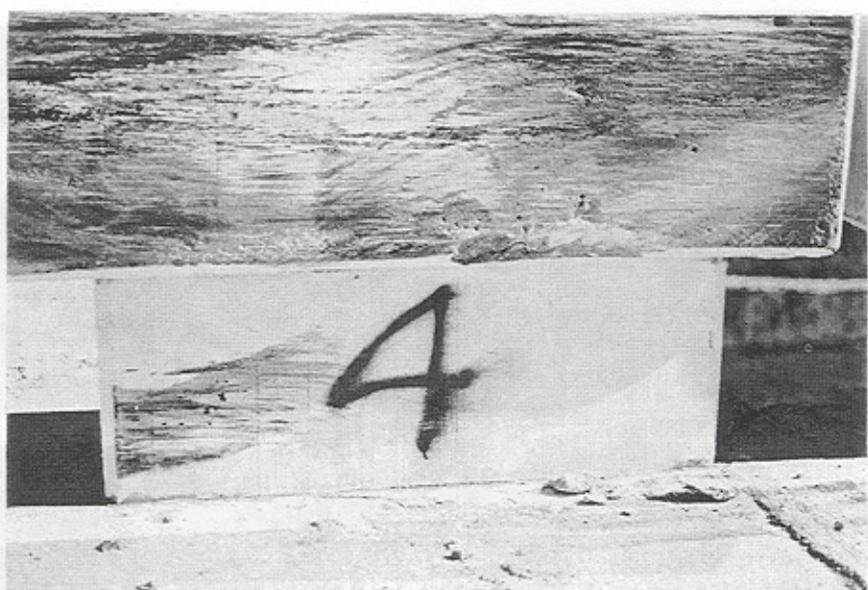
Bridge rail damage is shown in Figure 43. The damage was minor, consisting of tire marks, light concrete spalling from rim contact, and small cracks. Tire marks on the face of the rail ran from approximately 1.8-m (6-ft) upstream of the gap to 16.5-cm (6 ½-in) downstream of the gap and from the centerline of Post No. 19 to the downstream edge of the installation. Minor concrete spalling occurred at Post Nos. 4 and 5. One diagonal

crack formed in the rail near the downstream end of Post No. 3. There was no sign of snag at the 11.4-cm (4 ½-in.) gap.

FIGURE 43. Bridge Rail Damage, Test NEOCR-6

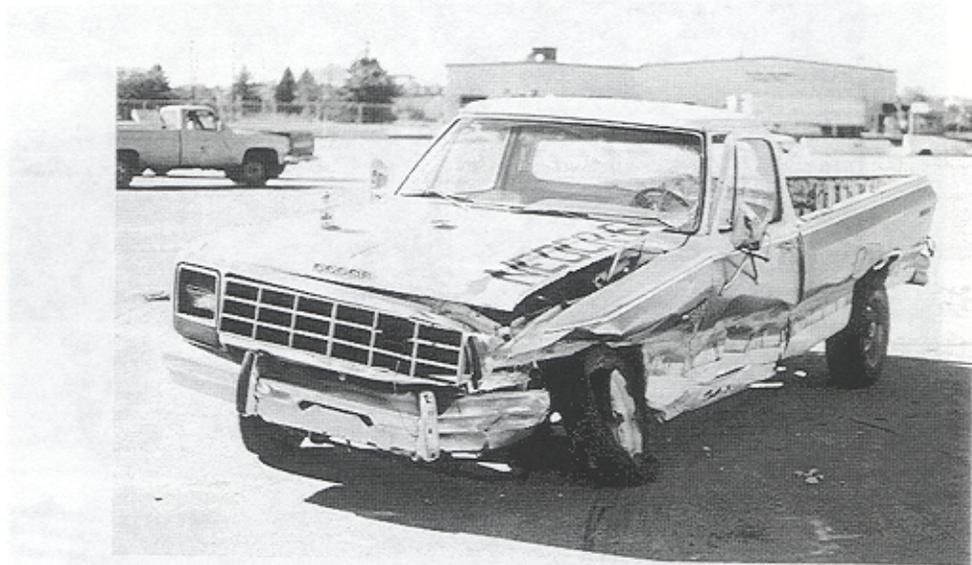
Vehicle damage is shown in Figure 44. The majority of the vehicle damage occurred on the left-side, consisting primarily of fender, bumper, and undercarriage deformation. The fender was crushed inward approximately two feet. Other damage included deformation inward of the door panel which caused the door to separate from the cab at the top, a cracked windshield, and major deformation to the left front wheel. Occupant compartment damage included crush upward and toward the passenger of the driver's side floorboard and some deformation along the transmission well. The maximum occupant compartment crush, located on the left floor pan area was approximately 89 mm (3 ½-in). These occupant compartment deformations were judged to be acceptable, based on the extent and location of the deformations, as discussed in Section 5. There was no roof, passenger side, or dash board deformation. The vehicle remained upright both during and after the impact. The vehicle damage was assessed by the traffic accident scale (TAD) (7) and the vehicle damage index (VDI) (8), as shown in Figure 39.

FIGURE 44. Vehicle Damage, Test NEOCR-6
