**DEVELOPMENT AND TESTING OF A
NEW VERTICAL-FACED TEMPORARY
CONCRETE BARRIER FOR USE ON
COMPOSITE PANEL BRIDGE DECKS**

MIDWEST ROADSIDE SAFETY FACILITY

MwRSF Research Report No. TRP-03-220-09

October 13, 2009

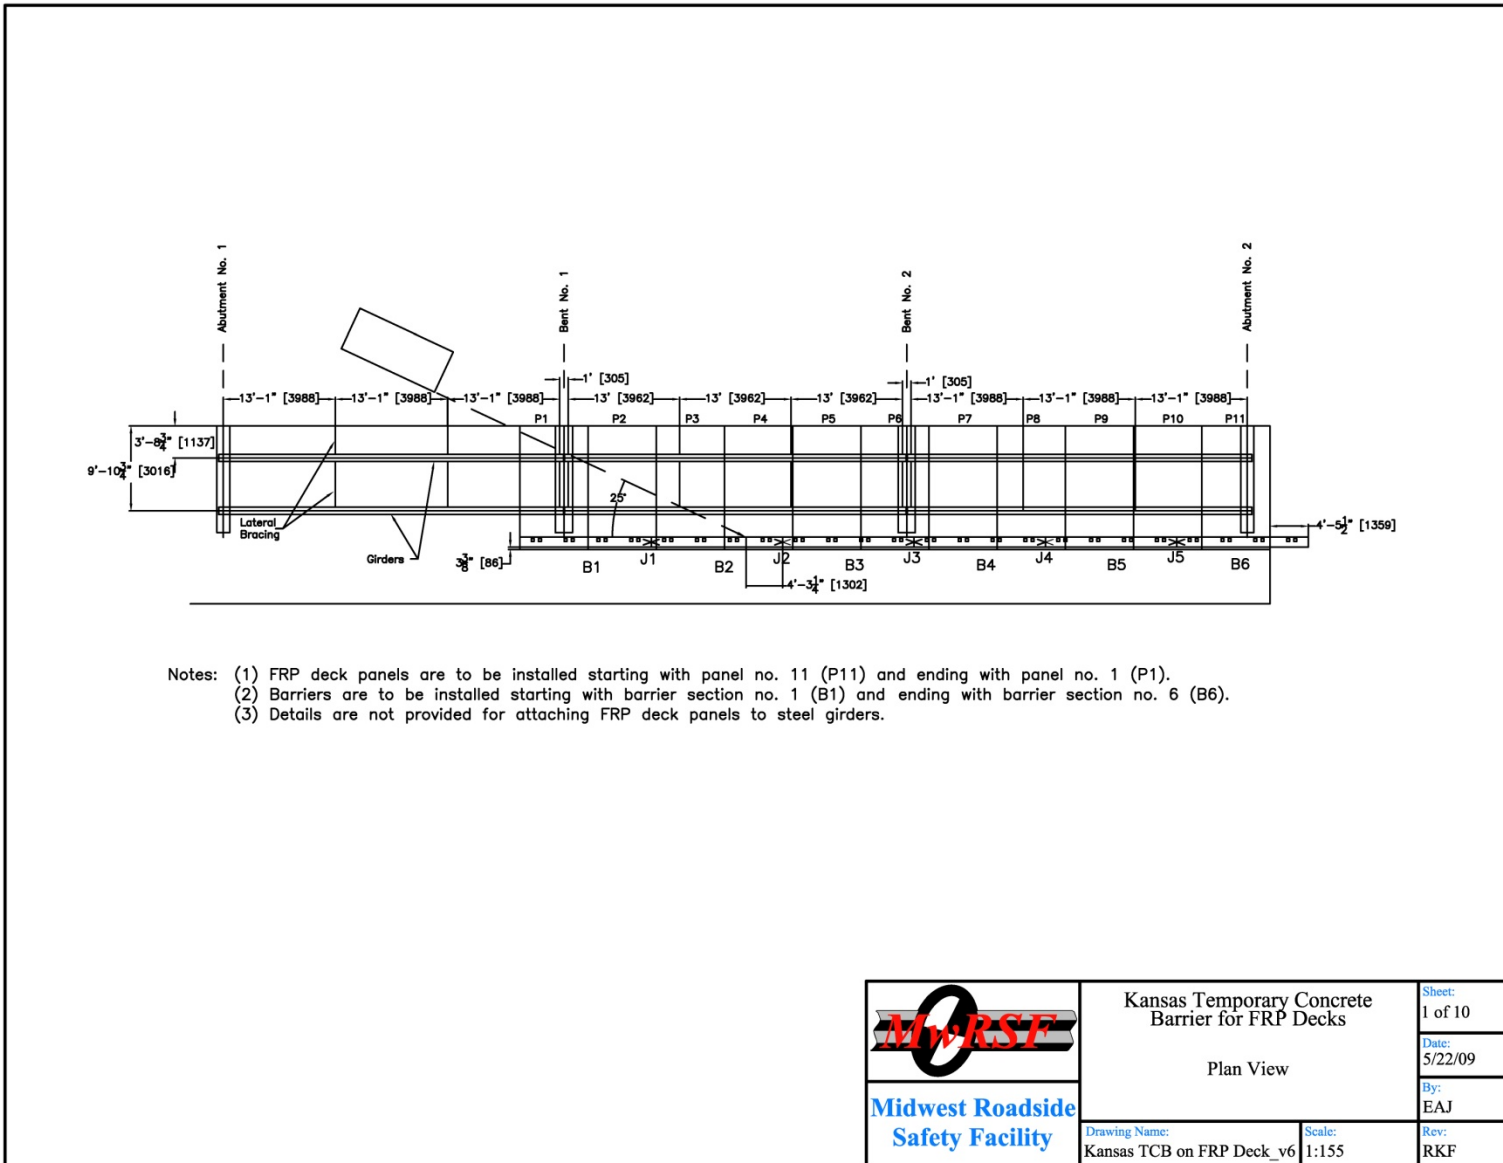
Figure 1. Test Installation Layout, Test No. KSFRP-1

It should be noted that the barrier segments were anchored to the FRP deck panels using an arrangement where the upstream end of barrier no. 1 was aligned with the upstream end of panel no. 1. With this configuration, a barrier joint occurred close to a panel joint at the end of barrier segment no. 2, and a vertical anchor rod was located close to the deck joint between panel nos. 4 and 5. As discussed later, initial vehicle impact was to occur 4 ft – 3¼ in. (1.30 m)

upstream from the center of the joint between barrier nos. 2 and 3 in order to maximize the impact loading imparted to barrier system at this critical location.

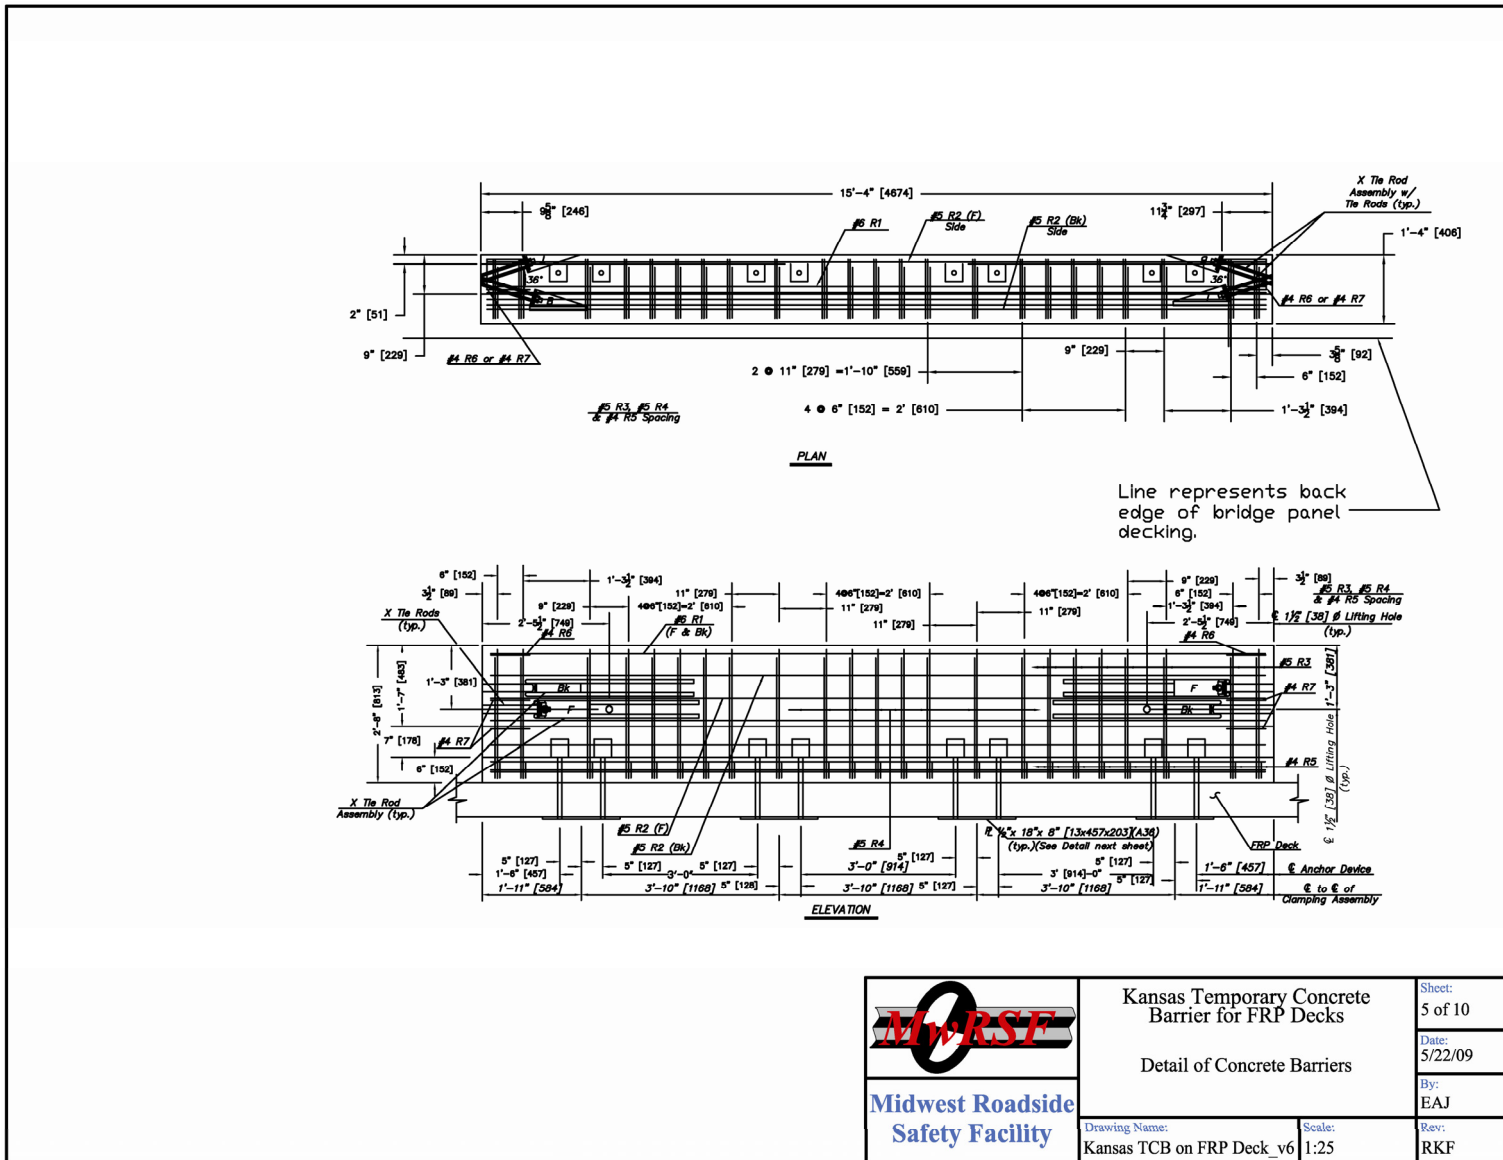
Figure 5. Concrete Barrier Details, Test No. KSFRP-1

• Total Length	92 ft (28.04 m)
• Key Component – Concrete Barrier Segment	
Description	Vertical Face
Length	15 ft – 4 in. (4.67 m)
Height	32 in. (813 mm)
Base Width	16 in. (406 mm)
Top Width	9 in. (229 mm)

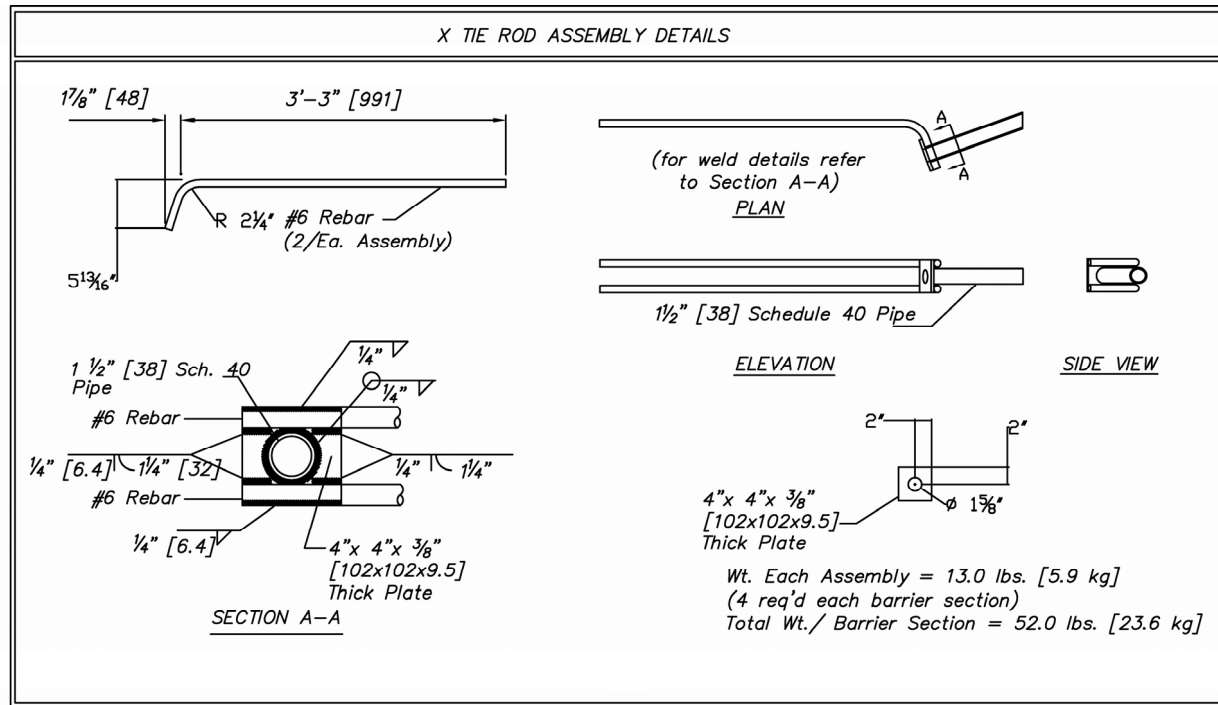
Figure 7. Concrete Barrier Connection Hardware Details, Test No. KSFRP-1

Kansas Temporary Concrete Barrier for FRP Decks Connection Detail	Sheet: 7 of 10
	Drawing Name: Kansas TCB on FRP Deck_v6	Scale: 1:15
Midwest Roadside Safety Facility	By: EAJ	Rev: RKF

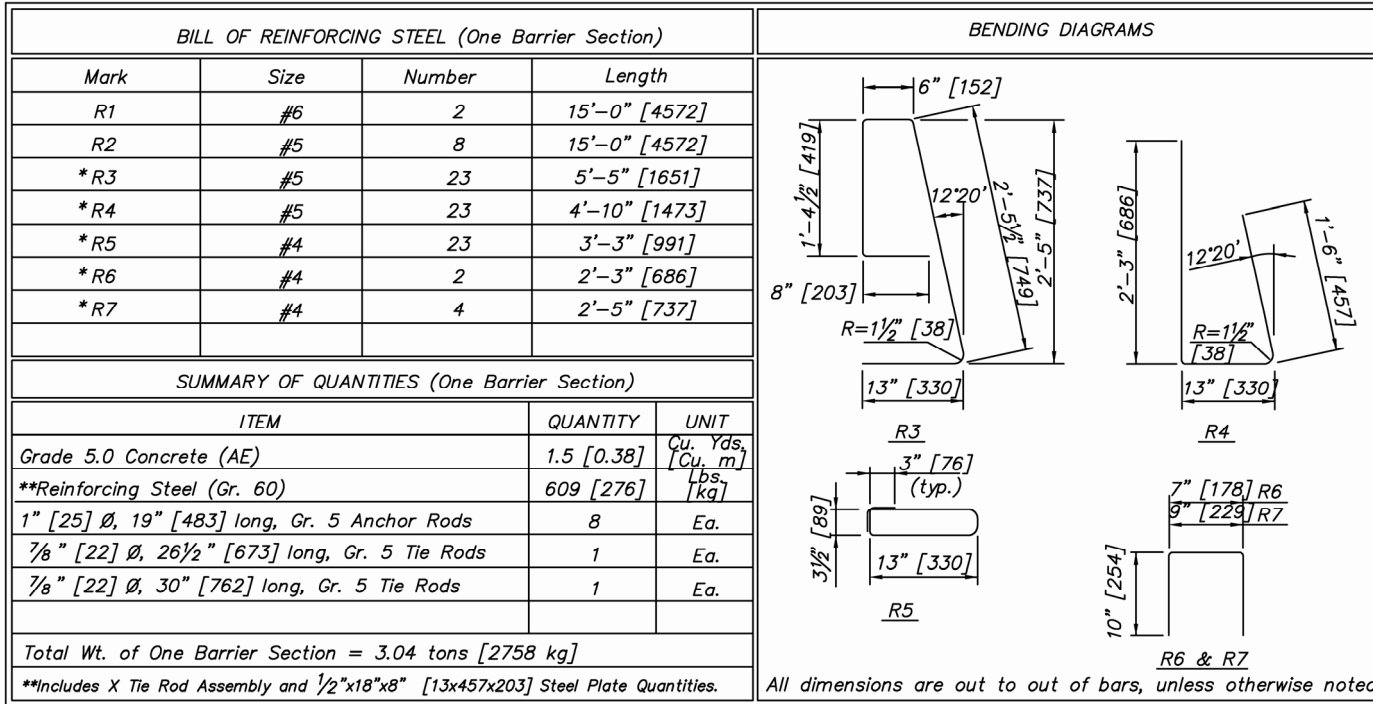
Figure 9. Reinforcement Specifications, Test No. KSFRP-1

Kansas Temporary Concrete Barrier for FRP Decks	Sheet: 9 of 10
	Rebar Details	Date: 5/22/09
Drawing Name: Kansas TCB on FRP Deck_v6	Scale: 1:15	By: EAJ
		Rev: RKF

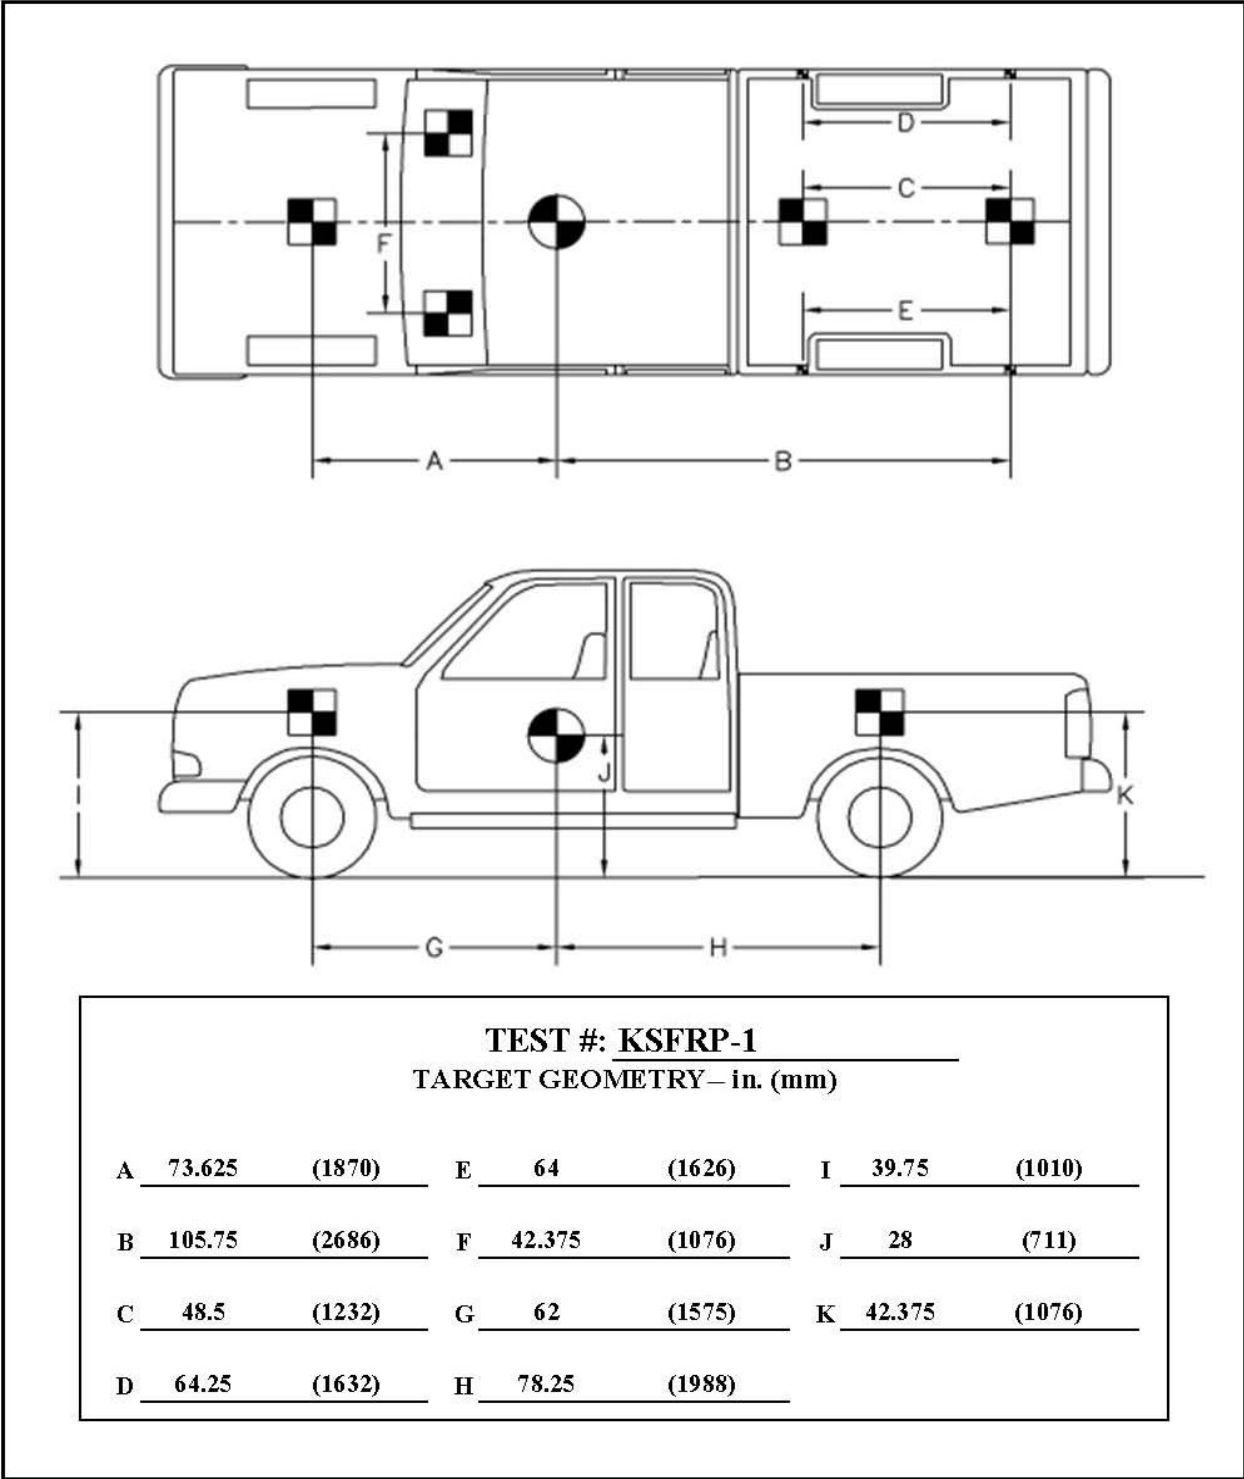
Figure 20. Target Geometry, Test No. KSFRP-1

Square black and white-checkered targets were placed on the vehicle to aid in the analysis of the high-speed videos, as shown in Figure 20. Round, checkered targets were placed on the center of gravity on the left-side door, the right-side door, and the roof of the vehicle. The remaining targets were located for references so that they could be viewed from the high-speed cameras for video analysis.

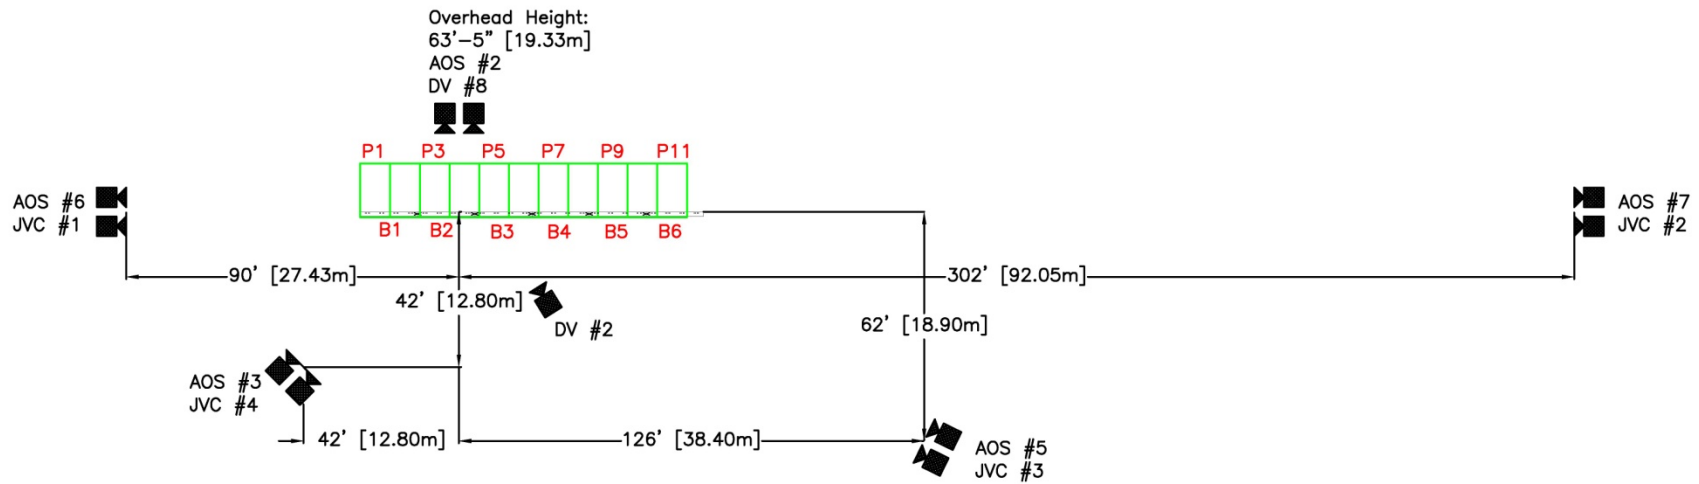
Figure 21. Camera Locations, Speeds, and Lens Settings, Test No. KSFRP-1

No.	Type	Operating Speed (frames/sec)	Lens	Lens Setting
High-Speed Video	2	Vitcam CTM	500	Cosmicar 12.5 mm Fixed	-
	3	Vitcam CTM	500	Sigma 24-135 mm	135
	5	X-PRI	500	Sigma 24-70 mm	70
	6	X-PRI	500	Fujinon 50 mm Fixed	-
	7	X-PRI	500	Sigma 70-200 mm	135
Digital Video	1	JVC - GZ-MC500 (Everio)	29.97		
	2	JVC - GZ-MC40u (Everio)	29.97		
	3	JVC - GZ-MC40u (Everio)	29.97		
	4	JVC - GZ-MC40u (Everio)	29.97		
	2	Canon-ZR90	29.97	DOC #2	
	8	Canon-ZR90	29.97	DOC #1

Two high-speed AOS VITcam digital video cameras, three high-speed AOS X-PRI digital video cameras, four JVC digital video cameras, and two Canon digital video cameras were utilized to film test no. KSFRP-1. A schematic of the camera locations along with the camera lens information and camera operating speed is shown in Figure 21. The high-speed videos were analyzed using ImageExpress MotionPlus software. Actual camera speed and camera divergence factors were considered in the analysis of the high-speed videos.

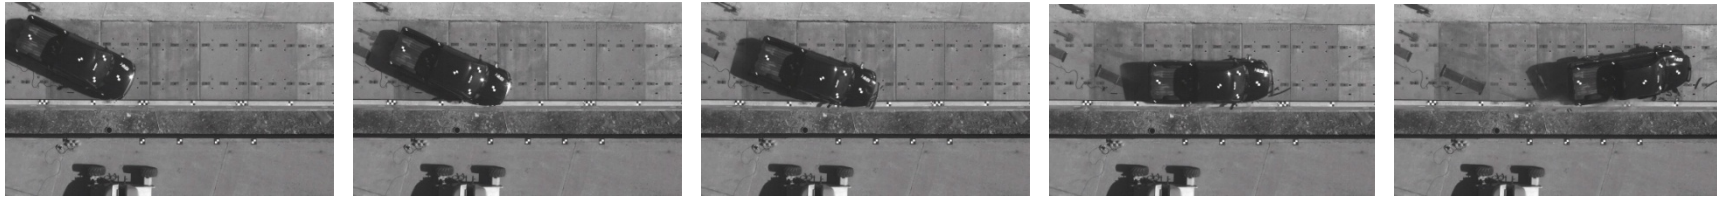
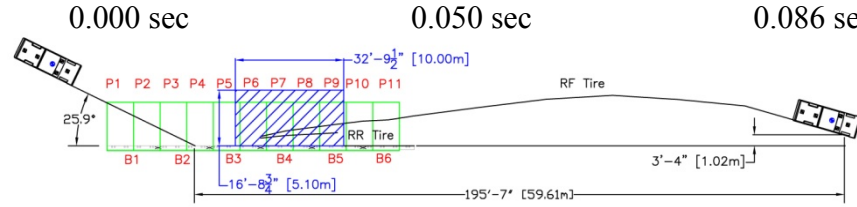
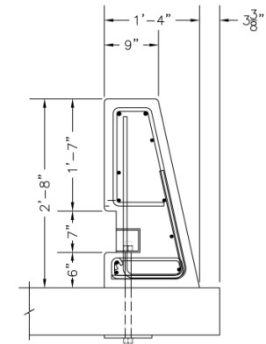
• Test Agency	MwRSF
• Test Number	KSFRP-1
• Date	3/13/09
• MASH Test Designation	3-11
• Test Article	Temporary Concrete Barrier on FRP Composite Bridge Deck

• Vehicle Model	2002 Dodge Ram 1500 Quad Cab Pickup
Curb	5,106 lbs (2,316 kg)
Test Inertial	5,009 lbs (2,272 kg)
Gross Static	5,179 lbs (2,349 kg)
• Impact Conditions	
Speed	61.1 mph (98.3 km/h)
Angle	25.9 deg
Impact Location	4 ft – 3 1/4 in. upstream of barrier nos. 2 and 3 joint

• Exit Conditions	
Speed	48.9 mph (78.7 km/h)
Angle	5.2 deg
• Vehicle Stability	Satisfactory
• Vehicle Stopping Distance	195 ft – 7 in. (59.61 m) downstream 3 ft – 4 in. (1.02 m) from traffic-side face

• Vehicle Damage	Moderate
VDS ^(a)	1-RFQ-3
CDC ⁽²⁾	01-RDEW3
Maximum Interior Deformation	1 in. (25 mm)
• Test Article Damage	Minor
• Test Article Deflections	
Permanent Set	7/8 in. (22 mm)
Dynamic	4.4 in. (112 mm)
Working Width	20.4 in. (518 mm)

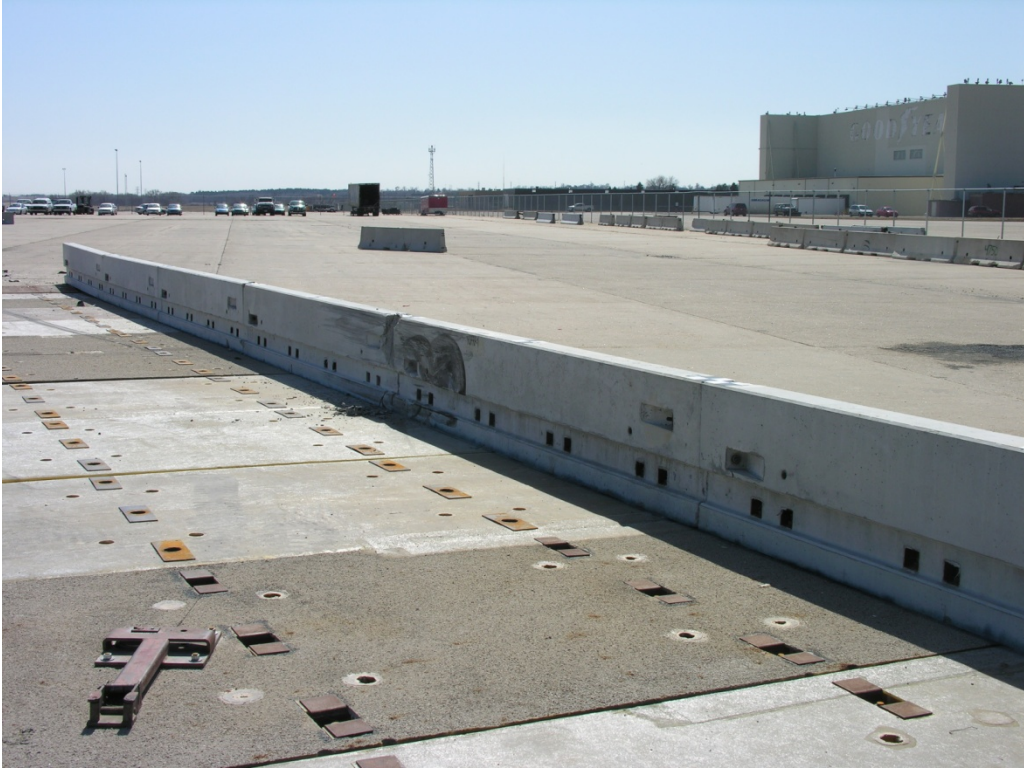
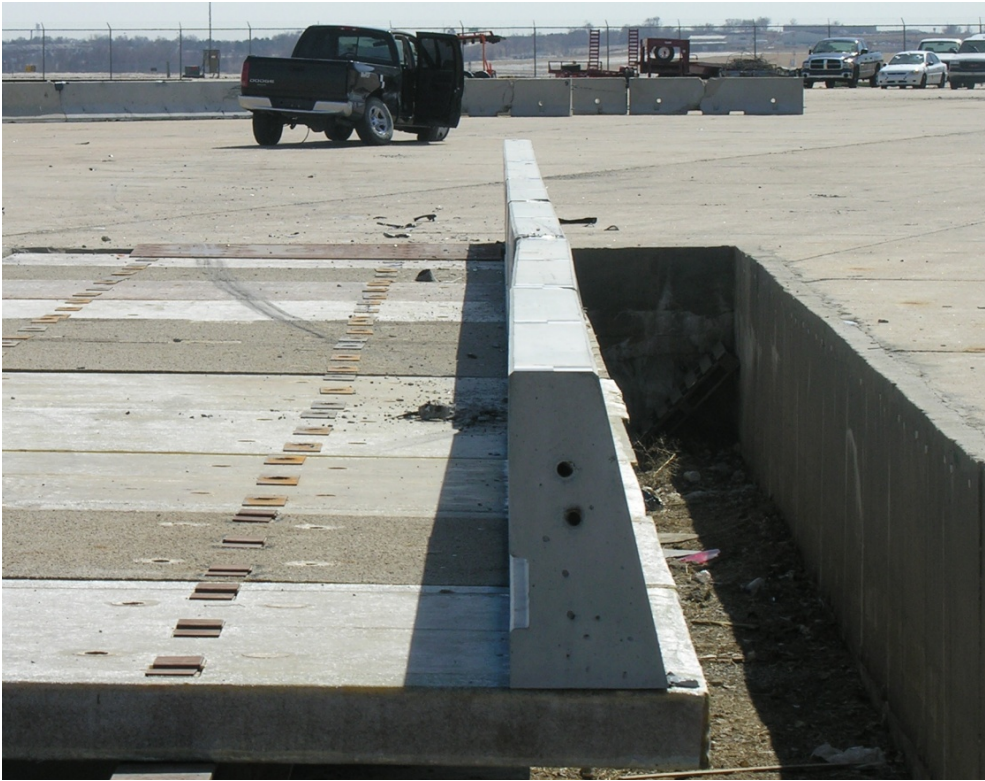
Figure 28. System Damage, Test No. KSFRP-1

Damage to the barrier was minimal, as shown in Figures 28 through 32. Barrier damage consisted of contact marks on the front face of the concrete segments, spalling of the concrete, and concrete cracking and failure. The length of vehicle contact along the barrier was approximately 11 ft – 5 in. (3.48 m), which spanned from 5 ft – 5 in. (1.65 m) upstream from the center of the joint between barrier nos. 2 and 3 to 6 ft (1.83 m) downstream from the center of the joint between barrier nos. 2 and 3.

Tire marks were visible on the front face of barrier nos. 2 and 3. Scuff marks were also found on the front and top faces of barrier nos. 2 and 3. The upper-rear corner at the downstream end of barrier no. 1 was fractured. Concrete spalling and cracking occurred at the downstream end of barrier no. 2 and upstream end of barrier no. 3. A 3-in. x 6-in. x 4½-in. (76-mm x 152-mm x 114-mm) piece of concrete was removed from the top corner of the downstream end of barrier no. 2. A 4½-in. x 8-in. x 10-in. (114-mm x 203-mm x 254-mm) piece of concrete was removed from the top-upstream corner of barrier no. 3. Another piece of concrete was fractured just below the removed corner of barrier no. 3, but it remained attached to the barrier. Concrete spalling occurred along the upper and lower edges of the shelf as well as around the edges of the threaded rod insets at the downstream end of barrier no. 2. Concrete spalling also occurred on the vertical face of the joint between barrier nos. 2 and 3.

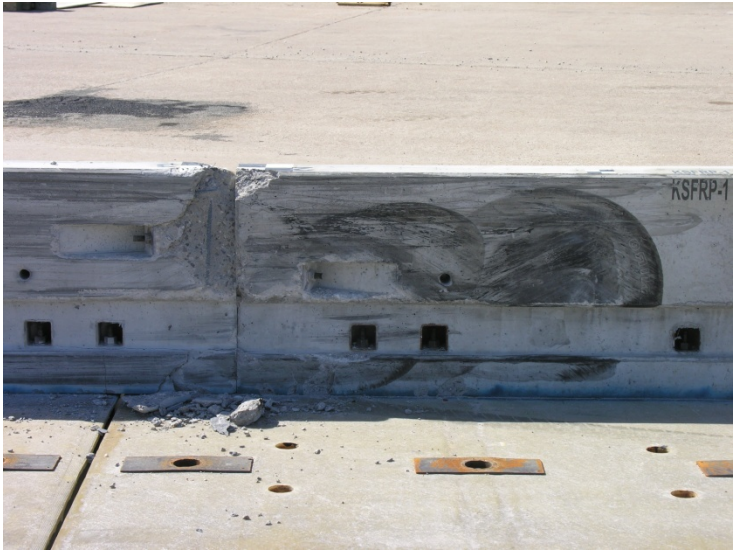
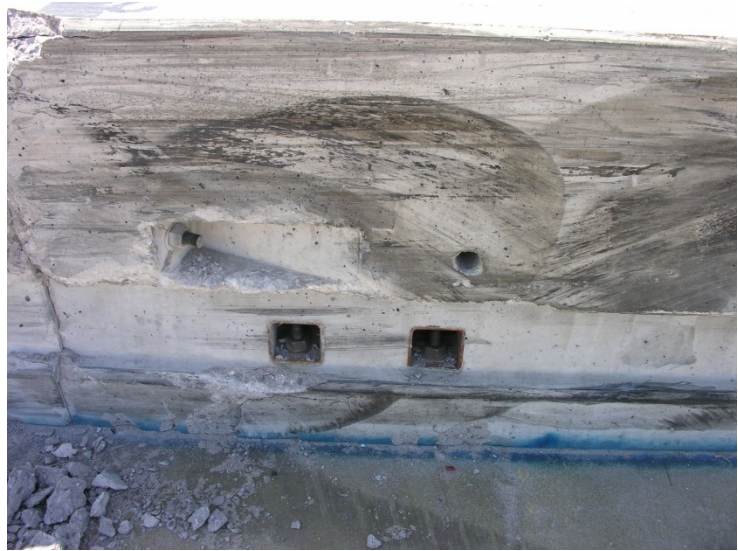
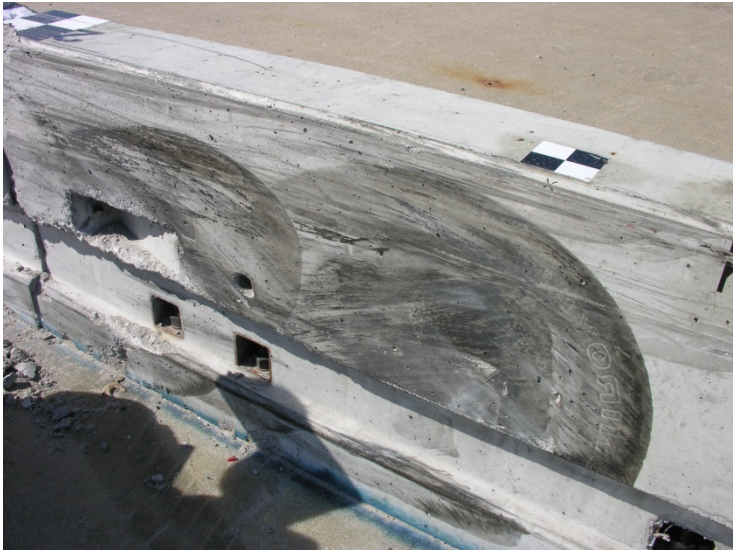
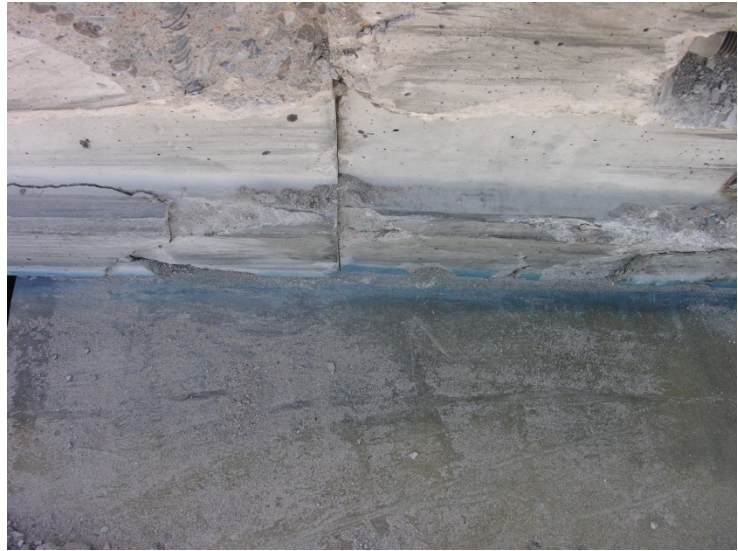
Figure 29. Barrier No. 2 Damage, Test No. KSFRP-1

A small gouge and crack were found 34 in. (864 mm) upstream from the downstream end of barrier no. 2 at its base. A larger gouge and crack were found 13 in. (330 mm) upstream from the downstream end of barrier no. 2 at its base. Small gouges and scratches were located across the front faces of barrier nos. 2 and 3. A 21-in. (533-mm) long crack was found at the base of barrier no. 3 starting 7 in. (178 mm) downstream from the upstream end of the barrier. A vertical

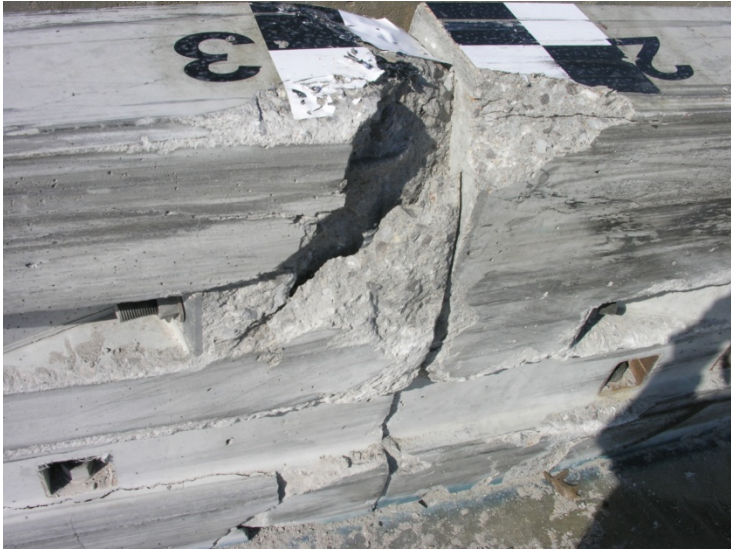
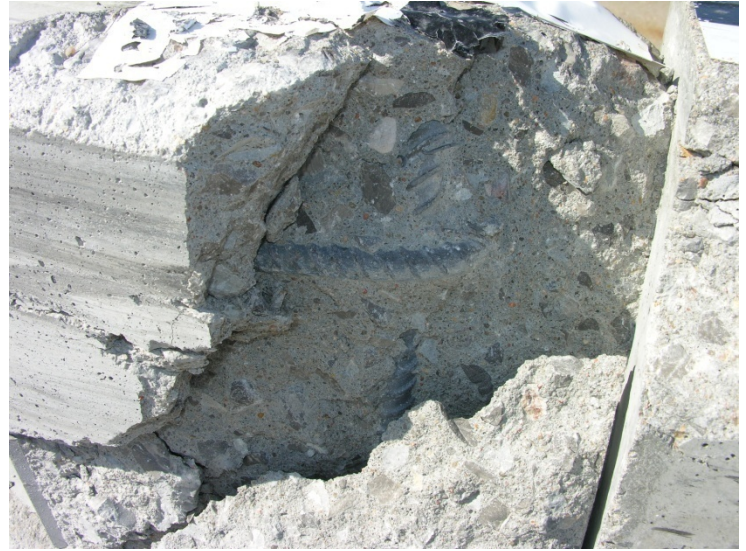
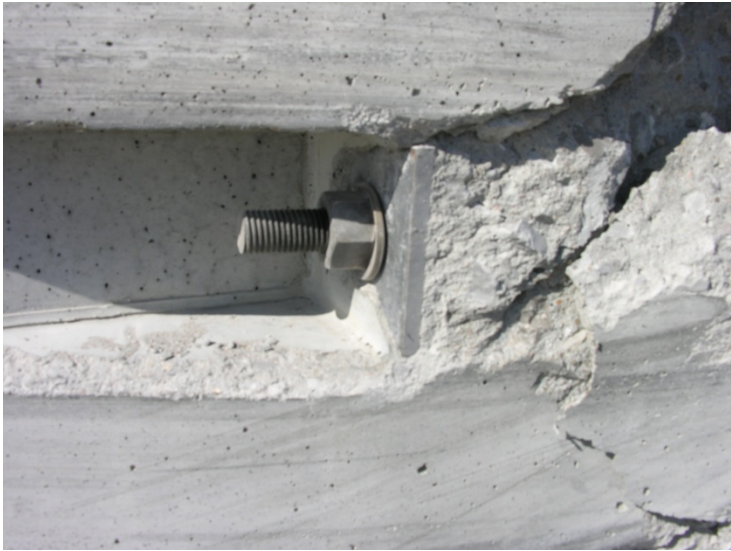
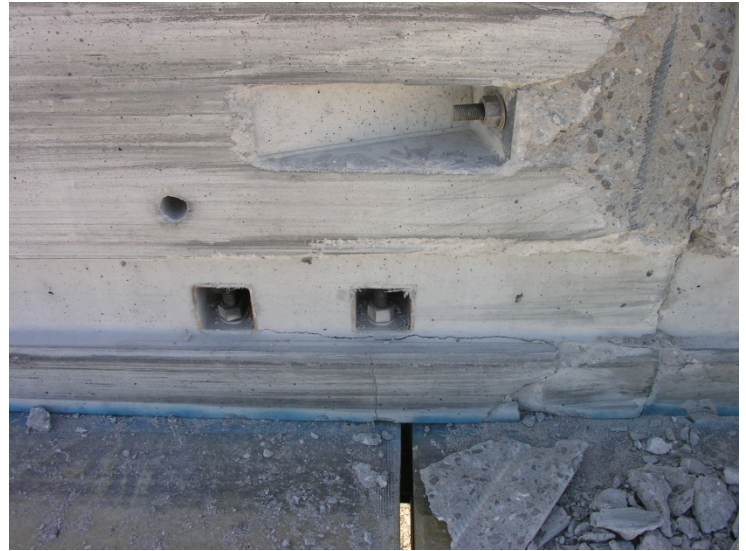
Figure 30. Joint Damage Between Barrier Nos. 2 and 3, Test No. KSFRP-1

crack was found 18½ in. (470 mm) downstream from the upstream end of barrier no. 3 at its base. A vertical crack was also found at the base of barrier no. 3 near its center.

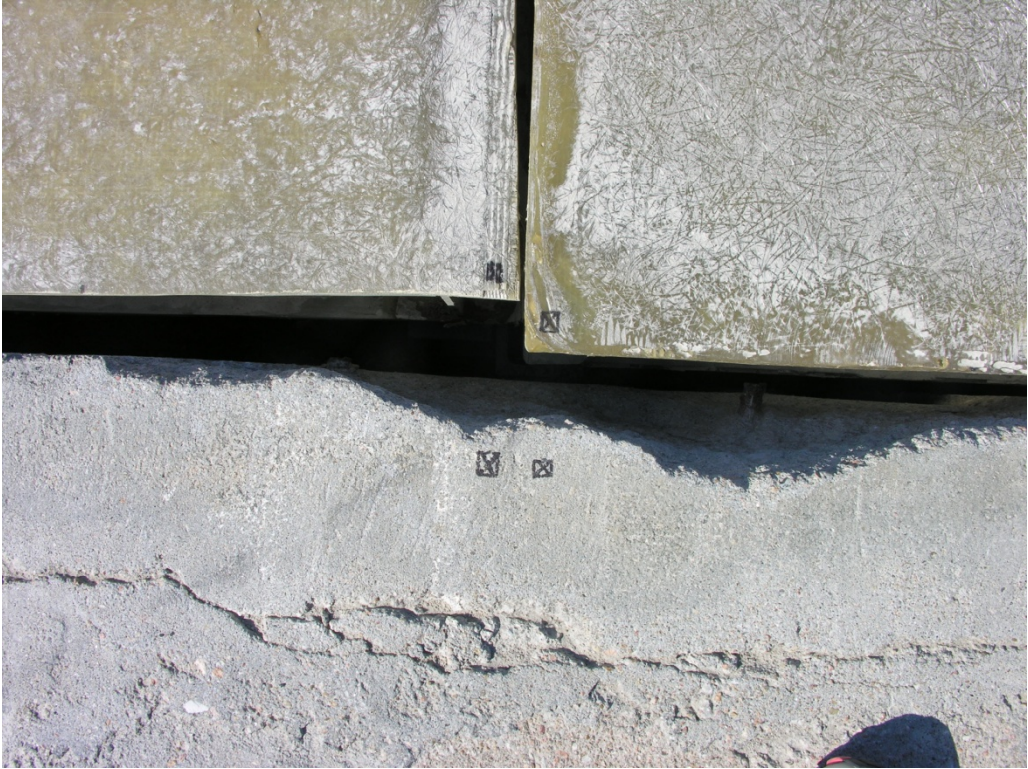
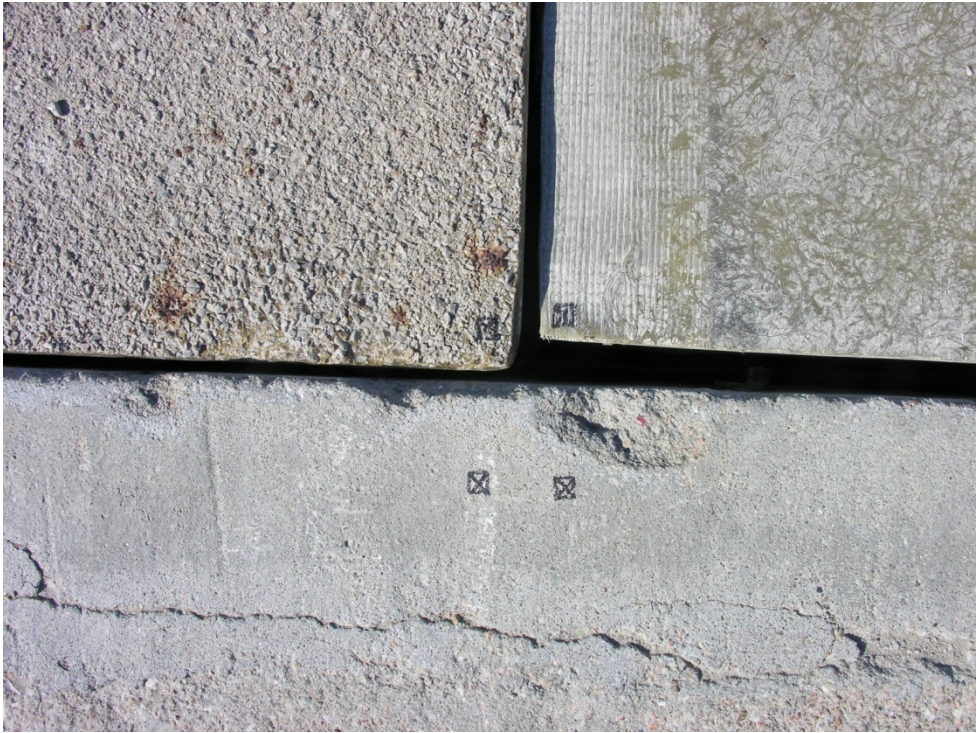
Figure 31. Panel Shift - Joints 3 and 4 (Top) and 4 and 5 (Bottom), Test No. KSFRP-1

No failure was observed in the FRP composite deck panels or at any of the anchor locations. Panel nos. 3 through 6 were laterally displaced, with panel no. 5 having a maximum displacement of ½ in. (13 mm), as shown in Figure 31.

The permanent set of the barrier system was ⅞ in. (22 mm), including a combination of barrier and deck panel shift, which occurred at the downstream end of barrier no. 2, as measured in the field. The maximum lateral dynamic barrier deflection, including tipping of the barrier along the top surface, was 4.4 in. (112 mm) at the downstream end of barrier no. 2, as determined from high-speed video analysis. The working width of the system was found to be 20.4 in. (518 mm).

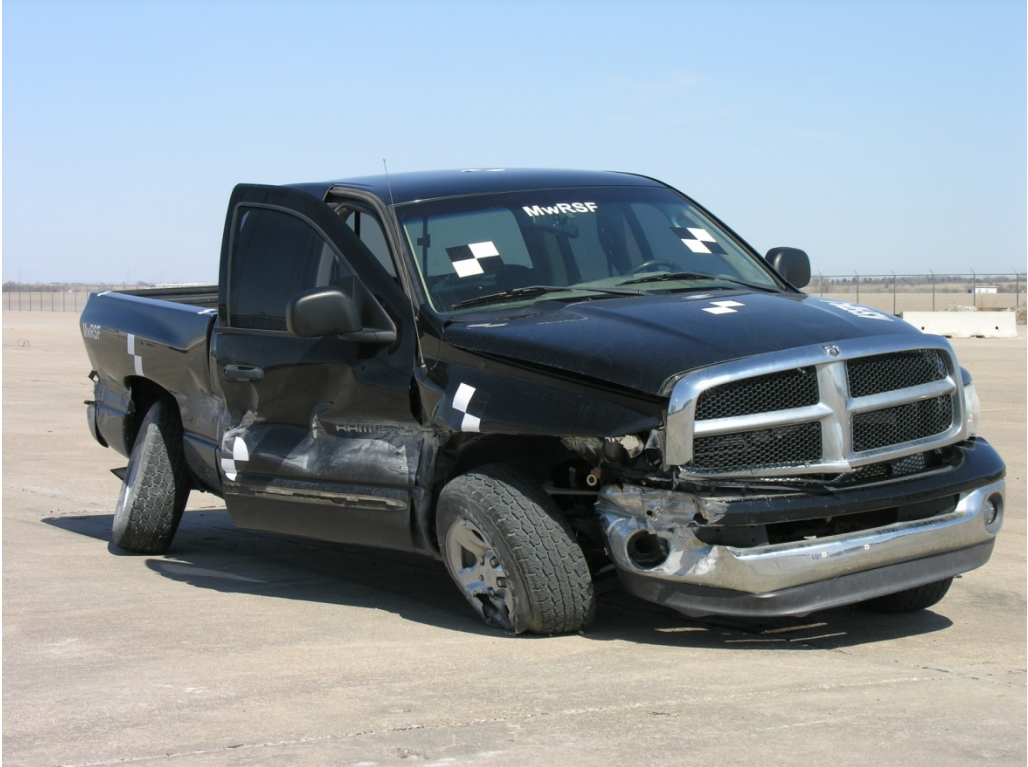
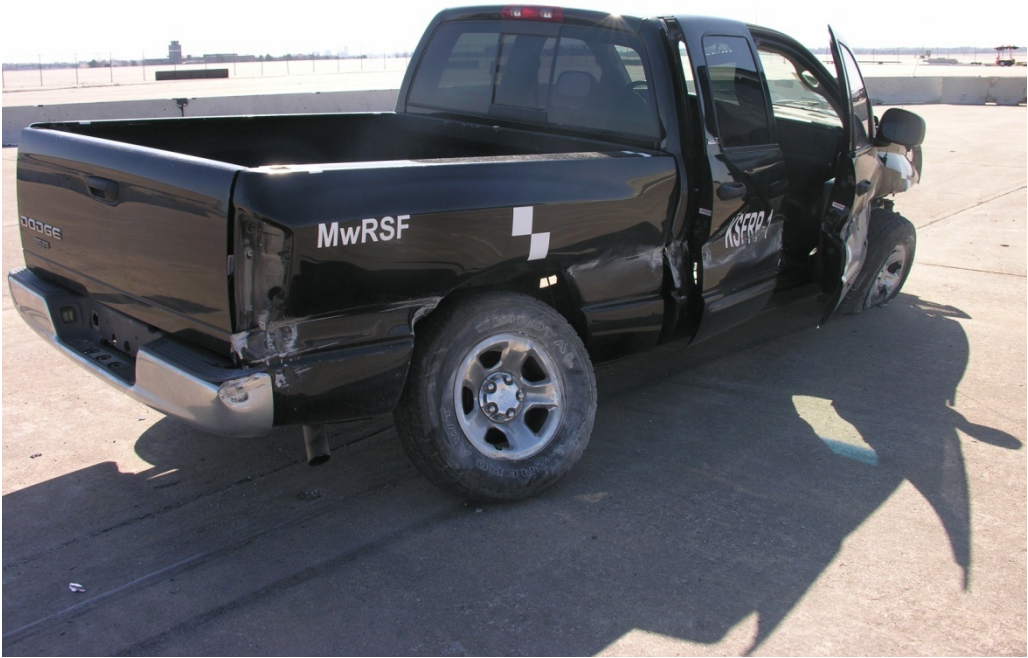
Figure 33. Vehicle Damage, Test No. KSFRP-1

Damage to the vehicle was moderate, as shown in Figures 33 through 36. Minimal occupant compartment deformations occurred to the right-side floor pan. A maximum lateral deflection of ¾ in. (19 mm) was located near the right front of the right-side floor pan. Maximum vertical deflections of ½ in. (13 mm) were found near the left side of the right-side floor pan. Maximum longitudinal deflections of ¾ in. (19 mm) were found near the center of the right-side floor pan. Complete occupant compartment and vehicle deformations and the corresponding locations are provided in Appendix C.

The majority of the damage was concentrated on the right-front corner and right side of the vehicle where the impact occurred. The right side of the bumper was crushed inward and back. The right-front fender was pushed upward near the door panel and was dented and torn behind the right-front wheel. The right-front steel rim was severely deformed with tears and

significant crushing. The right upper control arm was fractured. The right-front tire was torn and deformed. The grill was fractured around the right-side headlight assembly. The right-side headlight and fog lamp were removed from the vehicle. The right side of the radiator was pushed backward. Denting and scraping were observed on the entire right side. The right-front door was ajar, and creases were found in the door's sheet metal. The right-rear door was dented and was ajar approximately 4 in. (102 mm). The right-rear wheel assembly was deformed inward. The right-rear steel rim was crushed, and scuff marks were found on the tire. The tailgate was released from the hinges. The right taillight was removed. The right side of the rear bumper was dented and scuffed. The left side of the front bumper was deformed downward 2 in. (51 mm). The front of the hood had a 2-in. (51-mm) gap on the left side. The left-front fender was dented in at the top and back. There was a 2-in. (51-mm) gap between the left-front fender and the left-front door. The right side of the windshield had a hairline crack, and the lower-left side encountered minor cracking. The roof and remaining window glass remained undamaged.

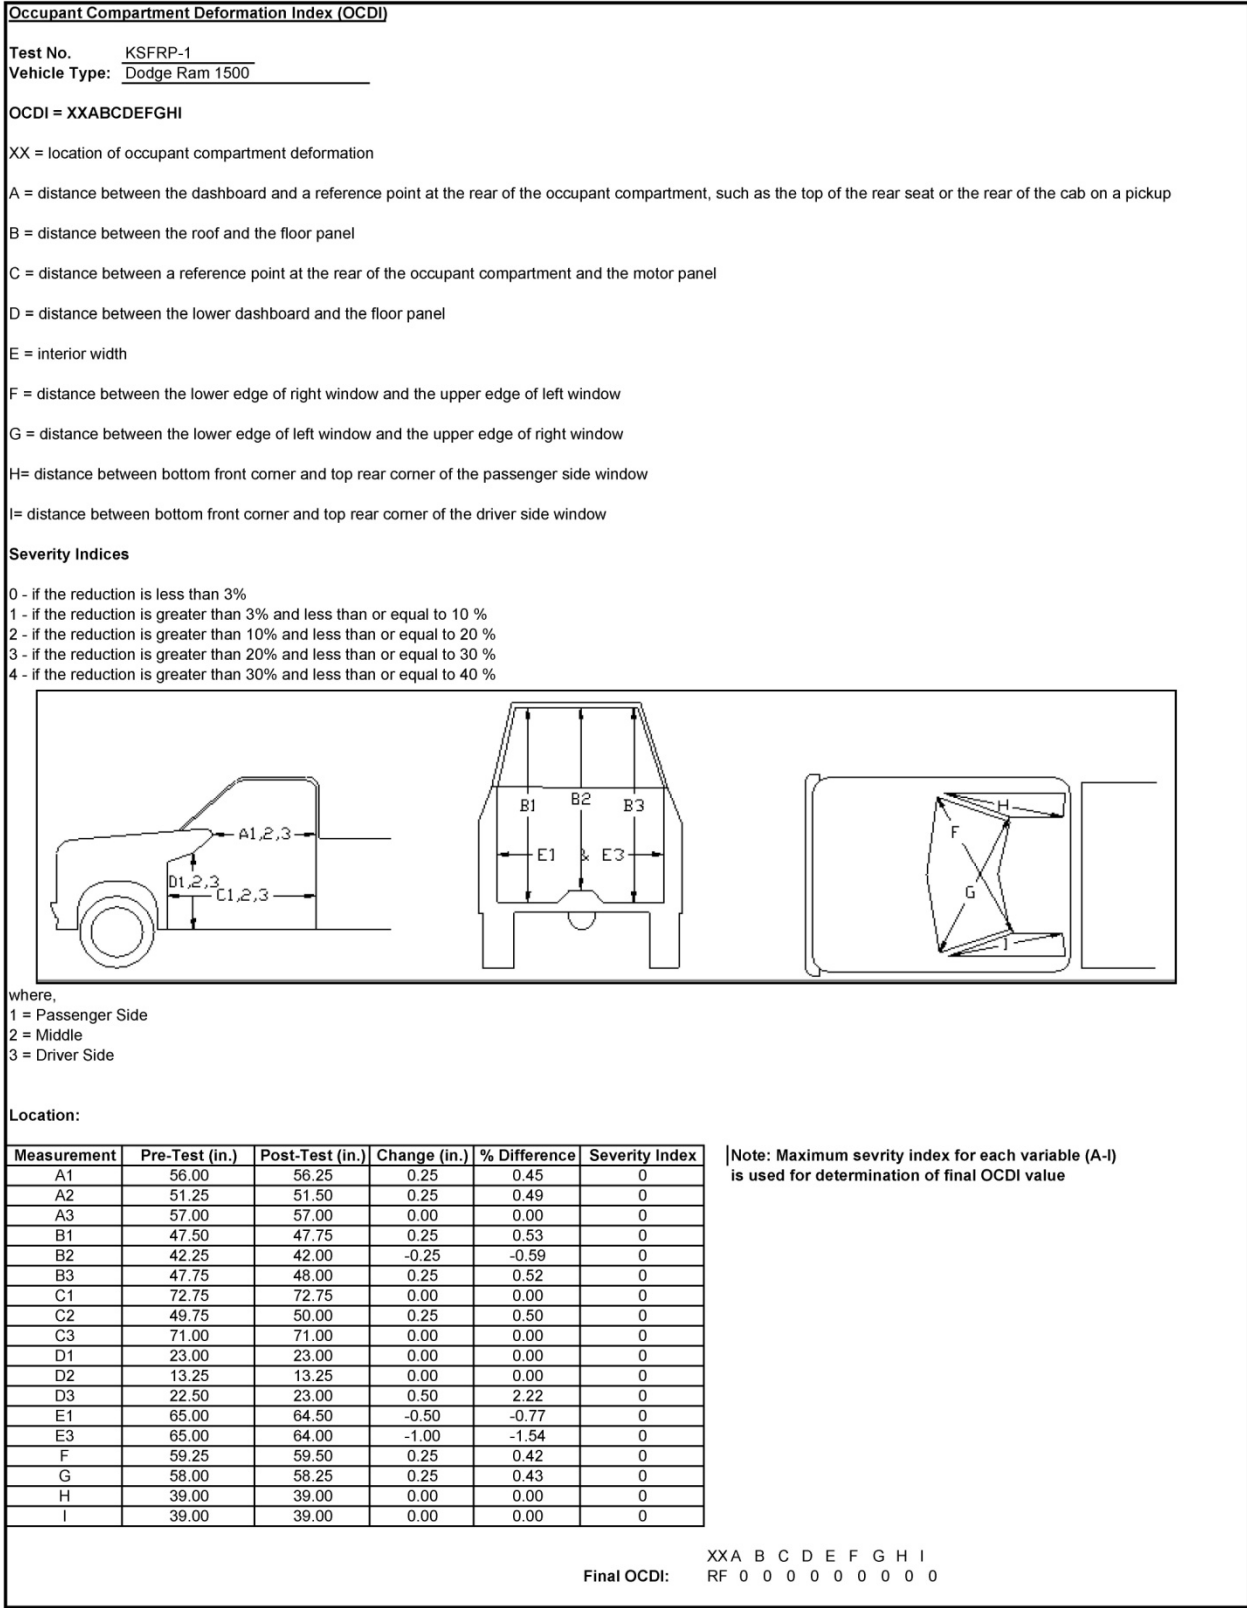
Figure C-3. Occupant Compartment Deformation Index, Test No. KSFRP-1

Date: 3/13/2009 Test Number: KSFRP-1
Make: Dodge Model: Ram 1500 Year: 2002

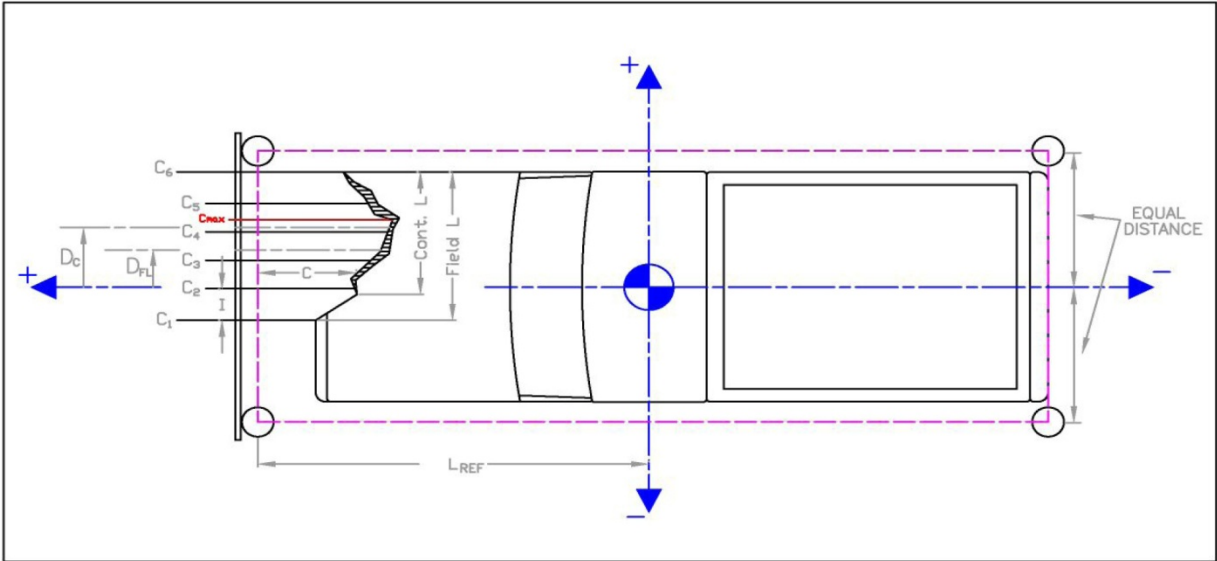
Figure C-4. Exterior Vehicle Crush (NASS) - Front, Test No. KSFRP-1

in.	(mm)
Distance from C.G. to reference line - L_{REF} :	117	(2972)
Width of contact and induced crush - Field L:	19	(483)
Crush measurement spacing interval (L/5) - I:	3.8	(97)
Distance from center of vehicle to center of Field L - D_{FL} :	28.5	(724)
Width of Contact Damage:	15.5	(394)
Distance from center of vehicle to center of contact damage - D_C :	18.5	(470)

Crush Measurement		Lateral Location		Original Profile Measurement		Dist. Between Ref. Lines		Actual Crush	
	in.	(mm)	in.	(mm)	in.	(mm)	in.	(mm)	in.	(mm)
C_1	17.75	(451)	19	(483)	12.3125	(313)	5.17103	(131)	0.26647	(7)
C_2	20.25	(514)	22.8	(579)	13.2344	(336)			1.8446	(47)
C_3	28.5	(724)	26.6	(676)	14.6875	(373)			8.64147	(219)
C_4	41.25	(1048)	30.4	(772)	16.2969	(414)			19.7821	(502)
C_5	41.25	(1048)	34.2	(869)	19.25	(489)			16.829	(427)
C_6	42.25	(1073)	38	(965)	29	(737)			8.07897	(205)
C_{MAX}	42.25	(1073)	19	(483)	12.3125	(313)			24.7665	(629)
