DEVELOPMENT OF LOW-VOLUME CURB-TYPE BRIDGE RAILINGS FOR TIMBER BRIDGE DECKS

MwRSF Research Report No. TRP-03-31-93

December 1993

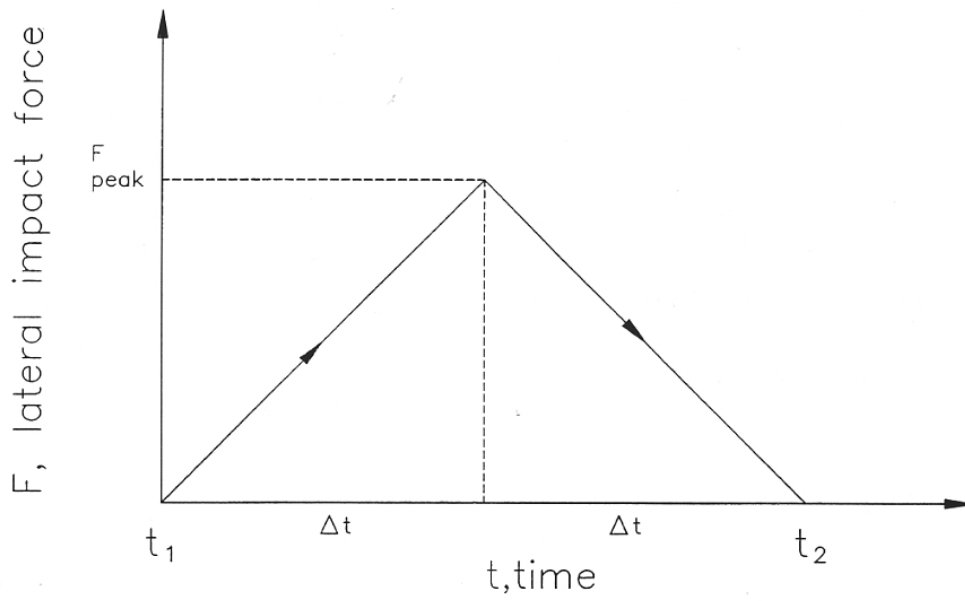
Figure 2. Saw-Tooth Forcing Function

Assuming a single, symmetrical saw-tooth forcing function, as shown in Figure 2, the impulse is equal to the area under the triangle or $\frac{1}{2}(2\Delta t)F_{\text{lat. peak}}$. If the time from impact until the vehicle becomes parallel to the bridge railing is 0.75 sec, as estimated previously, the peak lateral impact force is estimated to be 2,124 lbs. Thus both procedures predict that the peak lateral impact force should be approximately 2,125 lbs.

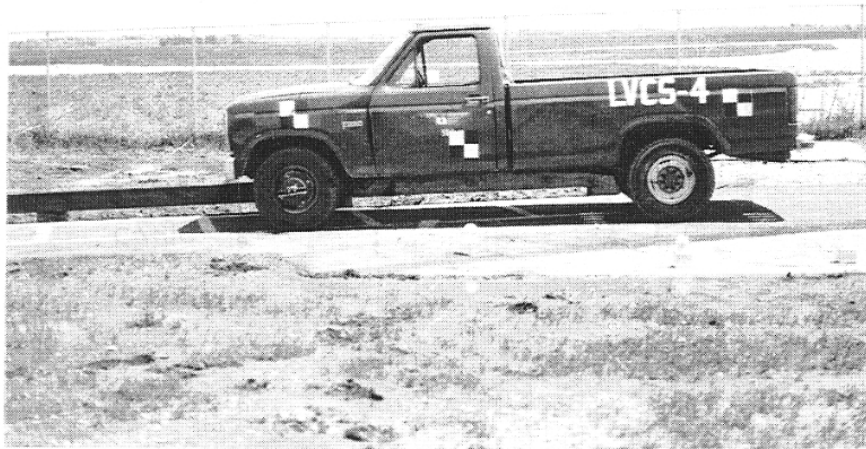
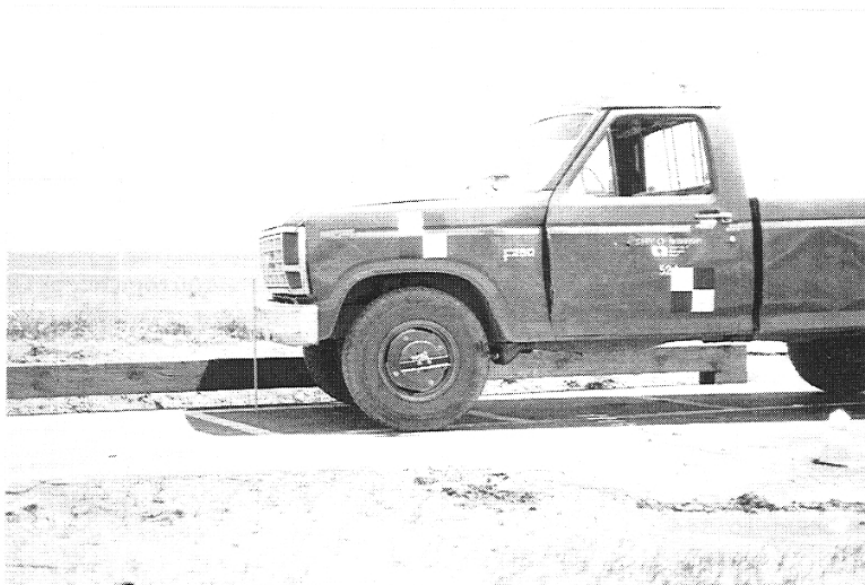
Figure 10. Crash Test Vehicle, Test LVCS-4

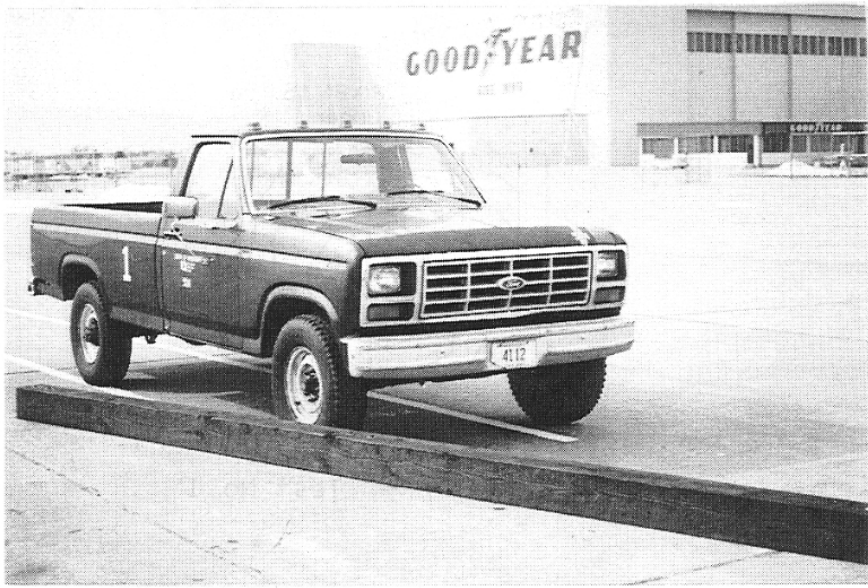
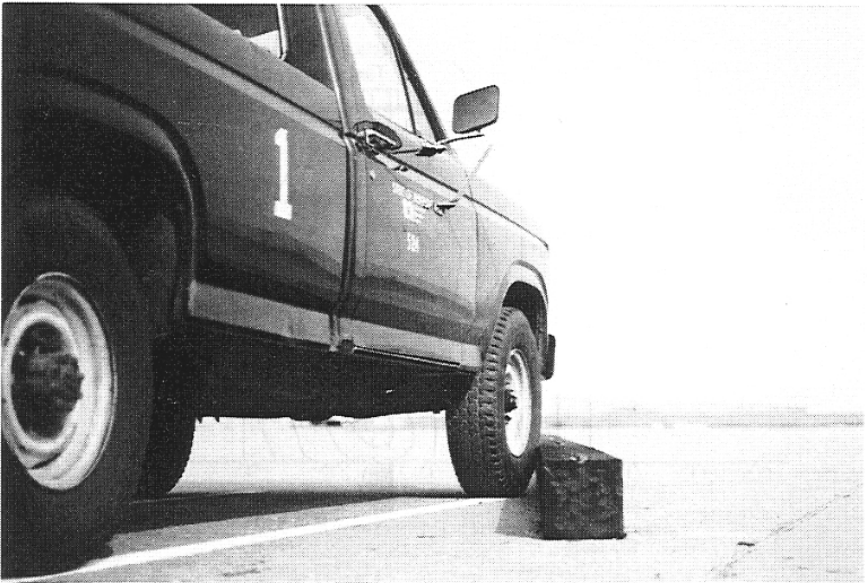
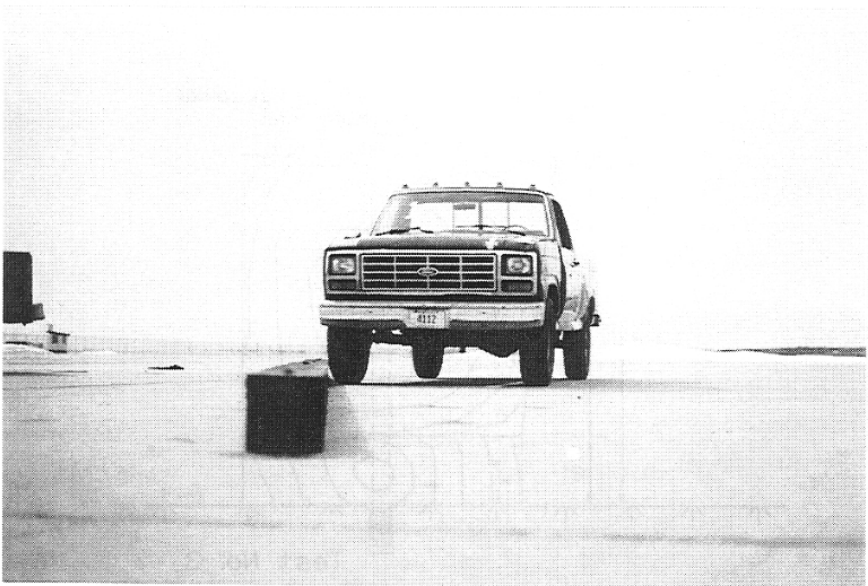
Figure 13. Square Curb Rail Attached to Concrete Apron

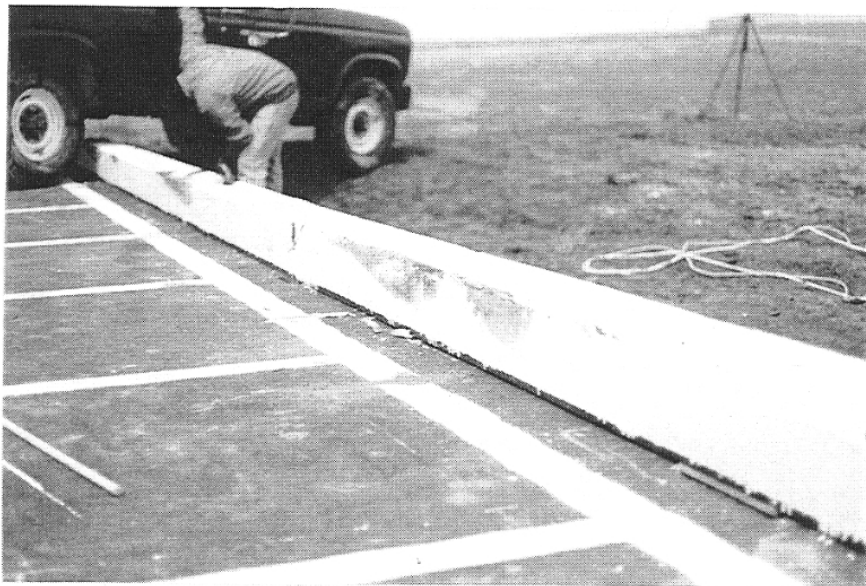
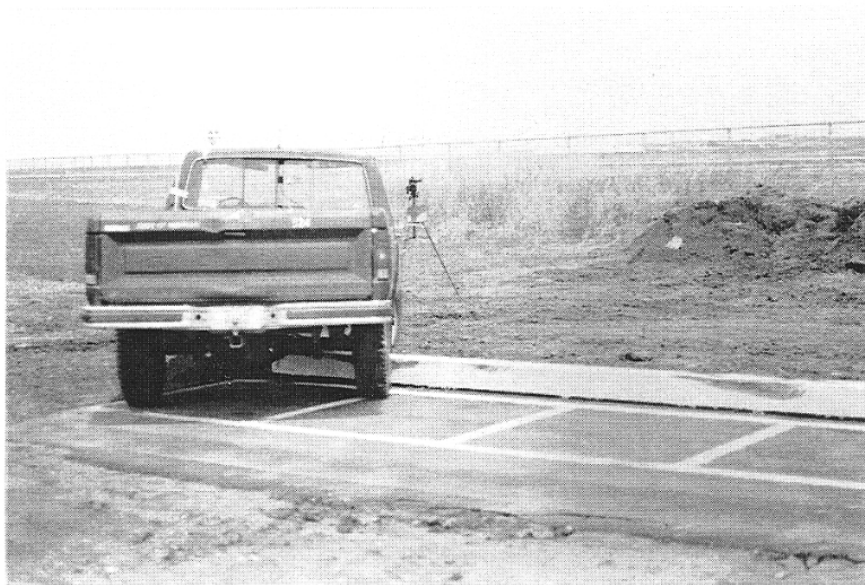
Figure 20. Tire Marks on Rail, Test LVCT-1a

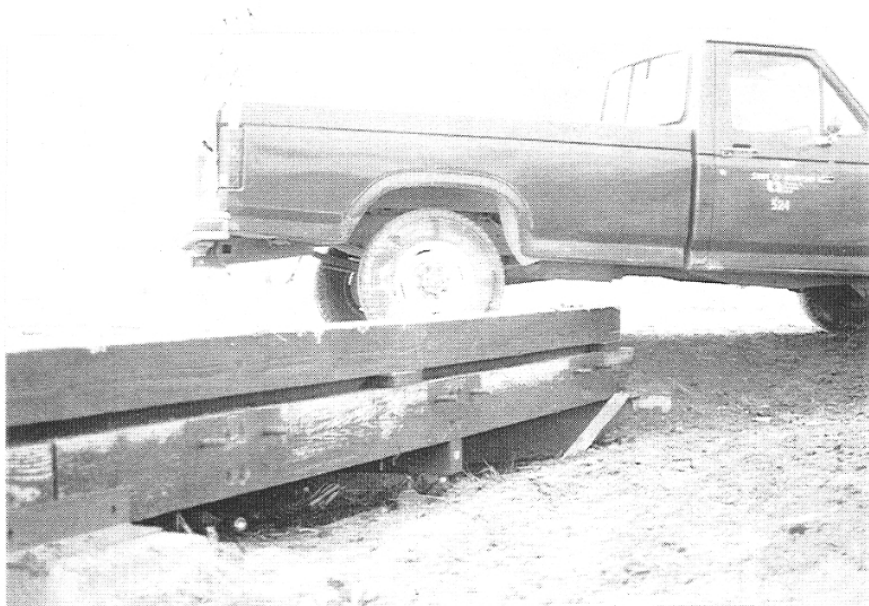
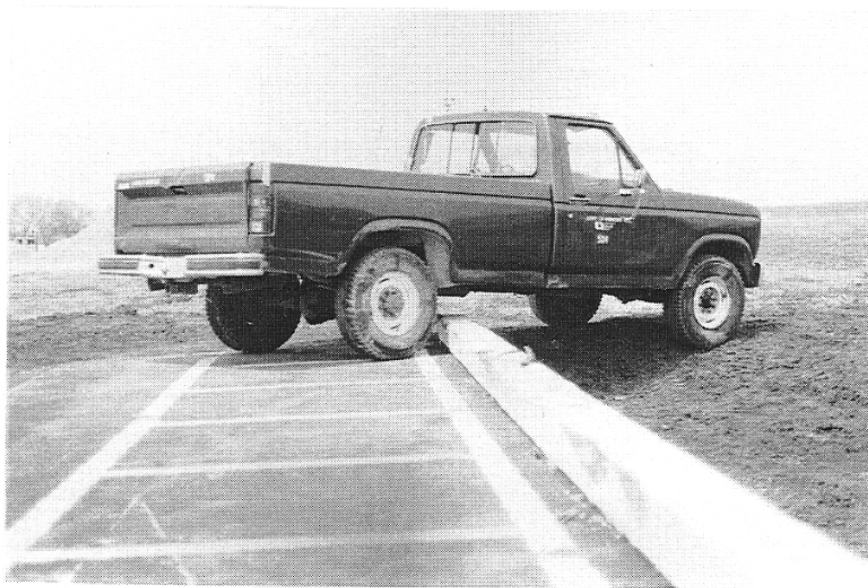
Figure 21. Vehicle Trajectory, Test LVCT-1a

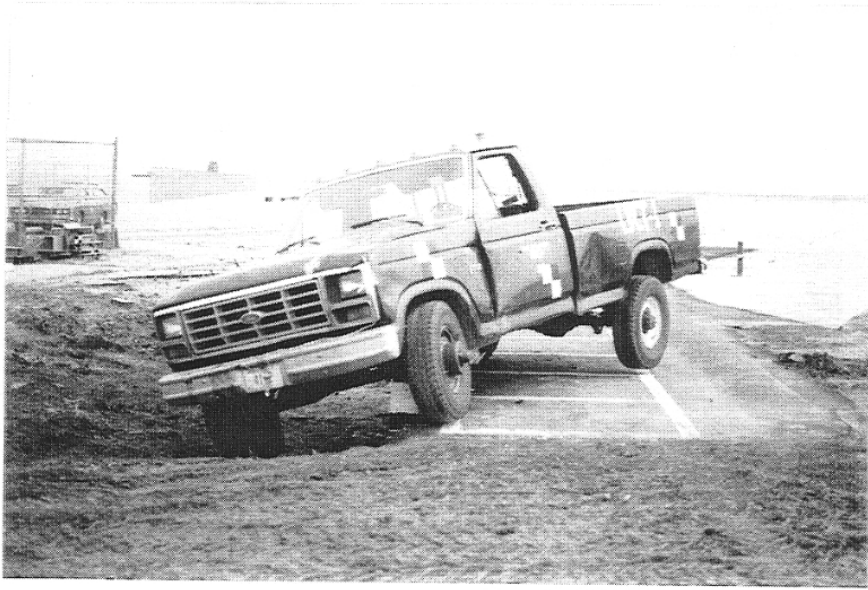
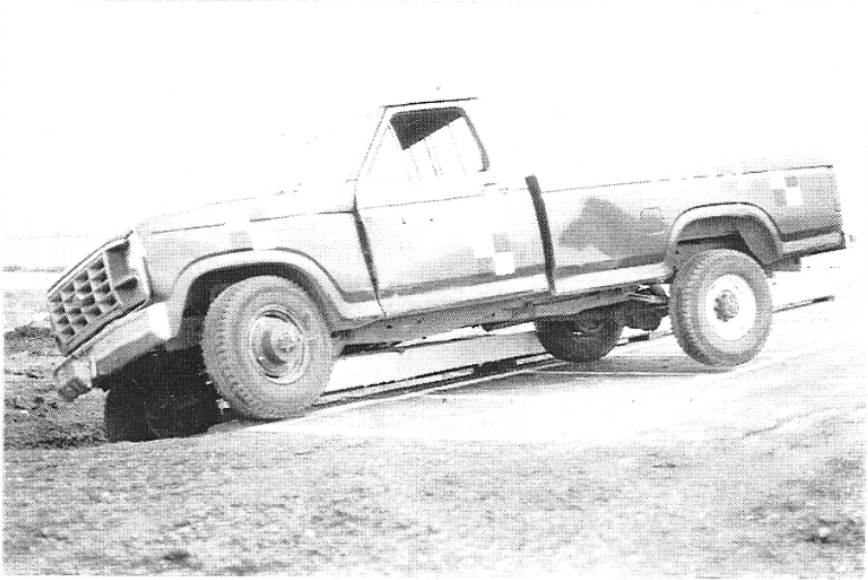
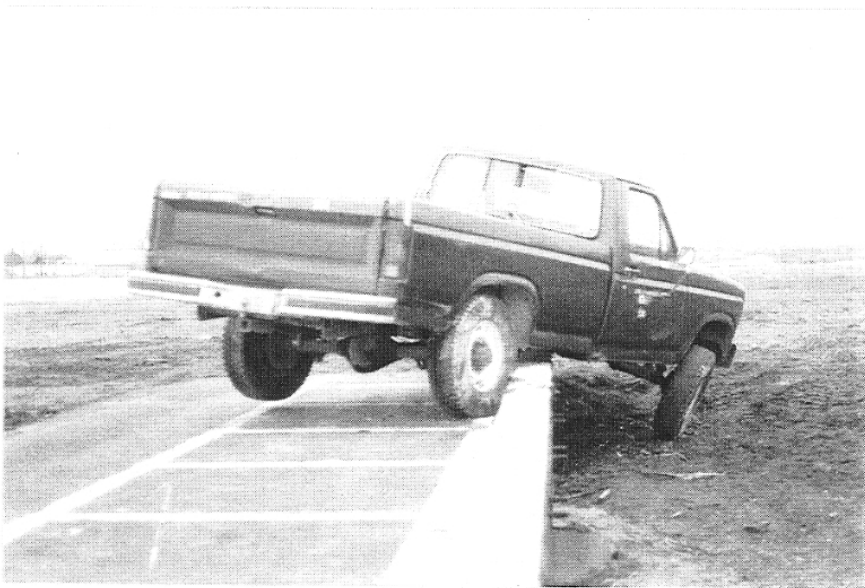
Figure 24. Vehicle Trajectory, Test LVCT-1c

was conducted on a 10-in. high trapezoidal shape curb in order to further check the results of the Developmental Testing - Phase I. The impact point for test LVCT-1c was the same as for the previous two tests. A schematic of the curb configuration is shown in Figure 22 and photographs of the installation are shown in Figure 23. The vehicles' tires again climbed over the top of the curb allowing the tires to go over the side of the bridge rail. The vehicle came to rest on top of the curb at the end of the installation, as shown in Figure 24.

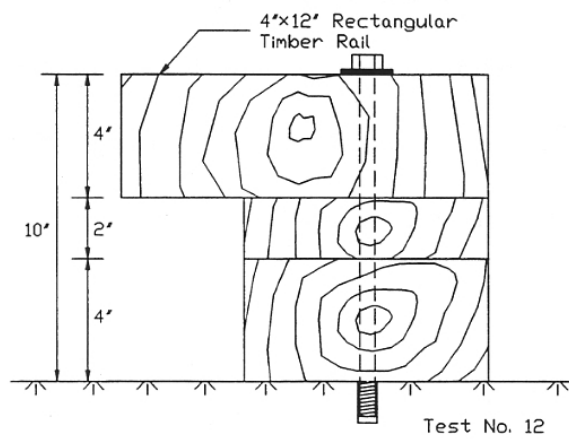
Figure 25. Curb Configurations for Developmental Testing - Phase II

Impact tests were performed on the three curb shapes mounted at heights ranging from 8 to 14 in. A total of eight curb configurations were evaluated as shown in Figures 25 through 27. Fifteen tests were conducted and are summarized in Table 4. For impacts at 15 mph and 15 degrees, a 12-in. mounting height successfully redirected the test vehicle for both the square and rectangular shapes with no tendency for vehicle climbing. However, for the same impact conditions, a 14-in. mounting height was required for the trapezoidal shape. For the 12-in. high trapezoidal shape, the sharp corner extending outward from the top of the front face was low enough to allow the tire to climb up and over the curb. Following these tests, it was determined that one full-scale vehicle crash test should be performed on one of the successful curb shapes. The 12-in. high, square shape was selected for full-scale vehicle crash testing since it offered the most economical design alternative.

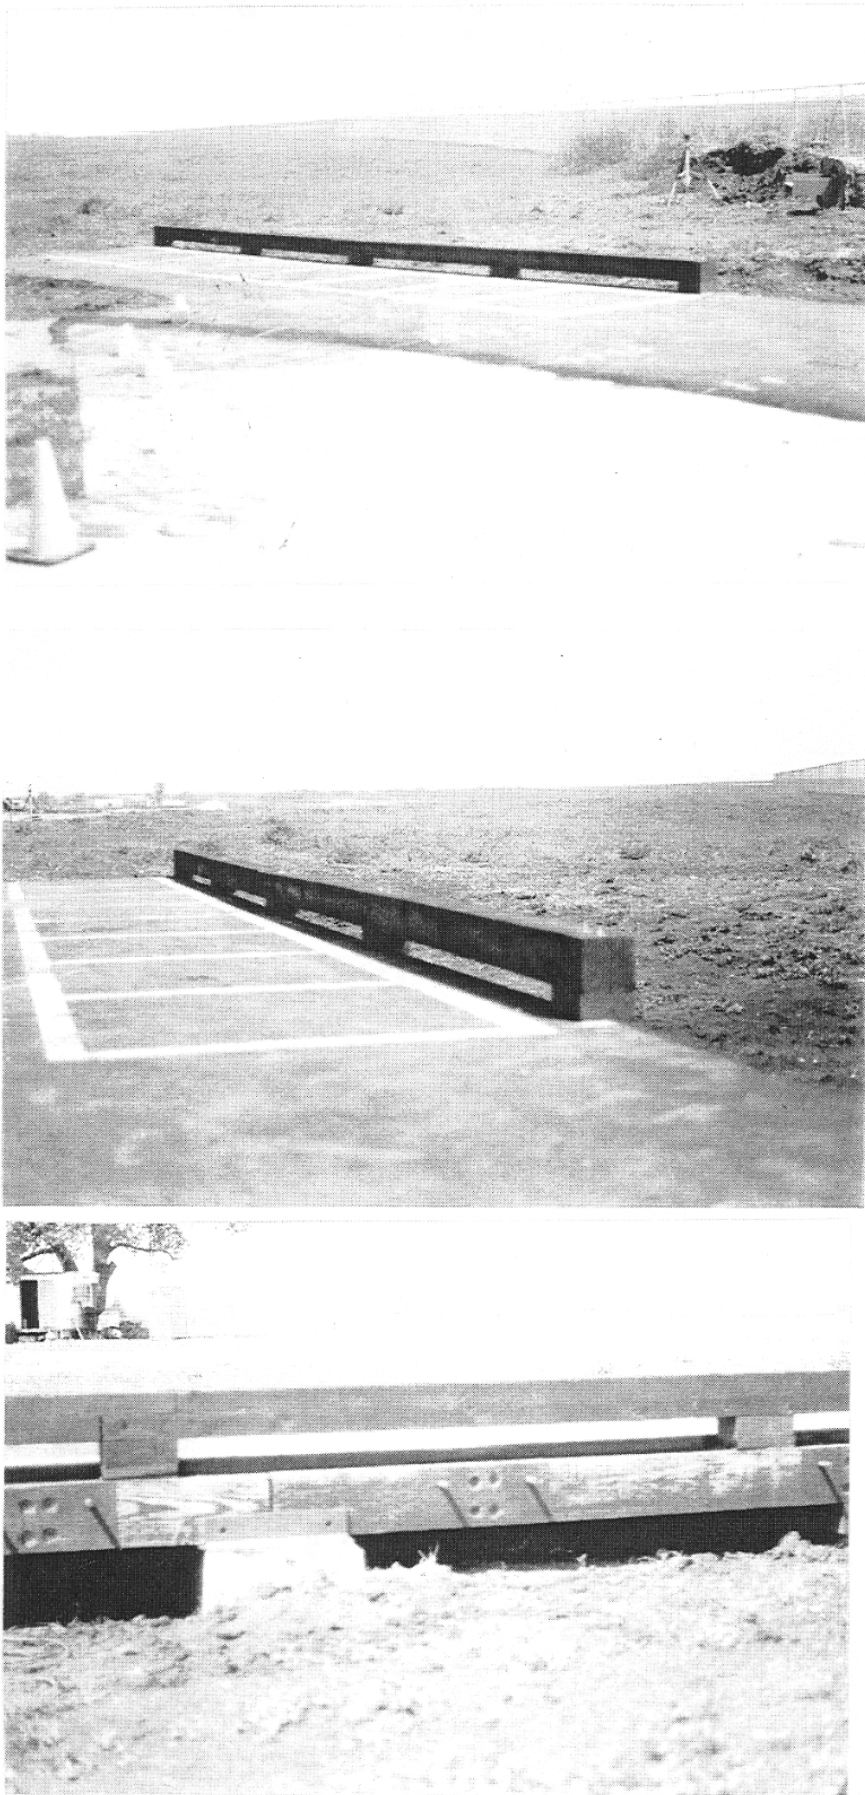
Figure 28. Square-Shape Timber Curb Rail, Test LVCS-4

One full-scale crash test was conducted on a 12-in. high, square shape curb rail as shown in Figures 28 through 30. A schematic of the curb configuration is shown in Figure 31. The weather conditions during the day of testing were recorded. Between 8:00 a.m. and 6:00 p.m. on 5/12/93, the minimum and maximum air temperatures were 62.4°F and 81.9°F, respectively.

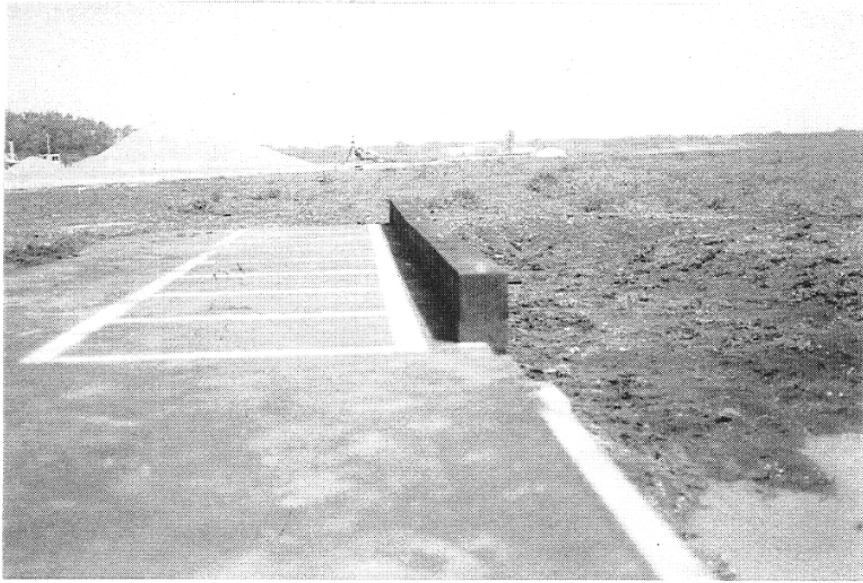
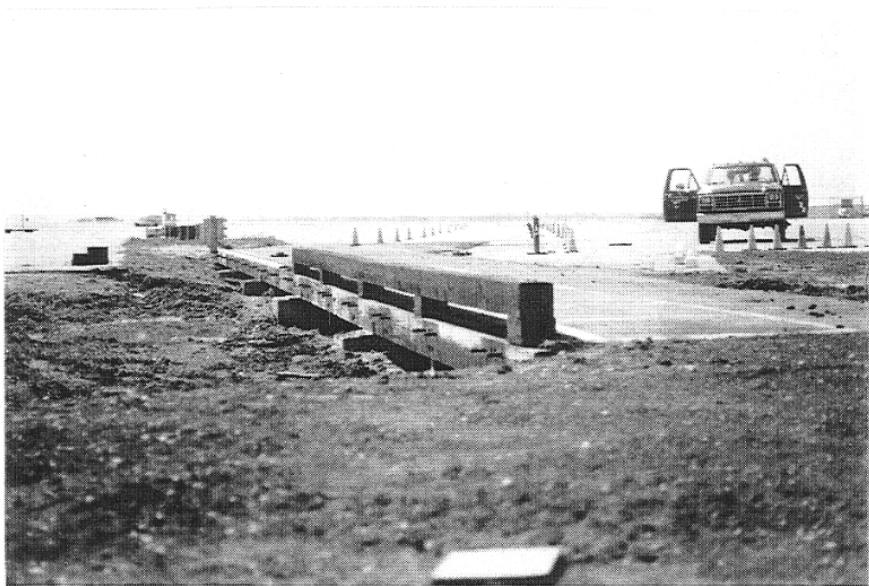
Figure 29. Square-Shape Timber Curb Rail, Test LVCS-4 (con't)

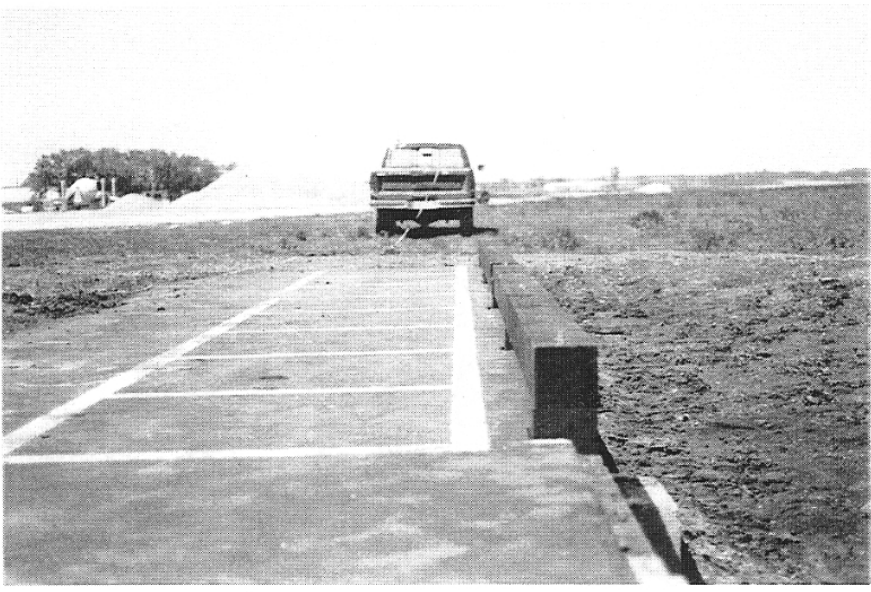
Figure 38. Vehicle Trajectory, Test LVCS-4

Except for minor scuff marks on the right-side tires, there was no visible vehicle damage, as shown in Figure 39. No damage occurred to the curb rail or steel hardware as shown in Figure 38. In addition, the glulam timber deck was not damaged.

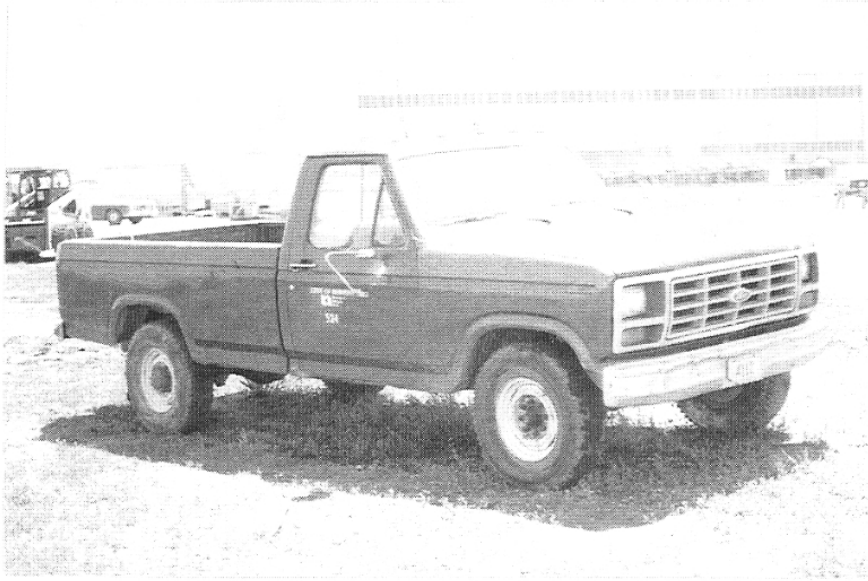
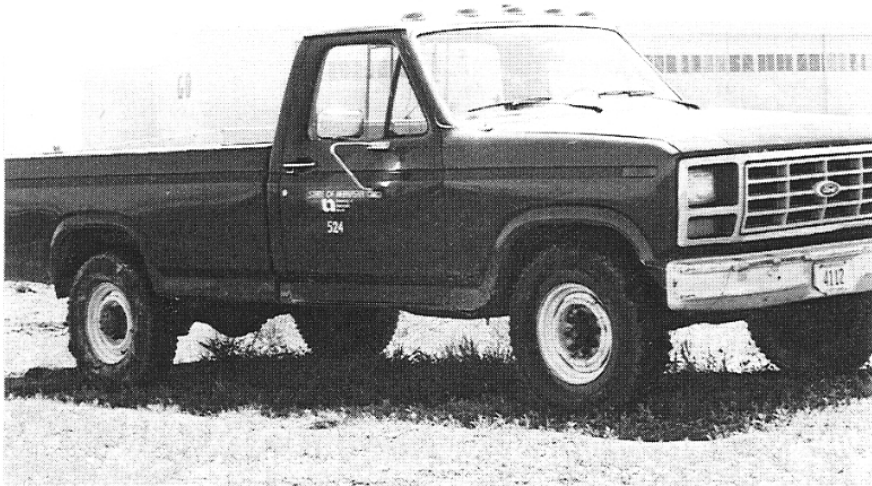
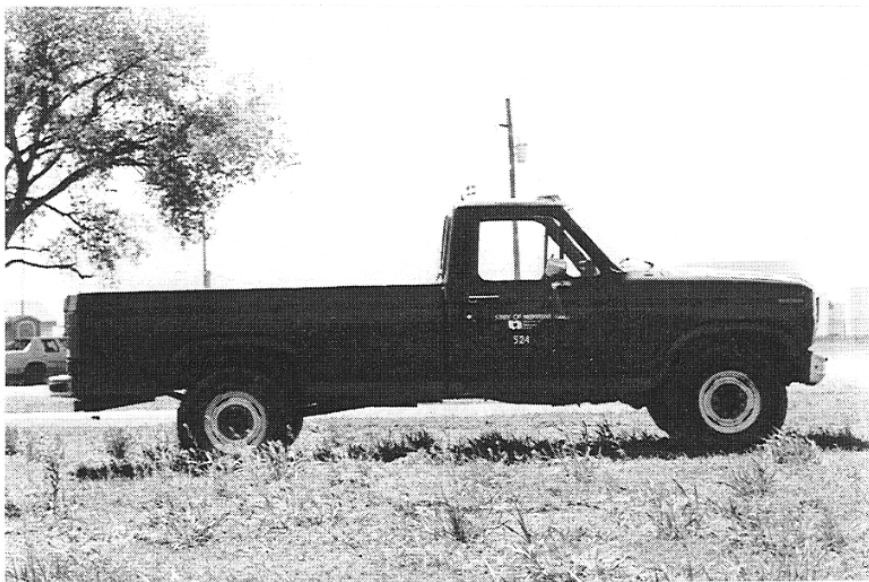
Figure 39. Vehicle Damage, Test LVCS-4
