TL-1 Curb-Type Bridge Railing for Longitudinal Glulam Timber Decks Located on Low-Volume Roads

MIDWEST ROADSIDE SAFETY FACILITY

MwRSF Research Report No. TRP-03-54-96

April 1996

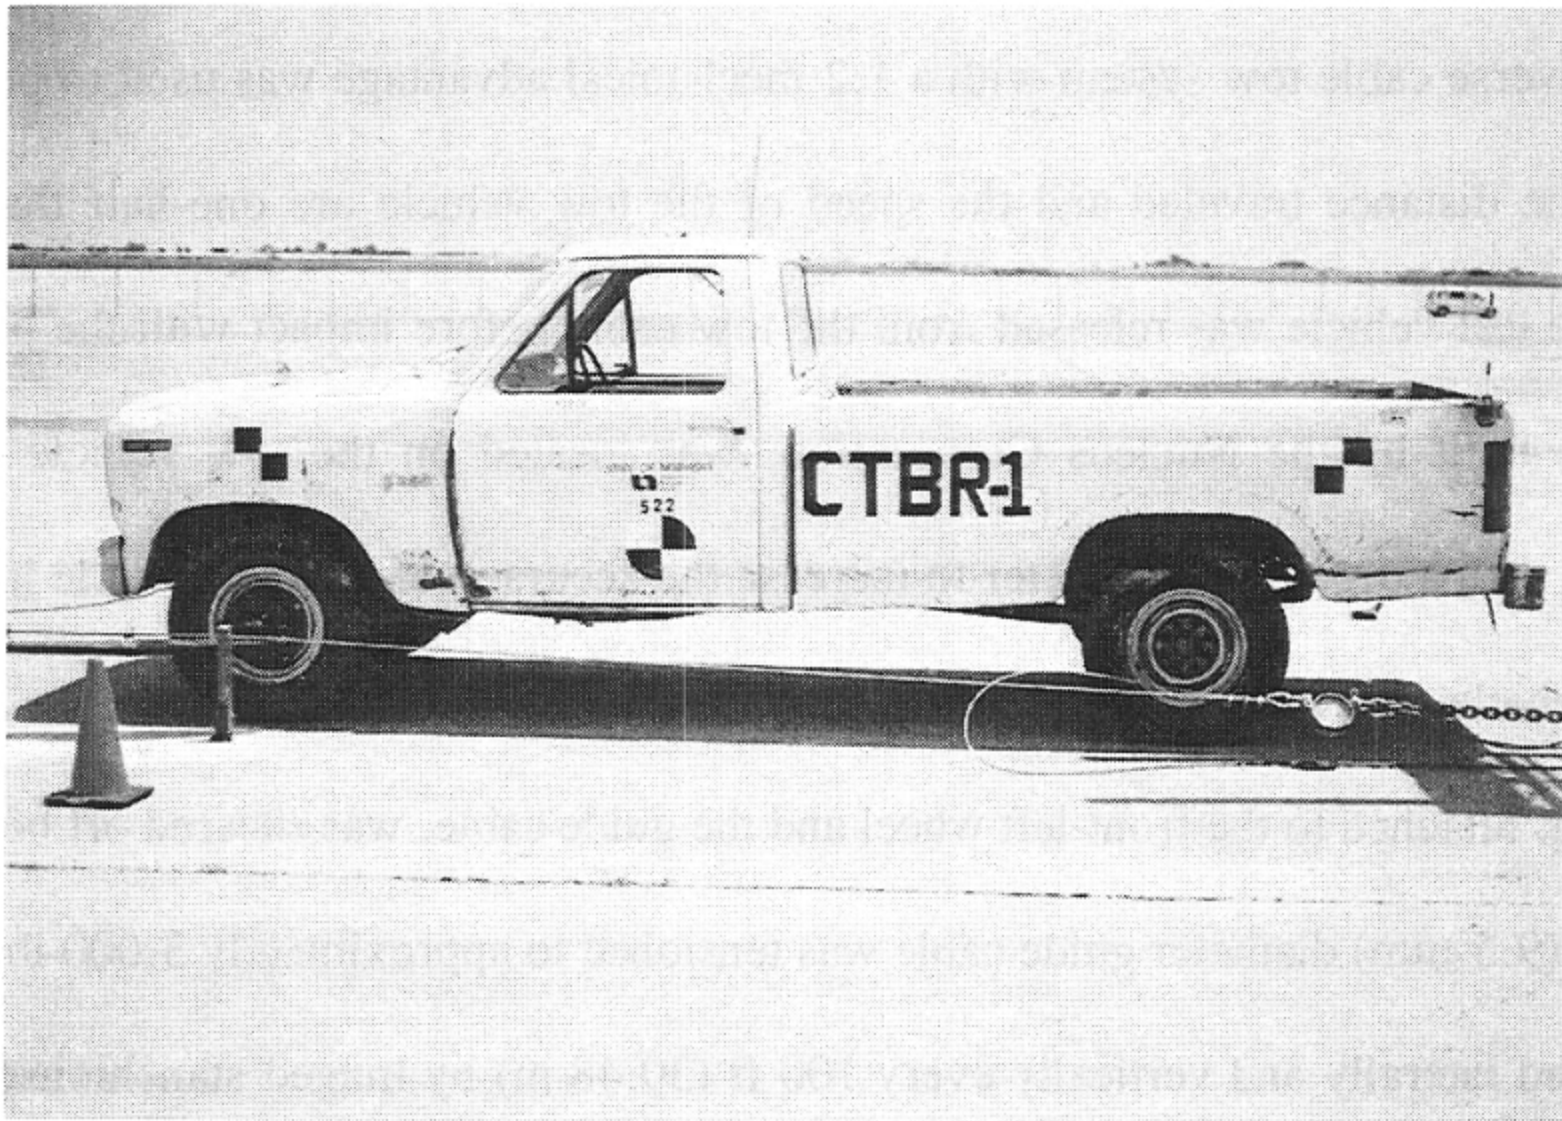
Figure 16. Test Vehicle, Test CTBR-1

A 1985 Ford F-250 ¾-ton pickup truck was used as the test vehicle. The test inertial and gross static weights were 4,435 lbs (2,012-kg). The test vehicle is shown in Figure 16 and vehicle dimensions are shown in Figure 17.

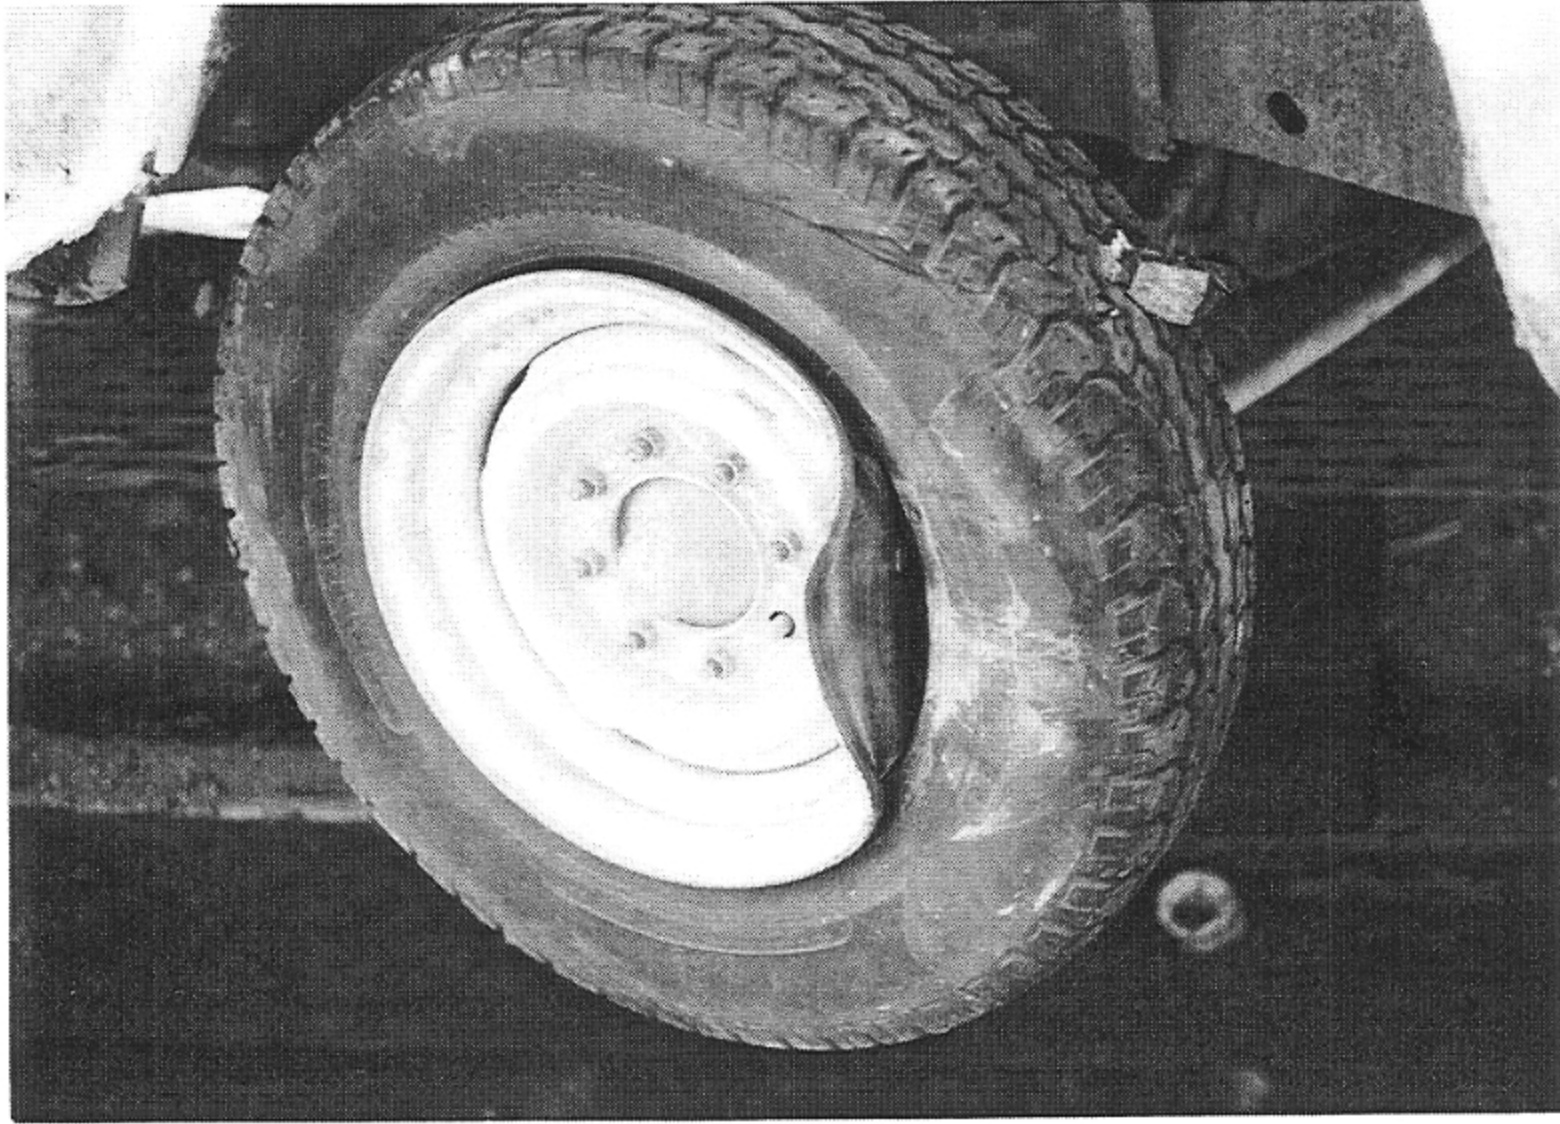
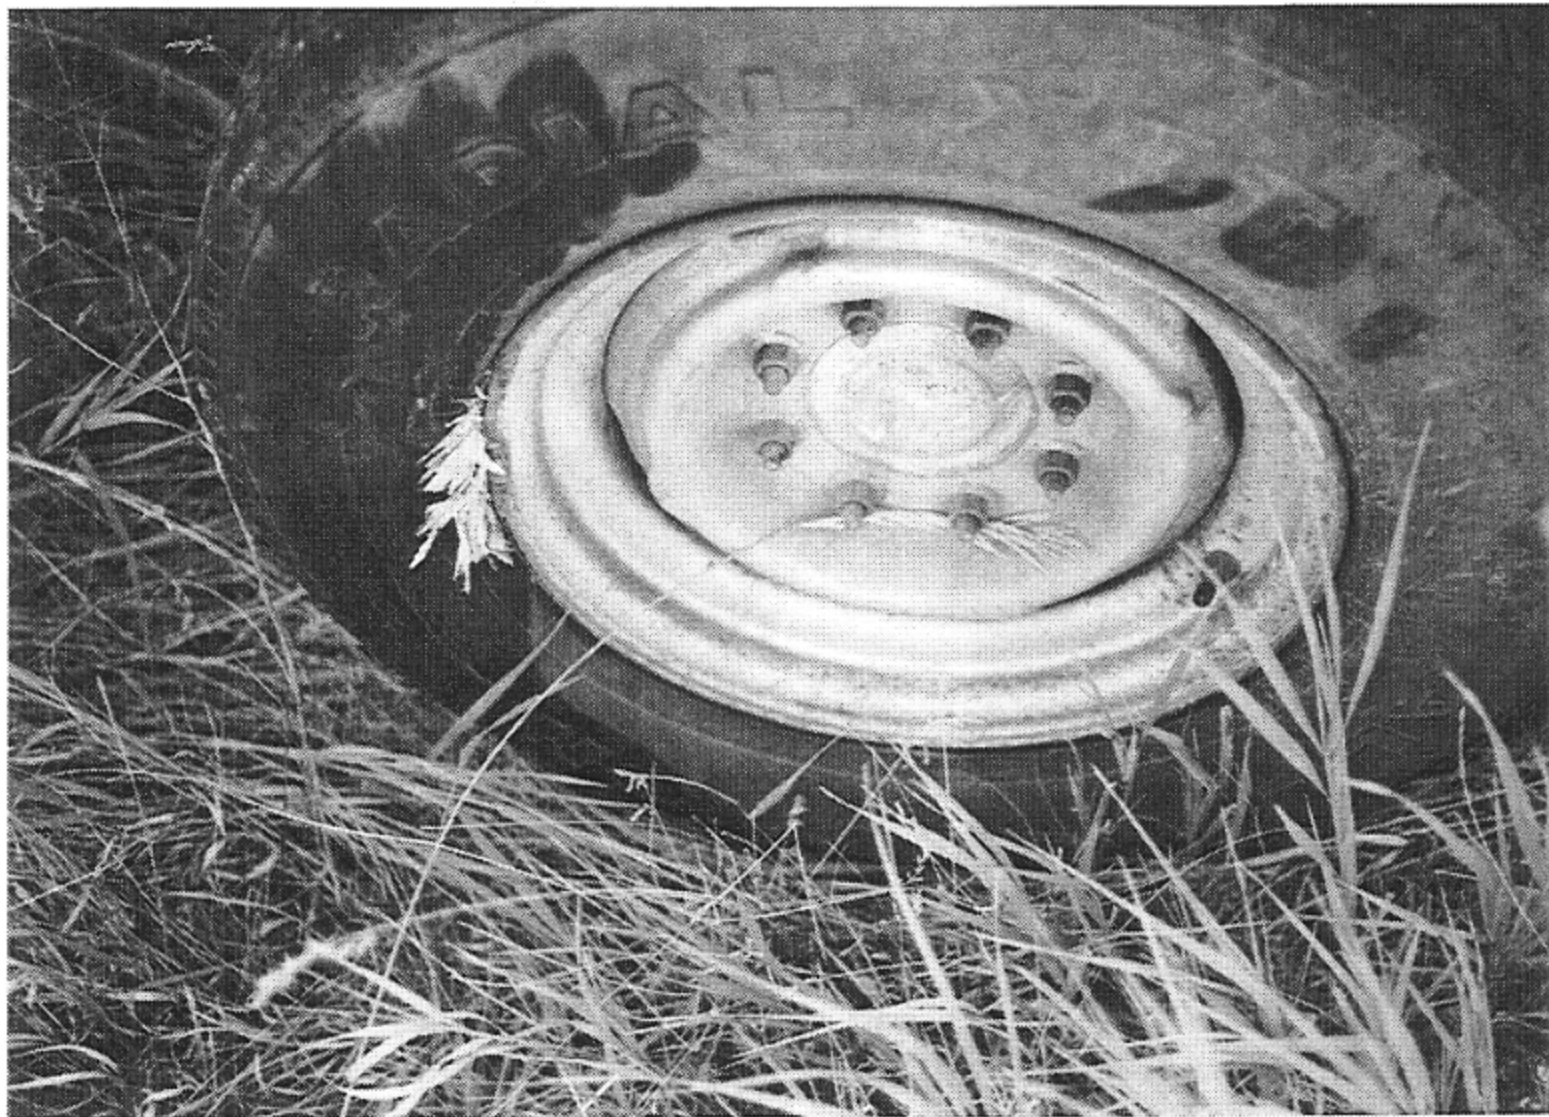
Figure 28. Steel Rim Deformations, Test CTBR-1

Exterior vehicle damage was minor and was limited to deformations of the steel frame and the steel rims of the right-side wheels. The steel frame was shifted slightly due to the oblique impact with the bridge rail. As shown in Figure 28, the right-front and right-rear steel rims were deformed due to the contact with the glulam rail, as evidenced by the wood fibers lodged between the tire and rim and gouges on the face of the glulam rail. Minor undercarriage damage was also observed. No damage occurred to the interior occupant compartment. The vehicle damage was also assessed by the traffic accident scale (TAD) (22) and the vehicle damage index (VDI) (23), as shown in Figure 21.
