# **Top-Mounted W-Beam Bridge Railing for Longitudinal Glulam Timber Decks Located on Low-Volume Roads**

## **MIDWEST ROADSIDE SAFETY FACILITY**

*MwRSF Research Report No. TRP-03-61-96*

September 1996

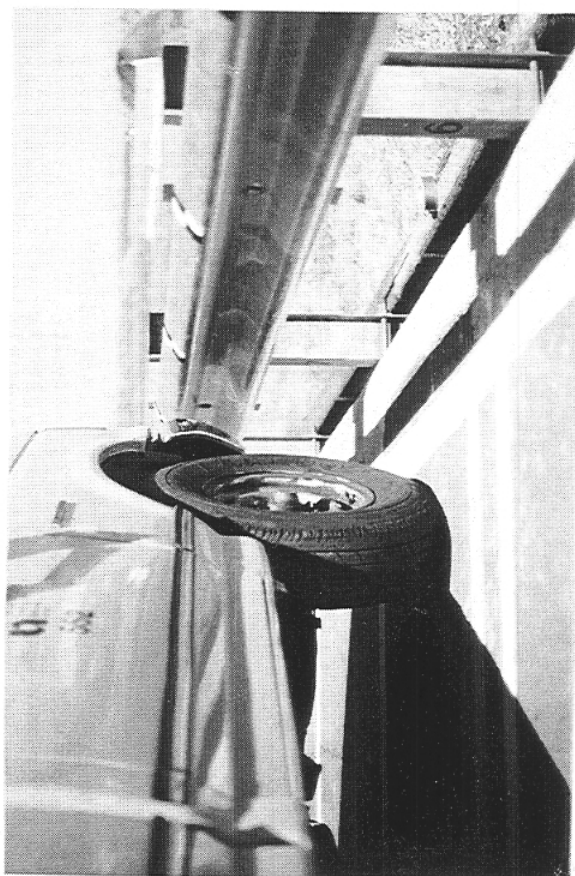
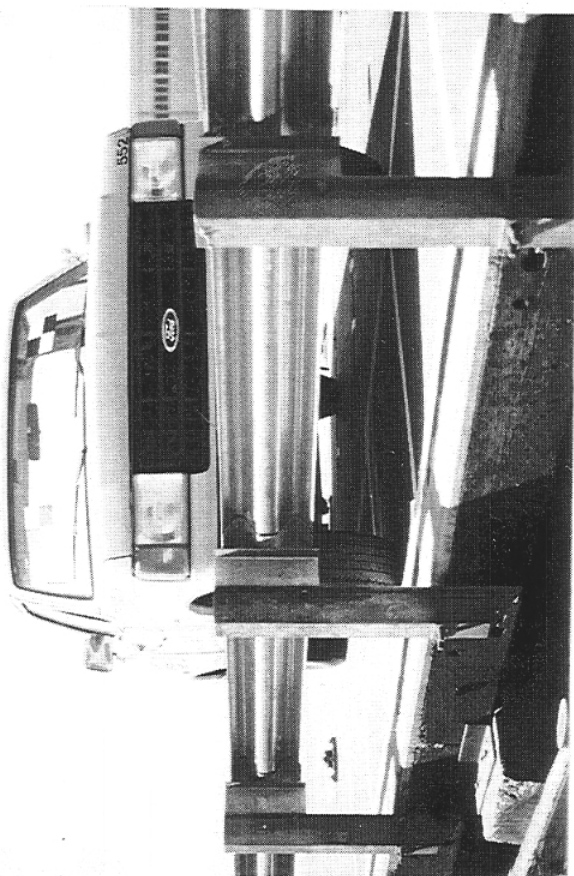
Figure 9. Impact Location, Test LVBR-3

The pickup truck impacted the W-beam bridge railing on the upstream-side of post no. 7, as shown in Figure 9. A summary of the test results and the sequential photographs is presented in Figure 10. Additional sequential photographs are shown in Figure 11.

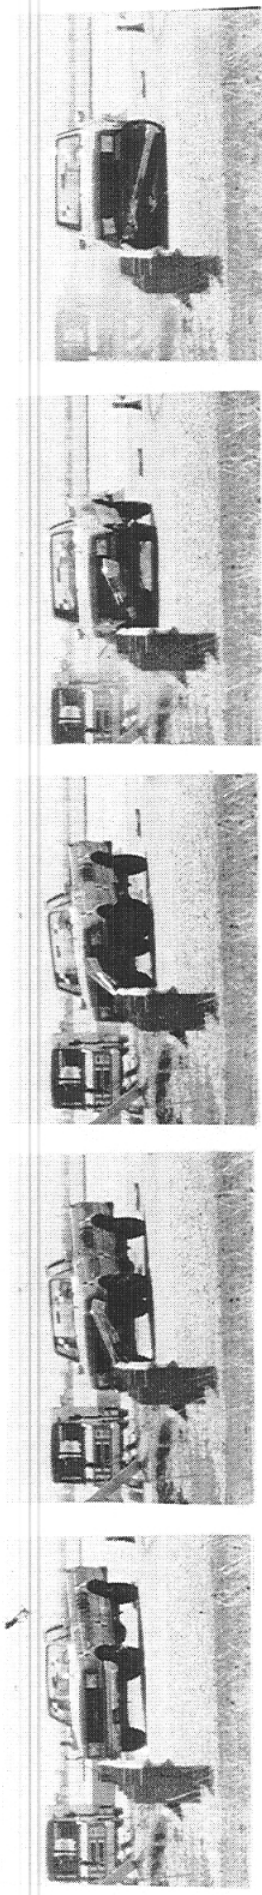
Figure 10. Summary of Test Results and Sequential Photographs, Test LVBR-3

• Test Number	LVBR-3	• Vehicle Model	1988 Ford F-250
• Date	4/25/96	• Curb Weight	1,987 kg
• Total Installation Length	60.96 m	• Test Inertial Weight	2,001 kg

• Bridge Rail Installation	Top-Mounted W-Beam Railing System	• Gross Static Weight	2,001 kg
• Bridge Rail Length	30.48 m	• Vehicle Speed	51.2 km/hr
• Steel W-Beam Rail		• Impact	NA

• Size	12 Gauge (2.66 mm)	• Exit	NA
• Center Rail Mounting Height	550 mm	• Vehicle Angle	25.2 degrees
• Steel Bridge Posts (No. 1 through 15)		• Impact	NA

• Anchor Bolts	Four 22.2-mm φ by 356-mm long	• Lateral	2.7 m/s ≤ 12 m/s
• Threaded Rods	Two 19.0-mm φ per post	• Vehicle Damage	Minor
• Post Washer	ASTM A36 4.8 mm x 50 mm x 100 mm	• TAD <sup>2</sup>	1-RFQ-3

• Lag Screws	Two 12.7-mm φ by 152-mm long	• SAE <sup>2</sup>	01RFEW2
• Bridge Deck Installation		• Vehicle Stopping Distance	7.6 m
• Type	Longitudinal Glulam Timber Bridge Deck Panels	• Barrier Damage	Plastic deformation of posts, spacers, rail, post washers, and threaded rods

The normalized longitudinal and lateral occupant impact velocities were determined to be 19.3 ft/sec (5.9 m/sec) and 8.8 ft/sec (2.7 m/sec), respectively. The maximum 0.010-sec average occupant ridedown decelerations in the longitudinal and lateral directions were 6.5 g's and 4.3 g's, respectively. It is noted that the occupant impact velocities and occupant ridedown decelerations were within the suggested limits provided in NCHRP Report No. 350. The results of the occupant risk, determined from accelerometer data, are summarized in Figure 10. Results are shown graphically in Appendix A.

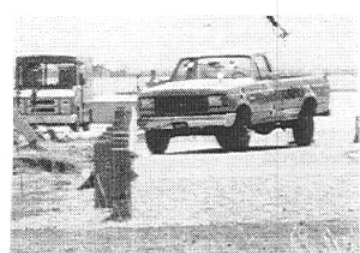
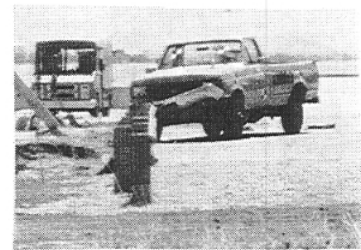
Figure 11. Additional Sequential Photographs, Test LVBR-3

Following the initial impact with the bridge rail, the right corner of the front bumper began to wedge between to the two humps of the W-beam rail section, and the left-side of the bumper began to release from the steel frame. Prior to testing, the original front bumper was removed since it contained significant deformations and replaced with a new, undamaged bumper. Round washers, instead of the standard bumper plate washers, were inadvertently used during the installation. This allowed the bolts, nuts, and round washers to pull through the holes in the steel frame during the impact. At 0.119 sec after impact, the left-side of the bumper was clearly dislodged from the vehicle frame. The front wheels began to turn towards the bridge rail at 0.131 sec. At 0.139 sec, the right-front corner of the vehicle was near post no. 8. From the overhead high-speed film, the maximum dynamic lateral deflection of 13.5 in. (343 mm) was observed at the midspan between post nos. 7 and 8 at 0.169 sec. The left-front tire was positioned approximately perpendicular to the bridge rail at 0.191 sec. At 0.322 sec, the left-rear tire became airborne, recontacting the ground at 0.433 sec. At 0.348 sec and 0.576 sec, the right-front corner of the vehicle was near post nos. 9 and 10, respectively. The vehicle temporarily lost contact with the bridge rail at 0.655 sec after impact. At 0.914 sec, the right-

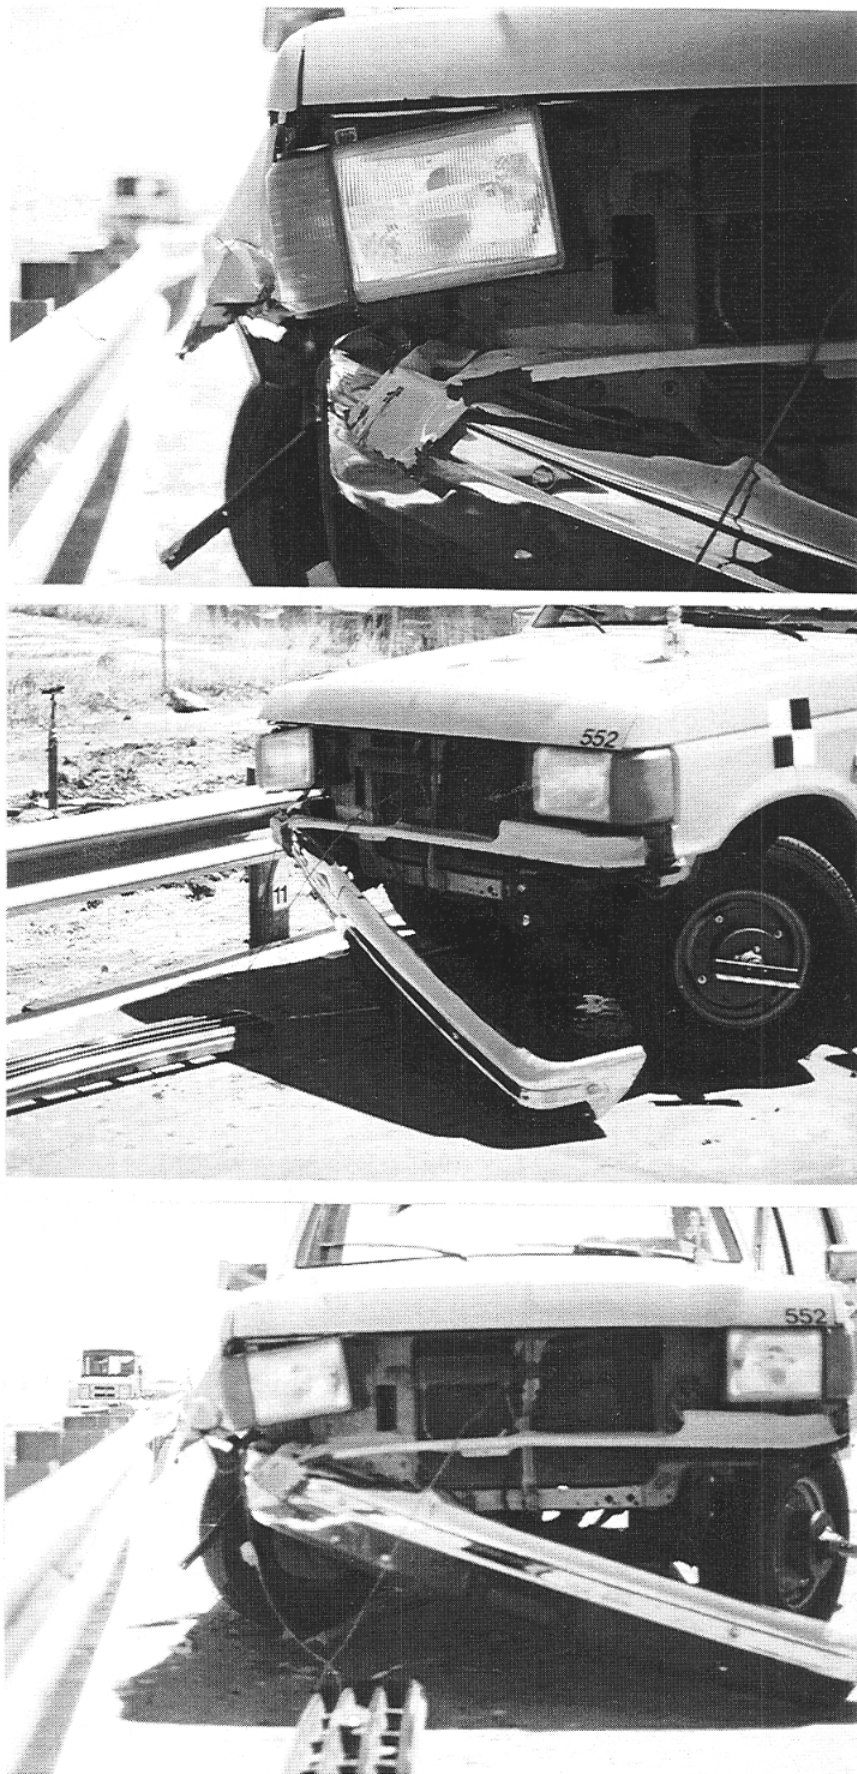
Figure 13. Vehicle Damage, Test LVBR-3

Exterior vehicle damage was relatively minor and was limited to deformations of the steel frame, right-front wheel, right-front quarter panel, grill and right-side head-lamp assembly, and front bumper, as shown in Figure 13. The steel frame was slightly shifted and twisted due to the oblique impact with the bridge rail. The right-front wheel was pushed backward and deformed due to minor snagging on the upstream side of post no. 8, and the right-front quarter panel was crushed inward. The plastic grill became dislodged and the right-side head-lamp assembly was deformed. The right-side corner of the front bumper was crushed inward while the left-side bumper attachment separated from the frame. No damage occurred to the interior occupant compartment. The vehicle damage was also assessed by the traffic accident scale (TAD) (22) and the vehicle damage index (VDI) (23), as shown in Figure 10.
