Development of a Flexible Bridge Railing for Longitudinal Timber Decks

MwRSF Research Report No. TRP-03-62-96

June 1997

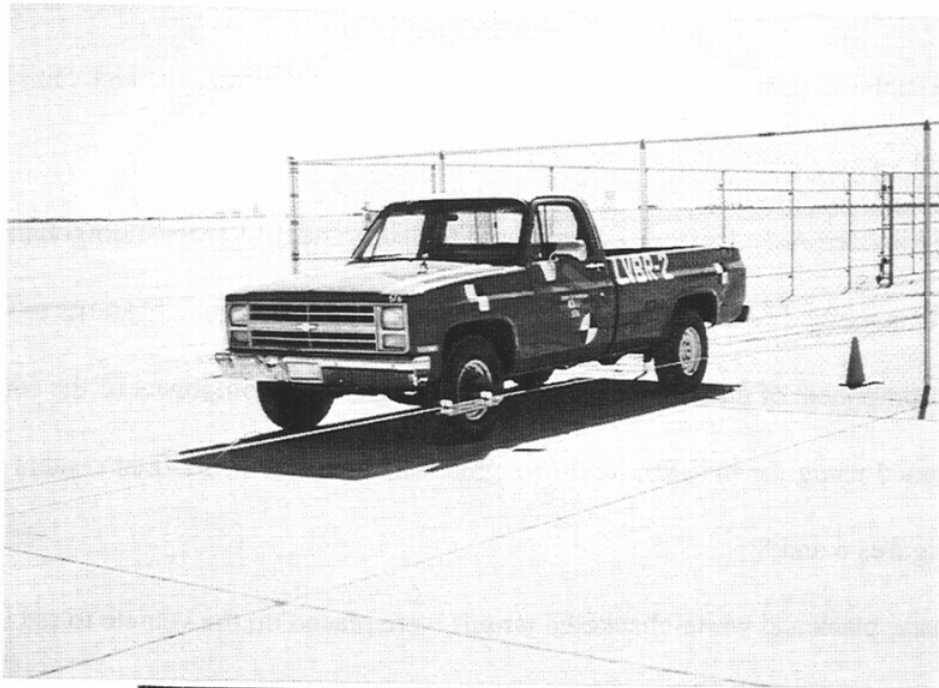
Figure 7. Test Vehicle, Test LVBR-2

Date: 3/18/94 Test Number: LVBR-2 Model: C-20
 Make: CHEVROLET Vehicle I.D.#: 1GCGC24MXF311219
 Tire Size: P235/85-R16 Year: 1985 Odometer: 132989

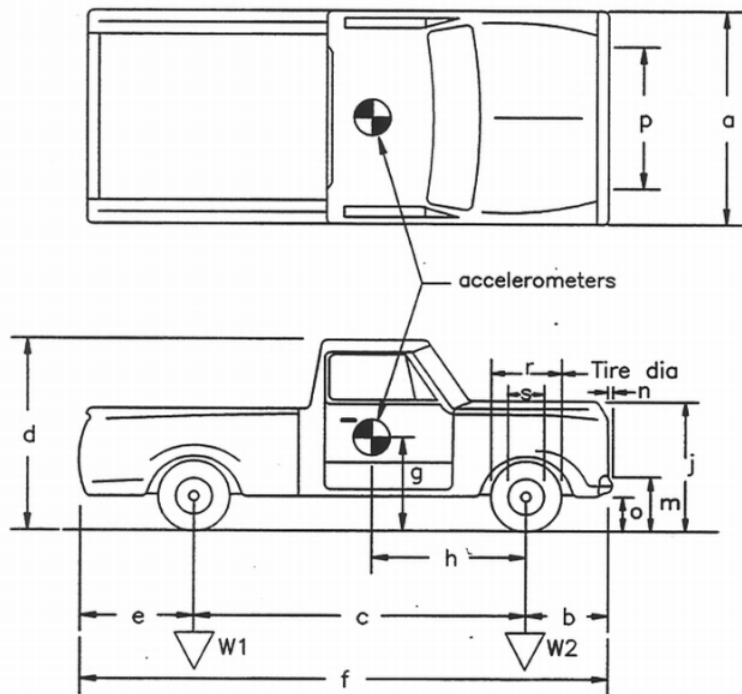
Figure 8. Vehicle Dimensions, Test LVBR-2

Vehicle Geometry - inches
 a 78.0 b 32.0
 c 131.5 d 73.0
 e 51.0 f 214.0
 g 29.0 h 57.5
 i --- j 50.0
 k --- l ---
 m 27.0 n 4.0
 o 16.0 p 65.5
 r 30.5 s 17.5

Weight - lbs	Curb	Test Inertial	Gross Static
W1	<u>1900</u>	<u>1963</u>	<u>1963</u>
W2	<u>2430</u>	<u>2541</u>	<u>2541</u>
Wtotal	<u>4330</u>	<u>4504</u>	<u>4504</u>

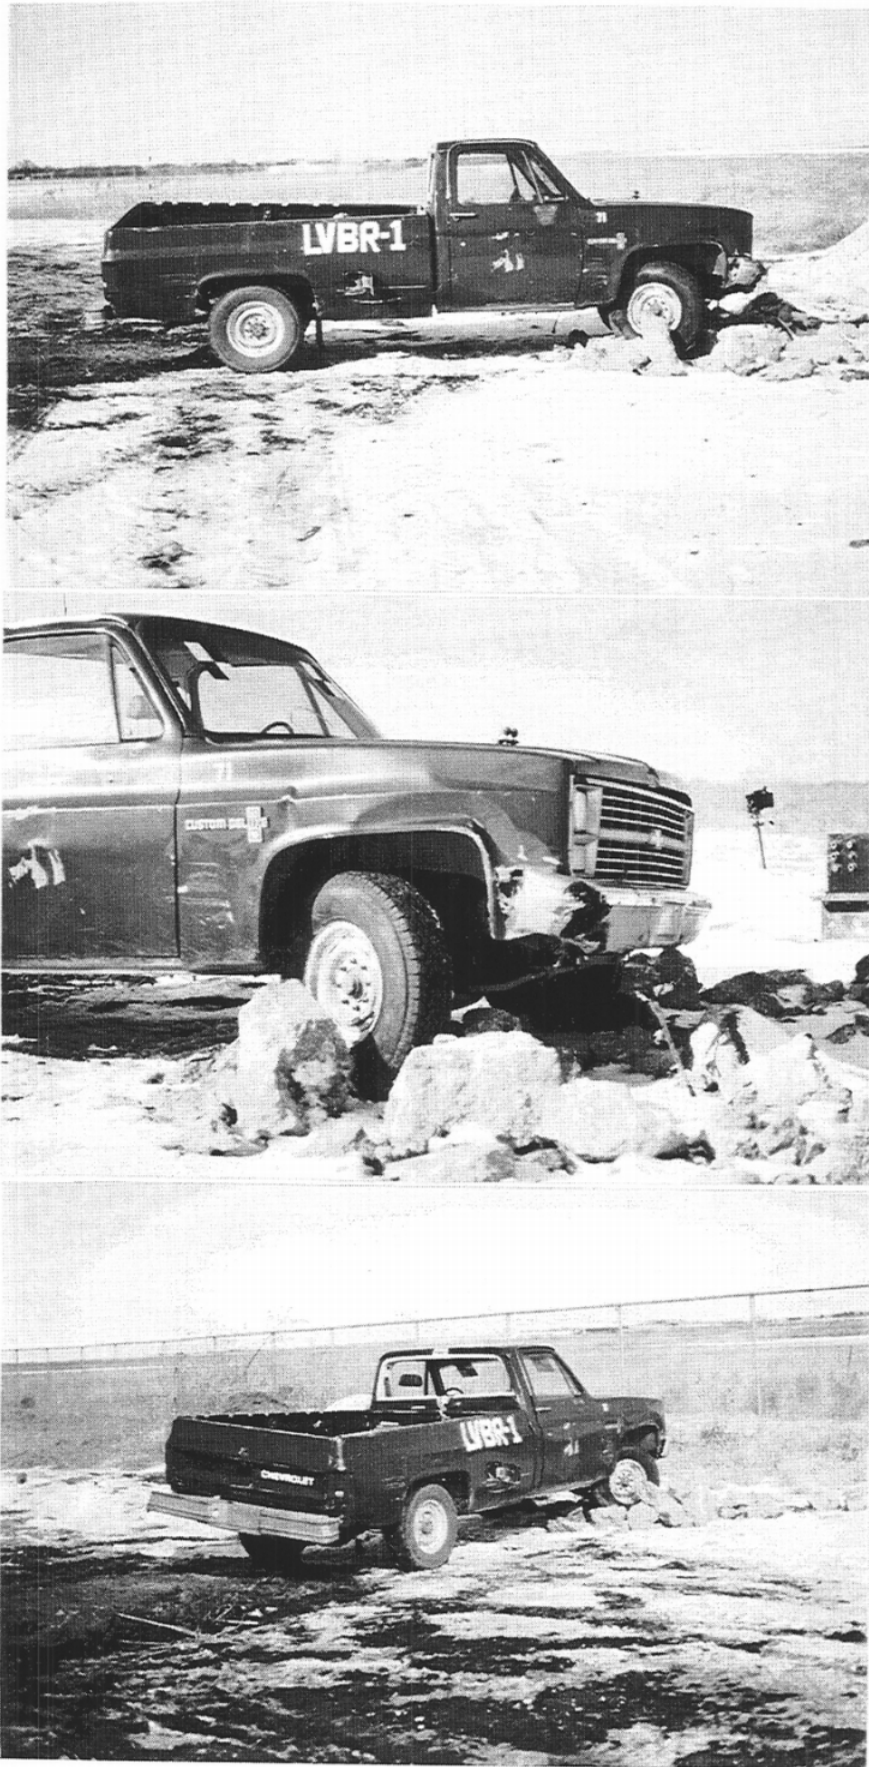
Figure 20. Vehicle Damage, Test LVBR-1

Exterior vehicle damage was relatively minor and was limited to deformations of the steel frame, right-front quarter panel, and front bumper, as shown in Figure 20. The steel frame was

twisted due to the pickup vaulting over the bridge rail and impacting the ground behind the bridge rail. The right-side corner of the front bumper and the right-front quarter panel contained minor deformations, likely caused from the impact with the ground. No damage occurred to the interior occupant compartment. The vehicle damage was also assessed by the traffic accident scale (TAD) (23) and the vehicle damage index (SAE) (24), as shown in Figure 14.

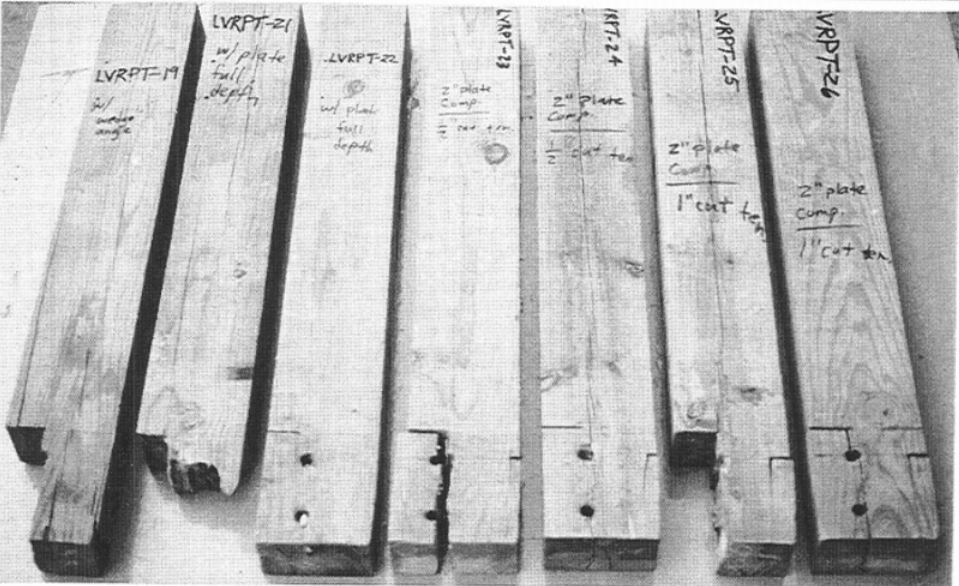
Figure 24. Typical Post Failures

Twenty-four static tests, as summarized in Table 4, were performed on posts with increased post height and saw cuts in the compression zone, tension zone, and combinations thereof. Various sawcut configurations were placed in the posts to minimize deformations to the connection hardware. Typical damage to the timber post specimens is shown in Figure 24. A 4-in. by 6-in (102-mm by 152-mm) dimension lumber post measuring 36.75-in. (933-mm) long with steel angles measuring 5 in. by 5 in. by $\frac{3}{8}$ in. (127 mm by 127 mm by 10 mm) was selected for the modified design. The modified post chosen for Design No. 2 included a 1-in. (25-mm) horizontal saw cut placed on the tension side of the post, 3 in. (76 mm) from the base of the 36.75-in. (933-mm) long post. This sawcut configuration was chosen because it provided the best alternative for reducing the load imparted to the connection hardware while maintaining a reasonable level of structural capacity. The maximum static force for this post size and sawcut configuration was 1.15 kips (5.12 kN), as shown in Table 4. The length of the lumber post was increased from that used during Phase I to allow for an increase in the top mounting height of the W-beam rail.

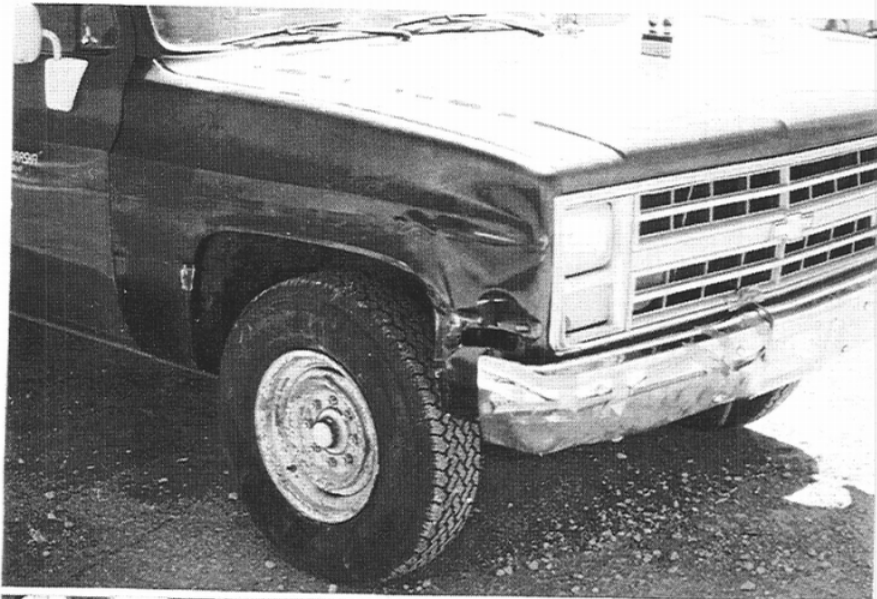
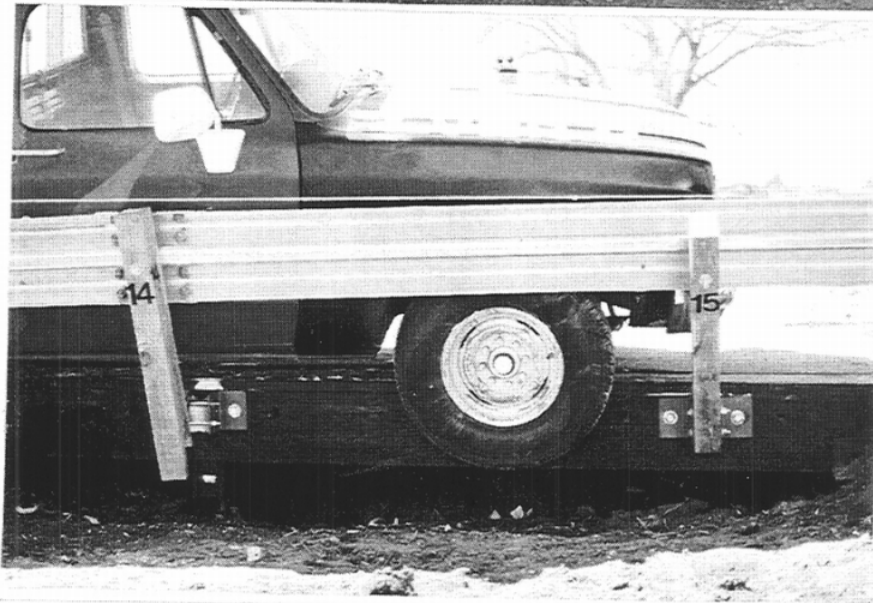
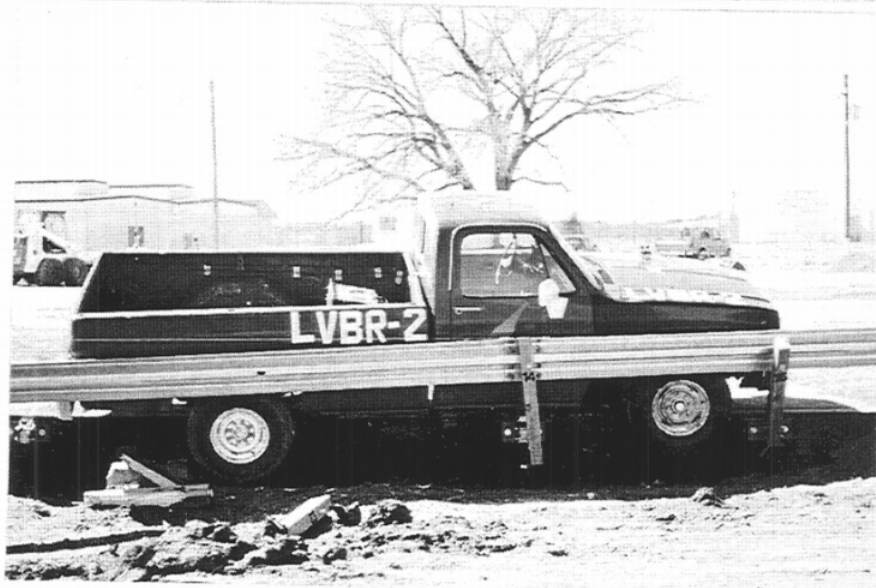
Figure 33. Vehicle Damage, Test LVBR-2

Exterior vehicle damage was minor. Damage was evident on the right-front quarter panel due to vehicle-rail contact and the right-side undercarriage due to contact with the outer top surface of

the deck, as shown in Figure 33. No damage occurred to the interior occupant compartment. Following the crash test, the vehicle's right-side tires were lifted onto the deck, and the vehicle was driven away. The vehicle damage was also assessed by the traffic accident scale (TAD) (23) and the vehicle damage index (SAE) (24), as shown in Figure 28.

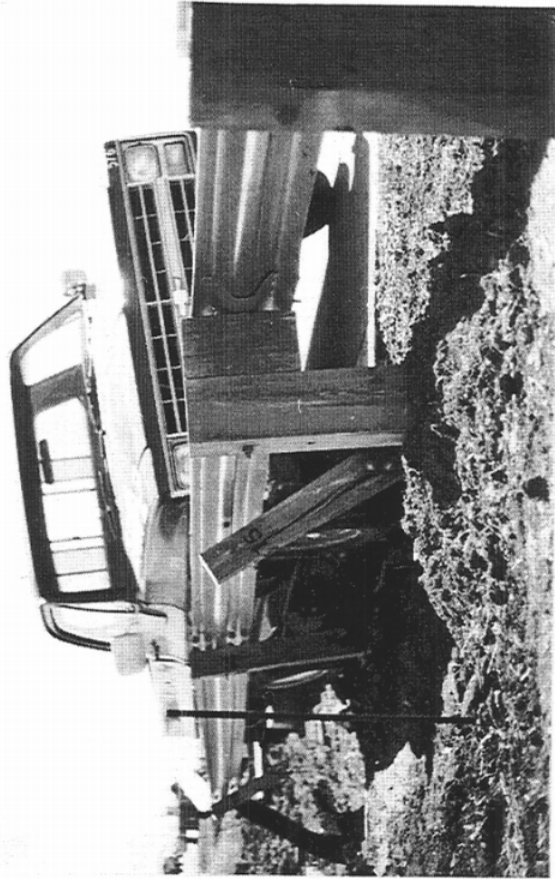
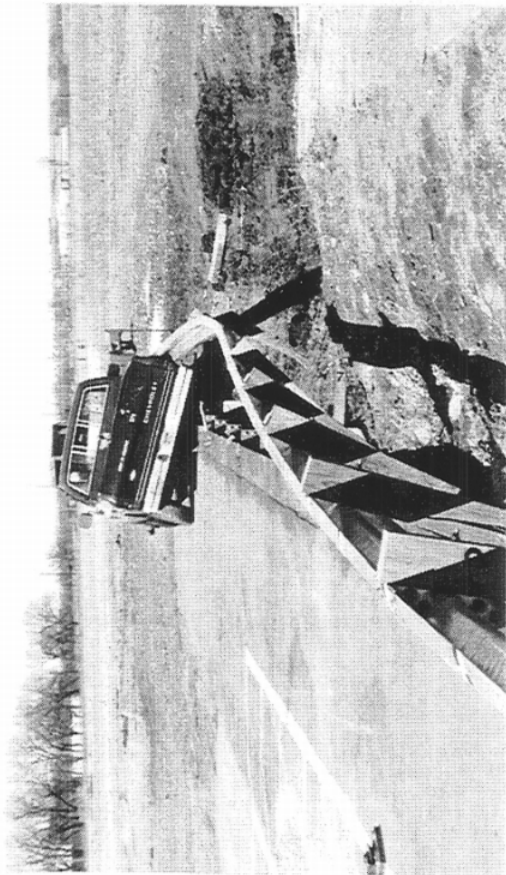
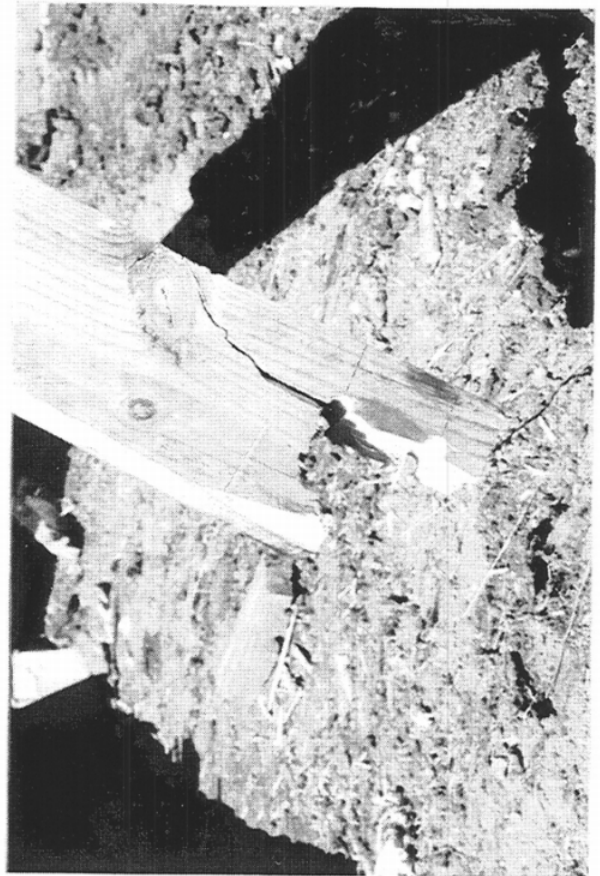
Figure 34. Typical Bridge Rail and Post Damage, Test LVBR-2

The moderate damage to the bridge railing system is shown in Figure 34, as well as in photographs provided in Figures 32 through 33. One 6-ft 3-in. (1.90-m) section of W-Beam rail was permanently damaged. Eleven posts, post nos. 4 through 14 fractured away from the deck attachment. In addition, five steel angles were deformed downstream of impact due to contact between the angles and the undercarriage of the vehicle. The timber deck surface near the edge was also scraped due contact from the vehicle undercarriage. The maximum permanent set and dynamic rail deflections were 45.4 in. (1,153 mm) and 51.9 in. (1,318 mm), respectively. No damage occurred to the timber bridge deck.
