**TWO TEST LEVEL 2 BRIDGE RAILING AND
TRANSITION SYSTEMS FOR TRANSVERSE
GLUE-LAMINATED TIMBER DECKS**

MwRSF Research Report No. TRP-03-125-03

March 11, 2003

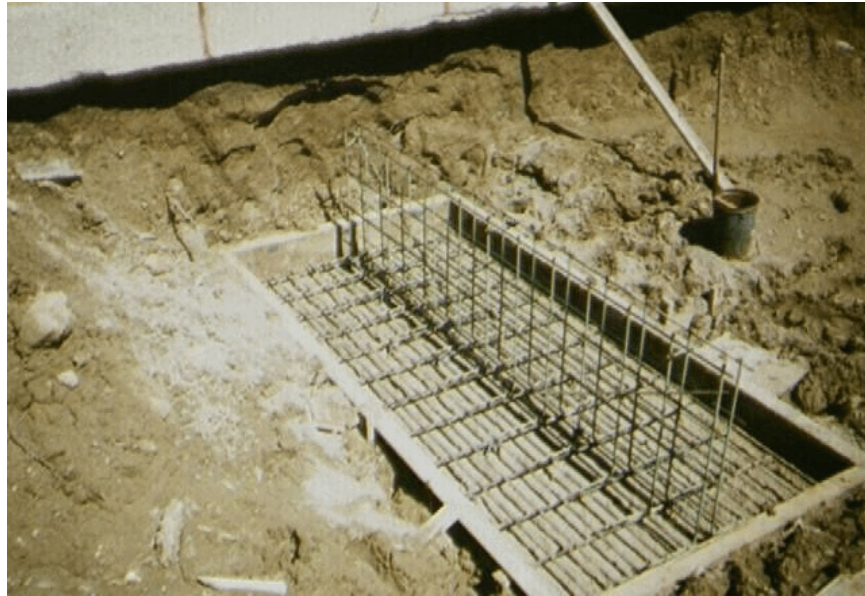
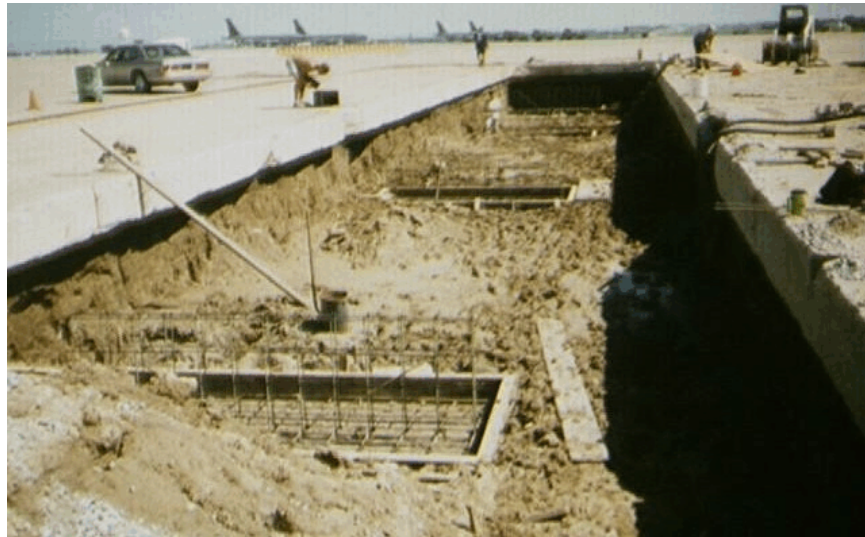
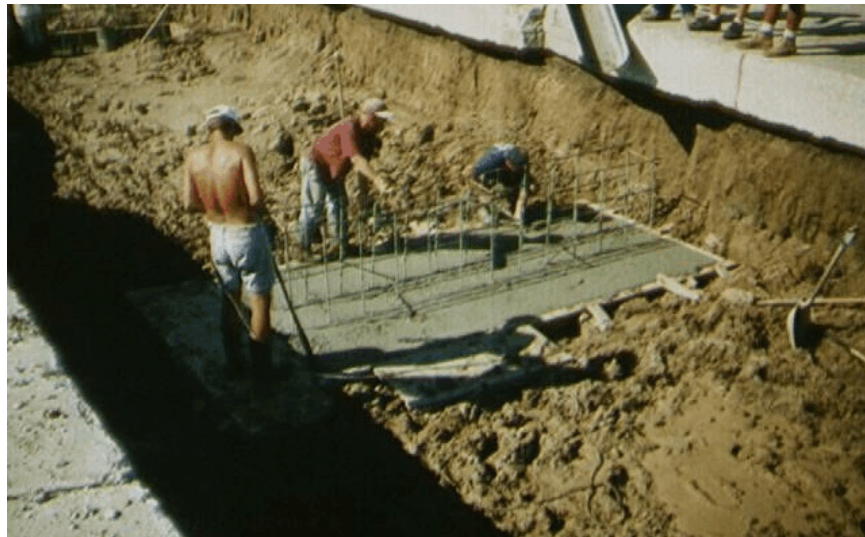
Figure 5. Bridge Substructure Construction

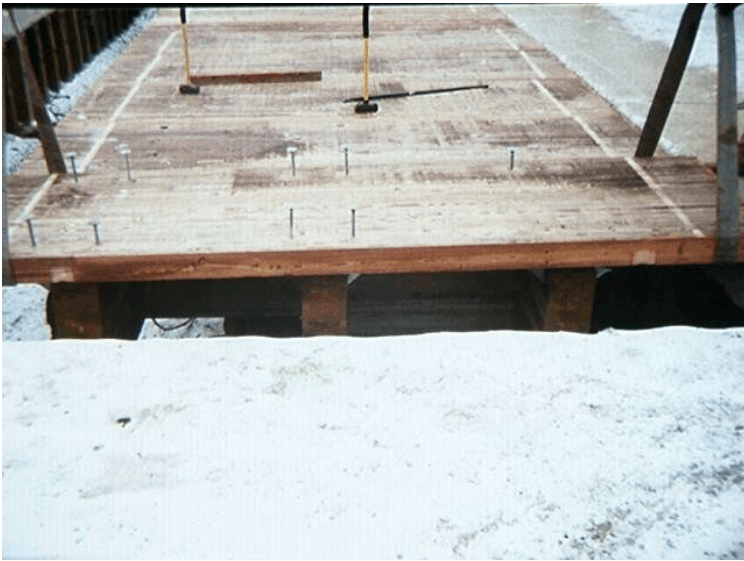
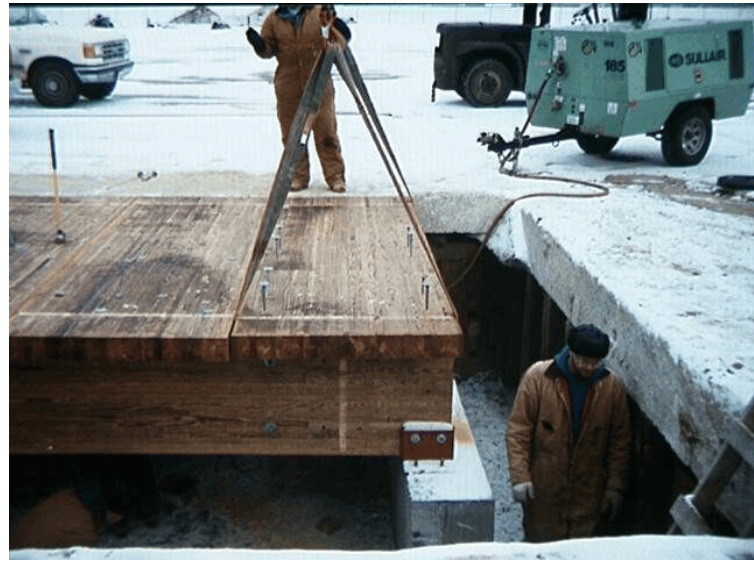
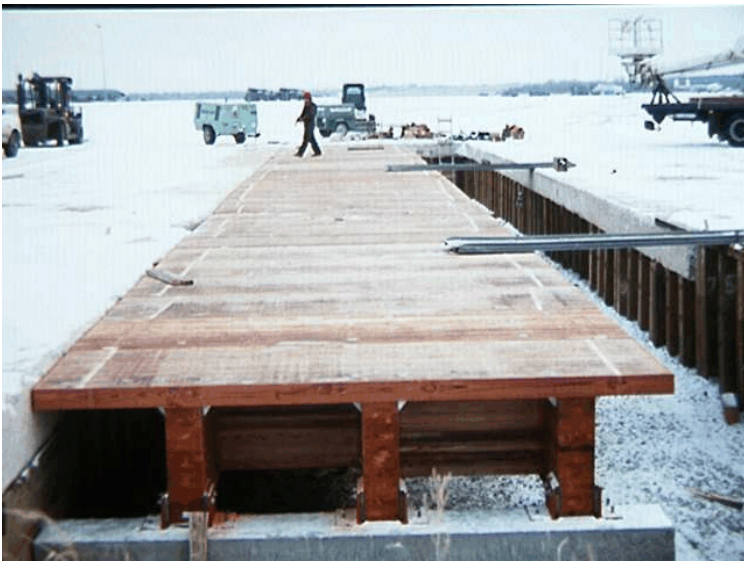
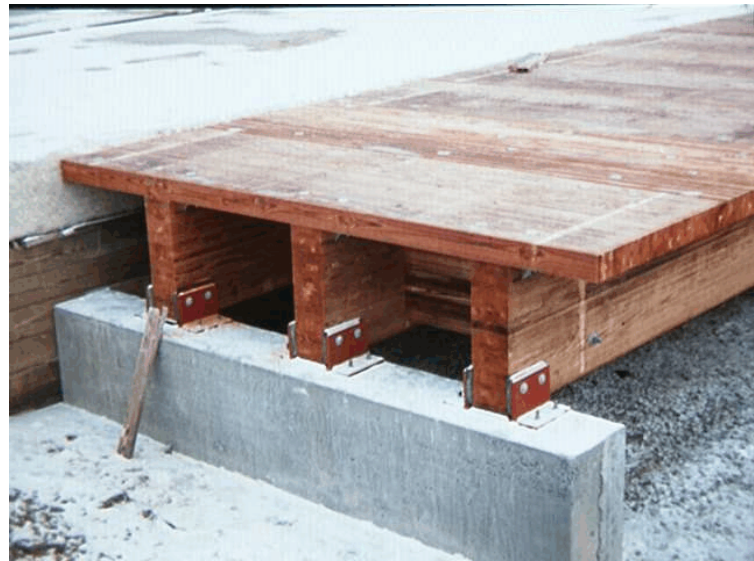
Figure 9. Bridge Superstructure Construction

Following the completion of the bridge substructure, the bridge superstructure was constructed. The superstructure consisted of nine glulam girders, twenty-four glulam diaphragms, and thirty transverse glulam deck panels. The bridge superstructure was constructed with three girders spanning between any two concrete bridge supports. For any two girders in a span, four glulam diaphragms were bolted between the girders to provide lateral stiffness to the bridge structure. Each glulam girder measured 222-mm wide by 768-mm deep by 12.17-m long, while the glulam diaphragms measured 130-mm wide by 629-mm deep by 997-mm long. The glulam panels were attached to the girders using standard aluminum deck brackets. Each glulam panel measured 130-mm thick by 1,216-mm wide by 3.96-m long. All glulam superstructure components were fabricated with Southern Yellow Pine (SYP) and treated with pentachlorophenol in heavy oil to a minimum net retention of 9.61 kg/m³ as specified in American Wood-Preservers' Association (AWPA) Standard C14 (28). The girders were fabricated to meet Grade 24F-V3 while the deck panels, and diaphragms were fabricated from Combination No. 47 material.

One of the advantages of timber bridges is the ease of construction and the fact that a bridge can be erected in seasonal conditions that would not be conducive to poured concrete construction. These advantages became evident in this project as it took less than three days in sub-freezing temperatures with minimal equipment and a relatively small labor force to erect the bridge superstructure. The sequence of the superstructure construction is shown in Figures 7 through 9.

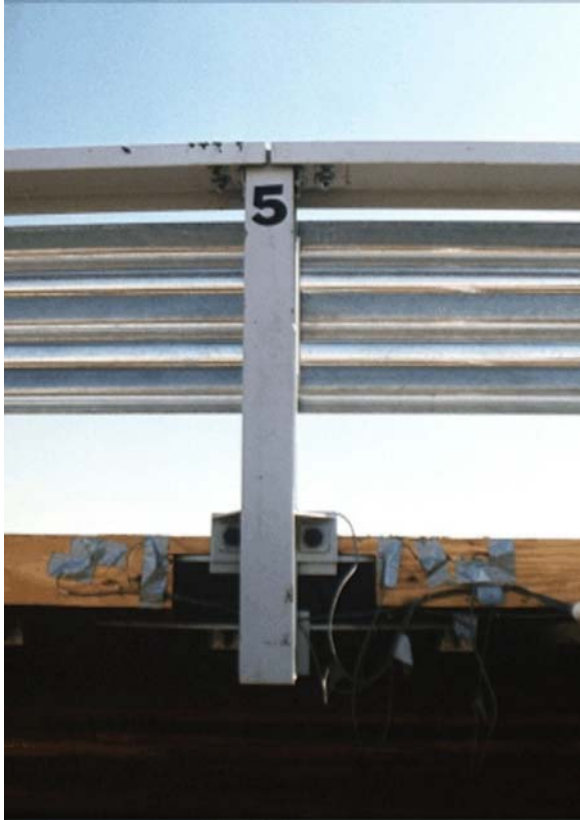
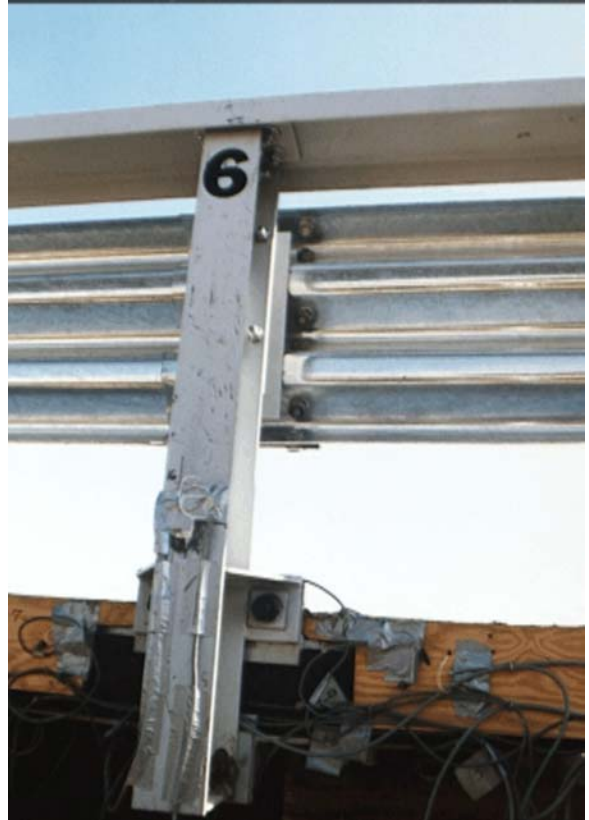
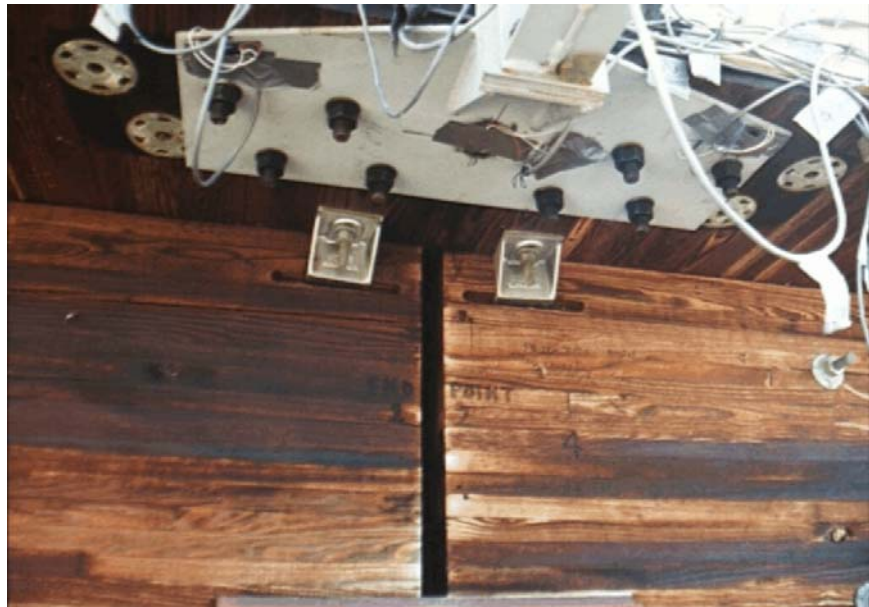
Figure 26. Typical Strain Gauge Locations, Test STCR-1

For tests STCR-1 and WRBP-1, the components were instrumented with weldable strain gauges, consisting of gauge type LWK-06-W250B-350. The nominal resistance of the gauges was 350.0 ± 1.4 ohms with a gauge factor equal to 2.02. The operating temperature limits of the gauges was -195 to +260 degrees Celsius. The strain limits of the gauges were 0.5% in tension or compression ($5000 \mu\epsilon$). The strain gauges were manufactured by the Micro-Measurements Division of Measurements Group, Inc. of Raleigh, North Carolina. The installation procedure required that the metal surface be clean and free from debris and oxidation. Once the surface had been prepared, the gauges were spot welded to the test surface.

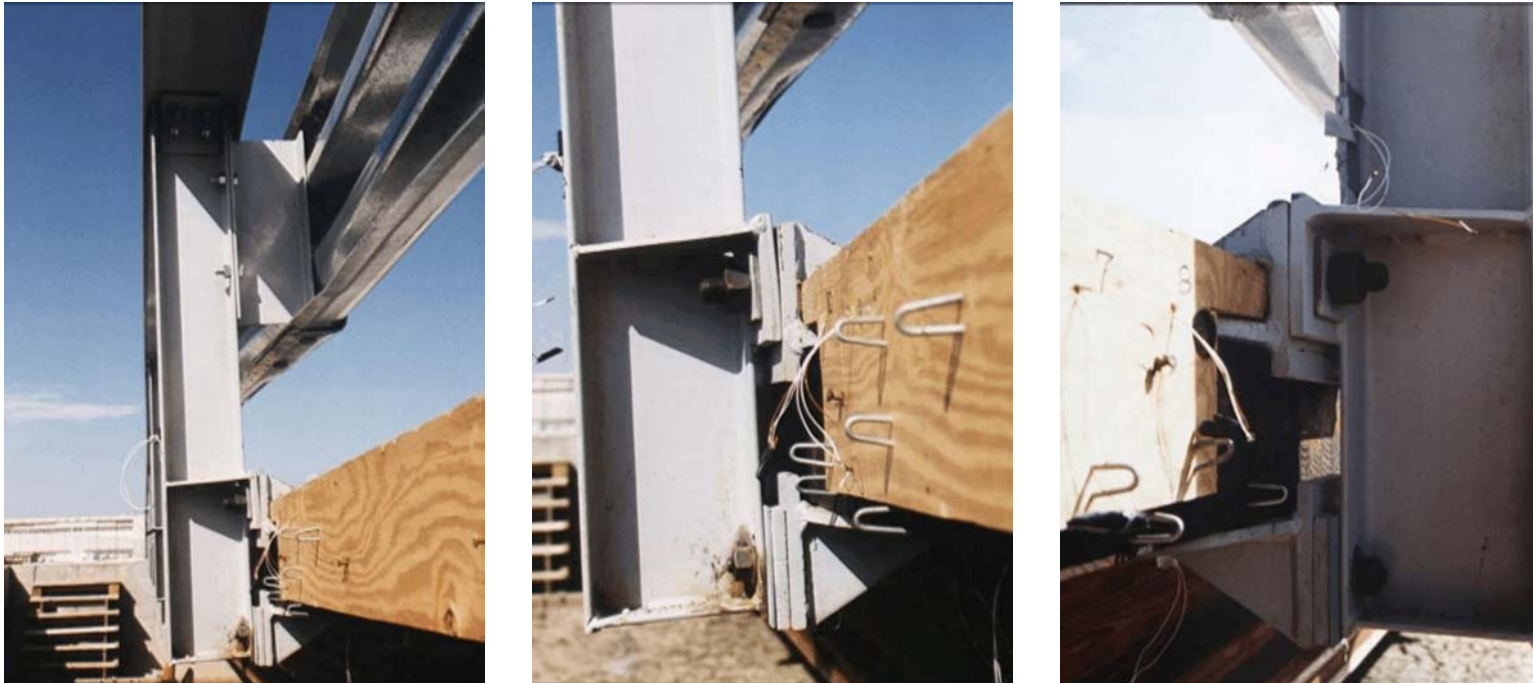
Figure 62. Post No. 6 Damage, Test STCR-1

found on the front face of post no. 6 about 152-mm up from the overlay surface. At post nos. 5 and 6, the Portland cement concrete overlay cracked, and a small separation between the post and deck plate occurred. At post no. 6, contact marks were also found on the exposed gussets of the deck plate. No significant post or guardrail damage occurred upstream of post no. 4 nor downstream of post no. 8.

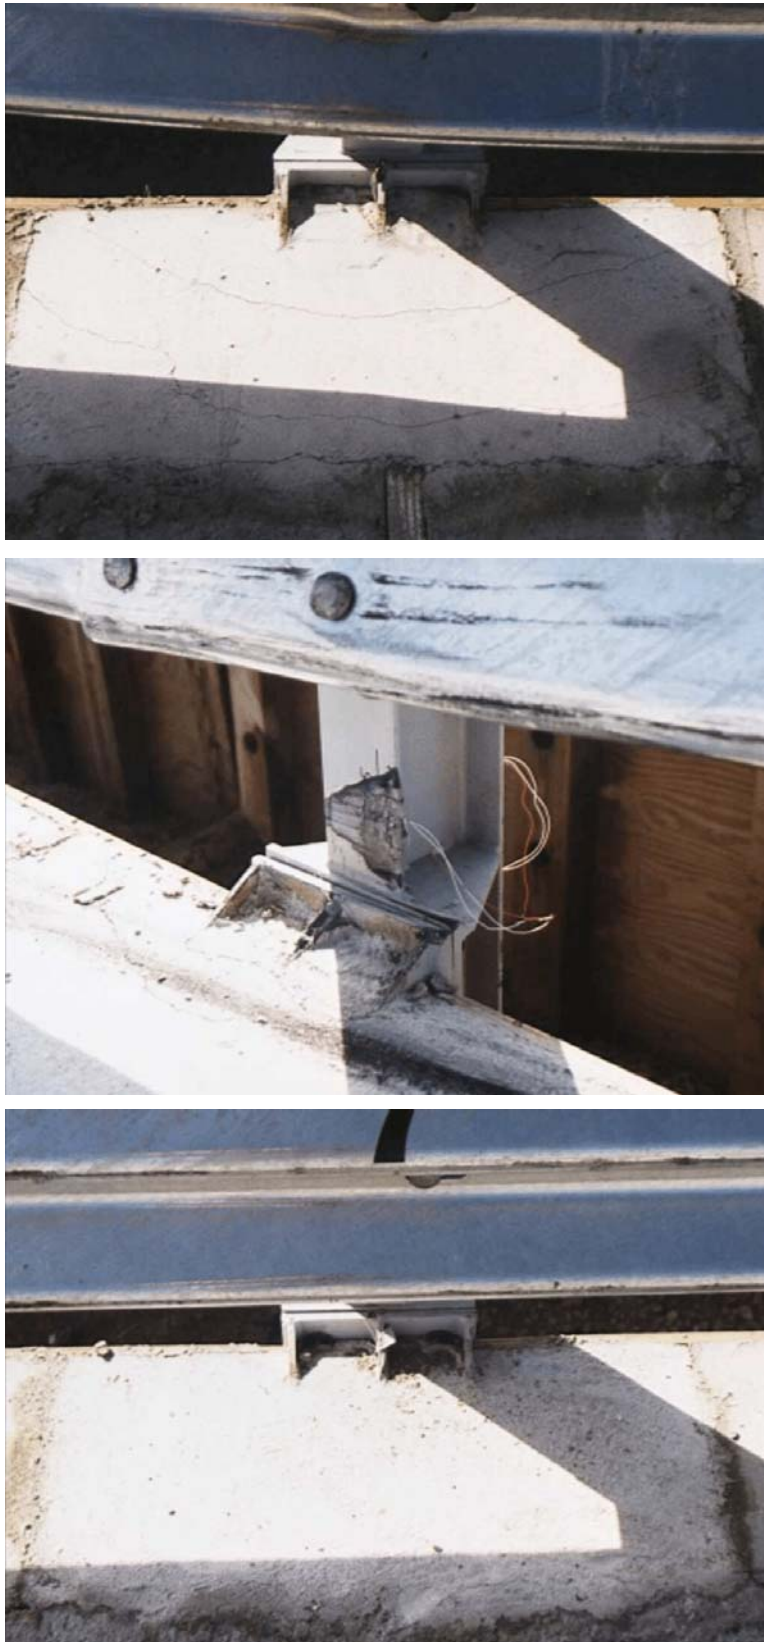
Figure 63. Cracking in Portland Cement Concrete Overlay, Test STCR-1

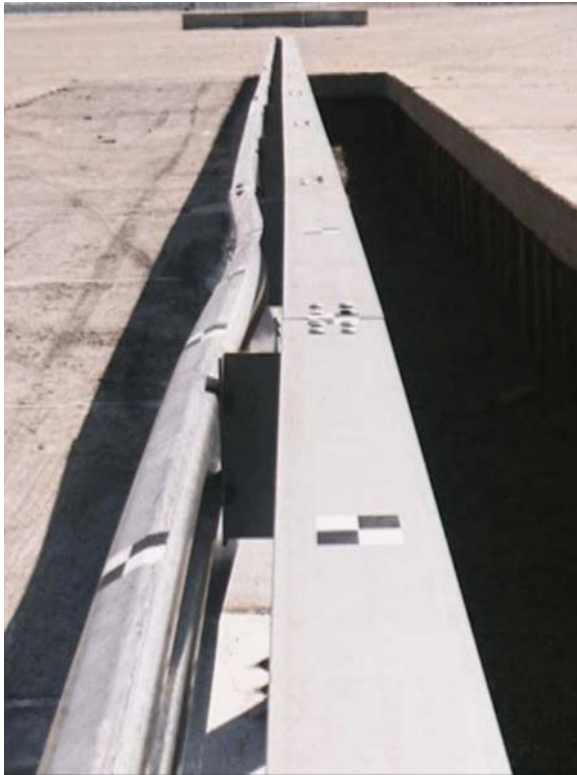
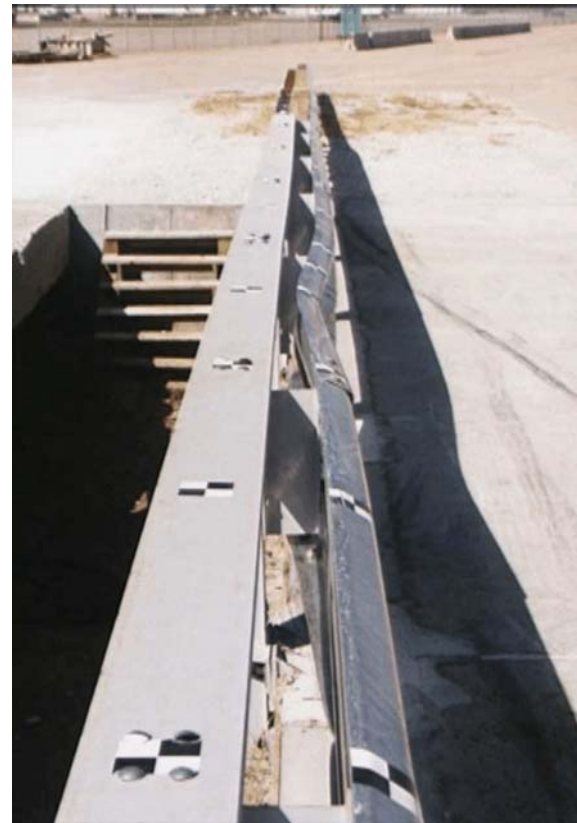
Figure 64. Permanent Set Deformations, Test STCR-1

Damage to the bridge rail was minimal, as shown in Figures 60 through 64. Bridge railing damage consisted mostly of a deformed thrie beam section, contact marks on a bridge rail section, deformed steel posts, and damaged spacer blocks. The physical damage to the thrie beam rail revealed that approximately 3.8 m of rail was damaged between bridge post nos. 5 and 7. The thrie beam rail damage consisted of scrape and contact marks along all corrugations in the impact area. The top channel rail remained undamaged.

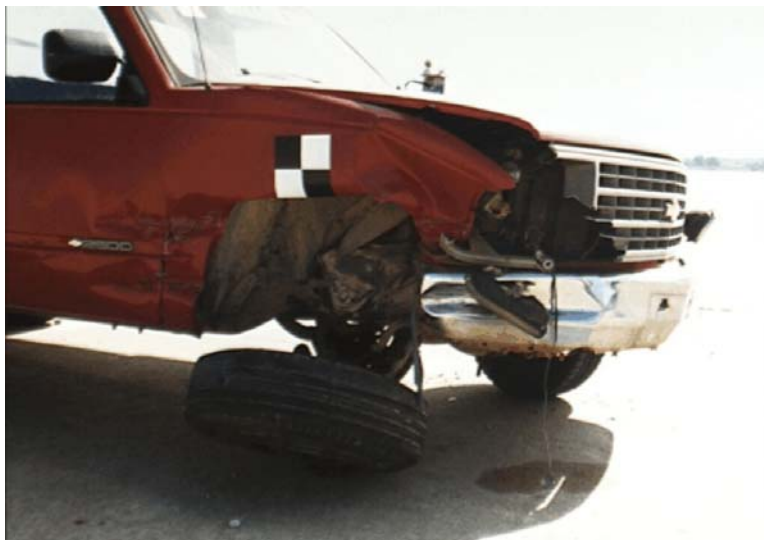
Figure 66. Vehicle Damage, Test STCR-1

Exterior vehicle damage was moderate and occurred at several vehicle body locations, as shown in Figures 65 through 67. Most of the vehicle damage occurred near the right-front corner of the vehicle, consisting primarily of damage to the fender, hood, bumper, door, and front wheel assembly. The right-front ball joint disengaged and the upper A-frame arm was bent back toward the firewall. The right-front lower control arm, tie-rod end, and sway bar were bent inward. The right corner of the front bumper was deformed around the frame horn. The right-front fender was deformed inward toward the engine compartment. Contact marks were found along the right-side door of the truck due to contact with the thrie beam rail. The top of the right-side door jarred open.

The right-rear steel rim was deformed, but the tire remained inflated. The right-rear box fender was deformed inward. The right corner of the rear bumper was scraped and deformed. Interior vehicle deformations to the right-side floorboard, as shown in Figure 67, were judged insufficient to cause serious injury to the vehicle occupants. No deformations occurred to the left side nor the roof, and all window glass remained undamaged.

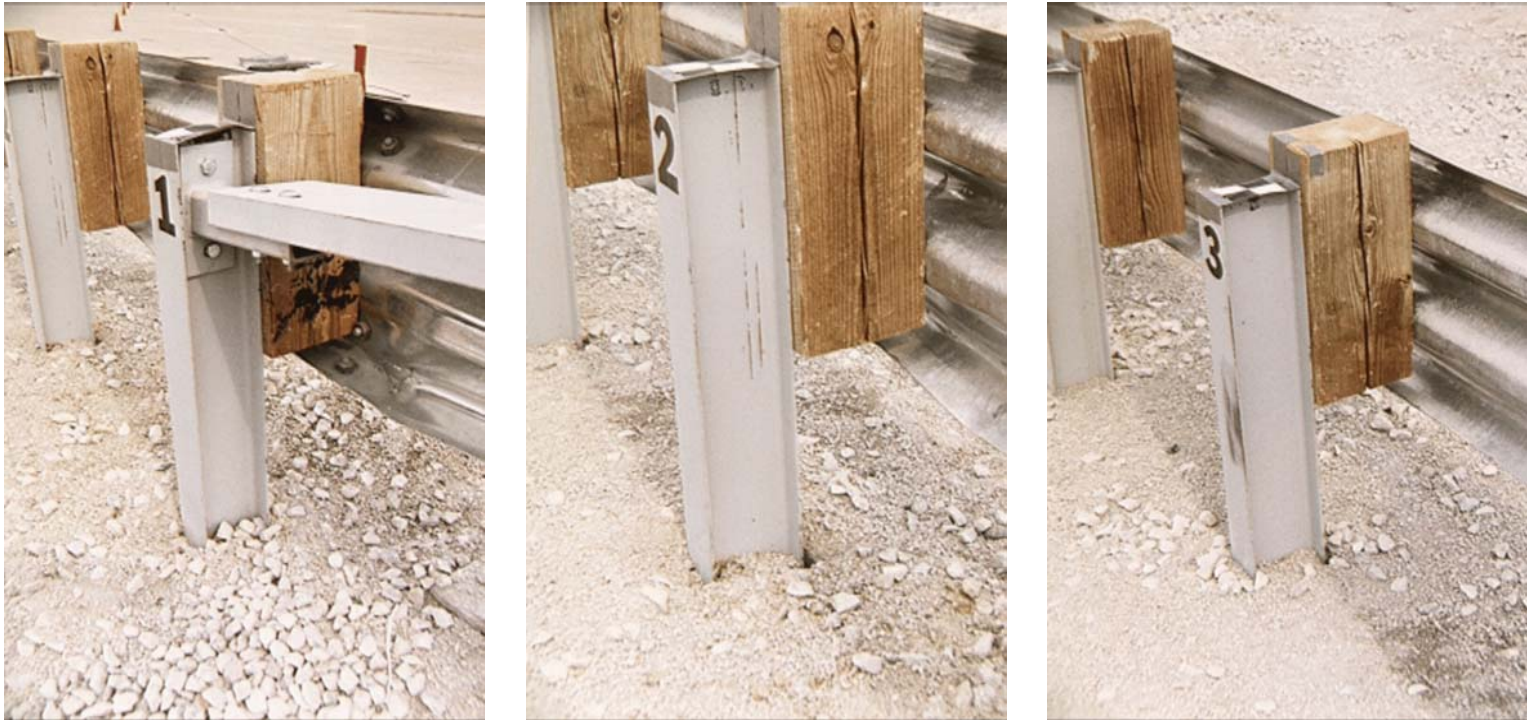
Figure 78. Guardrail Post Nos. 1 through 3 Damage, Test STCR-2

were found on the guardrail from 241-mm upstream of transition post no. 2 through transition post no. 2.

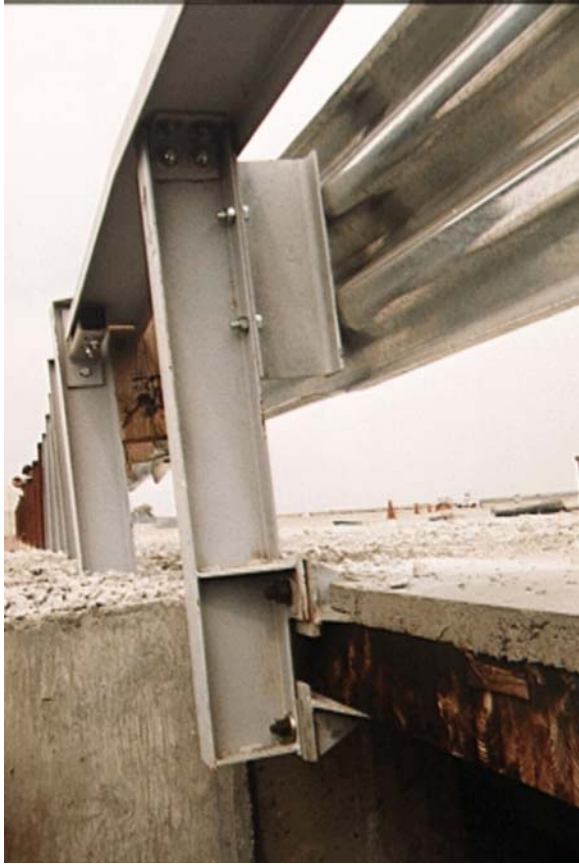
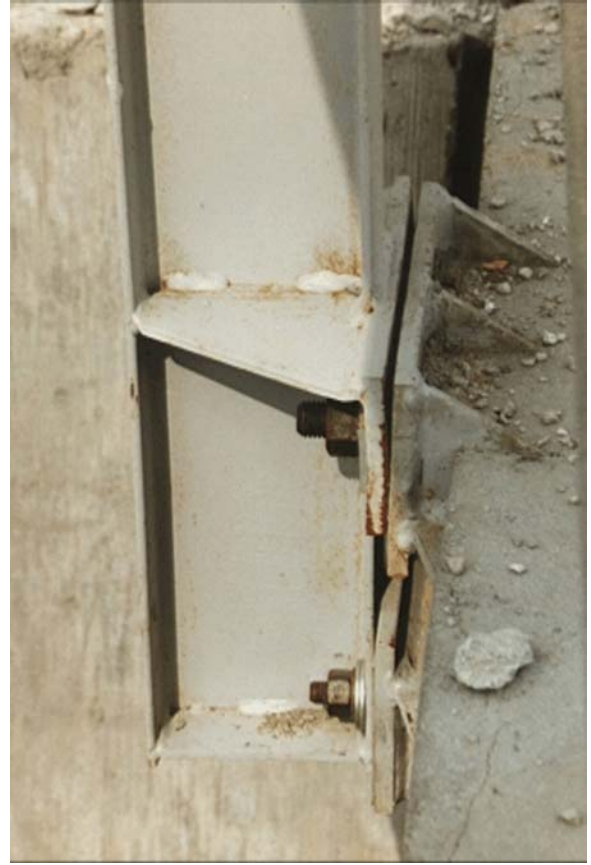
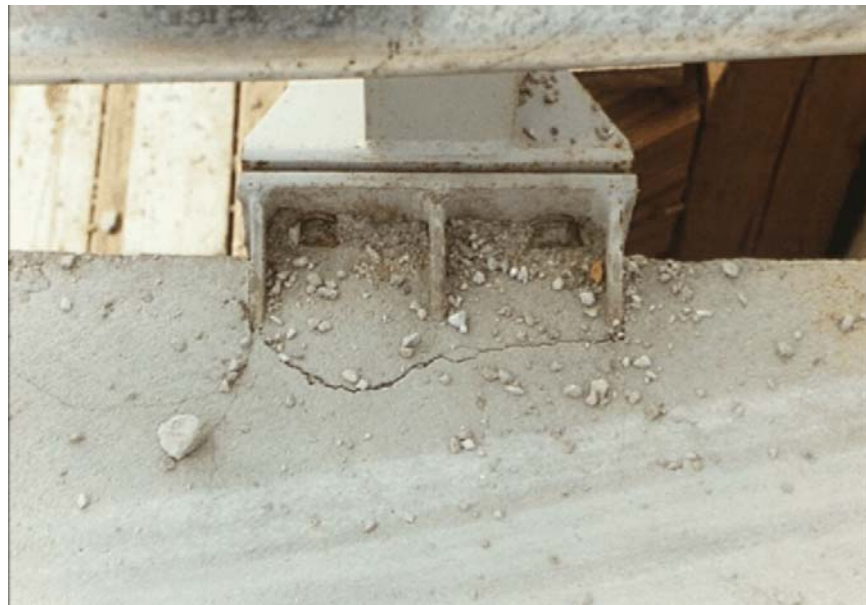
Figure 79. Bridge Post No. 1 Damage, Test STCR-2

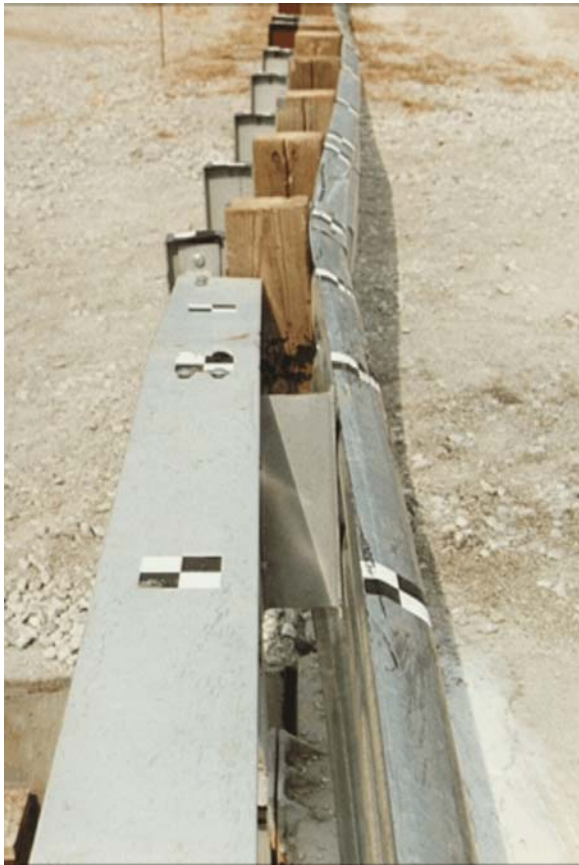
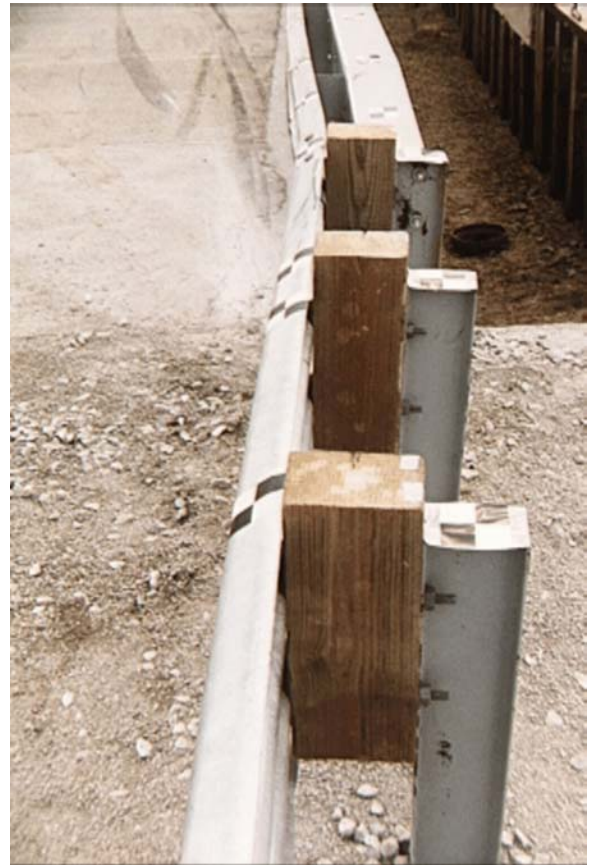
Figure 80. Permanent Set Deformations, Test STCR-2

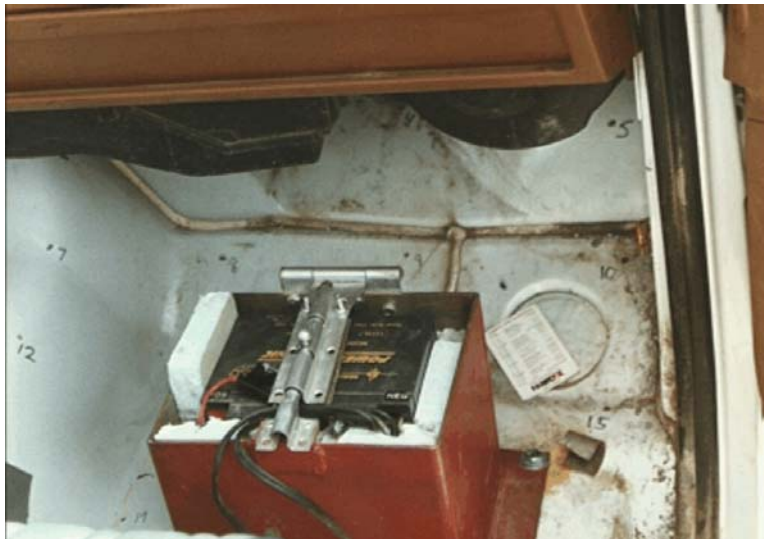
Figure 83. Occupant Compartment Deformations, Test STCR-2

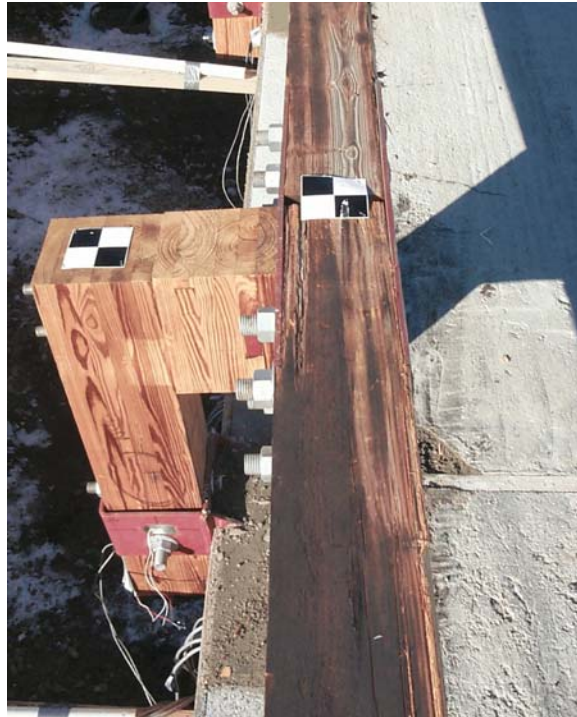
Figure 114. Typical Post Damage, Test WRBP-1

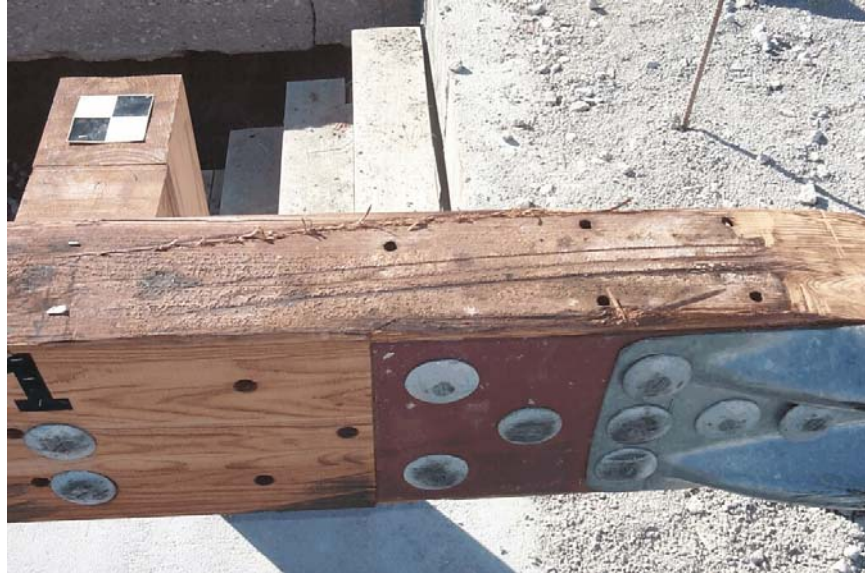
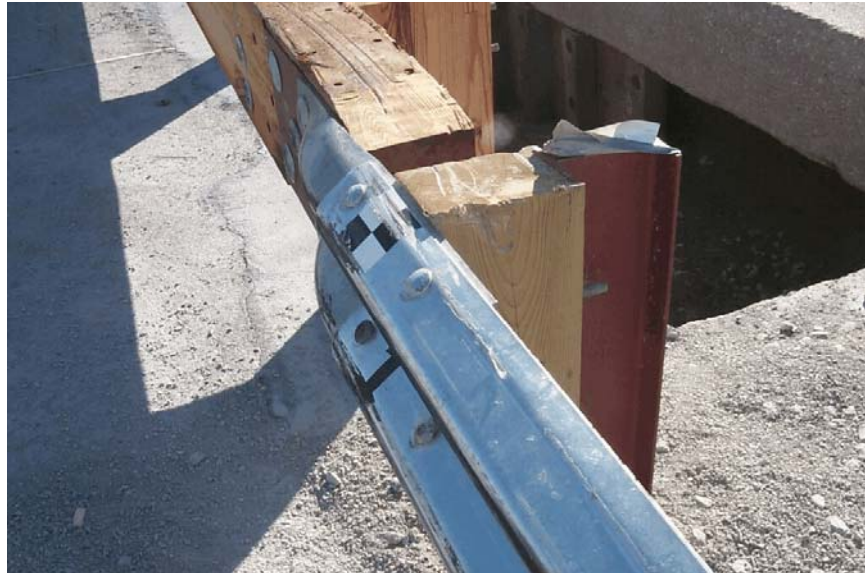
Figure 126. Barrier Damage, Test WRBP-2

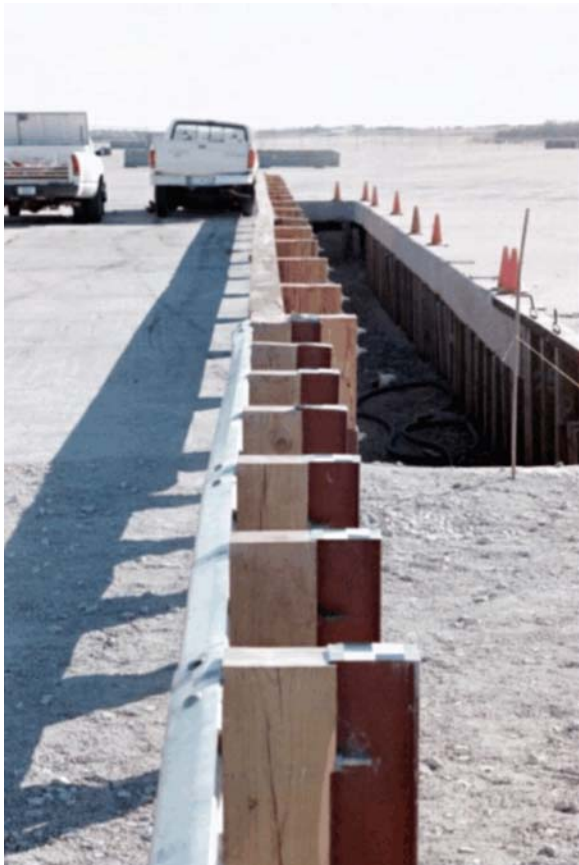
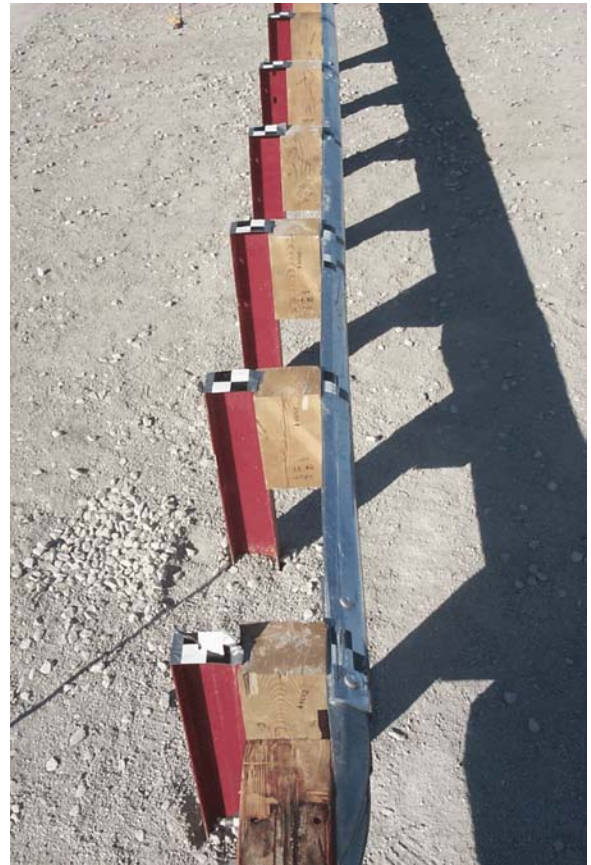
Figure 127. Permanent Set Deflections, Test WRBP-2
