## MASH 2016 Test 3-34 Summary

Figure 2 Summary of Test 3-34

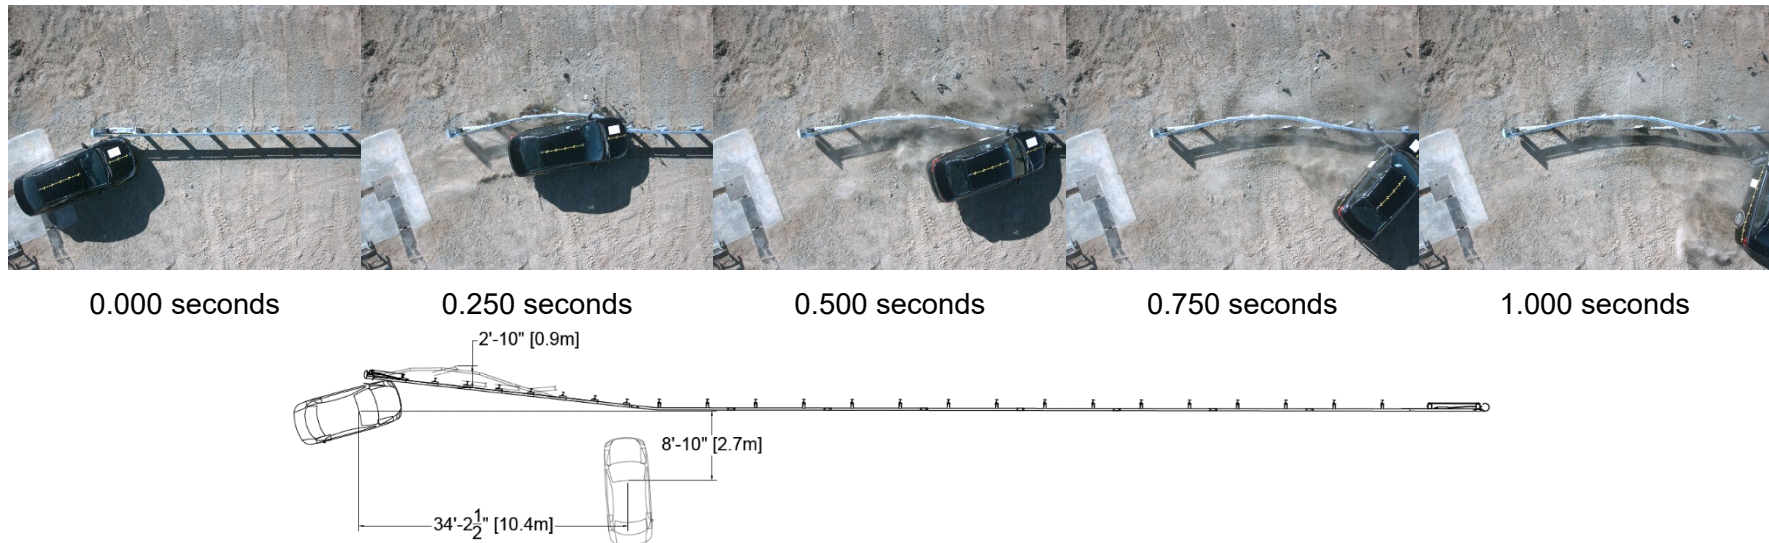
Name / Model..... 4F-T flared terminal  
Type..... Terminal  
Installation Length..... 141.4 ft. (43.1 m)  
Terminal Length..... 34.4 ft. (10.5 m)  
Road Surface..... Smooth concrete to fine silty soil

Impact Velocity..... 60.60 mph (97.53 km/h)  
Impact Angle..... 15.1° relative to downstream rail  
Location / Orientation..... 21.8 in. downstream from the center of post 1  
Impact Severity..... 20.3 kip-ft (27.5 kJ)  
Minimum IS Required..... 19.0 kip-ft (26.0 kJ)

Exit Velocity..... N/A  
Exit Angle..... N/A  
Final Vehicle Position..... 34.2 ft. (10.4 m) Downstream  
8.9 ft. (2.7 m) Right  
Vehicle Snagging..... Satisfactory  
Vehicle Pocketing..... Satisfactory  
Vehicle Stability..... Satisfactory  
Maximum Roll Angle..... 7.8 °  
Maximum Pitch Angle..... 8.0 °  
Maximum Yaw Angle..... -77.1 °

Static..... 2.2 ft. (0.7 m)  
Dynamic..... 2.5 ft. (0.8 m)  
Working Width..... 2.8 ft. (0.9 m)  
Debris Field..... N/A
