## MASH 2016 Test 3-35 Summary

Test Agency..... Applus IDIADA KARCO  
Test Number..... P43094-03  
Test Designation..... 3-35  
Test Date..... 8/3/23

Name / Model..... 4F-T flared terminal  
Type..... Terminal  
Installation Length..... 141.4 ft. (43.1 m)  
Terminal Length..... 34.4 ft. (10.5 m)  
Road Surface..... smooth concrete to fine silty soil

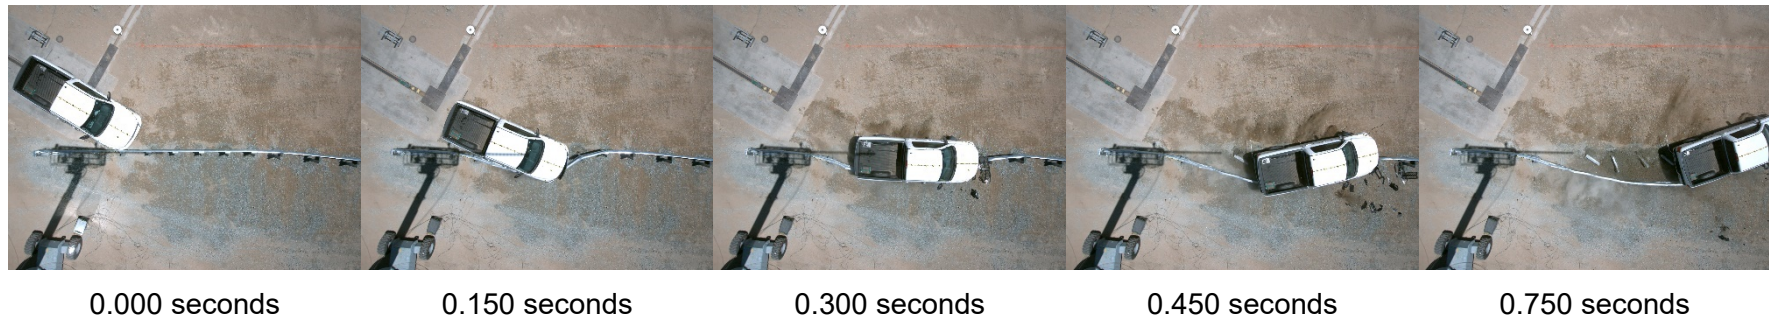
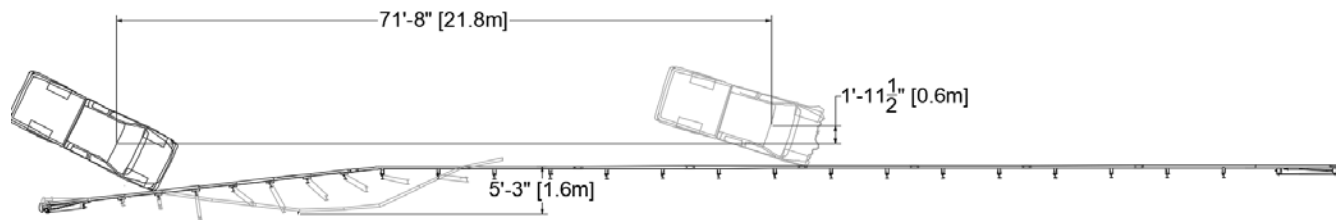
Figure 2 Summary of Test 3-35

Impact Velocity..... 62.62 mph (100.77 km/h)  
Impact Angle..... 24.8° relative to downstream rail  
Location / Orientation..... 3.46 in. (88 mm) upstream  
from center of post 4  
Impact Severity..... 115.4 kip-ft (156.5 kJ)  
Minimum IS Required..... 106.0 kip-ft (144.0 kJ)

Exit Velocity..... 14.80 mph (23.82 km/h)  
Exit Angle..... 25.8°  
Final Vehicle Position..... 71.7 ft. (21.8 m) Down  
2.0 ft. (0.6 m) Left  
Vehicle Snagging..... Satisfactory  
Vehicle Pocketing..... Satisfactory  
Vehicle Stability..... Satisfactory  
Maximum Roll Angle..... 25.7 °  
Maximum Pitch Angle..... 23.3 °  
Maximum Yaw Angle..... -47.0 °

Static..... 5.0 ft. (1.5 m)  
Dynamic..... 5.0 ft. (1.5 m)  
Working Width..... 5.3 ft. (1.6 m)  
Debris Field..... N/A

Vehicle Damage Scale..... 11-FL-4  
CDC..... 11FREN4  
Maximum Deformation.... MASH Deformation Limits Not  
Exceeded (0.0 in.) 0.0 mm
