**TESTING AND EVALUATION OF THE NEW YORK  
TWO-RAIL CURBLESS AND FOUR-RAIL CURBLESS  
BRIDGE RAILING AND THE BOX-BEAM TRANSITION**

Contract No. DTFH61-98-C-00056  
Report No. 404531-F

**September 1999**

**TEXAS TRANSPORTATION INSTITUTE  
THE TEXAS A & M UNIVERSITY SYSTEM  
COLLEGE STATION, TEXAS**

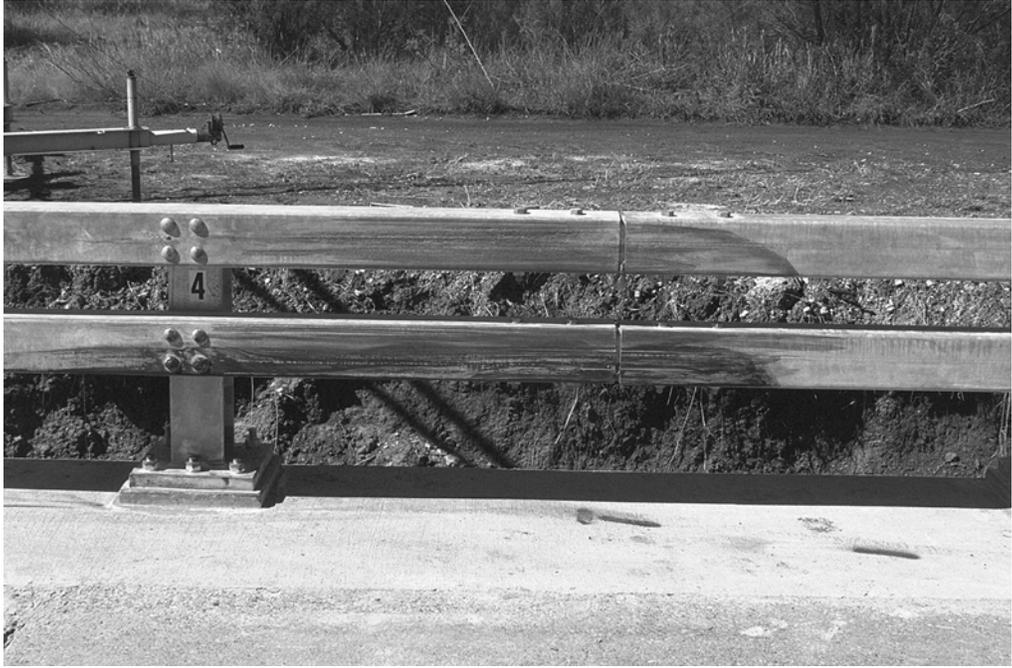
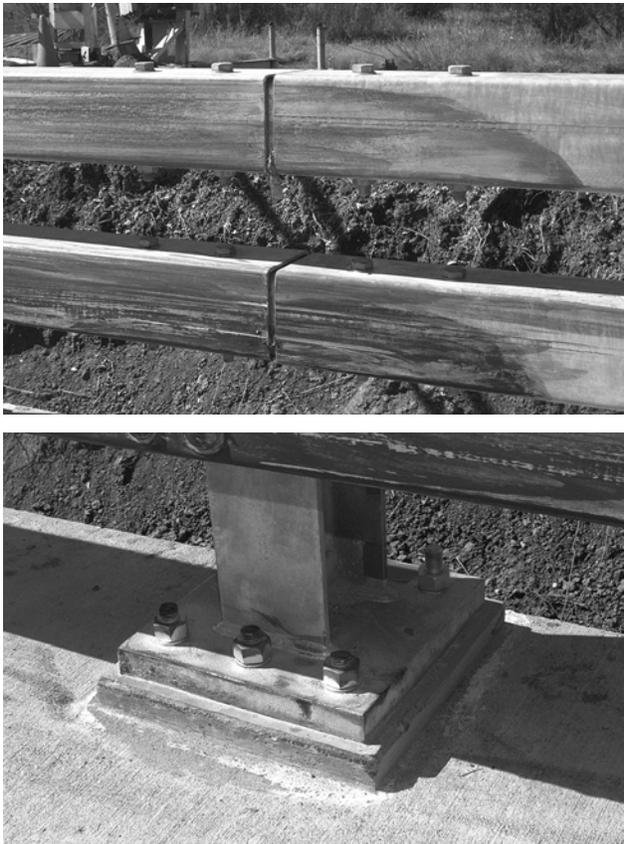
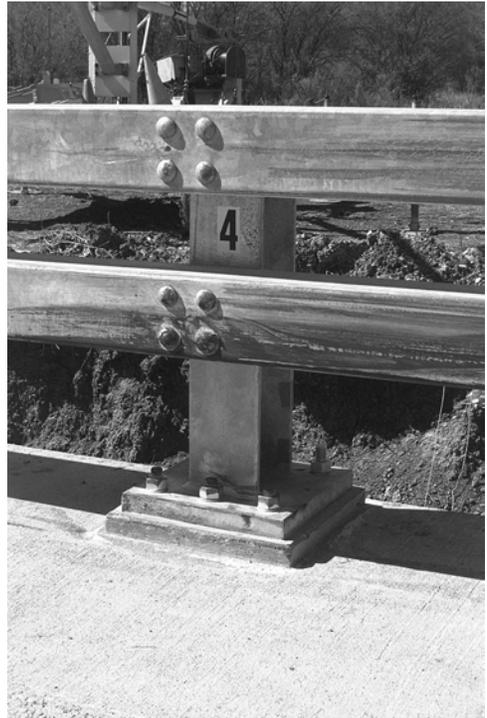
Figure 9. Installation after test 404531-1.

Damage to the New York Two-Rail Curbless Bridge Railing is shown in figures 8 and 9. Tire marks were on the baseplate and nuts at impact. No cracks in the deck were noticed after the test. There was cosmetic damage with no measurable deformation of the rail elements. Total length of vehicle contact with the rail element was 3.0 m.

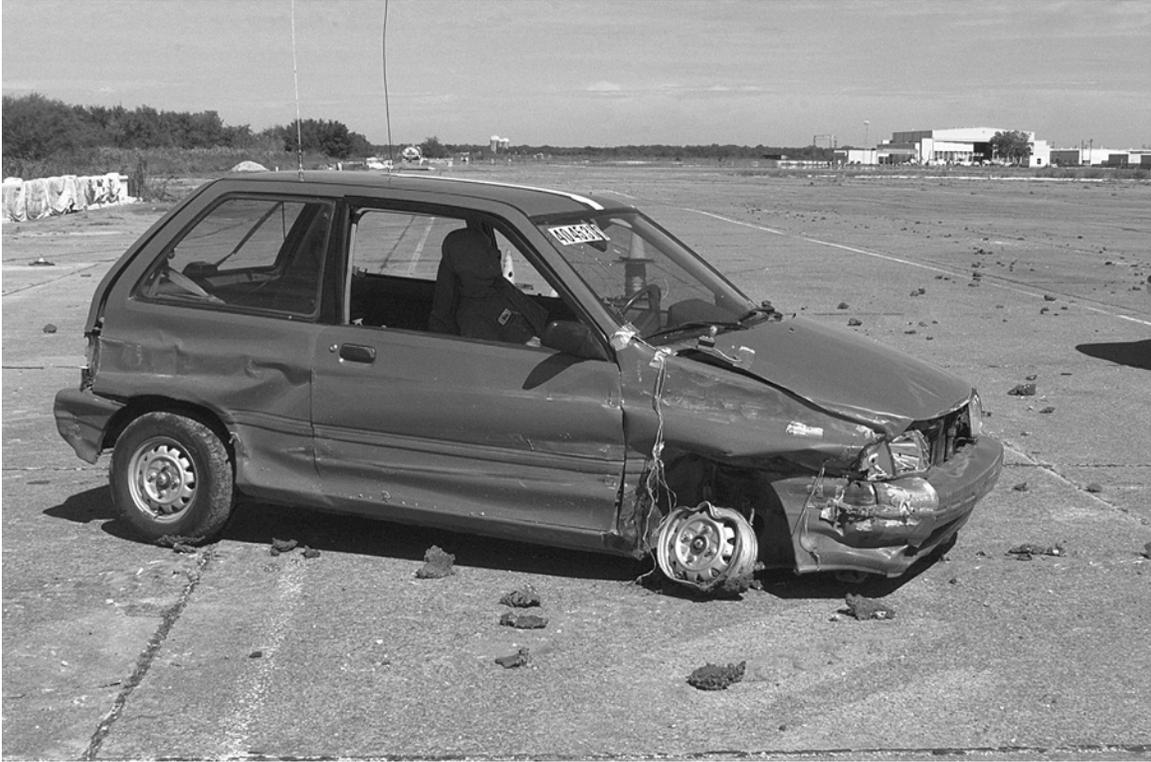
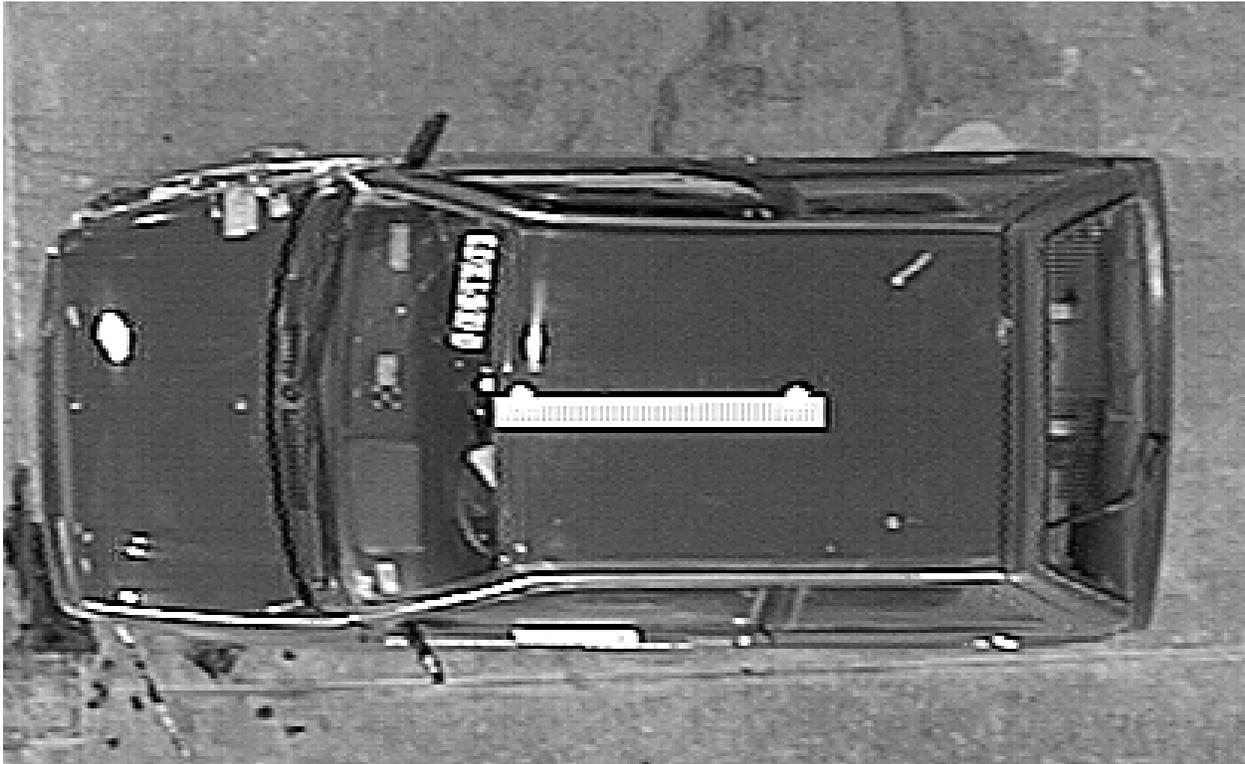
Figure 10. Vehicle after test 404531-1.

The vehicle sustained structural damage on the front right and right side. The sway bar, A-arm, motor support, and right strut and axle were all severely damaged. The front right portion of the bumper, fan, radiator, hood, tire, and wheel were damaged as shown in figure 10. The right front and rear quarter panels and right door were dented. The left front tire also sustained damage. The roof had a slight buckle on the passenger side. The maximum exterior crush was 190 mm, measured near bumper height on the right side. Maximum deformation of the occupant compartment was 15 mm (2-percent reduction in space) in the right firewall area. The door and the floor pan were deformed. The interior of the vehicle is shown in figure 11. Exterior vehicle crush and occupant compartment measurements are shown in appendix B, tables 11 and 12.

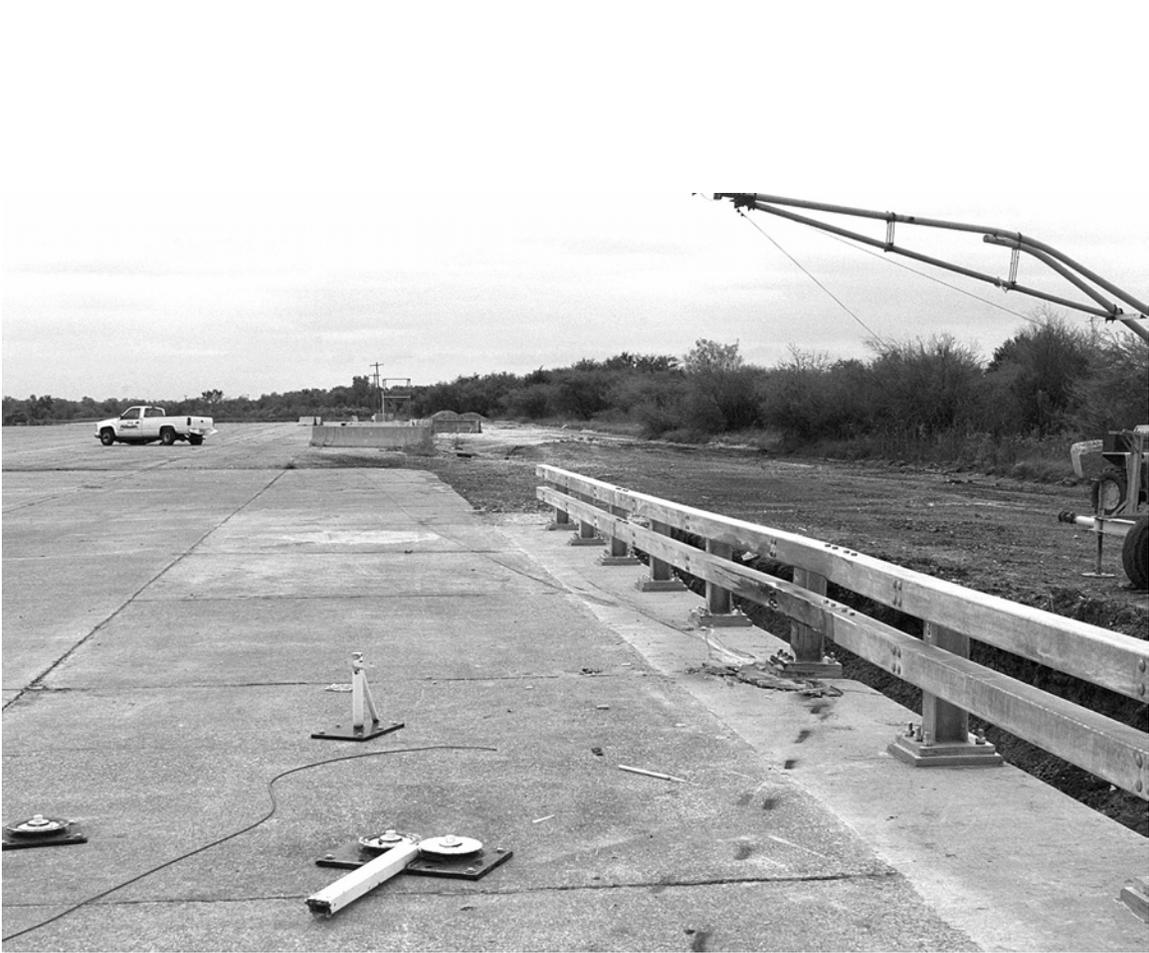
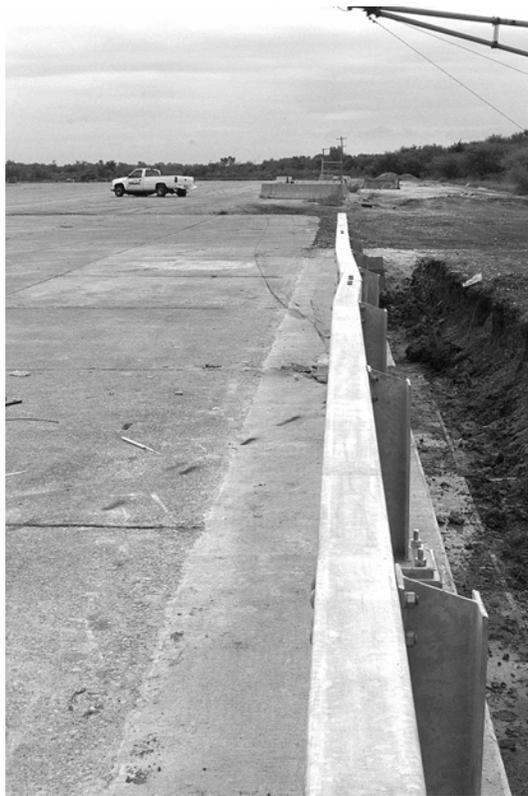
Figure 15. After-impact trajectory for test 404531-2.

Damage to the New York Two-Rail Curbless Bridge Railing is shown in figures 15 through 17. Tire marks extended 225 mm behind the rail element at impact and tire marks were on the edges of the front and rear flange on the impact side of post 4, on the front face of the post and on the front anchor bolts. The tubular element in the vicinity of post 4 was partially flattened and the four bolts connecting the lower element were partially pulled out and deformed (see figure 16). Numerous cracks in the concrete deck surrounded post 4 and part of the concrete deck was broken away. After removal of the broken concrete around post 4, the exposed reinforcement did not show any signs of damage (see figure 17). At post 5, tire marks were on the front flange on the impact side of the post and extended 200 mm behind the rail element. Total length of vehicle contact with the rail elements was 3.3 m.

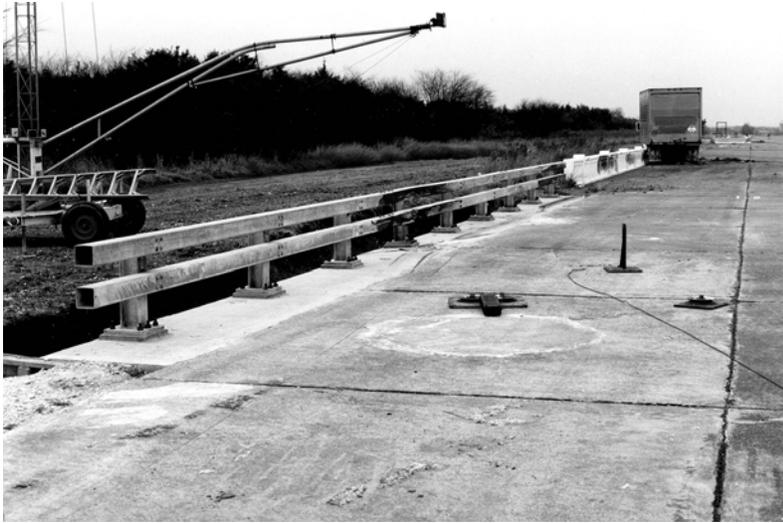
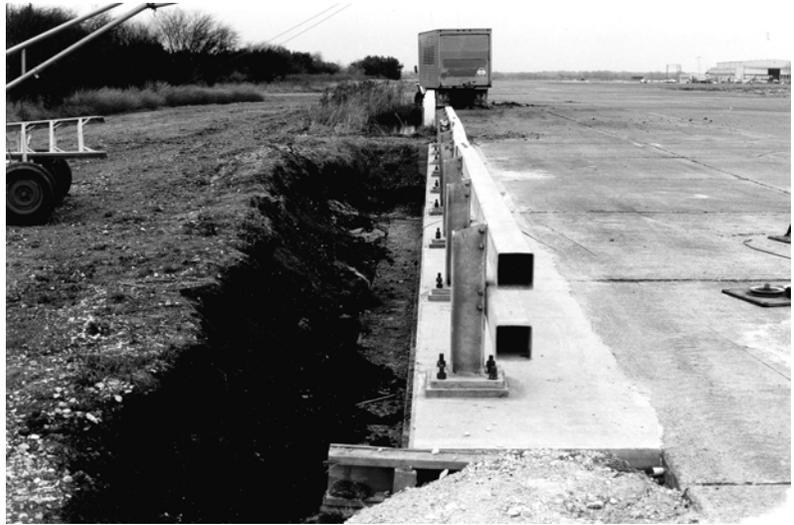
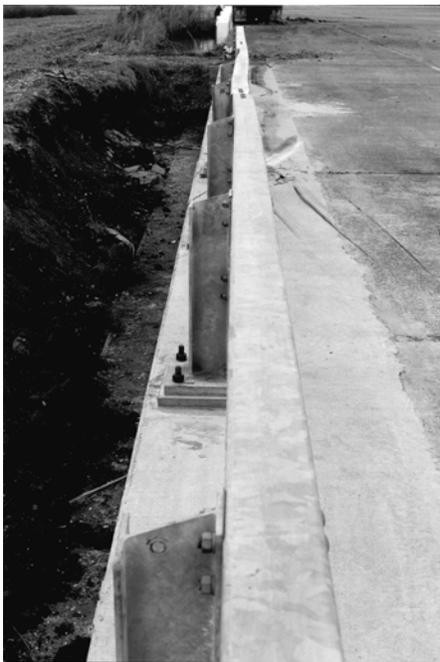
Figure 23. Vehicle trajectory path after test 404531-3.

Damage to the New York Two-Rail Curbless Bridge Railing is shown in figures 23 through 25. The bolts in the base of post 4 were rotated up and the rail element was partially flattened. The bolts in the lower rail element at post 4 were partially pulled out and deformed. The concrete deck around post 4 was structurally damaged. The vehicle was in contact with the bridge railing for 4.33 m. The bottom of the box-van caught the top of post 6, which rotated slightly. The vehicle lost contact, impacted the bridge railing again 400 mm downstream of post 7, and then rode along and off the end of the railing. Maximum dynamic deflection of the rail element was not attainable due to the vehicle size. Maximum permanent deformation was 30 mm.

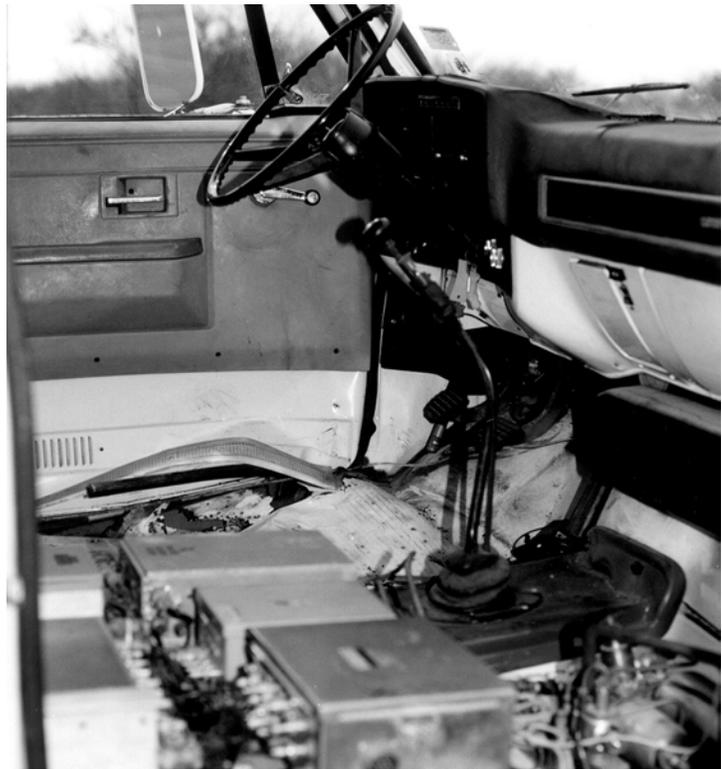
Figure 27. Interior of vehicle for test 404531-3.

Damage to the vehicle is shown in figure 26. Structural damage included deformed left front springs, U-bolts and shock bolt. Also damaged were the front bumper, left front quarter panel, left door, left side fuel tank, left front and rear outside wheel rims, and the under side of the box-van on the left front corner. Maximum exterior crush was 230 mm to the left side at the front corner near bumper height. Maximum occupant compartment deformation was 80 mm at the side panel near the driver door. The interior of the vehicle is shown in figure 27.

No detached elements, fragments, or other debris were present to penetrate or to show potential for penetrating the occupant compartment, nor to present hazard to others in the area. Maximum occupant compartment deformation was 80 mm in the side panel near the driver door.

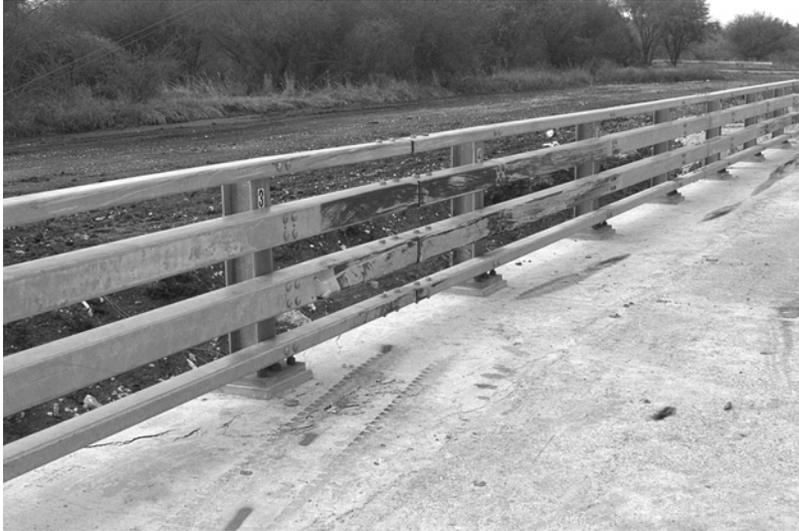
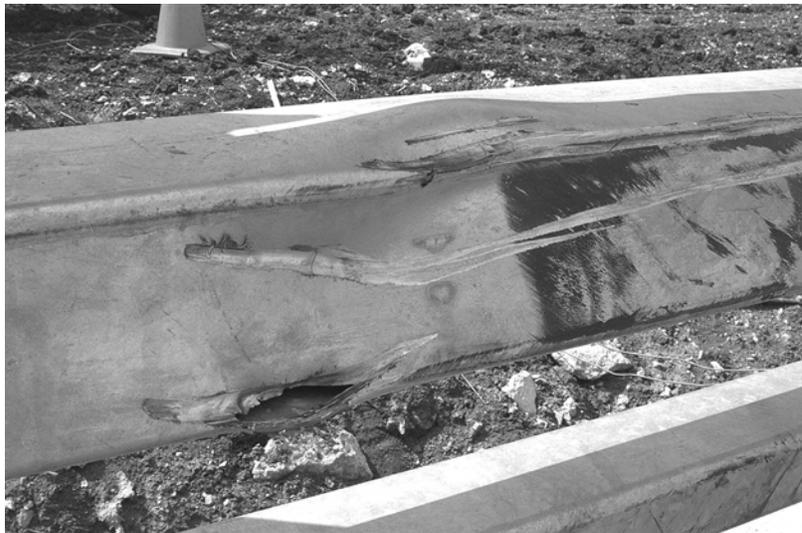
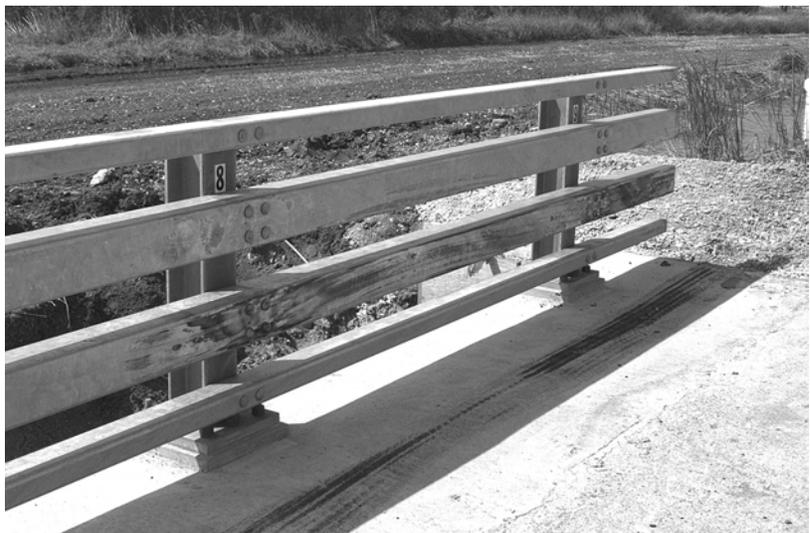
Figure 32. Installation after test 404531-4.

Damage to the New York Four-Rail Curbless Bridge Railing is shown in figures 31 through 33. The lower TS 152x152x4.8 tube was deformed inward where the vehicle made initial contact. The concrete deck around post 3 and 4 was structurally damaged. The vehicle was in contact with the railing 5.0 m and then again from post 8 to the end of the installation. Maximum dynamic deflection was not attainable due to vehicle blocking the view. Maximum permanent deformation was 10 mm.

The New York Four-Rail Curbless Bridge Railing contained and redirected the 8000S vehicle. The vehicle did not penetrate, underide, or override the installation. Minimal lateral deflection occurred; however, the bridge deck was structurally damaged around the posts on either side of impact.

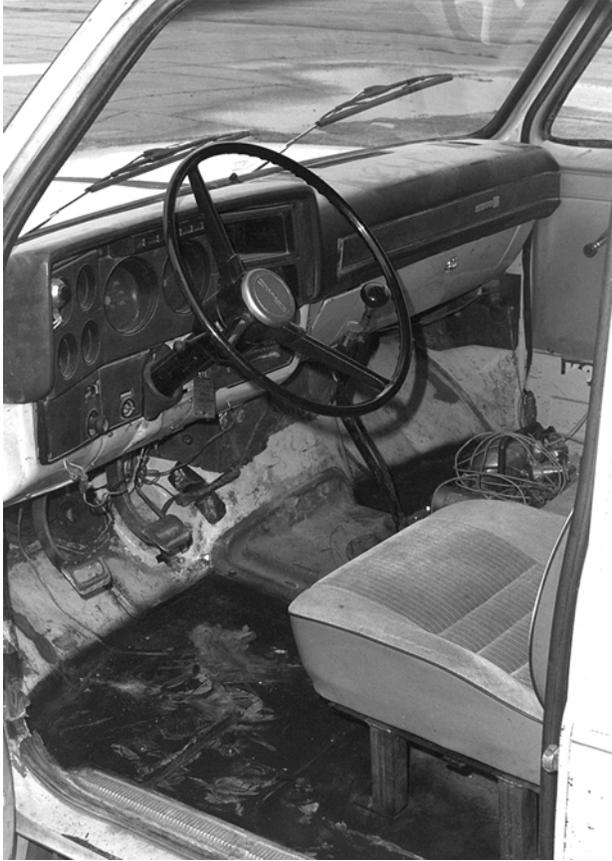
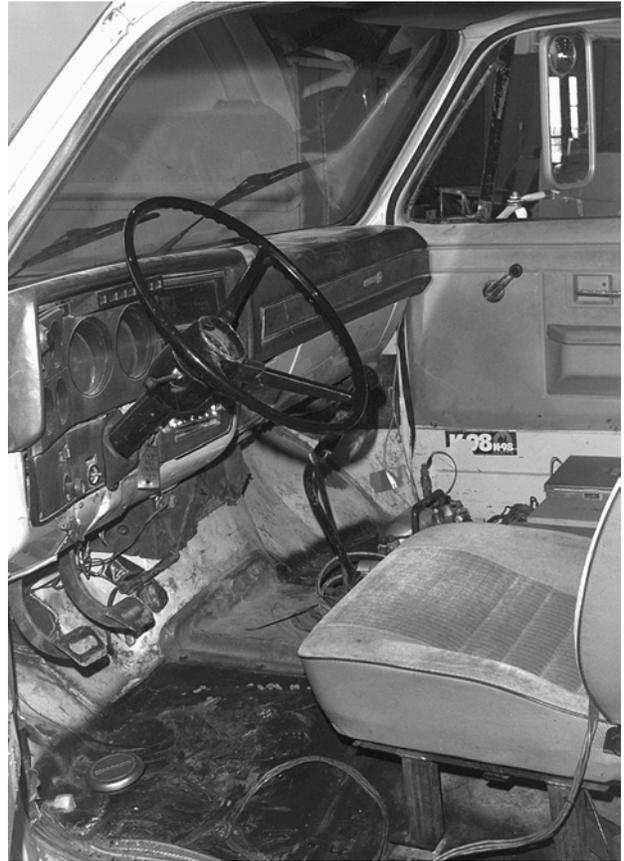
Figure 36. Interior of vehicle for test 404531-4.

The vehicle sustained damage to the left front corner as shown in figures 34 and 35. The front axle, springs, and shocks were separated from the vehicle. The steering arm, rod ends, and left front frame were deformed. Also damaged were the front bumper, hood, grill, fan, radiator, left front quarter panel, left door and step, left front tire and rim, left side of the box, right front quarter panel, and left rear outside tire and rim. The fuel tank straps were loose and the floor pan and firewall were slightly deformed. Maximum exterior crush to the vehicle was 300 mm to the left front corner at bumper height. No measurable deformation occurred to the interior occupant compartment. The interior of the vehicle is shown in figure 36.

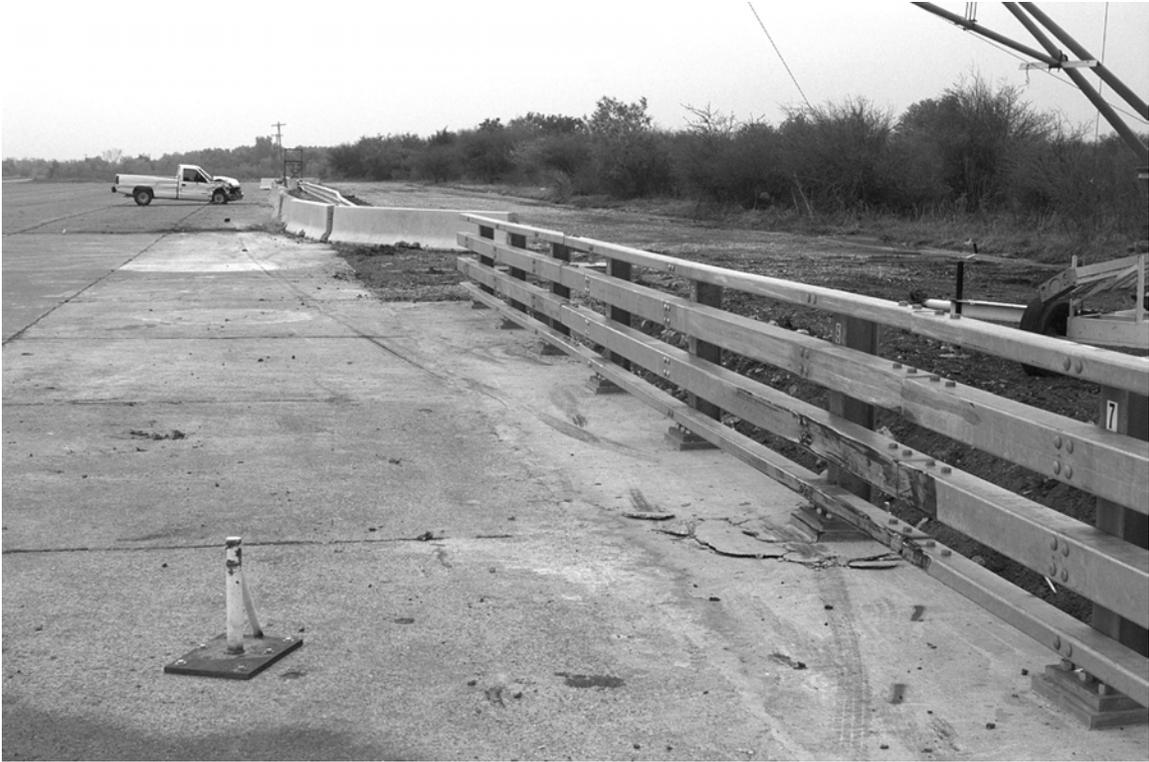
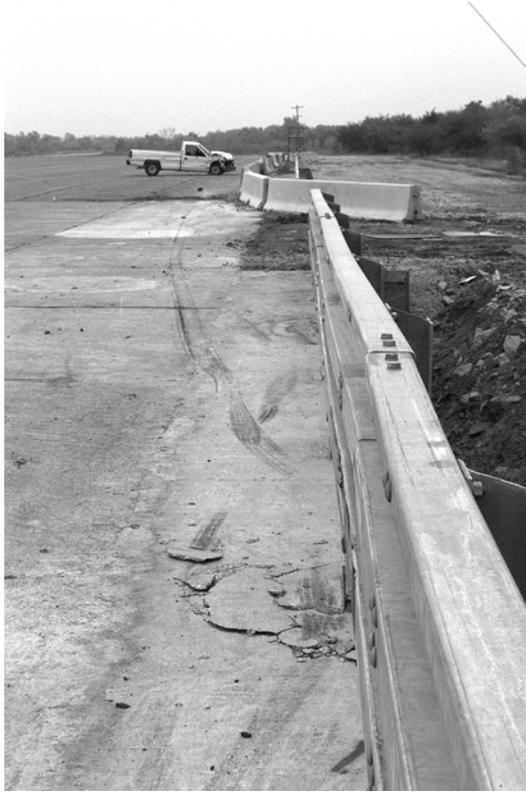
Figure 40. Vehicle trajectory path after test 404531-6.

Damage to the New York Four-Rail Curbless Bridge Railing is shown in figures 40 and 41. The bolts in the lower, wider rail element at post 6 were partially pulled out and deformed and the rail element was deformed inward. Cracks in the concrete bridge deck radiated toward the rear of the deck from the rear bolts at the base of post 7. The concrete deck around post 6 was structurally damaged. Length of contact of the vehicle with the rail element was 3.47 m. Maximum dynamic deflection of the rail element was 100 mm and maximum permanent deformation was 55 mm at post 6.

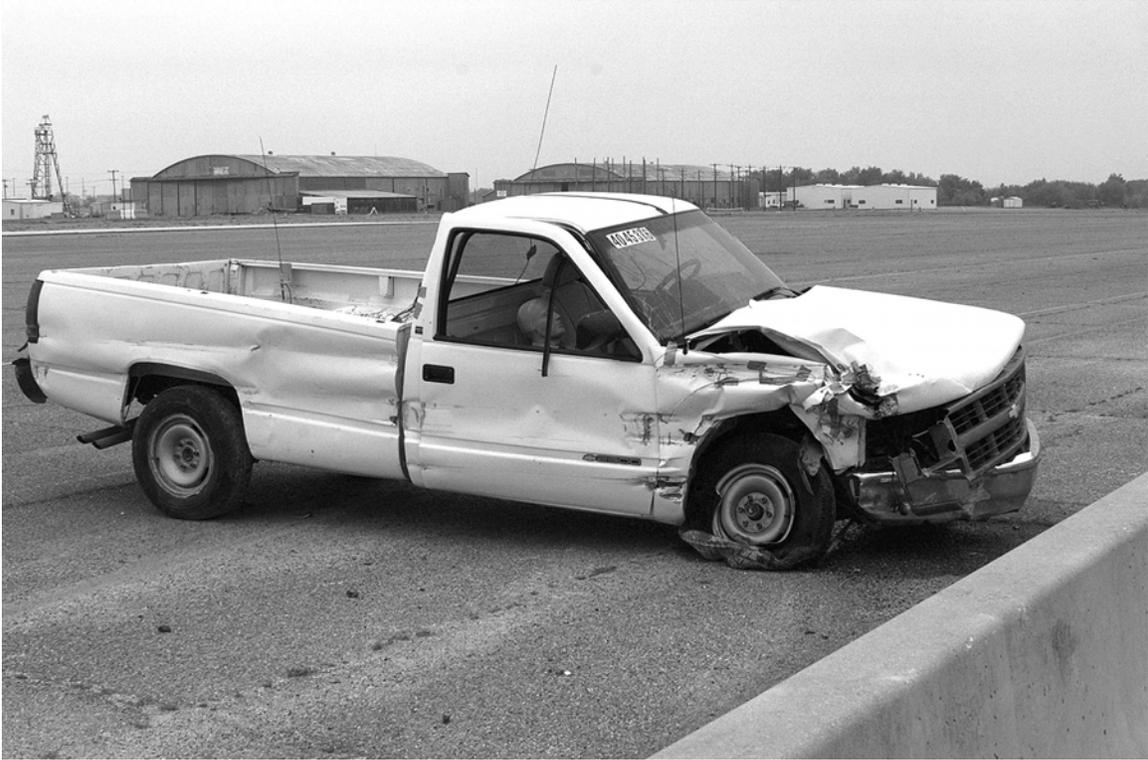
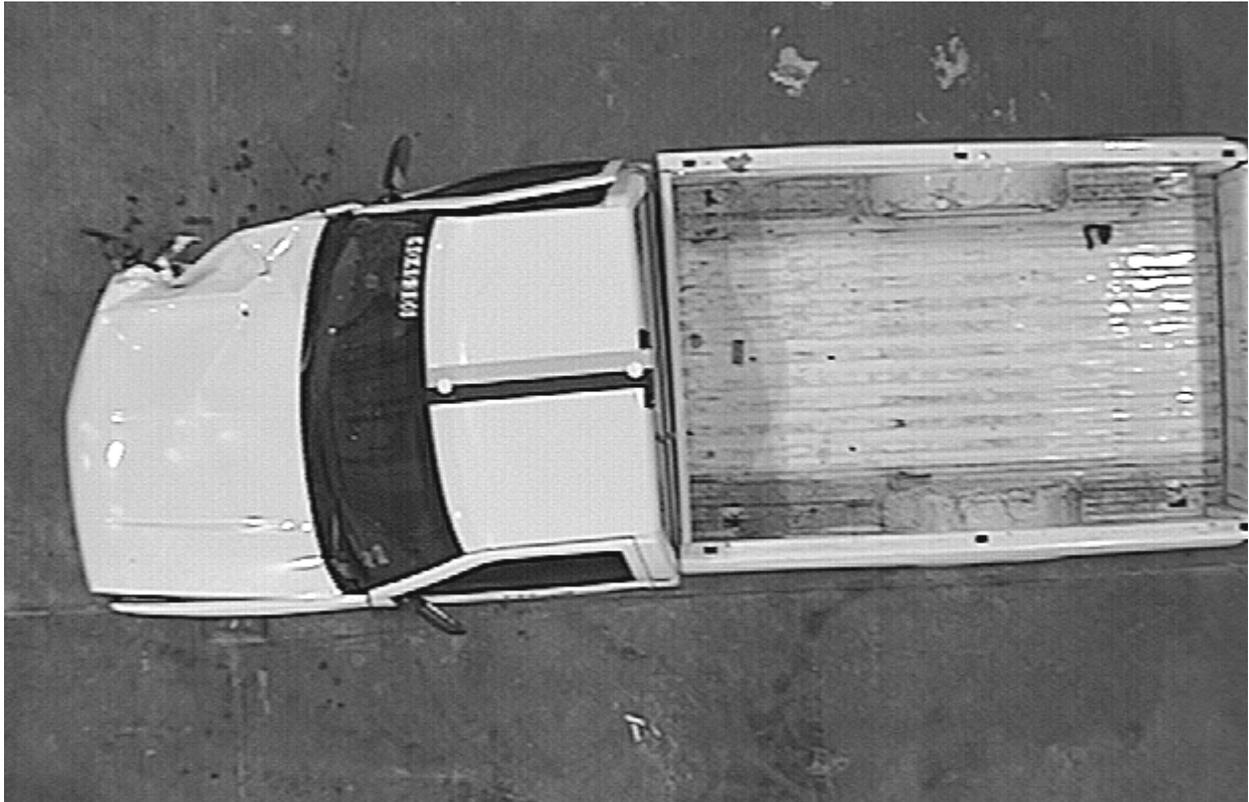
Figure 42. Vehicle after test 404531-6.

The 2000P vehicle was damaged as shown in figure 42. Structural damage was sustained by the right side upper and lower A-arms, rod ends, idler arm, stabilizer bar, engine supports, transmission supports and the right front frame. Also damaged were the front bumper, hood, grill, fan, radiator, radiator supports, right front quarter panel, right door and window glass, right side of the bed, and right front tire and rim. The windshield was shattered and the A and B pillars deformed. The floor pan and fire wall were deformed. Maximum exterior crush to the vehicle was 410 mm at the right front corner at bumper height. Maximum occupant compartment deformation was 65 mm (6 percent reduction in space) in the floor pan area. Also of note, the female end of the seat belt attachment broke apart allowing the seat belt to come loose. The interior of the vehicle is shown in figure 43. Exterior vehicle crush and occupant compartment measurements are shown in appendix B, tables 15 and 16.

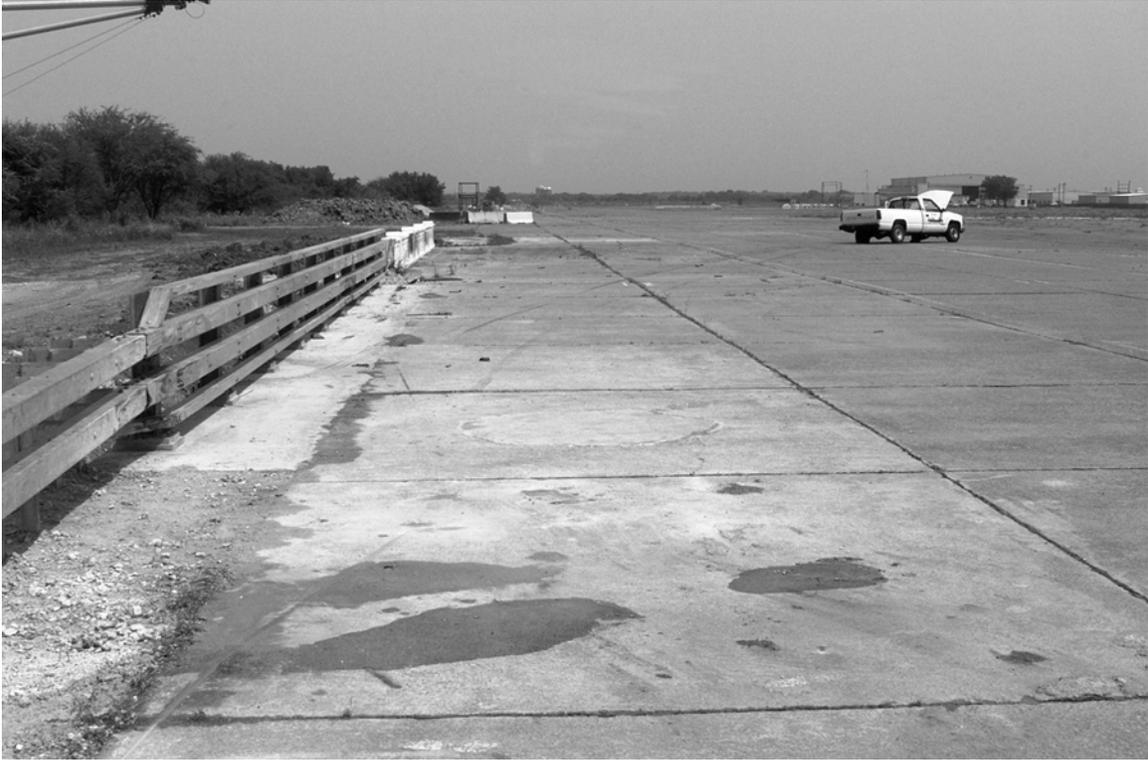
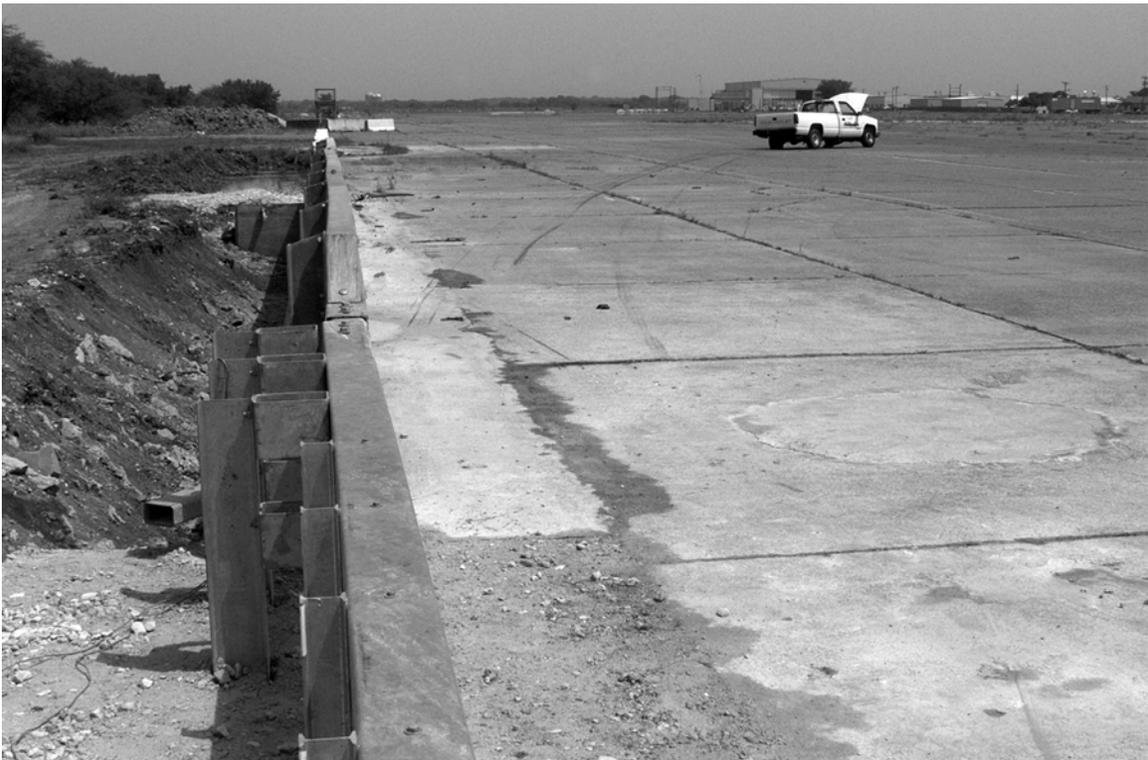
Figure 47. Vehicle trajectory path after test 404531-7.

Damage to the New York Four-Rail Curbless Bridge Railing Transition is shown in figures 47 and 48. Tire marks were on the face of the lower three tubes on the transition and the bridge railing for a total of 4.22 m. The lip of the rail splice joint between posts 22 and 23 (first bridge railing posts) was pulled up and the lower bolts on the third tube from the top on post 23 were partially pulled out in the area where the tube was partially collapsed. Tire marks on the bridge deck extended 470 mm behind the rail elements. Cracks in the deck radiated outward from the bolts of the base plate at post 23. Maximum permanent deformation of the rail elements was 65 mm between the transition and the bridge railing.

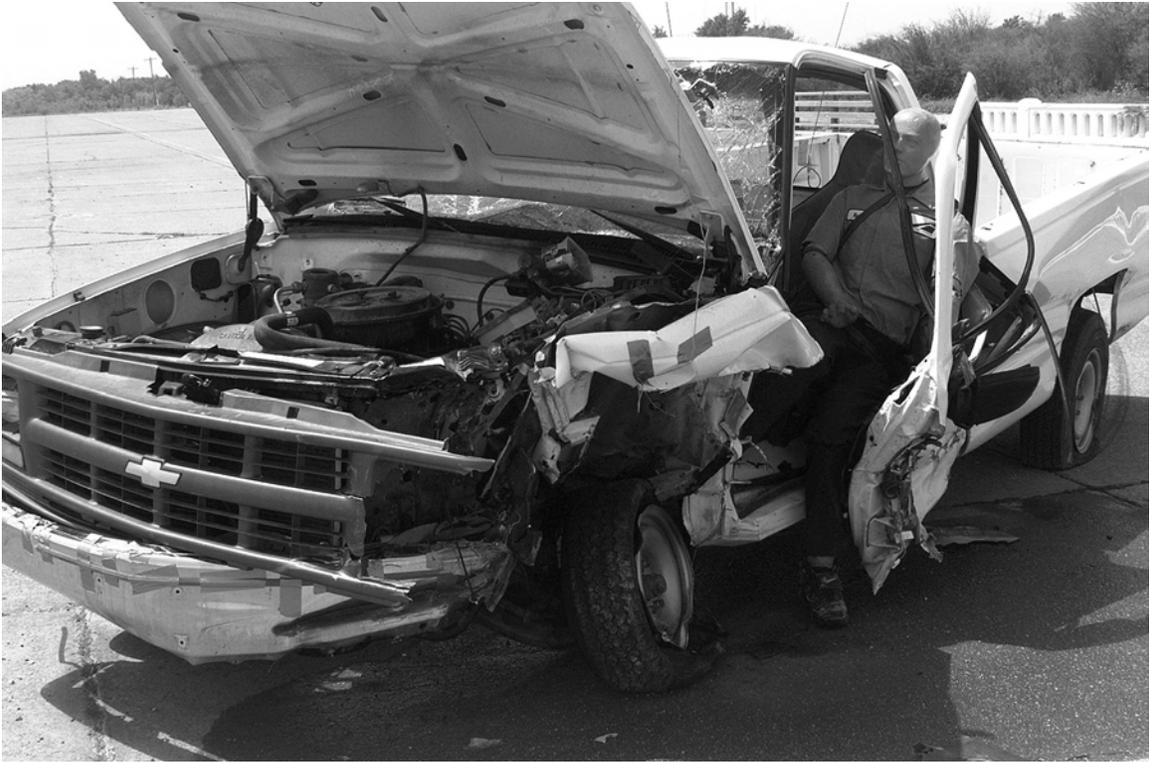
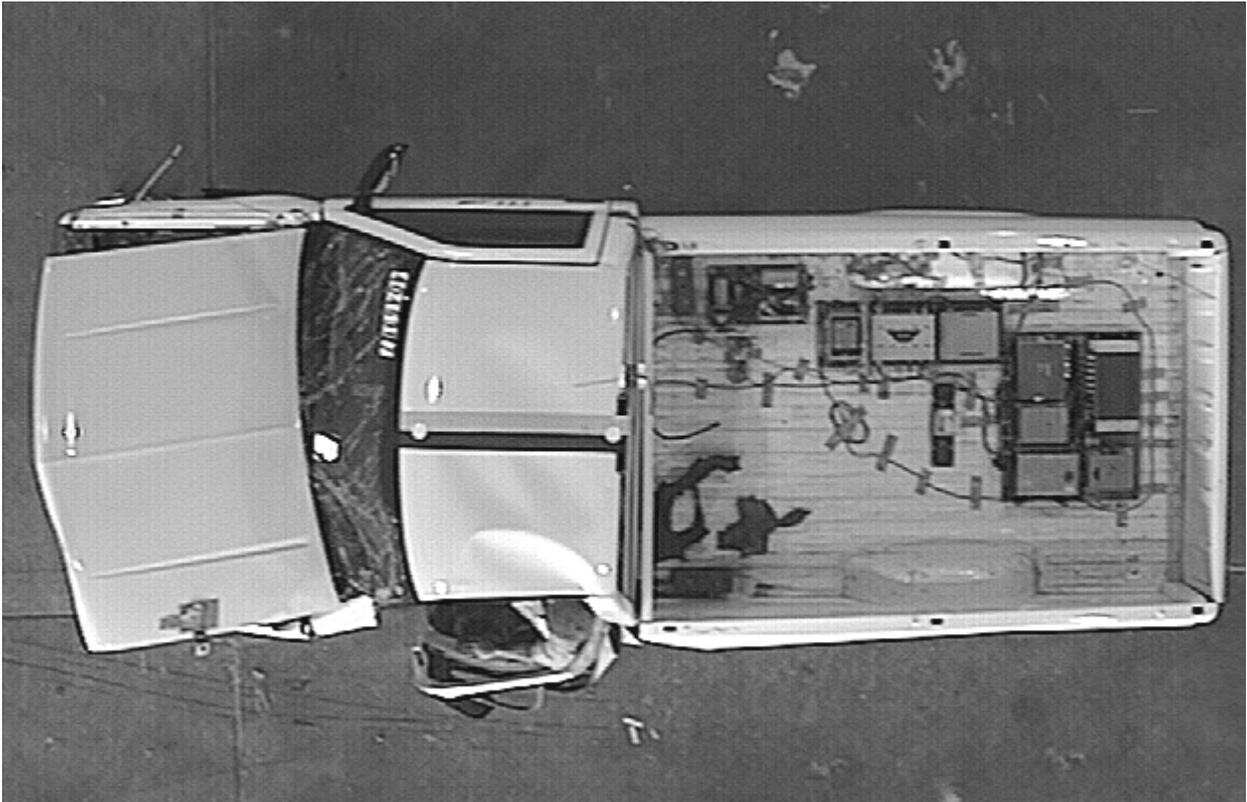
Figure 49. Vehicle after test 404531-7.

The 2000P vehicle was severely damaged as shown in figure 49. Structural damage included a deformed left front frame rail, broken left upper ball joint, deformed upper A-arm and deformed A-pillar and B-pillar. The front end was shifted 200 mm to the right. The windshield was shattered and the roof was buckled. The window glass in the driver side door was broken out, the side mirror pulled off and the driver side door was pulled open 220 mm at the hinges. Also damaged was the front bumper, grill, left headlight, radiator, master cylinder, brake booster, hood, left front tire and rim, left front quarter panel, left rear quarter panel, left rear tire and rim, and rear bumper. Maximum exterior crush to the vehicle was 470 mm to the frontal plane at the left corner and 510 mm to the left side plane at the front corner. The floor pan was deformed and separated with an opening 370 mm long by 60 mm wide near the area where the occupant's feet rest. The firewall and instrument panel were deformed. Deformations into the occupant compartment were as follows: 158 mm (18%) in the instrument panel area; 131 mm (12%) in the floor pan area; 95 mm (7%) in the firewall area; and 51 mm (32%) in the instrument panel to floor pan area. Photographs of the interior of the vehicle are shown in figures 50 and 51. Exterior vehicle crush and occupant compartment measurements are shown in appendix B, tables 17 and 18.

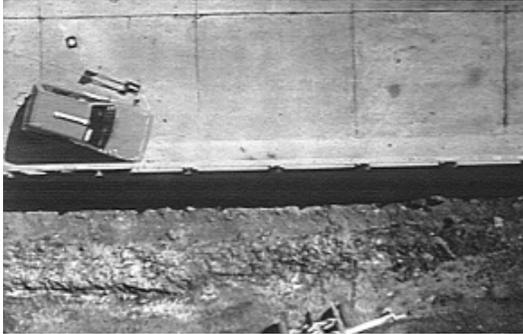
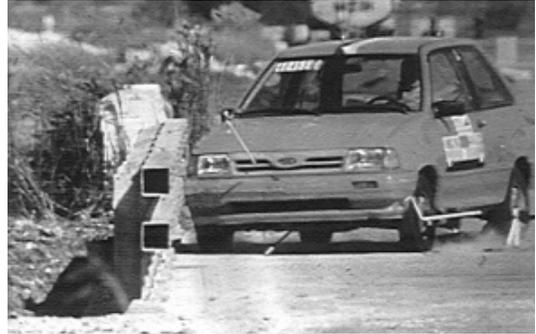
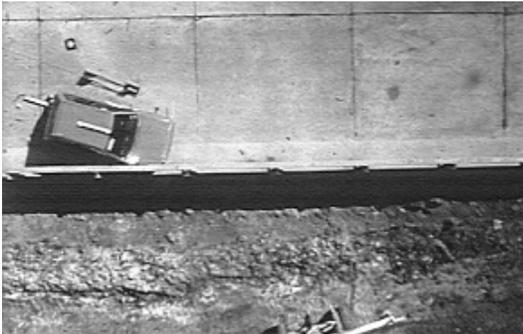
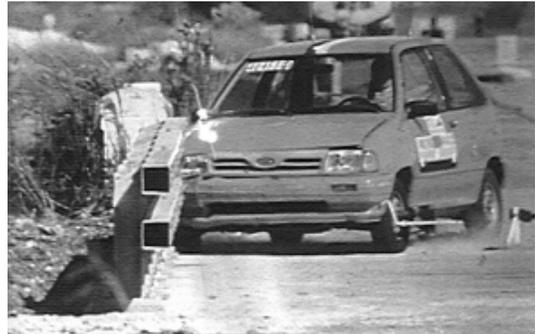
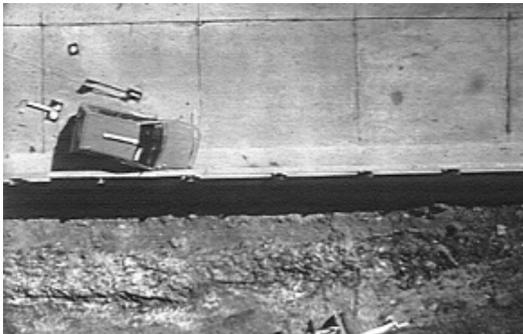
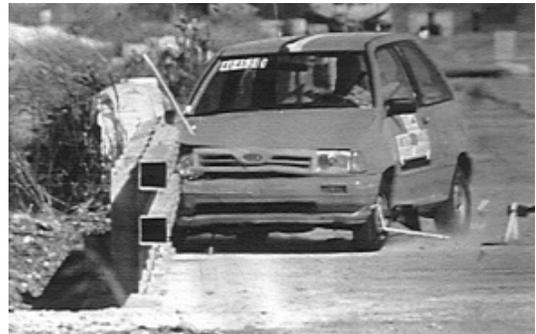
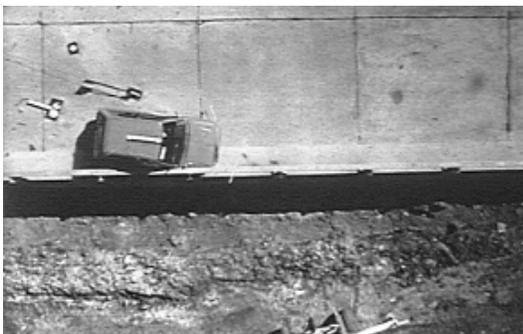
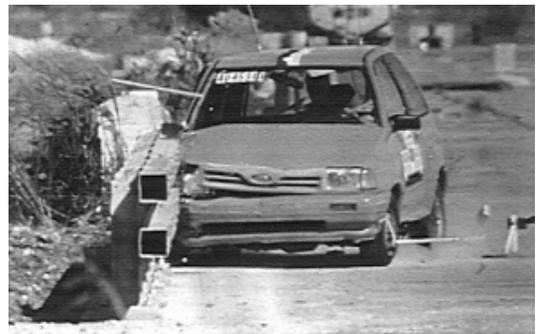
Figure 59. Sequential photographs for test 404531-1 (overhead and frontal views).

The vehicle, traveling at 100 km/h, impacted the two-rail bridge railing 1.2 m upstream from post 4, at a 19.1-degree angle. Shortly after impact, the bottom rail showed movement. At 0.010 s, the right front wheel steered left then traveled parallel with the railing. The upper rail moved at 0.012 s. At 0.017 s, the vehicle's right front wheel continued to steer left. Post 4 deformed at 0.019 s. At 0.024 s, the right front wheel canted as the upper part of the tire was pushed down from the lower bridge rail. The vehicle began to redirect at 0.038 s. The right front tire contacted the concrete and metal base of post 4 at 0.056 s, and at 0.066 s, the right front tire contacted post 4. At 0.068 s, the right-side passenger door window shattered, and at 0.097 s, the rear of the vehicle impacted the bridge railing. Traveling at 89.1 km/h, the vehicle was moving parallel to the rail element at 0.113 s. At 0.165 s, the left front tire steered right. At 0.224 s, traveling at 85.3 km/h, the vehicle lost contact with the bridge railing at a 0.8 degree angle. Brakes on the vehicle were applied at 1.4 s, bringing the vehicle to rest 52.7 m downstream from impact and 9.1 m behind the installation. Sequential photographs of the test period are shown in appendix C, figures 59 and 60.

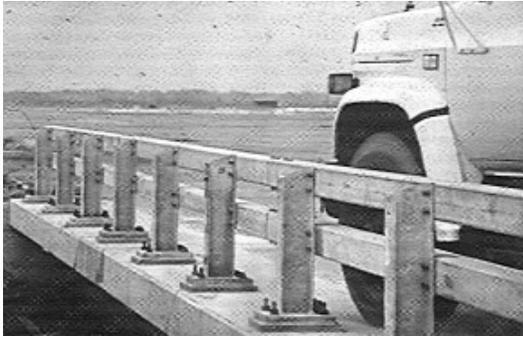
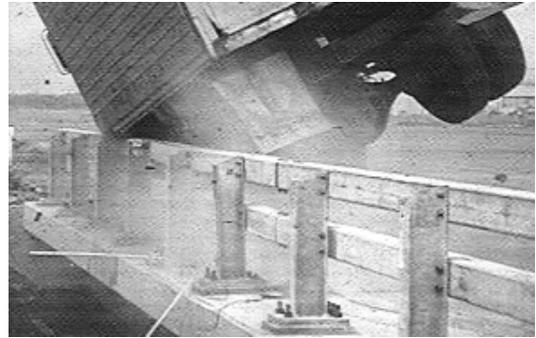
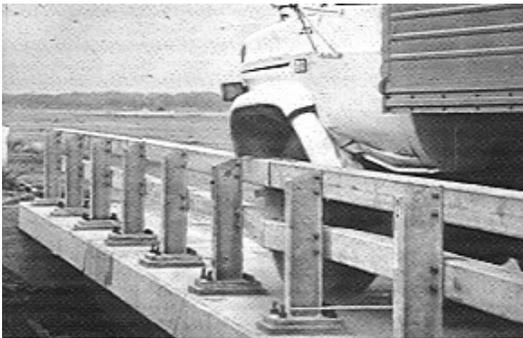
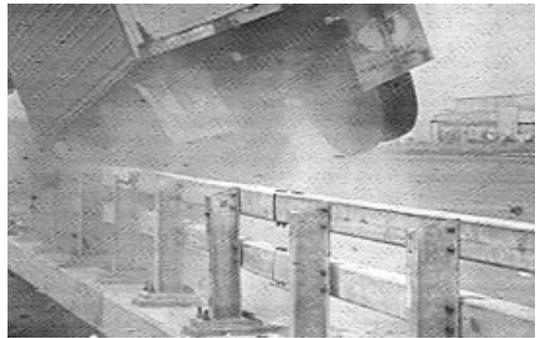
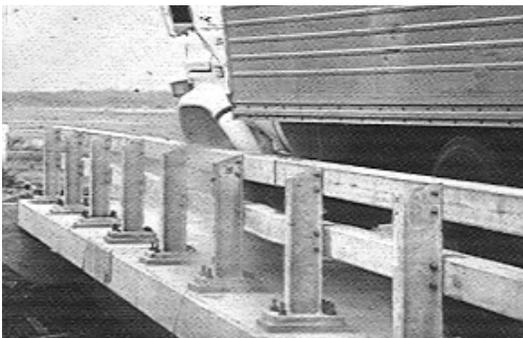
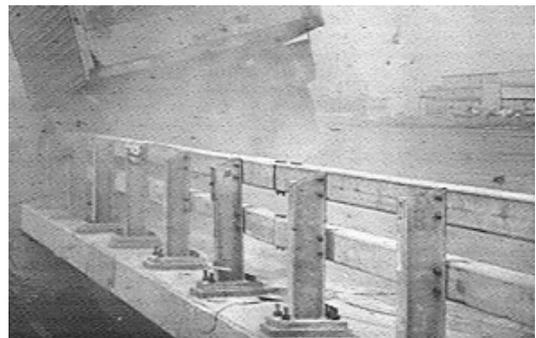
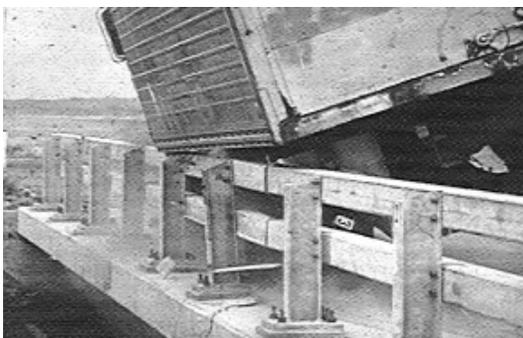
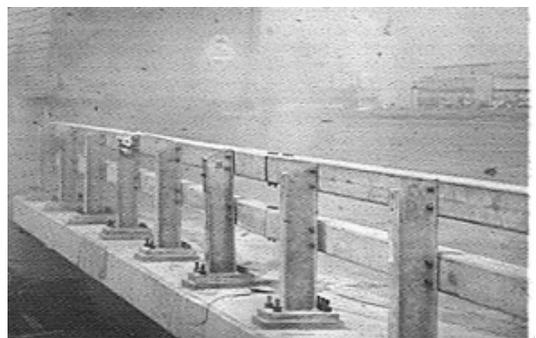
Figure 64. Sequential photographs for test 404531-3 (rear view).

the railing, the edge caught on the top of post 6 at 0.434 s. The left front tire contacted the rail element again at 0.578 s. At 0.829 s the vehicle lost contact with the bridge railing. Exit angle and speed were not attainable from the overhead camera; however, estimating from the tire marks, the vehicle exited the railing at approximately 2 degrees. Brakes on the vehicle were not applied. The vehicle contacted a second barrier downstream of the bridge railing and subsequently came to rest 42.7 m down from the impact point and in line with the bridge railing (against the second barrier). Sequential photographs of the test period are shown in appendix C, figures 63 and 64.
