**TESTING AND EVALUATION OF THE NEW YORK  
TWO-RAIL CURBLESS AND FOUR-RAIL CURBLESS  
BRIDGE RAILING AND THE BOX-BEAM TRANSITION**

Contract No. DTFH61-98-C-00056  
Report No. 404531-F

**September 1999**

**TEXAS TRANSPORTATION INSTITUTE  
THE TEXAS A & M UNIVERSITY SYSTEM  
COLLEGE STATION, TEXAS**

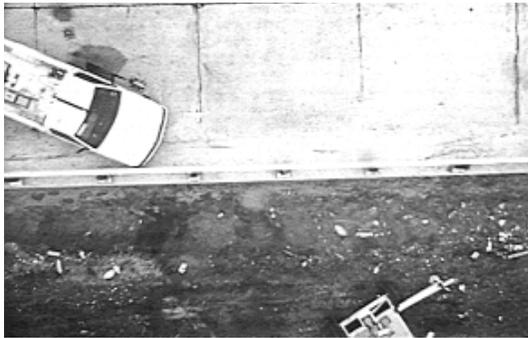
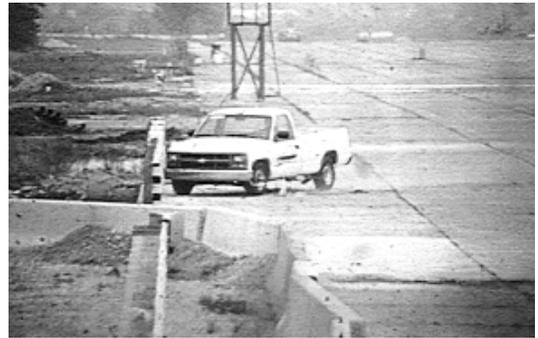
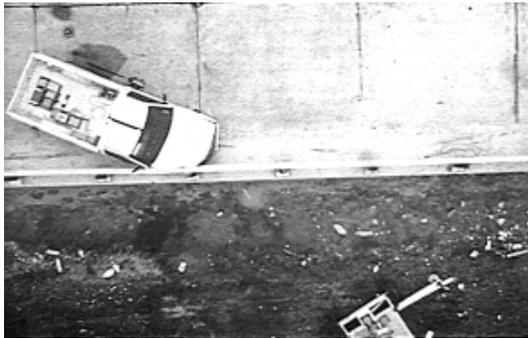
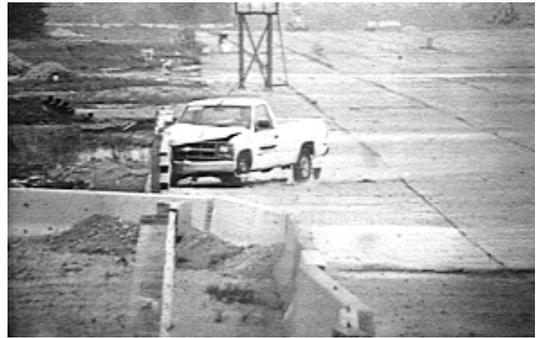
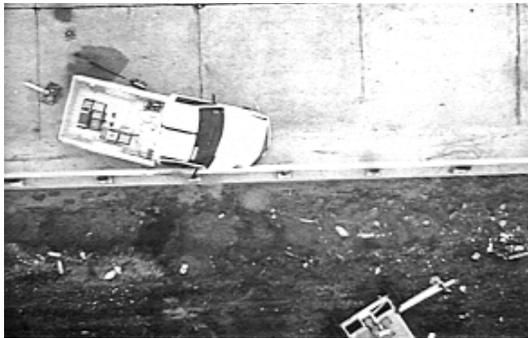
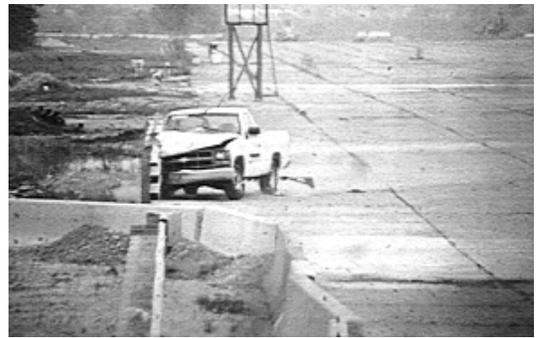
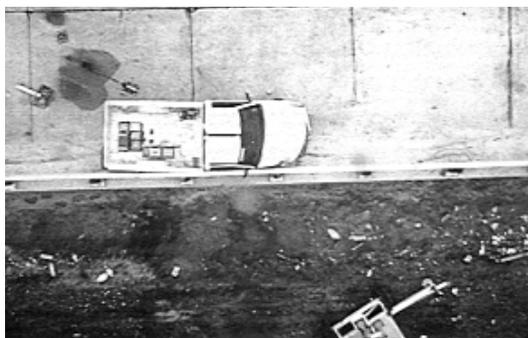
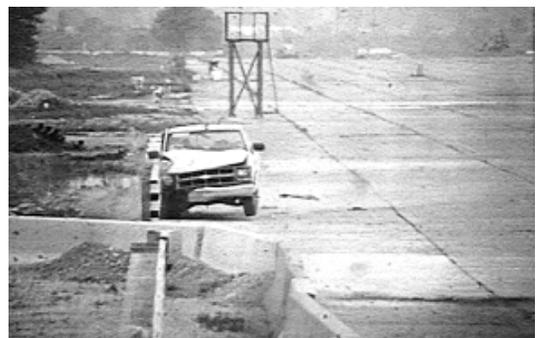
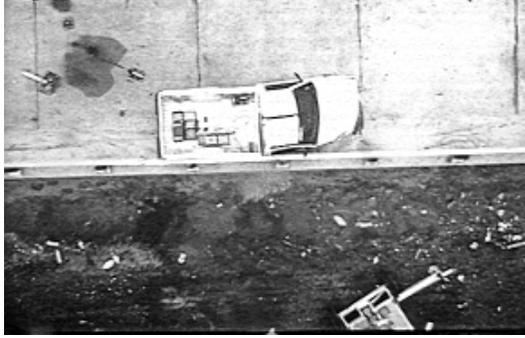
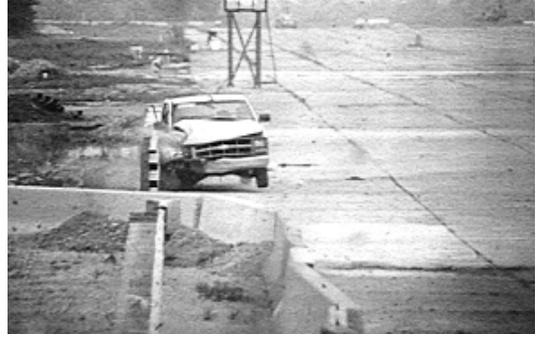
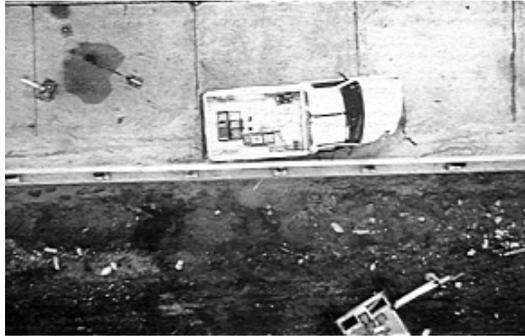
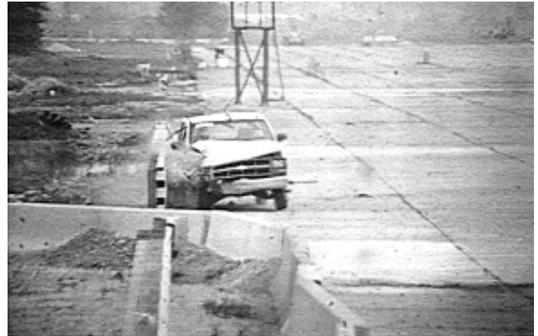
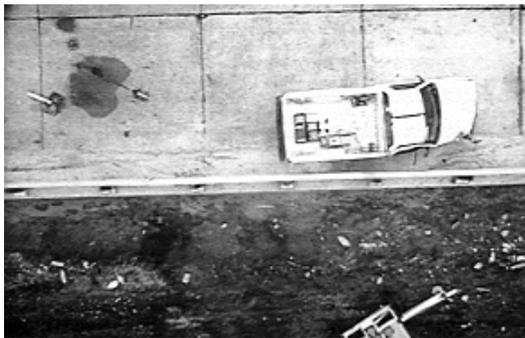
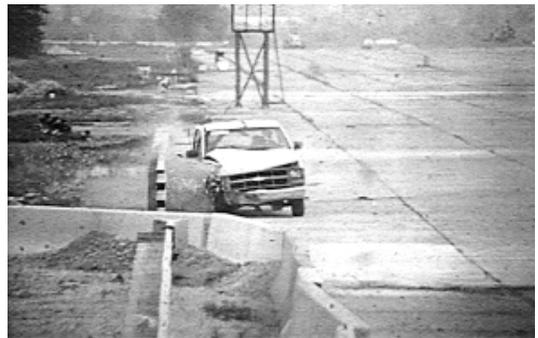
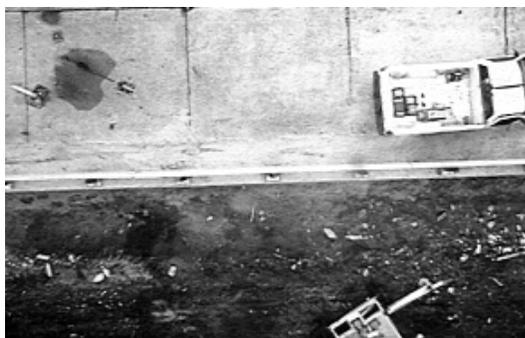
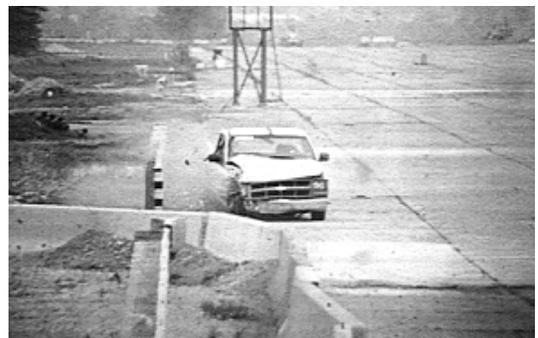
Figure 67. Sequential photographs for test 404531-6 (overhead and frontal views).

The 2000P truck impacted the New York Four-Rail Curbless Bridge Railing 1.4 m upstream from post 6. Upon impact, the vehicle was traveling at a speed and angle of 100.3 km/h and 25.1 degrees. At 0.028 s, post 6 moved, and at 0.041 s, the vehicle began to redirect. The first visible cracks in the deck appeared on the field side of the installation at 0.052 s. By 0.062 s, the passenger side window of the vehicle shattered, and by 0.131 s, the left front tire lost contact with the ground. The rear of the vehicle contacted the rail element at 0.174 s. Traveling at 87.3 km/h, the vehicle was traveling parallel to the test installation at 0.175 s. At 0.263 s, traveling at 94.6 km/h, the vehicle lost contact with the bridge railing at a 4.3 degree angle. The left front tire returned to the ground at 0.282 s. As the vehicle exited the railing, it was tracking straight forward. Brakes on the vehicle were applied at 1.4 seconds, and the vehicle yawed clockwise and lightly contacted a protective barrier. The vehicle rolled back and subsequently came to rest 70 m downstream and 5.5 m toward traffic lanes. Sequential photographs of the test period are shown in appendix C, figures 67 and 68.

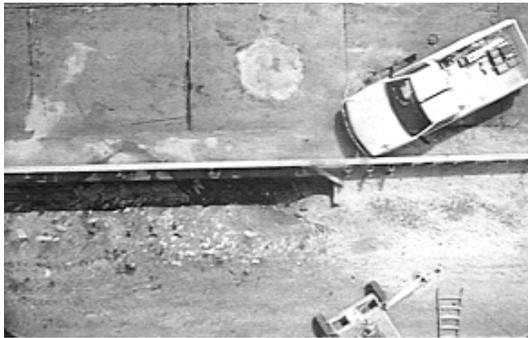
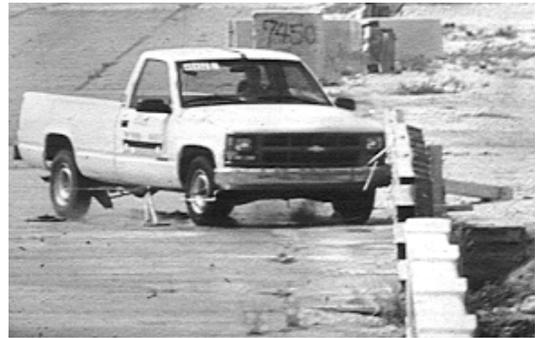
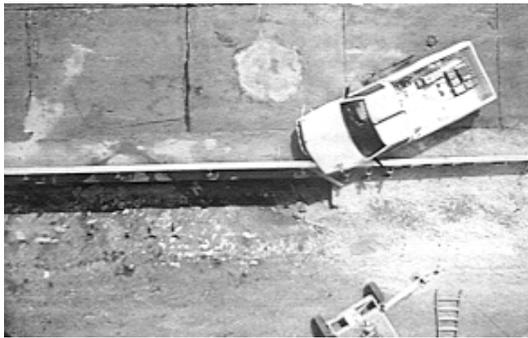
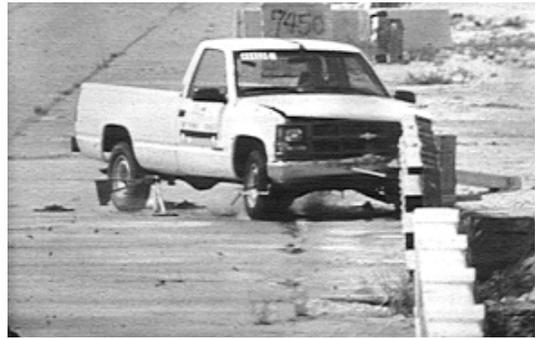
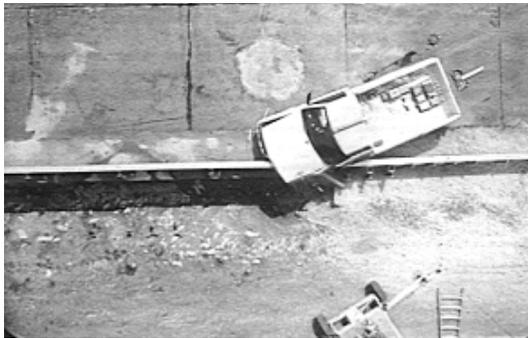
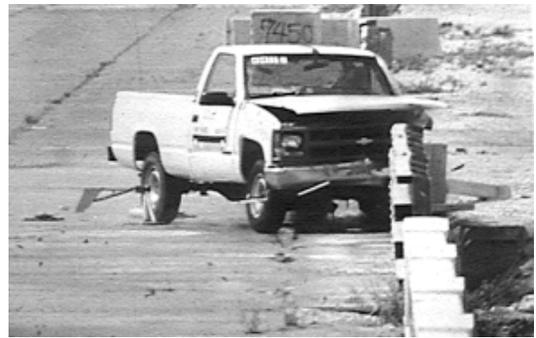
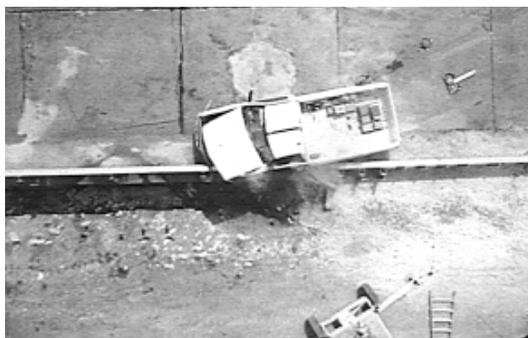
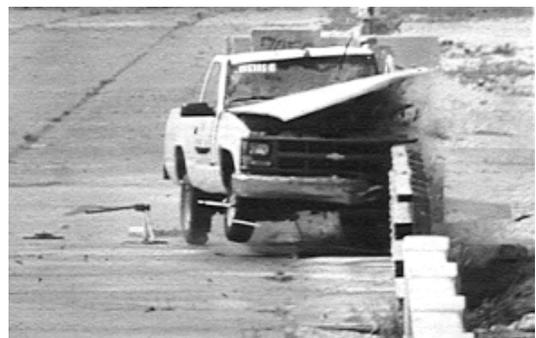
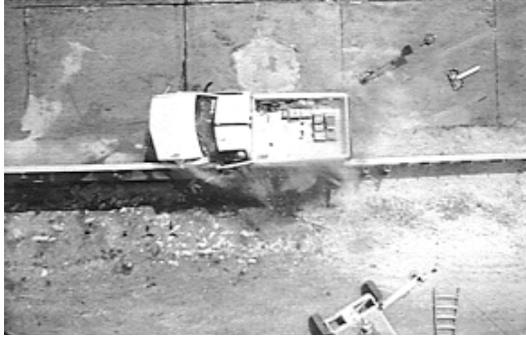
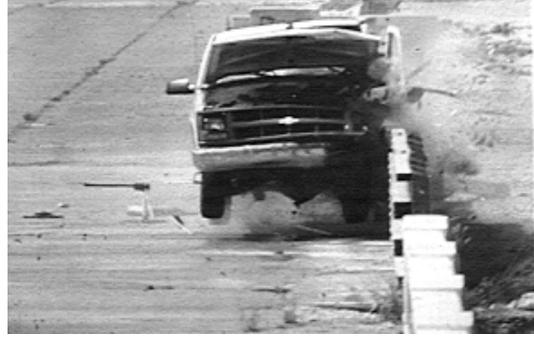
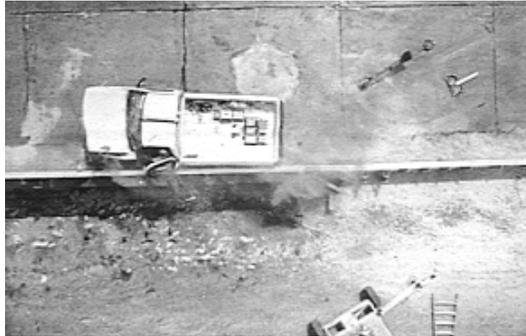
Figure 69. Sequential photographs for test 404531-7 (overhead and frontal views).

rear tire lost contact with the ground at 0.215 s and the front of the vehicle lost contact with the rail element at 0.236 s. At 0.240 s, the vehicle was traveling parallel with the bridge railing at a speed of 69.6 km/h and at 0.244 s the rear of the vehicle contacted the bridge rail element. The left rear tire lost contact with the bridge rail element at 0.355 s and the vehicle lost contact with the bridge railing at 0.393 s. At this time the vehicle was traveling at a speed of 65.3 km/h and an exit angle of 7.6 degrees. Between 0.416 s and 0.575 s all four tires returned to the ground. At 0.800 s the left leg of the dummy protruded out of the cab of the pickup allowing the foot to drag the ground until 0.843 s. Brakes on the vehicle were applied at 2.1 s after impact. The vehicle slowly yawed clockwise and subsequently came to rest 54.9 m down from impact and 19.1 m toward traffic lanes. As the vehicle stopped, the dummy's left leg was fully protruding out of the cab with the foot resting on the concrete pavement and the right leg partially out of the cab. Sequential photographs of the test period are shown in appendix C, figures 69 and 70.
