# Testing of New Bridge Rail and Transition Designs

## Volume I: Technical Report

PUBLICATION NO. FHWA-RD-93-058

7. Author(s) C. Eugene Buth, T. J. Hirsch, and Wanda L. Menges		8. Performing Organization Report No. Research Foundation 7069-Vol. I	
9. Performing Organization Name and Address Texas Transportation Institute The Texas A&M University System College Station, Texas 77843-3135		10. Work Unit No. NCP No. 3A5C0042	11. Contract or Grant No. DTFH61-86-C-00071

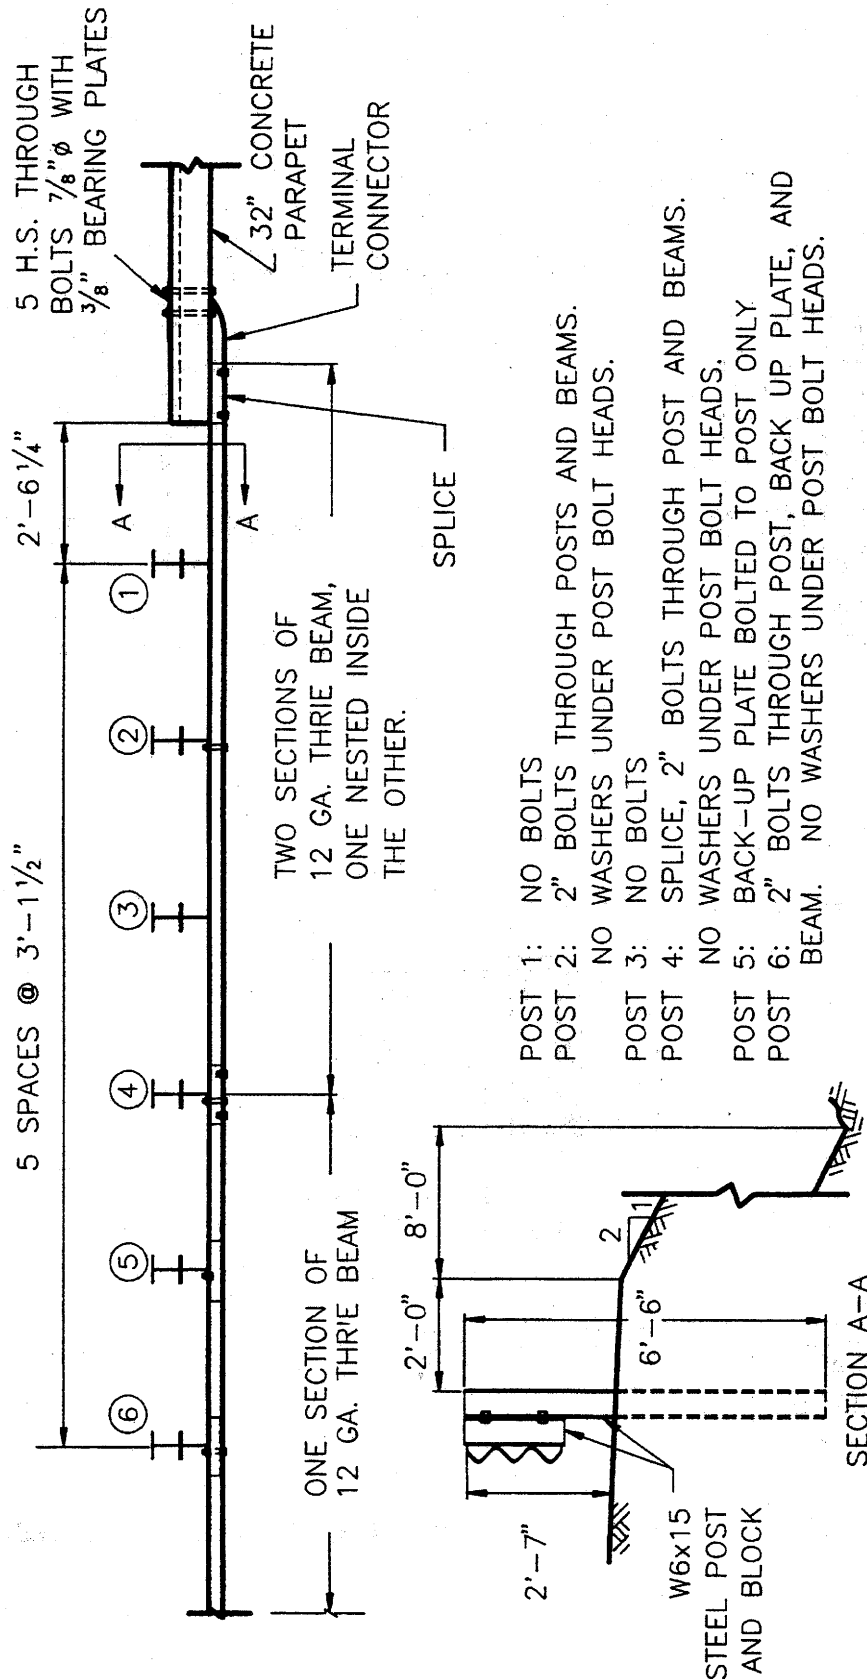
Figure 18. Cross section of 32-in (813-mm) thrie-beam transition.

Drawings for the 32-in (813-mm) thrie-beam transition are presented in figure 18. The prototype transition was installed on the 32-in (813-mm) concrete parapet for testing. A terminal connector was used at the transition-to-parapet connection. In the first two tests (automobile and pickup truck), a standard AASHTO terminal connector was used.<sup>(9)</sup> The terminal connector was lapped on the traffic face with the two layers of thrie-beam being sandwiched between the terminal connector and the parapet. In a connection such as this

with three layers of rail element, splice bolts cannot be inserted in the holes unless the holes in at least one layer of material are enlarged.

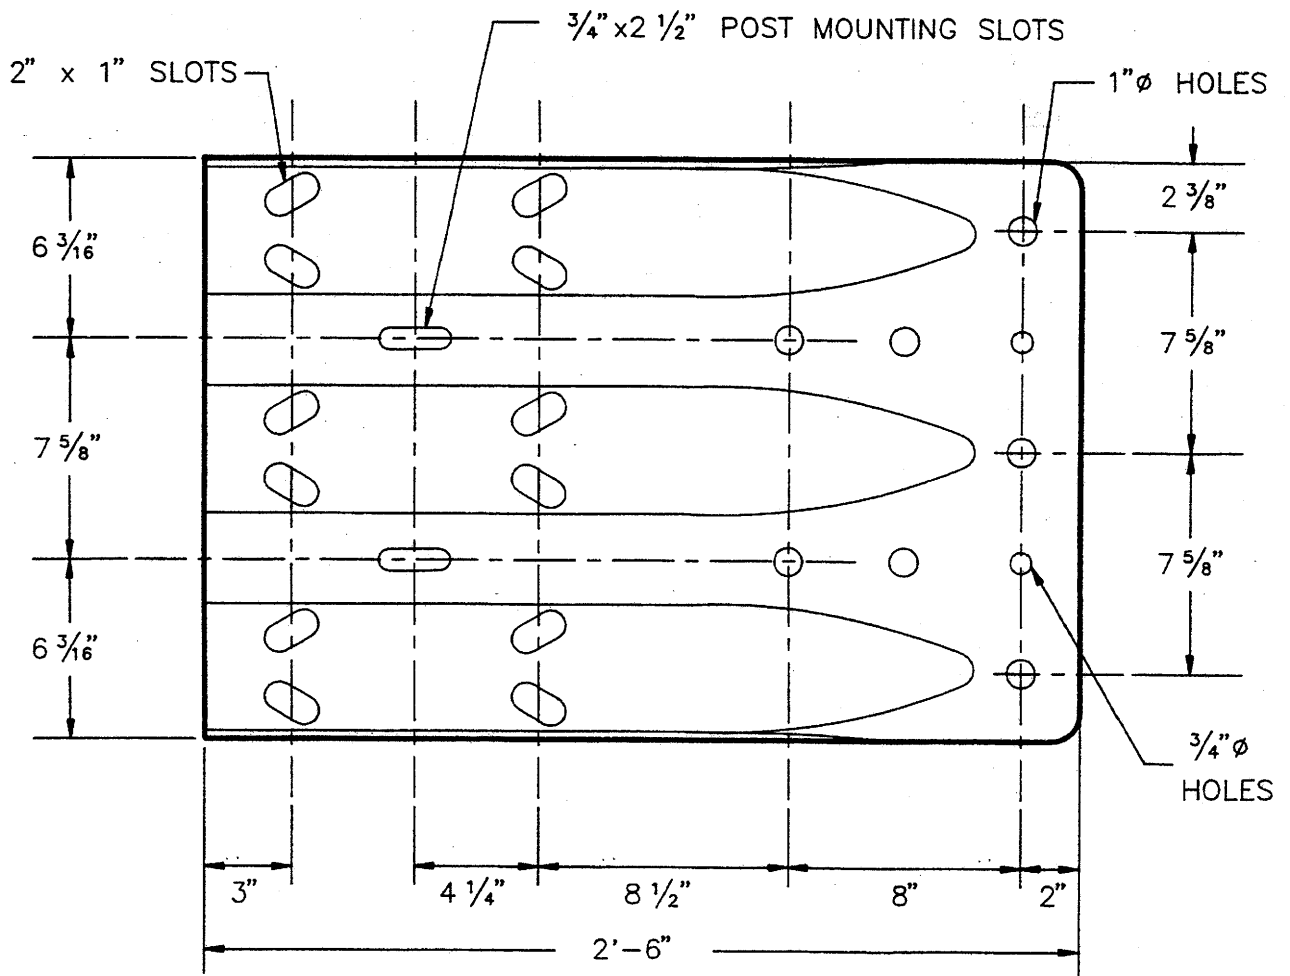
Figure 19. Modified terminal connector.

For the repeat of the pickup truck test (test 7069-21) and the 18,000-lb (8 172-kg) truck test (test 7069-29), a modified terminal connector was used. In test 21, the connector thickness was 12 gauge; and in test 29, it was 10 gauge. It has slanted, slotted holes to facilitate assembly of the splice as shown in figure 19. It was sandwiched between the two layers of thrie-beam rail element.

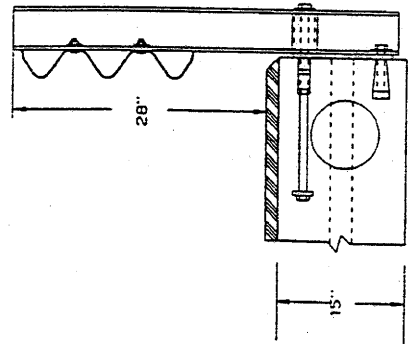
Figure 22. Summary of results for test 7069-17.

considered fair. The occupant risk factors were within the limits recommended in the 1989 AASHTO guide specifications.<sup>(3)</sup> The vehicle trajectory at loss of contact indicates minimum intrusion into adjacent traffic lanes.

Performance of the railing in this test is judged acceptable, as indicated in figure 22 and table 3.

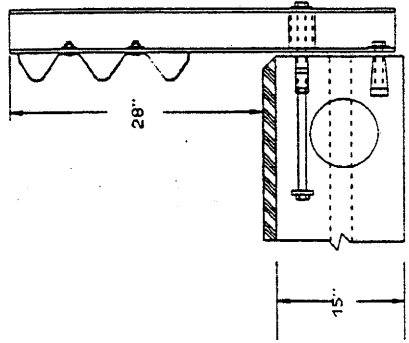
Figure 25. Summary of results for test 7069-18.

Performance of the railing in this test is judged acceptable, as indicated in figure 25 and table 4.

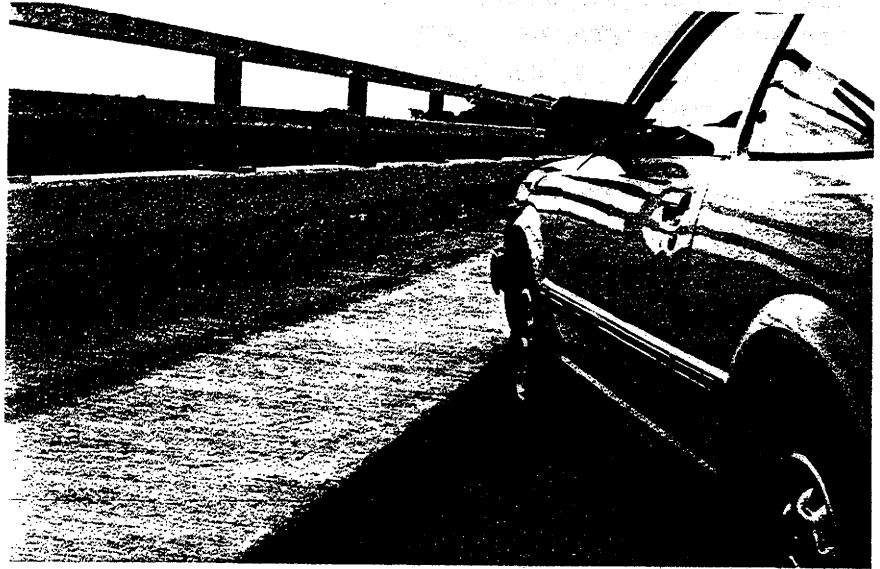
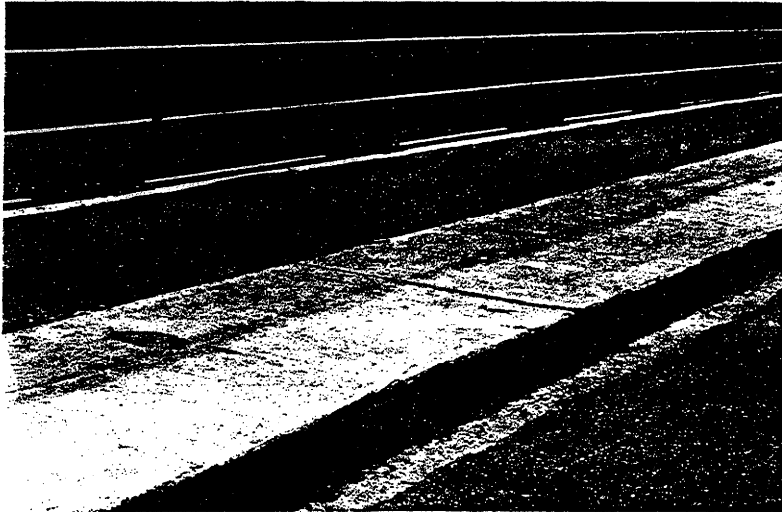
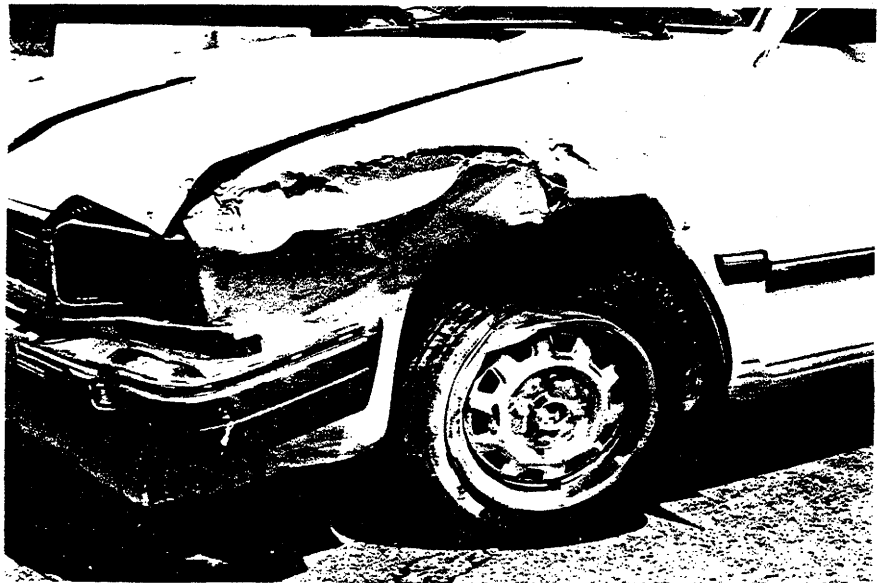
Figure 26. Vehicle and railing for test 7069-22.

As can be seen in figure 26, the bridge railing system received minimal damage. There was no measurable permanent deformation to the railing elements and only cosmetic damage to the concrete parapet. There were tire marks on the concrete parapet and on the face of the lower metal railing element in the area of impact, and also on the lower part of post 6. The vehicle was in contact with the bridge railing for 11.5 ft (3.5 m). Length of contact with the concrete parapet was 7.0 ft (2.1 m).

The vehicle sustained damage to the left side as shown in figure 26. Maximum crush at the left front corner at bumper height was 6.0 in (152 mm). The left front strut was damaged and the left front wheel was canted inward at the bottom and pushed back reducing the wheelbase on the driver side by 2 in (51 mm). Also, damage was done to the front bumper, hood, left headlight, left front quarter panel, left rear quarter panel, left front and rear tires and rims, and right front tire.

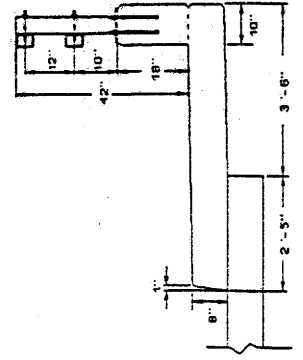
Figure 27. Summary of results for test 7069-22.

smoothly redirected the vehicle. The effective coefficient of friction was considered marginal. The occupant impact velocities and the occupant ridedown accelerations were within the limits. Vehicle trajectory at loss of contact indicated minimum intrusion into adjacent traffic lanes.

Performance of the railing in this test is judged acceptable, as indicated in figure 27 and table 5.

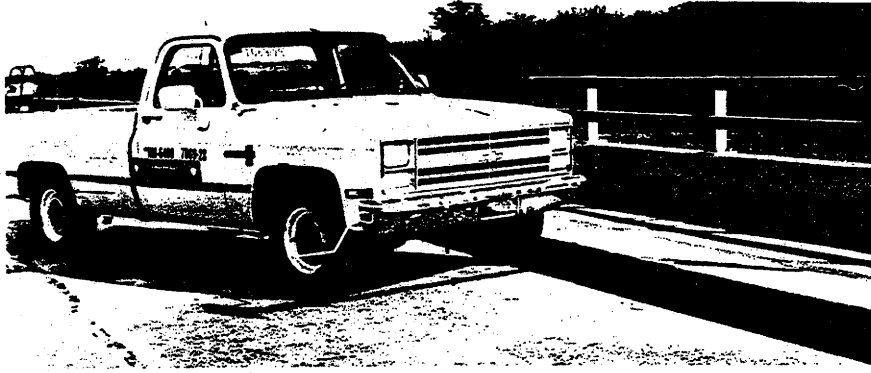
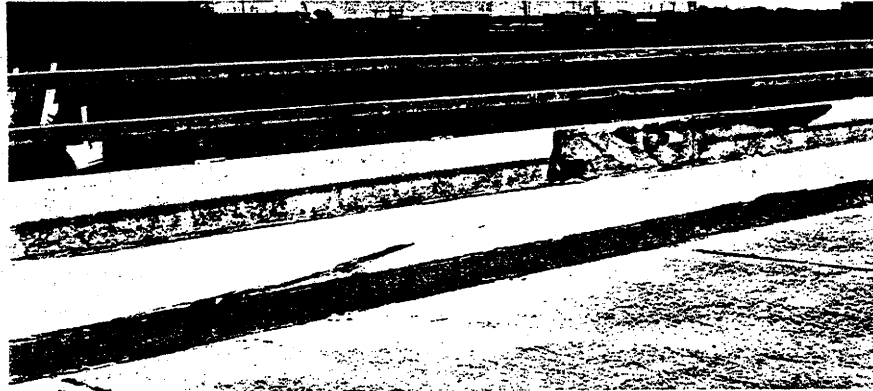
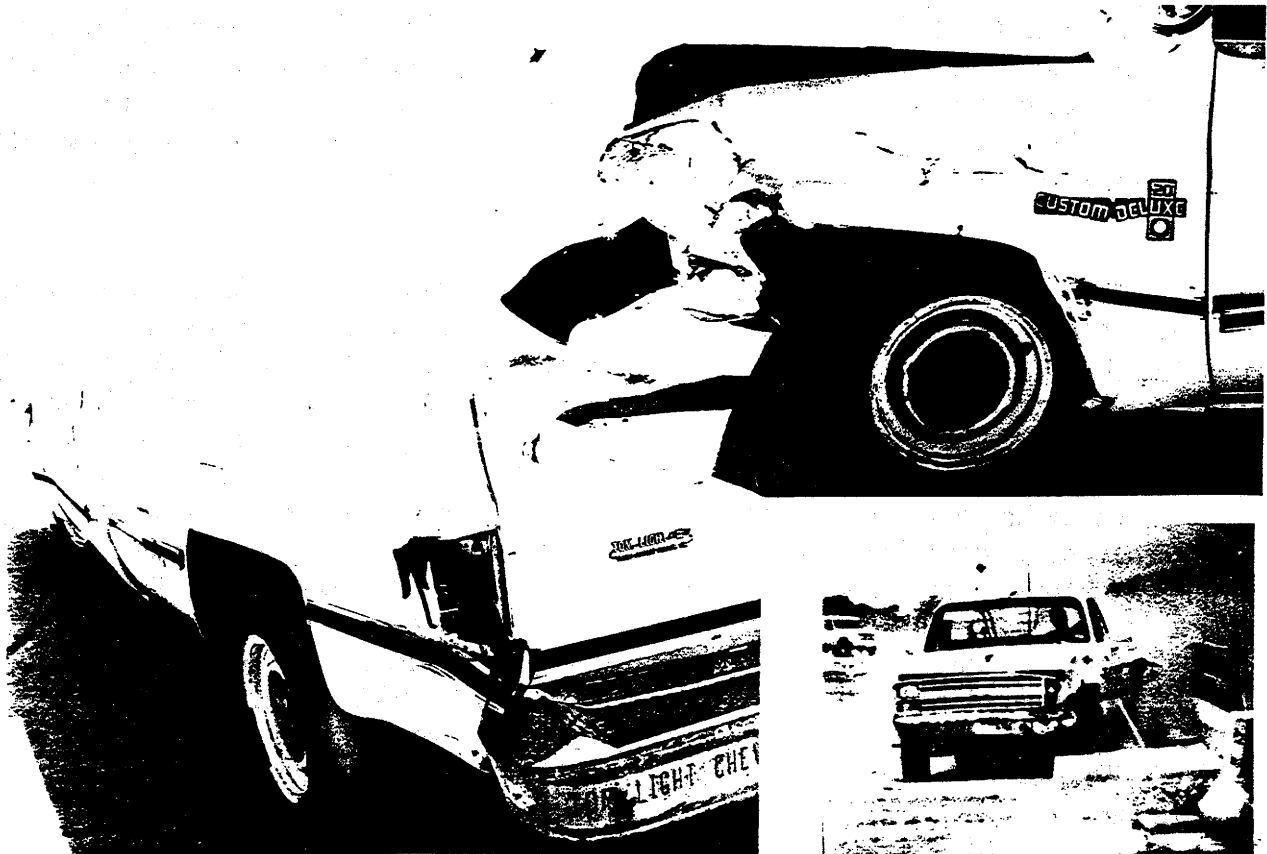
Figure 28. Vehicle and railing for test 7069-23.

The bridge railing received minimal damage (figure 28). The maximum permanent deformation to the railing element was 0.5 in (13 mm) between posts 5 and 6. Posts 5 and 6 were also pushed rearward approximately 3/16 in (05 mm). There was only cosmetic damage to the concrete parapet. There were tire marks on the concrete parapet, on the face of the lower metal railing element in the area of impact, and also on the lower part of posts 5 and 6.

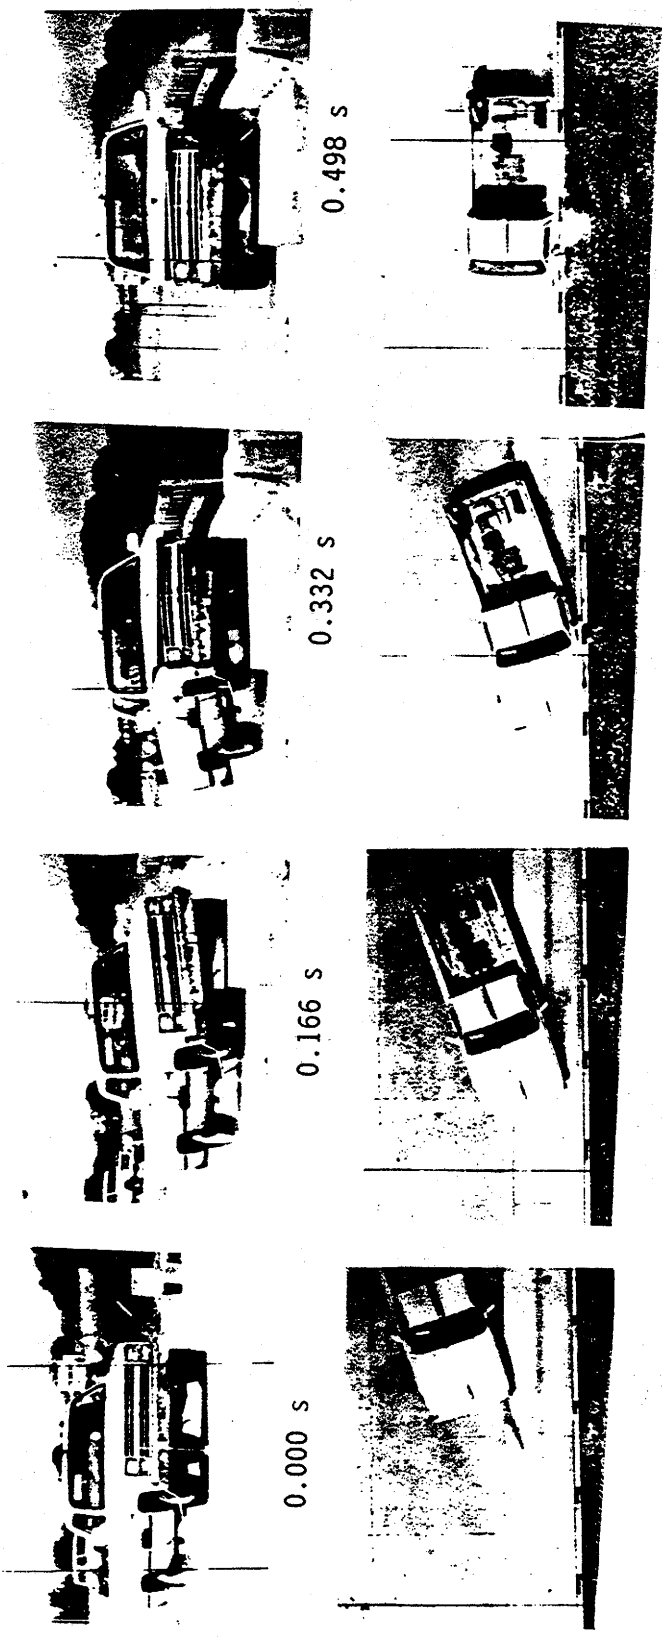
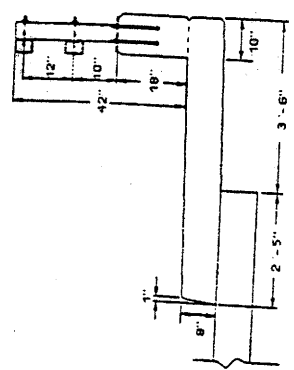
Figure 29. Summary of results for test 7069-23.

Performance of the railing in this test is judged acceptable, as indicated in figure 29 and table 6.

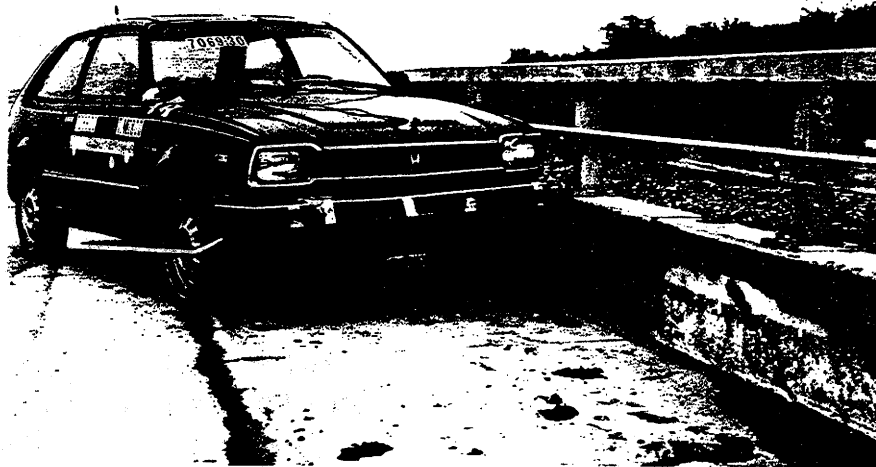
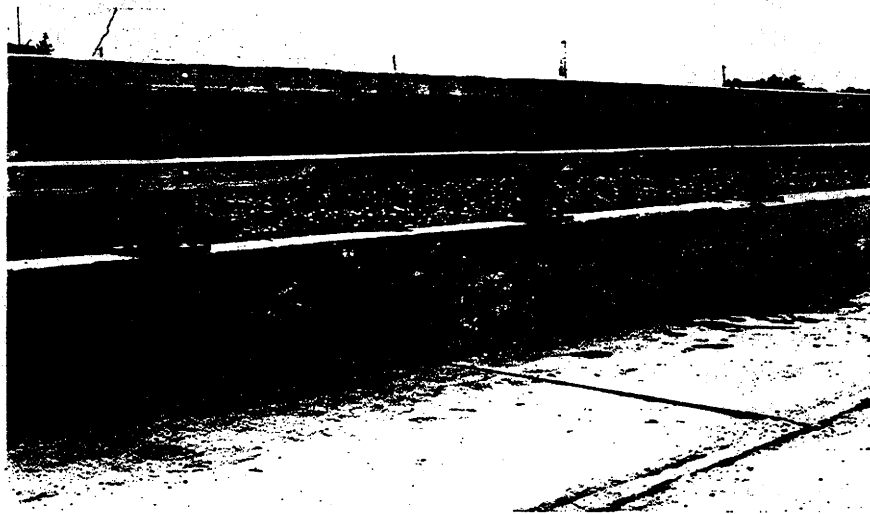
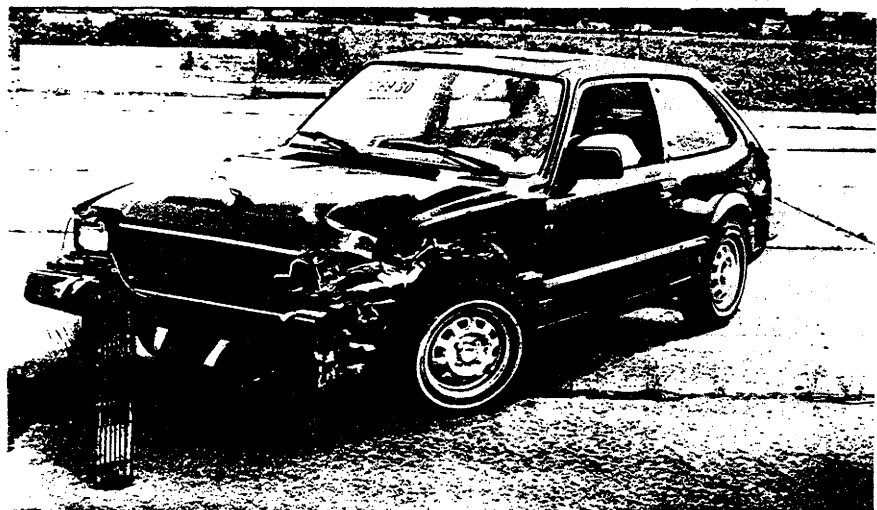
Figure 30. Vehicle and railing for test 7069-30.

The railing contained the vehicle with no lateral movement of the metal railing element of the bridge railing system. There was no intrusion of railing components into the occupant compartment and no debris to present undue hazard to other traffic. The integrity of the occupant compartment was maintained with no intrusion and no deformation. The vehicle remained upright and relatively stable during the collision. The bridge railing smoothly redirected the vehicle. The effective coefficient of friction was considered good. The occupant impact velocities and the occupant ridedown accelerations were within the limits. The vehicle trajectory at loss of contact indicated minimum intrusion into adjacent traffic lanes.

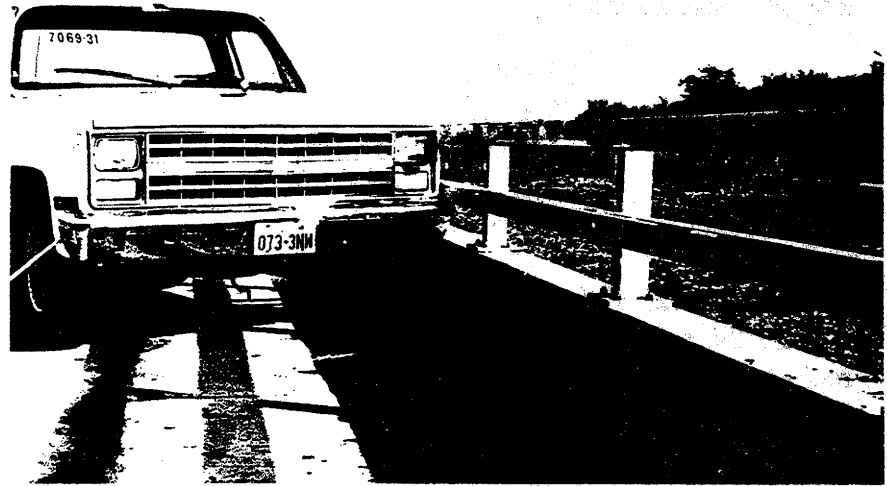
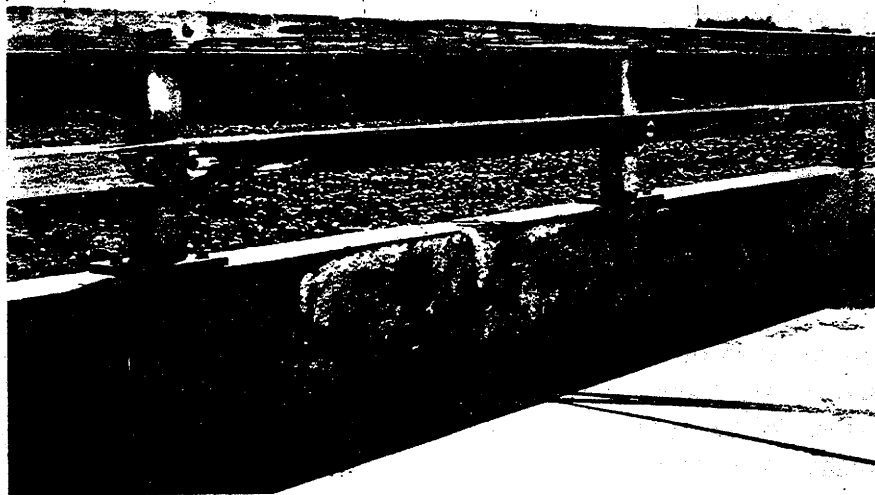
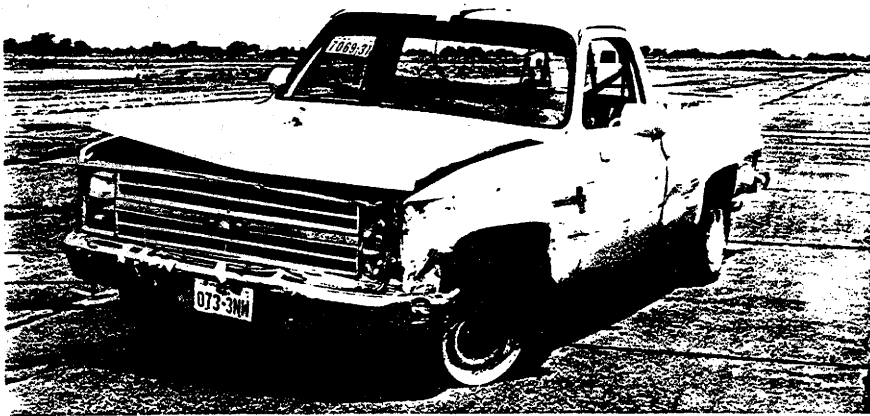
Figure 32. Vehicle and railing for test 7069-31.

The bridge railing received minimal damage (figure 32). The maximum permanent deformation to the railing element was 0.5 in (13 mm) between posts 5 and 6. There was only cosmetic damage to the concrete parapet. There were tire marks on the concrete parapet, on the face of the lower metal railing element in the area of impact, and also on the lower part of post 6.

Maximum crush of the vehicle at the left front corner at bumper height was 6.5 in (165 mm), and the right side was deformed outward 4.0 in (102 mm) (figure 32). Also, damage was done to the front bumper, hood, grill, left front quarter panel, left door, left rear quarter panel, left front and rear tires and rims, rear bumper, and right front quarter panel and right door.

The railing contained the vehicle with minimal lateral movement of the metal railing element of the bridge railing system. There was no intrusion of railing components into the occupant compartment and no debris to present undue hazard to other traffic. The integrity of the occupant compartment was maintained with no intrusion and no deformation. The vehicle remained upright and relatively stable during the collision. The bridge railing smoothly redirected the vehicle. The effective coefficient of friction was considered good. The occupant impact velocities and the occupant ridedown accelerations were within the limits. The vehicle trajectory at loss of contact indicated minimum intrusion into adjacent traffic lanes.

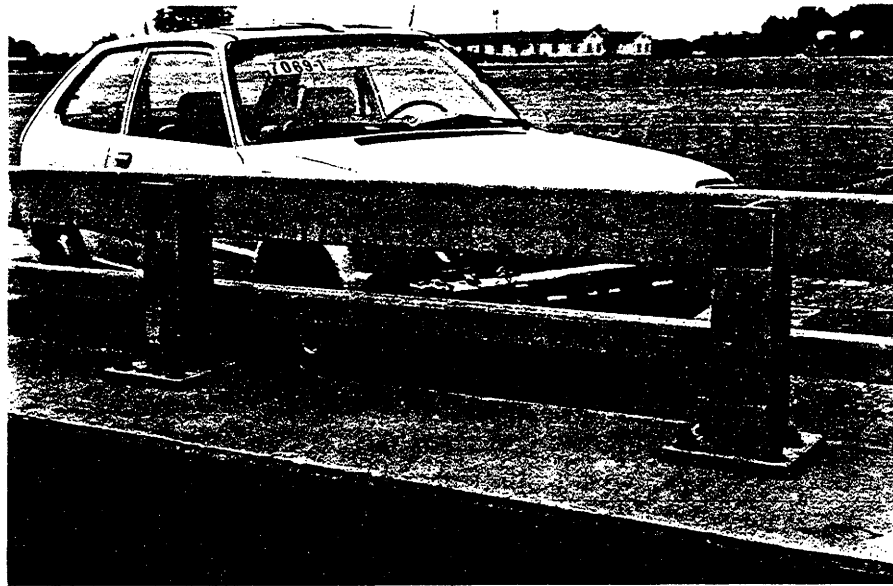
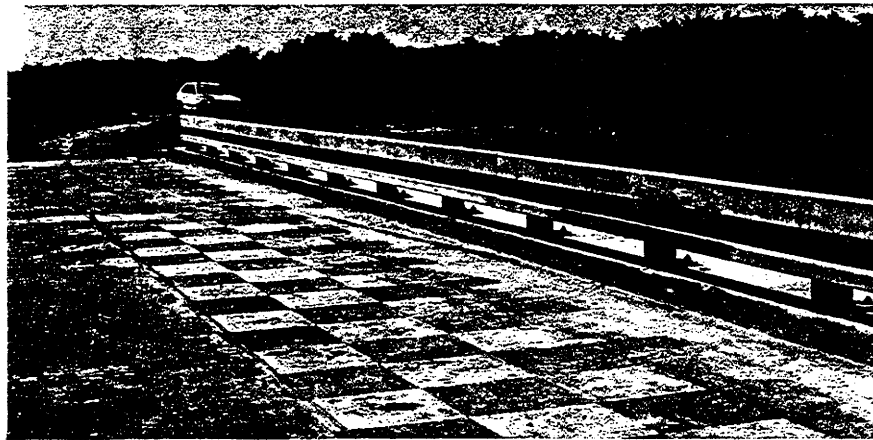
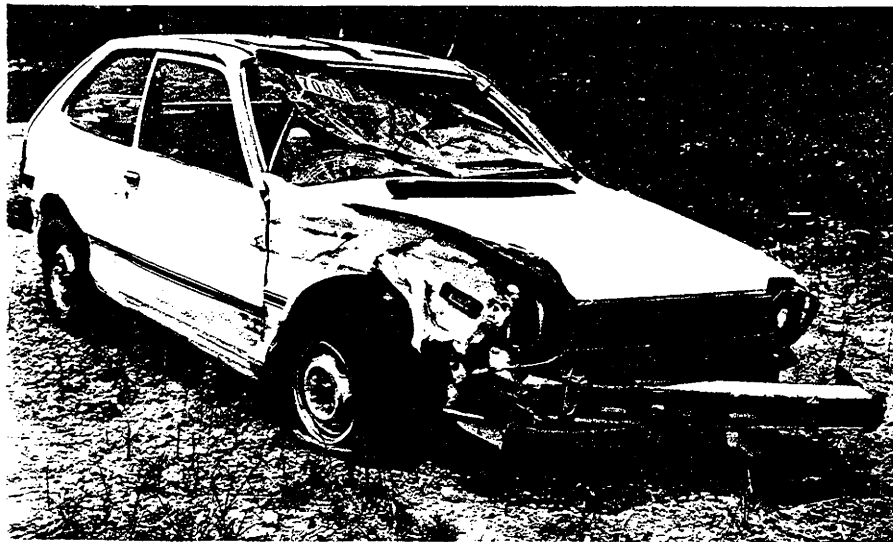
Figure 34. Vehicle and railing for test 7069-1.

The railing received very little damage (figure 34). There were tire marks on the face of the railings and the curb and minor chips on the edge of the curb. There was no measurable movement or deformation in the railing.

The vehicle sustained extensive damage to the right front (figure 34). Maximum crush at the right front corner at bumper height was 8.0 in (203 mm). The right front tire was deflated, the rim was bent, and the suspension was damaged. The front bumper was disconnected on the left side but still attached on the right side. The passenger door was bent and jammed and the right rear quarter panel was bent and scraped. The hood was bent and shifted to the left. The windshield frame was bent and the windshield was broken and partially out. The roof of the vehicle was twisted.

The railing contained and smoothly redirected the vehicle with no lateral movement of the railing. There were no debris or detached elements. There was minimal intrusion into the occupant compartment. The vehicle trajectory at loss of contact indicates minimum intrusion into adjacent traffic lanes. The vehicle remained upright and stable during the entire test period.

Due to the slightly high lateral occupant impact velocity of 25.1 ft/s (7.7 m/s), performance of the railing in this test is considered marginally acceptable (as indicated in figure 35 and table 10).

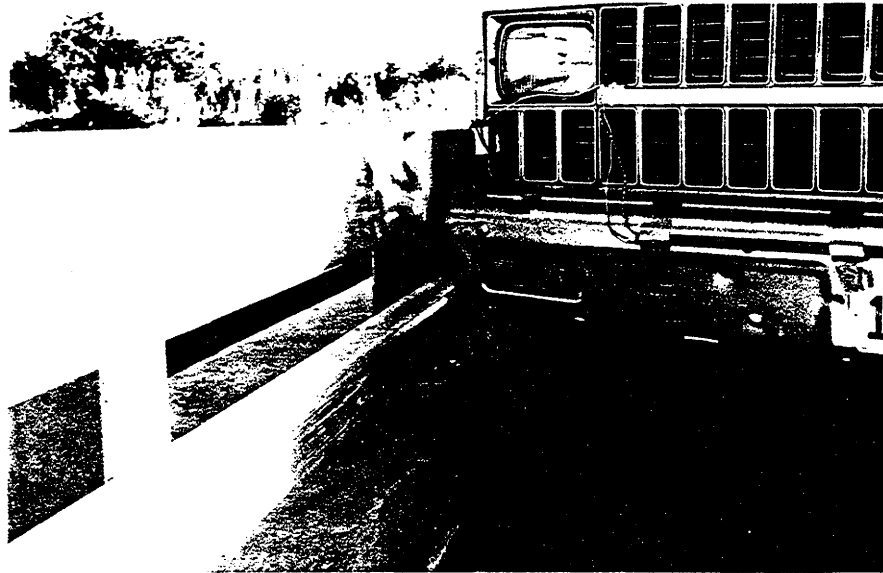
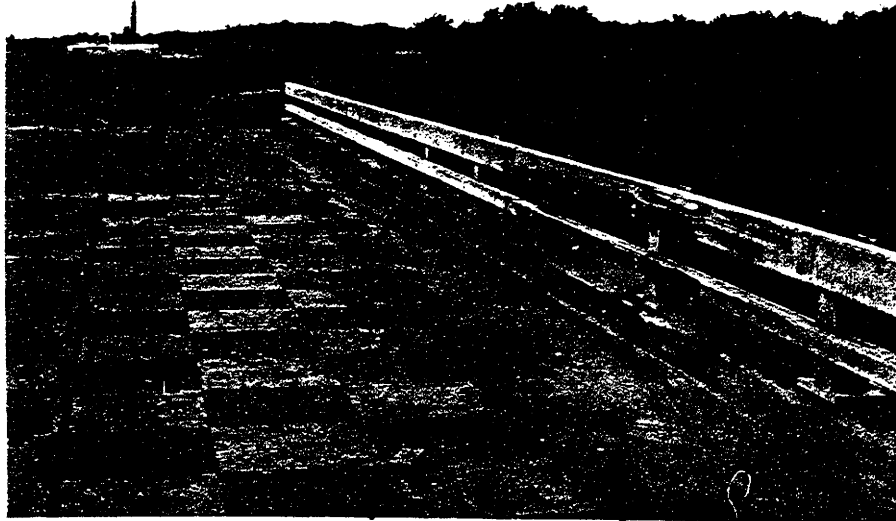
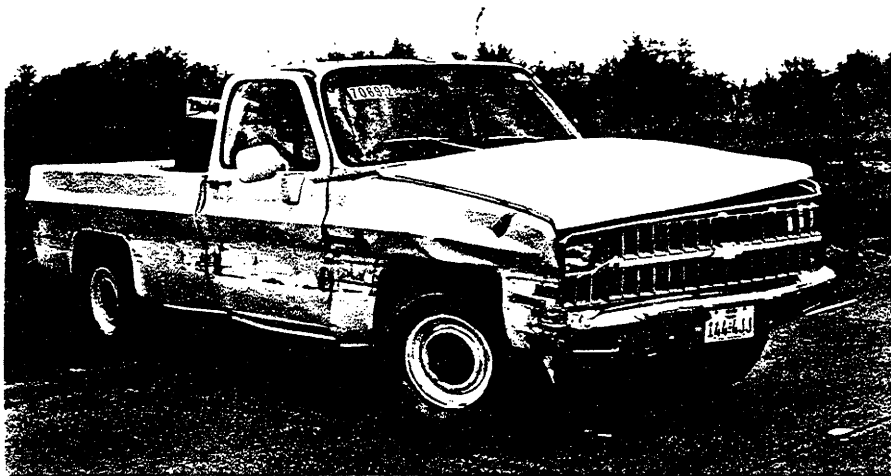
Figure 36. Vehicle and railing for test 7069-2.

The railing received moderate damage (figure 36). There were tire marks on the face of the railings and the curb and minor chips on the edge of the curb. The maximum dynamic deflection of the railing was 2.4 in (61 mm) and maximum permanent deformation was 0.5 in (13 mm). The front of the base plate on post 6 was pulled up slightly and the concrete was chipped around the bolts to the rear of the base plate.

The vehicle sustained extensive damage to the right front corner (figure 36). Maximum crush at the right front corner at bumper height was 5.0 in (127 mm). The right front and right rear wheel rims were bent and the wheel assembly and suspension damaged. The passenger door was bent and jammed and the right rear panel was dented and scraped. The hood was bent and shifted to the left. The windshield frame was bent and the windshield was cracked. The cab of the vehicle was twisted and the frame was bent.

The railing contained and smoothly redirected the vehicle with minimal lateral movement of the railing. There were no debris or detached elements. There was no intrusion into the occupant compartment. The vehicle trajectory at loss of contact indicated minimum intrusion into adjacent traffic lanes. The vehicle remained upright and stable during the entire test period.

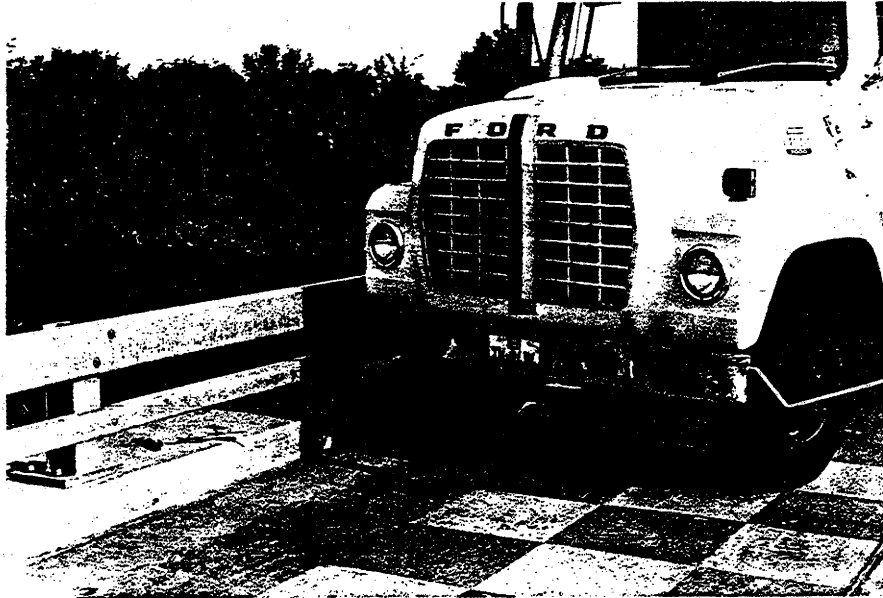
Figure 38. Vehicle and railing for test 7069-15.

The railing contained and smoothly redirected the vehicle with minimal lateral movement of the railing. There was no intrusion into the occupant compartment and very little deformation of the compartment. The vehicle trajectory at loss of contact indicated minimum intrusion into adjacent traffic lanes, and the vehicle remained relatively stable during the collision.

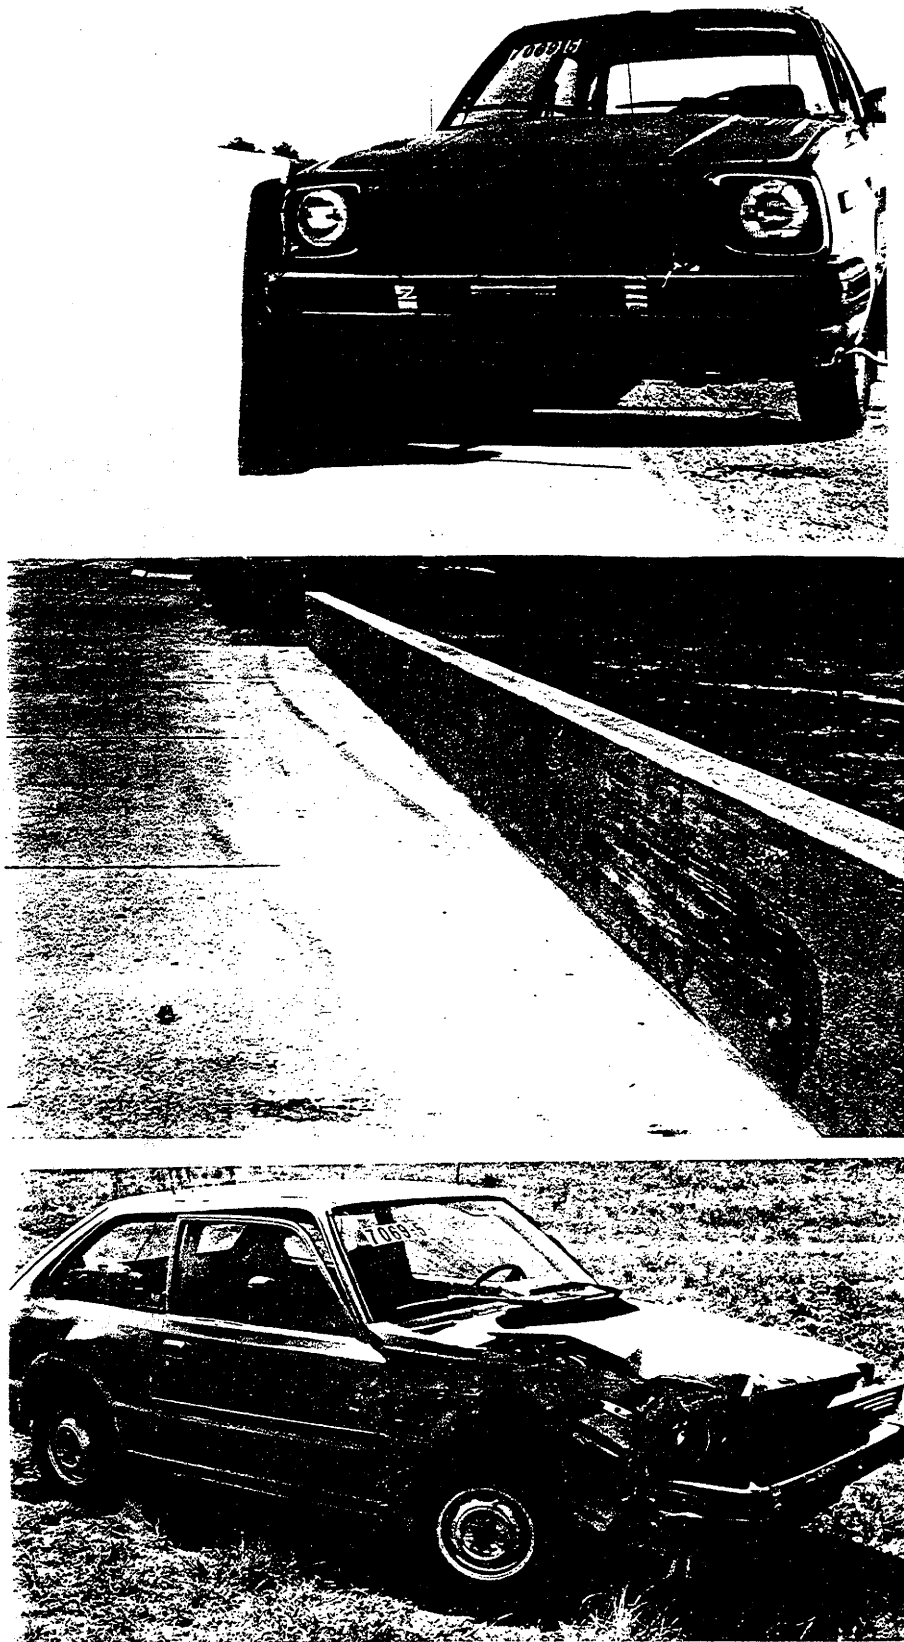
Figure 40. Vehicle and parapet for test 7069-5.

The parapet received cosmetic damage only (figure 40). There were tire marks on the face of the parapet. The vehicle was in contact with the parapet for 10.3 ft (3.1 m).

The vehicle sustained extensive damage to the right front as shown in figure 40. Maximum crush at the right front corner at bumper height was 5.0 in (127 mm). The right front and right rear wheel rims were bent, and the right front strut was bent. The passenger door was bent and jammed, and the right side was dented and scraped. The hood was bent and shifted to the left. The windshield frame was bent, and the windshield was cracked. The roof of the vehicle was buckled and twisted.

The parapet contained and smoothly redirected the vehicle with no lateral movement of the parapet. There were no debris or detached elements. There was no intrusion into the occupant compartment although some deformation of the compartment occurred. The vehicle trajectory at loss of contact indicated minimum intrusion into adjacent traffic lanes. The vehicle remained upright and stable during the entire test period.

The lateral occupant impact velocity of 26.0 ft/s (7.9 m/s) is higher than the maximum acceptable value of 25 ft/s (7.6 m/s). However, the authors conclude that the performance of this parapet in this test is acceptable on the basis of two arguments. The value obtained is marginally close to being acceptable. The acceptable value was selected as a reasonably achievable value for impact angles of 15 degrees, not the more severe condition of 20 degrees used in this test. See figure 41 and table 13.

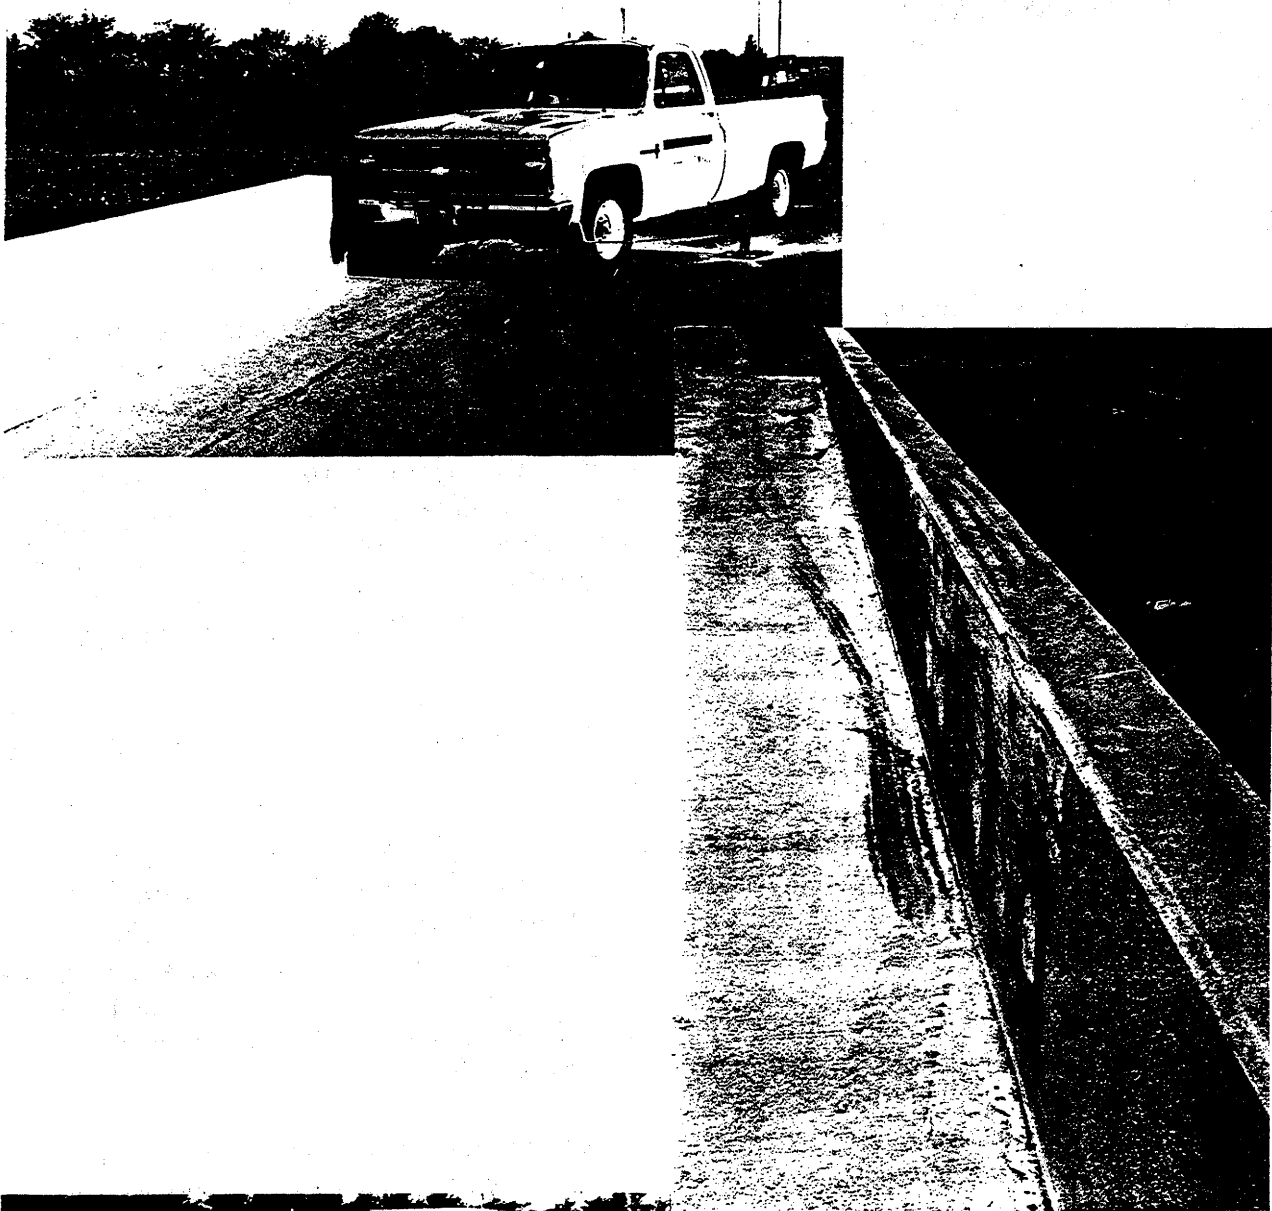
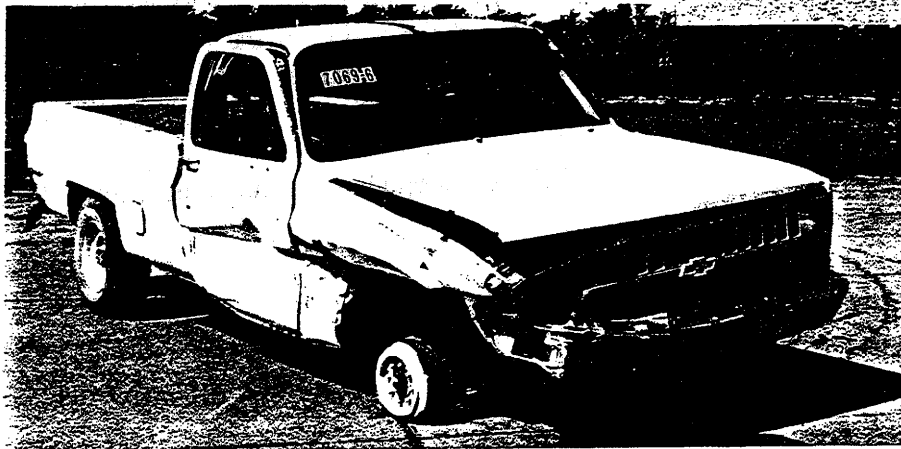
Figure 42. Vehicle and parapet for test 7069-6.

The parapet received only cosmetic damage as shown in figure 42. There were tire marks on the face of the parapet.

The vehicle sustained extensive damage to the right side (figure 42). Maximum crush at the right front corner at bumper height was 9.0 in (229 mm). The right front and right rear wheel rims were bent, and the welds had broken on the right front wheel rim, allowing the outer rim and tire to become completely separated. The wheel assembly and suspension were damaged. The passenger door was bent and jammed, and the window was broken. The right rear panel was dented and scraped. The hood was bent and shifted to the left. The cab of the vehicle was twisted, and the frame was bent.

The parapet contained and smoothly redirected the vehicle with minimal lateral movement of the parapet. There were no debris or detached elements. There was no intrusion into the occupant compartment although some deformation of the right door occurred. The vehicle trajectory at loss of contact indicated minimum intrusion into adjacent traffic lanes. The vehicle remained upright and stable during the entire test period.

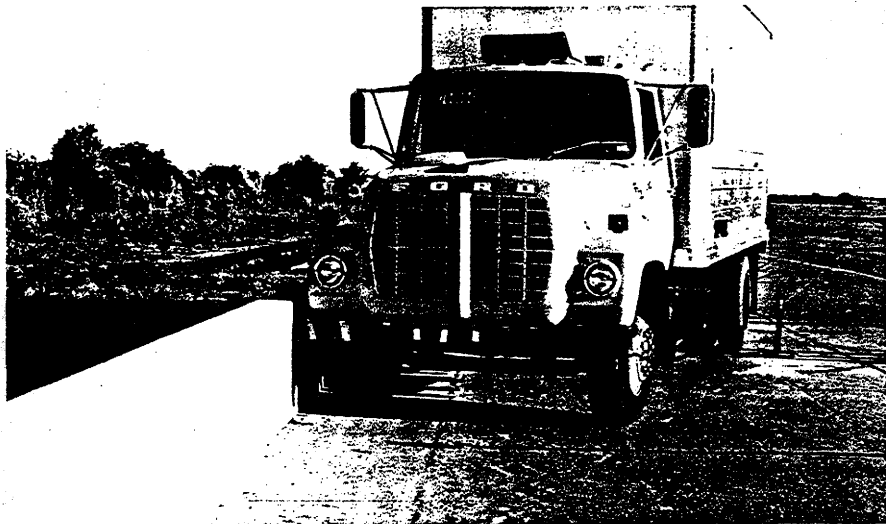
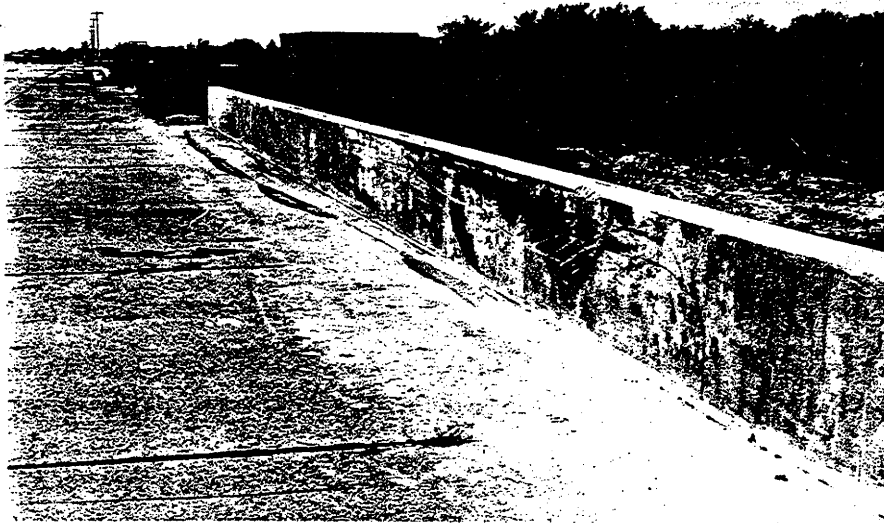
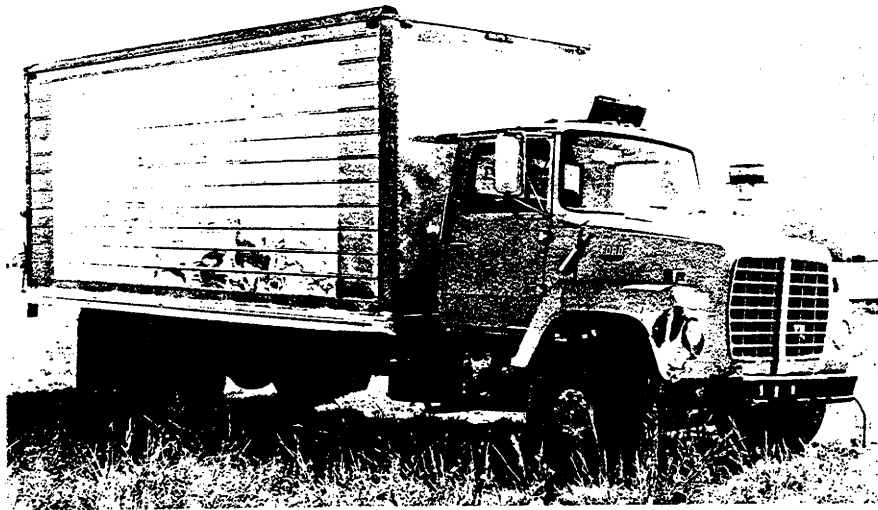
Figure 44. Vehicle and parapet for test 7069-16.

The parapet received only cosmetic damage (figure 44). There were tire marks on the face of the parapet and along the top for about 30 ft (9 m). The bed of the vehicle scraped the top of the parapet for another 15 ft (4.6 m).

The vehicle sustained moderate damage to the right side (figure 44). Maximum crush at the right front corner at bumper height was 10.0 in (254 mm). The front bumper, the hood, and the right front quarter were damaged, and the windshield was cracked. The rear U-bolt on the right front springs was broken, and the springs were dislocated. The fuel tank and straps were also damaged.

The parapet contained and smoothly redirected the vehicle with no lateral movement of the parapet. There was no intrusion into the occupant compartment and very little deformation of the compartment. The vehicle trajectory at loss of contact indicated minimum intrusion into adjacent traffic lanes.
