# Testing of New Bridge Rail and Transition Designs

## Volume I: Technical Report

PUBLICATION NO. FHWA-RD-93-058

7. Author(s) C. Eugene Buth, T. J. Hirsch, and Wanda L. Menges		8. Performing Organization Report No. Research Foundation 7069-Vol. I	
9. Performing Organization Name and Address Texas Transportation Institute The Texas A&M University System College Station, Texas 77843-3135		10. Work Unit No. NCP No. 3A5C0042	11. Contract or Grant No. DTFH61-86-C-00071

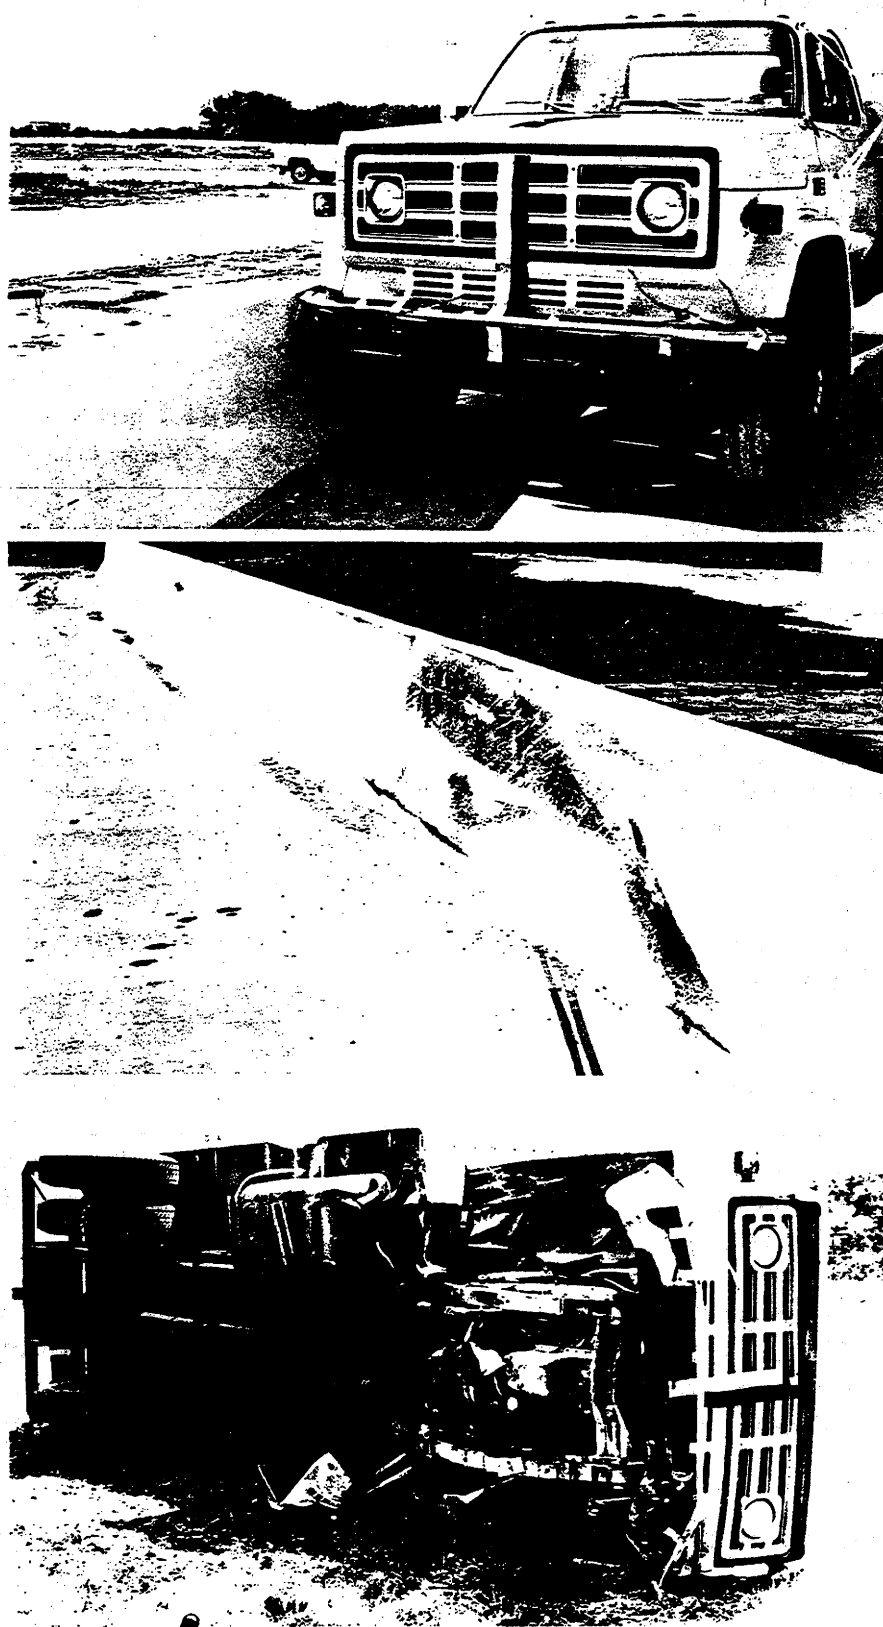
Figure 46. Vehicle and safety shape for test 7069-12.

The safety shape received only cosmetic damage and some scraping and gouging (figure 46). There were tire marks on the face and top of the safety shape. The top of the safety shape was scraped along the remaining length by the undercarriage of the truck.

The safety shape contained and redirected the vehicle with no lateral movement of the safety shape. There was no intrusion into the occupant compartment and very little deformation of the compartment. The vehicle trajectory at loss of contact indicated minimum intrusion into adjacent traffic lanes; however, the vehicle did not remain upright after collision.

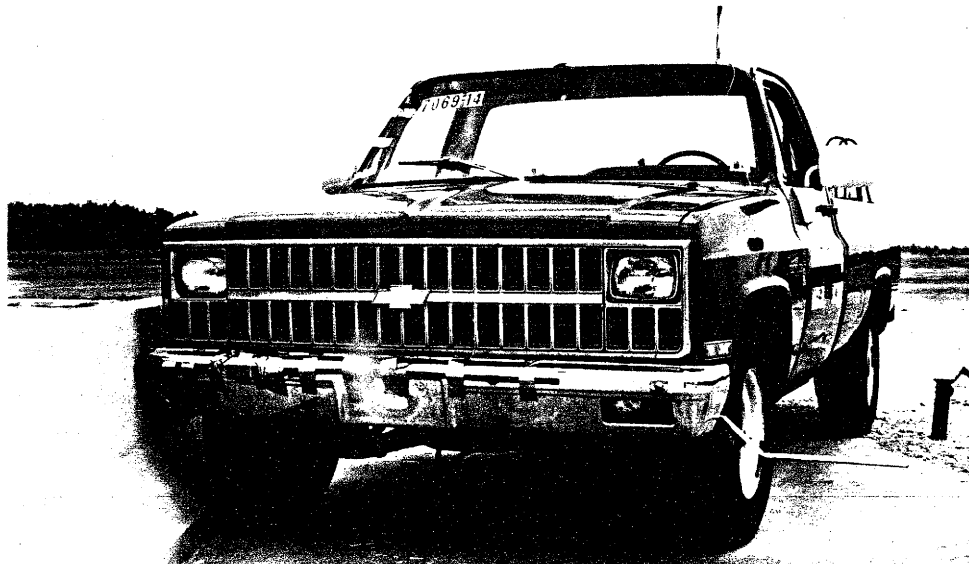
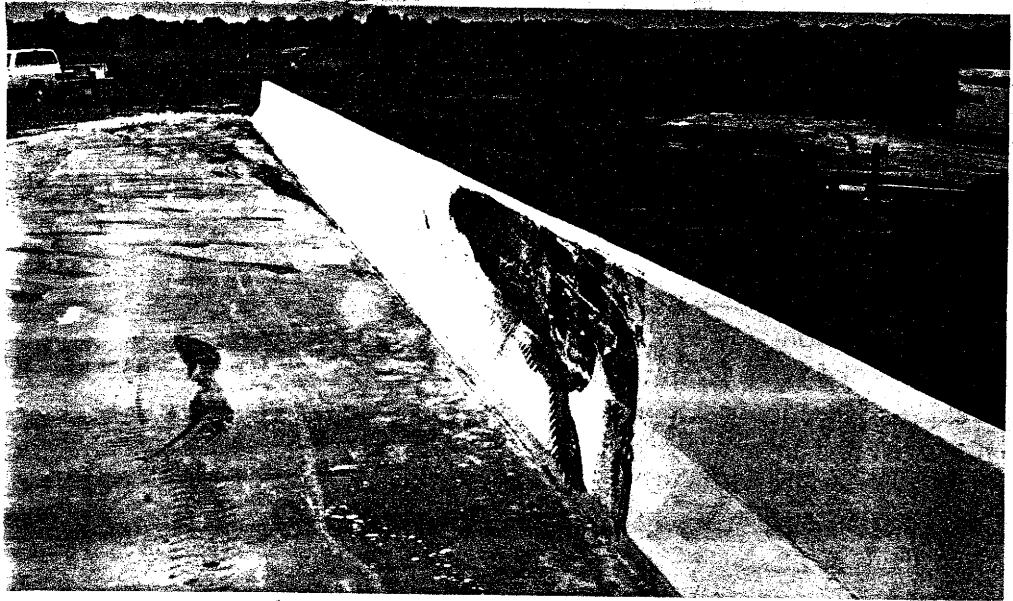
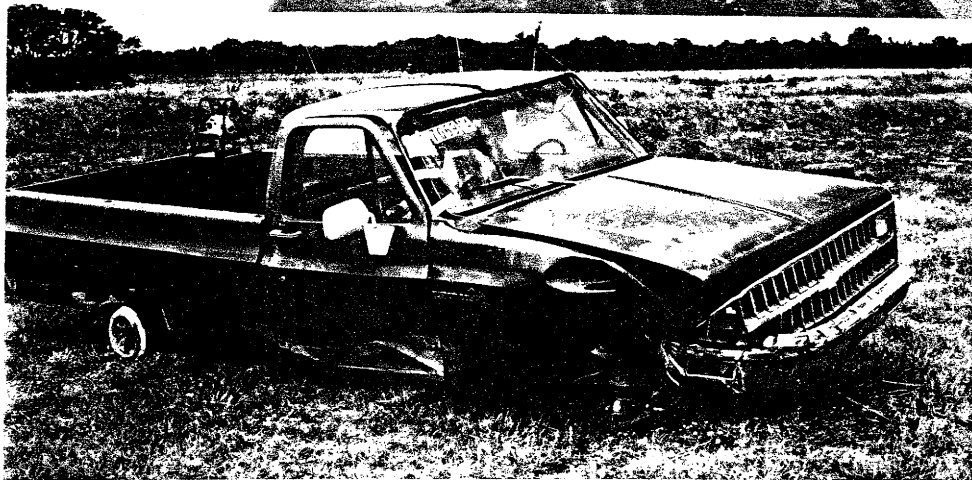
Figure 48. Vehicle and safety shape for test 7069-14.

The safety shape received only cosmetic damage (figure 48). There were tire marks on the face and top of the safety shape.

The vehicle sustained extensive damage to the right side (figure 48). Maximum crush at the right front corner at bumper height was 12.0 in (307 mm). The right front suspension system broke away from the vehicle, and the right rear tire and wheel rim broke at the welded connection points. There was damage to the right ball joints and tie rods, as well as the upper and lower control arms. The left rear tire was deflated.

The safety shape contained and smoothly redirected the vehicle with no lateral movement of the safety shape. There was no intrusion into the occupant compartment and minimal deformation of the compartment. The vehicle trajectory at loss of contact indicated minimum intrusion into adjacent traffic lanes. The vehicle remained upright and relatively stable during the collision.

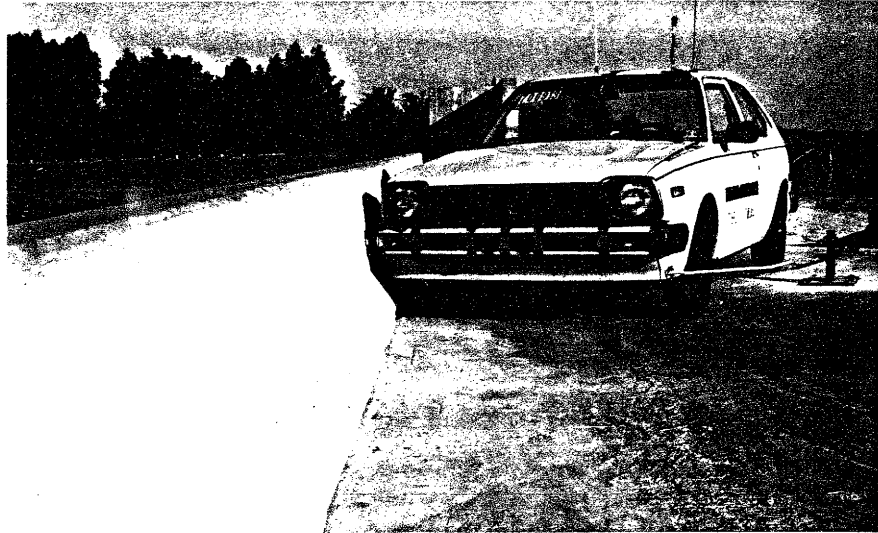
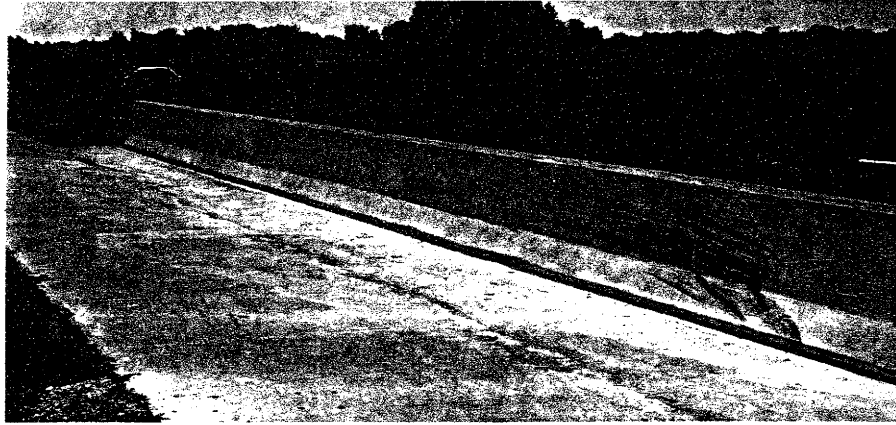
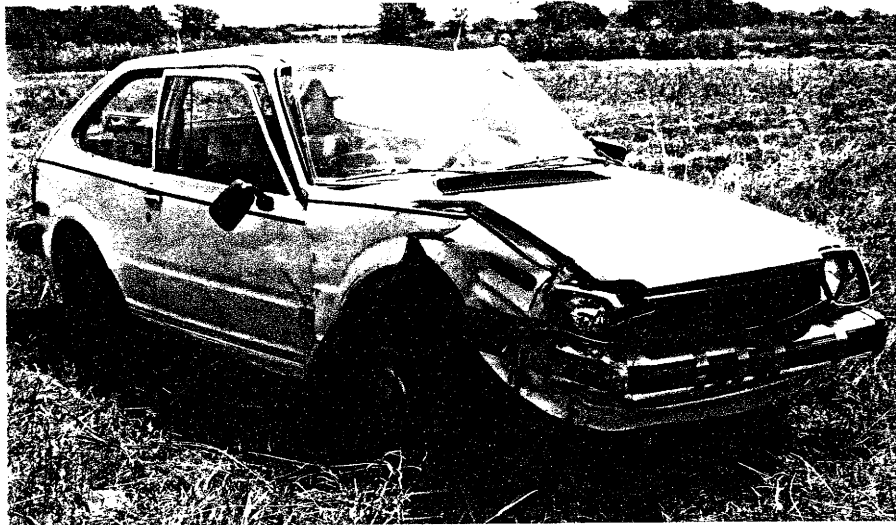
Figure 50. Vehicle and F-shape for test 7069-3.

The railing received cosmetic damage only (figure 50). There were tire marks on the face of the bridge railing indicating the vehicle rose a maximum height of about 27 in (610 mm).

The vehicle sustained extensive damage to the right front corner (figure 50). Maximum crush at the right front corner at bumper height was 9.0 in (229 mm). The right front and right rear wheel rims were bent and the wheel assembly and suspension damaged. The passenger door was bent and jammed and the right side was dented and scraped. The hood was bent and shifted to the left. The windshield frame was bent and the windshield was cracked. The roof of the vehicle was buckled and twisted.

The railing contained and smoothly redirected the vehicle with no lateral movement of the railing. There were no debris or detached elements. There was no intrusion into the occupant compartment although some deformation of the compartment occurred. The vehicle trajectory at loss of contact indicated minimum intrusion into adjacent traffic lanes. The vehicle remained upright and stable during the entire test period.

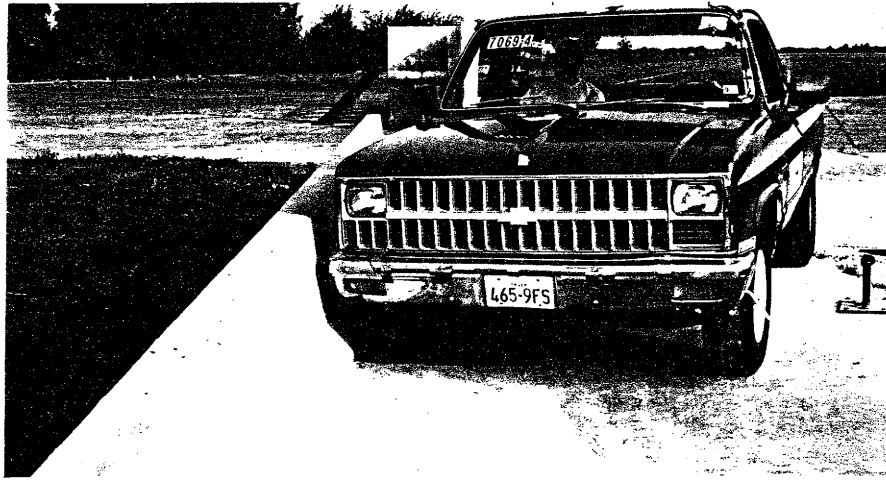
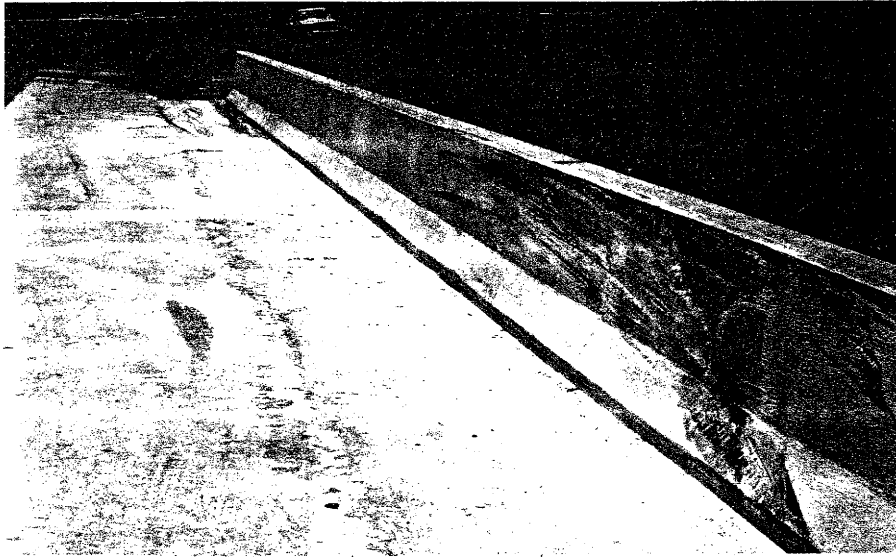
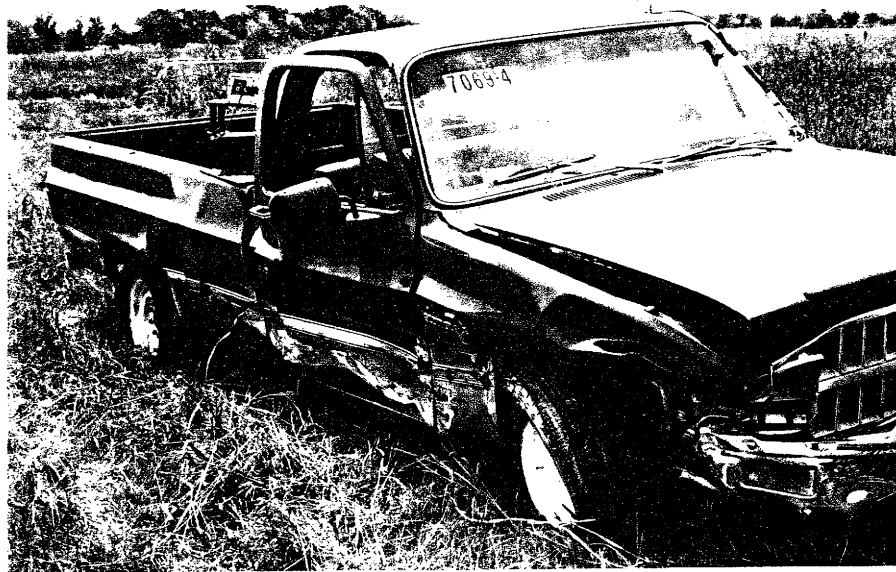
Figure 52. Vehicle and F-shape for test 7069-4.

The railing received only cosmetic damage (figure 52). There were tire marks on the face of the bridge railing which indicated the vehicle rose a maximum height of 24 in (610 mm) above the ground.

The vehicle sustained extensive damage to the right side (figure 52). Maximum crush at the right front corner at bumper height was 5.0 in (127 mm). The right front and right rear wheel rims were bent and the tires were deflated. The wheel assembly and suspension was damaged. The passenger door was bent and jammed and the window broken out. The right rear panel was dented and scraped. The hood was bent and shifted to the left. The cab of the vehicle was twisted.

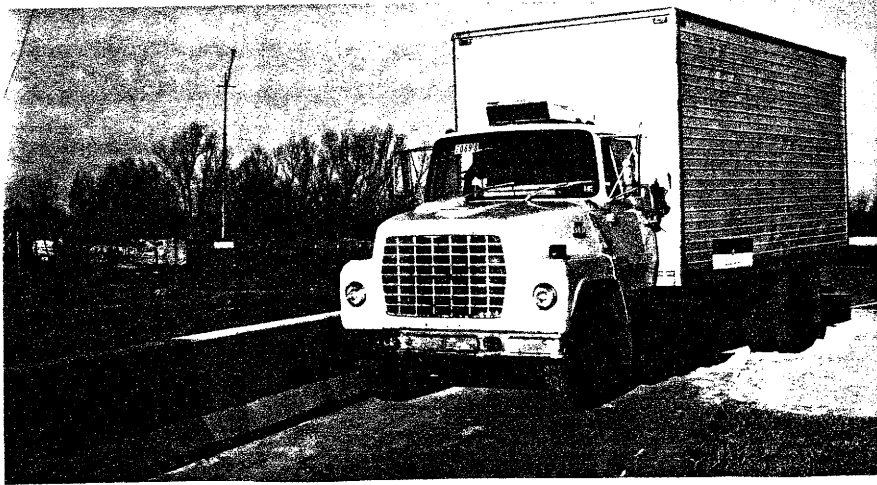
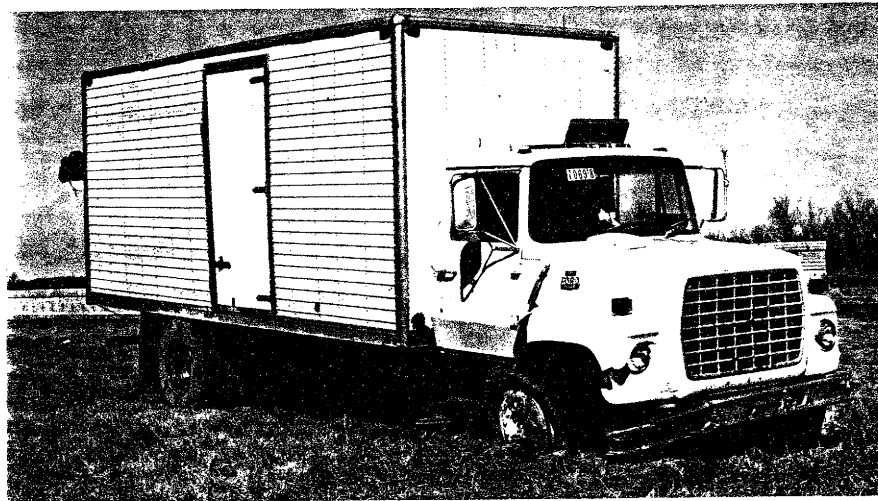
Figure 54. Vehicle and F-shape for test 7069-8.

The railing received only cosmetic damage (figure 54). There were tire marks on the face of the bridge railing and along the top. The top of the bridge railing was scraped along the remaining length from the lower edge of the bed of the truck.

The vehicle sustained extensive damage to the right side (figure 54). Maximum crush at the right front corner at bumper height was 6.0 in (152 mm). The right front wheel rim was bent and the tire damaged. The spring and spring shackle was broken loose from the axle. The steering gear box and steering cylinder was damaged. Also, the fuel tank broke loose from the truck.

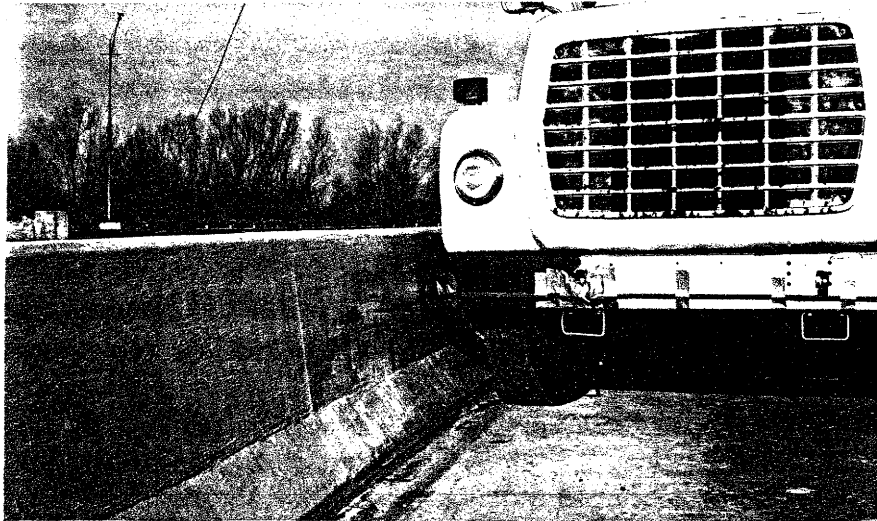
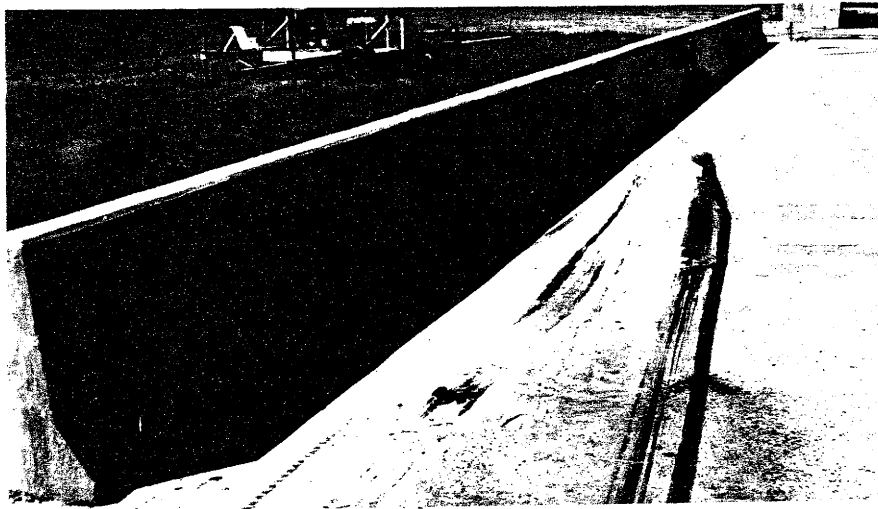
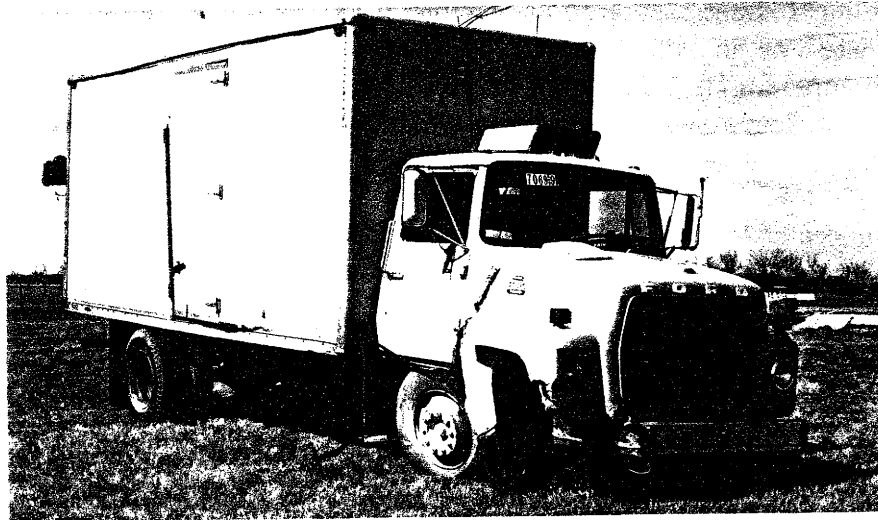
Figure 56. Vehicle and F-shape for test 7069-9.

The railing received only cosmetic damage (figure 56). There were tire marks on the face of the railing and along the top. The top of the bridge railing was scraped along the remaining length from the lower edge of the bed of the truck.

The vehicle sustained extensive damage to the right side (figure 56). Maximum crush at the right front corner at bumper height was 16.0 in (406 mm). The right front wheel rim was bent and the tire damaged. The spring and spring shackle was broken loose from the axle and the axle torn loose on the left side. The steering gear box and steering cylinder was damaged. Also, the fuel tank broke loose from the truck.

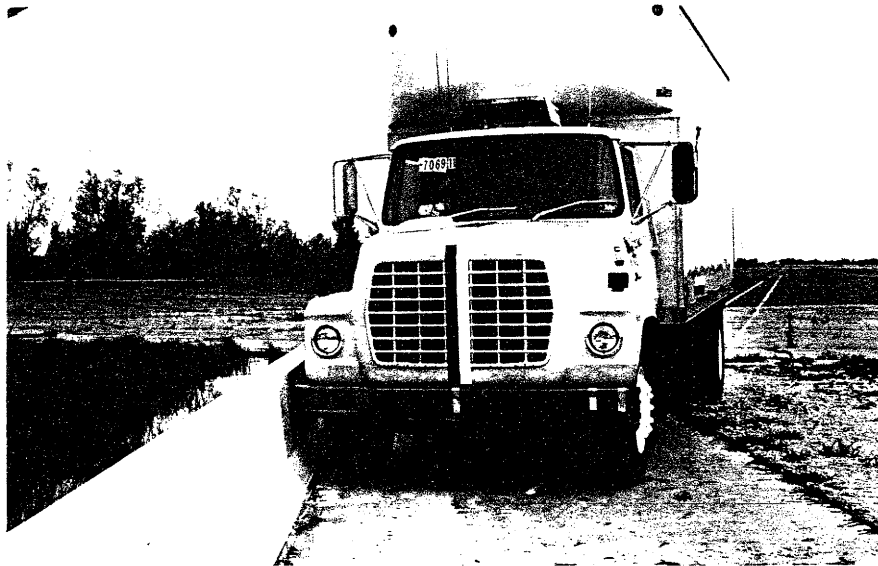
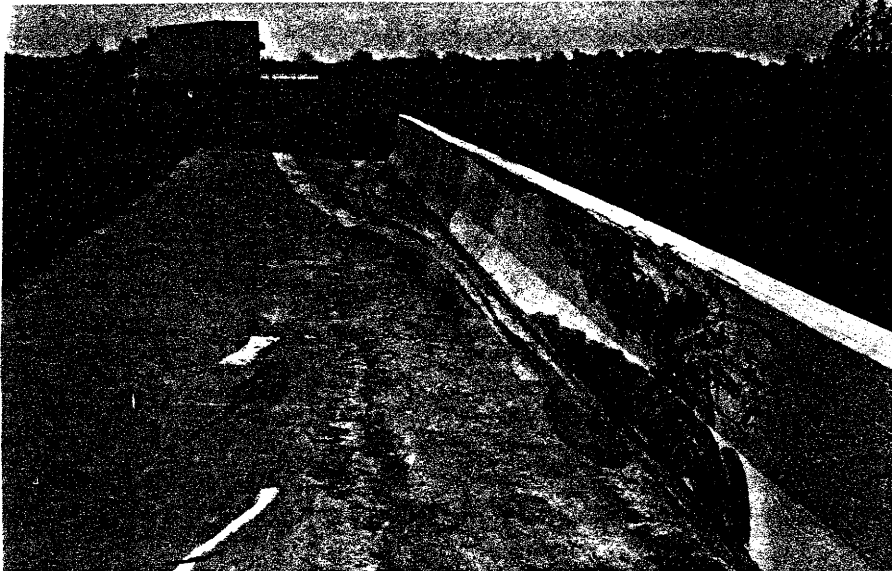
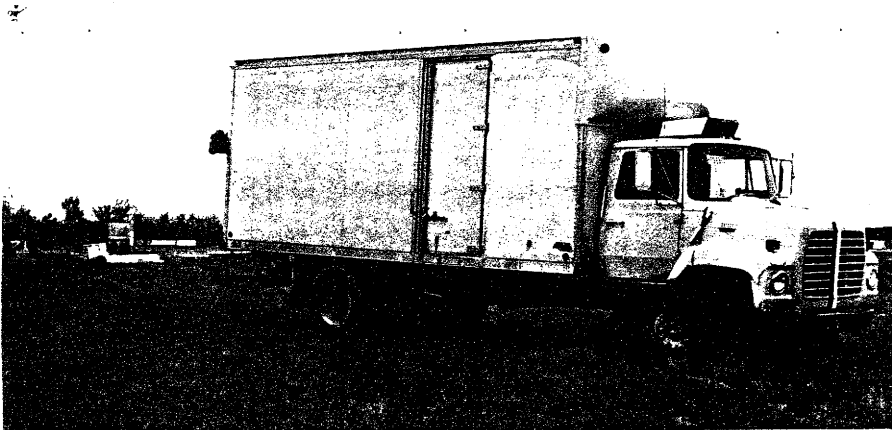
Figure 58. Vehicle and F-shape for test 7069-11.

The railing received only cosmetic damage (figure 58). There were tire marks on the face of the bridge railing and along the top. The top of the bridge railing was scraped along the remaining length from the lower edge of the bed of the truck. The vehicle was in contact with the bridge railing for 39 ft (12 m).

The vehicle sustained extensive damage to the right side as shown in figure 58. Maximum crush at the right front corner at bumper height was 20.0 (508 mm). The front axle was torn loose which caused damage to the springs, shackles, U-bolts, and tie rods. The steering arm and cylinder were damaged and the oil pan was dented. Also, the fuel tank broke loose from the truck.

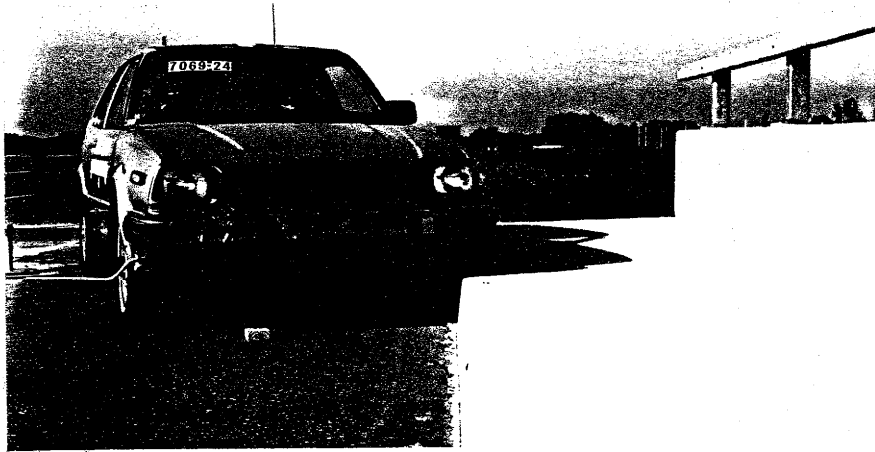
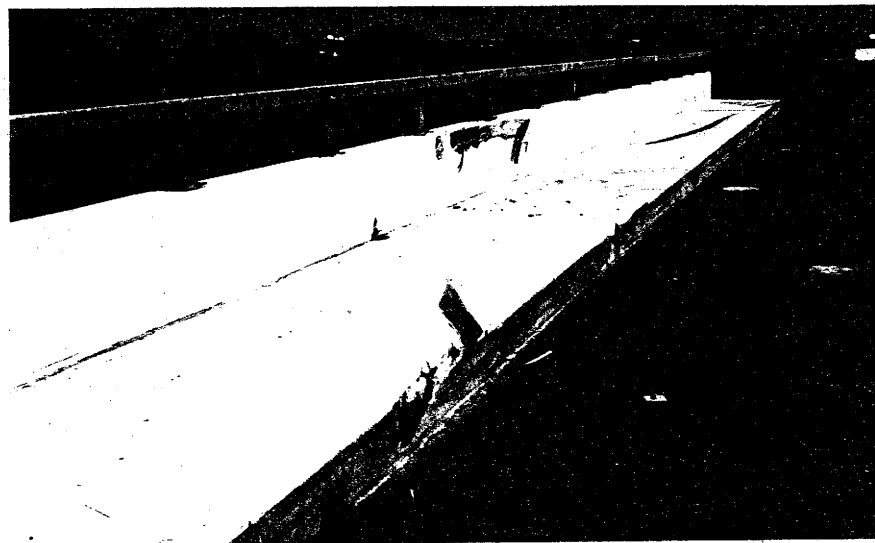
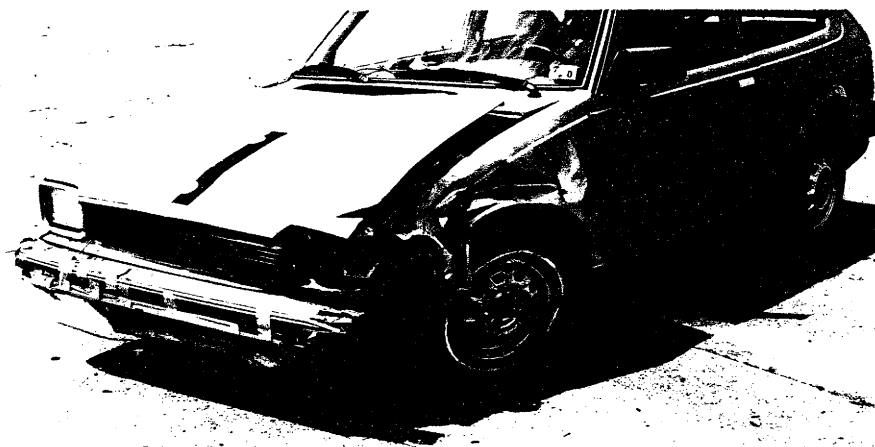
Figure 60. Vehicle and railing for test 7069-24.

The bridge railing system received minimal damage (figure 60). There was no measurable permanent deformation to the metal railing elements; however, the left corner of the bumper had snagged post 6 (leaving plastic trim). Also, posts 5 and 6 were pulled up such that the washers rotated freely under the nuts on the front side of the railing. There was only cosmetic damage to the concrete parapet, i.e., tire marks on the concrete parapet from post 5 on past post 6 and then again between posts 8 and 9 where the vehicle contacted the parapet the second time.

The vehicle sustained damage to the left side (figure 60). Maximum crush at the left front corner at bumper height was 7.5 in (191 mm). The left front strut was bent and the left front wheel was pushed back reducing the wheelbase on the driver side by 3 in (76 mm). Also damage was done to the front bumper, hood, left front quarter panel, left rear quarter panel, rear bumper, left front and rear tires and rims, and right front tire.

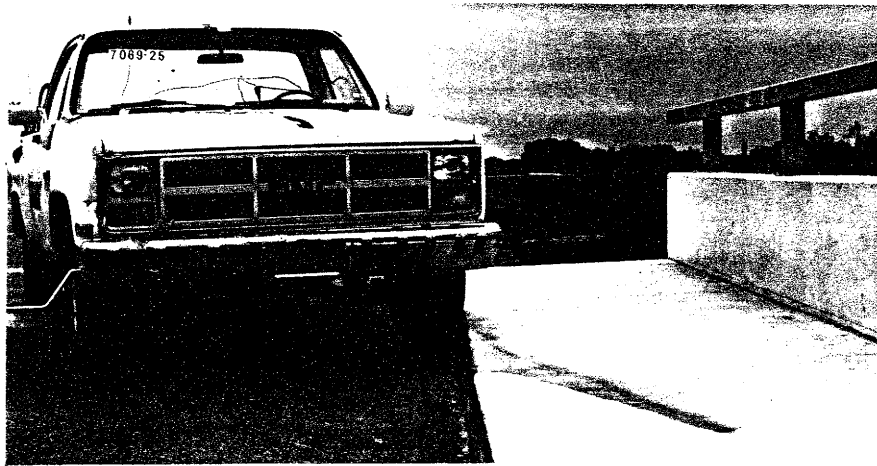
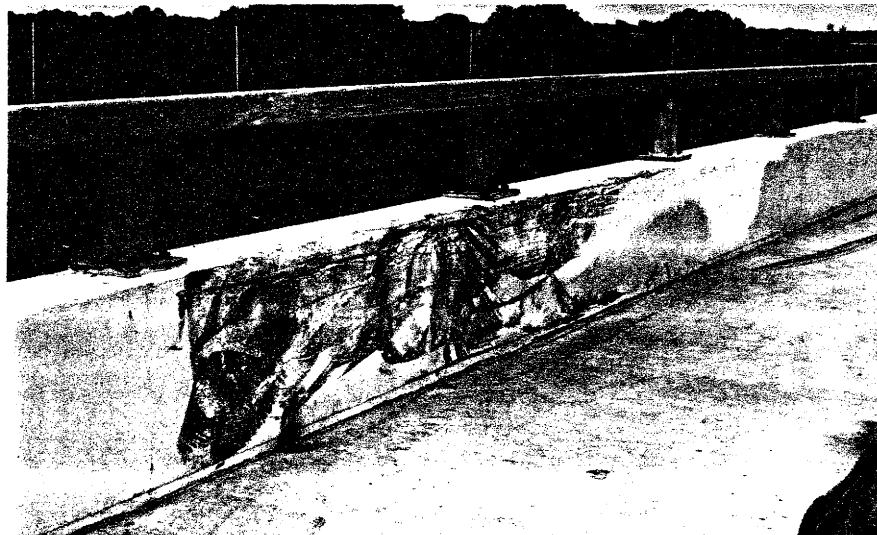
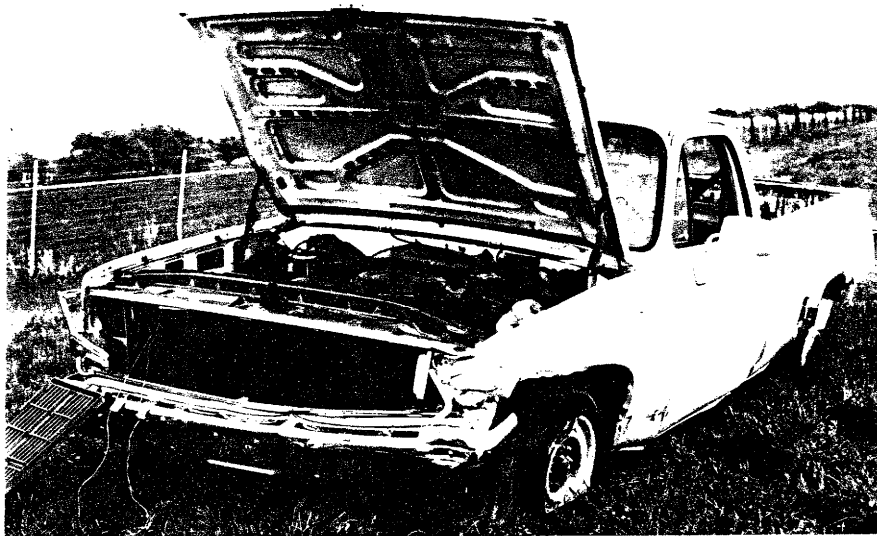
Figure 62. Vehicle and railing for test 7069-25.

The railing system received minimal damage (figure 62). There was no measurable permanent deformation to the metal railing elements; however, the left corner of the bumper had snagged post 5 and pulled it up such that the washer rotated freely under the nut on the left front side of the railing. There was only cosmetic damage to the concrete parapet, i.e., tire marks on the concrete parapet from post 4 to post 6.

The vehicle sustained damage to the left side (figure 62). Maximum crush at the left front corner at bumper height was 12.0 in (305 mm) and the right front corner was deformed outward 7.0 in (178 mm). The left front wheel was pushed back reducing the wheelbase on the driver side by 2.25 in (57 mm). Also, damage was done to the front bumper, hood, grill, the left front quarter panel, left door and glass, left rear quarter panel, rear bumper and tailgate, left front tire and rim, and right front tire. The welds on the left rear rim broke and the tire separated from the rim.

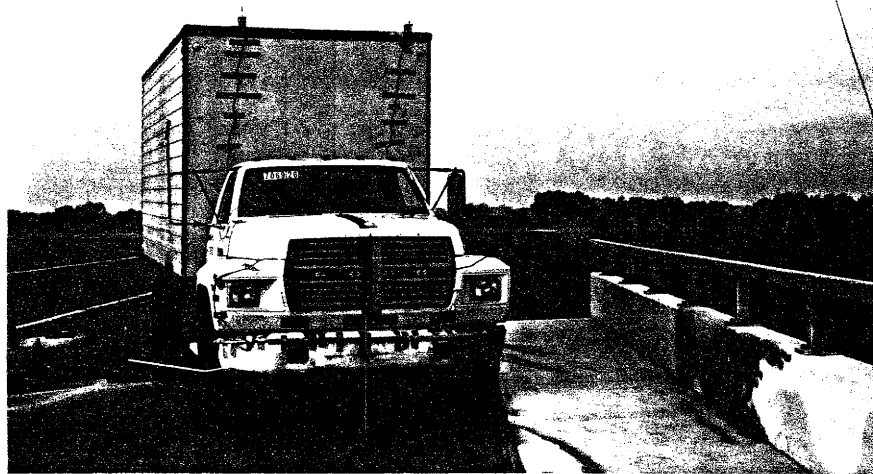
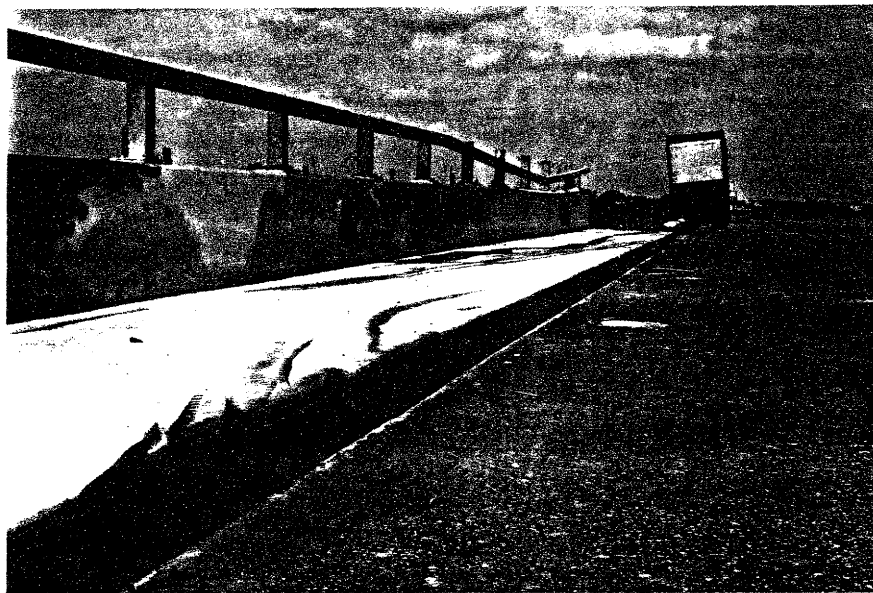
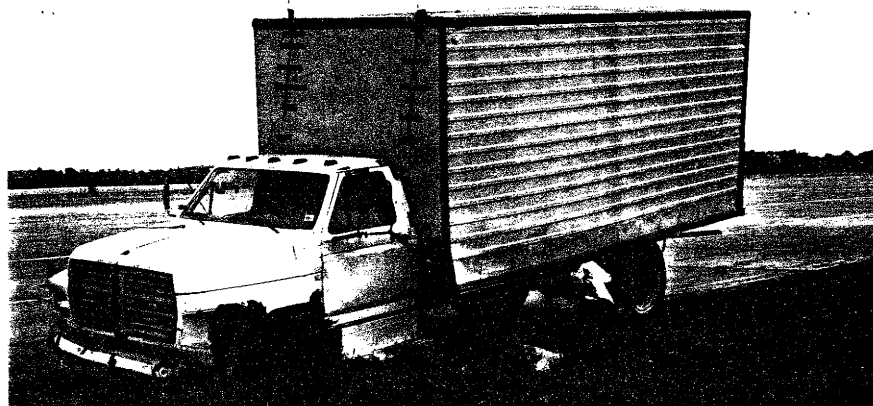
Figure 64. Vehicle and railing for test 7069-26.

The railing system received moderate damage (figure 64). There was no measurable permanent deformation to the metal railing elements in the immediate impact area; however the bolts connecting the railing to the posts from 10 through 14 were sheared as a result of vertical load from the cargo box. There was only cosmetic damage to the concrete parapet, i.e., tire marks on the concrete parapet from post midway of posts 7 and 8 to post 11 and then again from posts 13 to 14.

The vehicle sustained damage to the left side (figure 64). Maximum crush at the left front corner at bumper height was 6.0 in (152 mm). The front axle broke loose and became separated from the vehicle as did the drive shaft. There was damage to the springs and shocks, steering box, front bumper, left front quarter panel, left door, and left front tire and rim. The lower edge of the left side of the cargo box was also damaged.

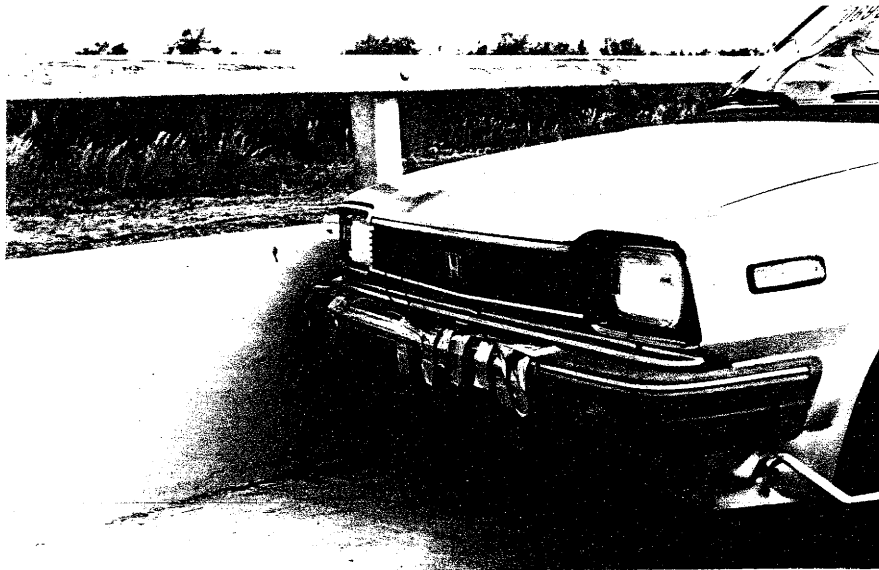
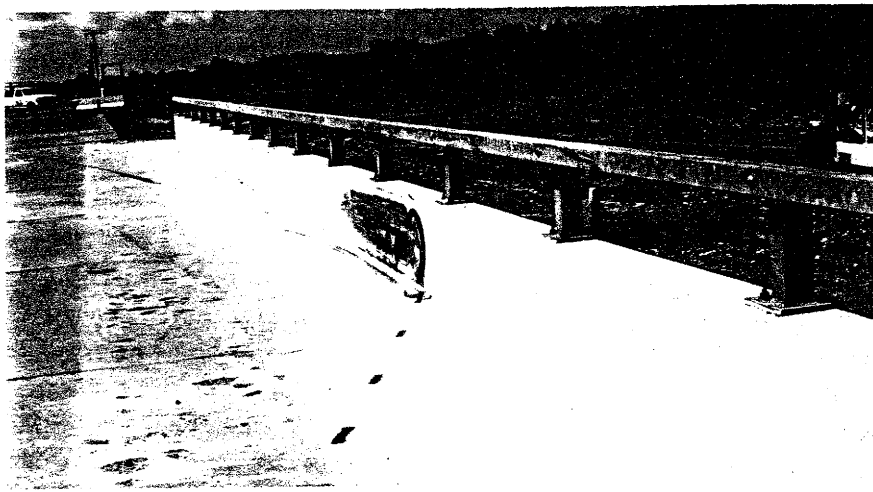
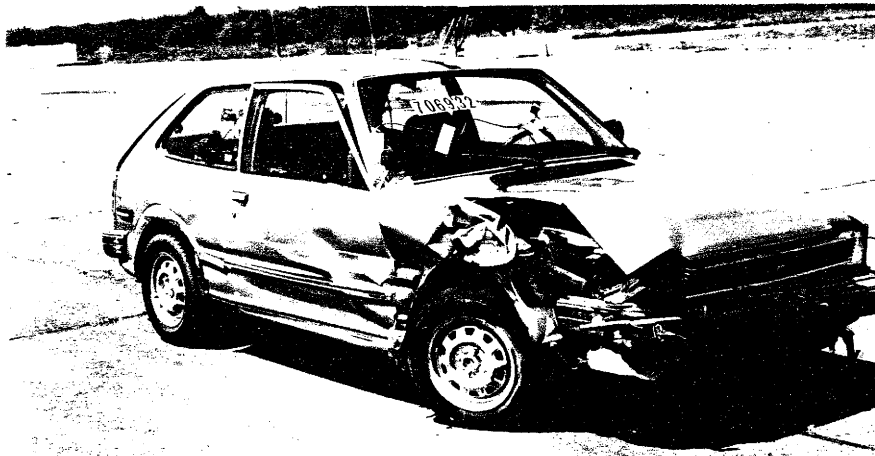
Figure 66. Vehicle and railing for test 7069-32.

The railing received minimal damage (figure 66). There was no deformation to the metal railing element.

The vehicle sustained damage to the right side (figure 66). Maximum crush at the right front corner at bumper height was 6.5 in (165 mm), and there was a 1.0-in (25-mm) dent into the occupant compartment at the fire wall. The passenger door was deformed outward approximately 1.3 in (33 mm) and the wheelbase on the right side was reduced 3.0 in (76 mm). An 8-in by 14-in by 7/16-in (203-mm by 356-mm by 11-mm) deep dent in the roof just over the right rear passenger location. The right front strut and sway bar were damaged and the instrument panel was bent. Also, damage was done to the front bumper, hood, grill, radiator, fan, right front quarter panel, right front rim, right door, right rear quarter panel, and right rear rim.

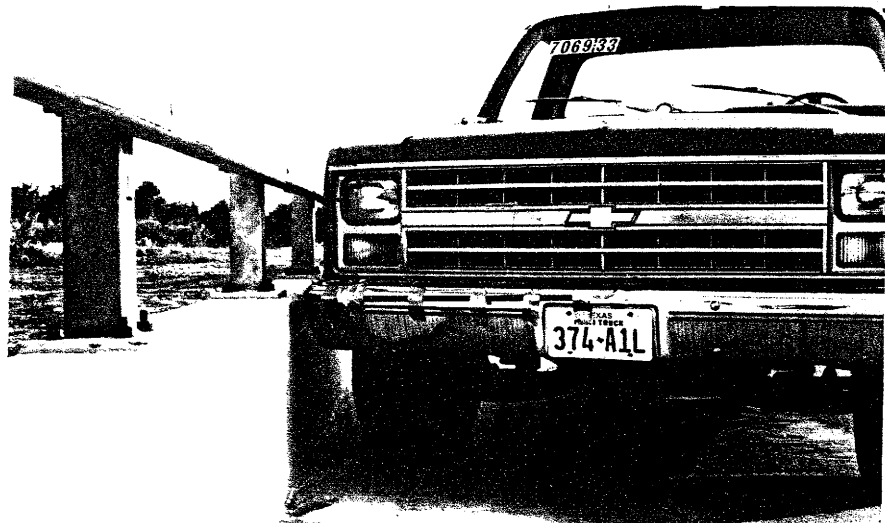
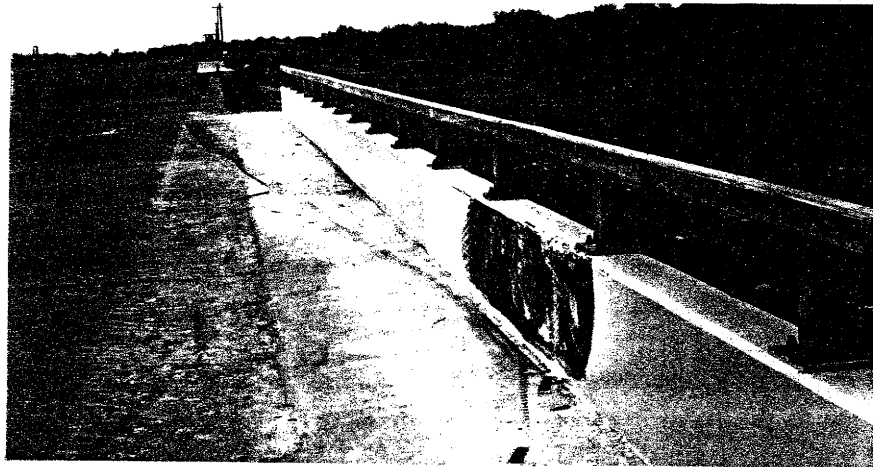
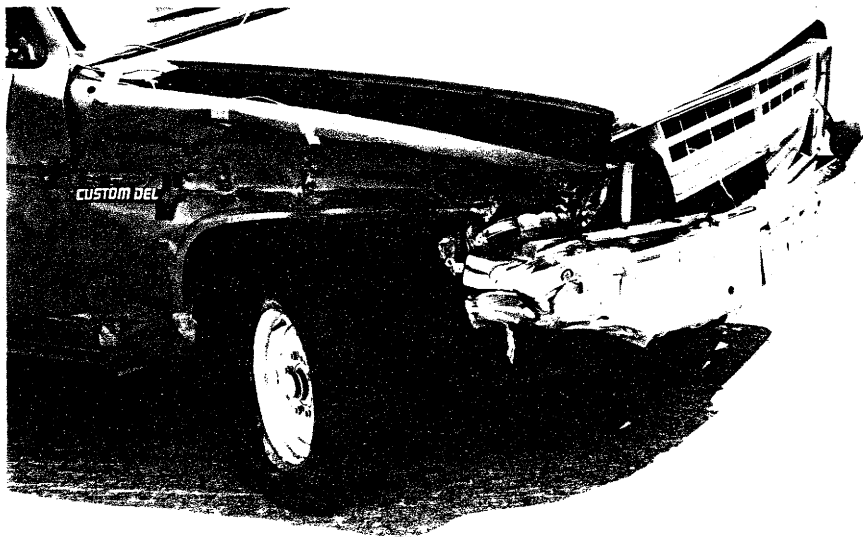
Figure 68. Vehicle and railing for test 7069-33.

The railing received minimal damage (figure 68). There was 0.5 in (13 mm) deformation to the lower metal railing element and there was a hairline crack in the concrete beam 17.5 in (445 mm) down from post 3.

The vehicle sustained damage to the right side (figure 68). Maximum crush at the right front corner at bumper height was 9.0 in (229 mm) and there was a 0.5-in (13-mm) dent into the occupant compartment at the fire wall. The wheelbase on the right side was reduced 2.0 in (51 mm). The sway bars were damaged and the frame was bent. Also, damage was done to the front bumper, hood, grill, radiator, fan, right front quarter panel, right front tire and rim, right door, right rear quarter panel, rear bumper, right rear rim, and left front quarter panel.

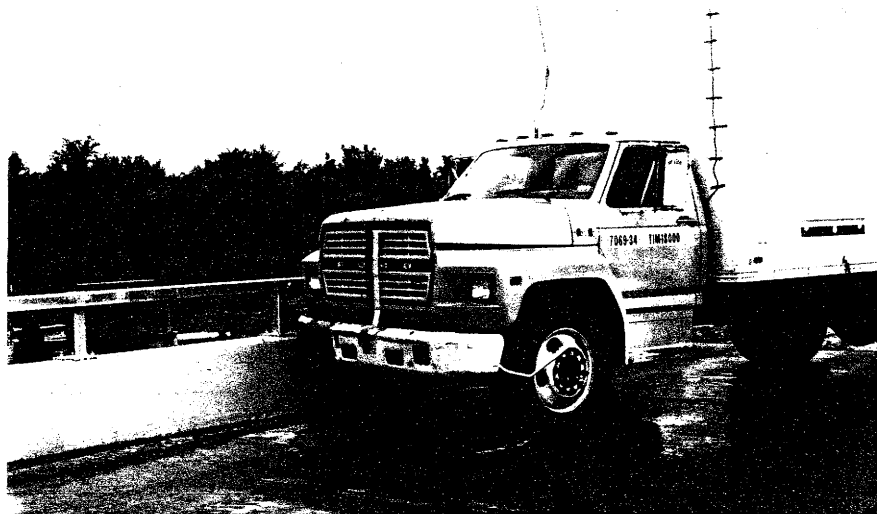
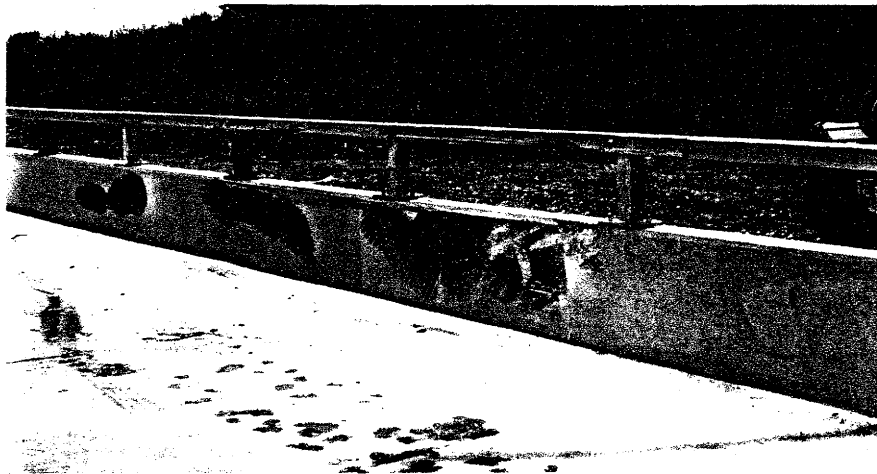
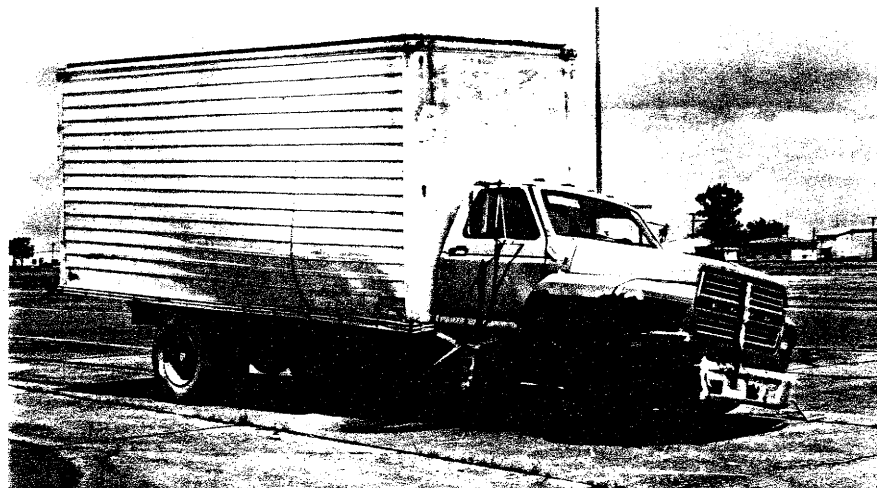
Figure 70. Vehicle and railing for test 7069-34.

The railing received minimal damage with most being contained within the area around posts 4, 5, and 6. Cracking occurred in posts 4 and 5 in the heat affected zone in the posts at the post-to-baseplate connection. The crack occurred at the corners on the traffic side of the tubular steel element (corner of maximum stress) and extended approximately 1 in in both directions. There was a hairline crack in the concrete parapet in line with the rear post bolts at post 4. There was 1.5 in (38 mm) deformation to the metal railing element between posts 4 and 5.

The vehicle sustained damage mostly to the right side (figure 70). Maximum crush at the right front corner at bumper height was 28.0 in (711 mm). The steering arm, front springs and shackles, left front king pin and front axle were damaged and the frame was bent. Also, damage was done to the front bumper, right front quarter panel, right front tire and rim, right door, right rear outside tire and rim, gas tank and box-van.

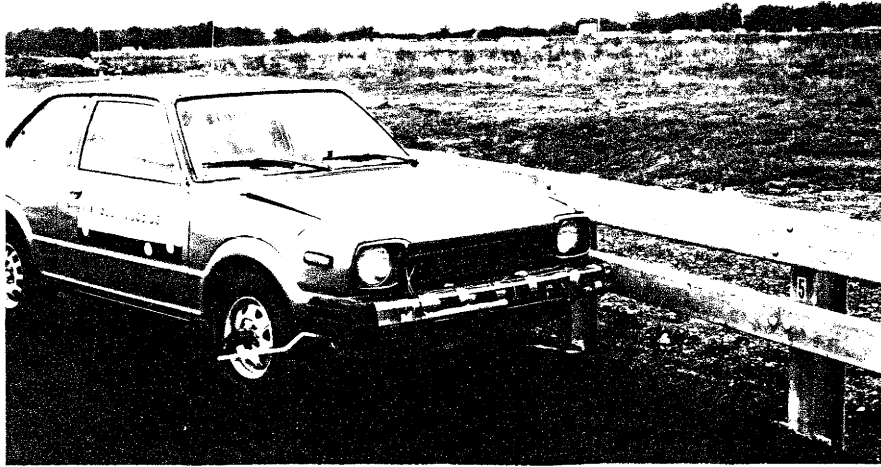
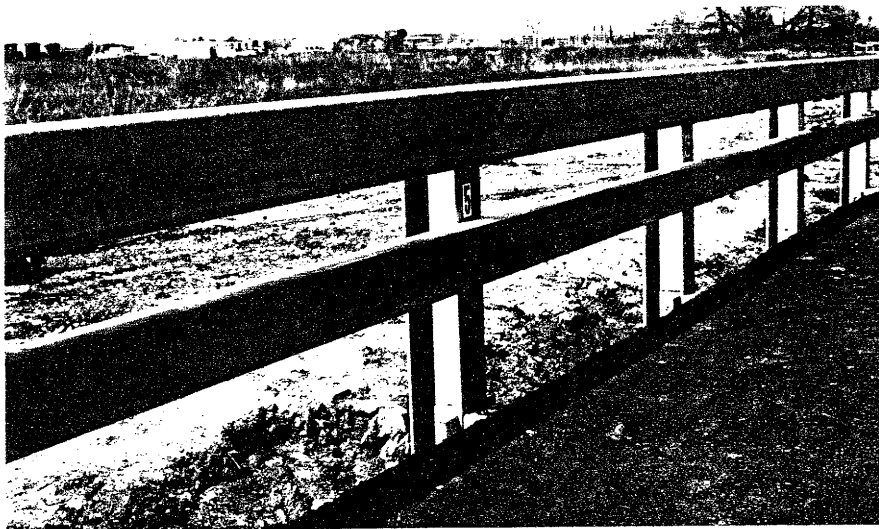
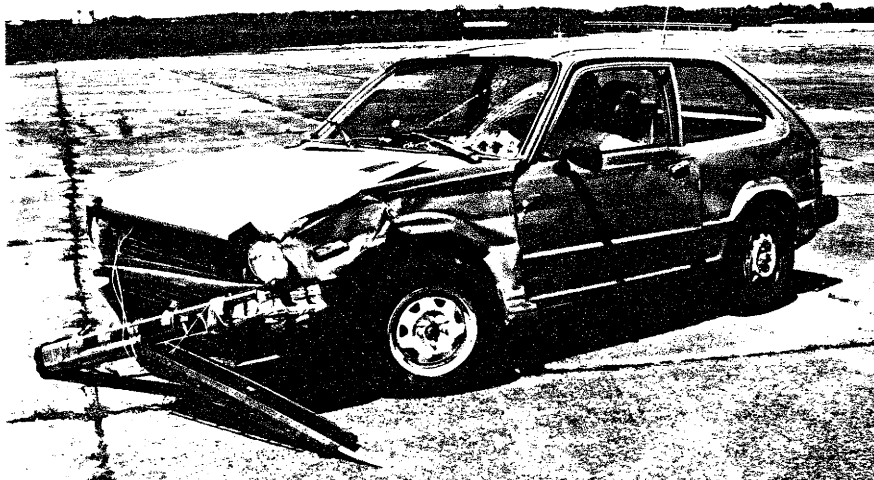
Figure 72. Vehicle and railing for test 7069-35.

The railing received minimal damage (figure 72). There was no deformation to the metal rail element.

The vehicle sustained damage to the left side (figure 72). Maximum crush at the left front corner at bumper height was 7.5 in (190 mm) and there was a 1.3-in (33-mm) dent into the occupant compartment at the fire wall. The driver door was deformed outward approximately 4.1 in (104 mm) and there was a small dent in the roof just above the B-pillar. The left front strut and sway bar were damaged, the instrument panel was bent, the windshield cracked, and the A-pillar was bent on the driver side. Also, damage was done to the front bumper, hood, grill, left front and rear quarter panel, left front and rear rim, and left door.
