# Testing of New Bridge Rail and Transition Designs

## Volume I: Technical Report

PUBLICATION NO. FHWA-RD-93-058

7. Author(s) C. Eugene Buth, T. J. Hirsch, and Wanda L. Menges		8. Performing Organization Report No. Research Foundation 7069-Vol. I	
9. Performing Organization Name and Address Texas Transportation Institute The Texas A&M University System College Station, Texas 77843-3135		10. Work Unit No. NCP No. 3A5C0042	11. Contract or Grant No. DTFH61-86-C-00071

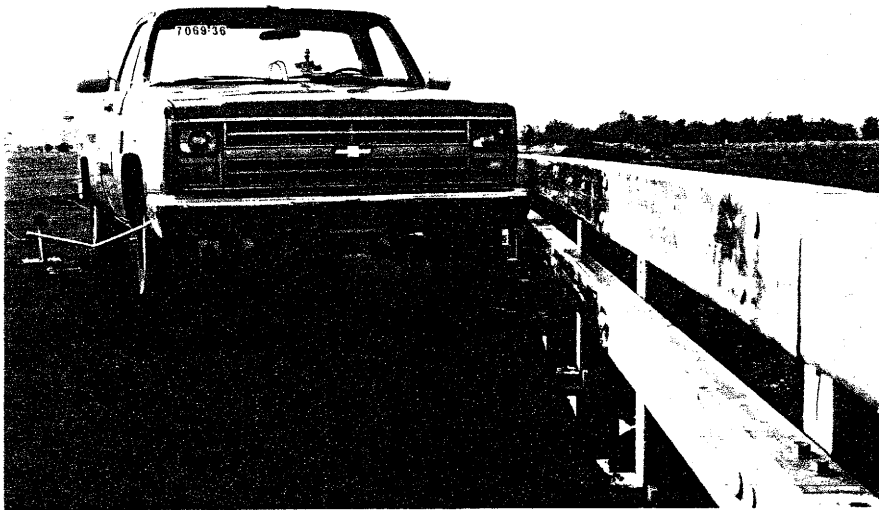
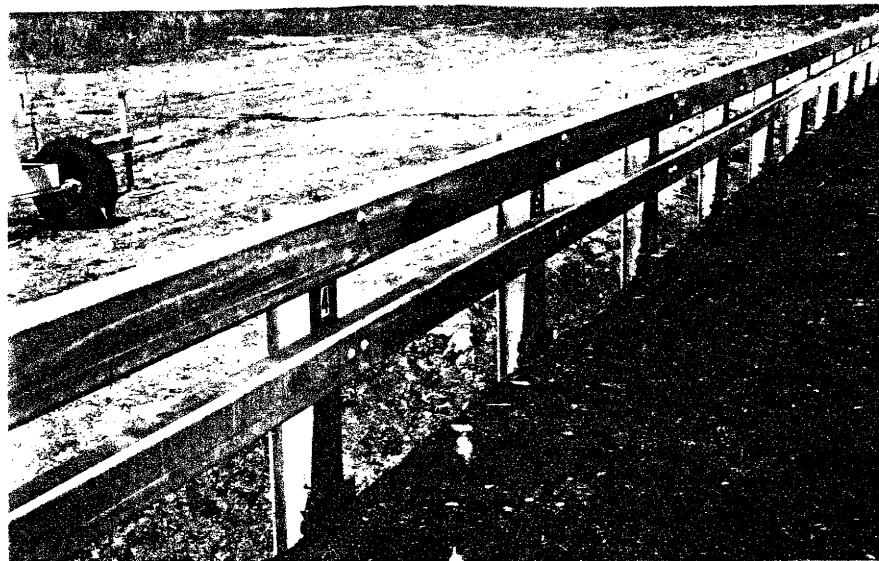
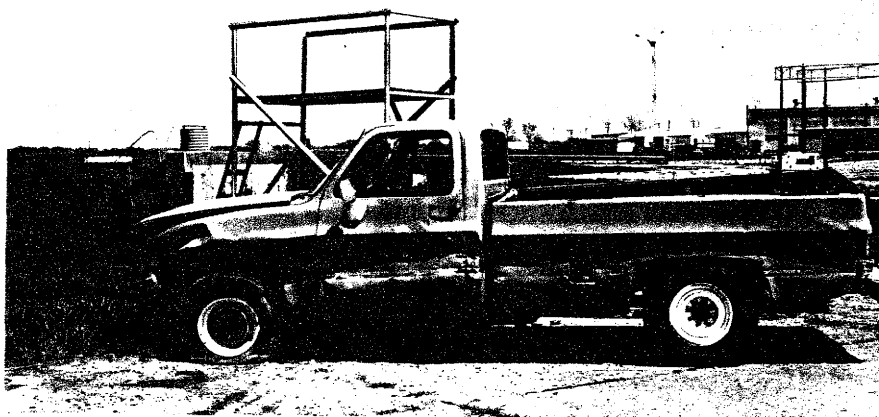
Figure 74. Vehicle and railing for test 7069-36.

The railing received moderate damage (figure 74). There was 1.0 in (25 mm) deformation to the upper rail element and 0.75 in (19 mm) to the lower rail element near post 5. The flanges on posts 4 and 5 were deformed just above the angles (L6x4x1/4x4) and these angles were bent.

The vehicle sustained damage to the left side. Maximum crush at the left front corner at bumper height was 13.0 in (330 mm) and there was a 0.4-in (10-mm) dent into the occupant compartment at the fire wall and center tunnel. The frame was bent and the door on the driver side was deformed outward 3.2 in (81 mm). Also, damage was done to the front bumper, hood, grill, radiator, fan, left front quarter panel, left front tire and rim, left door, left rear quarter panel, rear bumper, and left rear rim. Most of the damage to the right side of the vehicle was sustained when the vehicle impacted the protective barrier.

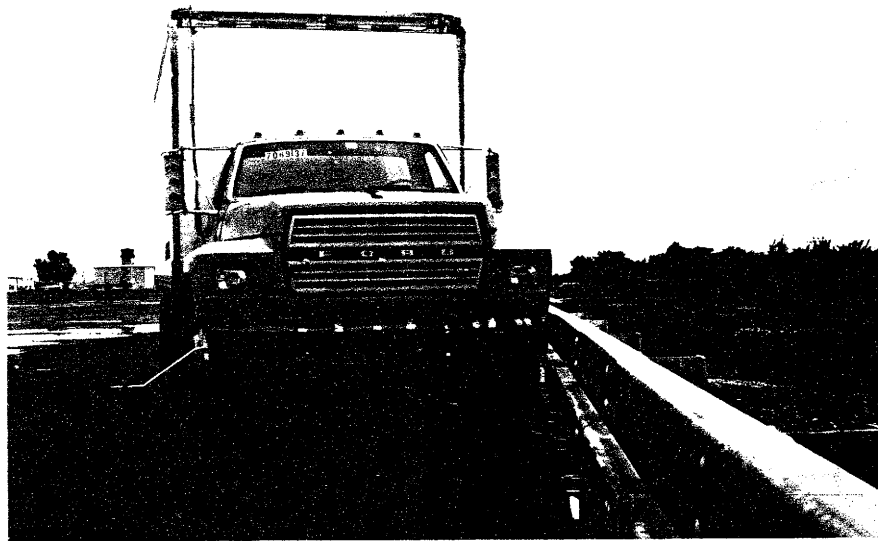
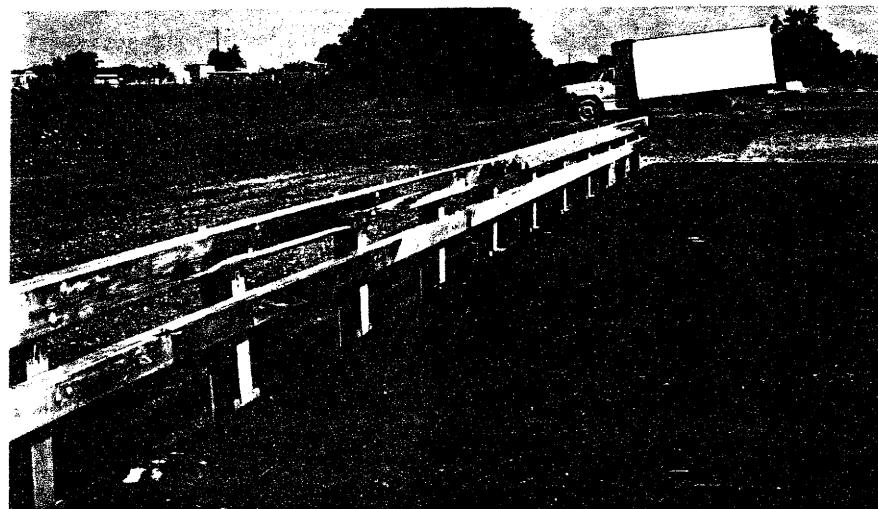
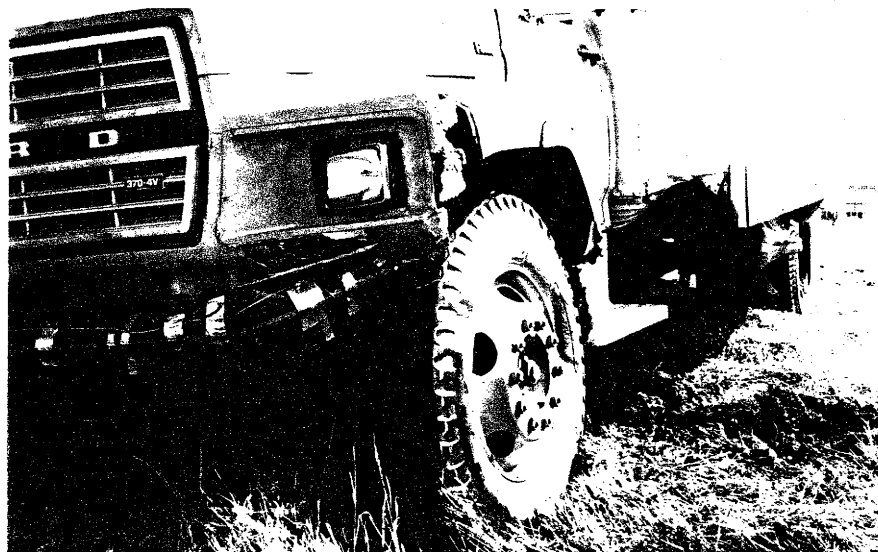
Figure 76. Vehicle and railing for test 7069-37.

The railing received moderate damage with most contained within the area between posts 4 through 7. The upper and lower rails sustained gouges between posts 4 and 5 from the lug nuts of the vehicle's wheel. The head of the lower bolt on the top rail at post 5 was torn off and the bolts on the lower element were loose. The angles at post 4 were slightly bent and those at posts 5 and 6 were deformed. The spacers at posts 4 and 5 were knocked loose and down. There was 2.5 in (64 mm) deformation to the upper rail element at post 5.

The vehicle sustained damage mostly to the left side (figure 76). Maximum crush at the left front corner at bumper height was 8.0 in (203 mm). The front springs, shackles, and U-bolt were damaged and the box-van shifted off the frame approximately 6 in (150 mm). Also, damage was done to the front bumper, left front quarter panel, left front tire and rim, left rear outside tire and rim, and lower edge of the box-van.

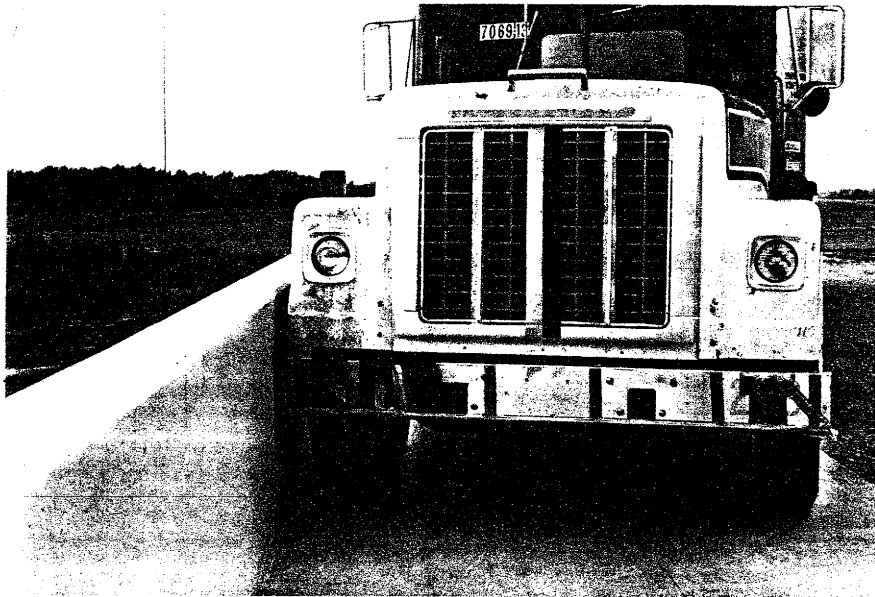
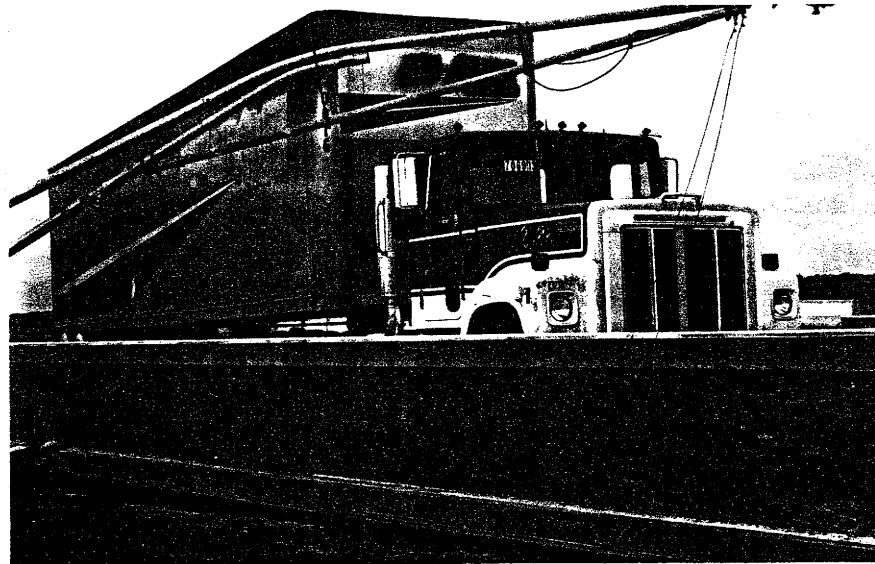
Figure 78. Vehicle and parapet for test 7069-13.

The parapet received only cosmetic damage (figure 78). There were tire marks on the parapet from just before the impact point extending a total of 85 ft (26 m) along the face. There was also a piece of the top of the parapet chipped off.

The vehicle sustained extensive damage to the right side. Maximum crush at the right front corner at bumper height was 18.0 in (457 mm). There was damage to the front axle, Pittman arm, U-bolts, front leaf springs and bolts, front shock mounts, air brake lines, right fuel cell, left rear spring pin and clamp, and exhaust pipe. The cab and left door were bent.

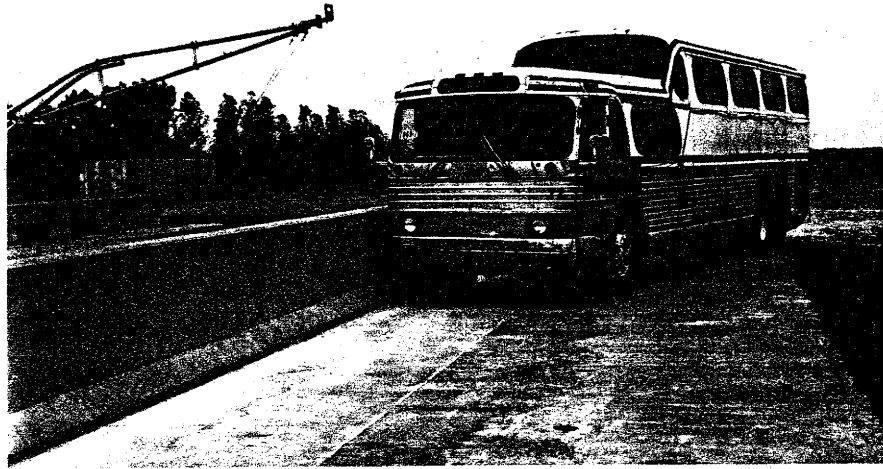
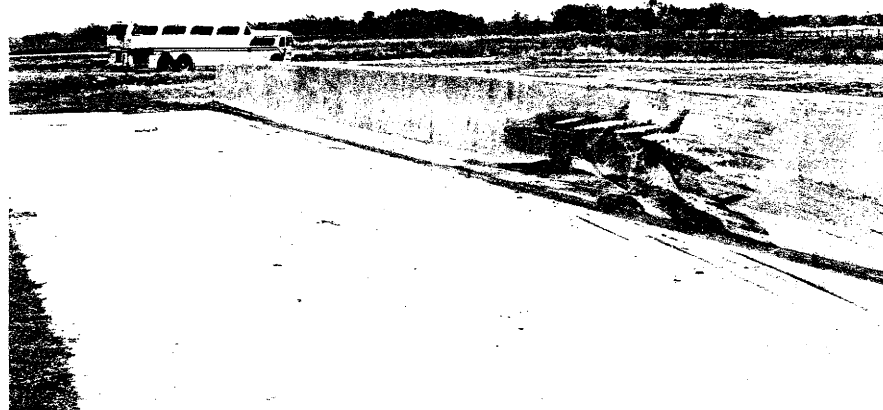
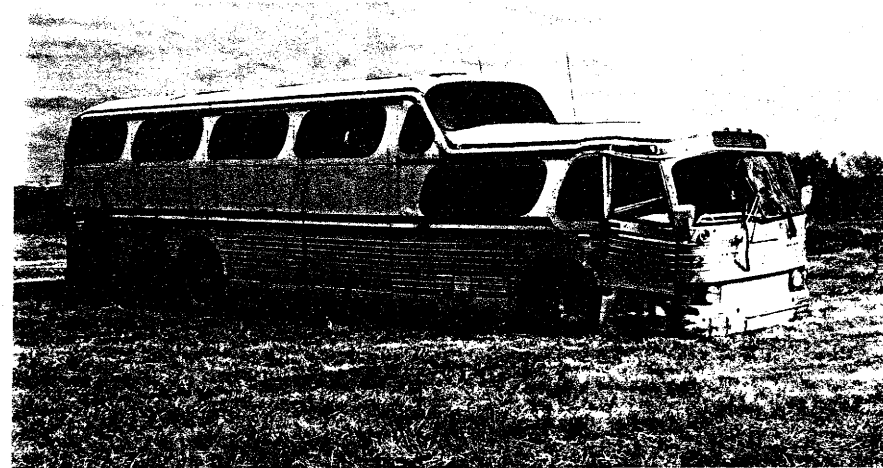
Figure 80. Vehicle and parapet for test 7069-7.

The railing received only cosmetic damage (figure 80). There were tire marks on the bridge railing from just before the impact point extending a total of 25 ft (7.6 m) along the face. The vehicle then lost contact for 26 ft (7.9 m) and contacted the bridge railing for another 21 ft (6.4 m) when the bridge railing ended. There was also a longitudinal hairline crack along the bridge deck starting approximately at the point of impact for about 35 ft (11 m) running parallel to and nominally 2 ft (0.6 m) from the base of the railing.

The vehicle sustained extensive damage to the right side. Maximum crush at the right front corner at bumper height was 4.0 in (102 mm). The right front and right rear wheel rims were scratched. The front wheel assembly and suspension was damaged. The door was bent and the windshield was broken out. The right rear panel was dented and scraped.

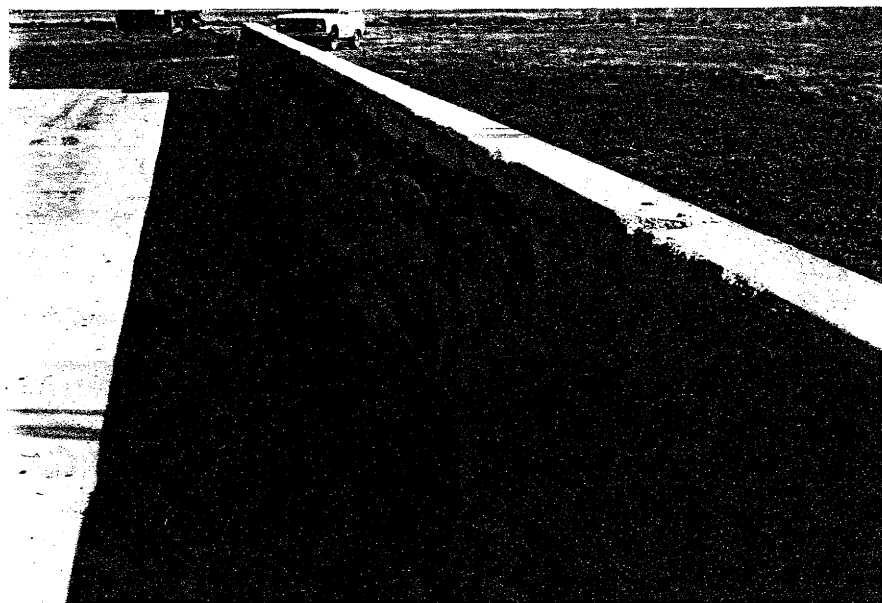
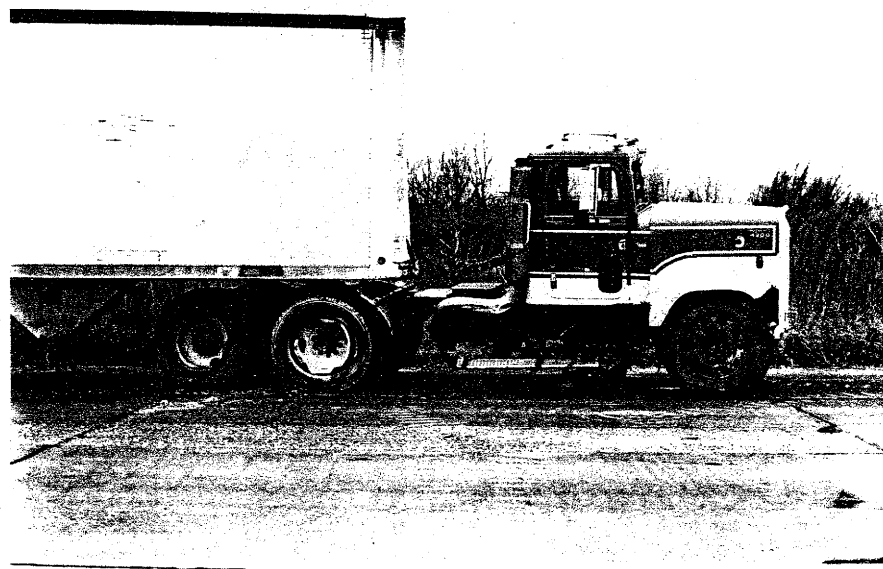
Figure 83. Vehicle and parapet after test 7069-10.

The railing received only cosmetic damage (figure 83). There were tire marks on the bridge railing from just before the impact point extending a total of 72 ft (21.9 m) along the face. There was also a piece of the top of the bridge railing chipped off where the edge of the trailer impacted.

The vehicle sustained extensive damage to the right side (figure 83). Maximum crush at the right front corner at bumper height was 18.0 in (457 mm). Both outside right rear wheel rims of the tractor were bent and the tires were deflated. The front wheel assembly and suspension were damaged. The shock mounts were broken, the tie rods bent, the steering rod was bent, and the springs were loose. The right side door was dented.

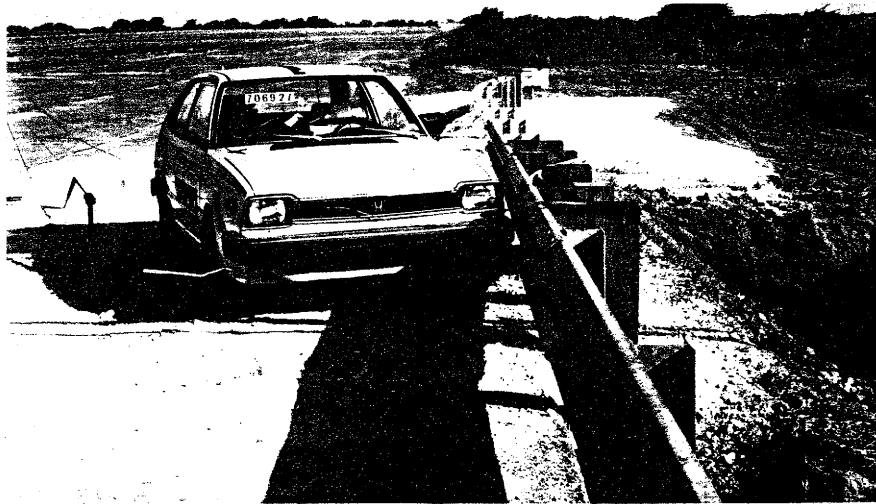
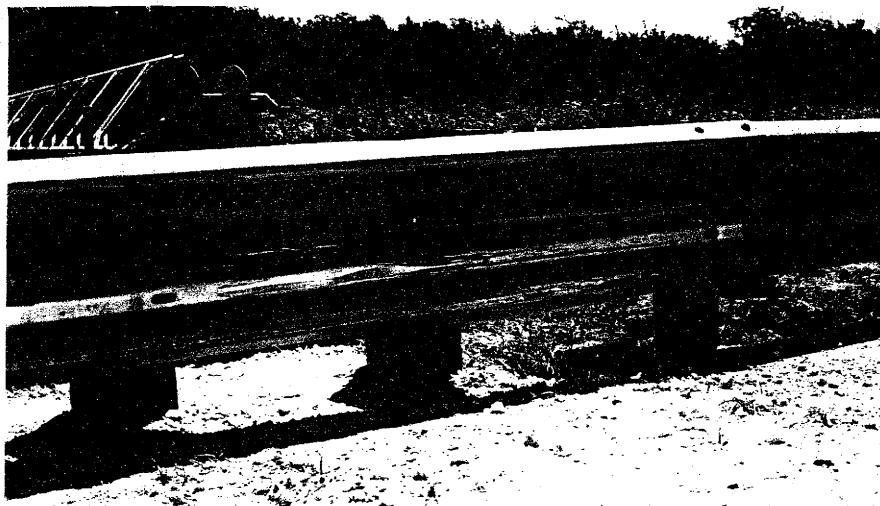
Figure 85. Vehicle and transition for test 7069-27.

The transition received minimal damage (figure 85). Maximum lateral permanent deformation was 0.5 in (13 mm).

The vehicle sustained damage to the left side as shown in figure 8. Maximum crush at the left front corner at bumper height was 8.0 in (203 mm), and the driver door was deformed outward approximately 8.0 in (203 mm). The driver side window was broken out and the door was jammed. Also, damage was done to the front bumper, hood, grill, left front quarter panel, left rear quarter panel, and left front tire and rim.

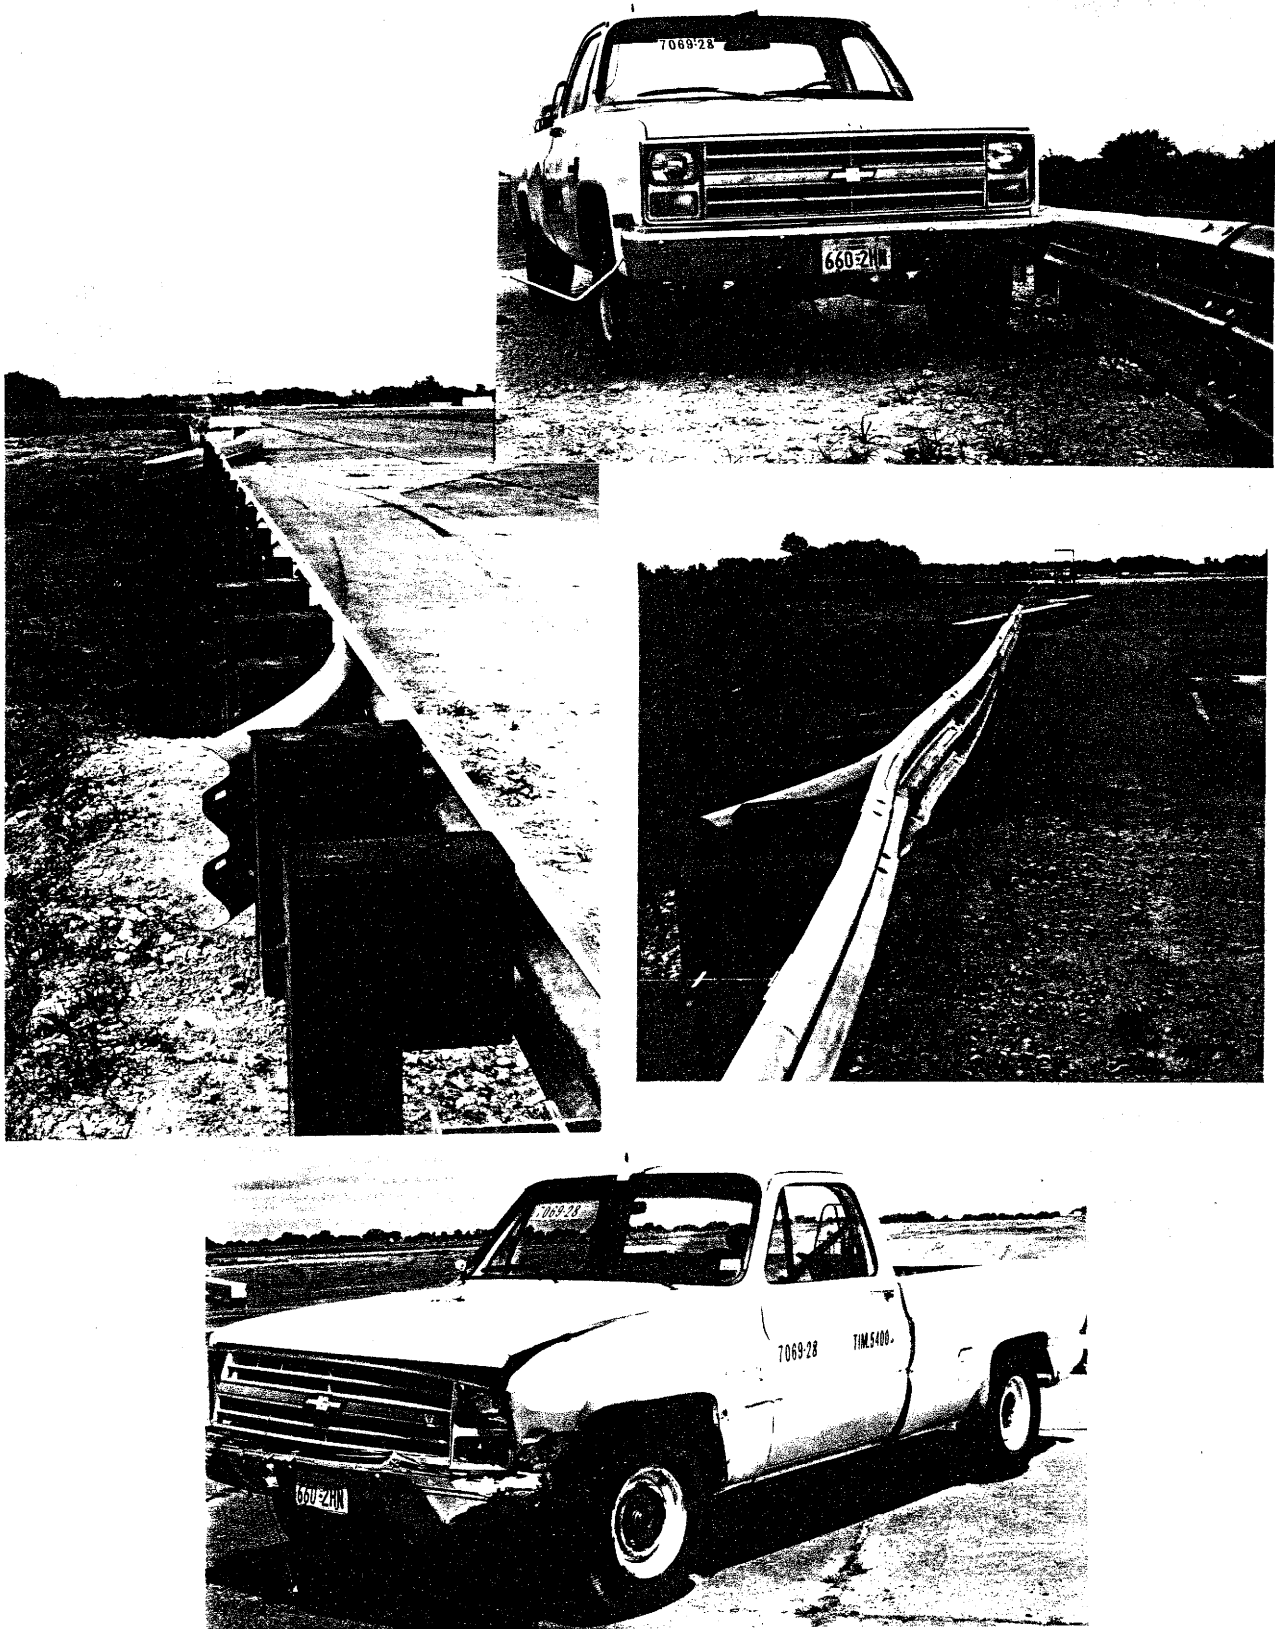
Figure 87. Vehicle and transition for test 7069-28.

The transition received minimal damage (figure 87). Maximum lateral permanent deformation was 3.5 in (89 mm).

The vehicle sustained damage to the left side (figure 87). Maximum crush at the left front corner at bumper height was 8.0 in (203 mm), and the driver door was deformed outward approximately 1.0 in (25 mm). The frame was bent and the cab was deformed. The driver side window was broken out and the door was jammed. Also, damage was done to the front bumper, hood, grill, left front quarter panel, left rear quarter panel, rear bumper, and left front tire and rim.

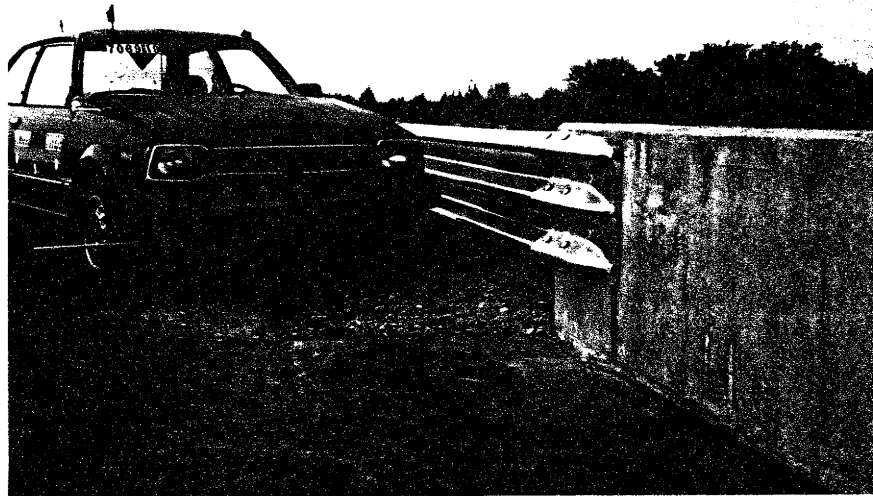
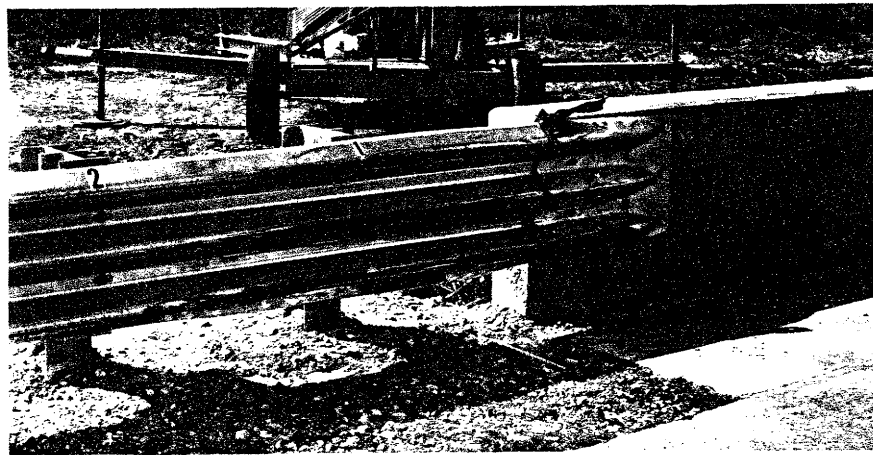
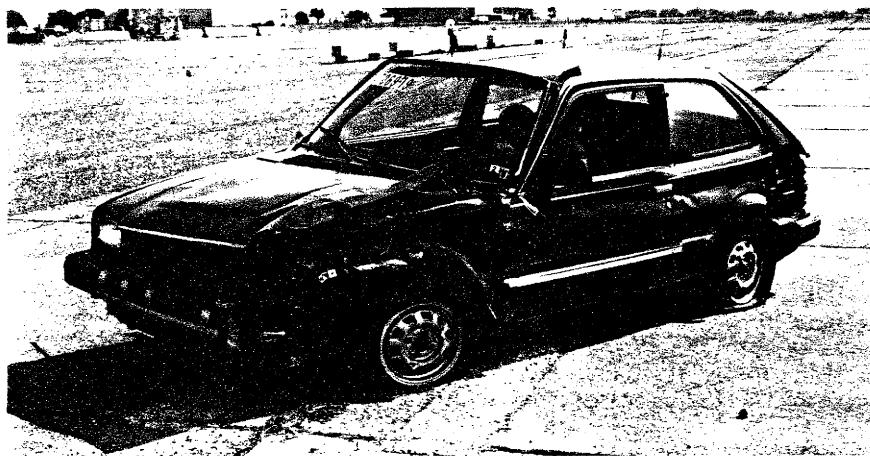
Figure 89. Vehicle and transition for test 7069-19.

The transition received minor damage, most of which was cosmetic in nature (figure 89). Maximum lateral deformation was 0.5 in (13 mm) at the post 2.

The vehicle sustained damage to the left side (figure 89). Maximum crush at the left front corner at bumper height was 11.0 in (279 mm). The strut and constant velocity joint on the left side were damaged and the roof was bent. The left front wheel was canted inward at the bottom and pushed back into the fender well. The left side window was broken out by the dummy's head. Also, damage was done to the front bumper, hood, grill, radiator and fan, left front quarter panel, left door, left rear quarter panel, and left rear tire and rim.

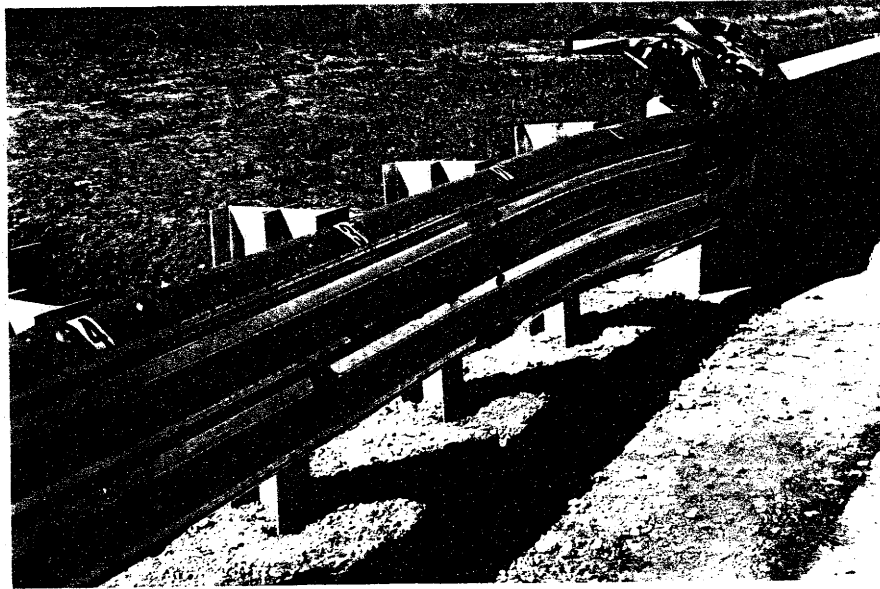
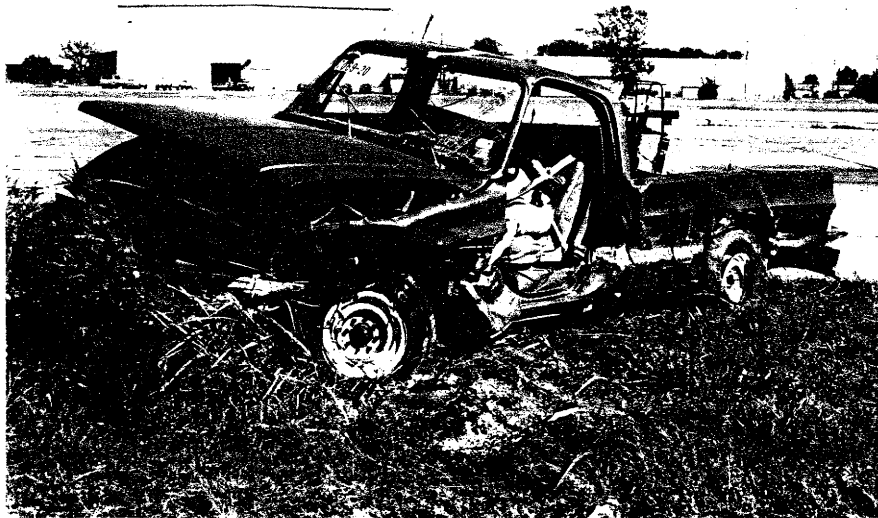
Figure 92. Vehicle and transition after test 7069-20.

The transition received moderate damage (figure 92). Maximum lateral deformation was 6.5 in (165 mm).

The vehicle sustained damage to the left side (figure 92). Maximum crush at the left front corner at bumper height was 22.0 in (559 mm). The sway bar and upper and lower control arm on the left side were damaged and the roof was bent. The left front wheel was canted inward at the bottom and pushed back into the fender well. The left side window was broken out. The door was separated from the vehicle and remained affixed to the transition at the terminal connector. Also, damage was done to the front bumper, hood, grill, radiator and fan, left front quarter panel, left rear quarter panel, and left rear tire and rim.

The transition contained the vehicle with minimal lateral movement of the transition. There was no intrusion of railing components into the occupant compartment; however, the door was detached from the vehicle and remained lodged on the railing. The vehicle remained upright and relatively stable during the collision. The transition redirected the vehicle but the effective coefficient of friction was quite high. Velocity change of the vehicle during the collision was 20.8 mi/h. The occupant impact velocities and the occupant ridedown accelerations were within the limits. The vehicle trajectory at loss of contact indicated minimum intrusion into adjacent traffic lanes.

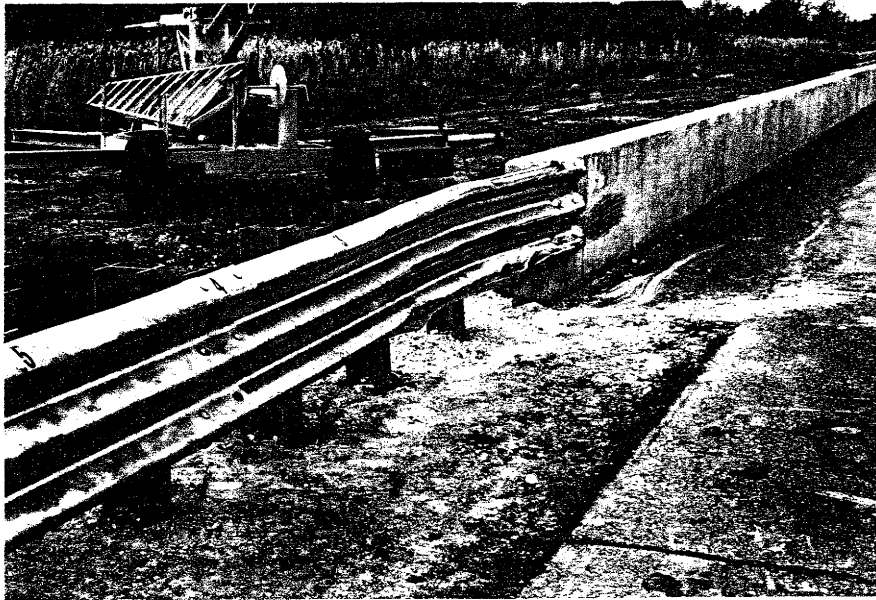
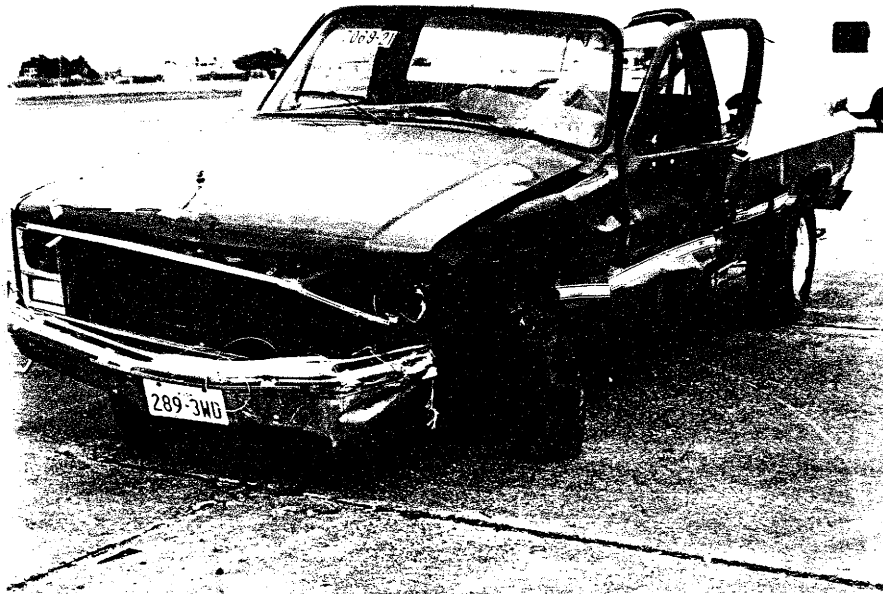
Figure 95. Vehicle and transition after test 7069-21.

The transition received moderate damage (figure 95). Maximum lateral permanent deformation was 5.0 in (127 mm).

The vehicle sustained damage to the left side (figure 95). Maximum crush at the left front corner at bumper height was 15.0 in (381 mm) and the right front corner was deformed outward approximately 4.75 in (121 mm). The sway bar and A-arms on the left side and gas tank were damaged, and the drive shaft, frame, and roof were bent. The floor pan was pushed into the occupant compartment approximately 5 to 7 in (130 to 180 mm) and the dash moved inward approximately 3 in (80 mm). The left front wheel was canted inward at the bottom and pushed back into the fender well reducing the wheelbase on the driver side by 14.0 in (356 mm). The driver side window was broken out and the door was jammed. Also, damage was done to the front bumper, hood, grill, radiator and fan, left front quarter panel, left rear quarter panel, and left rear tire and rim. The tailgate came off the vehicle during the test.

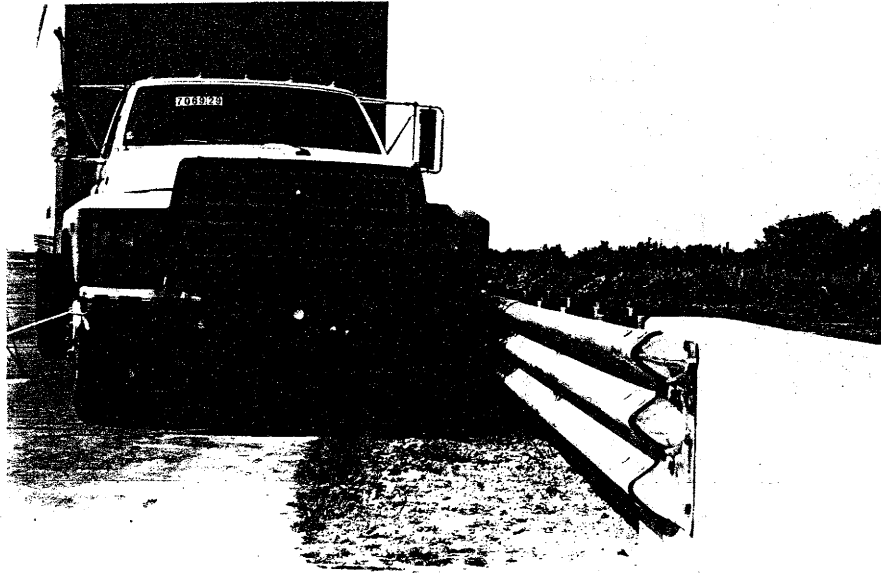
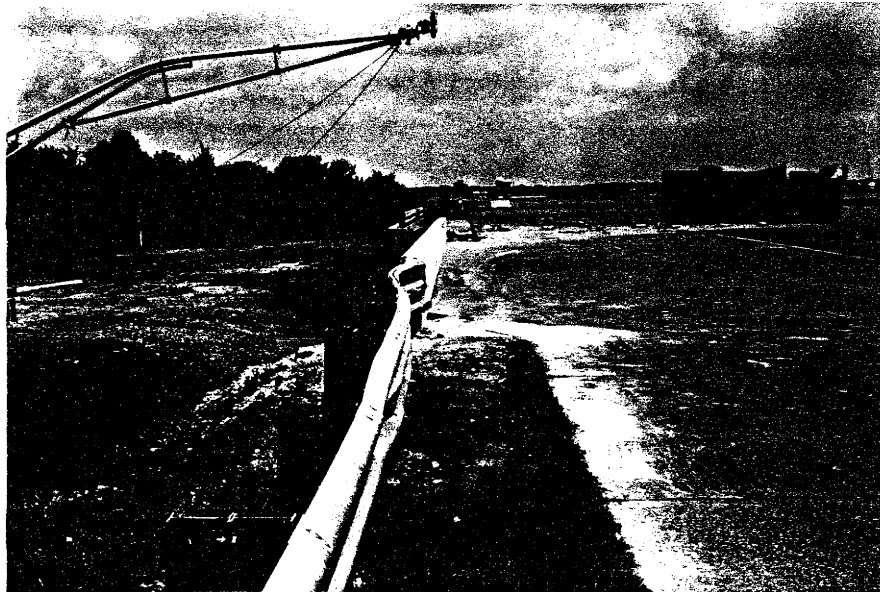
Figure 97. Vehicle and transition for test 7069-29.

The transition received moderate damage (figure 97). Maximum lateral permanent deformation to the transition was 10.0 in (254 mm). The end of the concrete parapet where the terminal connector attached was cracked.

The vehicle sustained damage to the left side. Maximum crush at the left front corner at bumper height was 13.0 in (330 mm). The floor pan was pushed inward and the cab was bent and twisted. The windshield and rear glass were broken. The frame at the rear axle was bent and the van-box was twisted and torn. The driver side window was broken out and the door was jammed. Also, damage was done to the front bumper, hood, left front quarter panel, and outer left rear tire and rim. The right door was also jammed.

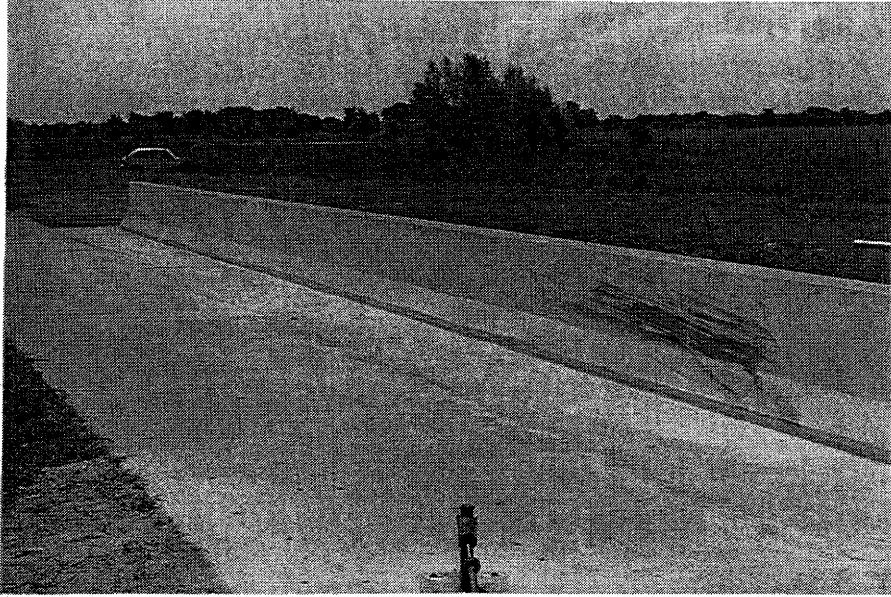
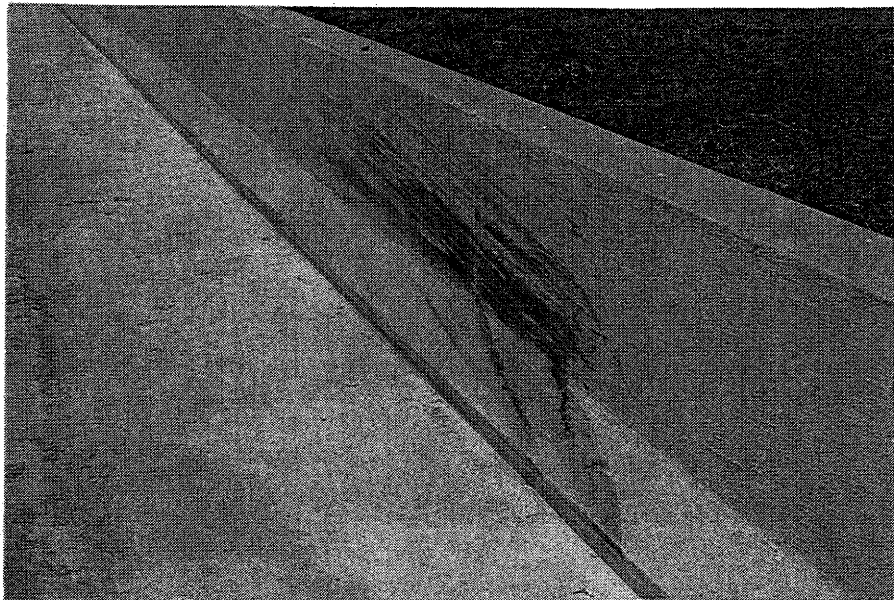
Figure 5. 32-in (813-mm) F-shape bridge railing after test 7069-13.

As can be seen in figure 5, the bridge railing received cosmetic damage only. There were tire marks on the face of the bridge railing indicating the vehicle rose a maximum height of about 27 in (686 mm). The vehicle was in contact with the bridge railing for 10.3 ft (3.1 m).

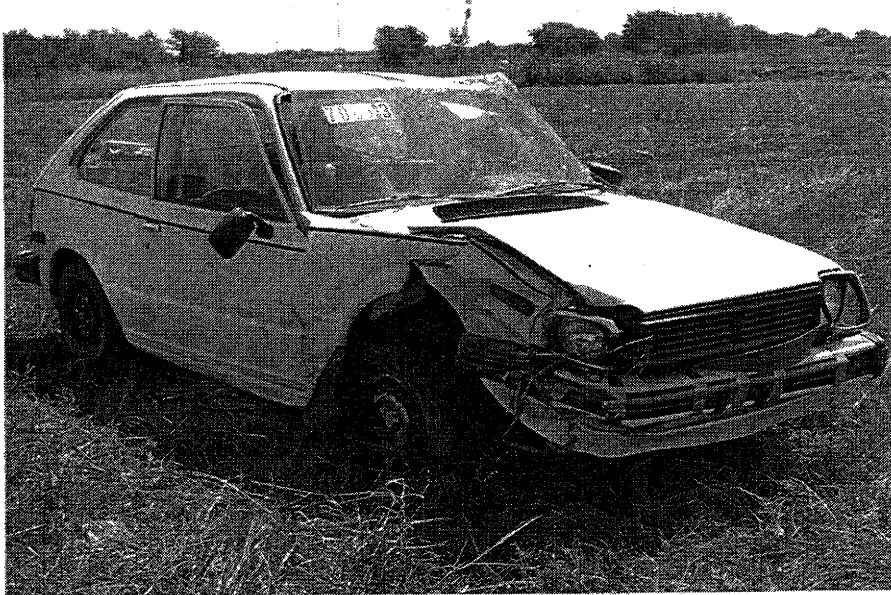
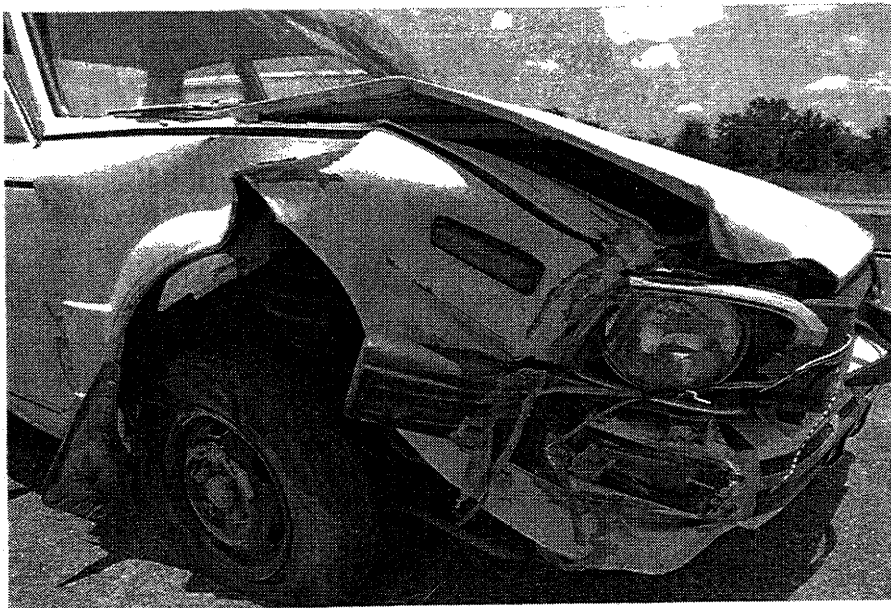
Figure 6. Vehicle after test 7069-3.

The vehicle sustained extensive damage to the right front as shown in figure 6. Maximum crush at the right front corner at bumper height was 9.0 in (229 mm). The right front and right rear wheel rims were bent and the wheel assembly and suspension damaged. The passenger door was bent and jammed and the right side was dented and scraped. The hood was bent and shifted to the left. The windshield frame was bent and the windshield was cracked. The roof of the vehicle was buckled and twisted.

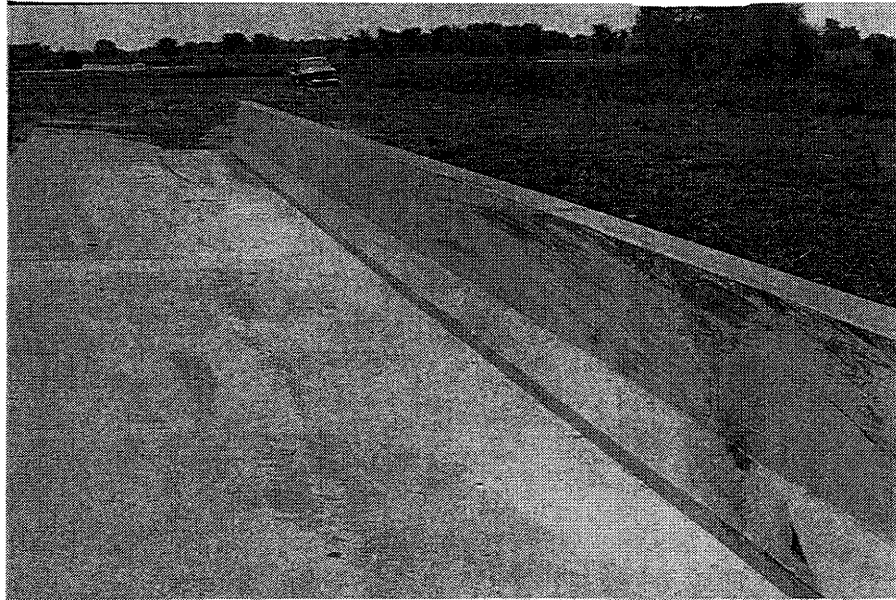
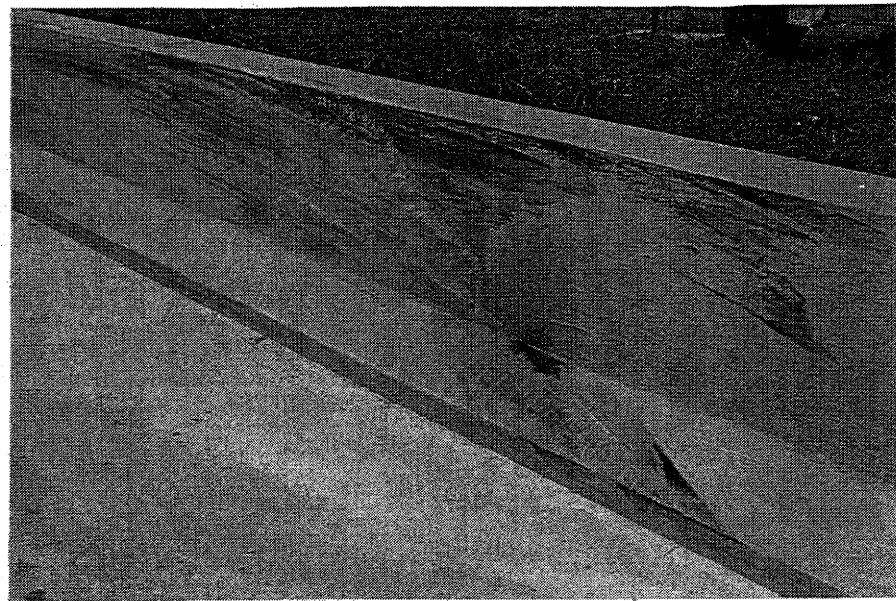
Figure 18. 32-in (813-mm) F-shape bridge railing after test 7069-4.

As can be seen in figure 18, the railing received cosmetic damage and some scraping. There were tire marks on the face of the bridge railing which indicated the vehicle rose a maximum height of 24 in (610 mm) above the ground. The vehicle was in contact with the bridge railing for 18.0 ft (5.5 m).

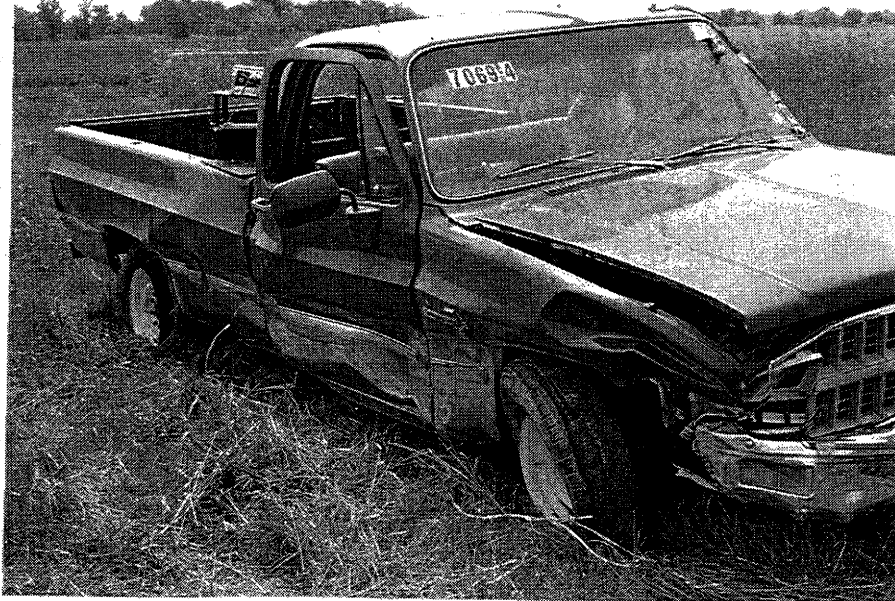
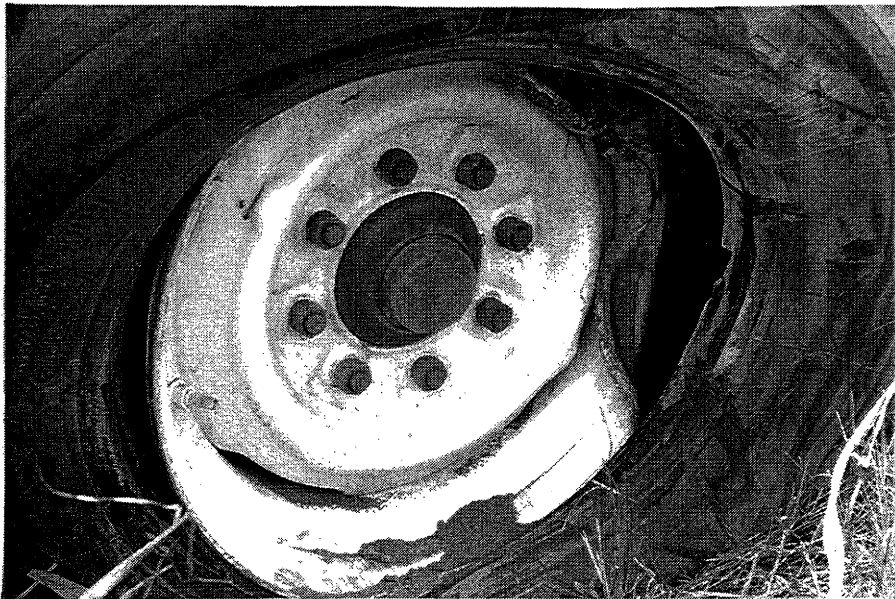
Figure 19. Vehicle after test 7069-4.

The vehicle sustained extensive damage to the right side as shown in figure 19. Maximum crush at the right front corner at bumper height was 5.0 in (127 mm). The right front and right rear wheel rims were bent and the tires aired out. The wheel assembly and suspension was damaged. The passenger door was bent and jammed and the window broken out. The right rear panel was dented and scraped. The hood was bent and shifted to the left. The cab of the vehicle was twisted.

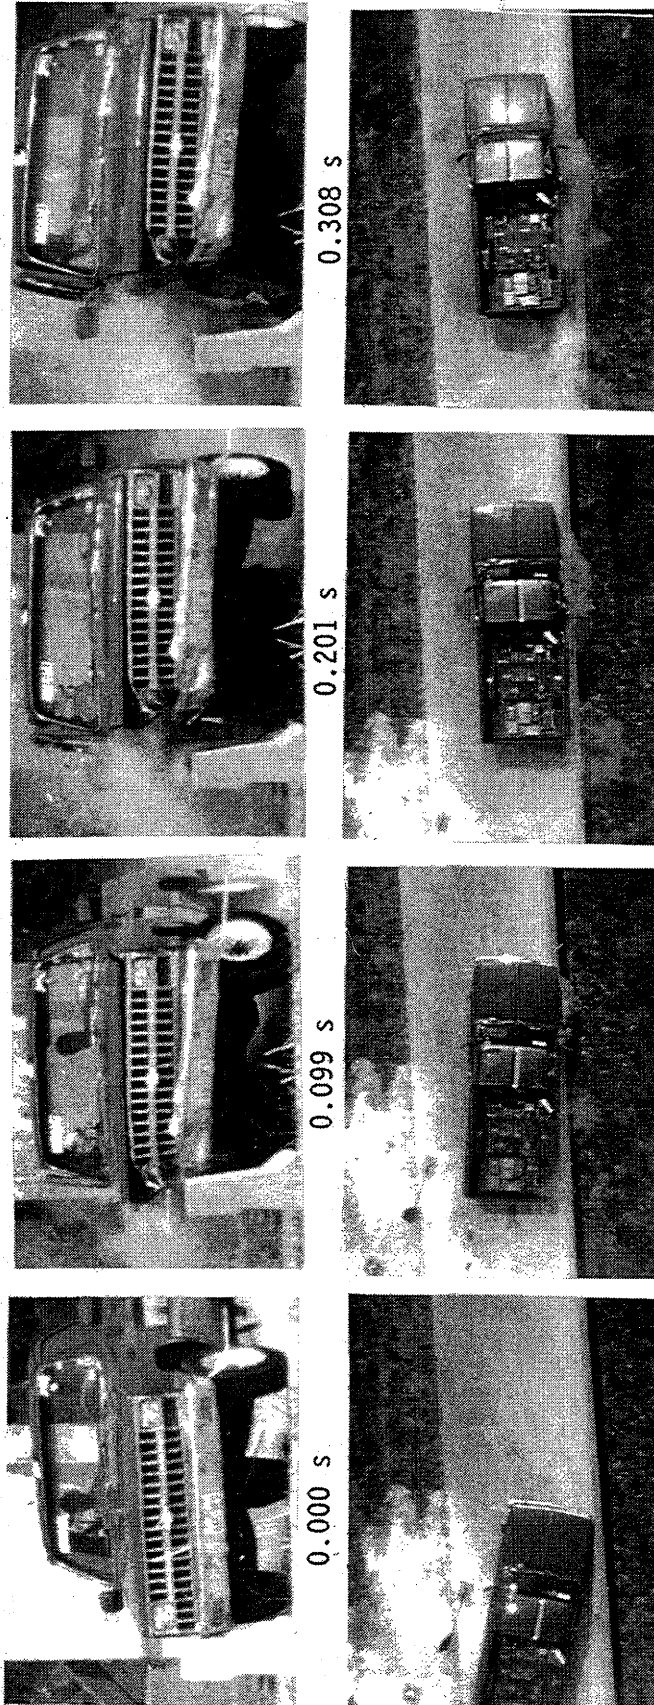
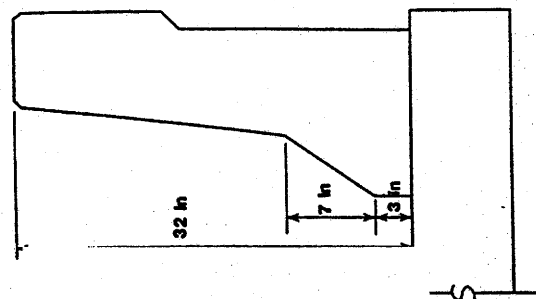
Test No. . . . . 7069-4  
 Date . . . . . 7/30/87  
 Test Installation . . . . . 32-in (813-mm) F-Shape Bridge Railing  
 Installation Length . . . . . 100 ft (30 m)  
 Vehicle . . . . . 1981 Chevrolet Pickup

H. Exit angle shall be less than 12 degrees	Exit angle was 7.3 degrees	Pass
