# Testing of New Bridge Rail and Transition Designs

## Volume I: Technical Report

PUBLICATION NO. FHWA-RD-93-058

7. Author(s) C. Eugene Buth, T. J. Hirsch, and Wanda L. Menges		8. Performing Organization Report No. Research Foundation 7069-Vol. I	
9. Performing Organization Name and Address Texas Transportation Institute The Texas A&M University System College Station, Texas 77843-3135		10. Work Unit No. NCP No. 3A5C0042	11. Contract or Grant No. DTFH61-86-C-00071

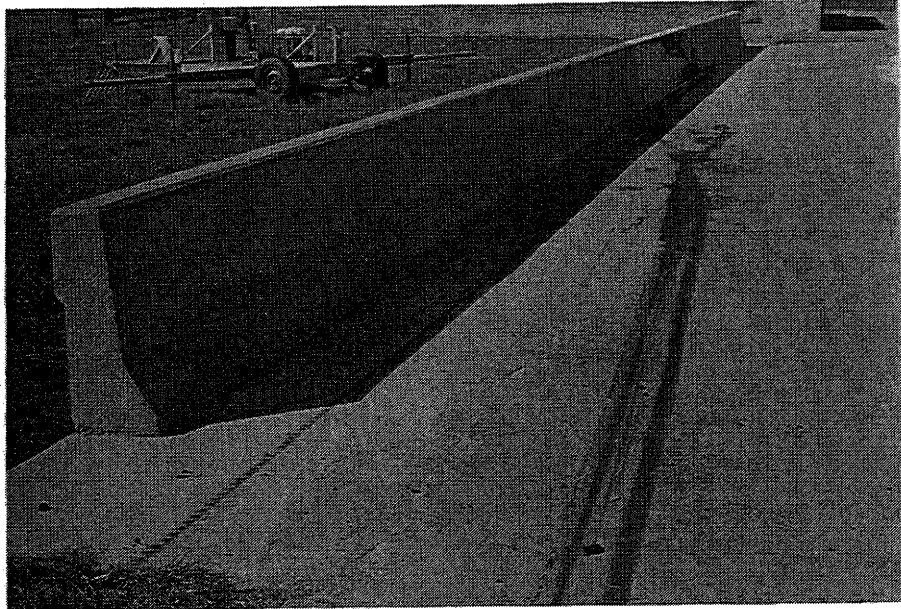
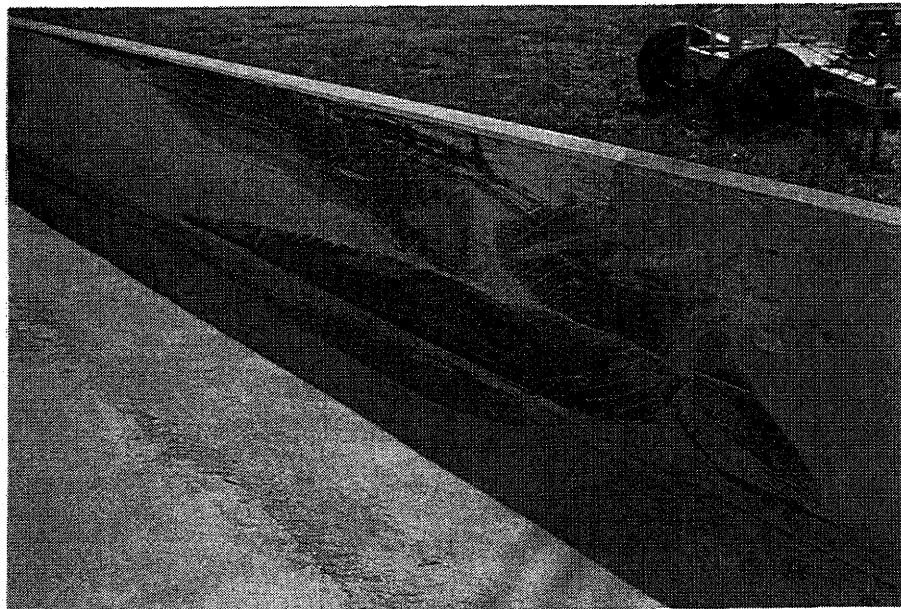
Figure 33. 32-in (813-mm) F-shape bridge railing after test 7069-8.

As can be seen in figure 33, the railing received cosmetic damage and some scraping. There were tire marks on the face of the bridge railing and along the top. The top of the bridge railing was scraped along the remaining length from the lower edge of the bed of the truck (see figure 34). The vehicle was in contact with the bridge railing for 60 ft (18 m).

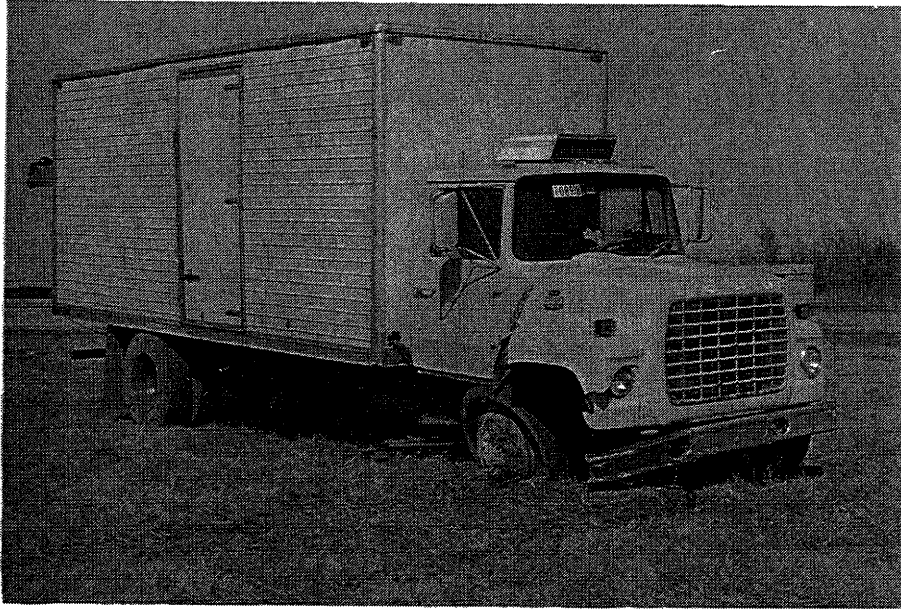
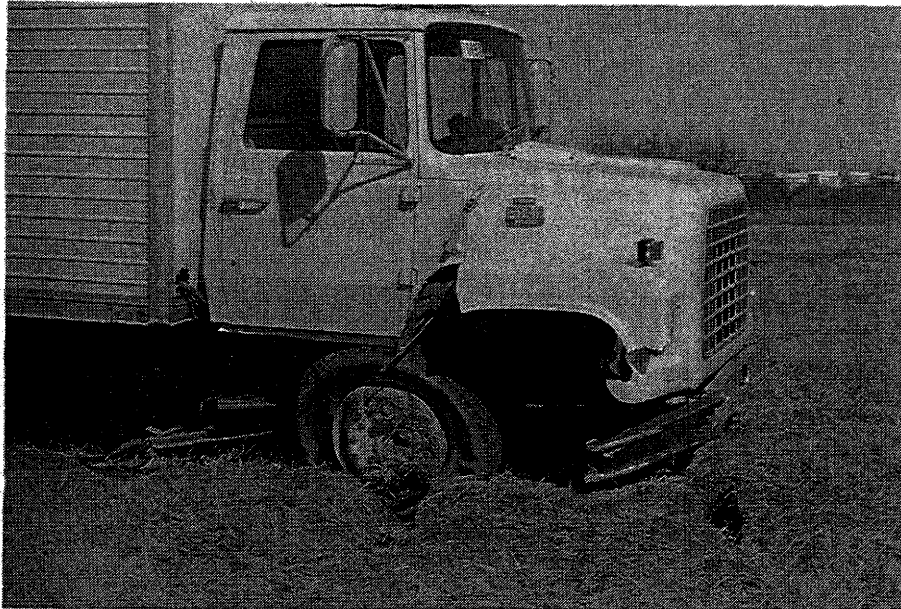
Figure 35. Vehicle after test 7069-8.

The vehicle sustained extensive damage to the right side as shown in figure 35. Maximum crush at the right front corner at bumper height was 6.0 in (152 mm). The right front wheel rim was bent and the tire damaged. The spring and spring shackle were broken loose from the axle. The steering gear box and steering cylinder were damaged. Also, the fuel tank broke loose from the truck.

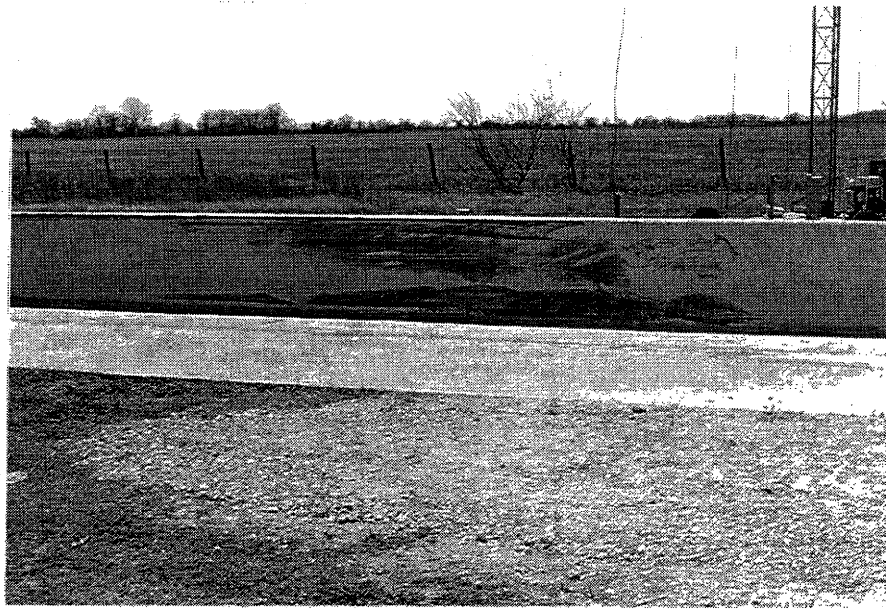
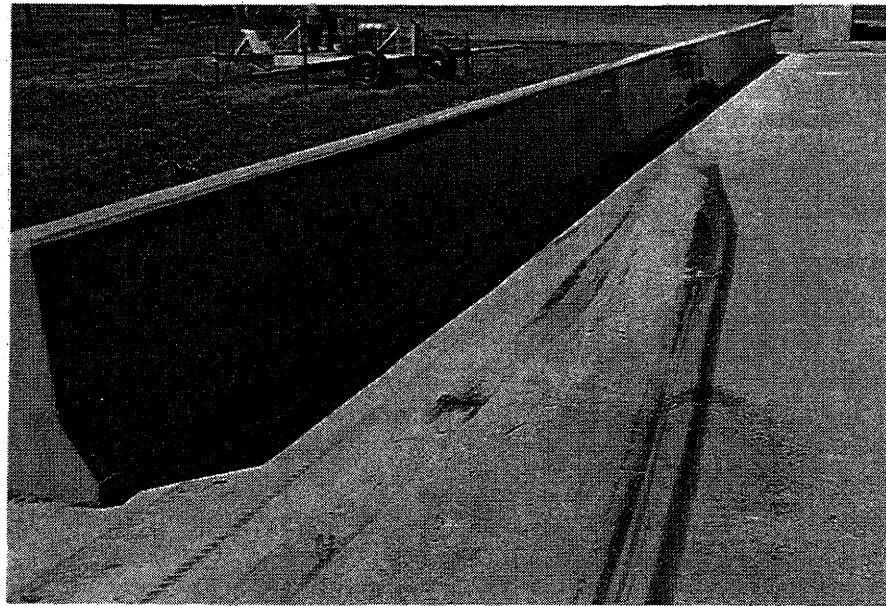
Figure 49. 32-in (813-mm) F-shape bridge railing after test 7069-9.

As can be seen in figure 49, the railing received cosmetic damage and some scraping. There were tire marks on the face of the bridge railing and along the top. The top of the bridge railing was scraped along the remaining length from the lower edge of the bed of the truck (see figure 50). The vehicle was in contact with the bridge railing for 58 ft (18 m).

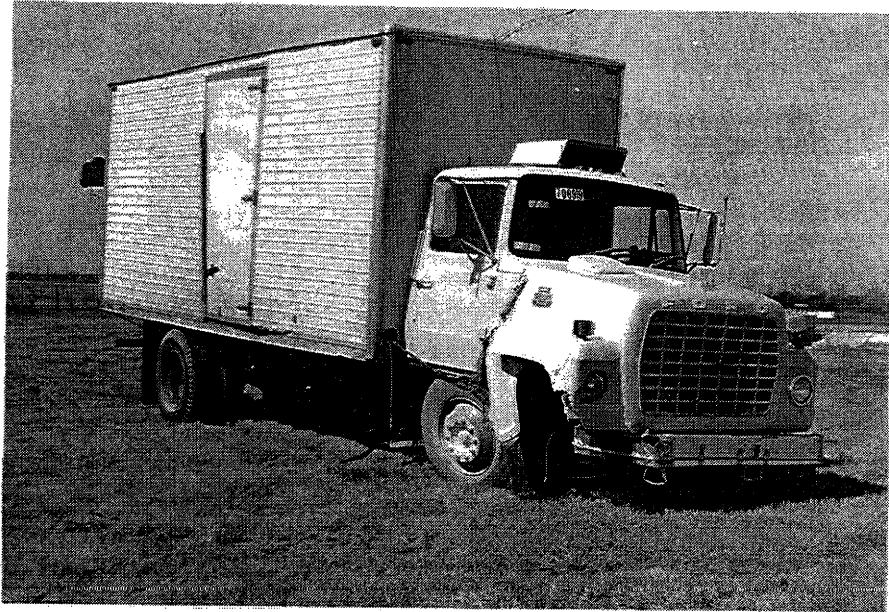
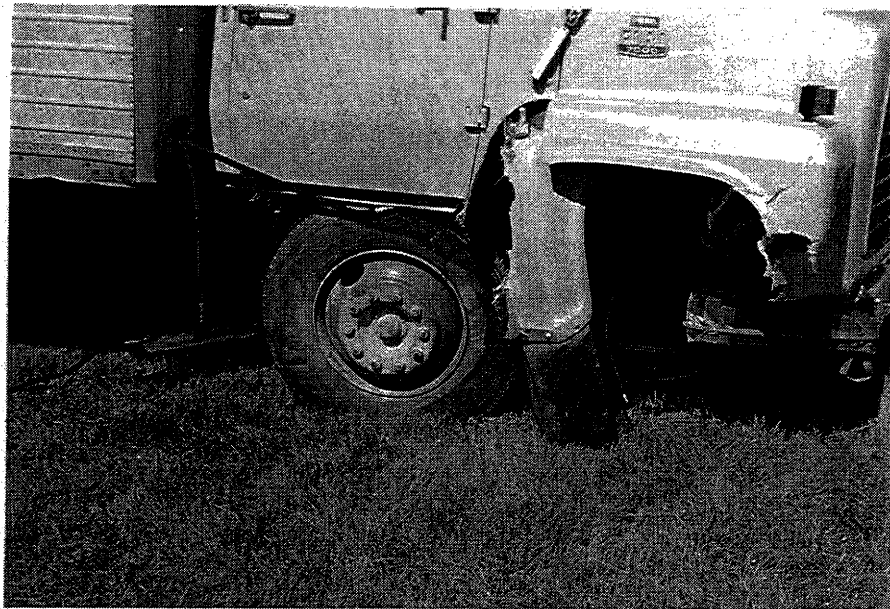
Figure 51. Vehicle after test 7069-9.

The vehicle sustained extensive damage to the right side as shown in figure 51. Maximum crush at the right front corner at bumper height was 16.0 in (406 mm). The right front wheel rim was bent and the tire damaged. The spring and spring shackle were broken loose from the axle and the axle torn loose on the left side. The steering gear box and steering cylinder were damaged. Also, the fuel tank broke loose from the truck.

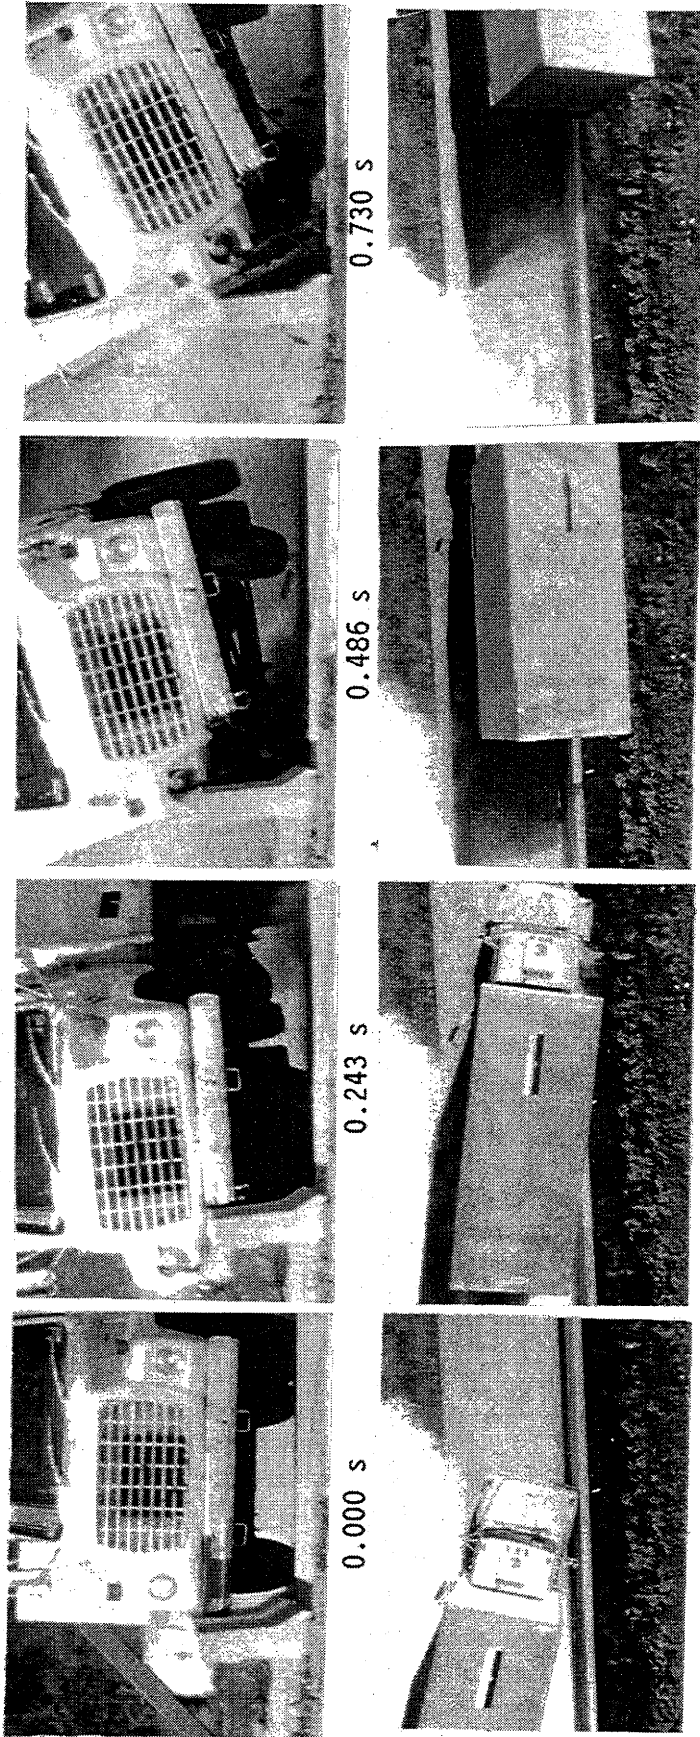
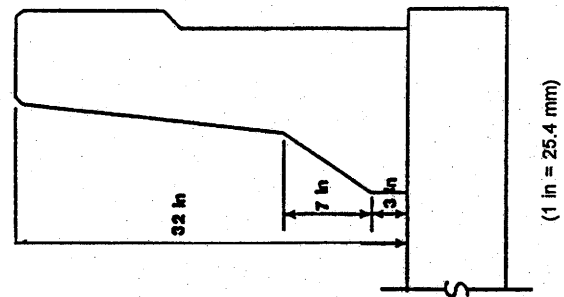
The 32-in (813-mm) F-shape bridge railing contained and smoothly redirected the vehicle with no lateral movement of the bridge railing. There were no debris or detached elements. There was no intrusion into the occupant compartment. The vehicle trajectory at loss of contact indicated minimum intrusion into adjacent traffic lanes. The vehicle remained upright and marginally stable during the entire test period. See table 6 for a more detailed description.

Test No. . . . .	7069-9	Impact Speed. . . . .	47.3 mi/h (76.1 km/h)
Date . . . . .	2/23/88	Impact Angle. . . . .	15.3 deg
Test Installation . . . . .	32-in (813-mm) F-Shape Bridge Railing	Exit Speed. . . . .	34.5 mi/h (55.5 km/h)
Installation Length. . . . .	100 ft (30 m)	Exit Trajectory . . . . .	2.0 deg
Vehicle . . . . .	1982 Ford Single-Unit Truck	Vehicle Accelerations (Max. 0.050-sec Avg)	
Vehicle Weight		Longitudinal. . . . .	-2.0 g
Empty Weight . . . . .	13,050 lb (6,288 kg)	Lateral . . . . .	2.9 g
Test Inertia . . . . .	18,050 lb (8,195 kg)	Occupant Impact Velocity	
Maximum Vehicle Crush . . . . .	16.0 in (406 mm)	Longitudinal. . . . .	11.7 ft/s (3.6 m/s)
		Lateral . . . . .	9.9 ft/s (3.0 m/s)
		Occupant Ridedown Accelerations	
		Longitudinal. . . . .	-2.7 g
		Lateral . . . . .	6.8 g

CRITERIA	TEST RESULTS	PASS/FAIL								
A. Must contain vehicle	Vehicle was contained	Pass								
B. Debris shall not penetrate passenger compartment	No debris penetrated passenger compartment	Pass								
C. Passenger compartment must have essentially no deformation	Acceptable deformation	Pass								
D. Vehicle must remain upright	Vehicle remained upright	Pass								
E. Must smoothly redirect the vehicle	Vehicle was smoothly redirected	Pass								
F. Effective coefficient of friction	$\mu$ .09 Assessment Good	Pass								
G. Shall be less than

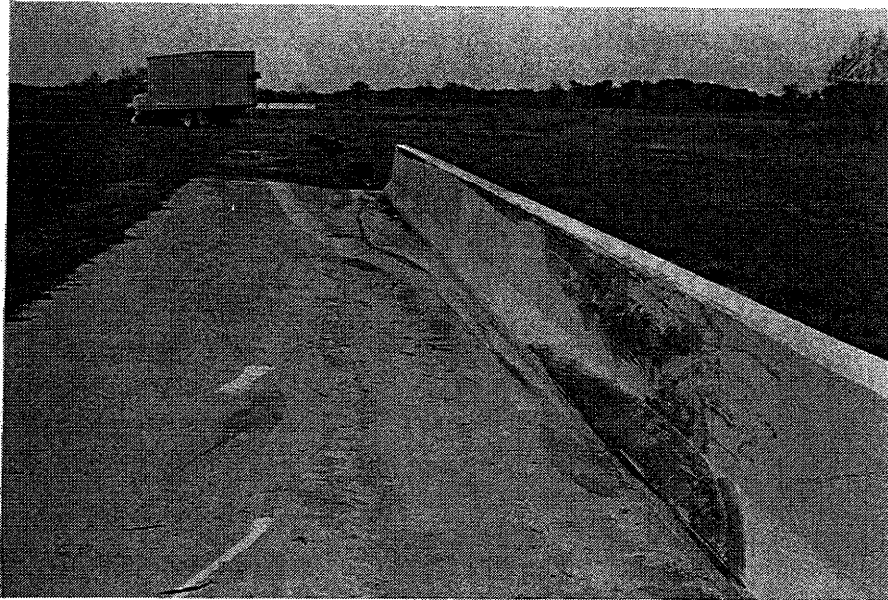
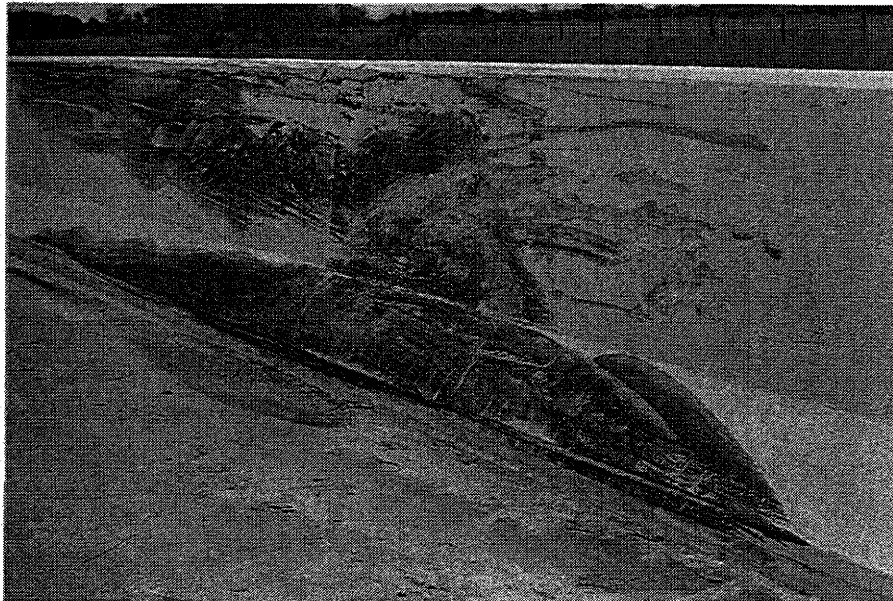
Figure 68. 32-in (813-mm) bridge railing after test 7069-11.

As can be seen in figure 68, the railing received cosmetic damage and some scraping. There were tire marks on the face of the bridge railing and along the top. The top of the bridge railing was scraped along the remaining length from the lower edge of the bed of the truck. The vehicle was in contact with the bridge railing for 39 ft (12 m).

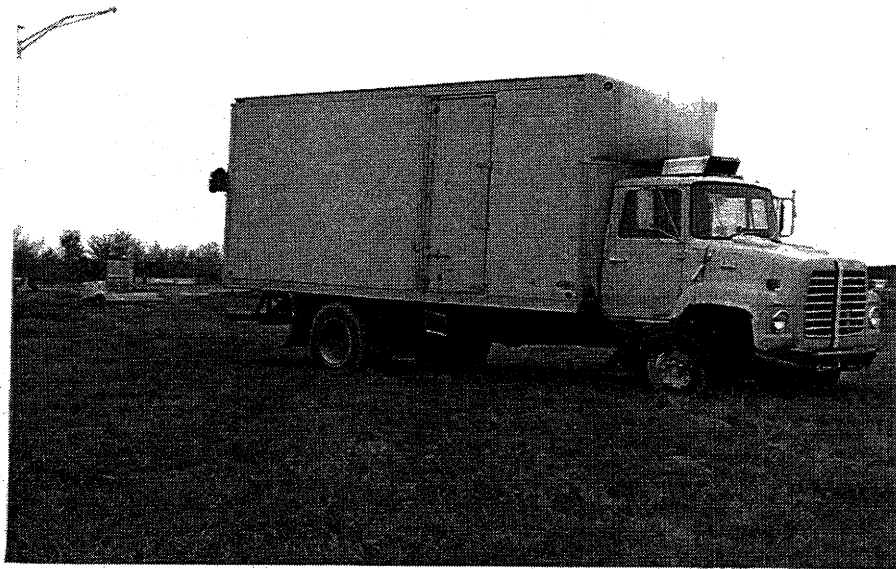
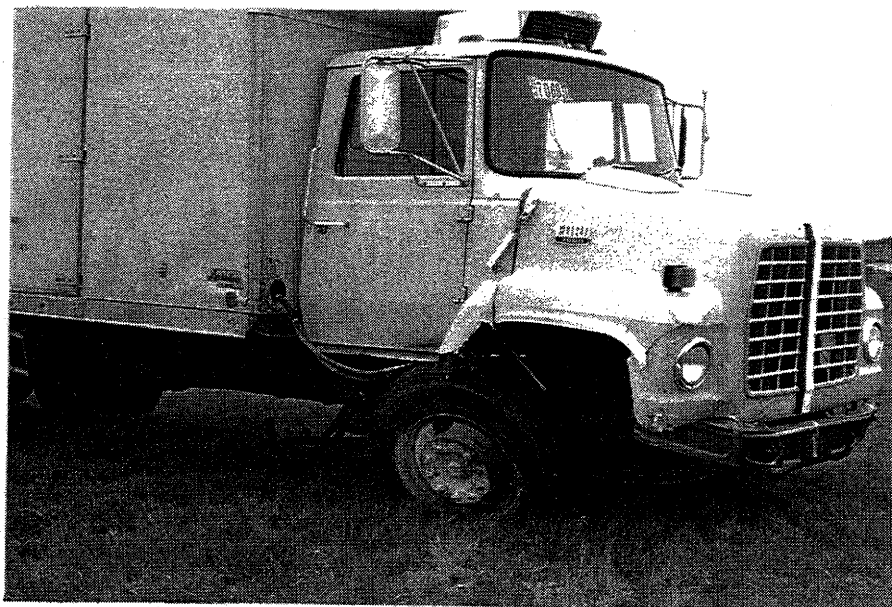
Figure 69. Vehicle after test 7069-11.

The vehicle sustained extensive damage to the right side as shown in figure 69. Maximum crush at the right front corner at bumper height was 20.0 (508 mm). The front axle was torn loose which caused damage to the springs, shackles, U-bolts, and tie rods. The steering arm and cylinder were damaged and the oil pan was dented. Also, the fuel tank broke loose from the truck.

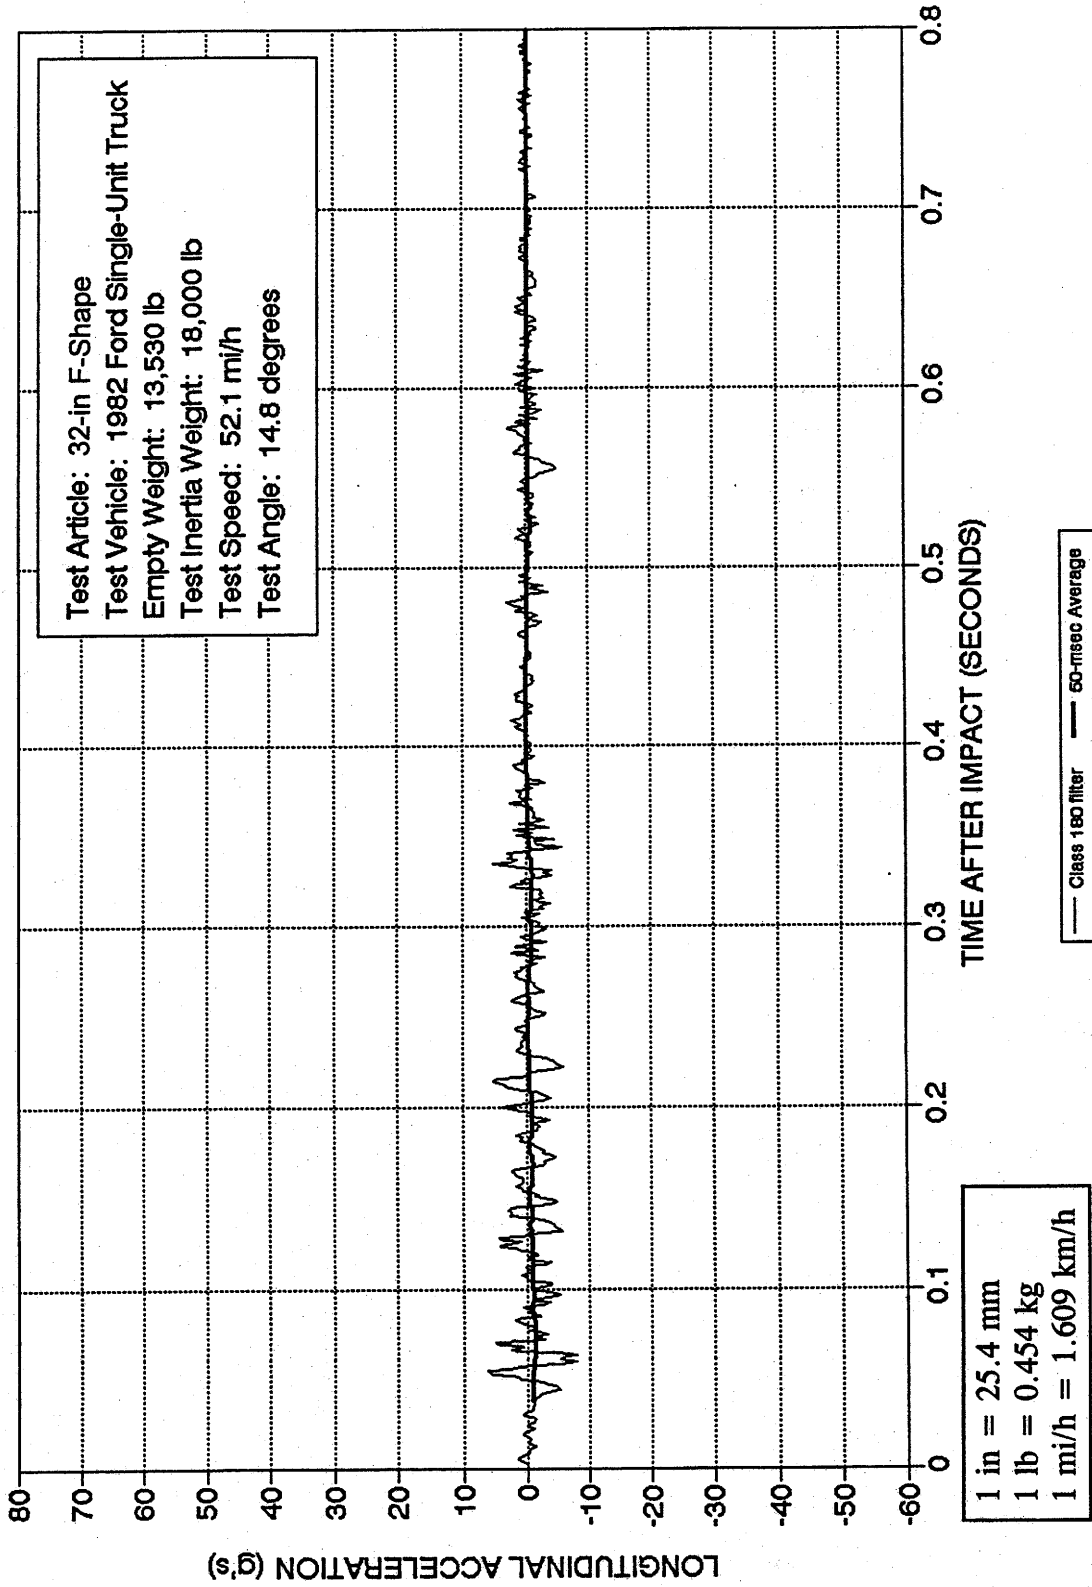
Figure 74. Vehicle longitudinal accelerometer trace for test 7069-11 (accelerometer located near center-of-gravity).

Impact speed was 52.1 mi/h (83.8 km/h) and the angle of impact was 14.8 degrees. The exit speed was not available. Exit angle was about 0 degrees. The effective coefficient of friction was calculated to be 0.12. Occupant impact velocity was 5.7 ft/s (1.7 m/s) in the longitudinal direction and 8.2 ft/s (2.5 m/s) in the lateral direction. The highest 0.010-s occupant ridedown accelerations were 1.3 g (longitudinal) and 5.4 g (lateral). These data and other pertinent information from the test are summarized in figure 70 and table 7. Sequential photographs are shown in figures 71 and 72. Vehicular angular displacements are displayed in figure 73. Vehicle accelerations versus time traces filtered with SAE J211

filters are presented in figures 74 through 80. These data were further analyzed to obtain 0.050-s average accelerations versus time. The maximum 0.050-s averages were -1.4 g (longitudinal) and 3.9 g (lateral).

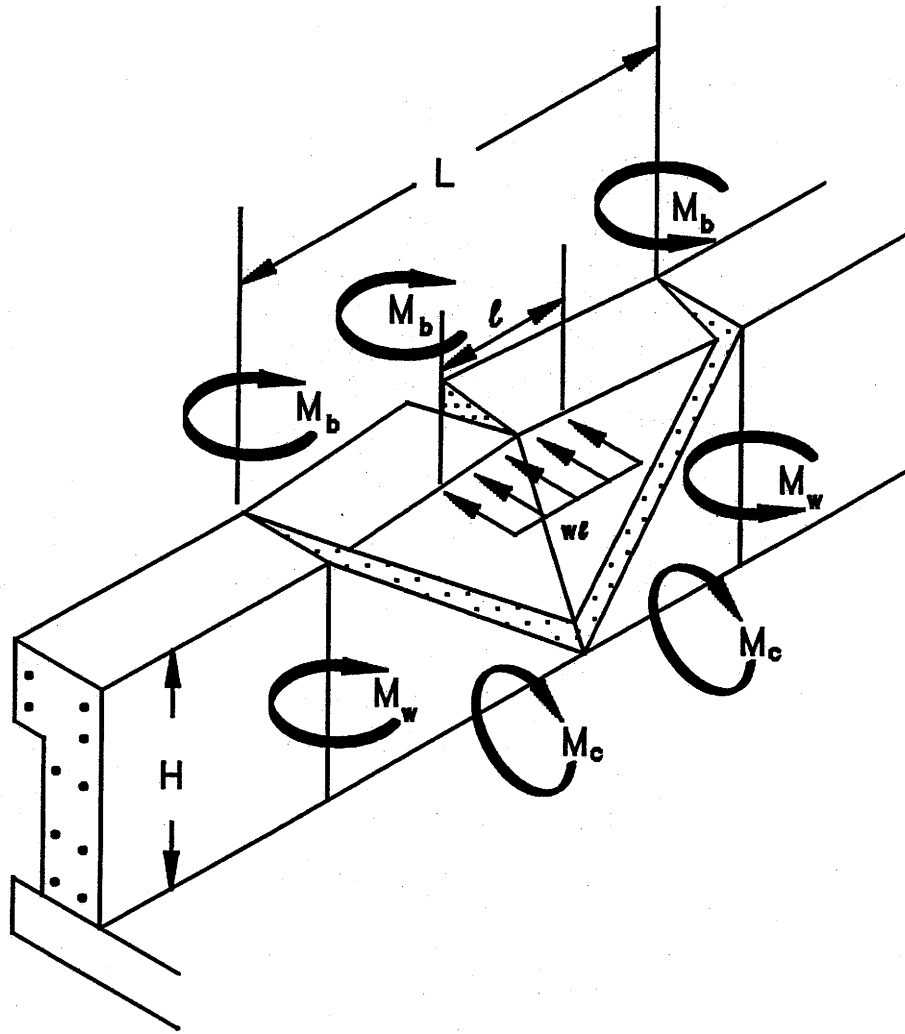
Figure 81. Yieldline failure pattern for concrete parapet.

Analysis of strength of the railing is based on yieldline failure pattern and equations shown in figure 72. Force from a colliding vehicle is idealized as being a uniformly distributed line load extending over 3.5 ft (1.07 m). The load may be applied at any location along the railing. Length of the failure pattern depends on the relative bending moment capacities of various elements of the railing. The computed cantilever moment capacity of parapet,  $M_c$ , is 10.6 ft-k/ft (47.2 m-kN/m) and the moment capacity about a vertical axis,  $M_w$ , is 4.89 ft-k/ft (21.8 m-kN/m). The additional moment capacity of the stiffening beam along the top of the parapet,  $M_b$ , is 6.8 ft-kips (9.2 m-kN). These values result in a length of yieldline pattern of 8.3 ft (211 mm) and the strength of the parapet is 59.1 kips (263 kN) located at the top of the parapet.
