1. Report No. FHWA/TX-04/4852-1		2. Government Accession No.		3. Recipient's Catalog No.	
4. Title and Subtitle CRASH TESTING AND EVALUATION OF THE MODIFIED T77 BRIDGE RAIL				5. Report Date September 2003

CRASH TESTING AND EVALUATION OF THE MODIFIED T77 BRIDGE RAIL

Report 4852-1
Project Number 0-4852
Research Project Title: Development of the T77 Bridge Rail

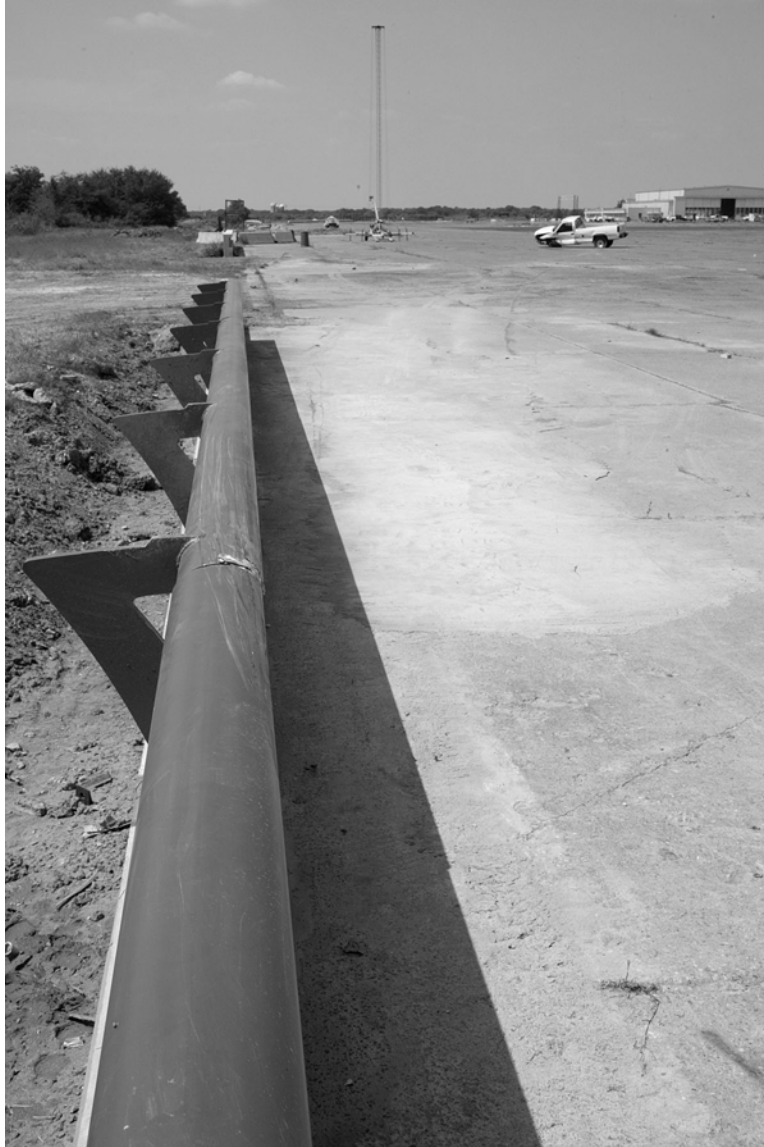
Figure 10. After Impact Trajectory Path for Test 448523-1.

Figures 10 and 11 show damage to the T77 bridge rail. The lower rail element had a 0.8 inch (21 mm) deep indentation in the traffic face. Cracks radiated out of the front and rear anchor bolts of post 7 and extended toward and down the rear side of the curb and into the deck. The traffic face of the curb was also fractured below the baseplate of post 7. Total length of contact of the vehicle with the bridge rail was 16.7 ft (5.1 m). Maximum dynamic deflection of the rail element was 1.1 inches (28 mm), and maximum permanent deformation was 0.8 inch (21 mm).

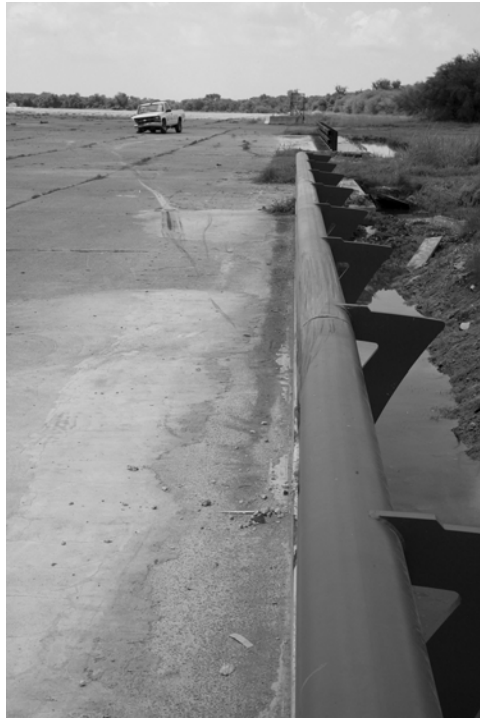
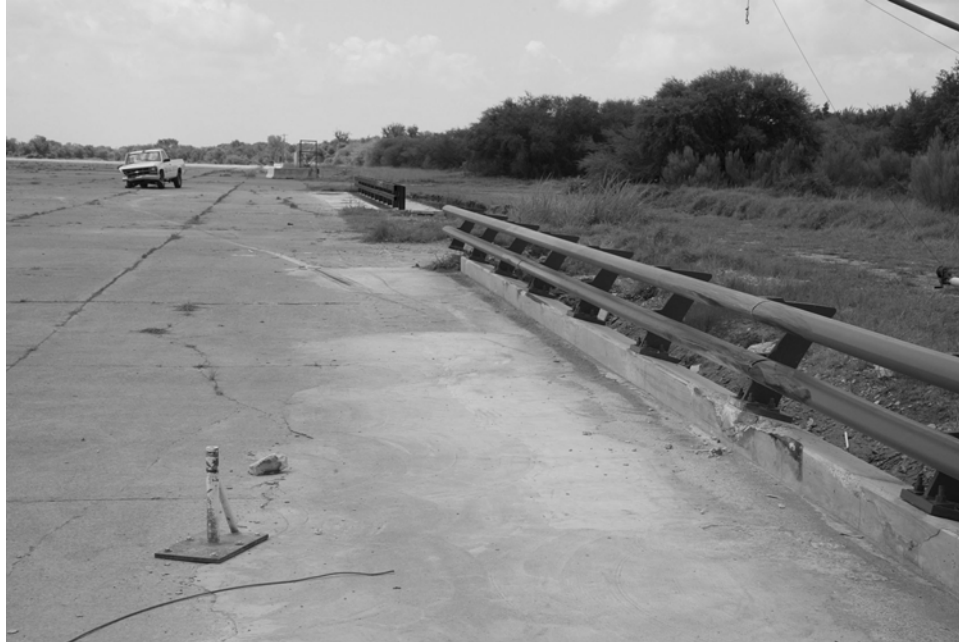
Figure 17. After Impact Trajectory Path for Test 409260-1.

Damage to the T77 bridge rail is shown in Figures 17 and 18. Cracks radiated out of the front and rear anchor bolts of post 3 and 4 and extended toward and down the rear side of the curb and into the deck. The traffic face of the curb was also fractured below the baseplate of post 4. Total length of contact of the vehicle with the bridge rail was 12.4 ft (3.8 m). Maximum dynamic deflection of the rail element was not attainable and maximum permanent deformation was 0.7 inch (18 mm).

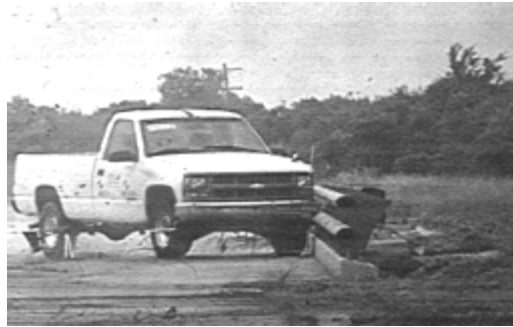
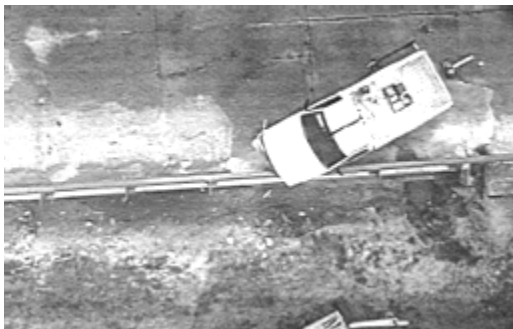
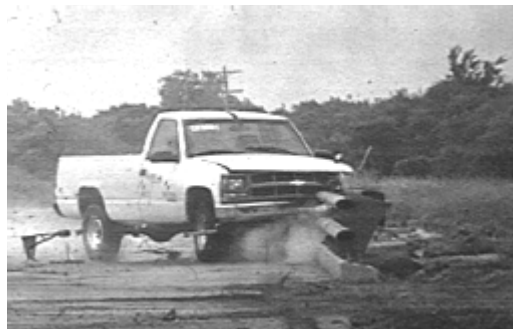
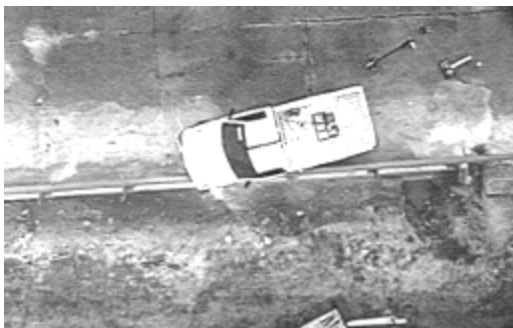
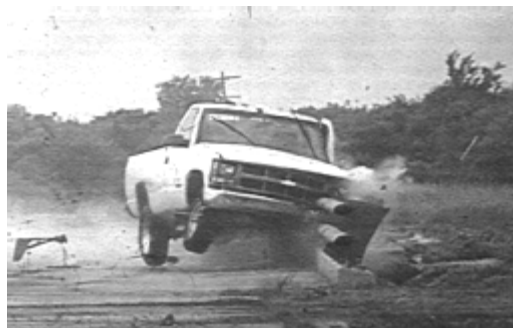
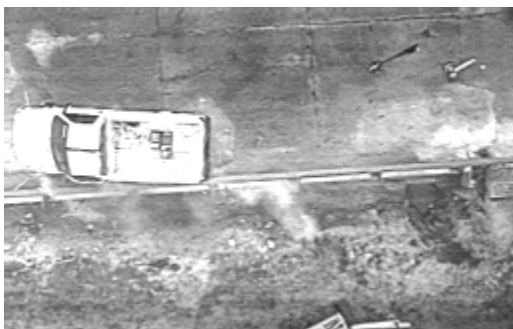
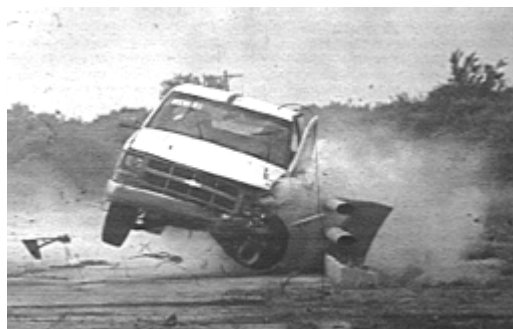
Figure 24. Sequential Photographs for Test 448523-1 (Overhead and Frontal Views).

The vehicle, traveling at 62.5 mph (100.6 km/h), impacted the T77 bridge rail 4.0 ft (1.2 m) upstream of post 7 at an impact angle of 24.6 degrees. Shortly after impact, the left front tire contacted the curb, and at 0.020 s, post 7 began to deflect toward the field side. The left front tire contacted the rail element at 0.022 s, and the tire blew out at 0.030 s. At 0.042 s, the front bumper contacted post 7, and at 0.050 s, the vehicle began to redirect. The left front wheel rim snagged on the lower splice at 0.062 s. The left rear tire contacted the curb at 0.203 s, and the tire blew out at 0.213 s. At 0.219 s, the vehicle was traveling parallel with the rail at a speed of 48.7 mph (78.4 km/h). The left front of the vehicle lost contact with the rail at 0.265 s. At 0.585 s, the vehicle lost contact with the bridge rail and was traveling at a speed of 46.4 mph (74.7 km/h) and an exit angle of 15.0 degrees. Brakes on the vehicle were applied at 3.65 s after impact. The vehicle subsequently yawed counterclockwise and came to rest 243.8 ft (74.3 m) downstream of impact and 62.5 ft (1.91 m) forward of the traffic face of the rail. Appendix C, Figures 24 and 25, show sequential photographs of the test period.

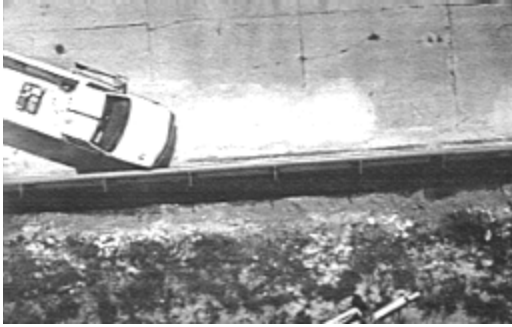
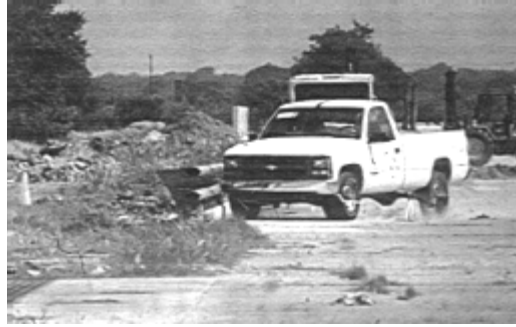
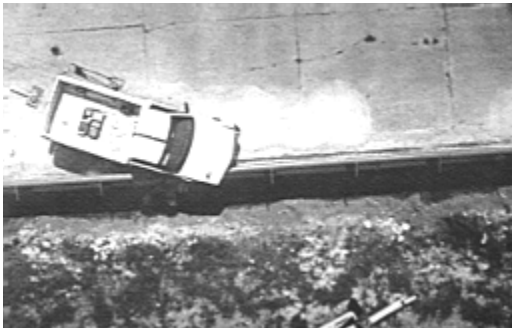
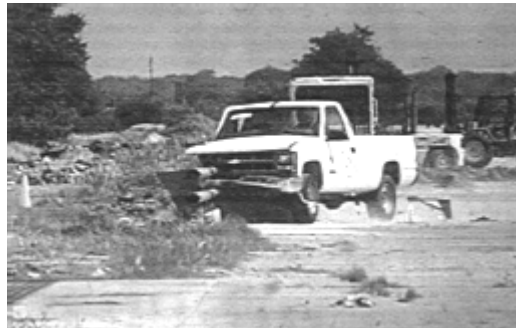
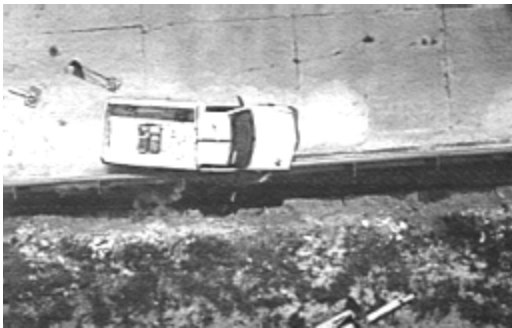
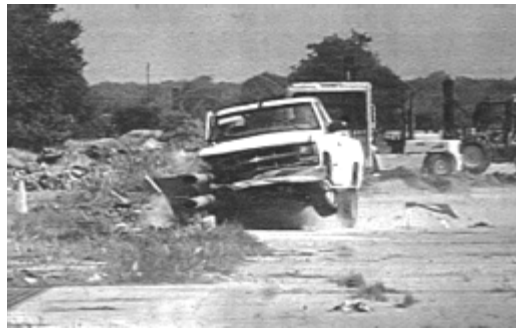
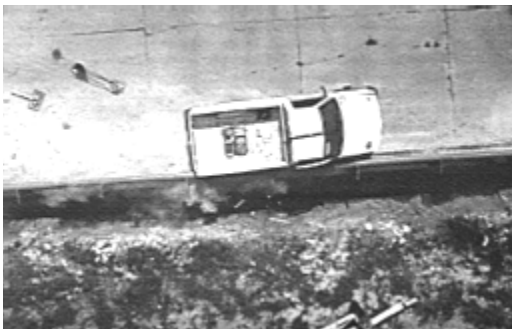
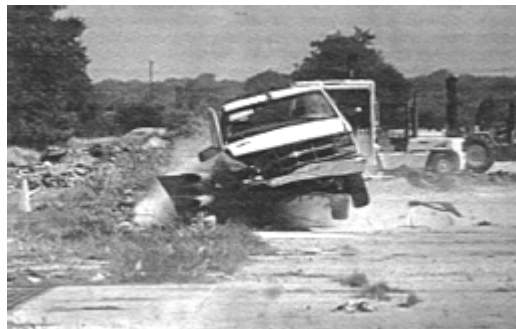
Figure 26. Sequential Photographs for Test 409260-1 (Overhead and Frontal Views).

The vehicle, traveling at 62.1 mph (99.9 km/h), impacted the T77 bridge rail 4.2 ft (1.3 m) upstream of post 4 at an impact angle of 25.1 degrees. Shortly after impact, the right front tire contacted the curb, and at 0.012 s, the front bumper protruded between the upper and lower rail elements. Post 4 began to deflect toward the field side at 0.017 s, and the right front tire blew out at 0.035 s. At 0.040 s, the front bumper contacted post 4, and at 0.047 s, the vehicle began to redirect. At 0.184 s, the vehicle was traveling parallel with the rail at a speed of 55.5 mph (89.3 km/h). The rear of the vehicle contacted the rail at 0.182 s, and the right front of the vehicle lost contact with the rail at 0.197 s. At 0.299 s, the vehicle lost contact with the bridge rail and was traveling at a speed of 55.1 mph (88.6 km/h) and an exit angle of 5.2 degrees. Brakes on the vehicle were applied 1.2 s after impact. The vehicle subsequently yawed clockwise and came to rest 217.5 ft (66.3 m) downstream of impact and 25.0 ft (7.6 m) forward of the traffic face of the rail. Appendix C, Figures 26 and 27, show sequential photographs of the test period.
