1. REPORT NO. FHWA/CA15-2181		2. GOVERNMENT ACCESSION NO.		3. RECIPIENT'S CATALOG NO.	
4. TITLE AND SUBTITLE COMPLIANCE CRASH TESTING OF THE TYPE 732SW BRIDGE RAIL				5. REPORT DATE April 2015/Revised May 2016/Revised September 2016

16. ABSTRACT <p>The Type 732SW bridge rail is an updated version of the Type 26 bridge rail and was tested for compliance to the Manual for Assessing Safety Hardware (MASH 09) as a part of this research project.</p> <p>The 732SW is a taller, stronger version of the Type 26 with a sidewalk. It is comprised of a sidewalk, vertical concrete wall, and steel handrail for pedestrians. The barrier tested was about 24 m (79 ft) long and was constructed at the Caltrans Dynamic Test Facility in West Sacramento, California.</p> <p>Three crash tests were conducted under MASH 09: Test 3-11 (the 2270P pickup at TL-3), Test 3-10 (the 1100C small car at TL-3), and Test 2-10 (the 1100C small car at TL-2) because Test 3-10 resulted in a ridedown acceleration that was outside of the MASH 09 limits. The results of Tests 3-11 and 2-10 were within the limits of the MASH 09 guidelines.</p> <p>The Type 732SW bridge rail is recommended for approval on California highways requi

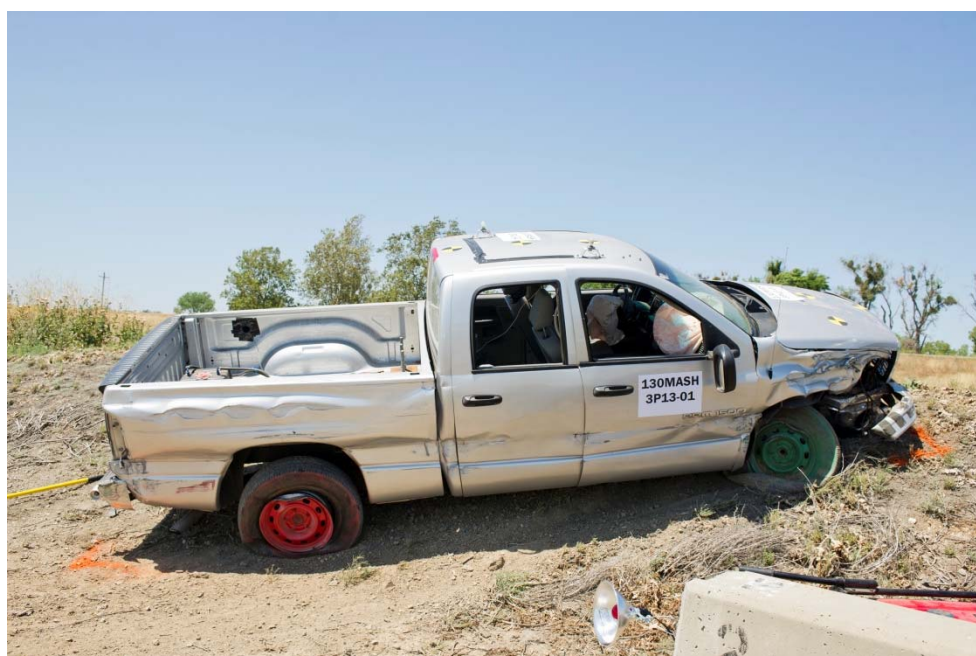
Figure 3-6 – Test vehicle after Test 130MASH3P13-01

The right front tire ruptured upon impact with the sidewalk. The right front corner of the vehicle was severely damaged in the impact with the barrier face. The right front fender, hood, bumper, headlamp area, grille, and suspension components were all affected. The passenger side doorframe was deformed outward but the doors remained latched. The left front and right rear tires were also ruptured. The top of the vertical concrete wall caused denting along the entire length of the passenger side as the vehicle continued to contact the barrier after the initial impact. The right front tire was pushed rearward and slightly into the passenger side foot well area. The maximum amount of passenger compartment deformation was 54 mm (2.1 in), which occurred in the floorboard and is below maximum MASH 09 limits. All other occupant compartment deformations were below MASH 09 limits for that area of the vehicle. The passenger side of the windshield cracked but did not separate or enter the occupant compartment.

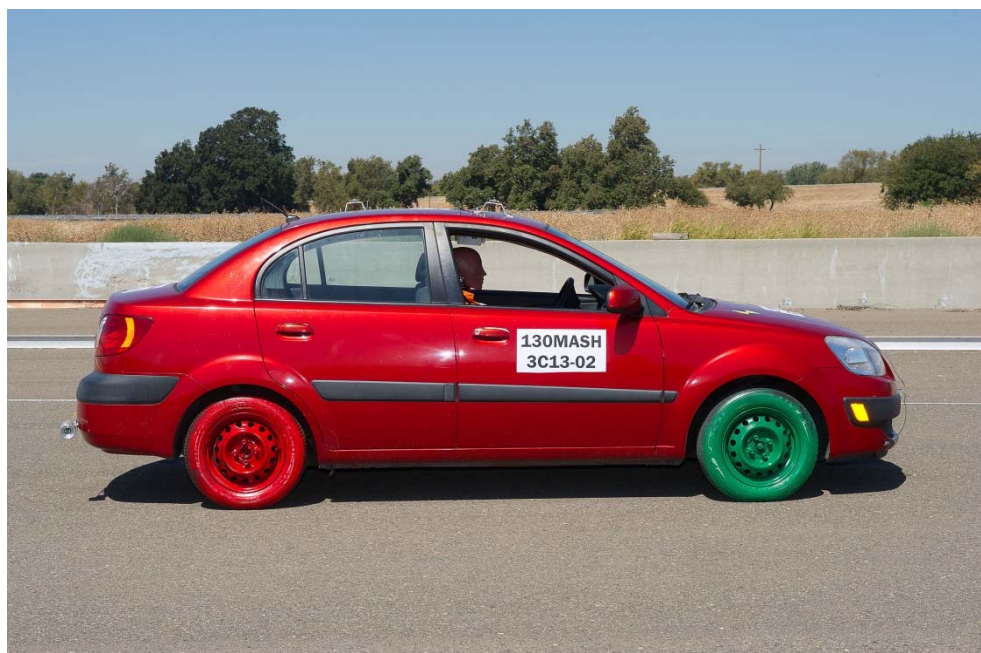
Figure 3-15 – Right side of test vehicle for 130MASH3C13-02

The front right wheel absorbed most of the impact with the barrier curb and face. The rim was bent during impact with the curb causing the tire to deflate. The wheel well of the test vehicle sustained most of the damage. Additional damage also occurred to the side of the vehicle as it scraped the barrier when redirected. Since the front right wheel took most of the impact, there was no distinguishable damage to the floorboard (see Figure 3-20). The right front corner of the vehicle was moderately damaged. The right front bumper and right fender were pushed rearward. The entire right side of the vehicle was moderately damaged. All four tires deflated during the impact. The maximum passenger compartment deformation was 1.7 inches at the floor pan near the center of the vehicle.

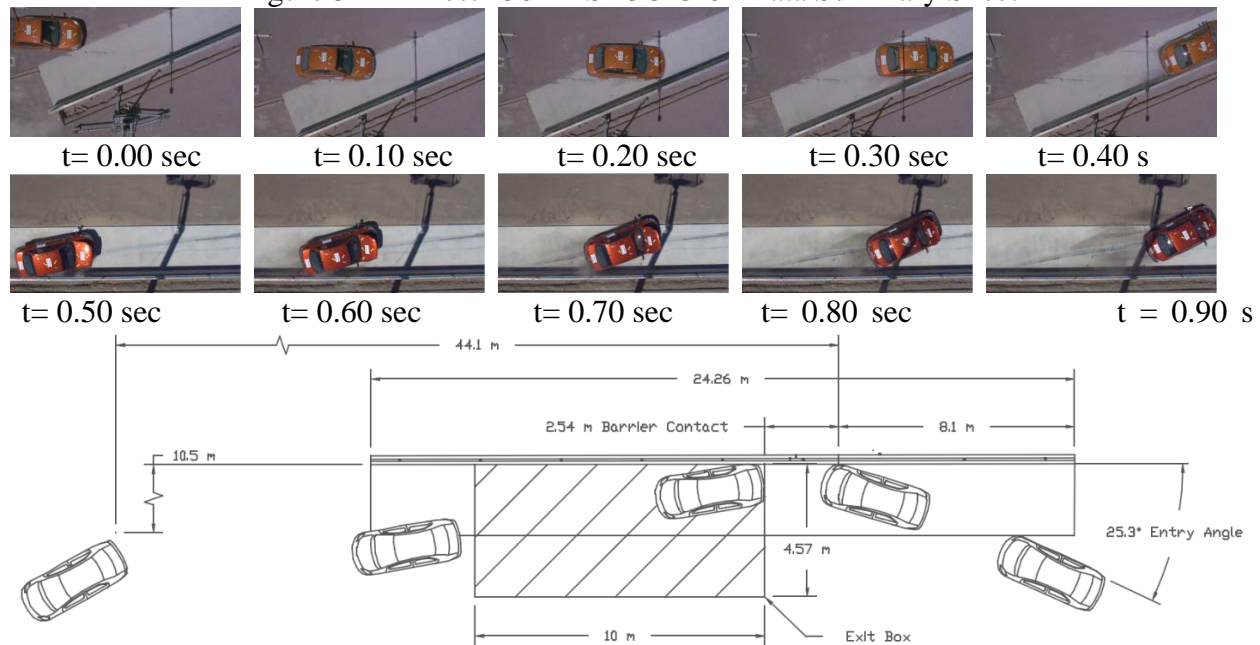
Figure 3-21 – Test 130MASH3C13-02 Data Summary Sheet

No deflection in steel handrail, minor superficial concrete spalling.

Longitudinal and Lateral	15.0 G	20.49 G	Longitudinal -9.5 g Lateral -23.8 g	Fail									
Vehicular Trajectory		<p>It is preferable that the vehicle be smoothly redirected, and this is typically indicated when the vehicle leaves the barrier within the "exit box". The concept of the exit box is defined by the initial traffic face of the barrier and a line parallel to the initial traffic face of the barrier, at a distance A plus the width of the vehicle plus 16 percent of the length of the vehicle, starting at the final intersection (break) of the wheel track with the initial traffic face of the barrier for a distance of B. All wheel tracks of the vehicle should not cross the parallel line within the distance B</p> <p><u>For Test 130MASH3C13-02: A = 15.0ft (4.57m) and B = 32.8ft (10.0m)</u></p> <p>Distance for Exit Box Criterion</p>

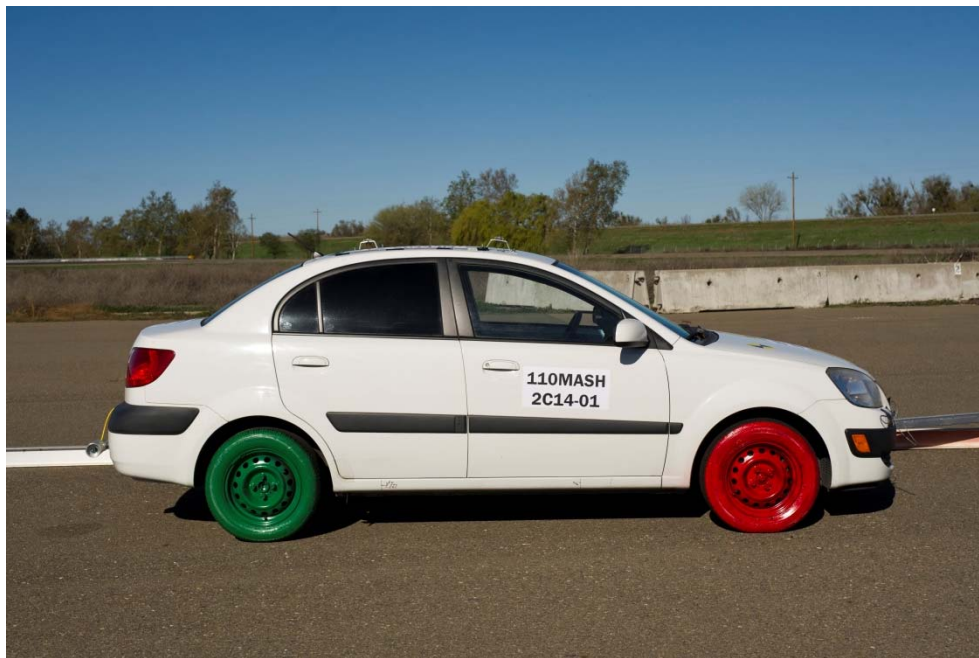
Figure 3-26 – Right side of test vehicle for Test 110MASH2C14-01

The front right wheel absorbed most of the impact. The rim was bent during impact causing the tire to deflate. The wheel well of the test vehicle sustained most of the damage. Additional damage also occurred to the side of the vehicle as it scraped the barrier when redirected. Since the front right wheel took most of the impact, there was no distinguishable damage to the floorboard (see Figure 3-31). The right front corner of the vehicle was moderately damaged. The right front bumper and right fender were pushed rearward. The right side of the vehicle at the front and rear was moderately damaged. The two front tires deflated during the impact. The maximum passenger compartment deformation was 0.6 inches at the floor pan near the passenger door.

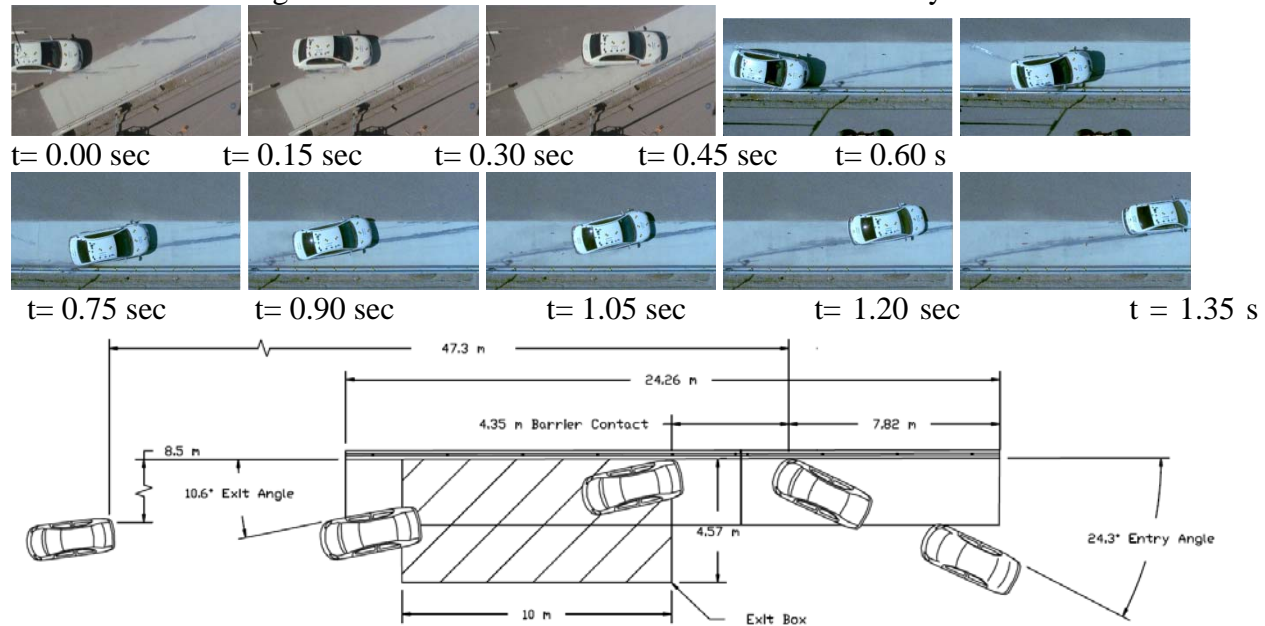
Figure 3-32 – Test 110MASH2C14-01 Data Summary Sheet

No deflection in steel handrail, minor superficial concrete spalling.
