TWO TEST LEVEL 4 BRIDGE RAILING AND TRANSITION SYSTEMS FOR TRANSVERSE GLUE-LAMINATED TIMBER DECKS

MwRSF Research Report No. TRP-03-71-01

January 30, 2002

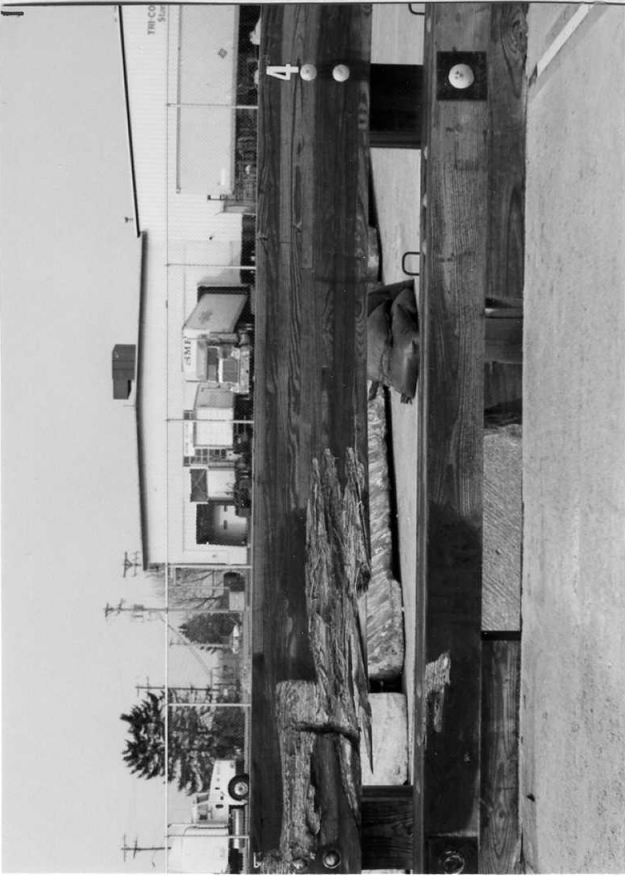
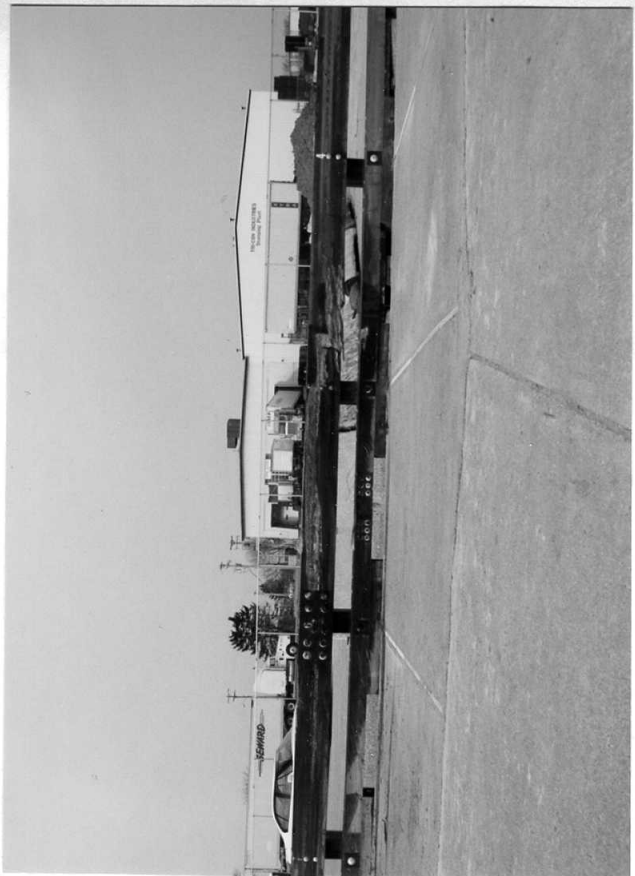
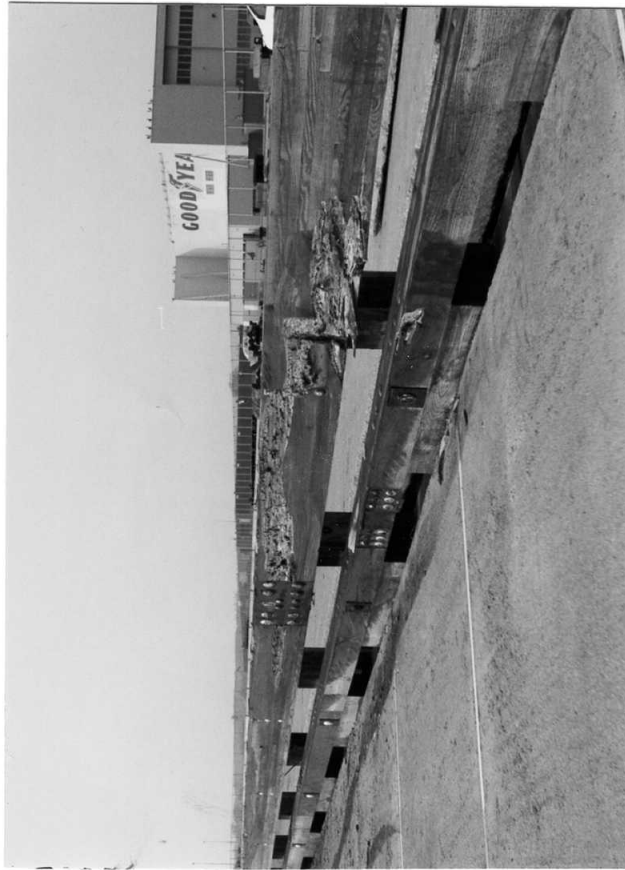
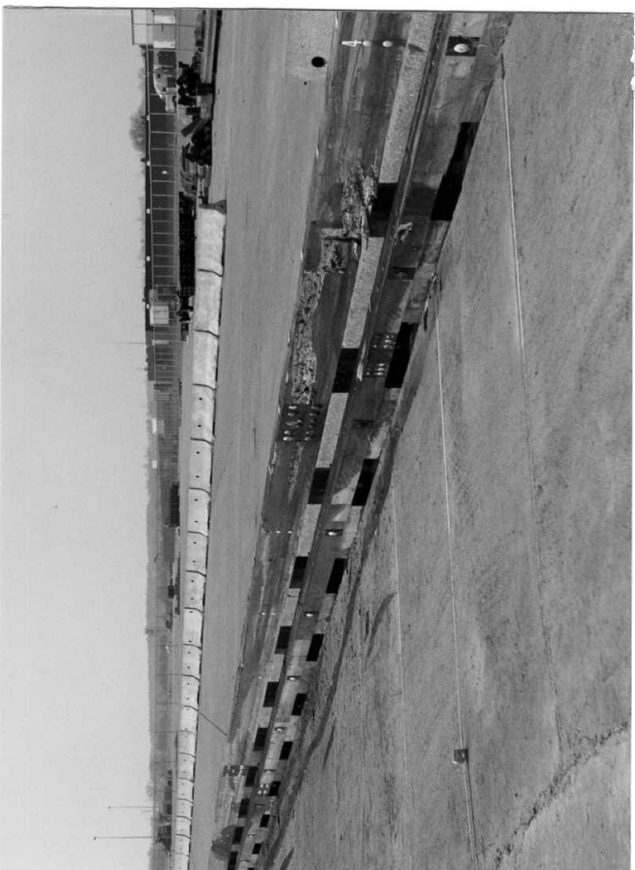
Figure 74. Barrier Damage, Test TRBR-1

The moderate bridge railing damage is shown in Figures 74 and 75. Significant gouging and scrapes occurred to the glulam rail from the midspan between post nos. 4 and 5 to post no. 6, as shown in Figure 74. Minor gouges and scrapes were found on top of the upper rail and occurred when the truck box leaned on the rail, as shown in Figures 74 and 75. The curb rail received gouges between post nos. 4 and 5, as shown in Figure 74.

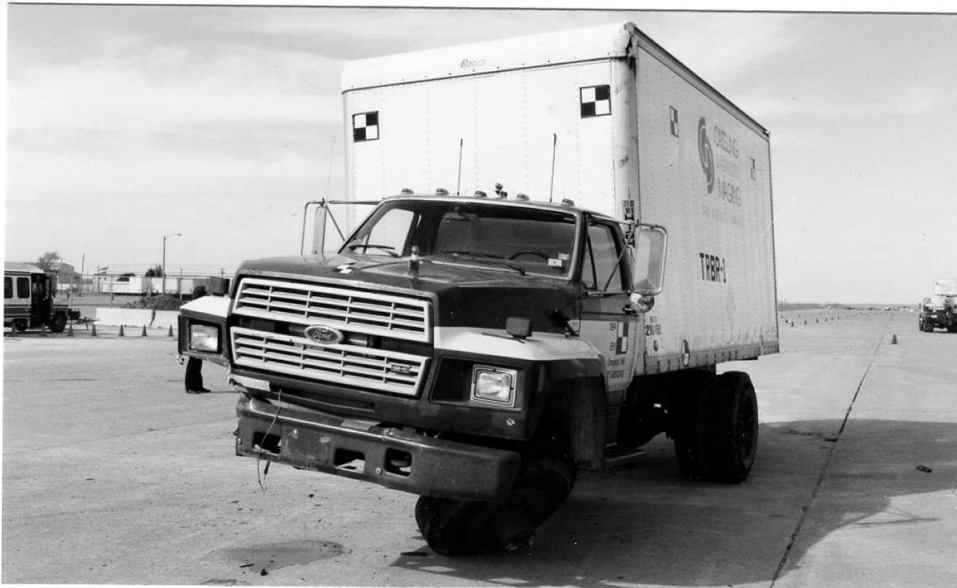
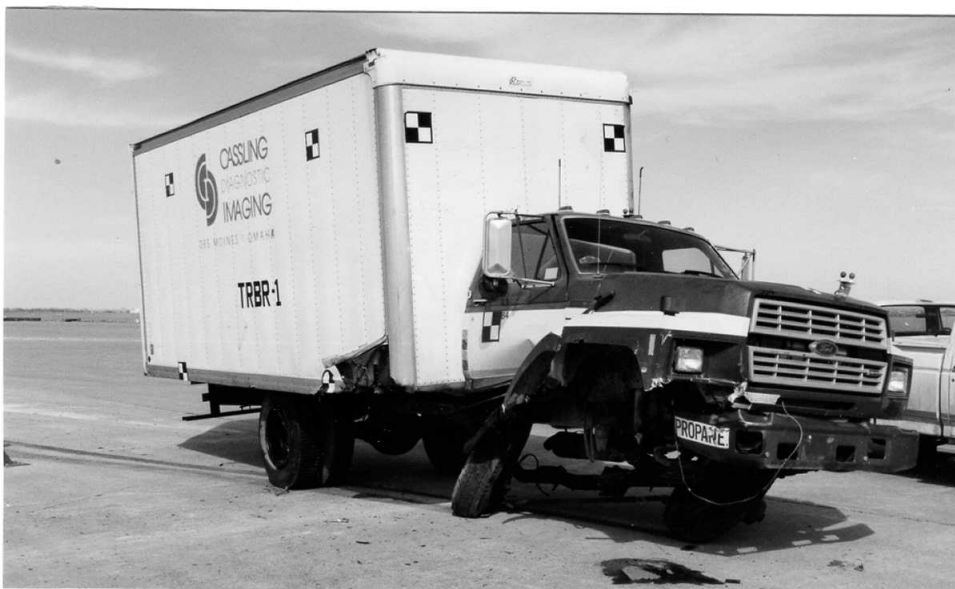
Figure 76. Vehicle Damage, Test TRBR-1

Exterior vehicle damage was moderate, as shown in Figures 76 through 78. Vehicle damage occurred to several body locations, such as right-side door and quarter panels, front bumper, right-side wheels and rims, front axle, truck box and support frame, and the side-mounted foot step. The right corner of the front bumper and the right-side door and quarter panels were crushed inward as shown in Figure 76. The lower right-front corner of the truck box was deformed inward, as shown in Figure 76. The front axle, with attached tires and steel rims, was removed from the truck and came to rest under the truck frame, as shown in Figures 76 and 77. The right-rear steel rim was also deformed, as shown in Figure 77. The truck box was shifted to the right of the longitudinal centerline of the truck cab and support frame. U-bolts, used to attach the box to the frame, were also deformed due to the box shift, as shown in Figure 78.

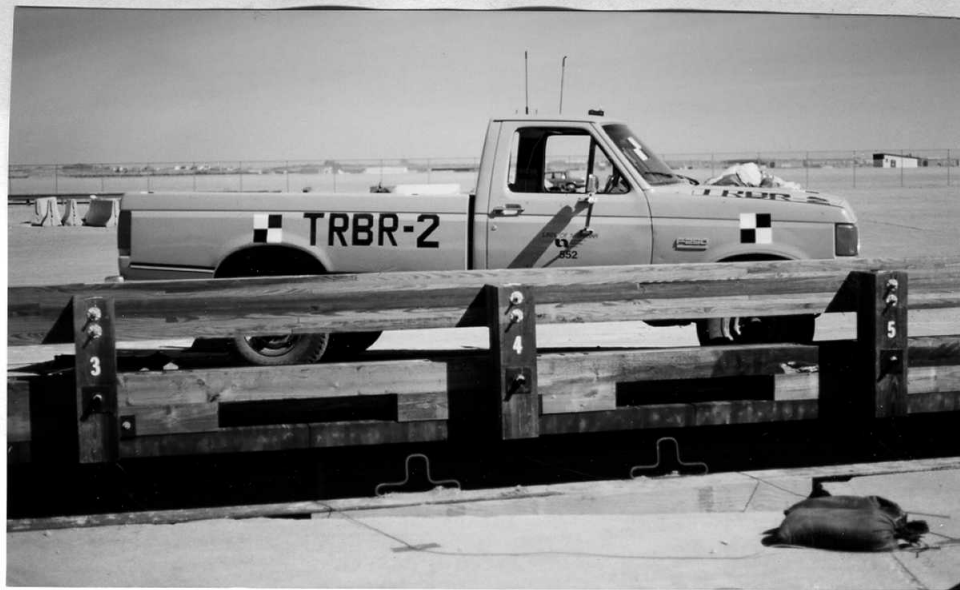
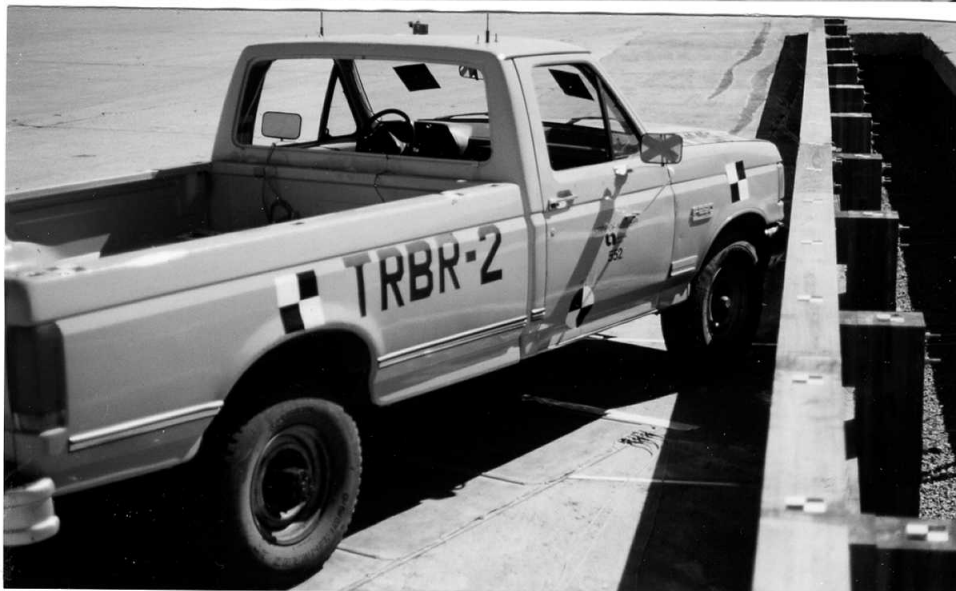
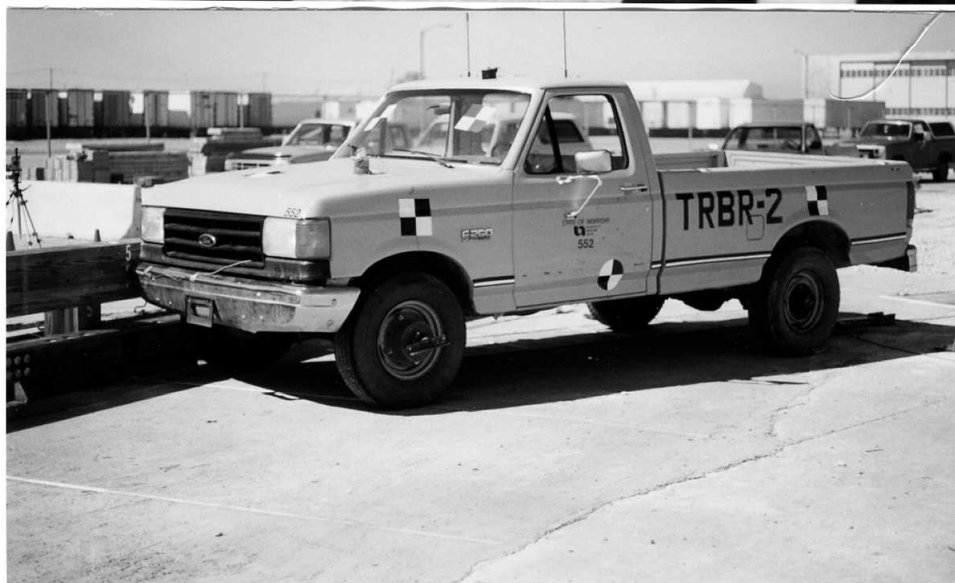
Figure 85. Impact Locations, Test TRBR-2

Initial impact occurred at the centerline of bridge post no. 5 or approximately 10,122 mm downstream from the upstream end of the bridge rail, as shown in Figure 85. After the initial impact with the bridge rail, the right-front tire was deformed, allowing the steel rim to gouge into the traffic-side face of both the curb and upper glulam rails. Subsequently, the right-front corner of the bumper and quarter panel crushed inward. At 0.122 sec, the maximum dynamic lateral deflection of 203 mm was measured at post no. 5. At 0.187 sec, the front of the truck was at post no. 7. The left-front tire lost contact with the ground at 0.191 sec. At 0.238 sec after impact, the vehicle became parallel to the bridge rail with a velocity of 66.0 km/hr when the right-rear tire contacted the rail. At 0.299 sec, the right-front tire lost contact with the ground, and the front of the truck was at post no. 8. At 0.323 sec, the entire pickup truck was airborne. The vehicle exited the bridge railing at a speed of approximately 62.3 km/hr and an angle of 2.1 degrees at 0.437 sec. At 0.514 sec, the left-front tire re-contacted the deck surface. At 0.667 sec, the vehicle achieved a maximum clockwise roll angle of approximately 33.7 degrees toward the rail. The vehicle's post-impact trajectory is shown in Figure 79. The vehicle's front-end came to rest approximately 47.5-m downstream from post no. 5, as shown in Figure 86. The rebound distance, as measured from the traffic-side face of the bridge

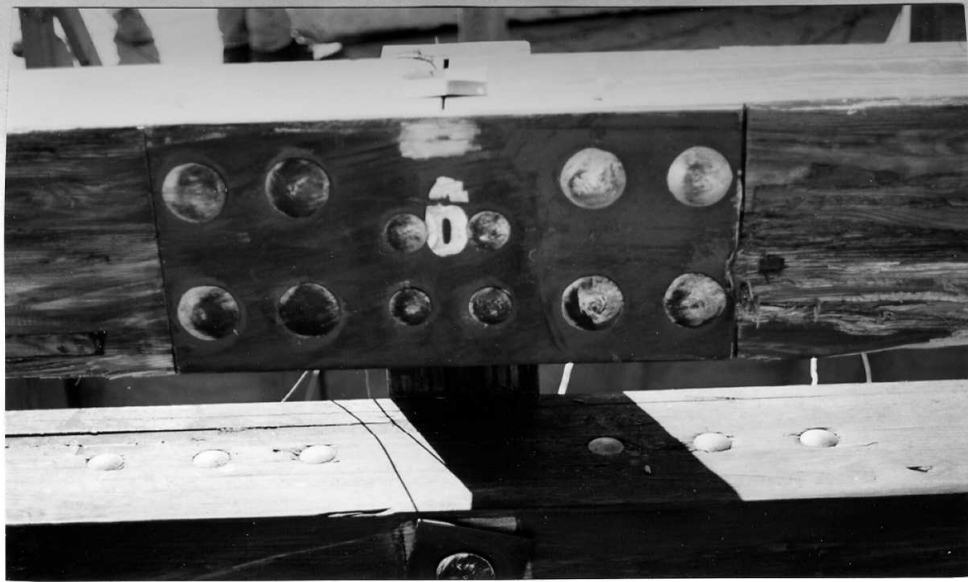
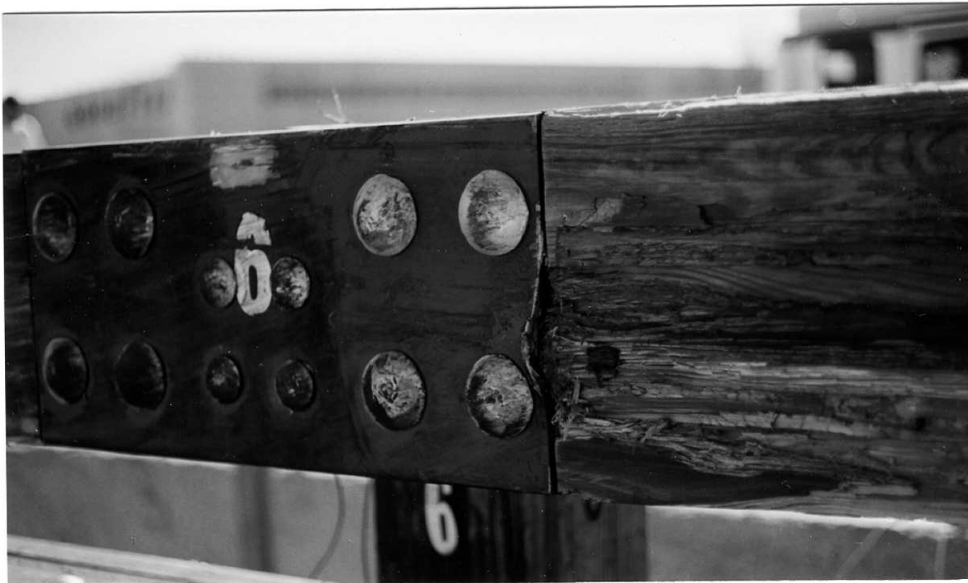
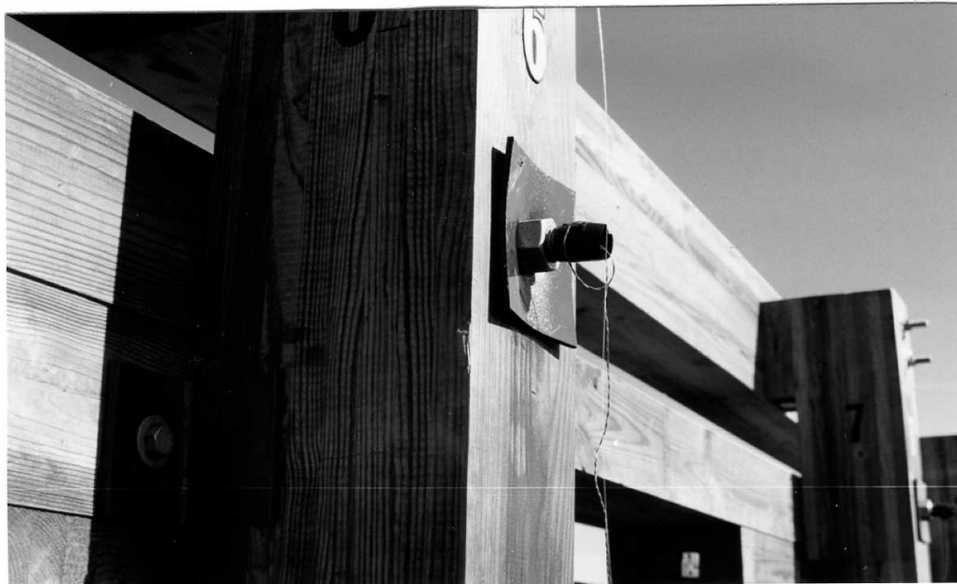
Figure 88. Steel Plate Deformations at Post No. 6, Test TRBR-2

Three steel plate washers, located on the back face of the curb rail at post nos. 5 through 7, were deformed due to high axial tension transmitted to the bolts, as shown in Figure 88. The steel splice plate located on the traffic-side face of the upper glulam rail at post no. 6 was deformed due to the vehicle snagging on the upstream edge of the plate. Also, the curb rail steel splice H-plate between post nos. 5 and 6 was slightly deformed.

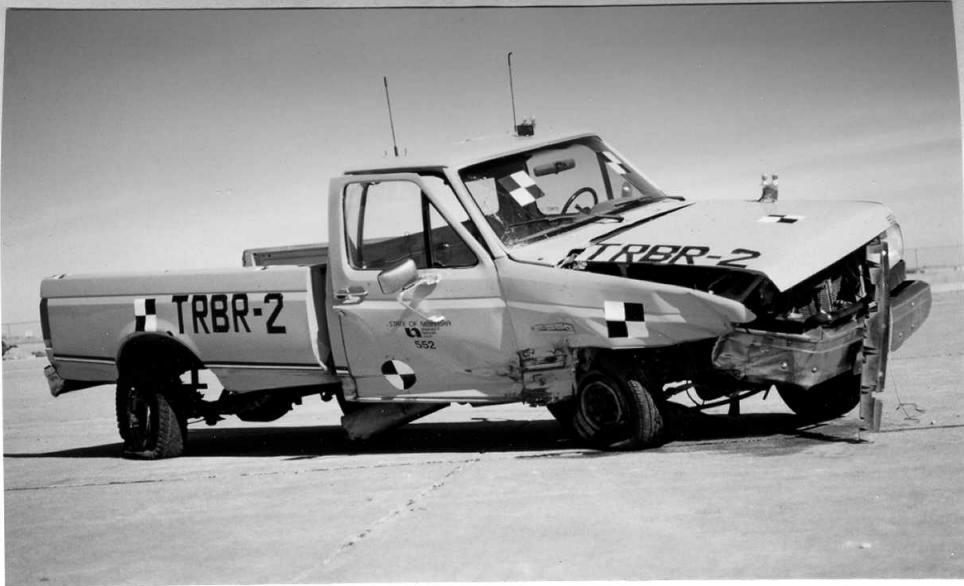
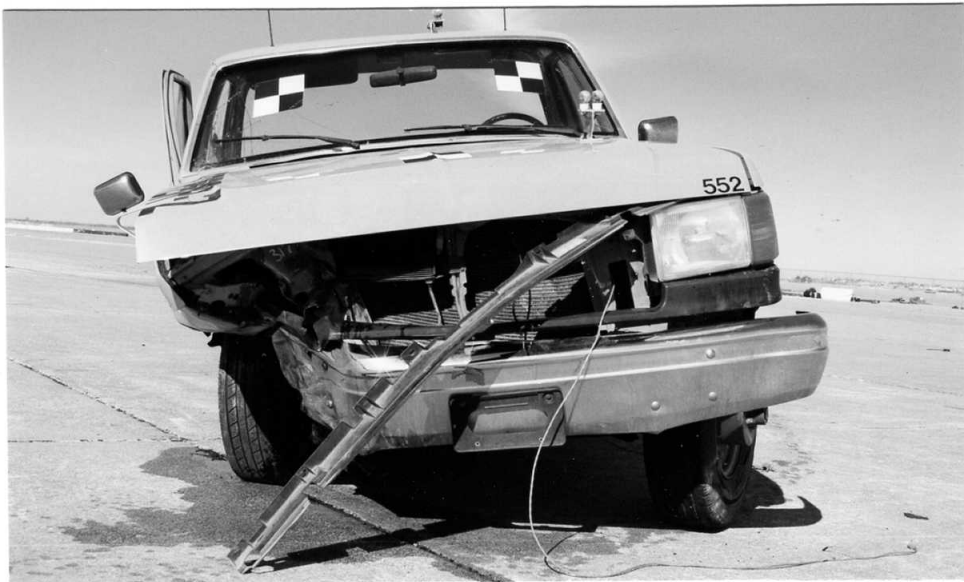
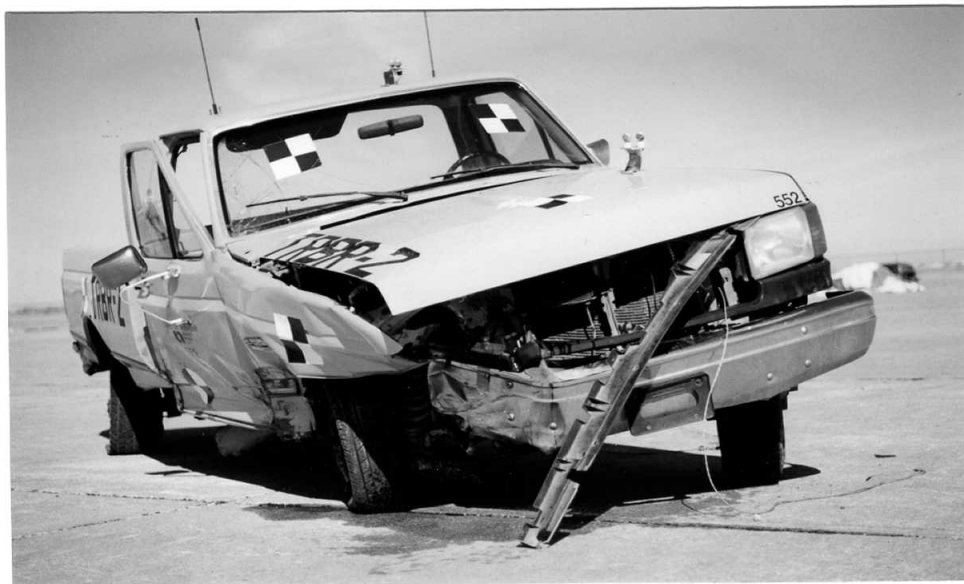
Figure 89. Vehicle Damage, Test TRBR-2

Exterior vehicle damage was moderate, as shown in Figures 89 through 91. Vehicle damage occurred to several body locations, such as right-side door and quarter panels, front bumper, right-side wheels and rims, windshield, and interior floorboard. The right corner of the front bumper and quarter panels were crushed inward due to contact with the upper glulam rail, as shown in Figure 89. The right-front wheel assembly was pushed back toward the firewall, as shown in Figure 89. The right-front tire was deflated and partially removed from the steel rim, and the right-front steel rim

was deformed, as shown in Figures 89 and 90. The right-rear wheel assembly and axle were pushed back, and the steel rim and tire were deformed and deflated, respectively, as shown in Figure 90. The front windshield was cracked on the passenger side. Maximum occupant compartment deformations to the floorboard were 127-mm lateral displacement near the firewall region, 102-mm longitudinal displacement near the right-side floorboard, and 91-mm vertical displacement under the seat along the centerline of the hump. Interior vehicle deformations to the floorboard, as shown in Figure 91, were judged insufficient to cause serious injury to the vehicle occupants. No deformation occurred to the interior front dashboard.

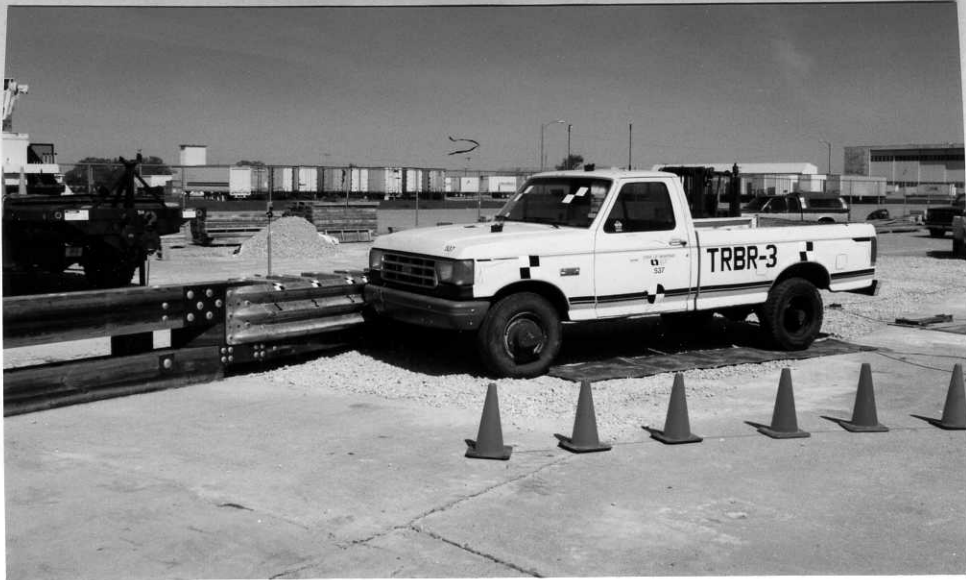
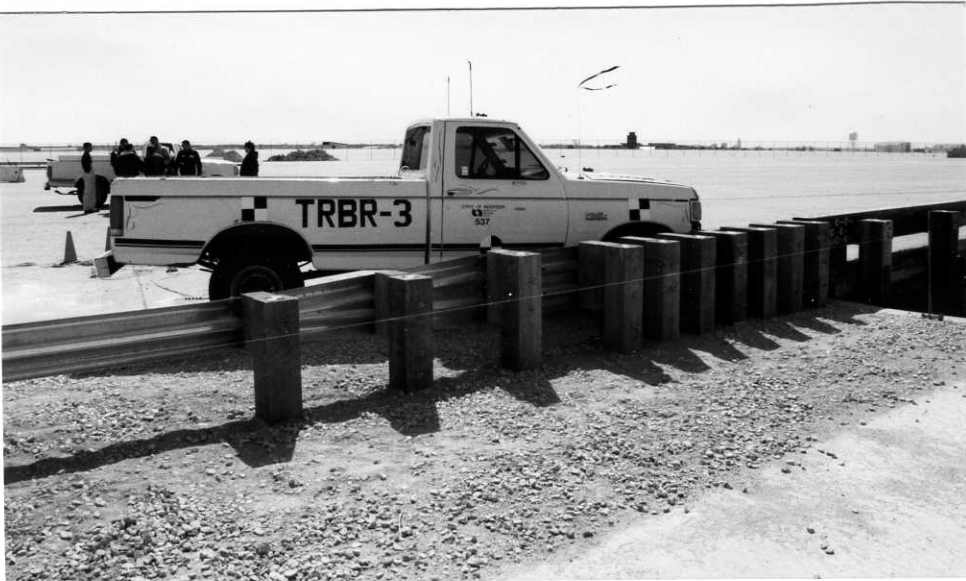
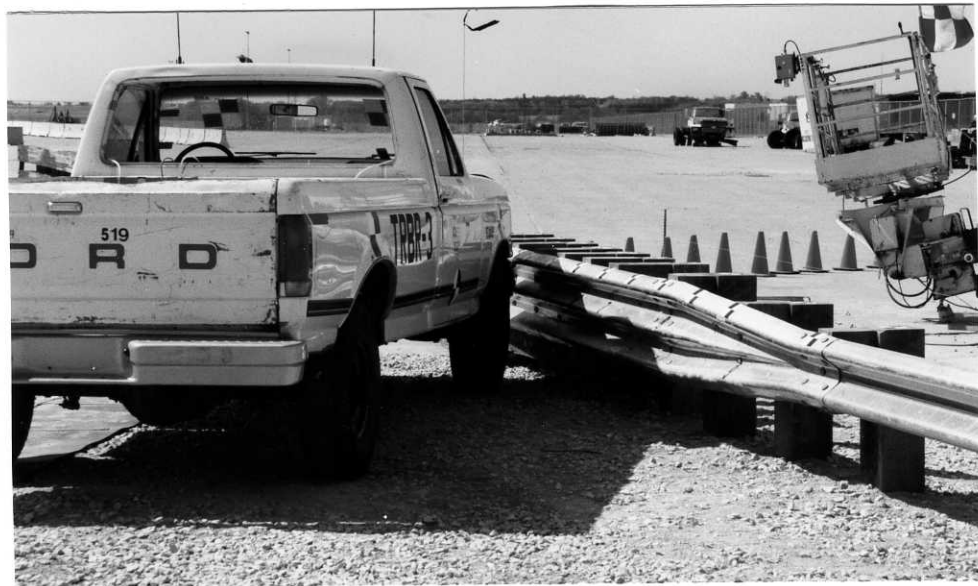
Figure 97. Impact Locations, Test TRBR-3

Initial impact occurred at the midspan between transition post nos. 3 and 4 or 1,432 mm upstream from the upstream end of the glulam bridge rail, as shown in Figures 97. After the initial impact with the approach guardrail transition, the right-front quarter panel and bumper were crushed inward. Subsequently, at 0.022 sec after impact, the right-front corner of the vehicle was at transition post no. 2 and with the engine hood extending over the rail. At 0.040 sec, the right-front corner of the vehicle was at transition post no. 1. The right-front corner of the vehicle was positioned at the midpoint between transition post no. 1 and bridge post no. 1 at 0.061 sec. At 0.067 sec, the right-front quarter panel contacted the upstream end of the upper glulam rail, resulting in moderate quarter panel deformations. The pickup truck's right-front corner was near bridge post no. 1 at 0.089 sec with the engine hood positioned laterally behind the back of the bridge post. In addition, deformations were evident in the right-side door as a gap appeared at the top. The maximum dynamic lateral deflection of 163 mm was measured at transition post no. 1 at 0.089 sec. The maximum vehicle extension over the bridge rail occurred at 0.091 sec. At 0.120 sec, the vehicle's right-front corner was approximately at the midpoint between bridge post nos. 1 and 2 and with bridge post no. 1 visibly rotated backward. At 0.150 sec, the left-front tire became airborne, while

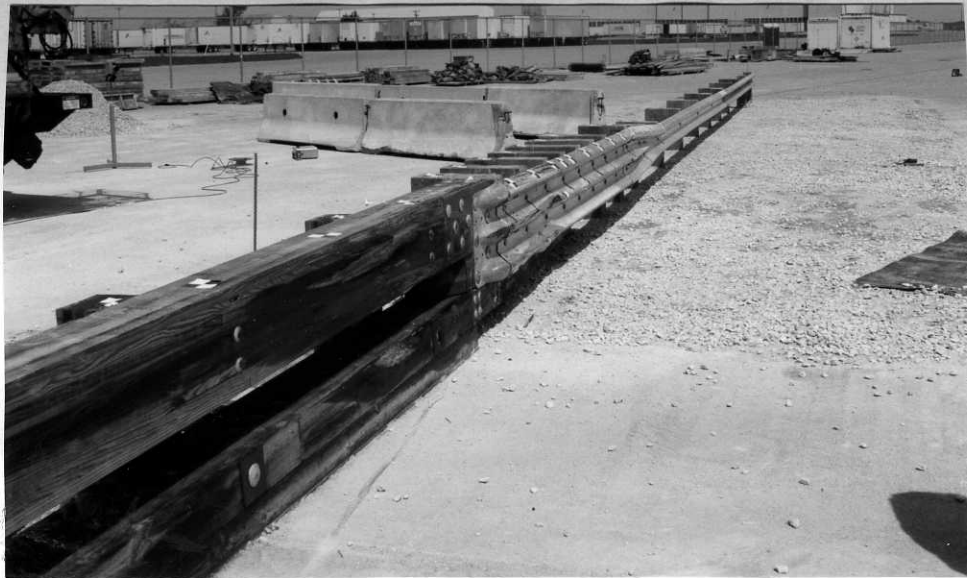
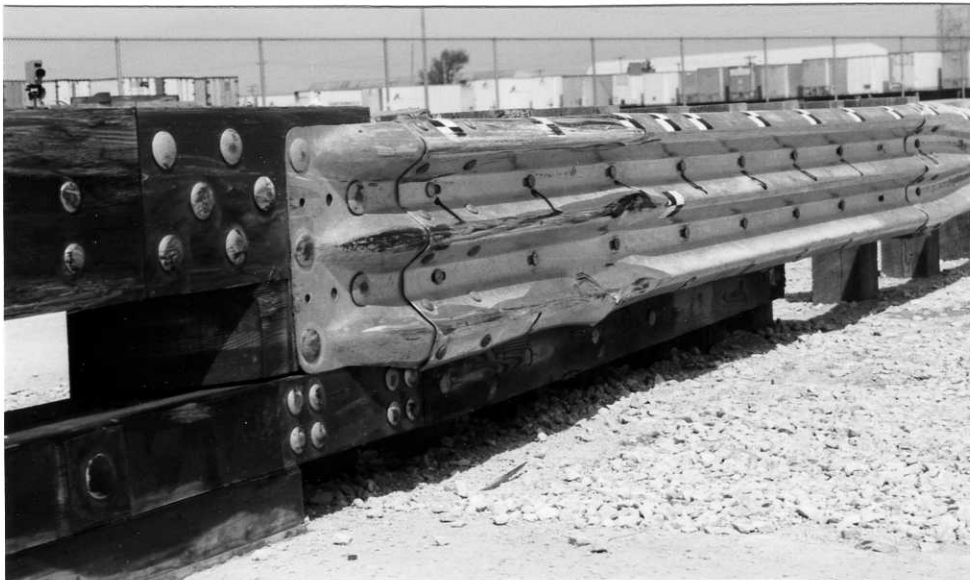
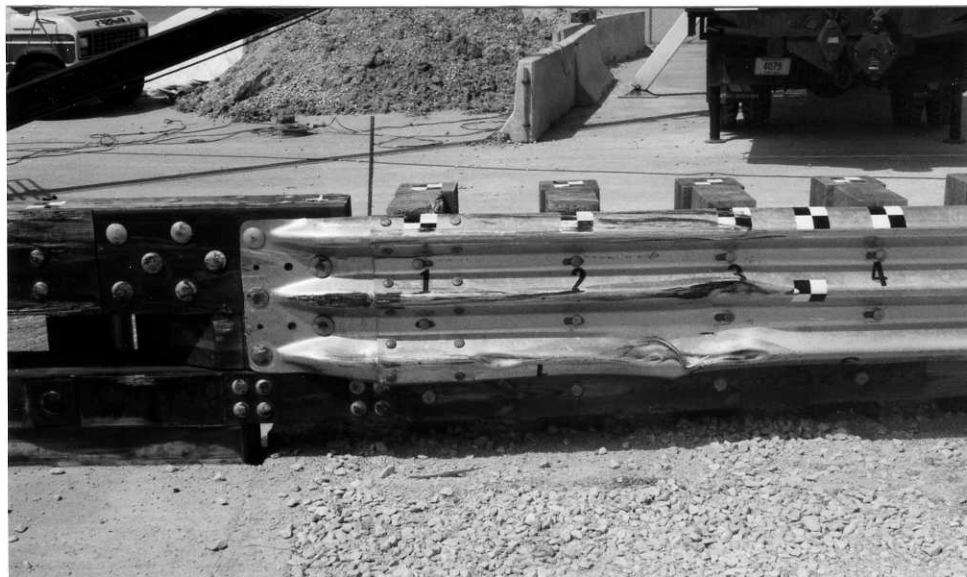
Figure 99. Barrier Damage, Test TRBR-3

The minor damage to the approach guardrail transition and bridge railing is shown in Figures 99 through 101. Damage consisted mostly of deformed thrie beam, displaced guardrail posts, and scrapes, black marks, and gouging on the various rails, posts, and blocks. As shown in Figures 99 and 100, gouging occurred on the middle and lower corrugations of the thrie beam rail near transition post no. 3. Black marks, scrapes, and gouging were visible on the thrie beam from the impact location through the thrie beam terminal connector. No visual contact marks or scrapes were found on the face of the timber curb rail below the thrie beam, except for the region where the deformed thrie contacted the curb corner. Minor contact marks were found on the curb transition splice plate. The spacer blocks for transition post nos. 1 and 2 were also contacted and gouged. Following a visual inspection after the crash test, no damage was observed in the guardrail posts. In addition, the maximum ground line soil deformations, occurring at transition post no. 1, were measured to be 19 mm and 22 mm on the front and back sides of the guardrail posts, respectively.

Gouging was observed on the upper surface of the top glulam bridge rail from the upstream end to 51 mm downstream of bridge post no. 2. Black contact marks and gouging were also observed on the upper rail's front face over the same length. On the upper rail's steel transition plate, contact marks and gouging were found on the front face. The right-side rear axle hub also contacted this plate as a bolt head from the hub was embedded in the front face. For the lower curb rail, contact marks and gouging were observed on the front surface from the curb transition splice plate to 686 mm downstream of bridge post no. 1. Minor gouging was also found on the curb transition block. Two steel plate washers, located on the back face of the curb rail at post nos. 1 and 2, were deformed due to high axial tension transmitted to the bolts.

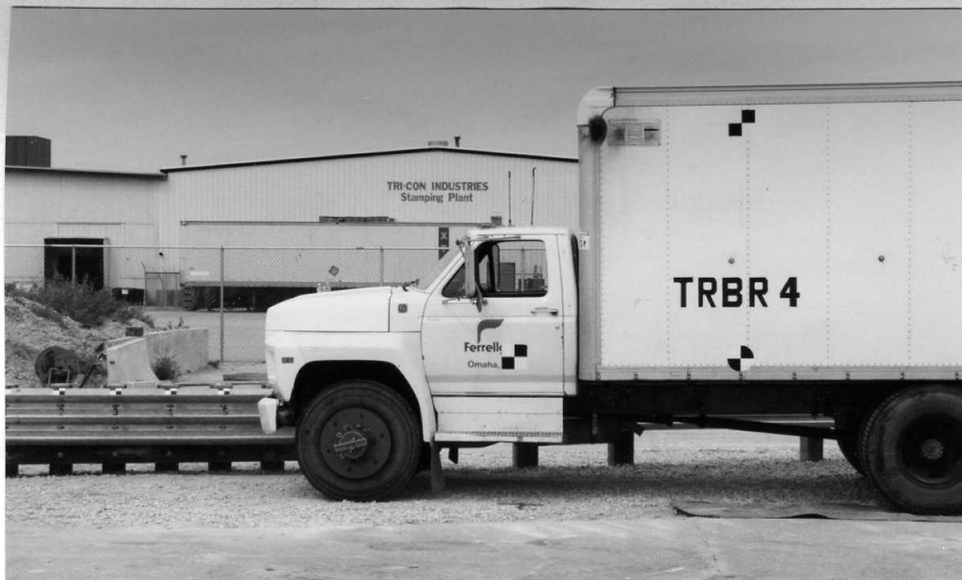
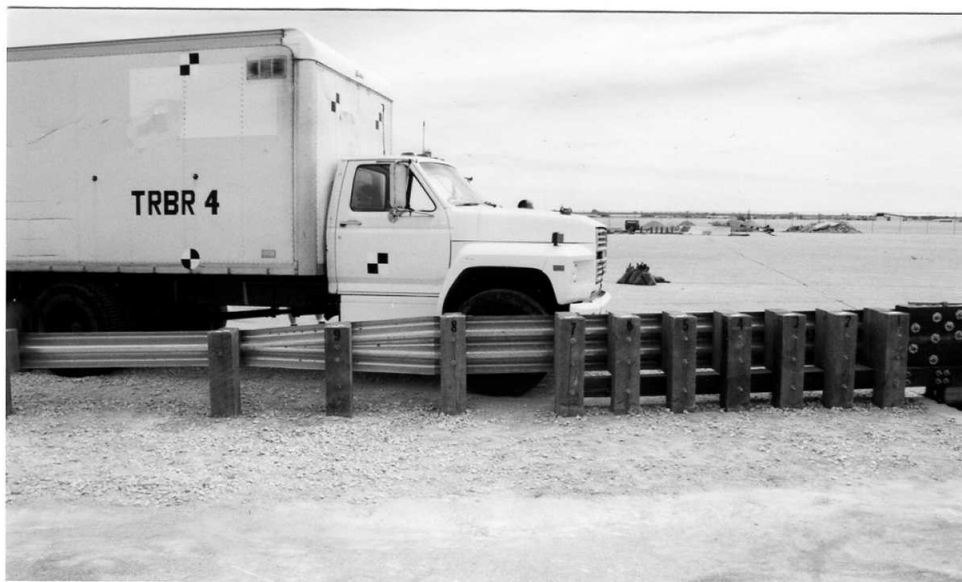
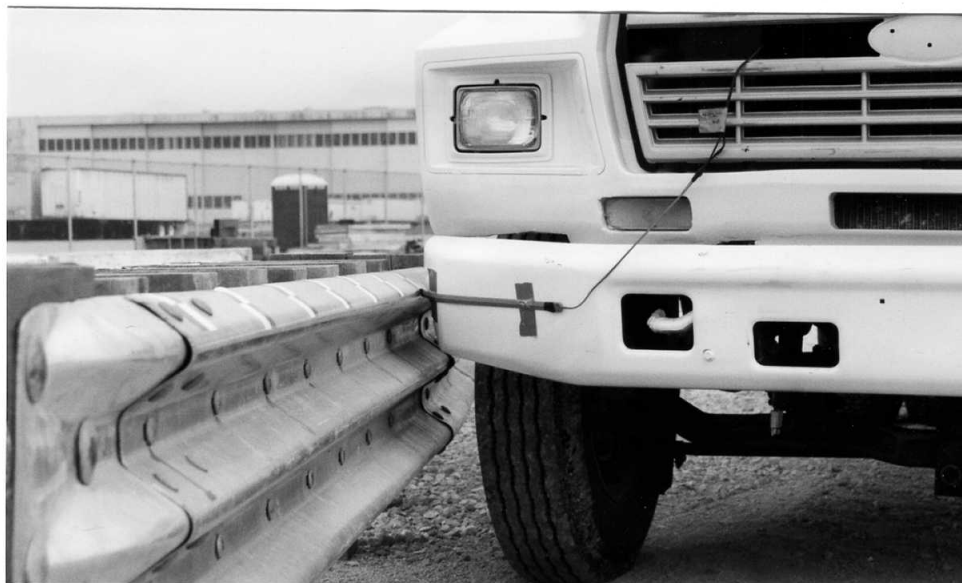
Figure 110. Impact Locations, Test TRBR-4

Initial impact occurred at the midspan between transition post nos. 6 and 7 or 2,861 mm upstream from the upstream end of the glulam bridge rail, as shown in Figure 110. After the initial impact with the approach guardrail transition, the right-front quarter panel and bumper were crushed inward. Subsequently, at 0.056 sec after impact, the right-front corner of the vehicle was at transition post no. 3 and with the quarter panel extending over the rail laterally to the back side of the wood blockout. At 0.102 sec, the right-front corner of the vehicle was at transition post no. 1 and with the quarter panel positioned above the midpoint of the post. At this same time, twisting of the truck cab toward the rail was observed as the right-front corner of the front bumper crushed inward. At 0.110 sec, the vehicle's left-front tire turned toward the barrier system. At 0.154 sec, the right-front corner of the vehicle was at bridge post no. 1 while extending over the top. At this same time, the right-front corner of the truck box was positioned near transition post no. 4 and with no apparent snagging. At 0.188 sec, the truck cab became level with the horizontal plane, and it was observed that material was fractured off from the right-front quarter panel. Subsequently, at 0.220 sec, the vehicle's right-front corner reached its maximum lateral extent over the bridge rail, slightly beyond the back side of the posts. The right-front corner of the truck was at bridge post no.2 at 0.232 sec after impact. At

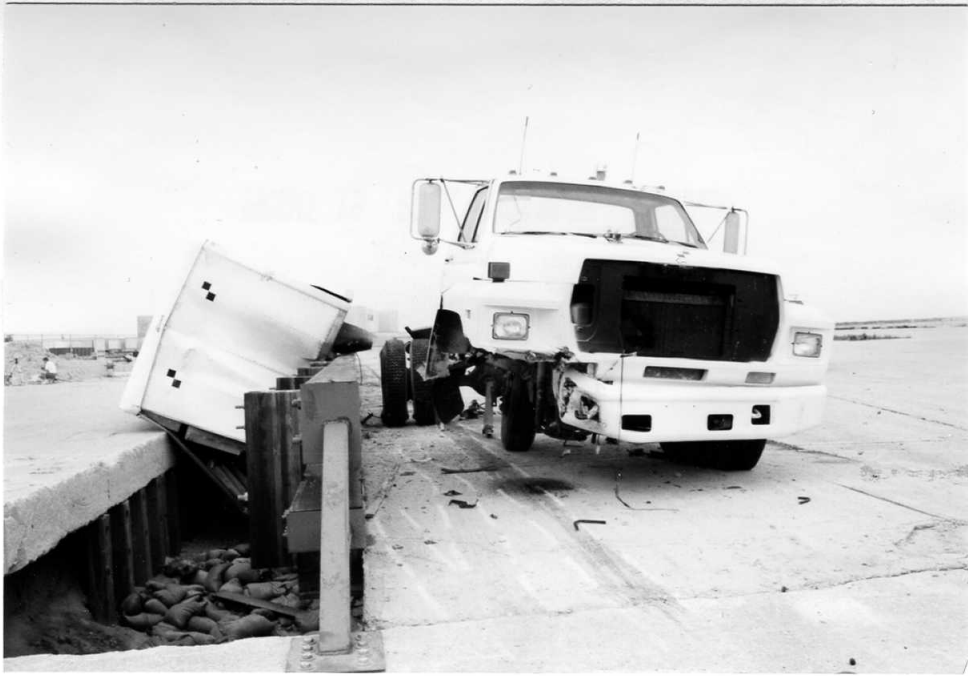
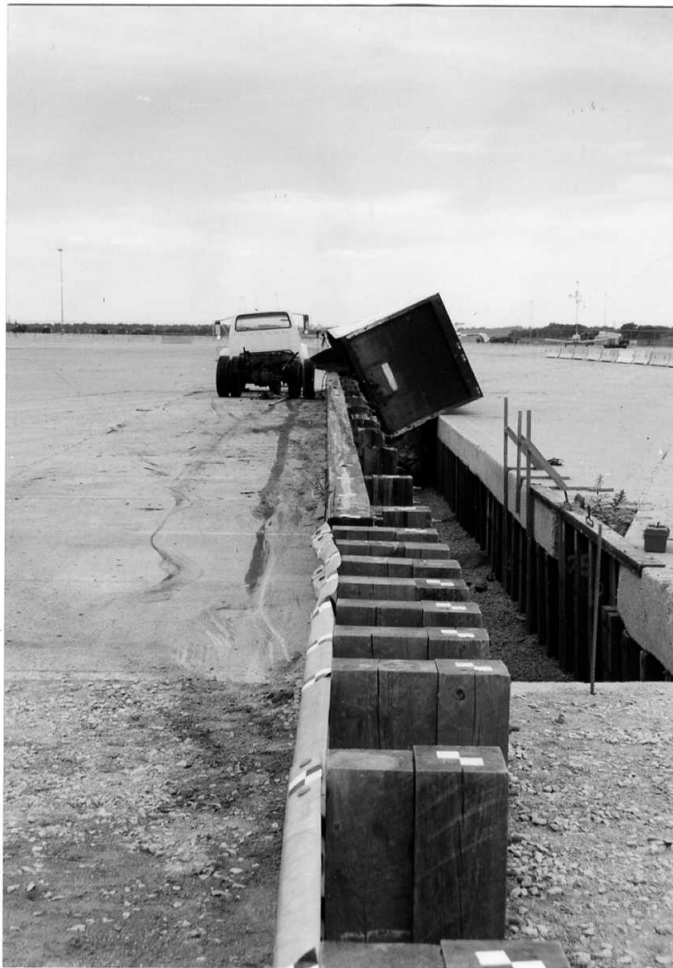
Figure 111. Final Vehicle Position, Test TRBR-4

downstream from the midspan location between transition post nos. 6 and 7, as shown in Figure 111. The rebound distance was approximately 0.76 m, as measured laterally from the traffic-side face of the barrier to the right side of the vehicle and longitudinally downstream from impact at a point of 30.48 m plus the length of the vehicle.

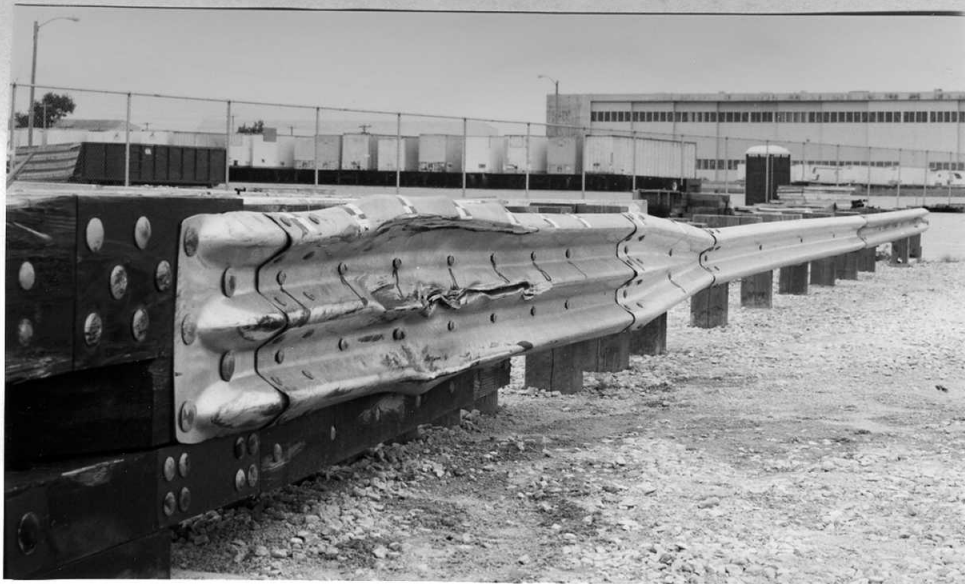
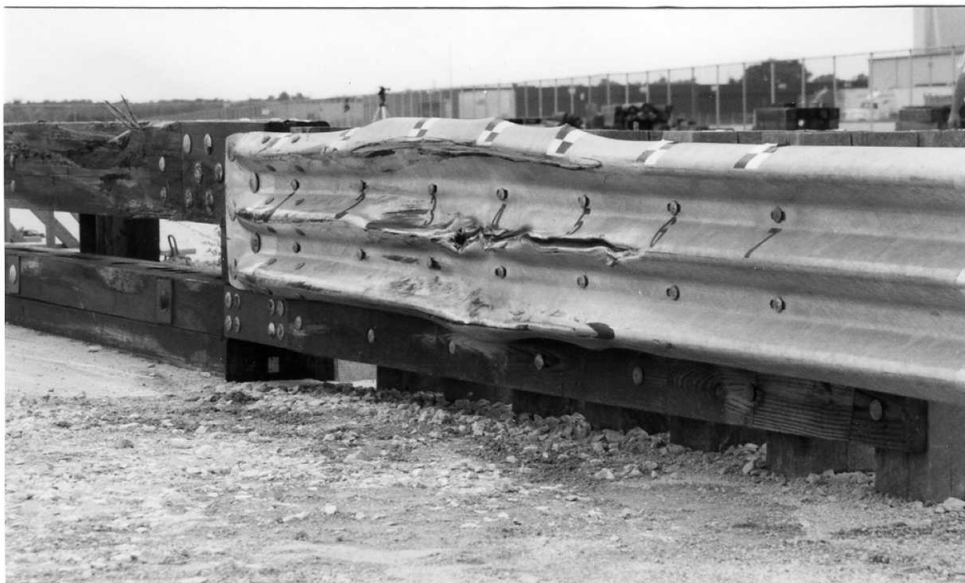
Figure 112. Barrier Damage, Test TRBR-4

The minor damage to the approach guardrail transition and bridge railing is shown in Figures 112 and 113. Damage consisted mostly of deformed thrie beam, displaced guardrail posts, and scrapes, black marks, and gouging on the various rails, posts, and blocks. As shown in Figure 112, gouging occurred on upper, middle, and lower corrugations of the thrie beam rail between transition post nos. 3 through 6. Black marks and scrapes were visible on the thrie beam from the midspan between transition post nos. 5 and 6 through the thrie beam terminal connector. No contact marks, gouging, or damage was observed on the transition posts nor attached blockouts. The maximum ground line soil deformations were measured to be 14 mm on the front side of transition post no. 3 and 13 mm on the back side of the transition post no. 4, respectively. Gouging was observed on the

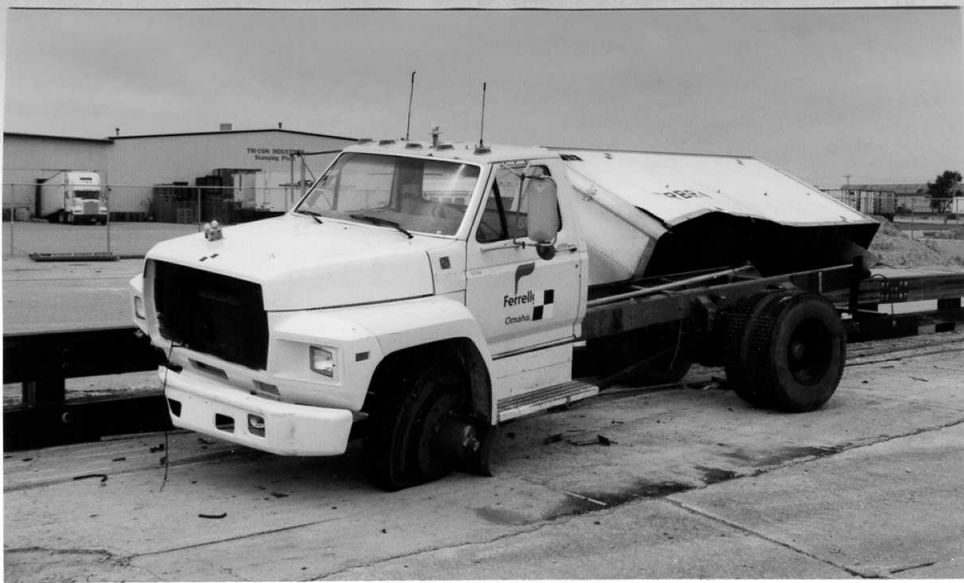
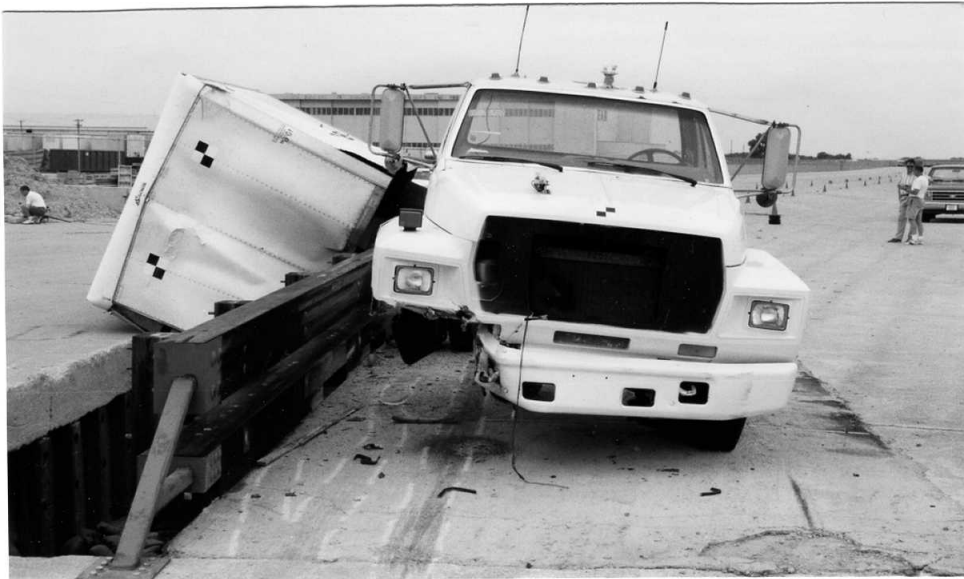
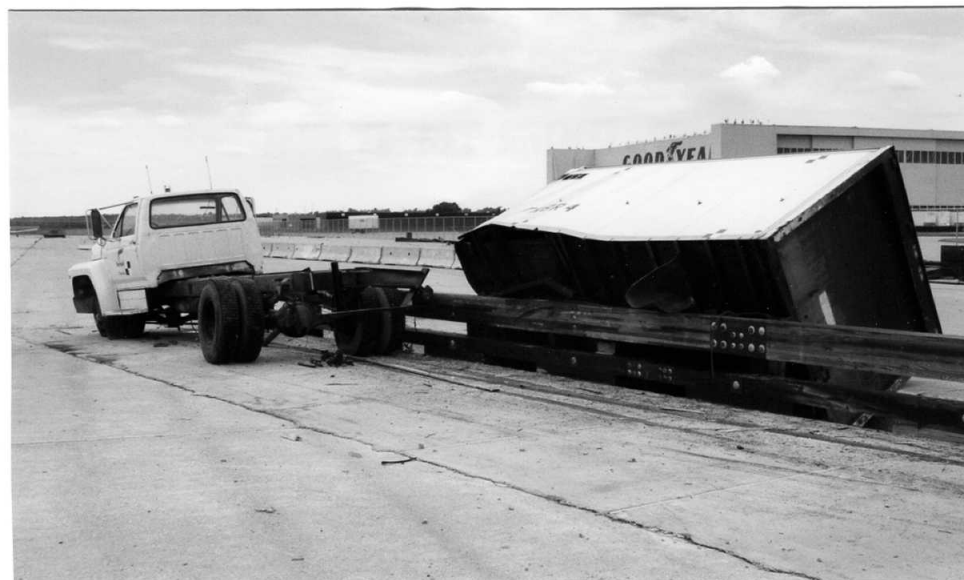
Figure 114. Vehicle Damage, Test TRBR-4

Exterior vehicle damage was extensive, as shown in Figures 114 and 115. However, it should be noted that significant portion of this damage occurred as a result of the truck box becoming detached from the steel truck frame. Vehicle damage occurred to several body locations, such as truck cab's right side, front quarter panel, front bumper, right-side wheels, rear steel frame, rear box and attachment hardware, and front and rear axles and suspension. As shown in Figures 114 and 115, the rear truck box came off the steel frame during the impact sequence. This failure occurred for several reasons. First, the right-side frame rail extension failed due to poor welding, as shown in Figure 115. Second, fabrication and welding of the rear bumper failed due to poor workmanship. Finally, all four sets of the 12.7-mm diameter threaded rods attaching the truck box to the frame failed. This was likely due to an inadequate number and size of connectors. It is noted that the truck and box were assembled by experienced personnel at a regional truck sales and repair business which followed industry guidelines for reattaching a box to a frame. The right-rear axle released from the leaf-spring due to fracture of the attachment hardware. The inner right-rear tire was deflated. The outer right-rear tire was punctured and deflated and with deformations to the steel rim. Interior

occupant compartment deformations to the right-side floorboard near the door were found but barely visible. Those deformations were judged insufficient to cause serious injury to the vehicle occupants. The right corner of the front bumper, quarter panel, and side step were crushed inward and deformed. The right-front wheel assembly and axle were released and pushed under the center of the truck behind the cab.

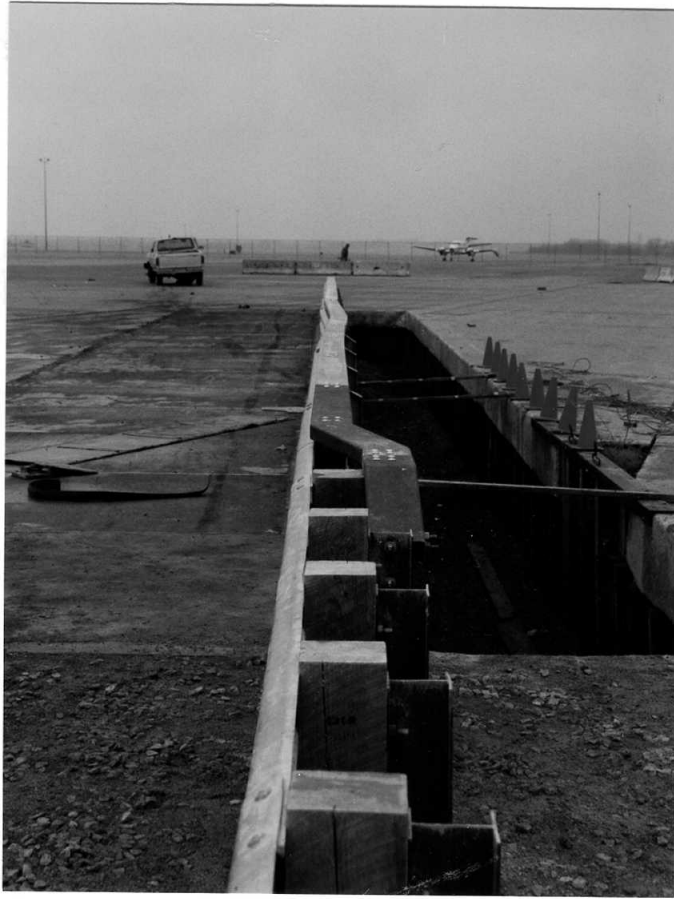
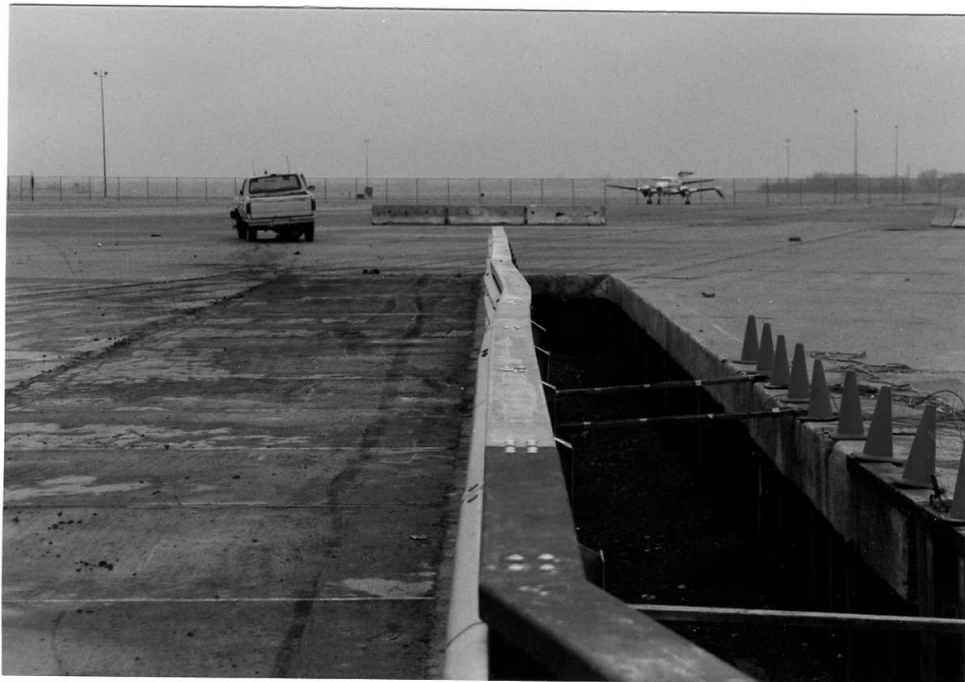
Figure 144. Impact Locations, Test STTR-1

left tires still airborne. At 0.320 sec, the truck returned to a non-pitched state but still airborne with only the right-side tires in contact with the ground. At 0.359 sec after impact, the truck exited the bridge rail at an angle of less than 1 degree and a speed of 62.3 km/hr. At 0.431 sec, the right-front corner of the truck was at post no. 9 but not in contact with the rail as the truck moved laterally away from the rail. At 0.512 sec, the right-front tire was deformed and rotated 90 degrees into the engine compartment. At this same time, the truck pitched forward while still at the same roll angle. At 0.650 sec, the truck returned to an unrolled state. At 0.774 sec, the left-front tire contacted the ground while the truck traveled downstream and laterally away from the rail. At this same time, the rear-end remained pitched upwards as the roll ceased. At 0.975 sec, the truck rolled away from the bridge rail. At 1.251 sec, the truck returned to a non-pitched and non-rolled state. The vehicle's trajectory is shown in Figure 139. The vehicle's rear-end came to rest approximately 52.0 m downstream from the impact point and 5.9 m laterally away from the traffic-side face of the bridge railing, as shown in Figure 145.
