TWO TEST LEVEL 4 BRIDGE RAILING AND TRANSITION SYSTEMS FOR TRANSVERSE GLUE-LAMINATED TIMBER DECKS

MwRSF Research Report No. TRP-03-71-01

January 30, 2002

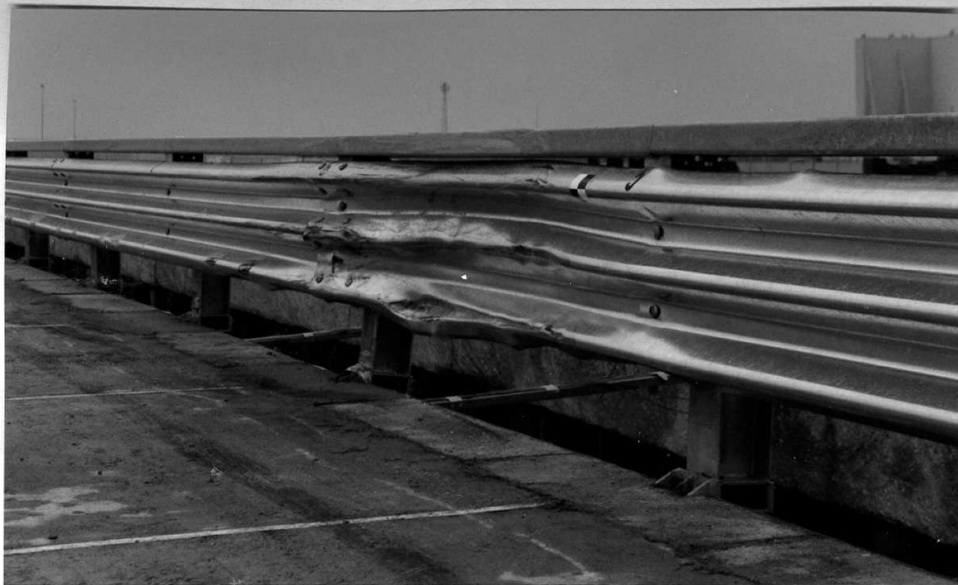
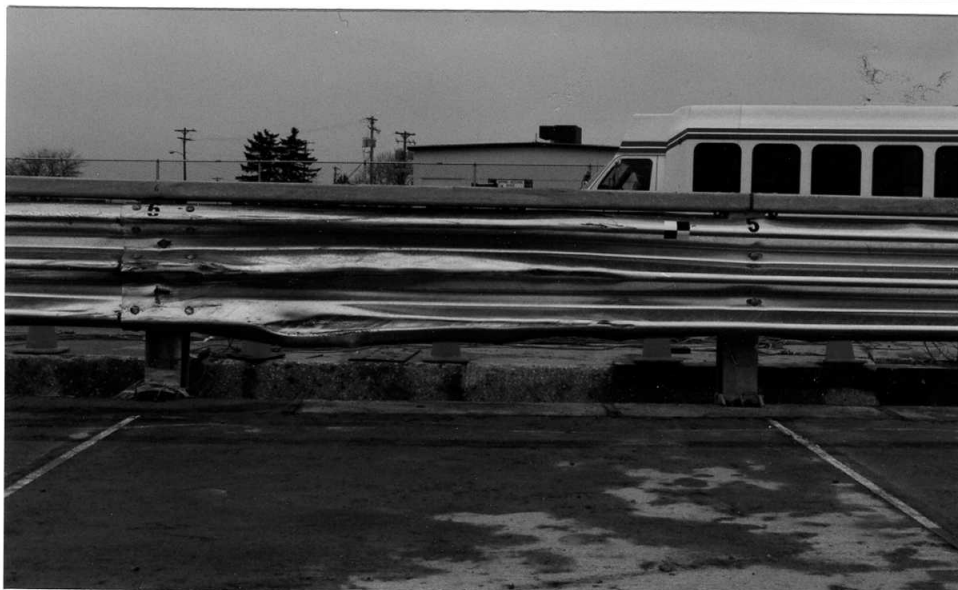
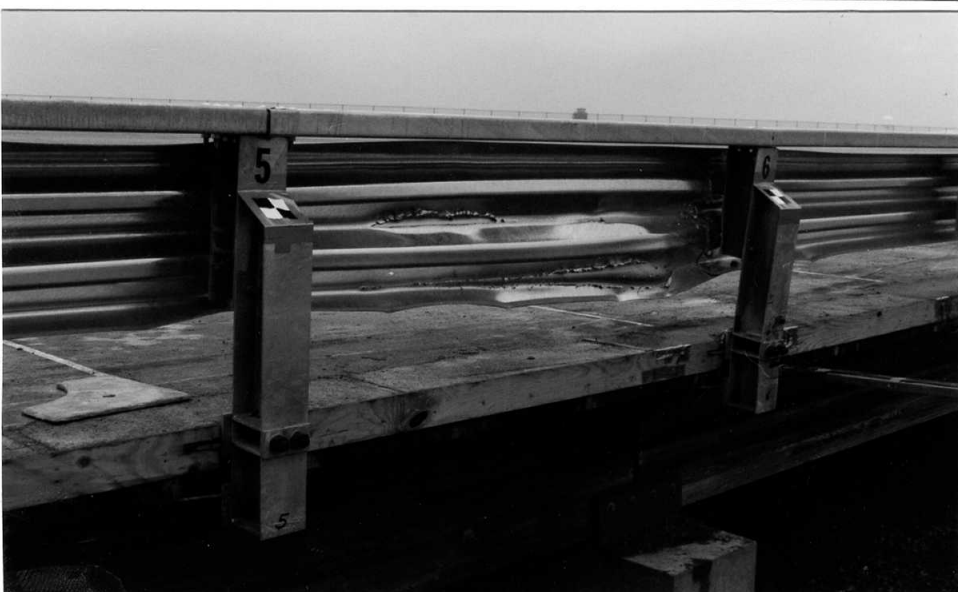
Figure 145. Final Vehicle Position, Test STTR-1

Damage to the bridge rail was moderate, as shown in Figures 146 through 149. Bridge railing damage consisted mostly of deformed thrie beam and tube rail sections, contact marks on a bridge rail section, deformed steel posts, and damaged spacer blocks. The physical damage to the thrie beam rail revealed that approximately 4.9 m of rail was damaged between post nos. 5 and 7. The thrie beam rail damage consisted of significant gouging of the lower corrugation, flattening of the middle and lower corrugations, and scrape marks along all corrugations. Spalling of the galvanized coating on the back side of the thrie beam rail between post nos. 5 and 6 indicated that there was intense vehicle contact with the thrie beam rail. The top of the thrie beam rail buckled at

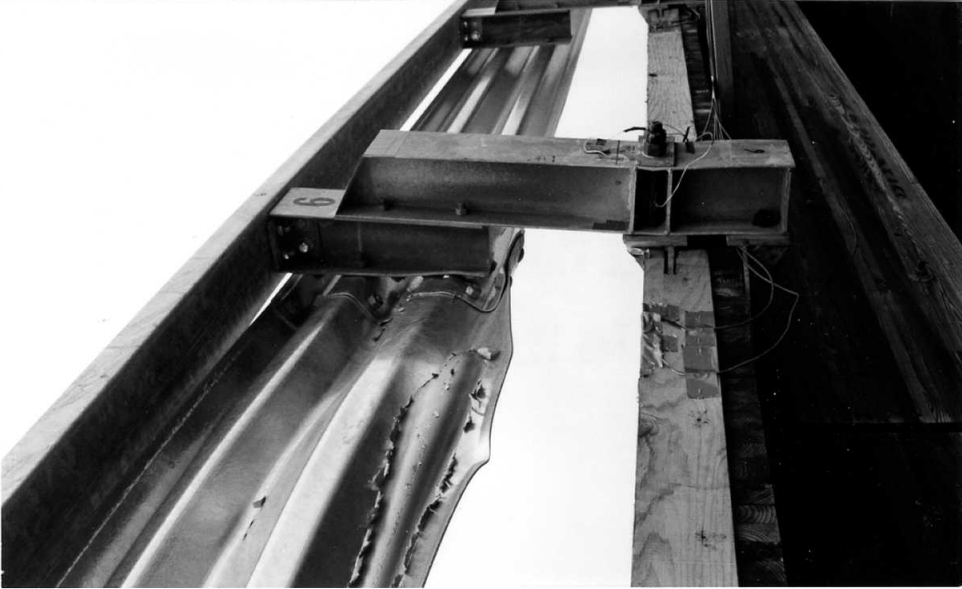
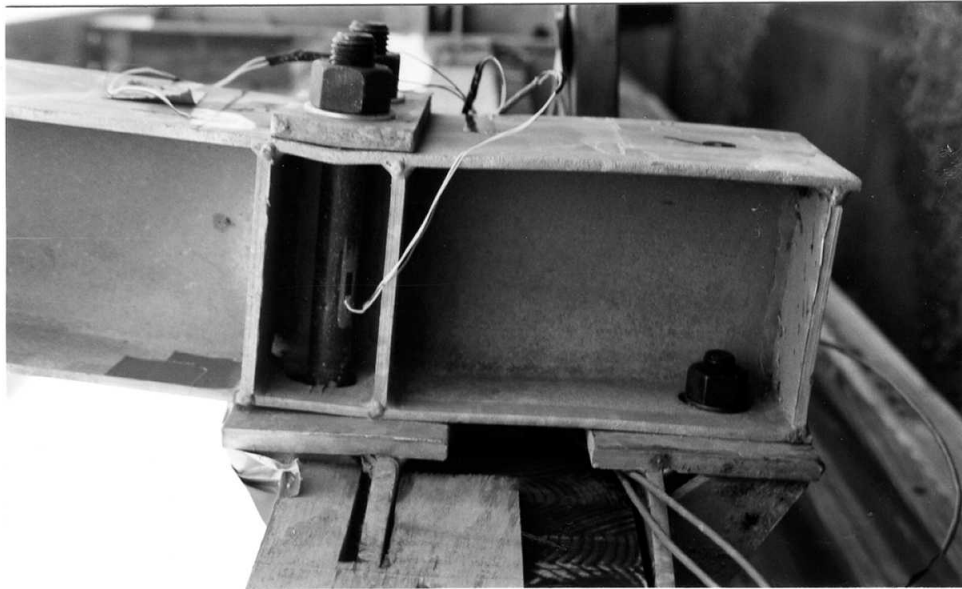
Figure 146. Barrier Damage, Test STTR-1

Four steel posts, post nos. 4 through 7, were permanently deformed during the test, as shown in Figures 148 and 149. The blockouts at post nos. 5 through 7 were also deformed. The bolt connecting the bottom of the thrie beam rail to the steel blockout sheared off at post no. 6. At post nos. 5 through 7, the concrete deck cracked near the bolts through the top plate assembly and post. No significant post or guardrail damage occurred upstream of post no. 4 nor downstream of post no. 8.

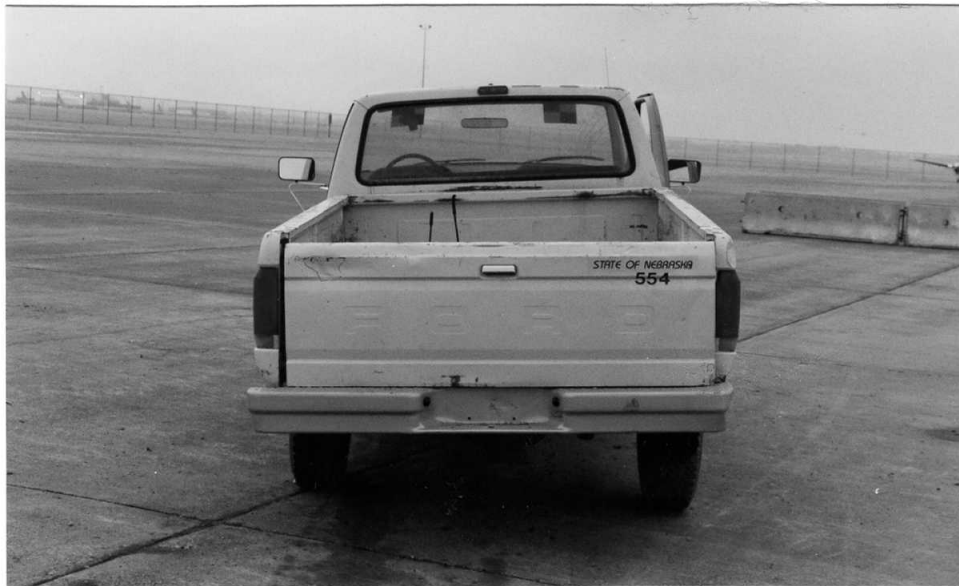
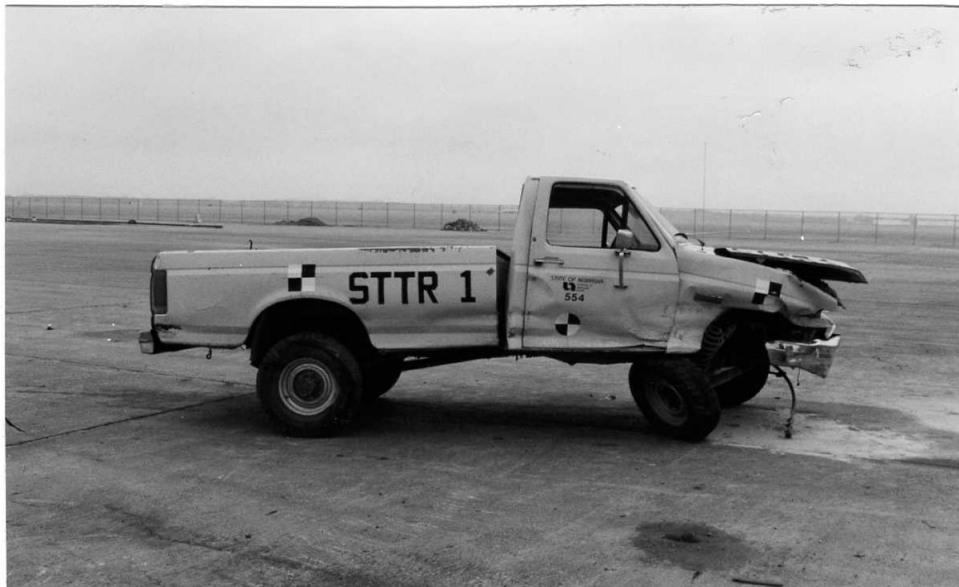
Figure 149. Typical Post and Blockout Deformations, Test STTR-1

Exterior vehicle damage was moderate, as shown in Figures 150 through 152. Vehicle damage occurred to several body locations, such as right-side door and quarter panel, front bumper, right-side wheels and rims, front axle, right-side of the pickup box, windshield, and interior floorboard. The right corner of the frontal bumper and the right-side door and quarter panel were crushed inward due to contact with the thrie beam rail, as shown in Figures 150 and 151. The right-front wheel assembly was pushed back toward the firewall, as shown in Figure 151. The right-rear steel rim was deformed with a 102-mm long indentation found on the rim's perimeter. Four of the nuts were removed from the studs on this same wheel. The front bumper buckled 305-mm off center

toward the right side. The hood shifted toward the left side. The front windshield was cracked on the right side. Maximum occupant compartment deformations to the floorboard were 83-mm lateral displacement near the center region of the right-side door, 38-mm longitudinal displacement near the firewall region, and 108-mm vertical displacement near the center of the floorboard's center hump. Interior vehicle deformations to the floorboard, as shown in Figure 152, were judged insufficient to cause serious injury to the vehicle occupants. No deformations occurred to the interior front dashboard nor the roof.

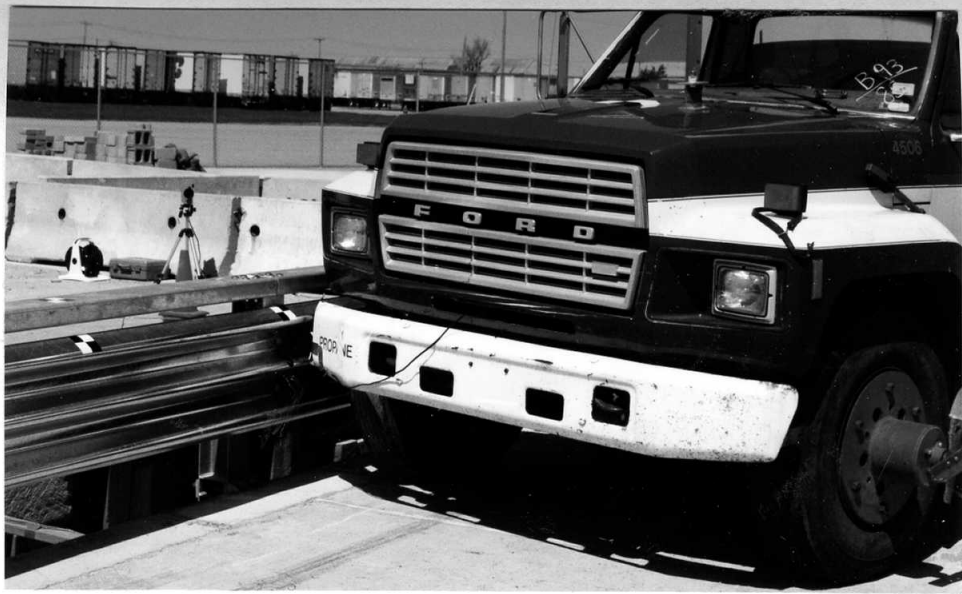
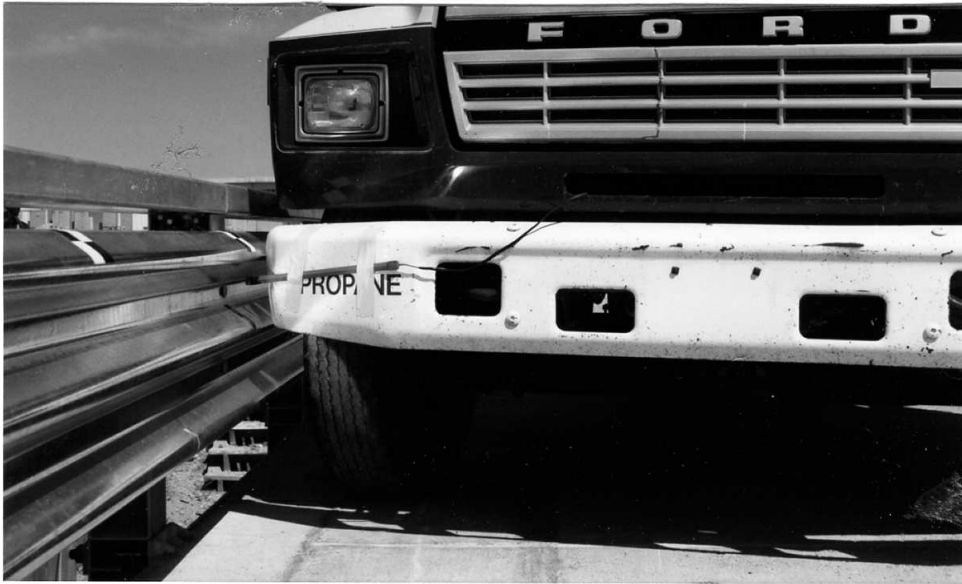
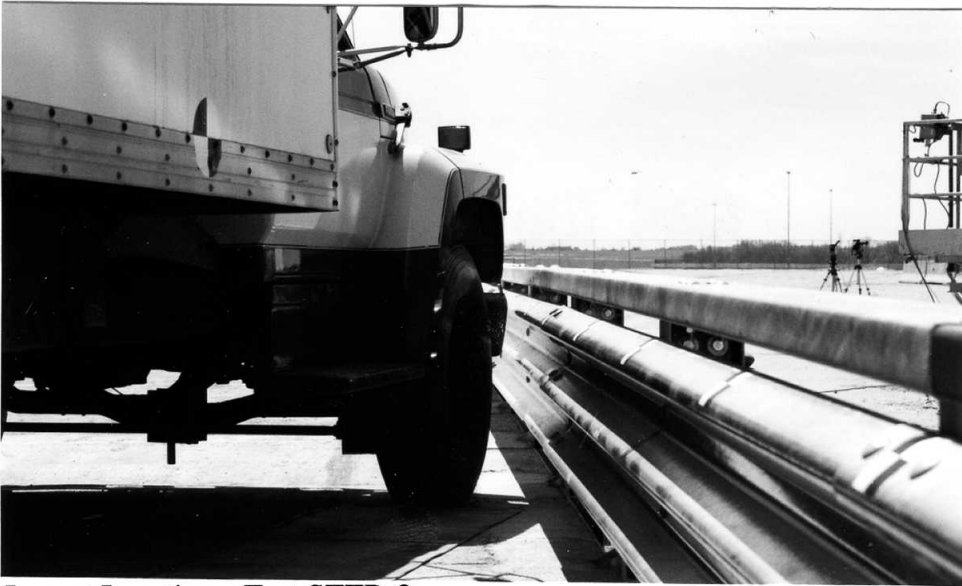
Figure 155. Additional Sequential Photographs, Test STTR-2

Initial impact occurred at the centerline of bridge post no. 5 or approximately 10,122 mm downstream from the upstream end of the bridge rail, as shown in Figure 156. At 0.047 sec, after initial impact, the front of the truck was at the midspan between post nos. 5 and 6. At 0.055 sec, the front bumper crushed inward toward the engine compartment. At 0.101 sec, the right-front corner of the truck was at post no. 6 as ripples appeared in the thrie beam rail. At this same time, the right-front fender extended over the top tube rail that was displaced. At 0.129 sec, the truck's cab rolled toward the rail while the box remained unaffected, and the right-front tire was deflated. At 0.136 sec, the right-front tire moved backward out of its normal position. At 0.156 sec, the front of the truck was at the midspan between post nos. 6 and 7, and the leading corner of the truck's box contacted the top tube rail at the midpoint between post nos. 5 and 6. At 0.168 sec, the right-front fender was extremely deformed and continued to extend over the top tube rail. At 0.205 sec, the front of the truck was at post no. 7. At 0.238 sec, the rear of the truck box contacted the rail as the box started to roll counter-clockwise (CCW) into the rail. At this same time, the front-right fender raised up off the tube rail. At 0.255 sec, the front of the truck was at the midspan between post no. 7 and 8 with the right-front corner protruding over the top tube rail. At this same time, the box rolled

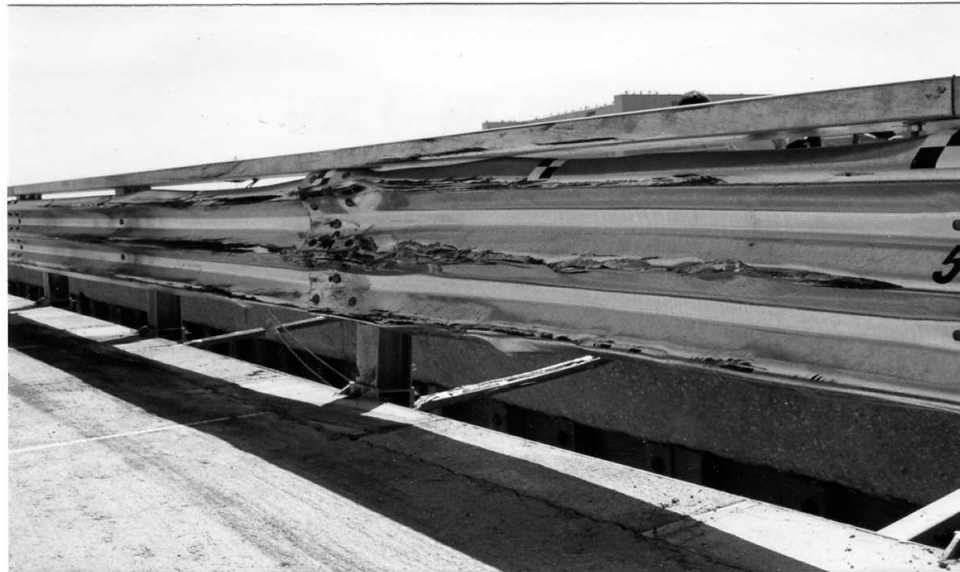
Figure 158. Barrier Damage, Test STTR-2

Three steel posts, post nos. 5 through 7, were permanently deformed during the test, as shown in Figures 159 and 160. The blockouts at post nos. 5 and 6 were also deformed. At post nos. 5 and 6, the concrete deck cracked around the deck-to-post connection. No significant post or guardrail damage occurred upstream of post no. 5 nor to the downstream end anchor.

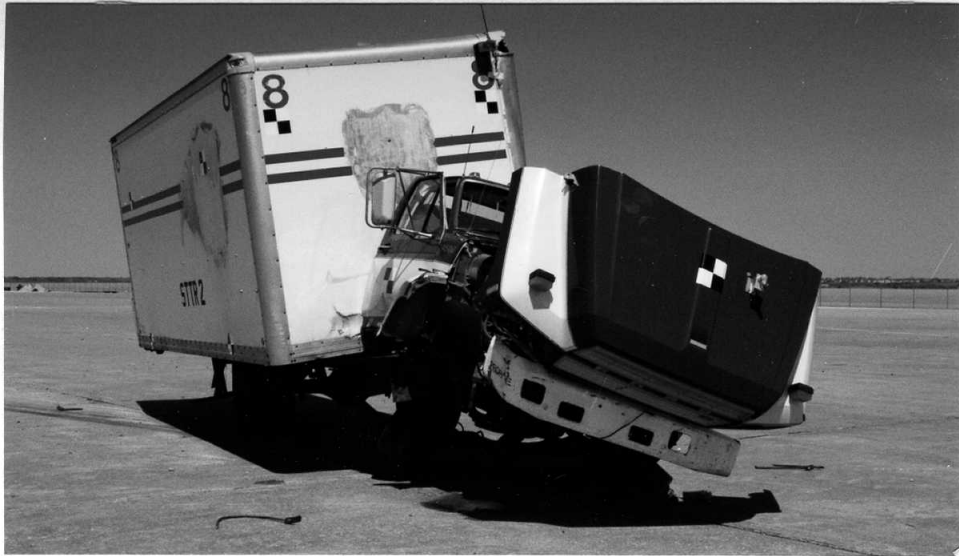
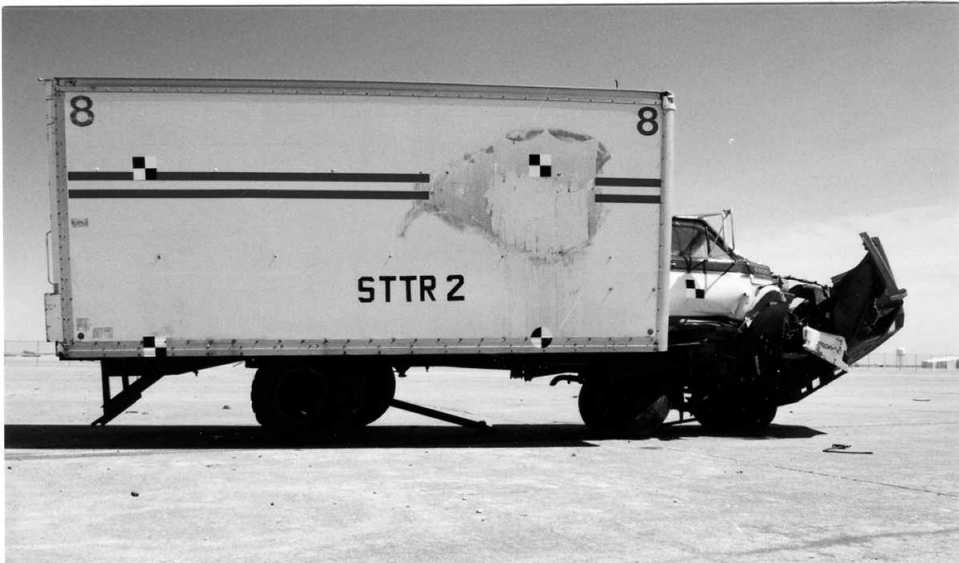
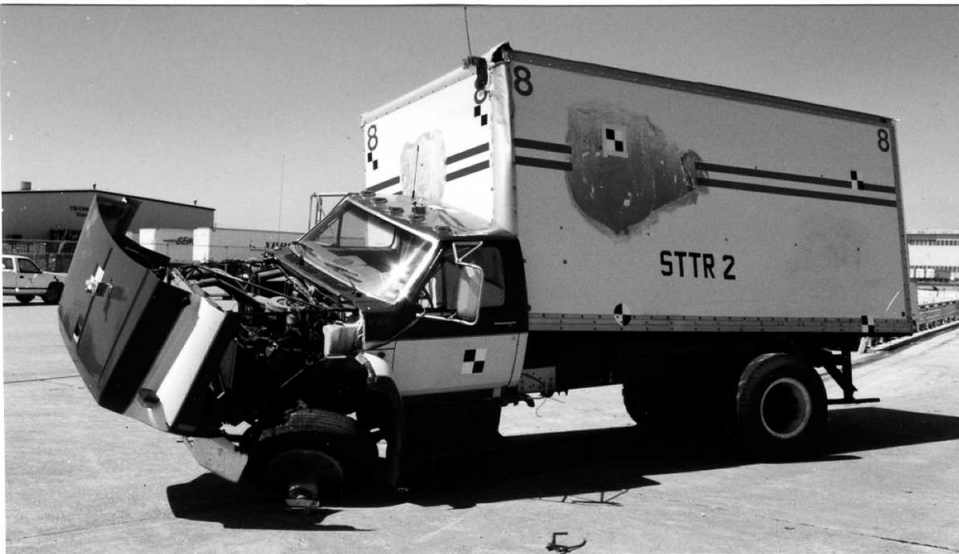
Figure 161. Vehicle Damage, Test STTR-2

Exterior vehicle damage was moderate, as shown in Figures 161 through 163. Vehicle damage occurred to several body locations, such as right-side door, quarter panel, and side step, front bumper, front axle, right-side wheels and rims, left-side front wheel and rim, drive shaft, steel frame and suspension, and interior floorboard. The right corner of the front bumper and the right-side door, quarter panel, and side step were crushed inward, as shown in Figure 161. The front axle was disengaged and wedged under the truck, as shown in Figure 161. The right-front tire was cut and deflated, and the right-front steel rim was deformed, as shown in Figures 161 and 162. The right-rear steel rim was deformed, and the tire was deflated, as shown in Figure 161. The left-front tire was removed from the rim, and the steel rim was also deformed. The drive shaft disengaged at the middle between the rear end and the transmission, as shown in Figure 162. The left side of the frame

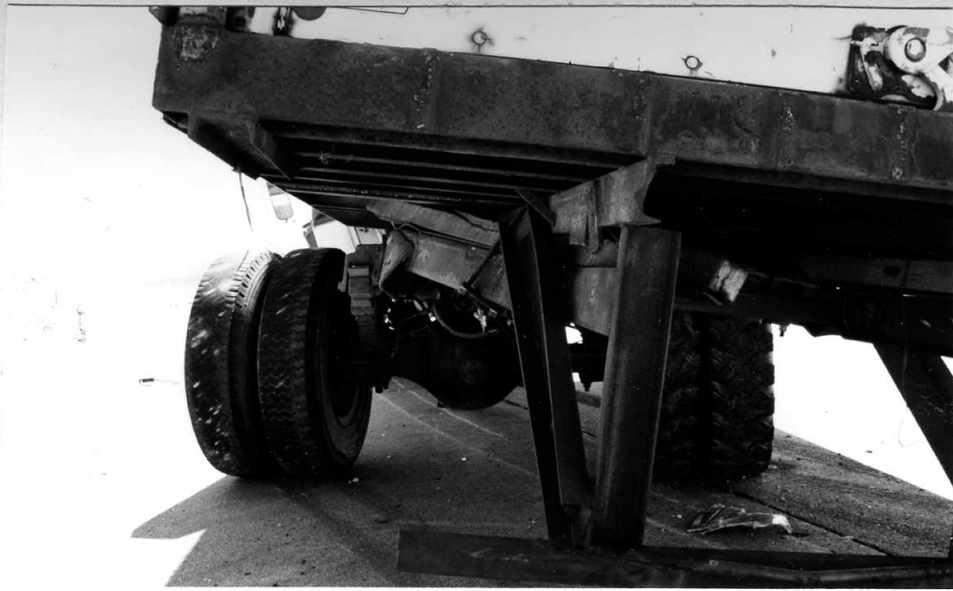
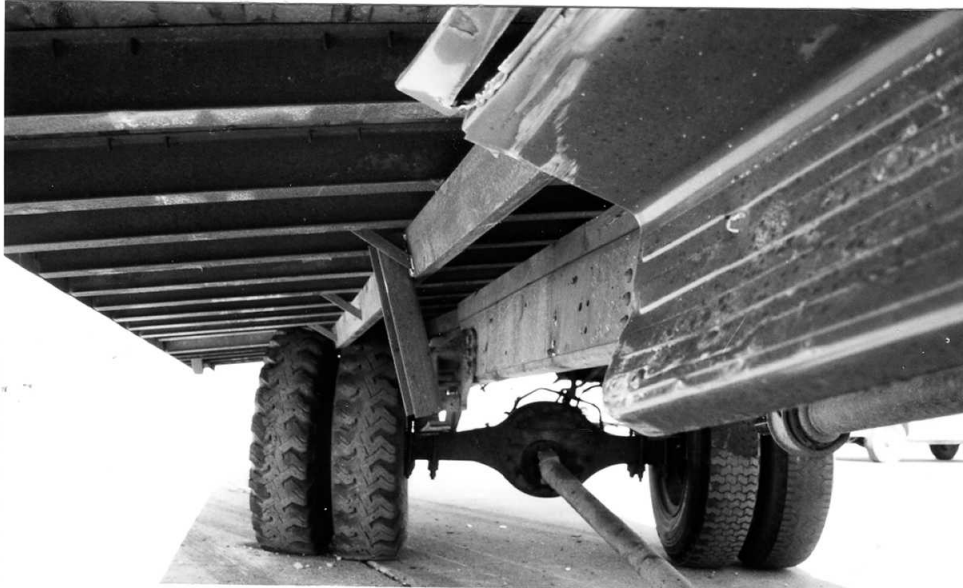
Figure 162. Truck Box and Frame Damage, Test STTR-2

bent toward the right side from the rear axle to the rear end of the truck. The front of the box shifted 660 mm to the right. The welds between the box frame and left-side box cross member failed from the front of the box to the rear axle, as shown in Figure 162. Two U-bolts on the front-right side failed. The hood also jarred open, as shown in Figure 161. Interior occupant compartment deformations to the right-side floorboard near the door, as shown in Figure 163, were judged insufficient to cause serious injury to the vehicle occupants. No deformations occurred to the interior front dashboard, the roof, nor the truck box.

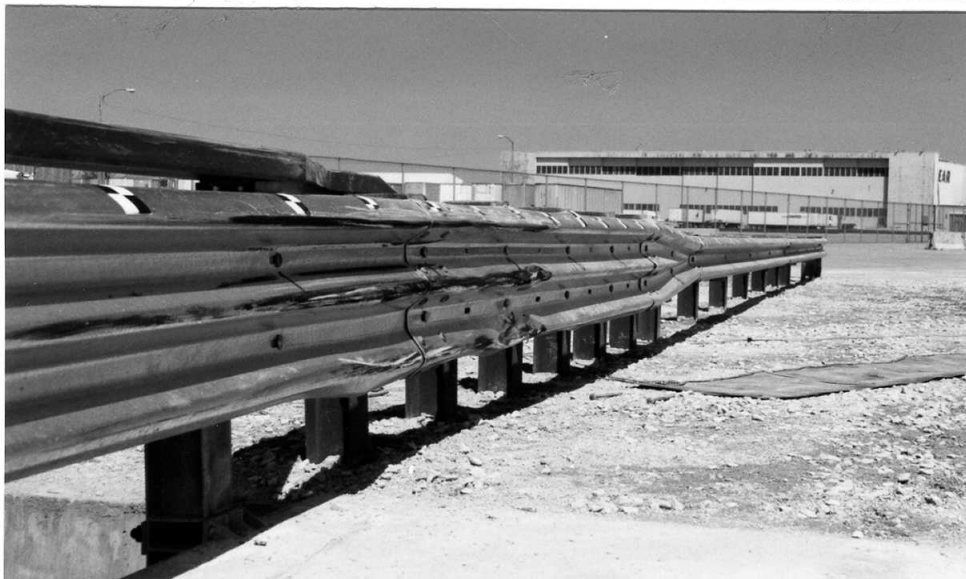
Figure 172. Barrier Damage, Test STTR-3

Damage to the approach guardrail transition and bridge railing was moderate, as shown in Figures 172 through 174. The damage consisted mostly of deformed thrie beam, contact marks on

a thrie beam section and a top tube rail section, displaced guardrail posts, and damaged spacer blocks. The physical damage to the thrie beam rail was found between transition post no. 3 through bridge post no. 2, as shown in Figure 172. The thrie beam damage consisted of moderate deformation and flattening of the impacted section of rail between transition post no. 3 and bridge post no. 1. Contact marks were found on the guardrail from the midspan between transition post nos. 2 and 3 through 610-mm upstream of bridge post no. 2. Contact marks were also found on the top and front faces of the top tube rail from 203-mm upstream of bridge post no. 1 through 381-mm upstream of bridge post no. 2.

Prior to performing the single-unit truck test, two sections of thrie beam located between transition post no. 4 and bridge post no. 2 were replaced. The top tube rail was removed, inspected, and then reinstalled with new hardware. Bridge post no. 1 and the wooden blockouts at transition post nos. 1 and 2 were replaced. Transition post nos. 1 through 5 were re-aligned by removing a 914-mm wide x 914-mm long x 610-mm deep section of soil in this area. The soil was replaced with new optimum moisture soil in lifts and then tamped with a pneumatic hand tamper.

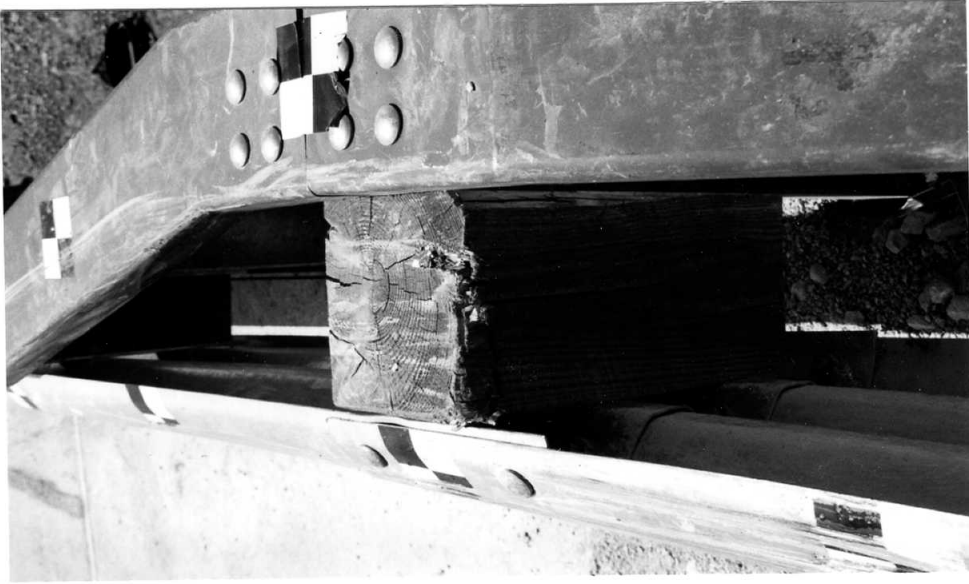
Figure 173. Barrier Damage, Test STTR-3

No contact marks or damage was observed on the transition posts, but movement of the posts was evident by the 32-mm, 25-mm, 6-mm, and 3-mm soil gaps at the front faces of transition post nos. 1, 2, 3, and 4, respectively. The blockouts at transition post nos. 1 and 2 were contacted and damaged slightly, as shown in Figure 173. Bridge post no. 1 was permanently deformed during the test, as shown in Figure 173. The concrete deck cracked around the deck-to-post connection at bridge post no. 1. No significant guardrail damage occurred upstream of transition post no. 3 nor downstream of bridge post no. 3.

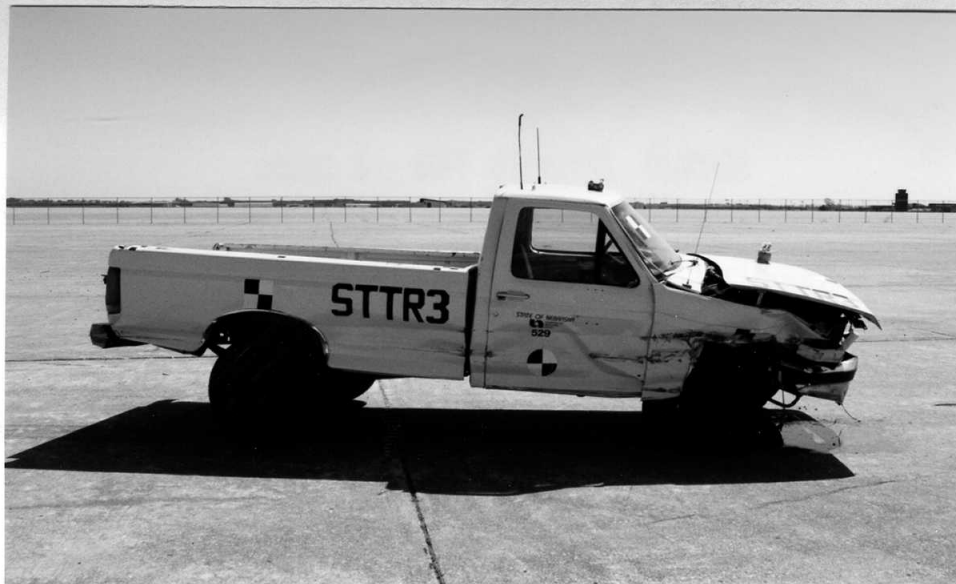
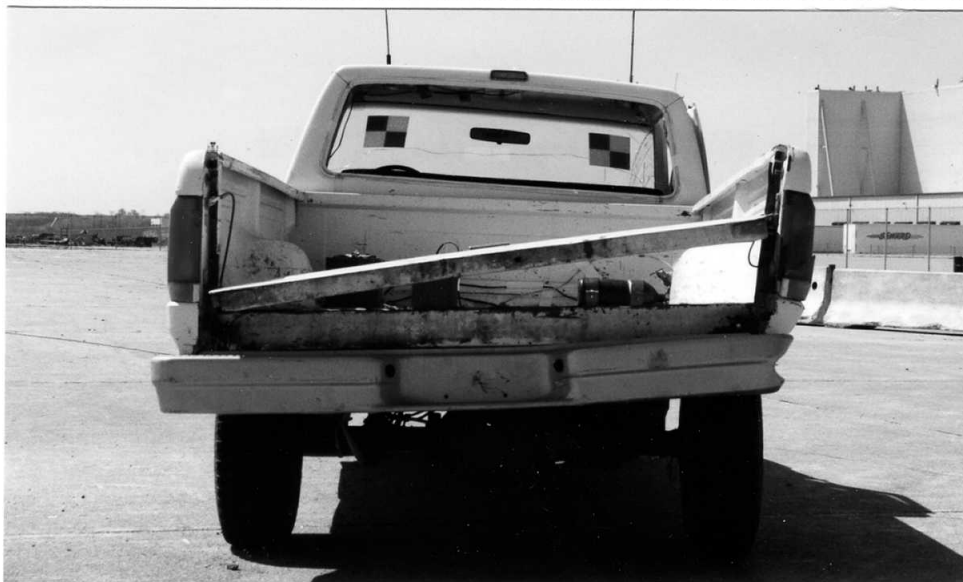
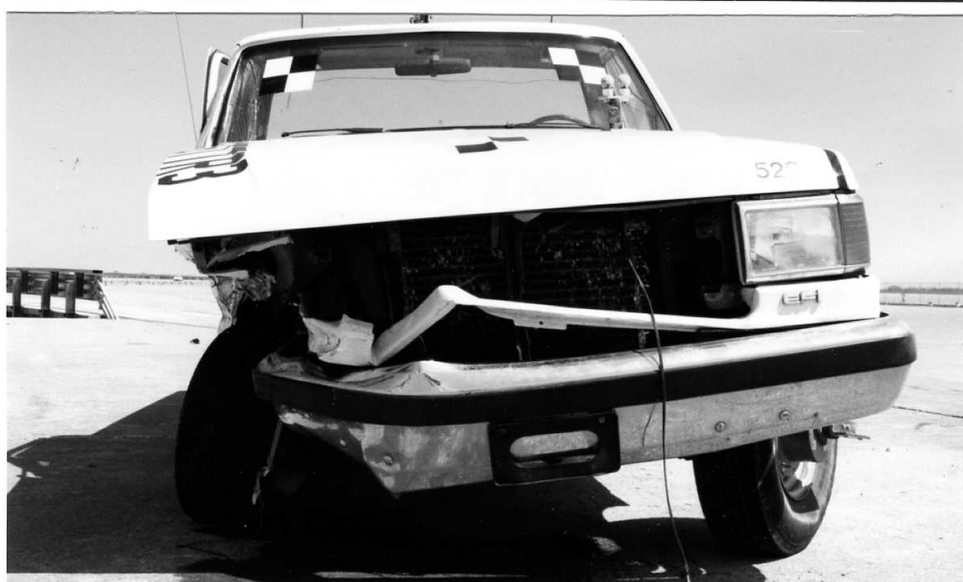
Figure 175. Vehicle Damage, Test STTR-3

Exterior vehicle damage was moderate, as shown in Figures 175 through 177. Vehicle damage occurred to several body locations, such as right-side door and quarter panel, front bumper, right-side wheels and rims, truck box and tailgate, steel frame and suspension, and windshield. The right corner of the front bumper and the right-side door and quarter panel were crushed inward, as shown in Figures 175 and 176. The front bumper buckled 152 mm from the frame's right side toward the center of the pickup. Both doors jarred open slightly. The right-front wheel assembly was pushed back toward the firewall, as shown in Figure 176. The right-front steel rim was deformed, and the tire was deflated, as shown in Figure 176. Contact marks were found along the right side, including the door, the side of the pickup box, and the rear bumper. The pickup box shifted 25 mm to the left, as shown in Figure 175. The tailgate disengaged from the box, but the cables remained intact to the box and the tailgate. The engine also shifted slightly toward the left. The suspension remained intact, but the lower support beam on the frame deformed approximately

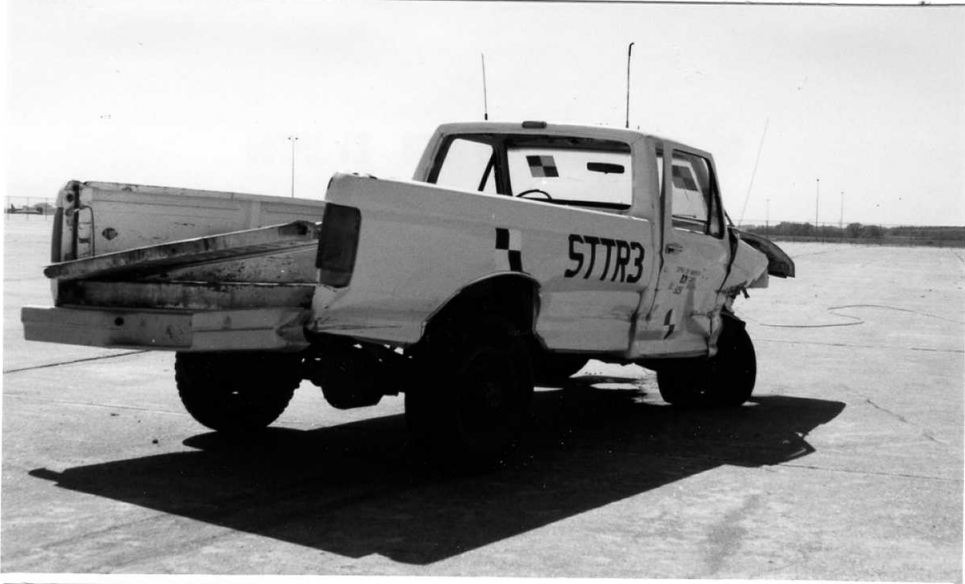
Figure 176. Vehicle Damage, Test STTR-3

90 degrees toward the rear. The front windshield was cracked on the right side, as shown in Figure 176. Interior occupant compartment deformations to the right-side floorboard near the door and the front dashboard, as shown in Figure 177, were judged insufficient to cause serious injury to the vehicle occupants.

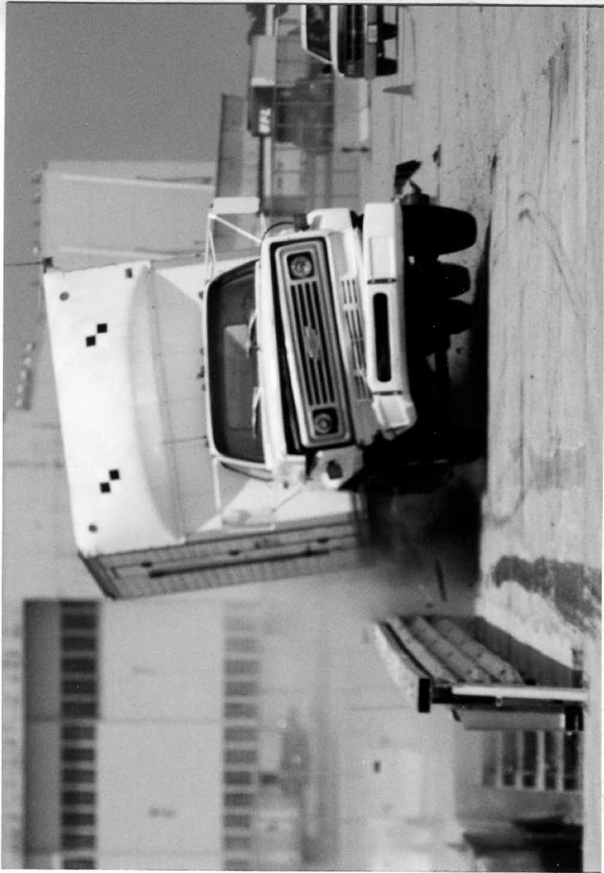
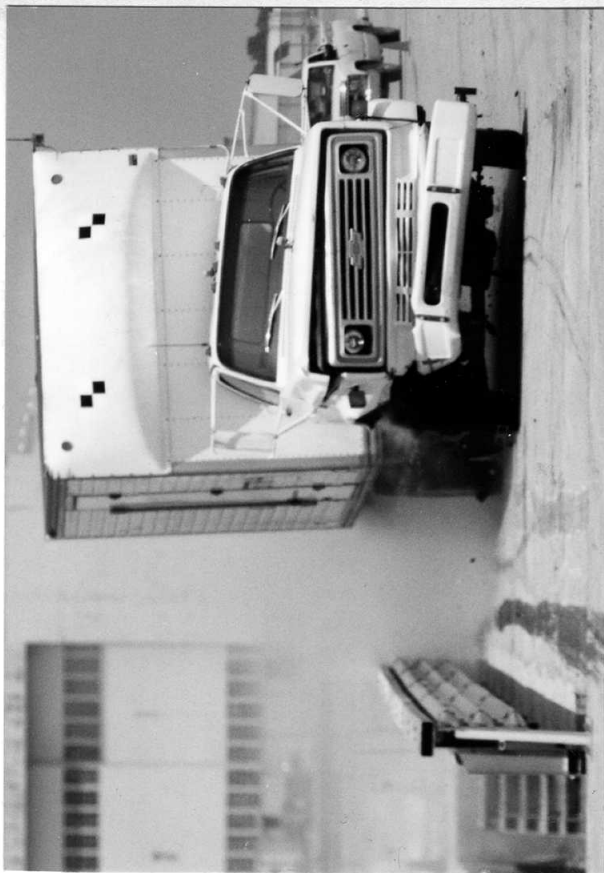
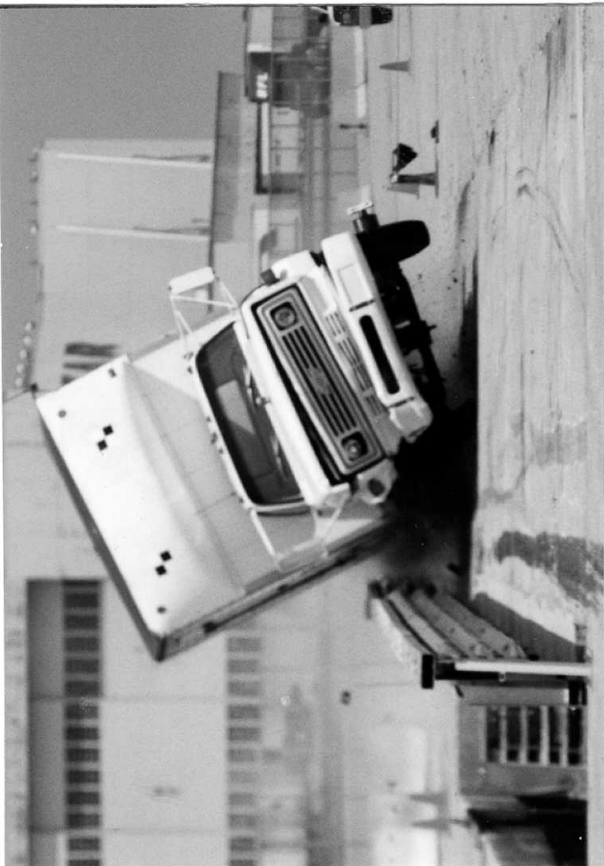
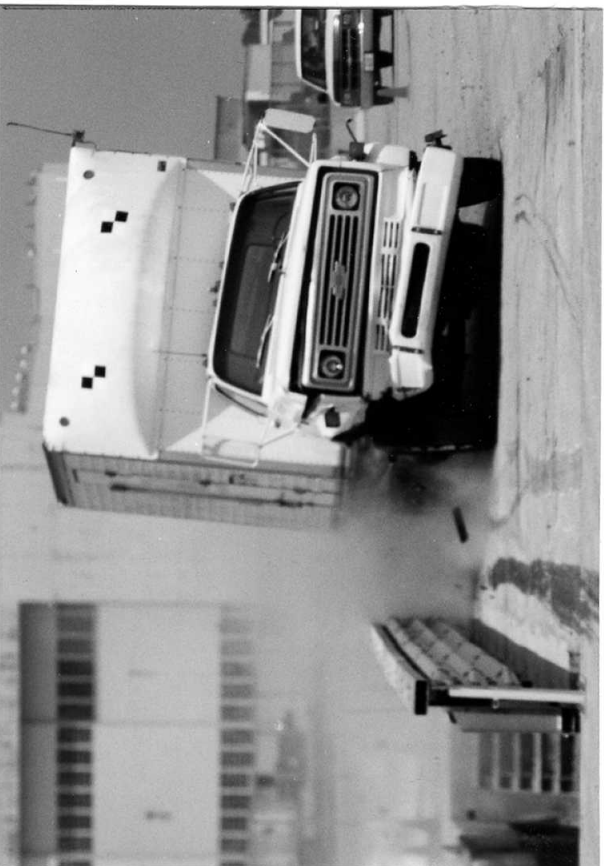
Figure 181. Documentary Photographs, Test STTR-4

The 8,006-kg single-unit truck impacted the approach guardrail transition at a speed of 81.8 km/hr and at an angle of 15.2 degrees. A summary of the test results and the sequential photographs are shown in Figure 178. Additional sequential photographs are shown in Figures 179 and 180. Documentary photographs of the crash test are shown in Figures 181 through 183.

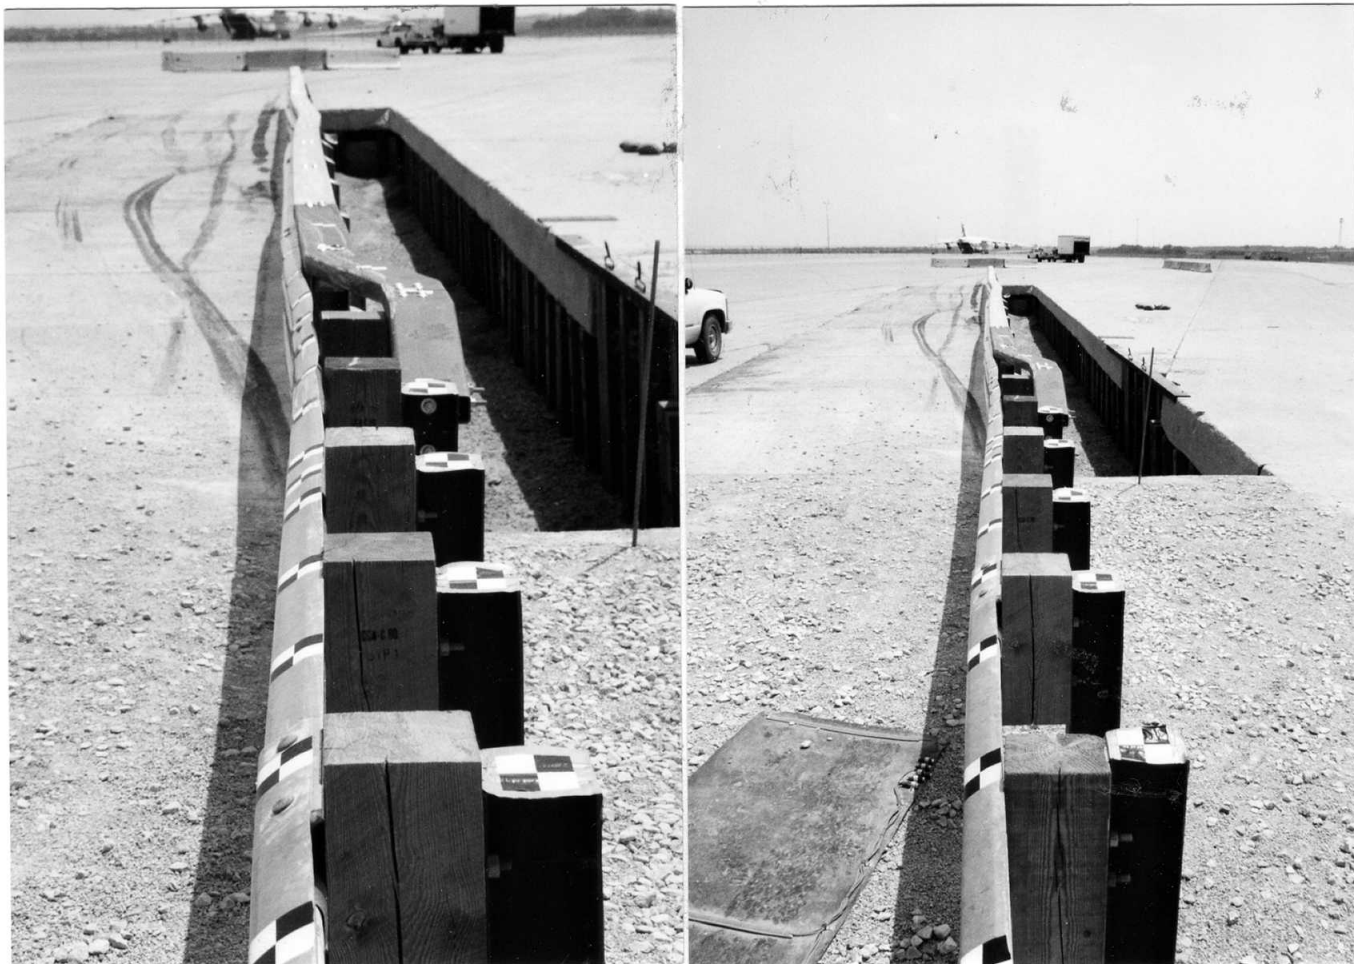
Figure 184. Impact Locations, Test STTR-4

Initial impact occurred between transition post nos. 3 and 4 or 2,384 mm upstream from the upstream end of the steel bridge rail, as shown in Figure 184. At 0.032 sec, the right-front corner of the truck was at transition post no. 3. At 0.080 sec, the deformed right-front corner of the truck was at transition post no. 2, and the front of the right-front fender snagged the blockout at transition post no. 2. At this same time, the front nose of the truck rolled into the rail. At 0.085 sec, the rear of the right-front fender snagged the blockout at transition post no. 3. At 0.114 sec, the right-front corner of the box was in contact with the rail at the midspan between transition post nos. 3 and 4. At this same time, the right-front corner of the truck was at transition post no. 1, and the nose of the truck began to roll into the rail. At 0.161 sec, the right-front corner of the truck was at bridge post no. 1. At 0.209 sec, the right-front corner of the box was at transition post no. 1. At this same time, the crushed right-front fender slid along the top tube rail. At 0.243 sec, the right-front corner of the truck was at bridge post no. 2 as the rear end of the truck was yawing and rolling toward the rail. At 0.261 sec, the rear corner of the box passed the vertical plane of the rail face. At 0.293 sec, the right-front corner of the box landed on top of the tube rail as the box continued to roll into the rail. At 0.312 sec, the left-rear tires were airborne. At 0.333 sec, the truck became parallel to the bridge

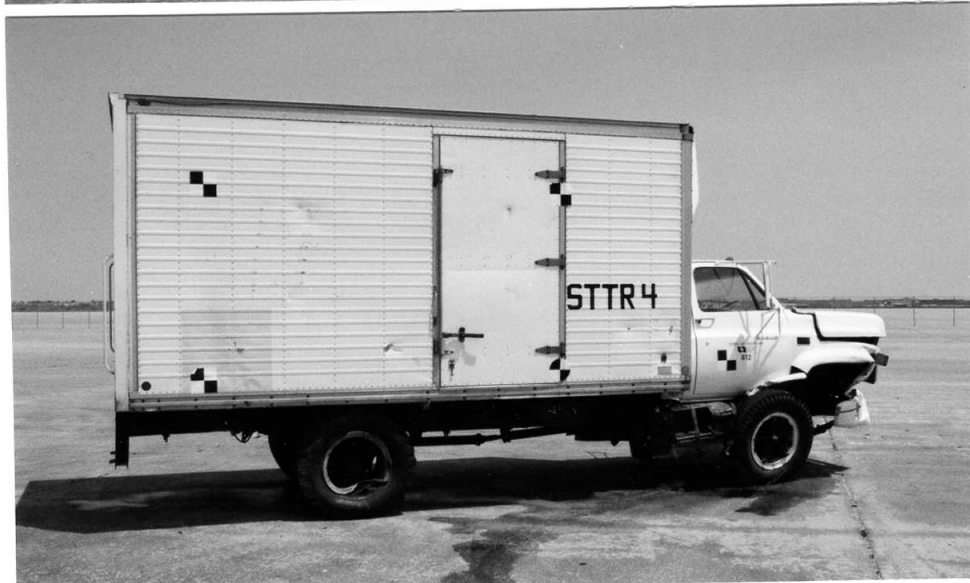
Figure 189. Vehicle Damage, Test STTR-4

Exterior vehicle damage was minor, as shown in Figures 189 through 190. Vehicle damage occurred to several body locations, such as the right-side quarter panel, front bumper, right-rear rim, and truck box. The right-side quarter panel and right corner of the front bumper were crushed inward, as shown in Figures 189 and 190. The right-rear steel rim was deformed extensively, as shown in Figure 190. A small gouge on the right side of the truck box was located slightly in front of the right-rear tire. The front axle was bent and shifted toward the rear of the cab, as shown in Figure 189. The right-front shock and brake line disengaged. The hood jarred open. Minor dents were evident on the right-side gas tank. There was no intrusion nor deformation of the occupant compartment. No other damage to the vehicle was observed.
