GUARDRAIL TESTING – MODIFIED ECCENTRIC  
LOADER TERMINAL (MELT) AT NCHRP 350 TL-2

Prepared for  
The New England Transportation Consortium

July 2002

NETCR 35

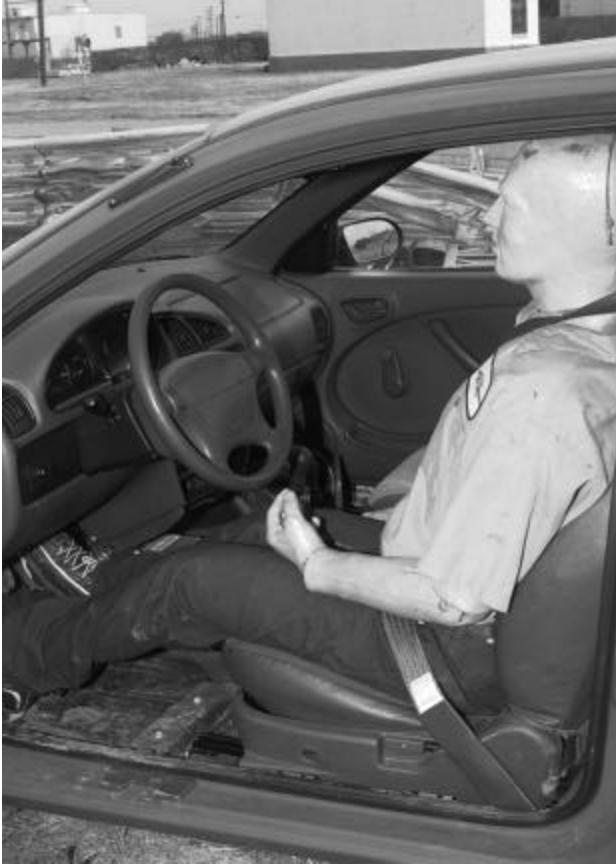
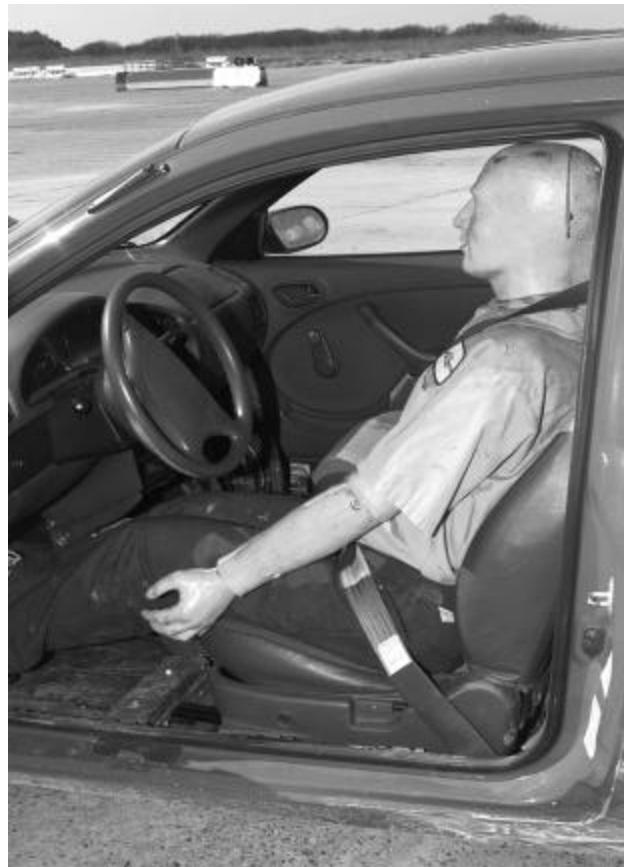
Figure 10. Interior of vehicle for test 400401-1.

The vehicle sustained damage to the front as shown in figure 9. Structural damage was imparted to the right front strut, right front mount, and right front axle, and the firewall and floor pan were deformed. Also damaged were the front bumper, hood, fan, radiator, radiator support, right and left front quarter panels, left front tire and wheel rim, and the left rear tire. The right door was jammed and the windshield sustained stress cracking. Maximum exterior crush to the vehicle was 400 mm at the right front quarter point near bumper height. Maximum occupant compartment deformation was 37 mm just to the right of the center firewall area. Photographs of the interior of the vehicle are shown in figure 10. Exterior vehicle crush and occupant compartment measurements are shown in appendix B, tables 3 and 4.

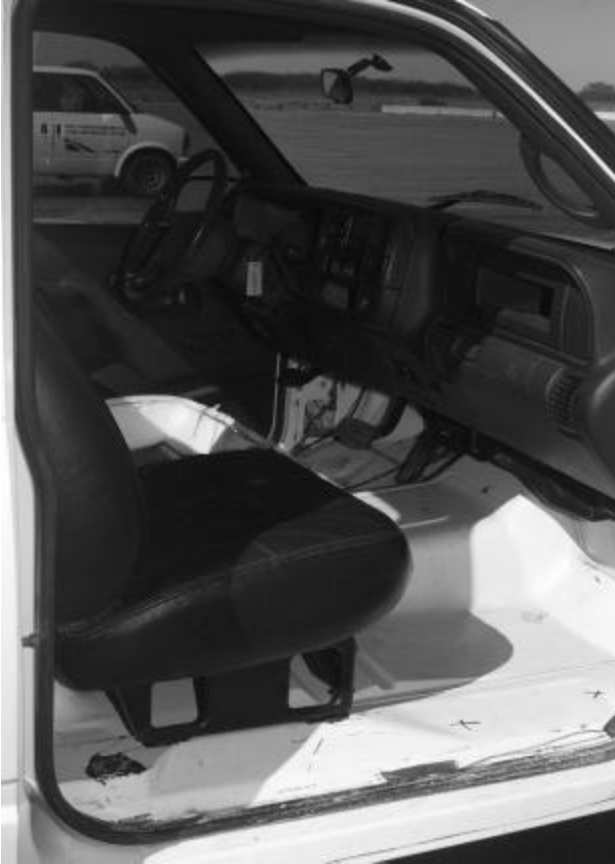
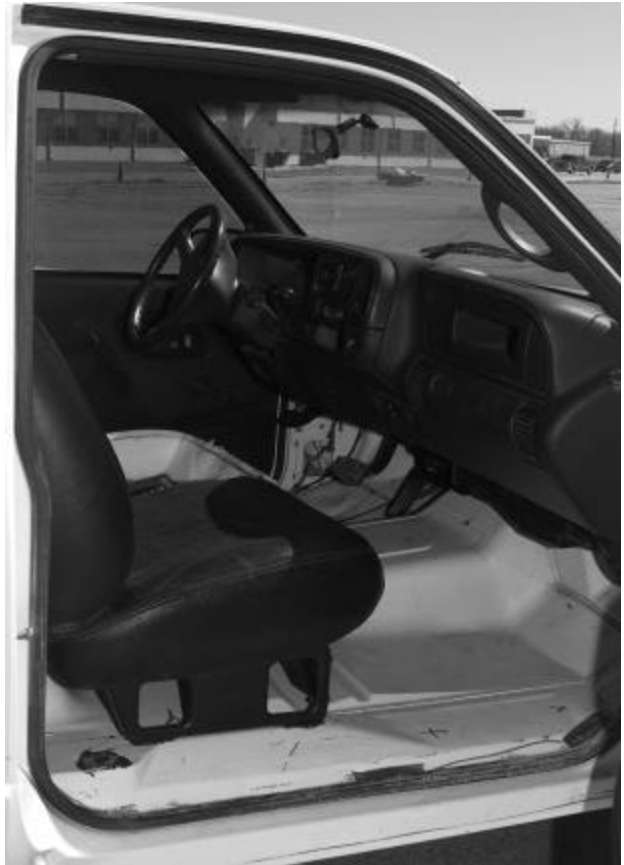
Figure 17. Interior of vehicle for test 400401-2.

Damage to the vehicle was restricted to the front of the vehicle, as shown in figure 16. The stabilizer bar and the left and right front of the frame were deformed. Also damaged were the front bumper, fan, and radiator. Maximum exterior crush to the vehicle was 340 mm at the center front at bumper height. No deformation of the occupant compartment occurred. Photographs of the interior of the vehicle are shown in figure 17. Exterior vehicle crush and occupant compartment measurements are shown in appendix B, tables 5 and 6.
