*Hawaii Department of Transportation  
Research Project Number 67167*

# **CRASH TESTING AND EVALUATION OF THE HDOT 34-IN. TALL AESTHETIC CONCRETE BRIDGE RAIL: MASH TEST DESIGNATION NOS. 3-10 AND 3-11**

## **MIDWEST ROADSIDE SAFETY FACILITY**

MwRSF Research Report No. TRP-03-420-19

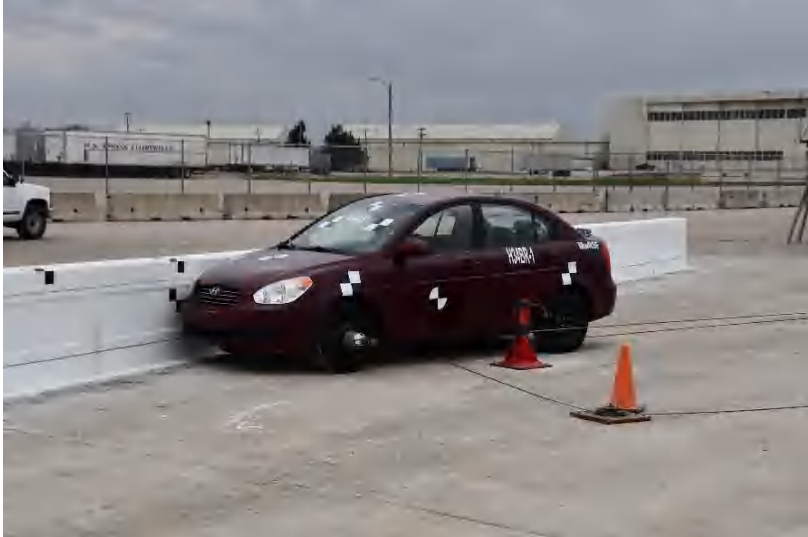
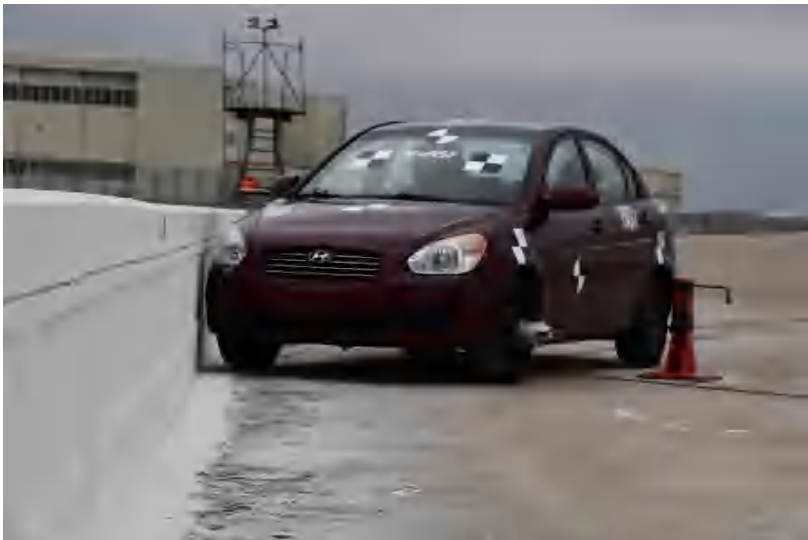
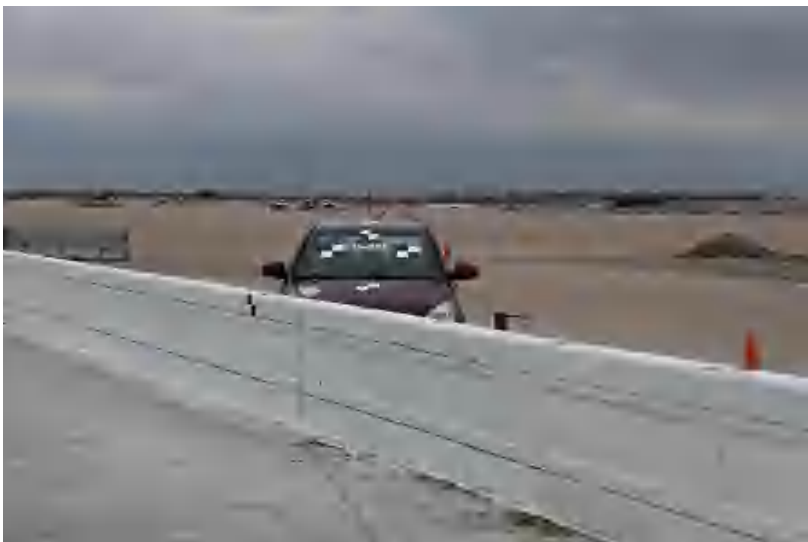
Figure 28. Impact Location, Test No. H34BR-1

Initial vehicle impact was to occur  $43\frac{3}{16}$  in. upstream from the expansion joint between barrier segment nos. 3 and 4, as shown in Figure 28, which was selected using the CIP plots found in Table 2.7 of MASH 2016 to increase the probability of vehicle snag and maximize loading of the critical section of the rail expansion joint, which was discussed further in Section 2.1. The 2,430-lb small car impacted the HDOT 34-in. tall, Aesthetic Concrete Bridge Rail at a speed of 62.4 mph and at an angle of 25.7 degrees. The actual point of impact was  $\frac{5}{8}$  in. downstream from the targeted point. The vehicle was captured and redirected by the 34-in. tall bridge rail. During the redirection of the vehicle, the right-front fender and right-front wheel experienced snag on the expansion joint and the edge of the aesthetic asperities downstream from impact. The snag was sufficient to push the right-front tire backward and crush the front portion of the right-front fender. However, the snag of the vehicle components did not pose a risk to the vehicle occupant compartment nor did it pose a hazard due to the velocity change or deceleration of the vehicle. The vehicle came to rest 161 ft – 9 in. downstream and 23 ft – 3 in. in front of the system after brakes were applied. Impact Severity (I.S.) is an additional limiting condition required in MASH 2016. The measured I.S. of test no. H34BR-1 was 59.2 kip-ft, which fell into the acceptable range of greater than or equal to 51 kip-ft as defined in MASH 2016 for test designation no. 3-10.

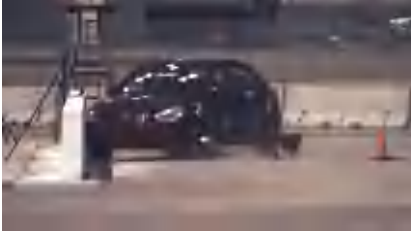
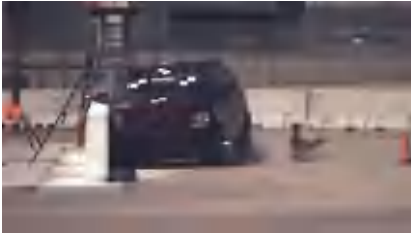
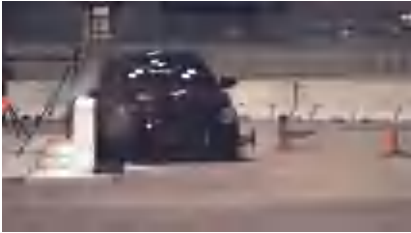
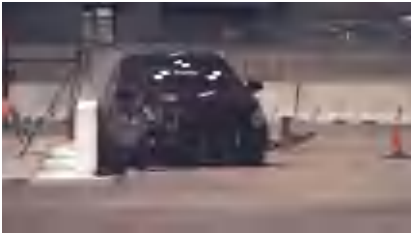
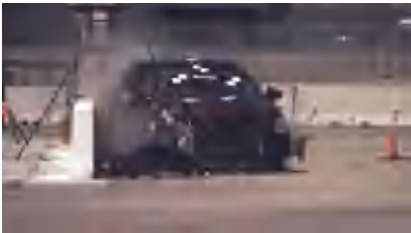
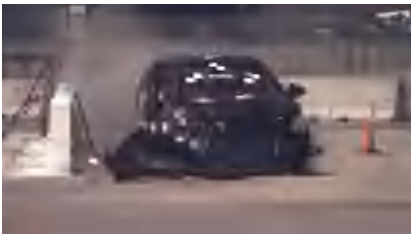
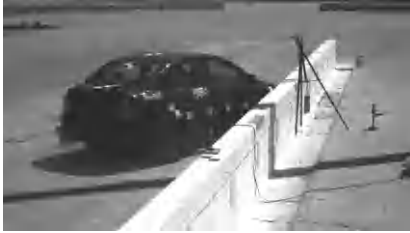
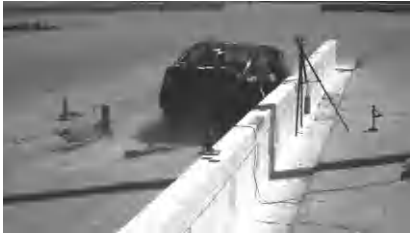
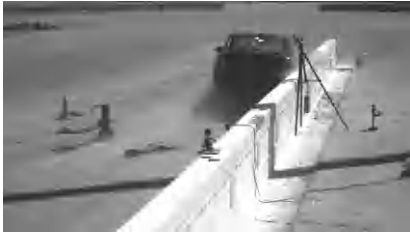
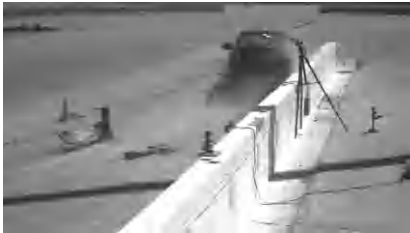
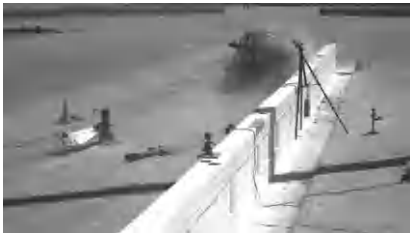
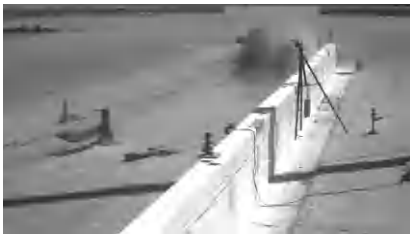
Figure 29. Sequential Photographs, Test No. H34BR-1

0.012	Vehicle's right headlight shattered, vehicle's hood contacted barrier no. 3.
0.014	Barrier no. 3 spalled on front-side downstream end.
0.016	Vehicle's hood deformed, vehicle yawed away from system.

0.020	Vehicle pitched downward.
0.024	Vehicle rolled toward system.
0.030	Vehicle's right-front door contacted barrier no. 3.
0.032	Vehicle's windshield cracked, vehicle's right-front door flexed away from frame.

0.052	Barrier no. 3 cracked on front-side downstream end.
0.064	Vehicle's right-front window shattered.
0.066	Vehicle's left-rear tire became airborne.
0.076	Occupant's head passed through window.

0.080	Vehicle's left-rear tire became airborne.
0.084	Barrier no. 4 spalled on front-side upstream end.
0.088	Barrier no. 4 cracked on front-side upstream end.

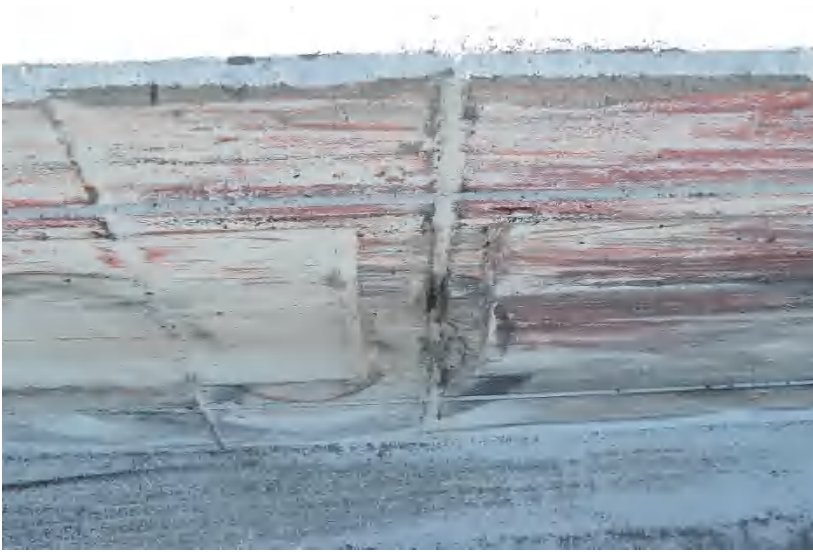
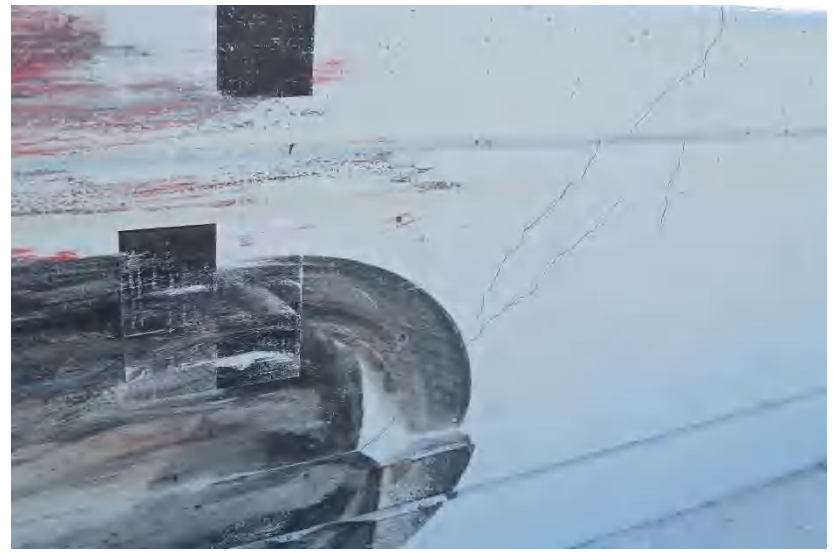
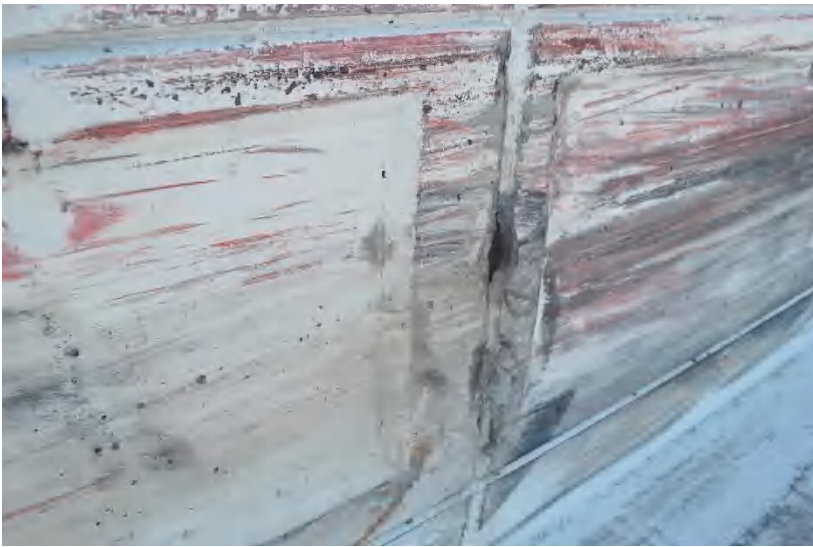
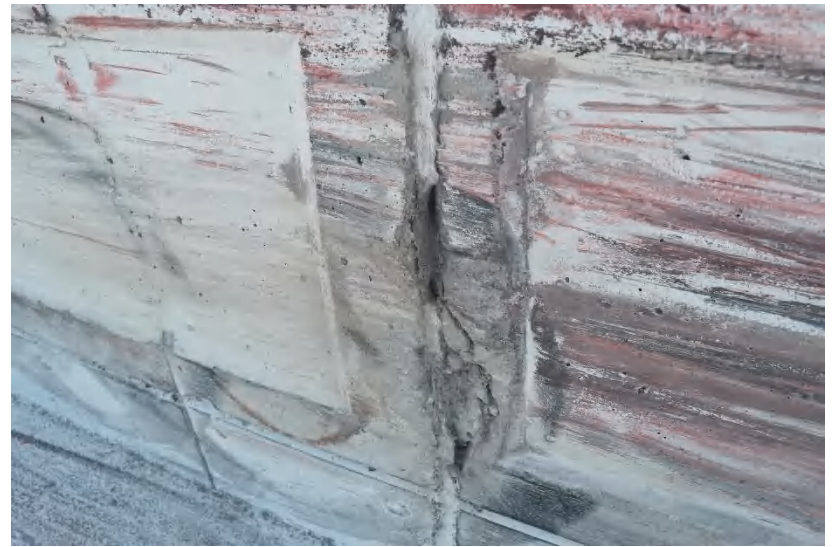
Figure 38. Traffic-Side System Damage, Test No. H34BR-1

Damage to the barrier was minor, as shown in Figures 35 through 39. Barrier damage consisted of minor cracking, spalling, and contact marks on the parapet and minor cracking and spalling at the expansion joint between barrier nos. 3 and 4. The locations for all of the listed damage were measured from the expansion joint between barrier nos. 3 and 4 as a reference point. The length of vehicle contact along the barrier was approximately 11 ft – 3 in. which spanned from 4 ft – 9 in. upstream from the expansion joint to 6 ft – 6 in. downstream from the expansion joint.

A 45-in. long and 1½-in. tall spall on the aesthetic asperity was observed 51 in. upstream from the expansion joint. Spalling measuring 4 in. long and 2½ in. wide was found 45 in. upstream from the expansion joint and 14 in. above the ground. Spalling measuring 11 in. long and ½ in. wide was found 34 in. upstream from the expansion joint and 23 in. above the ground. Spalling measuring 5½ in. long and 2½ in. wide was found 33 in. upstream from the expansion joint and 15 in. above the ground. Spalling measuring 61½ in. long was found 32 in. upstream from the expansion joint to 29½ in. downstream of the expansion joint and 32 in. above the ground. Spalling measuring 5 in. long, 10 in. wide, and ½ in. deep was found 3 in. upstream from the expansion joint and 14 in. above the ground. Spalling measuring 6 in. long was found 2 in. upstream from the expansion joint and 24 in. above the ground. A ½-in. diameter by ½-in. deep hole was observed 53 in. upstream from the expansion joint and 17½ in. above the ground. A 1-in. diameter by ½-in. deep hole was observed 24 in. upstream from the expansion joint and 23½ in. above the ground. Grout was disengaged over a 12½ in. height at the expansion joint was observed located 9½ in. above the ground.

Minor cracking of the barrier was also observed in several locations. A 19½-in. diagonal crack that started 18½ in. above the ground and ended 33½ in. above the ground was found 70½ in. upstream from the expansion joint. An 18½-in. diagonal crack that started 11 in. above the ground and ended 18½ in. above the ground was found 60 in. upstream from the expansion joint. A third smaller crack was noted on the top of the barrier starting near the middle of the expansion joint between barrier nos. 3 and 4 and extending diagonally approximately 8 in. downstream and toward the back of the barrier.

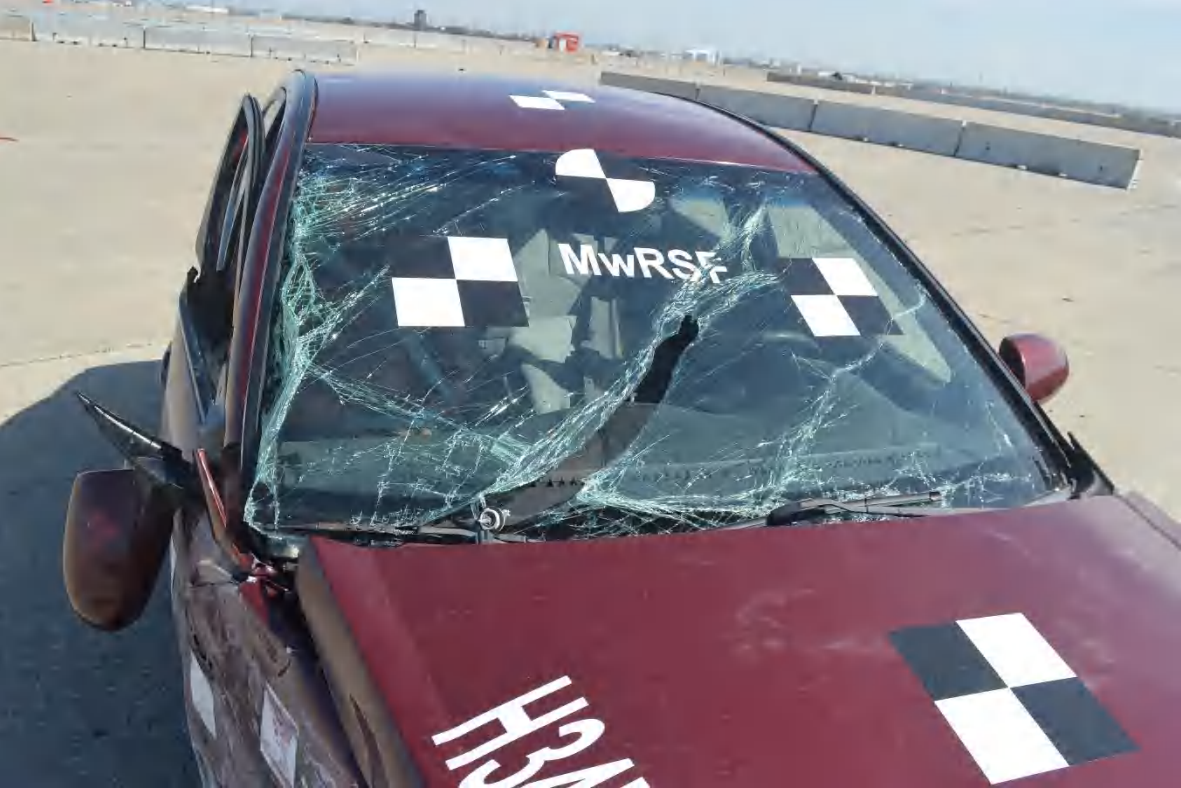
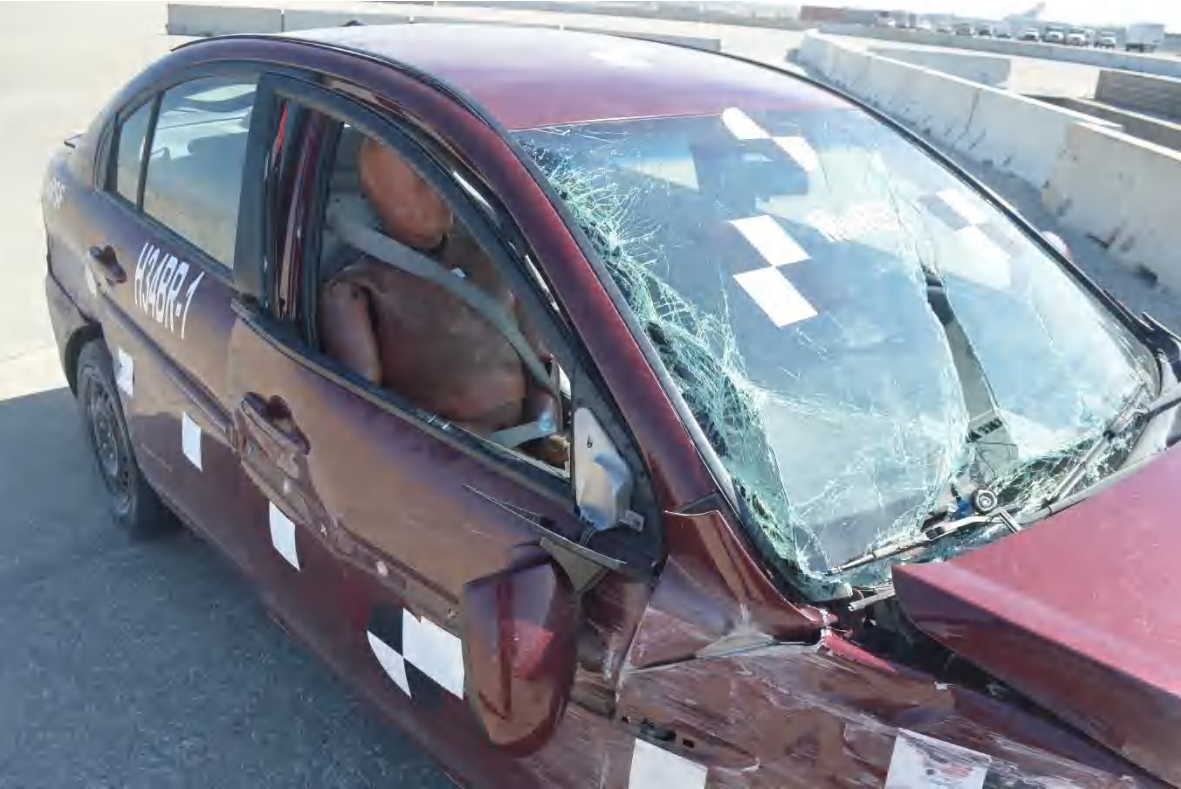
Figure 43. Vehicle Damage, Test No. H34BR-1

The damage to the vehicle was moderate, as shown in Figures 41 through 45. The maximum occupant compartment intrusions are listed in Table 5 along with the intrusion limits established in MASH 2016 for various areas of the occupant compartment. MASH 2016 defines intrusion or deformation as the occupant compartment being deformed and reduced in size with no observed penetration. Note that none of the established MASH 2016 intrusion limits were violated. The lateral B-Pillar and side door above and below the seat deformed slightly outward, which is not considered crush toward the occupant, is denoted as negative numbers in Table 5, and is not evaluated by MASH 2016 criteria. Complete occupant compartment and vehicle intrusions and the corresponding locations are provided in Appendix C.

The majority of the damage was concentrated on the right-front fender and right-front wheel of the vehicle where the impact had occurred. A small section of the seam where the floor pan and toe pan connected near the left-front corner of the right-side floor pan split due to floor pan deformation. The split seam was not due to intrusion of the barrier or a component of the vehicle. The vehicle's engine hood partially disengaged, but it remained attached to the vehicle's body. The front bumper and bumper cover disengaged from the vehicle. Kinks were found on the bottom support of the radiator, and the right radiator support was bent toward the engine compartment. A 2 $\frac{3}{8}$ -in. dent on the right side of the hood crushed 5 in. inward and toward the engine compartment. The right-front fender was crushed and had contact marks with the most significant occurring near the front of the wheel well. A 3 $\frac{8}{2}$ -in. long x 7 $\frac{1}{8}$ -in. wide x 1 $\frac{1}{2}$ -in. deep dent was found on the right-front door. The right-rear door was dented and scraped just ahead of the rear quarter panel.

It should be noted that the passenger side window fractured, and a large tear was visible in the vehicle windshield. Review of the high-speed video revealed that the side window damage was due to crush of the side of the vehicle door and not due to direct contact with the test article. Similarly, the video data showed that the tearing of the windshield was formed due to crushing of the right front corner of the windshield which propagated a shear crack through the glass and the liner. Neither of these items were in violation of the MASH 2016 criteria as none of the damage occurred due to contact with the test article or debris, nor was there the potential for the barrier to intrude into the occupant compartment.

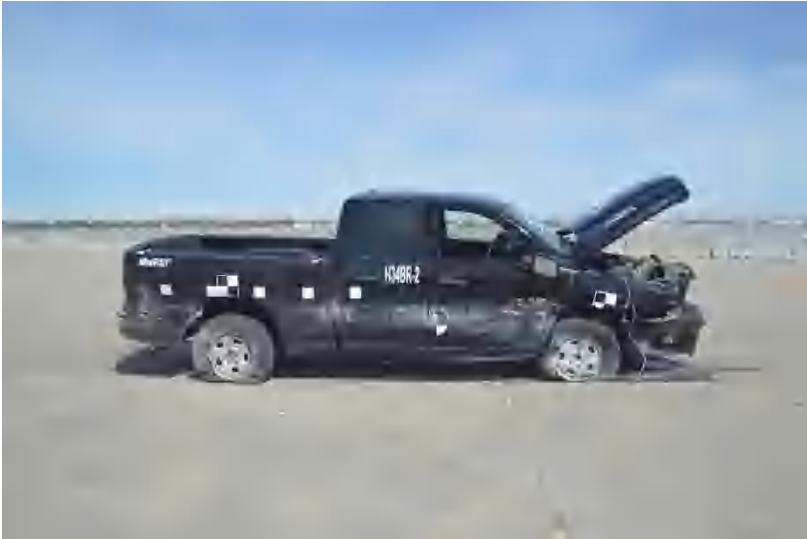
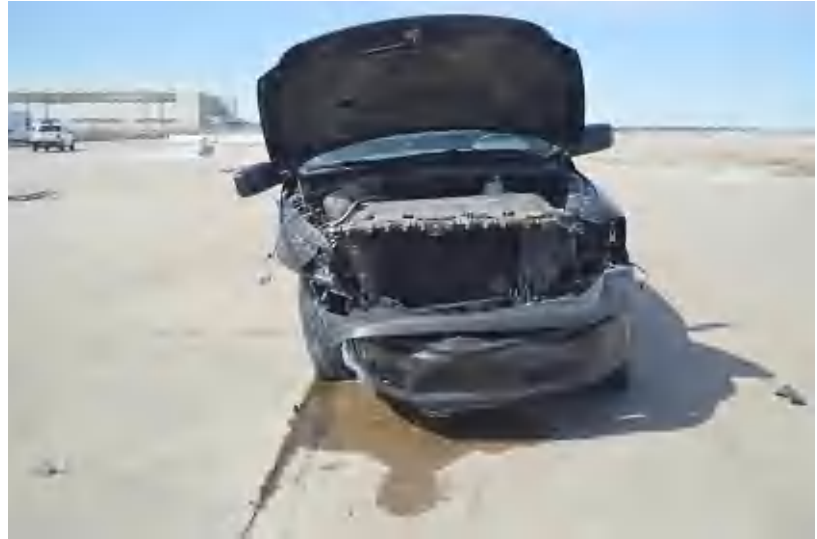
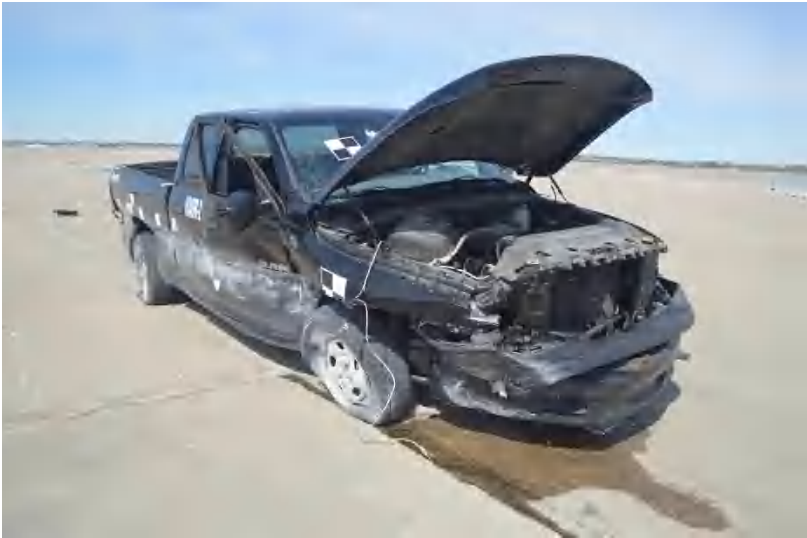
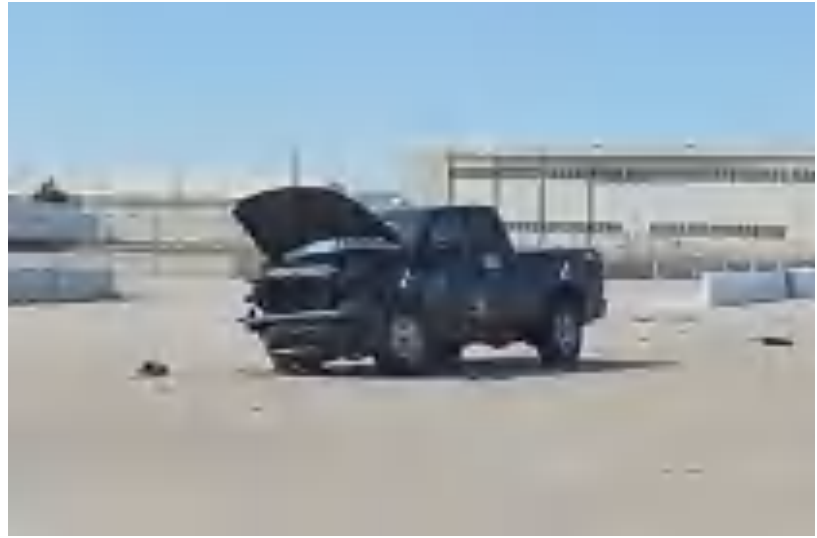
Figure 60. Vehicle Damage, Test No. H34BR-2

The damage to the vehicle was moderate, as shown in Figures 60 through 64. The maximum occupant compartment intrusions are listed in Table 9 along with the intrusion limits established in MASH 2016 for various areas of the occupant compartment. MASH 2016 defines intrusion or deformation as the occupant compartment being deformed and reduced in size with no observed penetration. Note that none of the established MASH 2016 intrusion limits were violated. The lateral A- and B-pillars and the side door above the seat deformed slightly outward, which is not considered crush toward the occupant, is denoted as negative numbers in Table 9, and is not evaluated by MASH 2016 criteria. Complete occupant compartment and vehicle intrusions and the corresponding locations are provided in Appendix C.

The majority of the damage was concentrated on the right-front corner and right side of the vehicle where the impact had occurred. The right side of the bumper was crushed inward and backward. The right-front fender was crushed inward toward the centerline of the vehicle and engine compartment. The right-front steel rim was deformed and crushed, and the right-front tire was torn and deformed. The right upper control arm was fractured. The grille was disengaged away

from the vehicle. The left-side headlight was disengaged away from the vehicle and right-side headlight and fog light were shattered. The right side of the radiator was pushed backward. A 16 $\frac{1}{2}$ -in. long x 21-in. wide x 2 $\frac{1}{2}$ -in. deep dent and scraping were observed on the entire right side. The right-front door was ajar, and creases were found in the door's sheet metal. The right-rear steel rim was crushed, and the tire was torn. The right side of the rear bumper was dented and scuffed. It should be noted that the window on the right-front side was shattered. It should be noted that the passenger side window was fractured. Review of the high-speed video revealed that the side window damage was due to crush of the side of the vehicle door and not due to direct contact with the test article. Thus, the side window damage was not in violation of the MASH criteria as it did not occur due to contact with the test article or debris. The bottom-right side of the windshield had a hairline crack, and no cracks were found on the left side of the windshield. The left-front fender was dented at the top and back. Minor scrapes and dents were found at the left-front and left-rear doors. The roof and remaining window glass remained undamaged.
