U.S. Department
of Transportation
**Federal Highway
Administration**

The following device is eligible within the length-of-need, with details provided in the form which is attached as an integral part of this letter:

- Hercules TL2 P

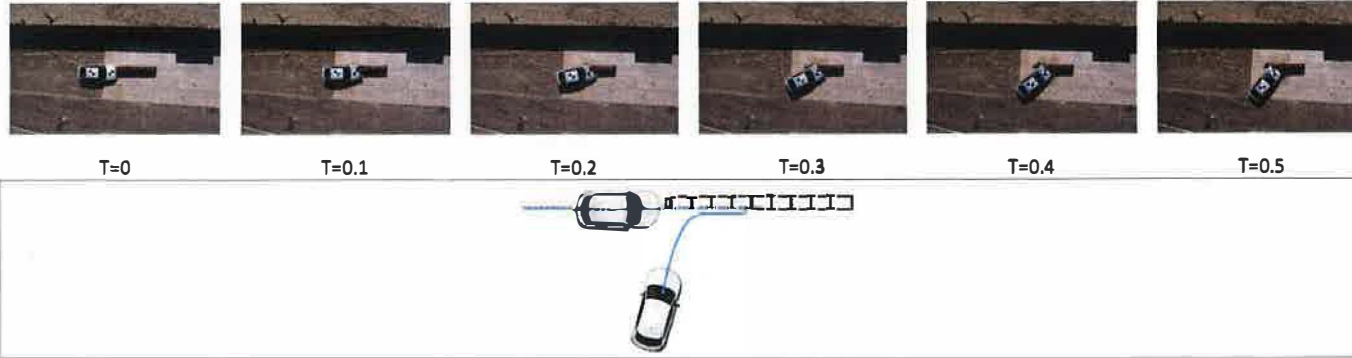
General Information		Post-Impact Trajectory	
Test agency.....	CSI S.p.A.	Vehicle Stability.....	Satisfactory
Test No.	Test 2-30	Stopping Distance.....	3 m upstream 6 m lateral
Date.....	29/03/2021	Vehicle snagging.....	None
Test Article		Vehicle pocketing.....	None
Type.....	HERCULES TL2 P	Occupant Risk Values	
Installation length [m].....	4.396	Impact Velocity [m/s]	
Size and/or dimension and material of key Elements.....	See attached drawings	X-direction.....	10.5
Foundation type and condition.....	Concrete	Y-direction.....	-0.7
Test Vehicle		Ridedown Acceleration [g's]	
Type/ Designation.....	1100C	X-direction.....	-14.4
Model.....	HONDA CIVIC	Y-direction.....	-3.6
Mass [kg]		THIV	37.8
Curb.....	1049.2	PHD	14.4
Test Inertial.....	1104.6	ASI 2010.....	0.88
Gross static.....	1180.2	Test Article Damage	
Impact Conditions		Test Article Deflections [m]	
Speed [km/h].....	70.4	Permanent	1.55
Angle [deg].....	0.0	Dynamic	1.55

Impact Severity [kJ].....	225.7	Working Width.....	0.65
Impact Location.....	Frontal, offset W/4, 0°	Vehicle Damage	
Exit Speed [km/h].....	< 10	See appendix A	
Exit Angle [deg].....	N/A	Maximum internal deformation.....	15 mm
		Maximum external deformation.....	140 mm

T=0 T=0.1 T=0.2 T=0.3 T=0.4 T=0.5

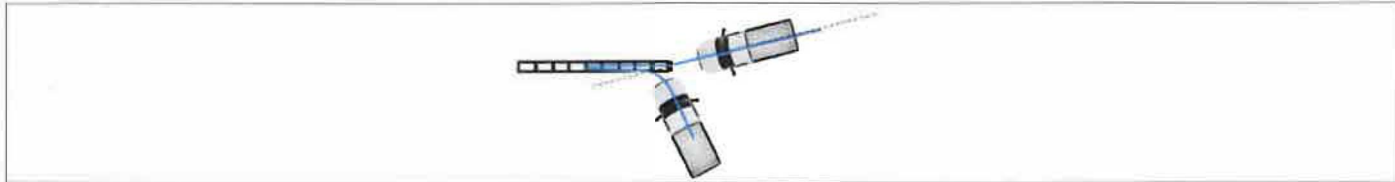
T=0 T=0.1 T=0.2 T=0.3 T=0.4 T=0.5

General Information		Post-Impact Trajectory	
Test agency.....	CSI S.p.A.	Vehicle Stability.....	Satisfactory
Test No.	Test 2-33	Stopping Distance.....	1 m upstream 2 m laterally
Date.....	07/04/2021	Vehicle snagging.....	None
Test Article		Vehicle pocketing.....	None
Type.....	HERCULES TL2 P	Occupant Risk Values	
Installation length [m].....	4.396	Impact Velocity [m/s]	
Size and/or dimension and material of key	See attached drawings	X-direction.....	9.7
Elements.....	Concrete (anchored)	Y-direction.....	-1.1
Foundation type and condition.....		Ridedown Acceleration [g's]	
Test Vehicle		X-direction.....	-11.0
Type/ Designation.....	2270P	Y-direction.....	-3.2
Model.....	CHEVROLET SILVERADO 1500	THIV	35.4
Mass [kg]		PHD	11.4
Curb.....	2212.0	ASI 2010.....	0.85
Test Inertial.....	2239.4	Test Article Damage	Moderate
Gross static.....	2239.4	Test Article Deflections [m]	
Impact Conditions		Permanent	2.25
Speed [km/h].....	70.2	Dynamic	2.25

Angle [deg].....	15.0	Working Width.....	0.71
Impact Severity [kJ].....	425.8	Vehicle Damage	
Impact Location.....	Front, head centered, 15°	See appendix A	
Exit Speed [km/h].....	< 10	Maximum internal deformation.....	29 mm
Exit Angle [deg].....	N/A	Maximum external deformation.....	330 mm

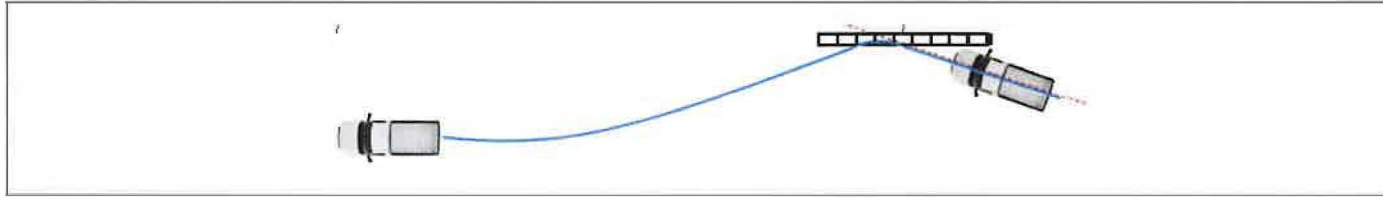
General Information		Post-Impact Trajectory	
Test agency.....	CSI S.p.A.	Vehicle Stability.....	Satisfactory
Test No.	Test 2-34	Stopping Distance.....	48 m downstream
Date.....	13/04/2021	Vehicle snagging.....	None
Test Article		Vehicle pocketing.....	None
Type.....	HERCULES TL2 P	Occupant Risk Values	
Installation length [m].....	4.396	Impact Velocity [m/s]	
Size and/or dimension and material of key		X-direction.....	2.9
Elements.....	See attached drawings	Y-direction.....	-4.9
Foundation type and condition.....	Concrete	Ridedown Acceleration [g's]	
Test Vehicle		X-direction.....	1.4
Type/ Designation.....	1100C	Y-direction.....	5.6
Model.....	HONDA CIVIC	THIV	20.7
Mass [kg]		PHD	5.6
Curb.....	1039.8	ASI 2010.....	0.99
Test Inertial.....	1096.0	Test Article Damage	Moderate
Gross static.....	1171.6	Test Article Deflections [m]	
Impact Conditions		Permanent	0.04
Speed [km/h].....	69.7	Dynamic	0.05
Angle [deg].....	15.0	Working Width.....	0.75

Impact Severity [kJ].....	14.7	Vehicle Damage	
Impact Location.....	Laterally	See appendix A	
Exit Speed [km/h].....	65	Maximum internal deformation.....	4 mm
Exit Angle [deg].....	9	Maximum external deformation.....	30 mm

2-34 (1100C)	<p>Test 2-34 involves a 1100C passenger car impacting the crash cushion at a nominal impact speed of 70 km/h and an impact at 15 degrees with the CIP at the point where the crash cushion behavior changes from capturing to redirective. This test is preliminary intended to evaluate occupant risk and vehicle trajectory criteria. For this test a Honda Civic 1171.6 kg impacted the Hercules Crash Cushion at a speed 69.7 km/h and an angle of 15 degrees. The impact point was downstream the trolley. Upon the impact the vehicle was smoothly redirected. The test vehicle sustained damage to its right front corner, doors and rear quarter panel. The occupant compartment was within allowable limits. The maximum roll and pitch angles did not exceed 75 deg. and the occupant risk values were within limits per the MASH specifications for OIV and ORA. Hercules Crash Cushion passed all evaluation criteria for test 2-34.</p>	PASS
