U.S. Department  
of Transportation  
**Federal Highway  
Administration**

In Reply Refer To:  
HSST-1/SS-185

The following device is eligible within the length-of-need, with details provided in the form which is attached as an integral part of this letter:

- Telespar Sign Support

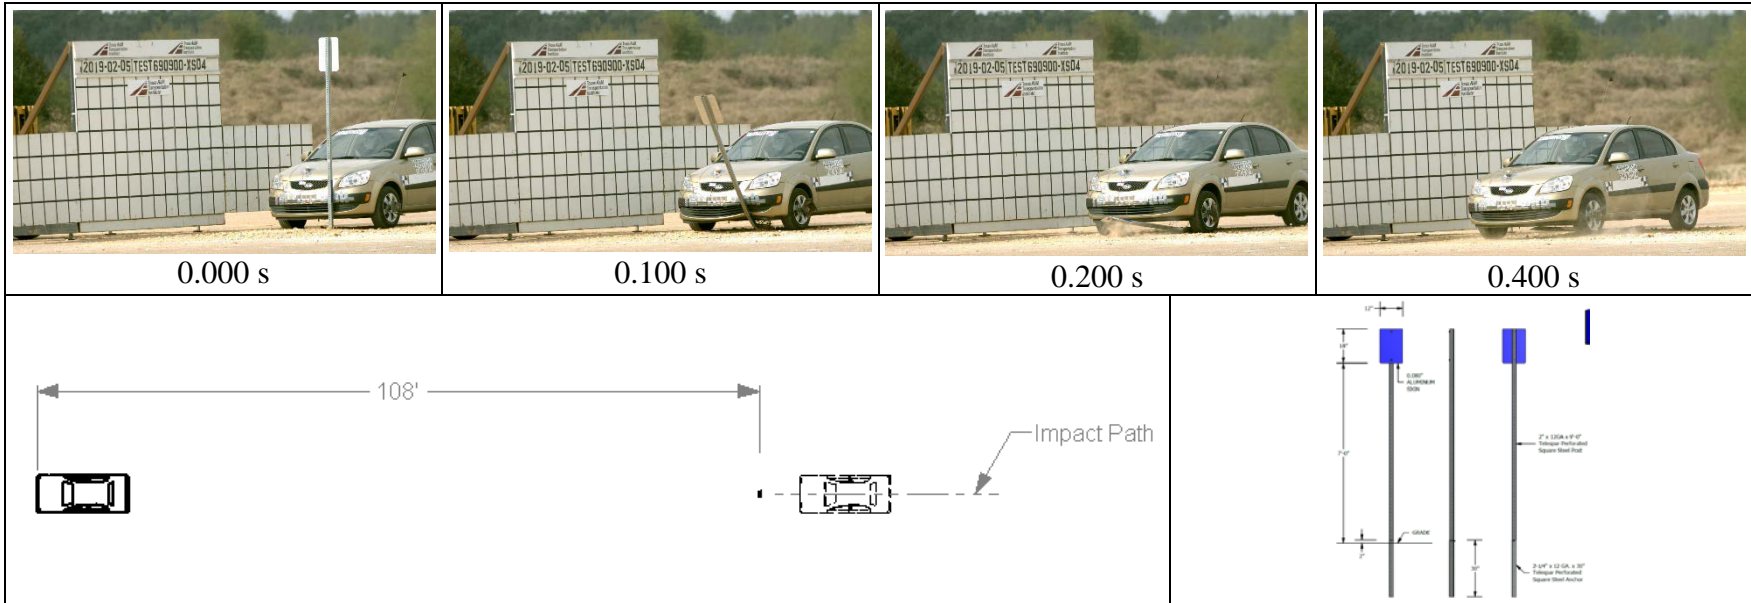
**Figure 5.6. Summary of Results for MASH Test 3-60 at 0° on Telespar Sign Support.**

Test Agency..... Texas A&M Transportation Institute (TTI)  
 Test Standard Test No. .... MASH Test 3-60  
 TTI Test No. .... 690900-XSD4  
 Test Date ..... 2019-02-05

Type ..... Support Structure (Sign Support)  
 Name ..... Telespar Sign Support  
 Installation Height ..... 7 ft above grade  
 Material or Key Elements ... 2-inch x 14 gauge square perforated steel support post inserted 8 inches into 2 1/4-inch x 12 gauge x 30 inches long square perforated steel anchor post protruding 2 inches above grade; 12x18x0.080 inch aluminum sign panel  
**Soil Type and Condition** .... Installed in AASHTO M147-65(2004), grading B Soil (crushed limestone), Damp

Type/Designation ..... 1100C  
 Make and Model ..... 2009 Kia Rio  
 Curb ..... 2407 lb  
 Test Inertial ..... 2434 lb  
 Dummy ..... 165 lb  
 Gross Static ..... 2599 lb

Speed ..... 18.8 mi/h  
 Angle ..... 0°  
 Location/Orientation ..... Left quarter point  
**Impact Severity**..... 29 kip-ft

Speed ..... 16.1 mi/h  
 Angle ..... 0°

Longitudinal OIV ..... 3.6 ft/s  
 Lateral OIV ..... 0.0 ft/s  
 Longitudinal Ridedown ..... 0.5 g  
 Lateral Ridedown ..... 1.3 g  
 THIV ..... 4.1 km/h  
 PHD ..... 1.3 g  
 ASI ..... 0.10  
 Max. 0.050-s Average  
 Longitudinal ..... -1.2 g  
 Lateral ..... 0.3 g  
 Vertical ..... -0.4 g

Stopping Distance ..... 108 ft downstream

VDS ..... 12FL1  
 CDC ..... 12FLEN1  
 Max. Exterior Deformation ..... Not measurable  
 OCDI ..... FS0000000  
 Max. Occupant Compartment Deformation ..... None

| Required Test Number | Narrative Description | Evaluation Results |
|---|---|---|
| 3-60 (1100C) | <p>MASH Test 3-60 was successfully performed on the Telespar sign support system at both 0 and 90 degrees. In both tests (690900-XSD 4&amp;5), the support yielded and was overridden by the vehicle. The vehicle remained stable and upright. The support post was partially fractured, but the components of the sign support system remained intact. The vehicle sustained a small indentation at the at the location of impact, but it was so minimal as to be not measurable. Occupant risk indices (occupant impact velocity and ridedown acceleration) were within MASH thresholds. No occupant compartment deformation or intrusion was observed.</p> | PASS |

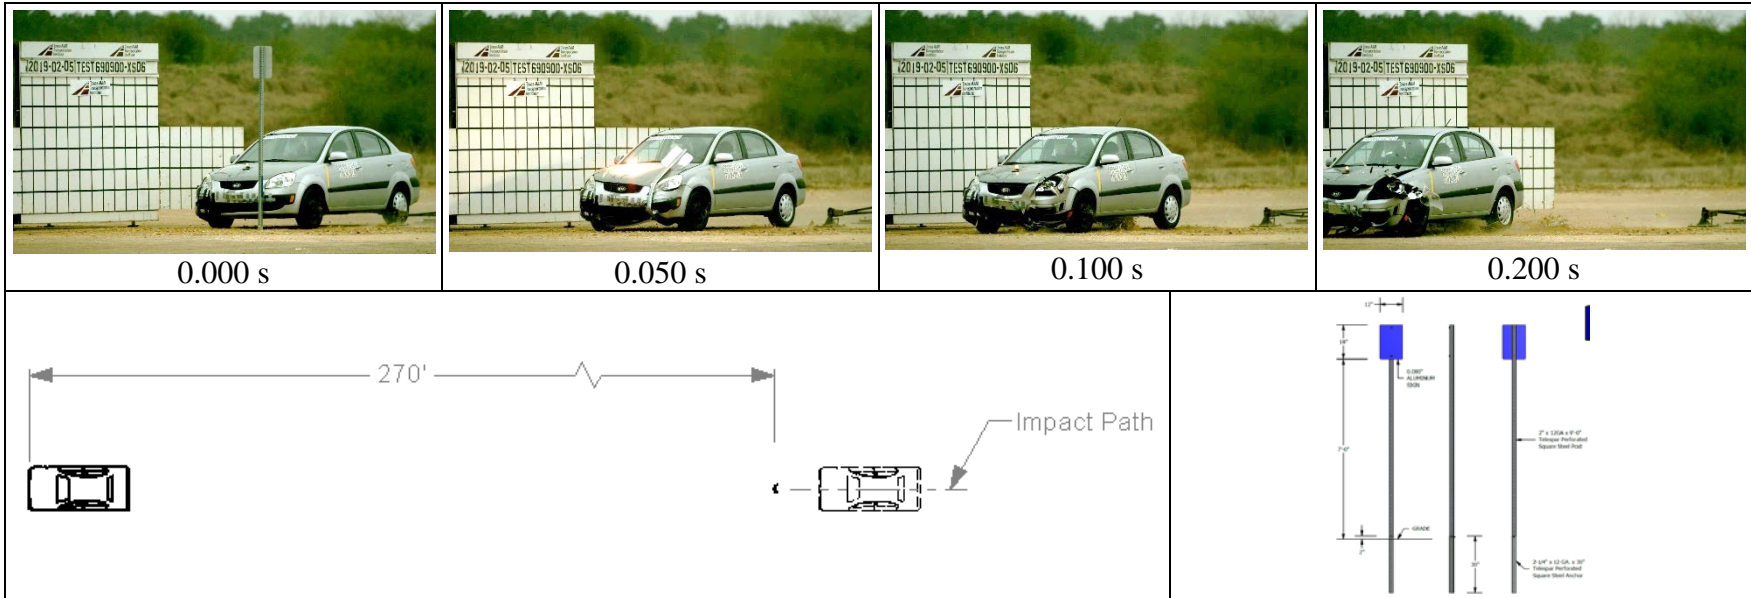
**Figure 7.6. Summary of Results for MASH Test 3-61 at 0° on Telespar Sign Support.**

| <p><b>General Information</b><br/> Test Agency..... Texas A&amp;M Transportation Institute (TTI)<br/> Test Standard Test No. .... MASH Test 3-61<br/> TTI Test No. .... 690900-XSD6<br/> Test Date ..... 2019-02-05</p> <p><b>Test Article</b><br/> Type ..... Support Structure (Sign Support)<br/> Name..... Telespar Sign Support<br/> Installation Height ..... 7 ft above grade<br/> Material or Key Elements... 2-inch x 14 gauge square perforated steel support post inserted 8 inches into 2¼-inch x 12 gauge x 30 inches long square perforated steel anchor post protruding 2 inches above grade; 12x18x0.080 aluminum sign panel</p> <p><b>Soil Type and Condition</b> .... Installed in AASHTO M147-65(2004), grading B Soil (crushed limestone), Damp</p> <p><b>Test Vehicle</b><br/> Type/Designation ..... 1100C<br/> Make and Model ..... 2009 Kia Rio<br/> Curb..... 2480 lb<br/> Test Inertial..... 2440 lb<br/> Dummy ..... 165 lb<br/> Gross Static ..... 2605 lb</p> | <p><b>Impact Conditions</b><br/> Speed ..... 63.5 mi/h<br/> Angle ..... 0°<br/> Location/Orientation ..... Left quarter point</p> <p><b>Impact Severity</b>..... 329 kip-ft</p> <p><b>Exit Conditions</b><br/> Speed ..... 60.2 mi/h<br/> Angle ..... 0°</p> <p><b>Occupant Risk Values</b><br/> Longitudinal OIV ..... 3.6 ft/s<br/> Lateral OIV..... 2.0 ft/s<br/> Longitudinal Ridedown ..... 0.2 g<br/> Lateral Ridedown ..... 0.6 g<br/> THIV ..... 4.5 km/h<br/> PHD ..... 0.6 g<br/> ASI..... 0.15<br/> Max. 0.050-s Average<br/> Longitudinal ..... -1.7 g<br/> Lateral..... 0.6 g<br/> Vertical..... 1.3 g</p> | <p><b>Post-Impact Trajectory</b><br/> Stopping Distance..... 270 ft downstream</p> <p><b>Vehicle Stability</b><br/> Maximum Yaw Angle ..... 5°<br/> Maximum Pitch Angle ..... 1°<br/> Maximum Roll Angle ..... 6°</p> <p><b>Test Article Scatter</b><br/> Longitudinal ..... Remained at<br/> Lateral ..... impact site</p> <p><b>Vehicle Damage</b><br/> VDS ..... 12FL1<br/> CDC..... 12FLEN1<br/> Max. Exterior Deformation..... 1.5 inches<br/> OCDI..... FS0000000<br/> Max. Occupant Compartment Deformation ..... None</p> |

| Required Test Number | Narrative Description | Evaluation Results |
|---|--|---|
| 3-61 (1100C) | <p>MASH Test 3-61 was successfully performed on the Telespar sign support system at both 0 and 90 degrees. In both tests, the support yielded and was overridden by the vehicle. The vehicle remained stable and upright. In the 0-degree test (690900-XSD 6), the support post was partially fractured at several locations, but the components of the sign support system remained intact. The vehicle sustained minor damage, including a 1.5-inch deep indentation in the hood. Occupant risk indices were within MASH thresholds. No occupant compartment deformation or intrusion was observed.</p> <p>In the 90-degree test (690900-XSD 7), the support post fractured and separated into two pieces. The lower 4 ft of the support remained with the anchor post. The sign detached from the upper section of the post. The vehicle sustained minor damage, including a 2-inch deep indentation in the hood. Occupant risk indices were within MASH thresholds. No occupant compartment deformation or intrusion was observed.</p> | PASS |

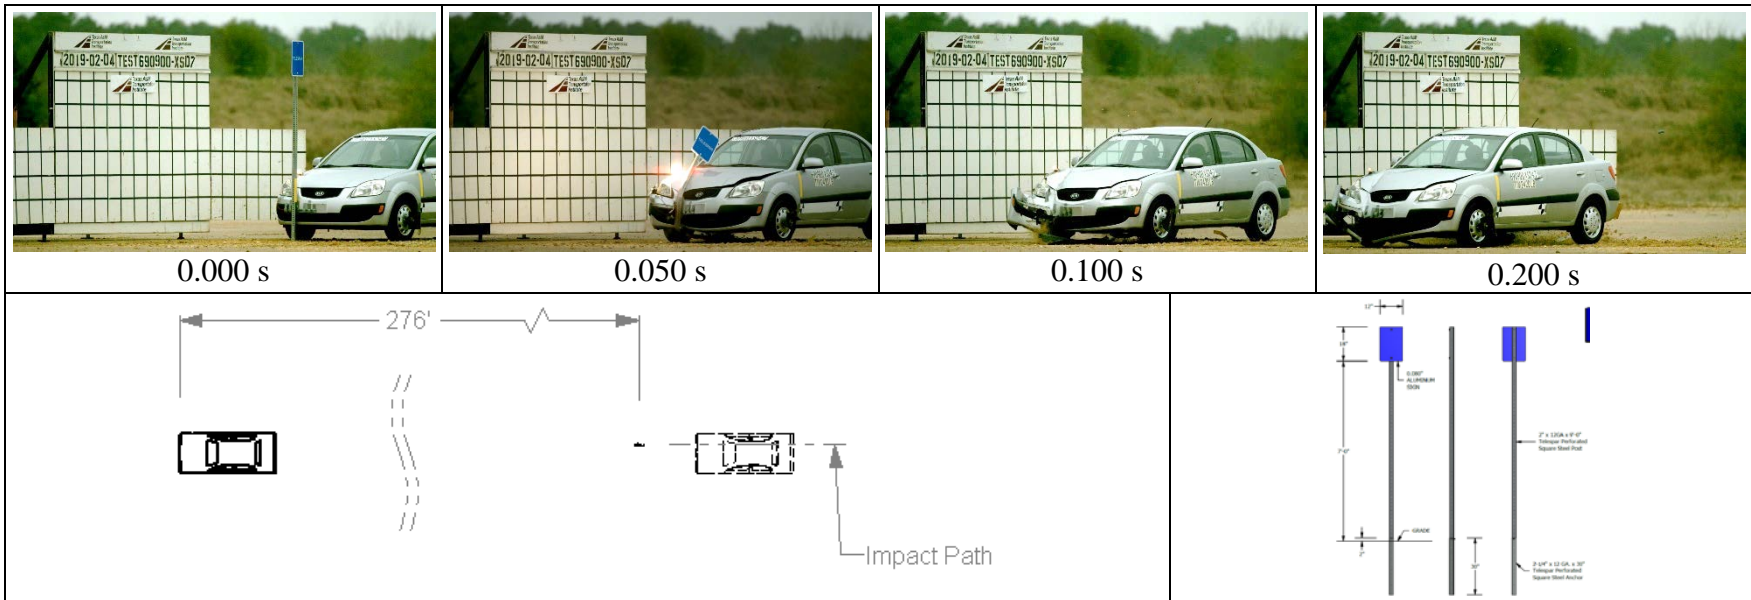
**Figure 8.6. Summary of Results for MASH Test 3-61 at 90° on Telespar Sign Support.**

Test Agency..... Texas A&M Transportation Institute (TTI)  
 Test Standard Test No. .... MASH Test 3-61  
 TTI Test No. .... 690900-XSD7  
 Test Date ..... 2019-02-04

Type ..... Support Structure (Sign Support)  
 Name..... Telespar Sign Support  
 Installation Height ..... 7 ft above grade  
 Material or Key Elements... 2-inch x 14 gauge square perforated steel support post inserted 8 inches into 2 1/4-inch x 12 gauge x 30 inches long square perforated steel anchor post protruding 2 inches above grade; 12x18x0.080 aluminum sign panel  
**Soil Type and Condition** .... Installed in AASHTO M147-65(2004), grading B Soil (crushed limestone), Damp

VDS ..... 12FR1  
 CDC..... 12FREN1  
 Max. Exterior Deformation..... 2.0 inches  
 OCDI..... FS0000000  
 Max. Occupant Compartment Deformation ..... None

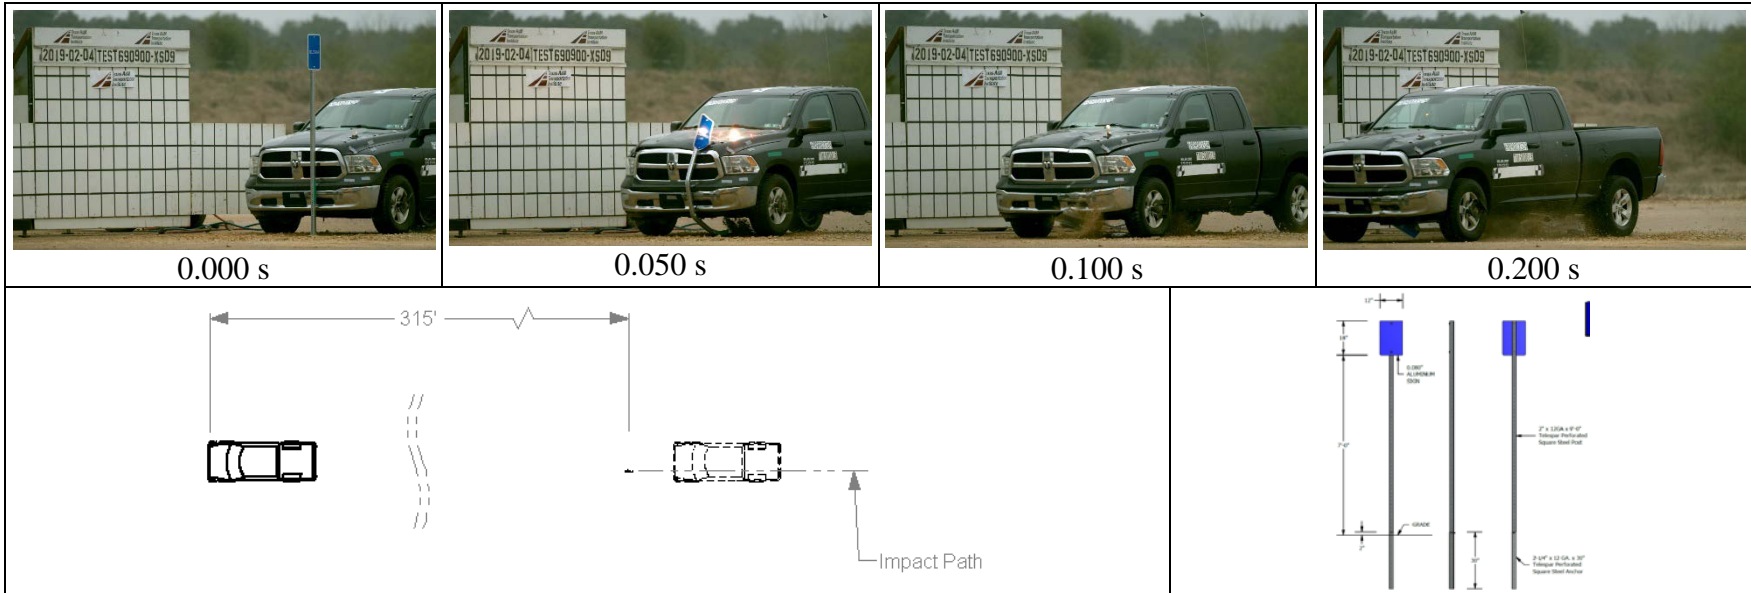
**Figure 10.6. Summary of Results for MASH Test 3-62 at 90° on Telespar Sign Support.**

Test Agency ..... Texas A&M Transportation Institute (TTI)  
 Test Standard Test No. .... MASH Test 3-62  
 TTI Test No. .... 690900-XSD9  
 Test Date ..... 2019-02-04

Type ..... Support Structure (Sign Support)  
 Name ..... Telespar Sign Support  
 Installation Height ..... 7 ft above grade  
 Material or Key Elements ... 2-inch x 14 gauge square perforated steel support post inserted 8 inches into 2 1/4-inch x 12 gauge x 30 inches long square perforated steel anchor post protruding 2 inches above grade; 12x18x0.080 aluminum sign panel  
 Soil Type and Condition .... Installed in AASHTO M147-65(2004), grading B Soil (crushed limestone), Damp

| Required Test Number | Narrative Description | Evaluation Results |
|---|--|---|
| 3-62 (2270P) | <p>MASH Test 3-62 was successfully performed on the Telespar sign support system at both 0 and 90 degrees. In both tests, the support yielded and was overridden by the vehicle. The vehicle remained stable and upright. In the 0-degree test (690900-XSD 8), the support post was partially fractured at several locations, but the components of the sign support system remained intact. The vehicle sustained minor damage, including a 1.5-inch deep indentation in the hood. Occupant risk indices were within MASH thresholds. No occupant compartment deformation or intrusion was observed.</p> <p>In the 90-degree test (690900-XSD 9), the support post fractured and separated into two pieces. The lower 4.5 ft of the support remained with the anchor post. The sign detached from the upper section of the post. The vehicle sustained minor damage, including a 2-inch deep indentation in the hood. Occupant risk indices were within MASH thresholds. No occupant compartment deformation or intrusion was observed.</p> | PASS |

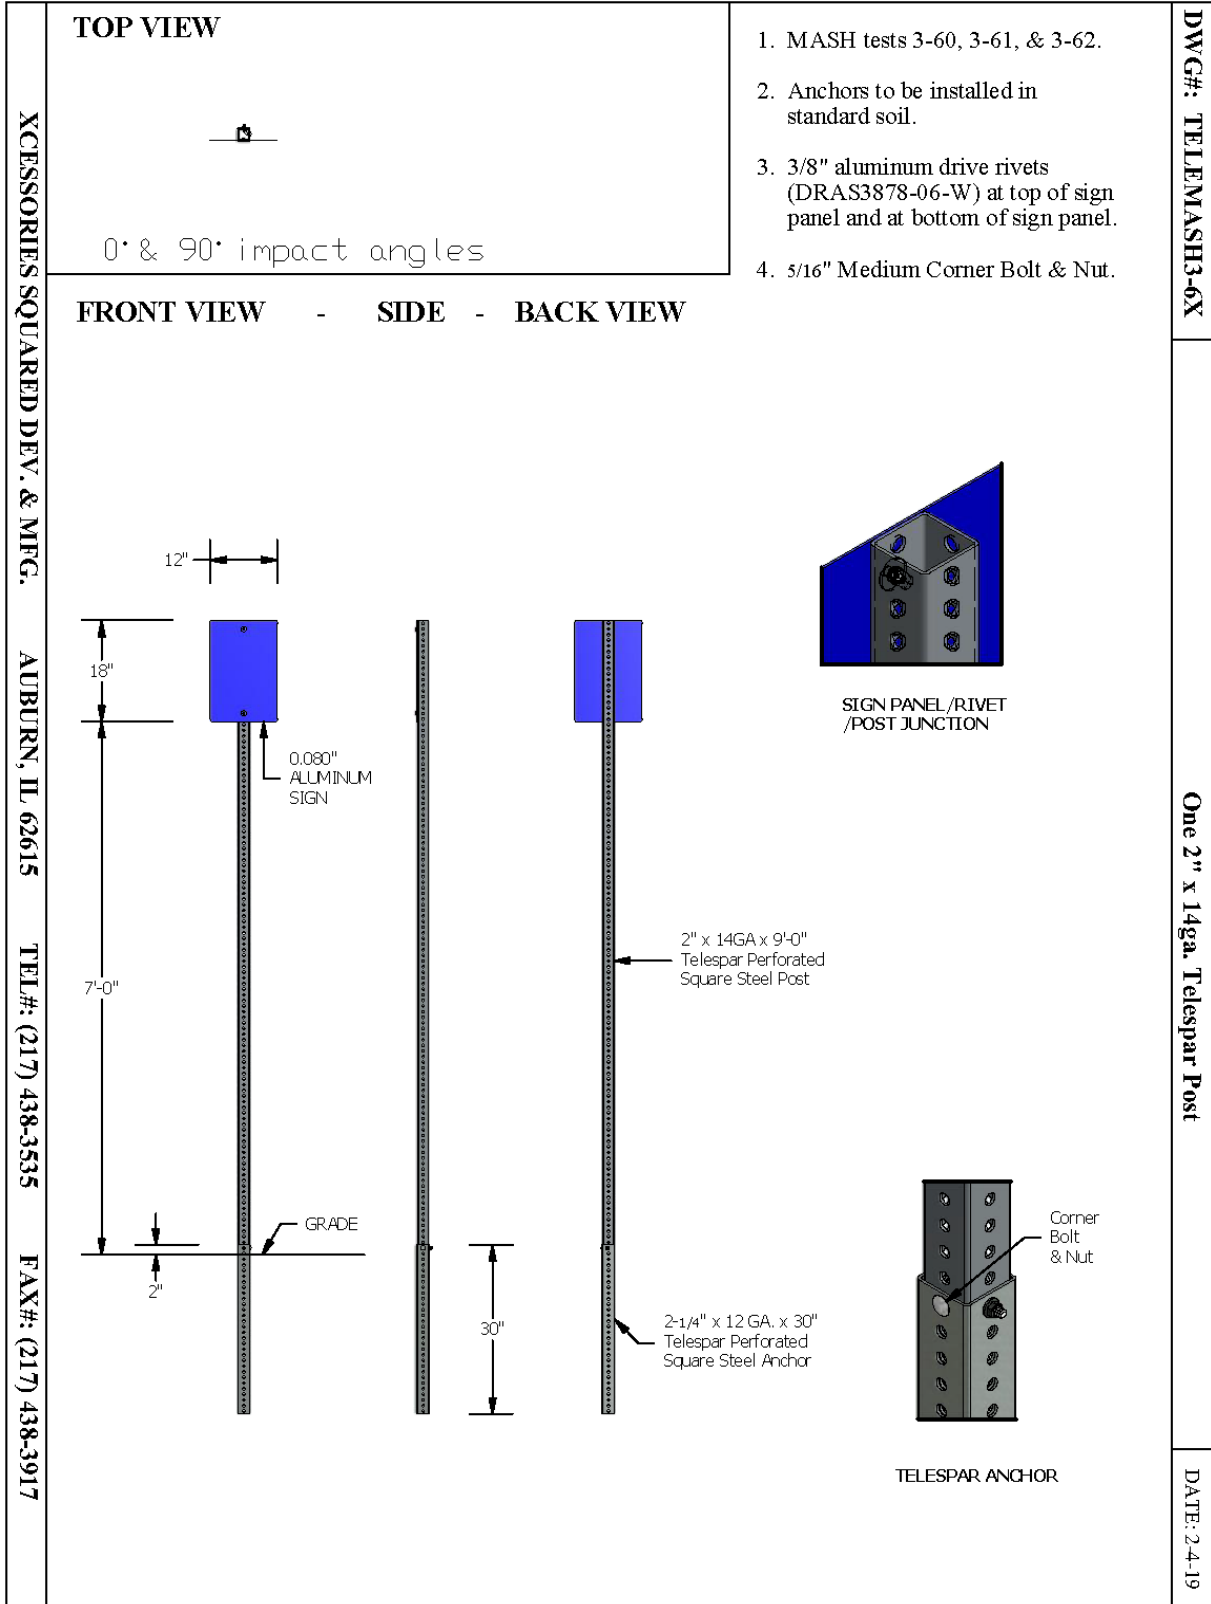
DWG#: TELEMASH3-6X

# APPENDIX A. DETAILS OF TELES PAR SIGN SUPPORT

One 2" x 14ga. Telespar Post
