Memorandum

Subject: <u>INFORMATION</u>: Acceptance of Oregon 3-Tube Bridge Rail

In your April 18 memorandum to Mr. Richard Powers of my staff, you requested formal acceptance of the Oregon Department of Transportation 3-Tube Bridge Rail for use on the National Highway System (NHS). This design was tested by the Texas Transportation Institute to the National Cooperative Highway Research Program (NCHRP) Report 350 test level 4 (TL-4) and documented in three separate reports, all dated May 2000, entitled "NCHRP Report 350 Test 4-10 of the Oregon 3-Tube Bridge Rail", "NCHRP Report 350 Test 4-11 of the Oregon 3-Tube Bridge Rail", respectively.

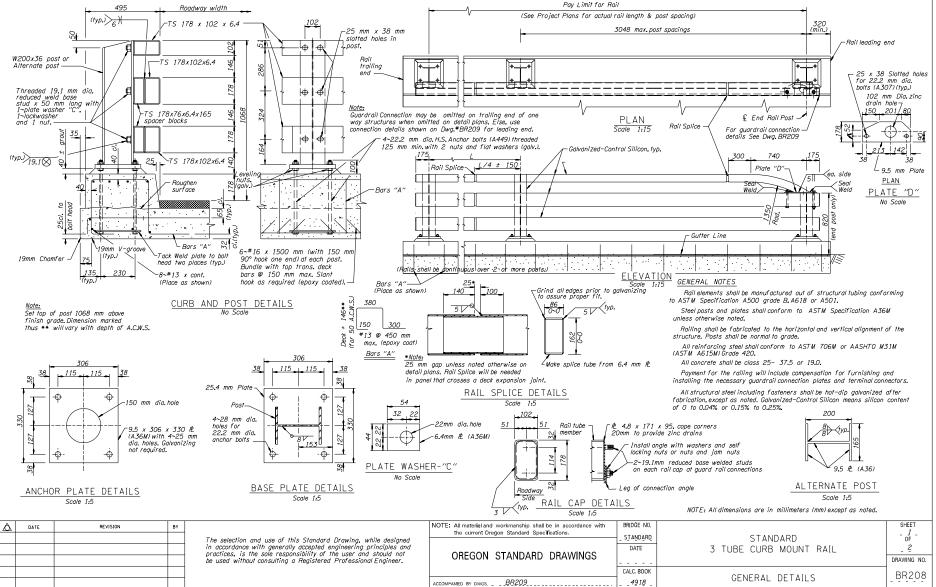
Attachment

The Oregon 3-Tube Bridge Rail consists of three TS $178 \times 102 \times 6.4$ tubes supported by W200 x 36 steel posts on 3-meter centers. The top rail is 1068 mm above the deck surface, the middle rail is 820 mm above the deck and the lower rail is 496-mm high. The lower two rails are blocked out from the support posts with TS $178 \times 76 \times 6.4$ steel tubes, each 165-mm long. The top tube is installed with the narrow side against the post so the traffic sides of the rail elements lie in the same plane. The posts are mounted on a 178-mm high curb with four 22.2-mm diameter A325 steel bolts. These and additional details are shown in the attachment to this memorandum.
