Single Slope Concrete Median Barrier

**DEVELOPMENT OF A SINGLE SLOPE  
CONCRETE MEDIAN BARRIER**

**REPORT NO. 9429C-1**

**TEXAS TRANSPORTATION INSTITUTE  
THE TEXAS A&M UNIVERSITY SYSTEM  
COLLEGE STATION, TEXAS**

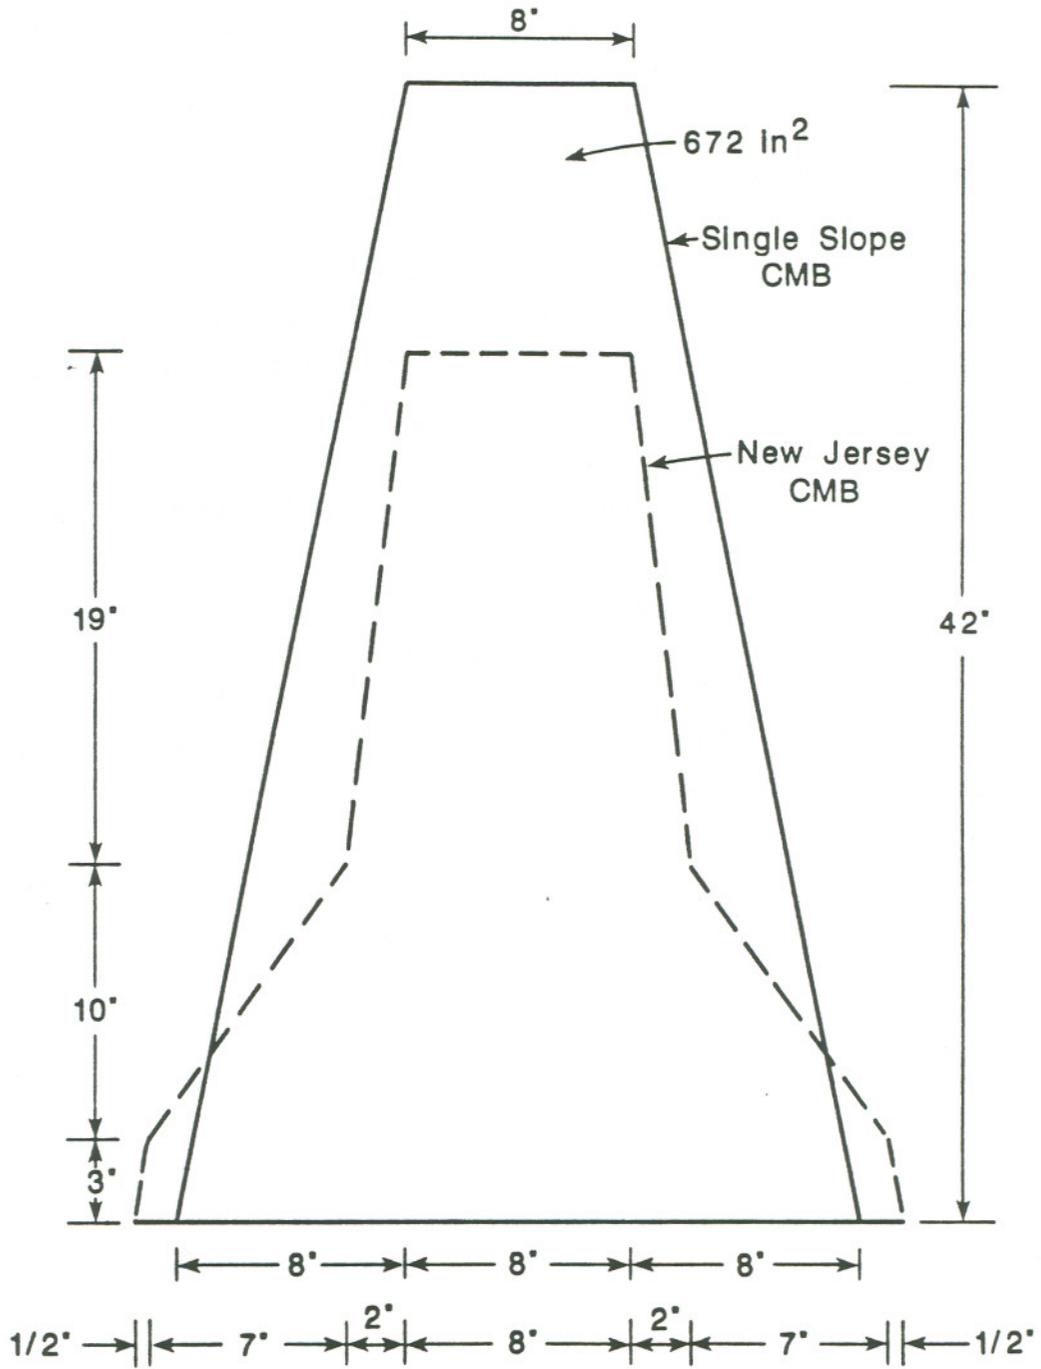
Figure 4. Comparison of Single Slope and New Jersey CMB's.

The remainder of this report is divided into three major sections. The next section presents a description of the newly developed single slope CMB. This is followed by a section on the full scale testing of the single slope CMB. The final section presents conclusions and recommendations for the use of the single slope CMB.

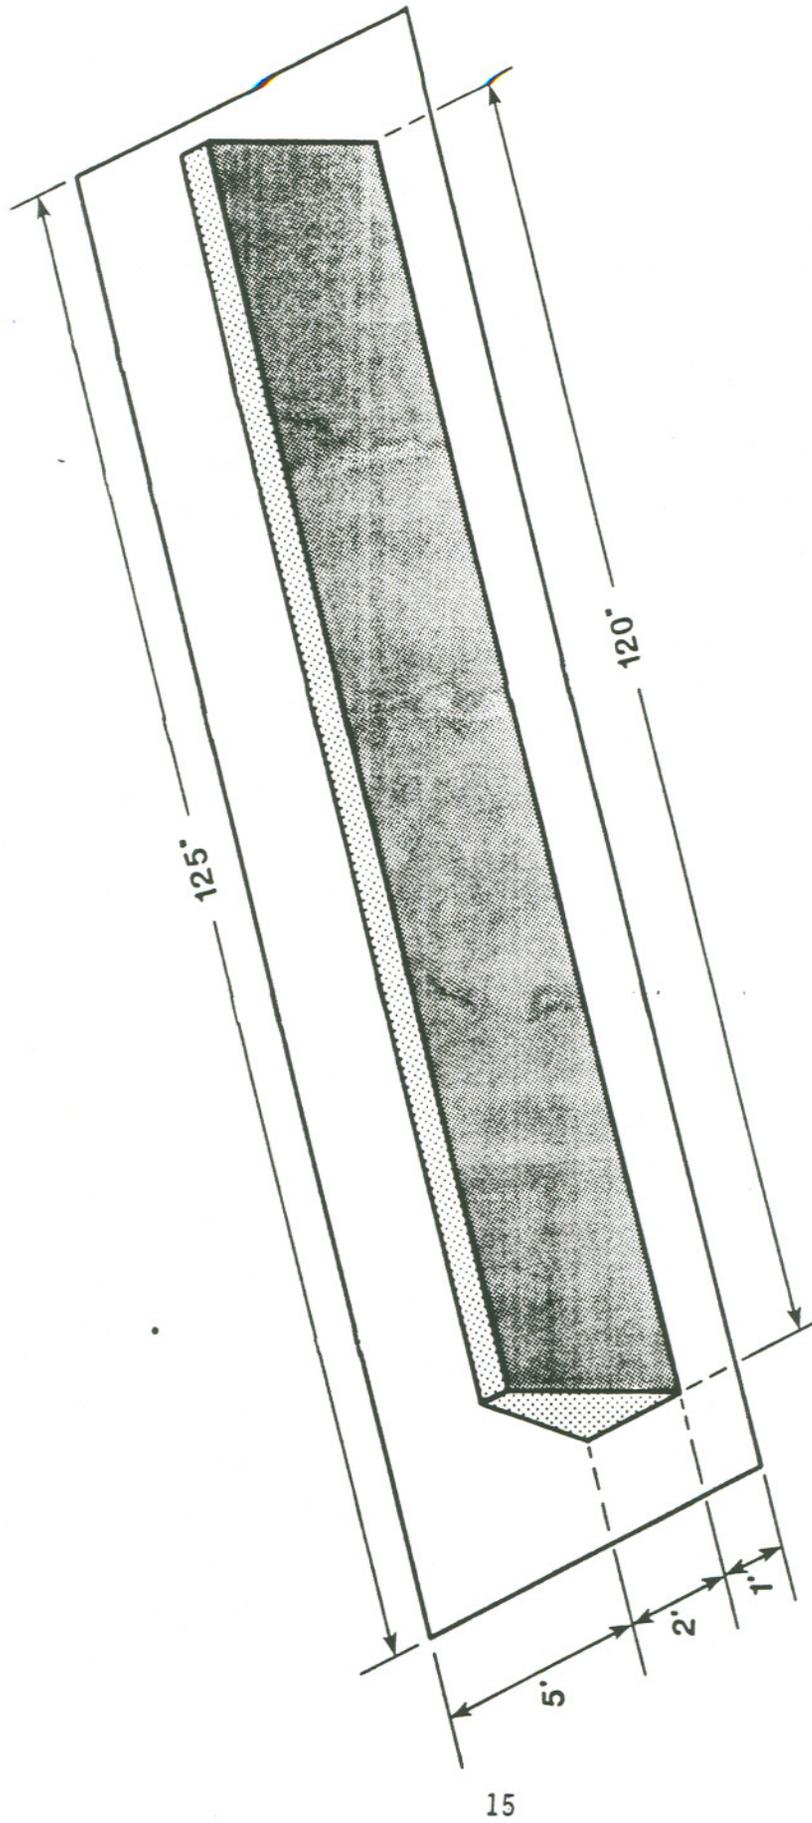
Figure 7. Permanent Single Slope CMB Installation.

(.3 m) wide addition of asphalt on the impact side of the barrier and a 5 ft (1.5 m) wide addition of asphalt on the opposite side of the barrier as shown in Figure 7. Finally, the barrier slots, the gap between the barrier segment ends, and the angle splice insets on the ends of the barrier were all grouted with a mixture of one part sand and two parts cement. The grout was applied so that the 120 ft (36.4 m) barrier had the appearance of a continuous barrier. The use of the angle splice connection in the permanent configuration is optional and it was not used in the permanent installation described in this report.

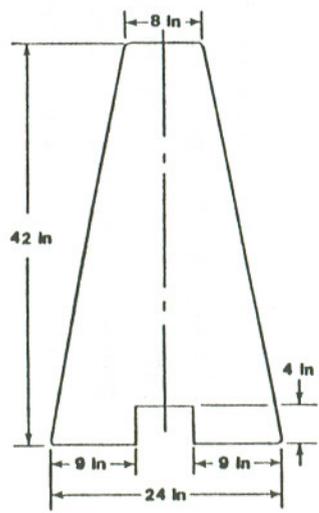
Test No. . . . .	9429C-1	Impact Speed. . .	60.3 mi/h (97.0 km/h)
Date . . . . .	11/22/88	Impact Angle. . .	15.2 deg
Test Installation . .	Single Slope Concrete Barrier	Exit Speed. . . .	51.3 (82.5 km/h)
Installation Length. .	120 ft (36.6 m)	Exit Trajectory .	0.5 deg
Vehicle . . . . .	1980 Cadillac Sedan DeVille	Vehicle Accelerations (Max. 0.050-sec Avg)	
Vehicle Weight		Longitudinal. . .	-3.3 g
Test Inertia . . . . .	4,500 lb (2,043 kg)	Lateral . . . . .	-6.8 g
Vehicle Damage Classification		Occupant Impact Velocity	
TAD . . . . .	11LFQ4	Longitudinal. . .	14.4 ft/s (4.4 m/s)
CDC . . . . .	11FLEK2 & 11LFEW3	Lateral . . . . .	17.6 ft/s (5.4 m/s)
Maximum Vehicle Crush.	12.0 in (30.5 cm)	Occupant Ridedown Accelerations	
Max. Barrier Movement.	7.0 in (17.8 cm)	Longitudinal. . .	-2.5 g
		Lateral . . . . .	-7.7 g

Figure 16. Summary of results for test 9429C-1.

vehicles but were computed and reported for information only. The occupant impact velocity was 14.4 ft/s (4.4 m/s) in the longitudinal direction and 17.6 ft/s (5.4 m/s) in the lateral direction. The highest 0.010 second occupant ridedown accelerations were -2.5 g (longitudinal) and -7.7 g (lateral). These data and other pertinent information from the test are summarized in Figure 16.

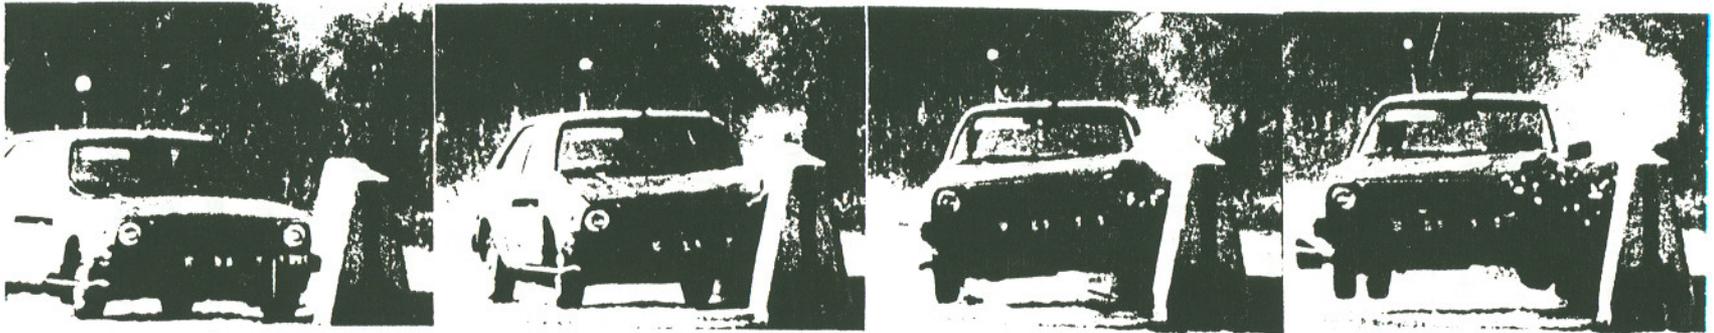
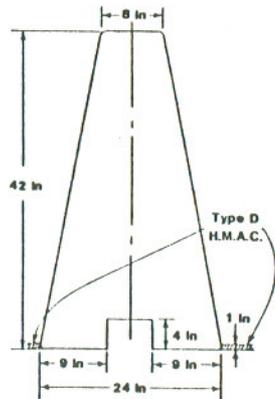
Test No. . . . . 9429C-2  
 Date . . . . . 12/05/88  
 Test Installation . . Single Slope  
                           Concrete Barrier  
 Installation Length. . 120 ft (36.6 m)  
 Vehicle . . . . . 1980 Honda  
                           Civic  
 Vehicle Weight  
 Test Inertia . . . . . 1,800 lb (817 kg)  
 Vehicle Damage Classification  
 TAD . . . . . 11LFQ5  
 CDC . . . . . 11LFEW3  
 Maximum Vehicle Crush. 7.0 in (17.8 cm)

Impact Speed. . . 60.7 mi/h (97.7 km/h)  
 Impact Angle. . . 19.9 deg  
 Exit Speed. . . . 52.1 (83.8 km/h)  
 Exit Trajectory . 4.3 deg  
 Vehicle Accelerations  
 (Max. 0.050-sec Avg)  
 Longitudinal. . . -6.5 g  
 Lateral . . . . . -15.3 g  
 Occupant Impact Velocity  
 Longitudinal. . . 15.7 ft/s (4.8 m/s)  
 Lateral . . . . . 27.7 ft/s (8.4 m/s)  
 Occupant Ridedown Accelerations  
 Longitudinal. . . -2.3 g  
 Lateral . . . . . -9.2 g

Figure 23. Summary of results for test 9429C-2.

conducted with 1,800 lb (817 kg) vehicles impacting longitudinal barriers with a speeds of 60 mph (96 km/h) and angles of 15 degrees (1). These limits do not apply to this particular test because the impact angle was 20 degrees. However, these limits were computed and reported for information purposes only. The occupant impact velocity was 15.7 ft/s (4.8 m/s) in the longitudinal direction and 27.7 ft/s (8.4 m/s) in the lateral direction. The highest 0.010 second occupant ridedown accelerations were -2.3 g (longitudinal) and -9.2 g (lateral). These data and other pertinent information from the test are summarized in Figure 23.

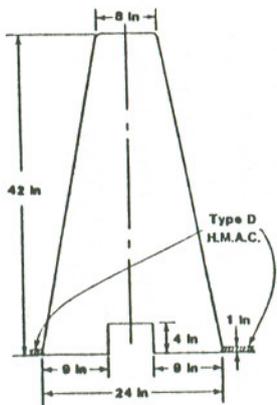
Test No. . . . .	9429C-3	Impact Speed. . .	63.1 mi/h (101.5 km/h)
Date . . . . .	12/12/88	Impact Angle. . .	26.5 deg
Test Installation . .	Single Slope Concrete Barrier	Exit Speed. . . .	51.8 (83.3 km/h)
Installation Length. .	120 ft (36.6 m)	Exit Trajectory . .	8.5 deg
Vehicle . . . . .	1979 Cadillac Sedan deVille	Vehicle Accelerations (Max. 0.050-sec Avg)	
Vehicle Weight		Longitudinal. . .	-6.4 g
Test Inertia . . . . .	4,500 lb (2,043 kg)	Lateral . . . . .	-13.1 g
Vehicle Damage Classification		Occupant Impact Velocity	
TAD . . . . .	11LFQ5	Longitudinal. . .	22.1 ft/s (6.7 m/s)
CDC . . . . .	11LFAW3	Lateral . . . . .	28.9 ft/s (8.8 m/s)
Maximum Vehicle Crush. 12.0 in (30.5 cm)		Occupant Ridedown Accelerations	
		Longitudinal. . .	-4.2 g
		Lateral . . . . .	-10.7 g

Figure 30. Summary of results for test 9429C-3.

As stated previously, the impact speed was 63.1 mi/h (101.5 km/h) and the angle of impact was 26.5 degrees. The vehicle lost contact with the barrier travelling at 51.8 mi/h (83.3 km/h) and 8.5 degrees. NCHRP 230 describes occupant risk criteria and places limits on these for acceptable performance for tests involving 1,800 lb (817 kg) impacting at 15 degrees with a velocity of 60 mph (96 km/h) (1). These limits do not apply to tests conducted at 25 degree impact angles but were computed and reported for information only. Occupant impact velocity was 22.1 ft/s (6.7 m/s) in the longitudinal direction and 28.9 ft/s (8.8 m/s) in the lateral direction. The highest 0.010 second occupant ridedown accelerations were -4.2 g (longitudinal) and -10.7 g (lateral). These data and other pertinent information from the test are summarized in Figure 30.
